Interim Reclamation and Stormwater Inspection

Operator: RED HAWK PETROLEUM LLC - 10503

Location ID: 428225

Inspection Photos
Location Name: Leggett 1-5H
Location ID: 428225

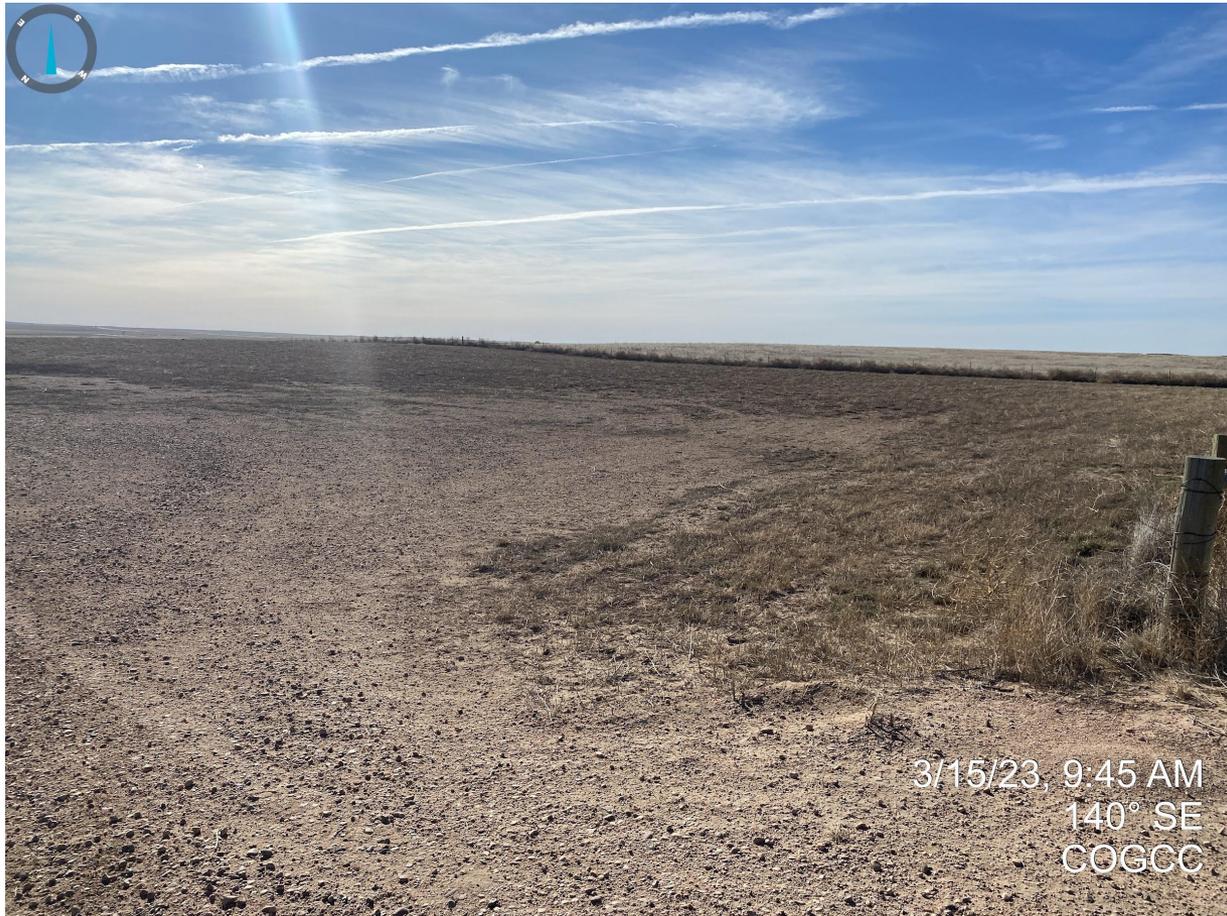
Photo 1. Facing southeast from the entrance to the location. Photo illustrates that it appears that interim reclamation activities have been performed, however, portions of the interim areas have failed to revegetate resulting in bare soil, or undesirable vegetation (e.g. kochia and russian thistle) was observed at the time of this inspection.

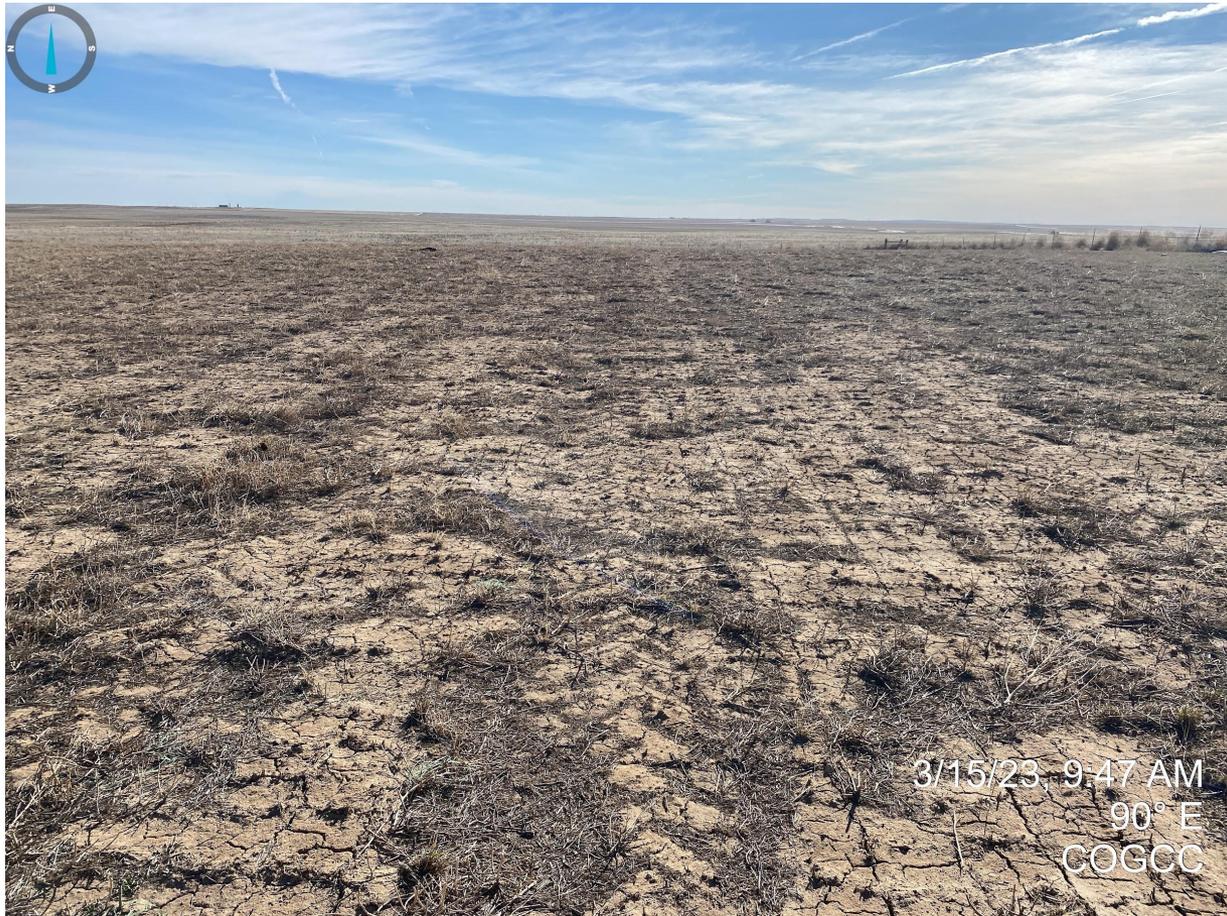
Photo 2. Facing east from the southern interim area; see comments in Photo 1.

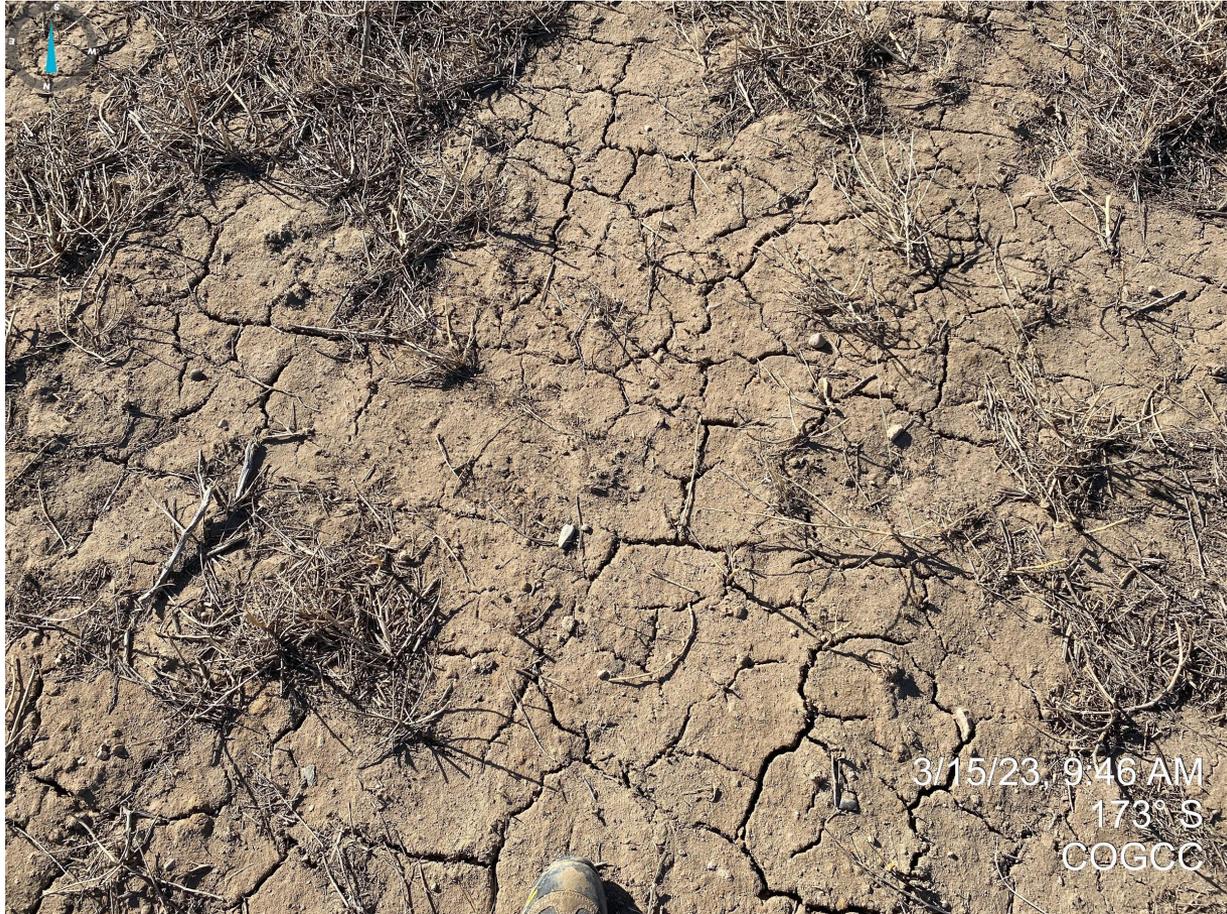
Photo 3. Closeup of interim area; see comments in Photo 1.

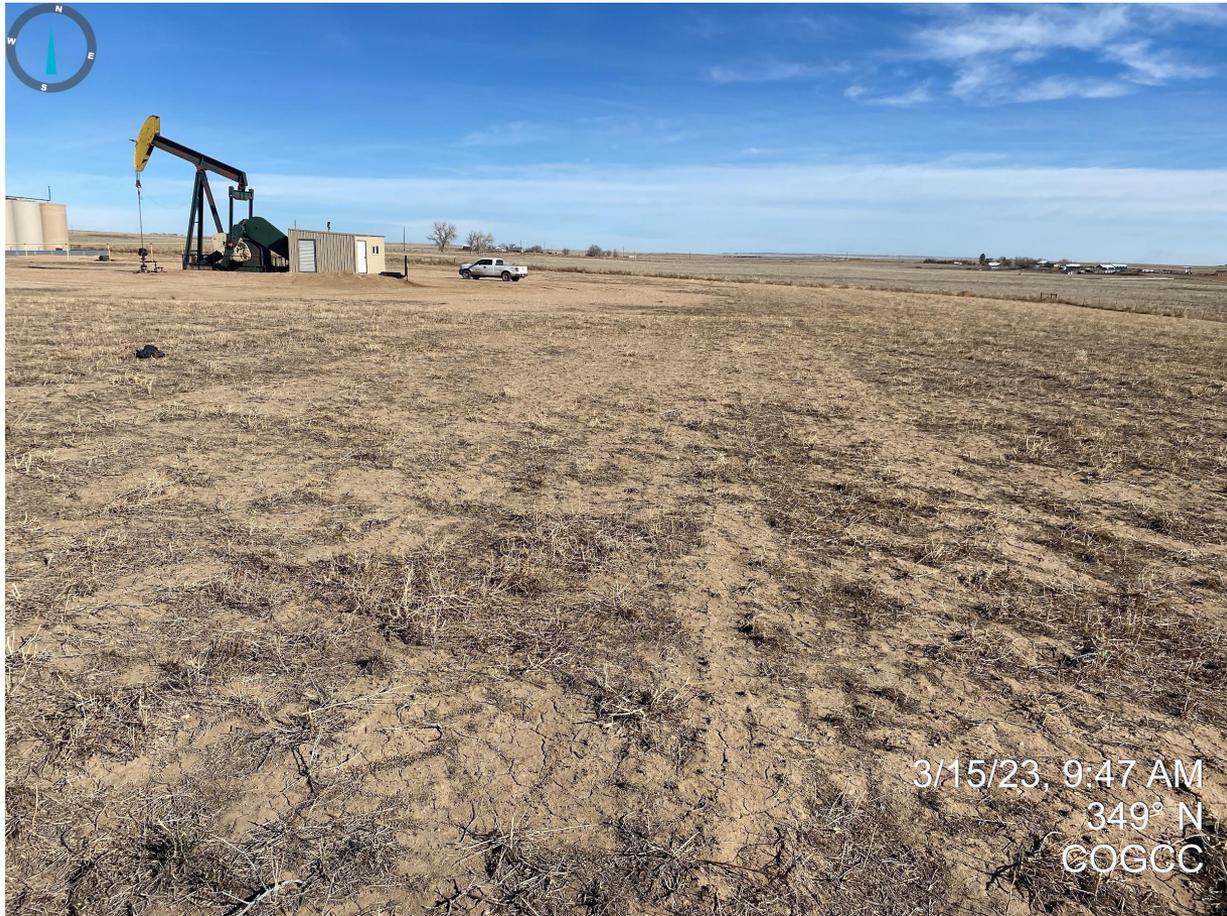
Photo 4. Facing north from the eastern portion of interim area; see comments in Photo 1.

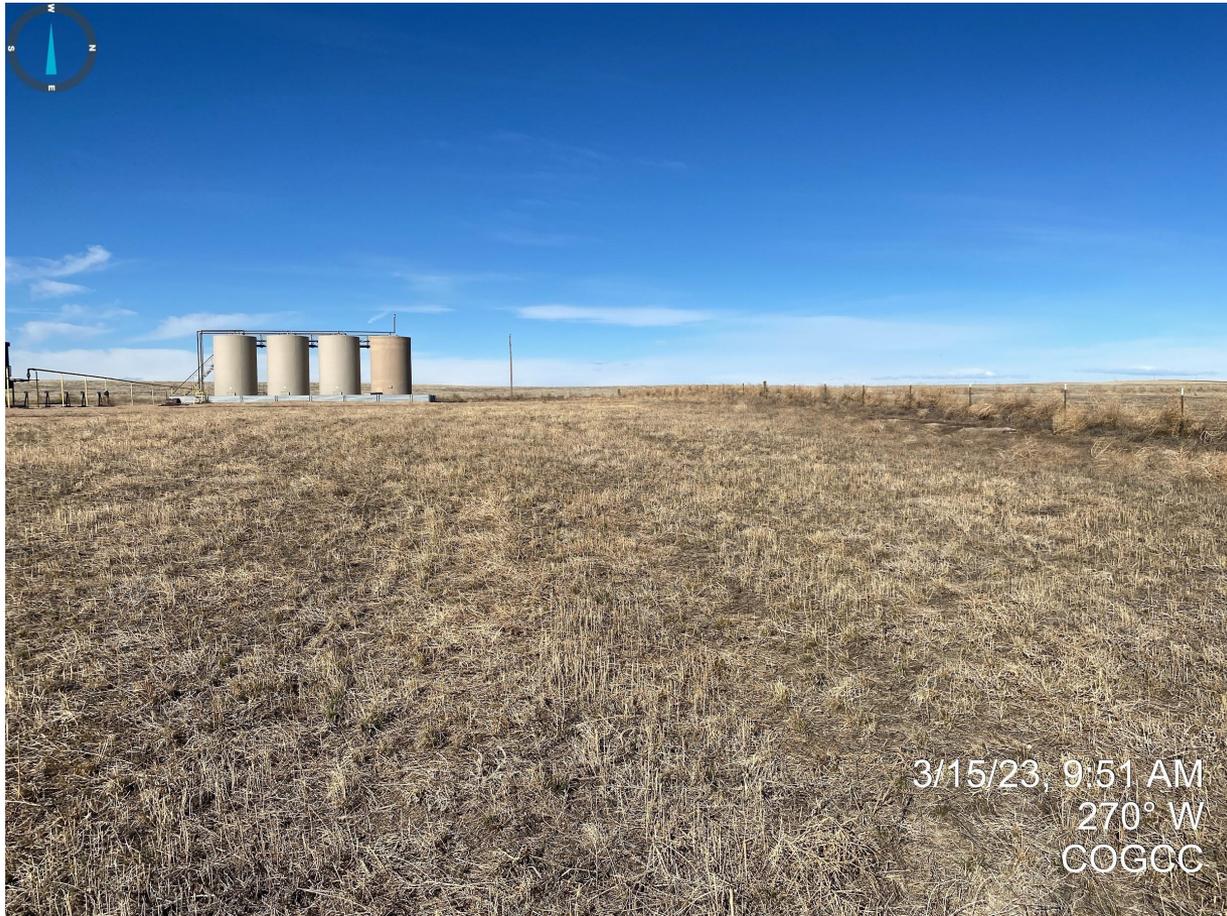
Photo 5. Facing west from the northern portion of the interim areas; predominantly undesirable species with some desirable species mixed throughout.

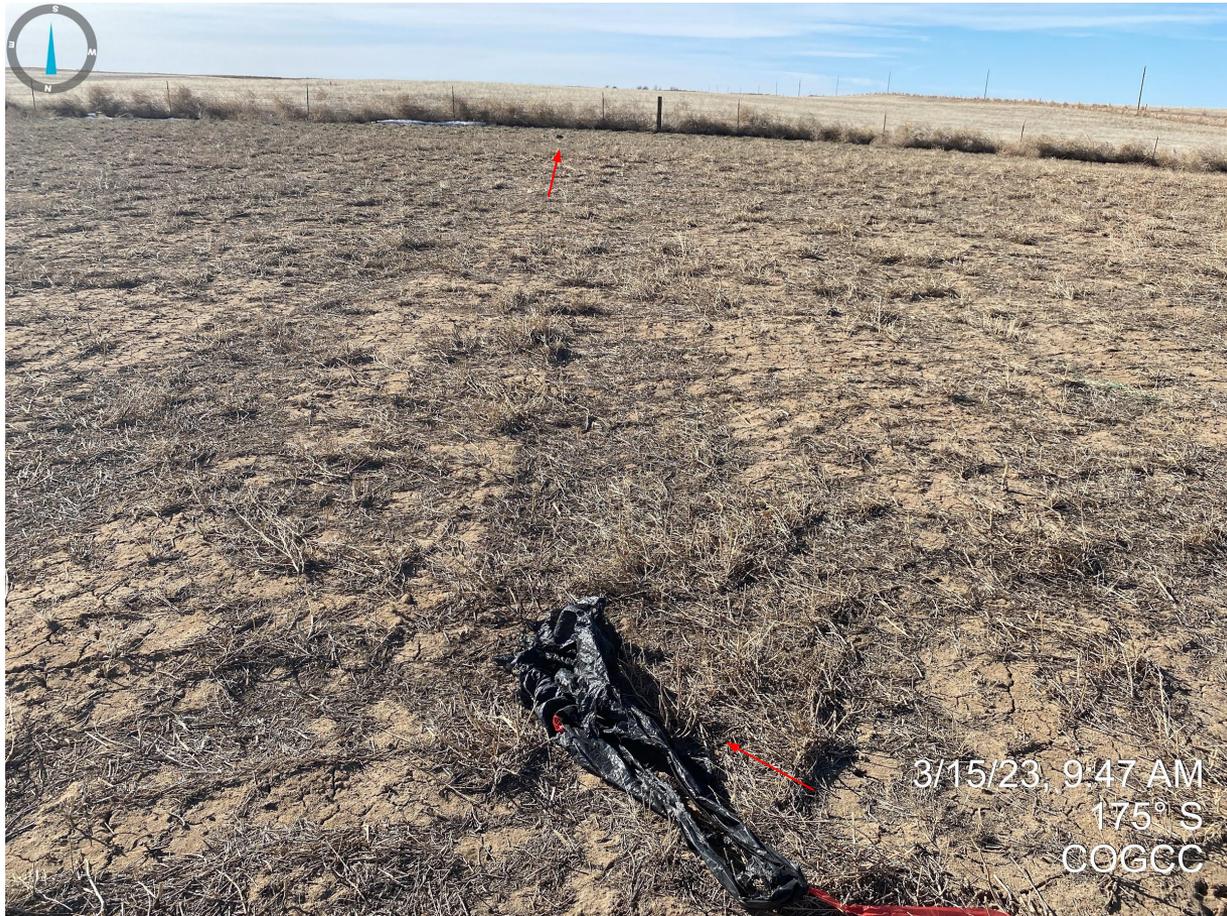
Photo 6. Facing south from southeastern portion of interim area. Trash will need to be properly disposed of.

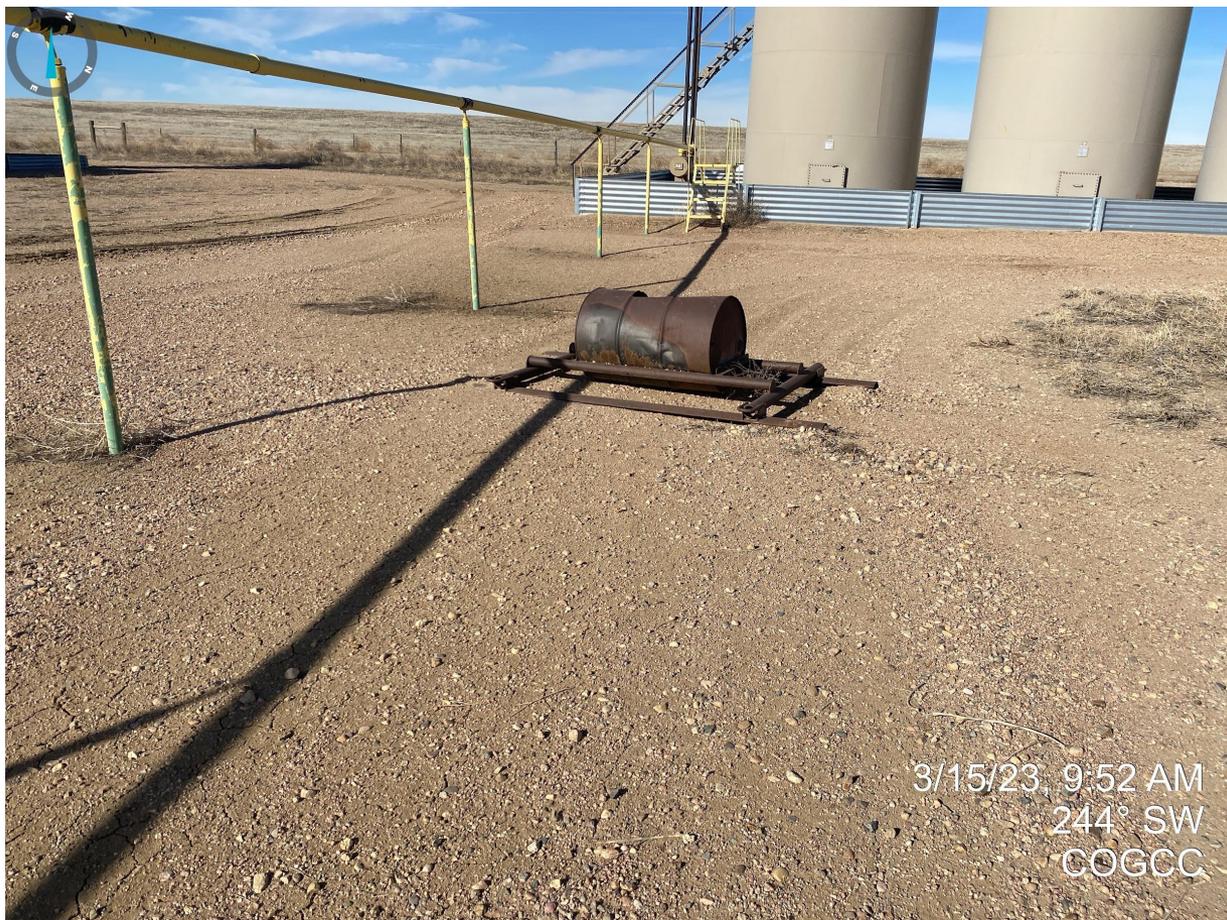
Photo 7. Facing southwest near battery. Road drag/maintainer observed being stored on location. This will need to be removed as equipment cannot be stored on location.
