# Storm Water Management and Erosion control

## Location Name: TEP ROCKY MOUNTAIN LLC CLOUGH-66S95W /33SESW

### Location #: 334877

**Location Overview: Location is approximately 392 yards from the Colorado River. The location is in a high priority habitat area.**  
**Section/Township/Range: 33 6S95W**

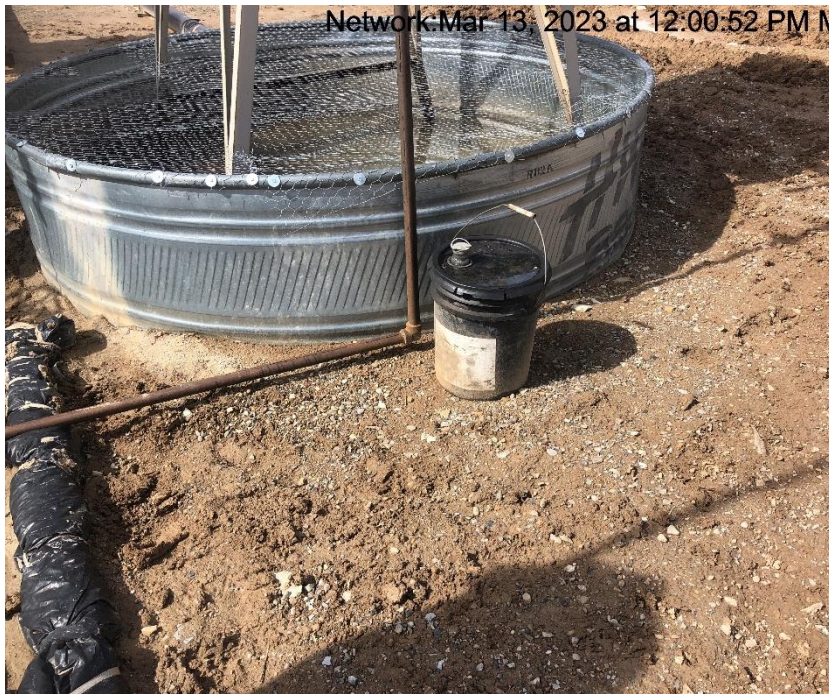
**Photo #9210 Spill prevention and control BMPs not being implemented**

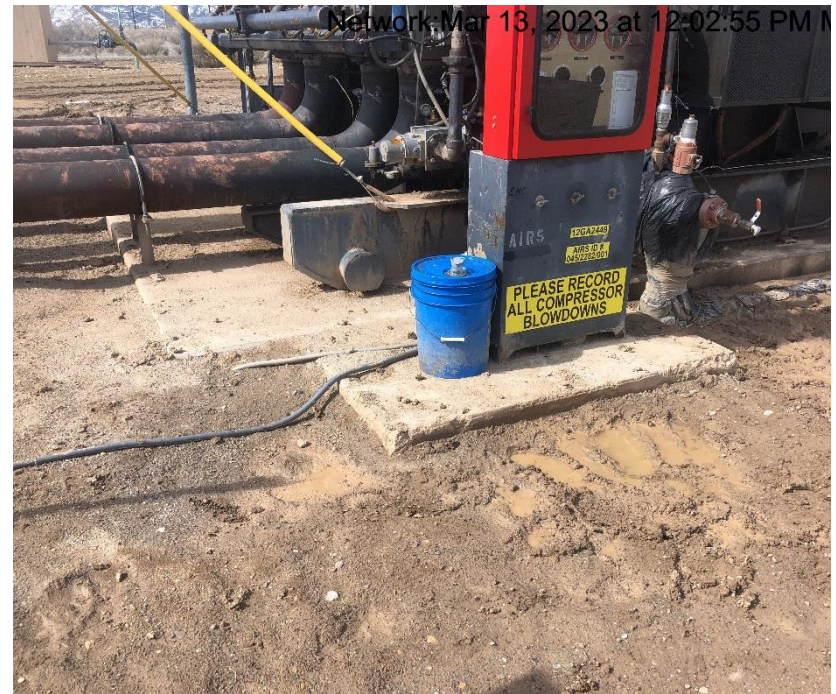
**Photo #9216 Spill prevention and control BMPs not being implemented**

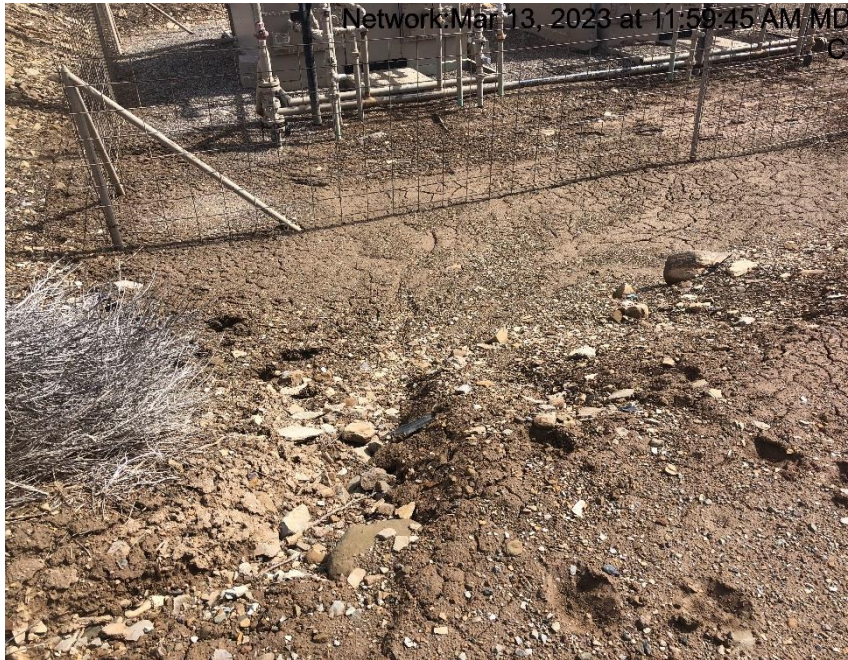
**Photo #9206 Run on to location is not being controlled.**

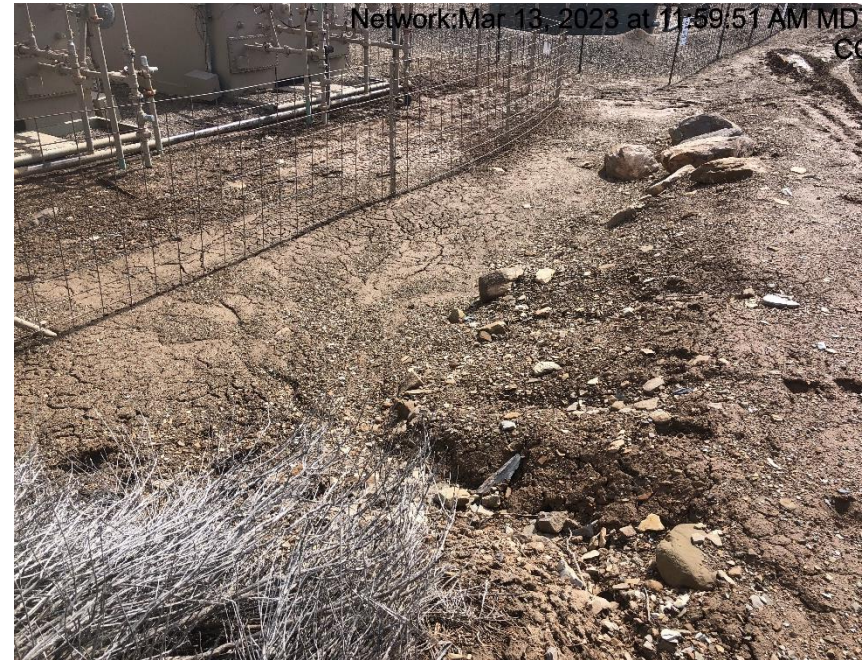
**Photo #9207 Run on to location is not being controlled.**

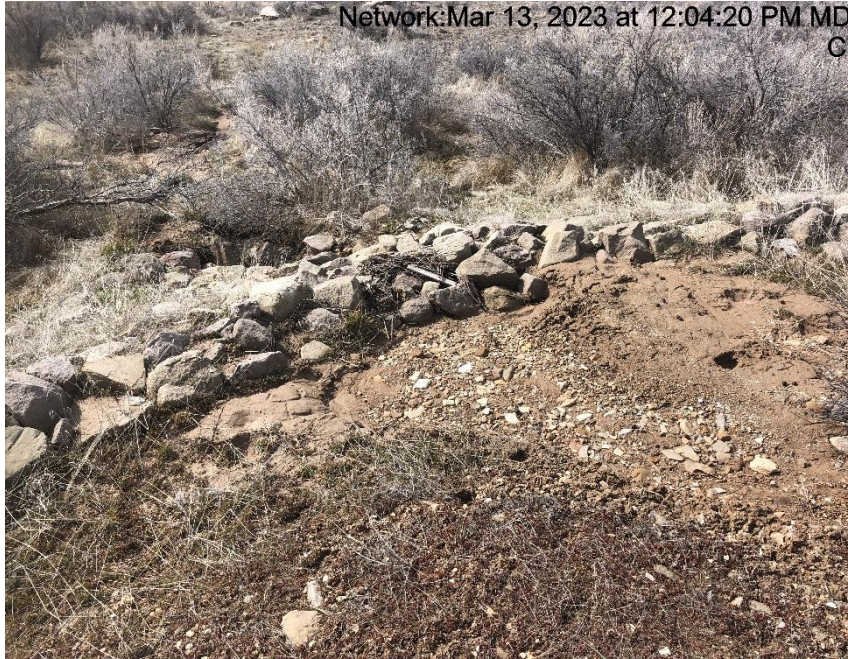
**Photo #9221 Sediment trap insufficient. Sediment is being transport off location.**

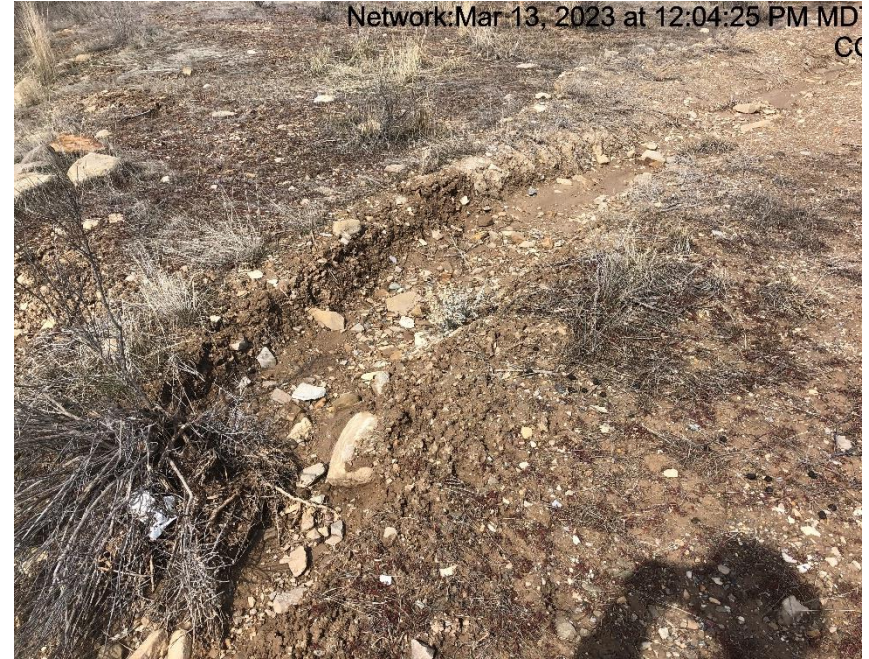
**Photo #9222 Sediment trap insufficient. Sediment is being transport off location.**

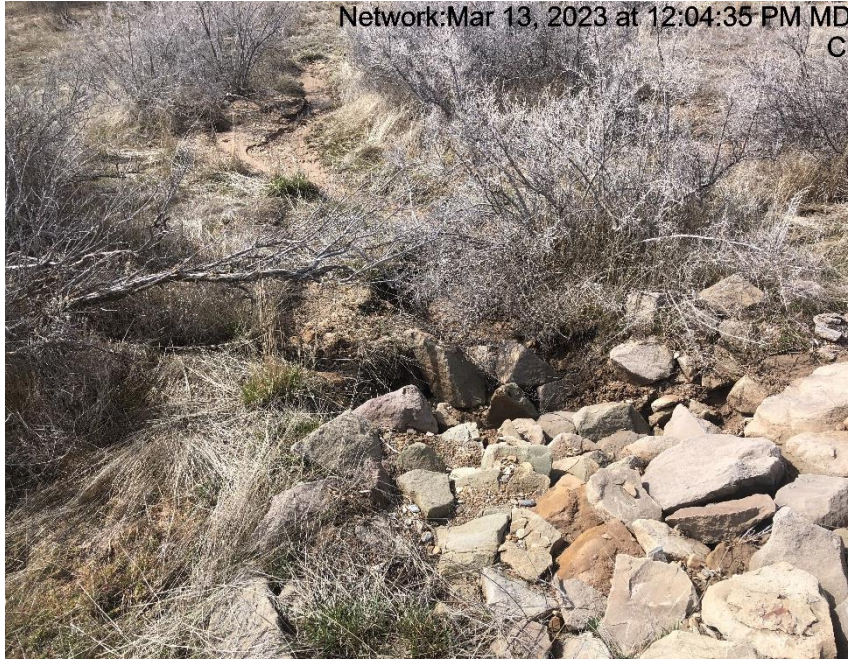
**Photo #9223 Sediment trap insufficient. Sediment is being transport off location.**

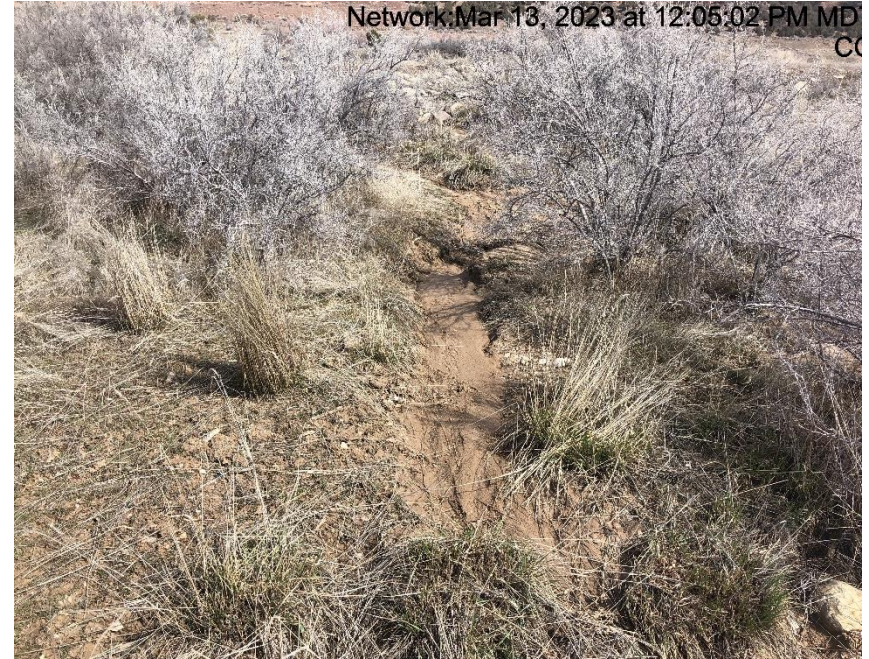
**Photo #9224 Sediment trap insufficient. Sediment is being transport off location.**

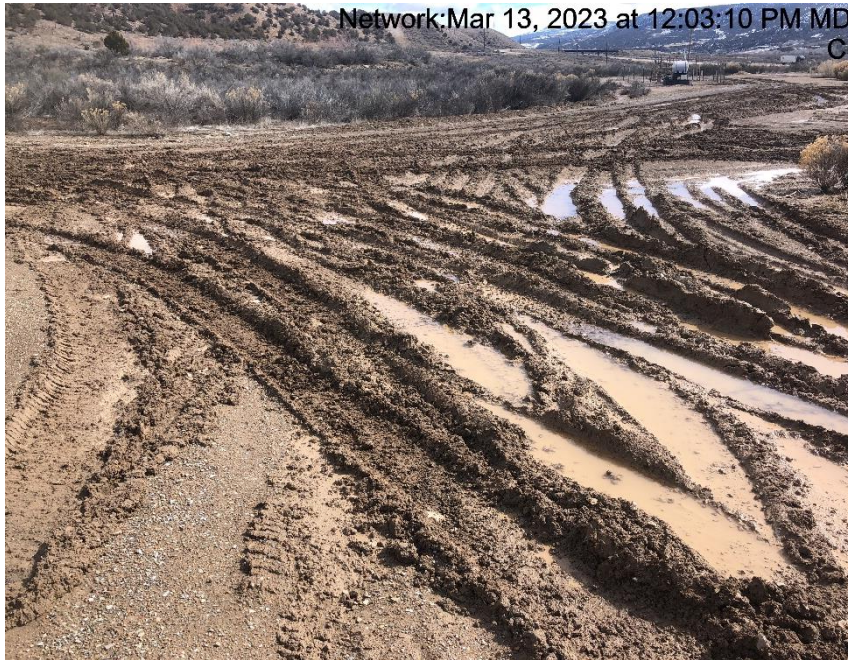
**Photo #9217 Location lacks stabilization.**

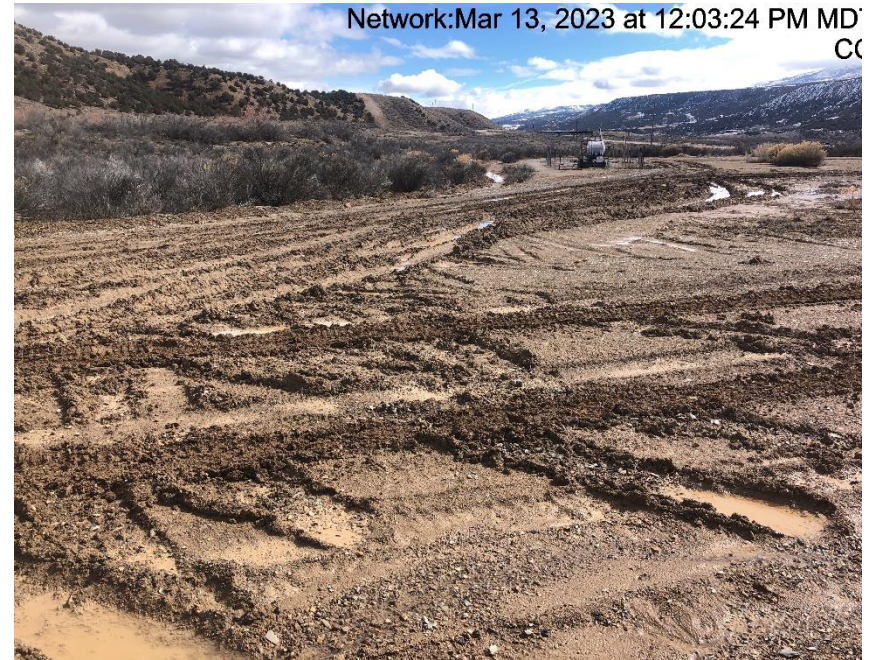
**Photo #9218 Location lacks stabilization.**

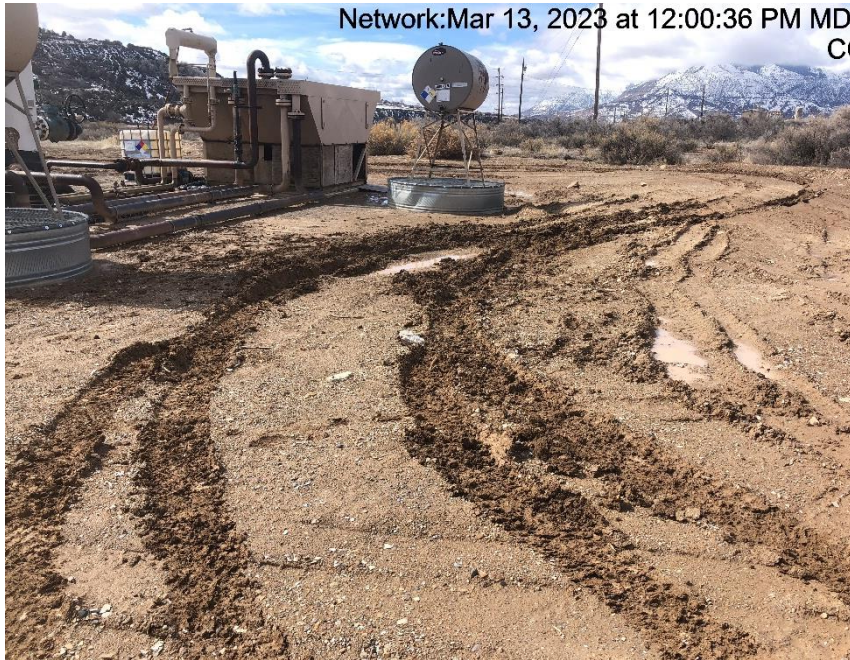
**Photo #9209 Location lacks stabilization**

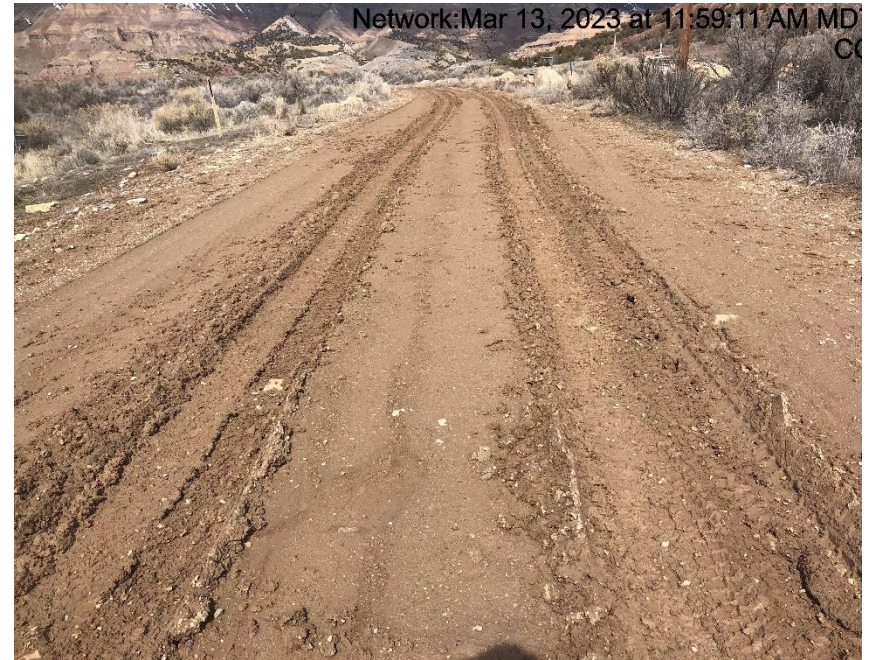
**Photo #9204 Insufficient tracking BMP at entrance to location to minimize the transport of sediment.**

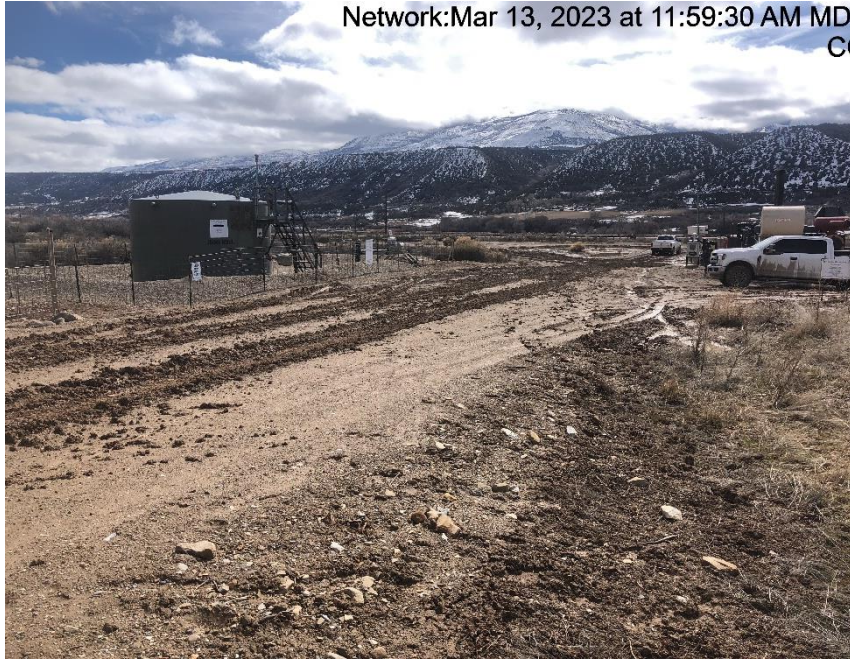
**Photo #9205 Insufficient tracking BMP at entrance  
to location to minimize the transport of sediment.**

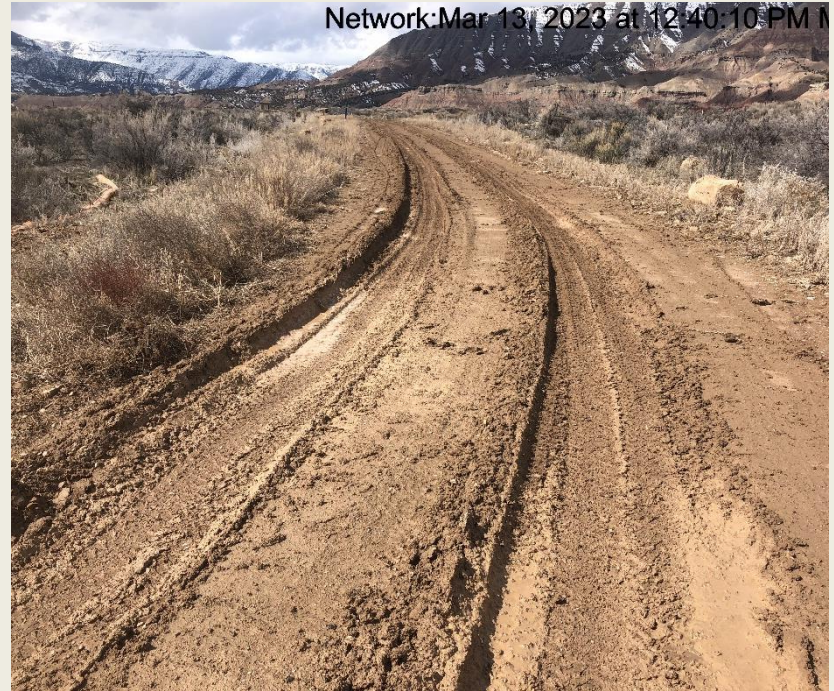
Photo #9228 Access road lack stabilization.

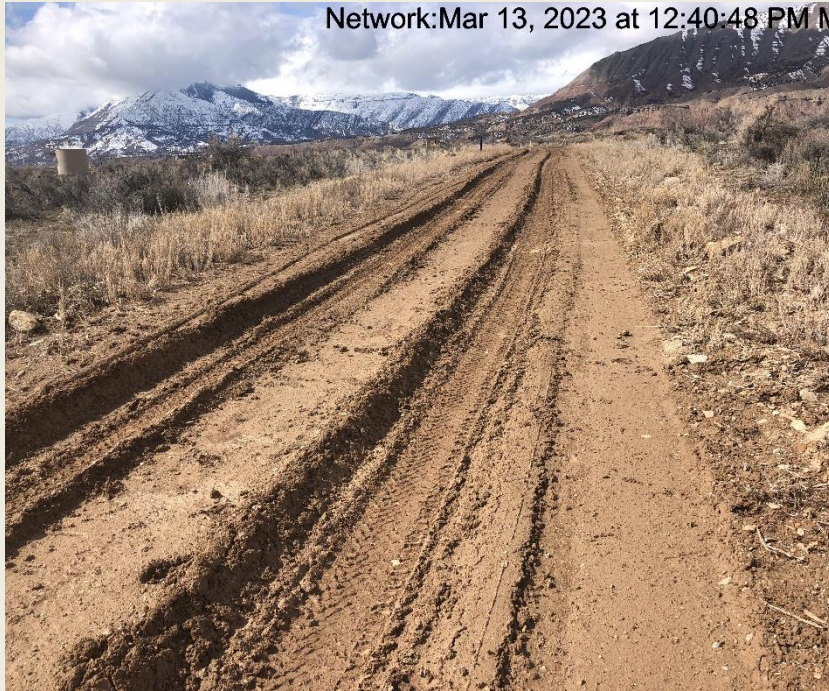
Photo #9229 Access road lacks stabilization.

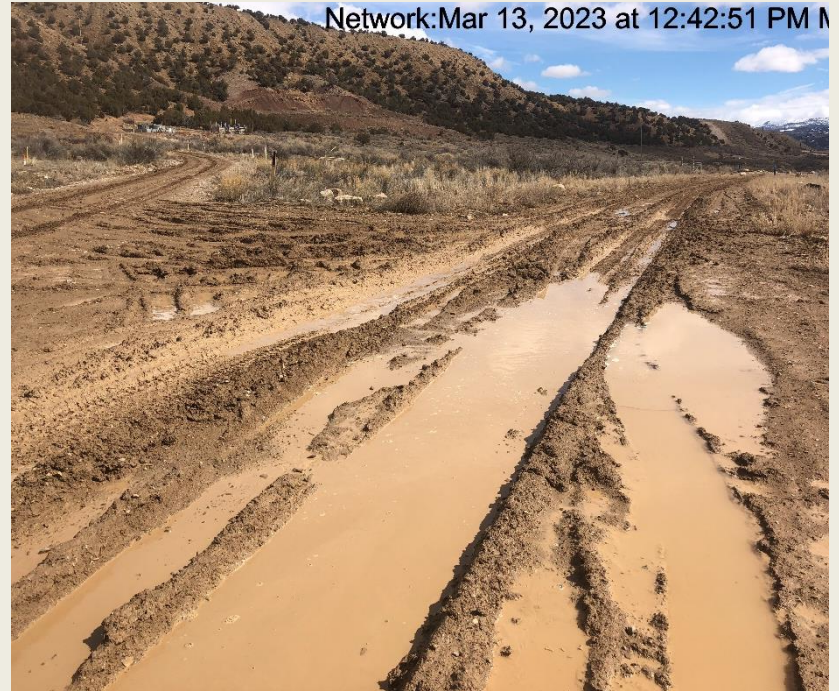
Photo #9230 Insufficient tracking BMP at entrance to access road.
