## Inspection Photos

Location Name: TEP ROCKY MOUNTAIN LLC UNOCAL GR 31-2 Pad

Location ID: 323884

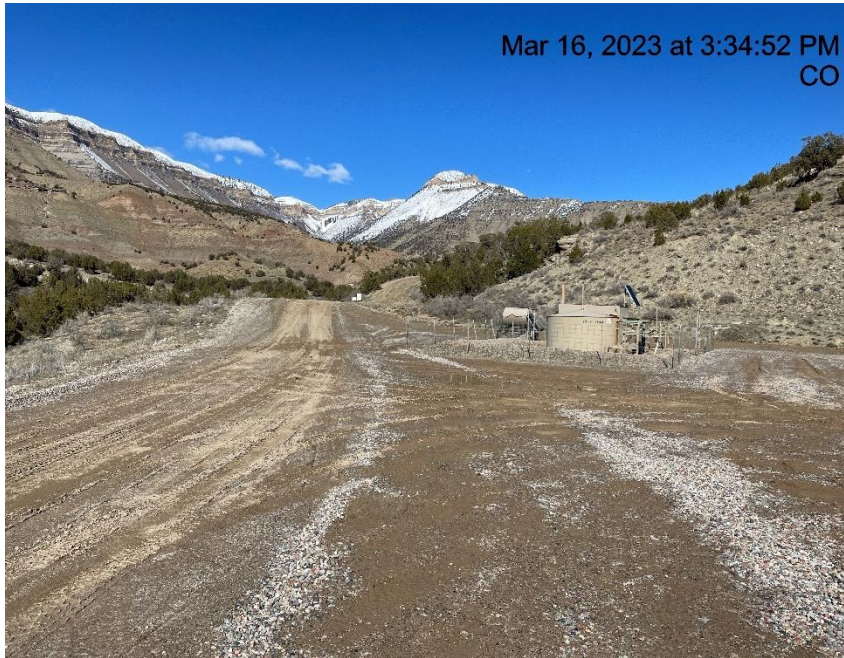
Photo # 2538 From entrance to location

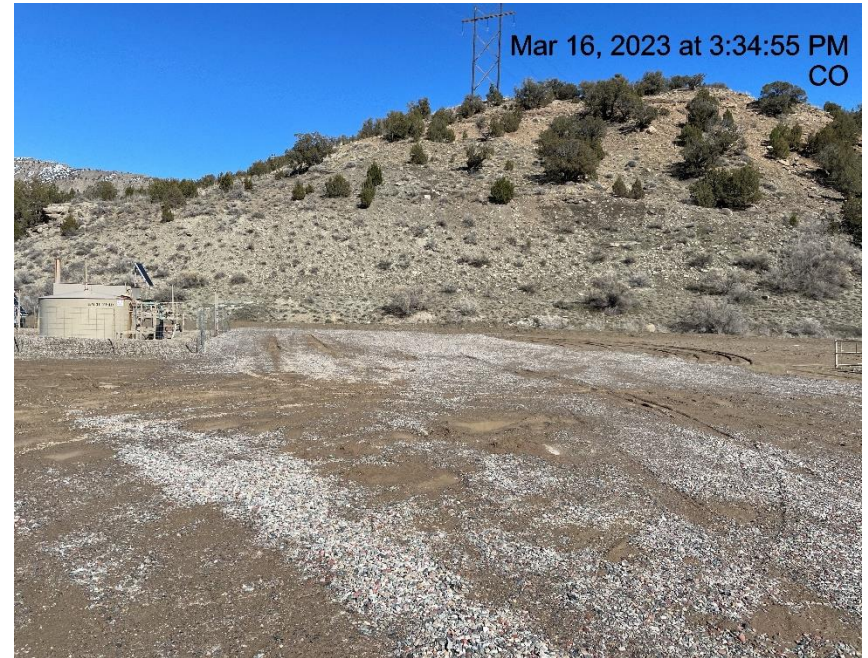
Photo # 2539 From entrance to location

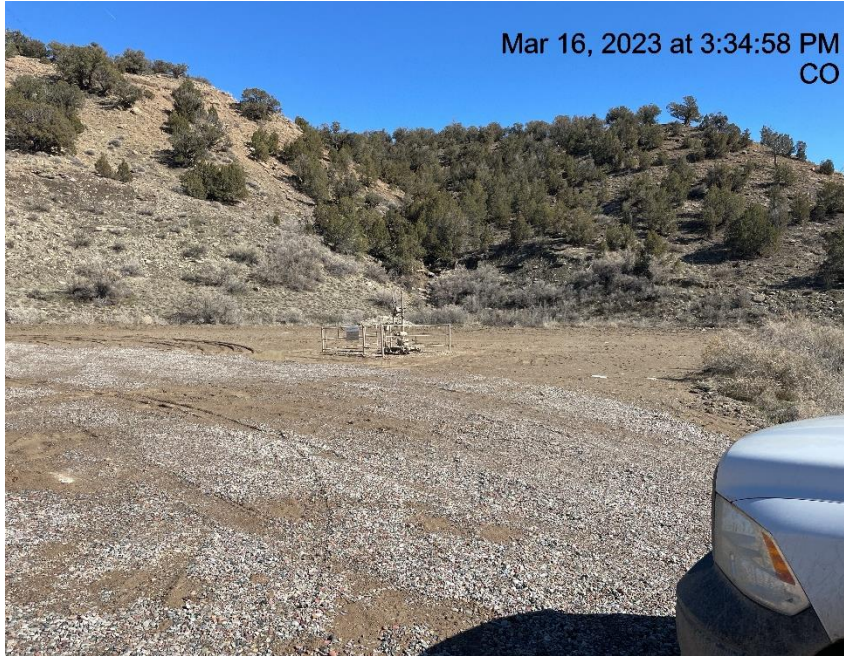
Photo # 2540 From entrance to location

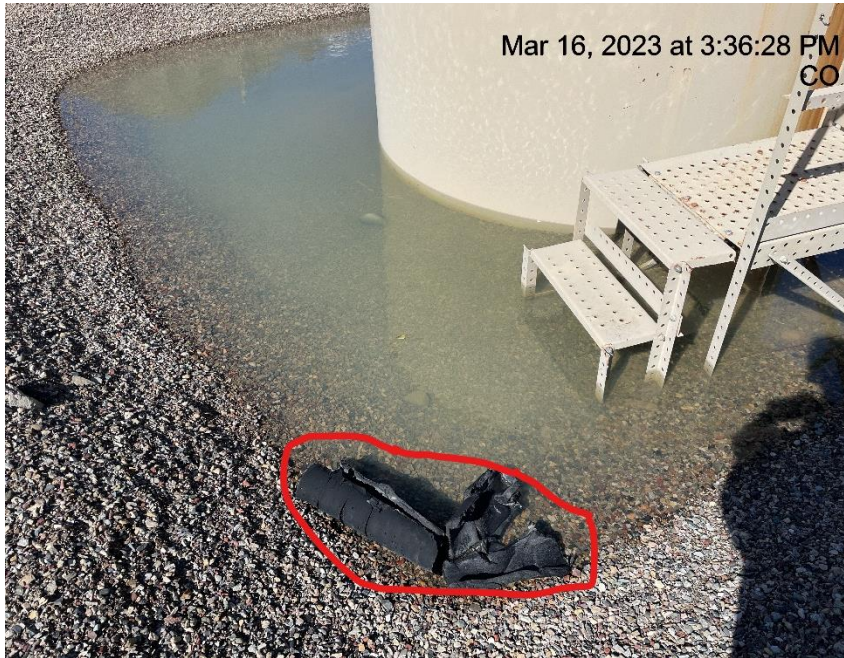
Photo # 2546 Debris

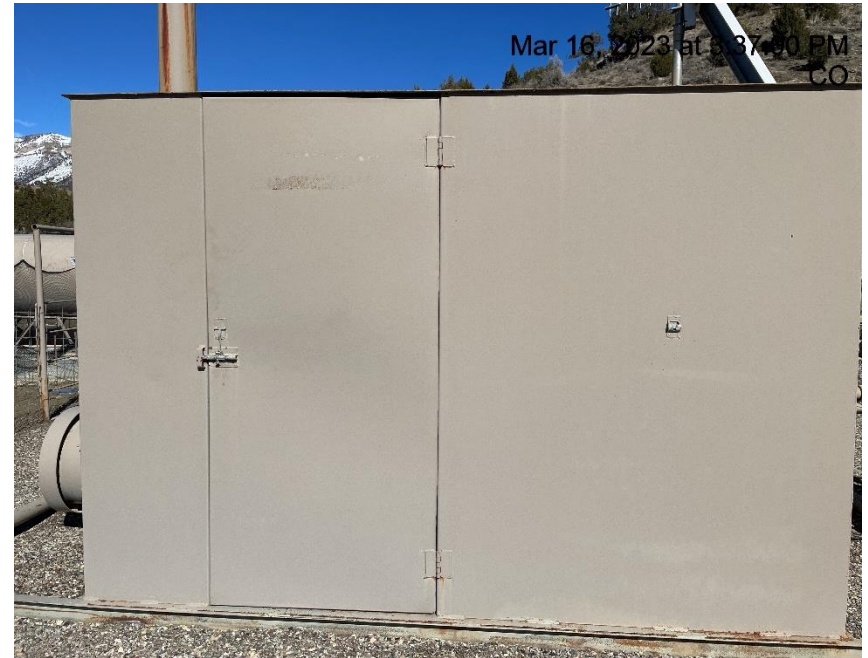
Photo # 2548 Calibration info not conspicuously posted

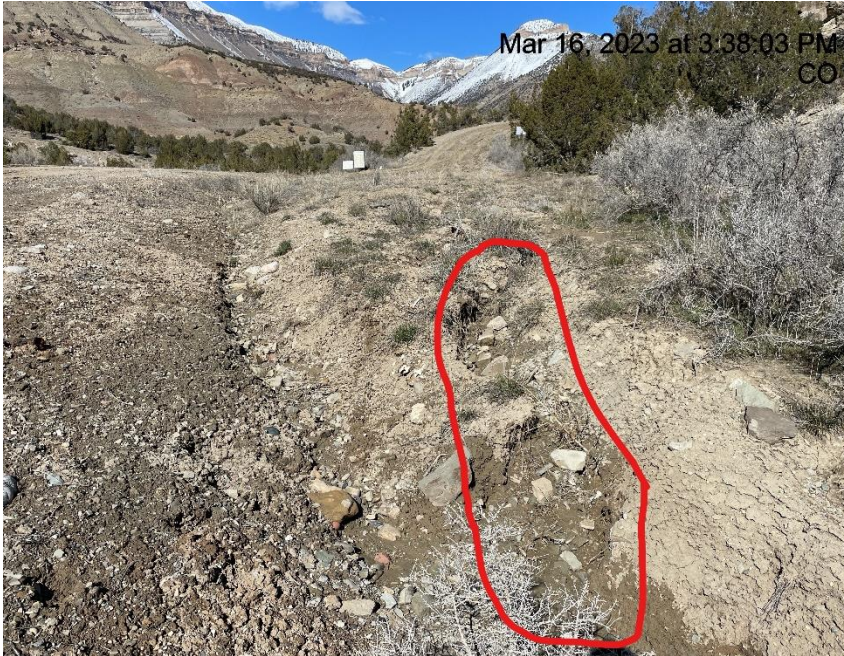
**Photo # 2549 Gulley erosion into ditch (SE corner of location near road)**

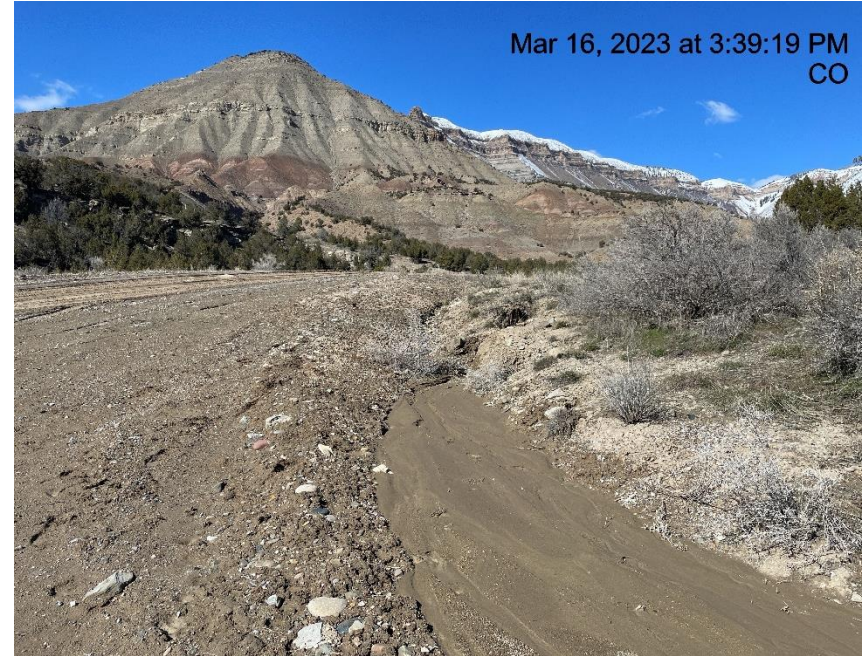
**Photo # 2550 Ditch needs maintenance (SE corner of location)**

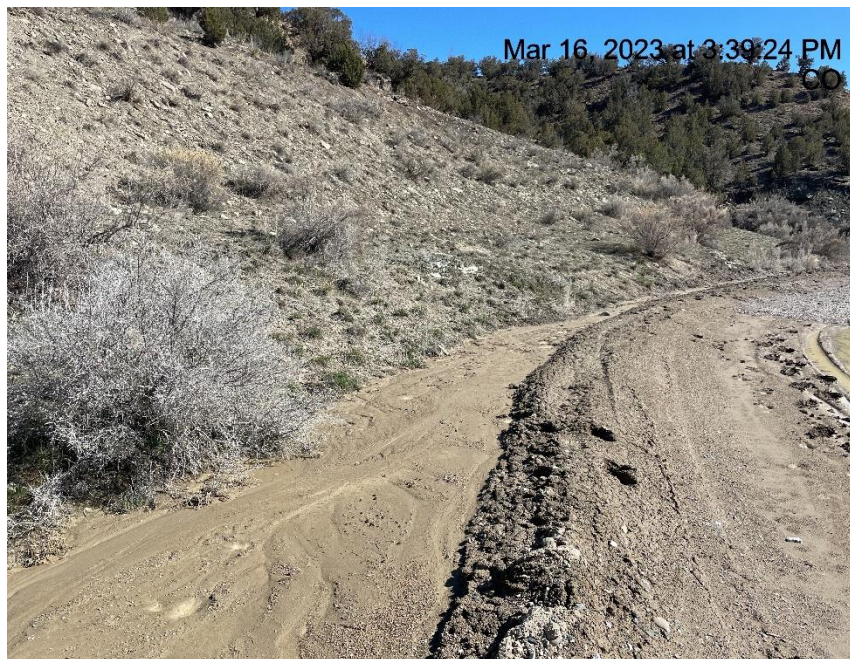
Photo # 2551 Ditch needs maintenance (S/SE side of location)

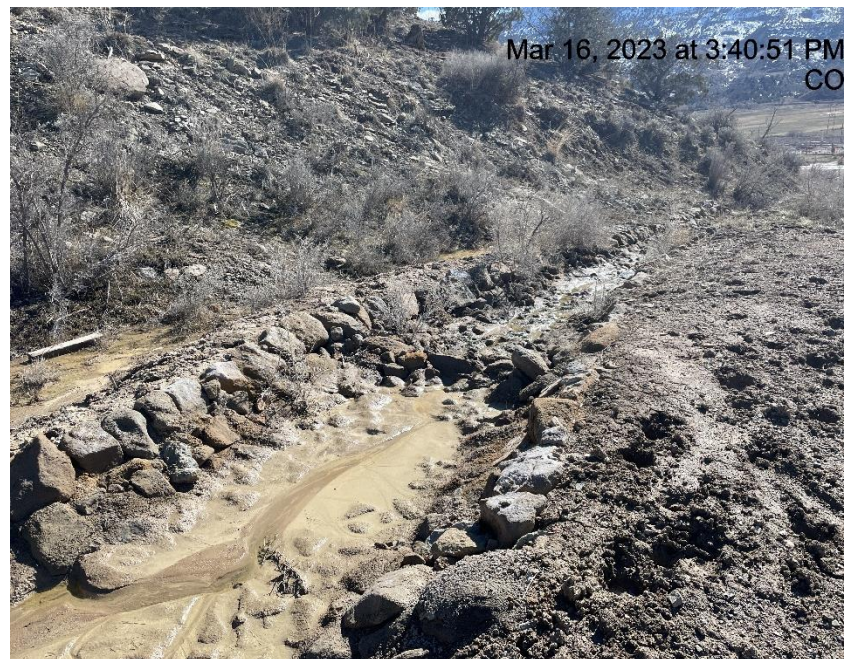
Photo # 2553 Rip Rap needs maintenance (SW corner of location)

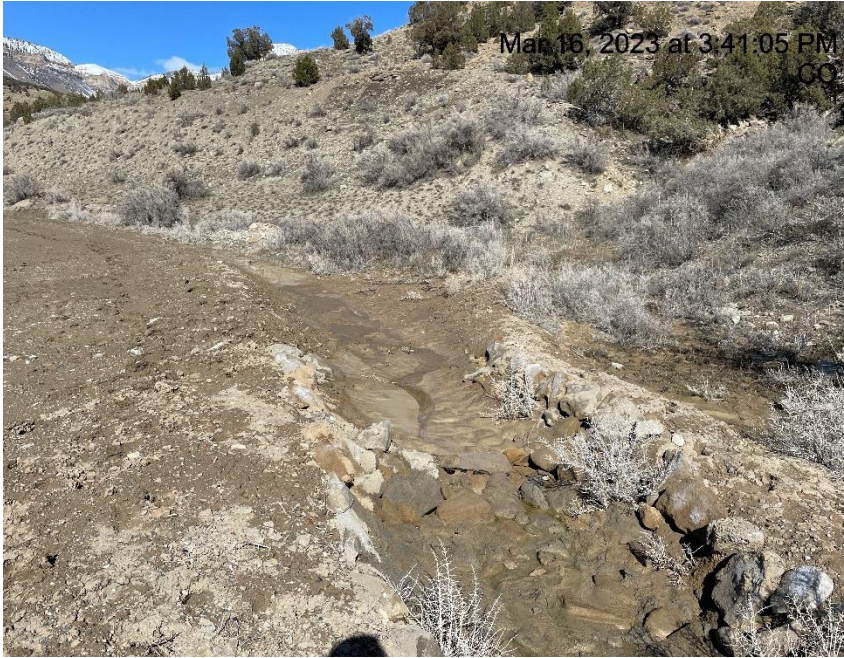
**Photo # 2554 Rip Rap needs maintenance (SW corner of location)**

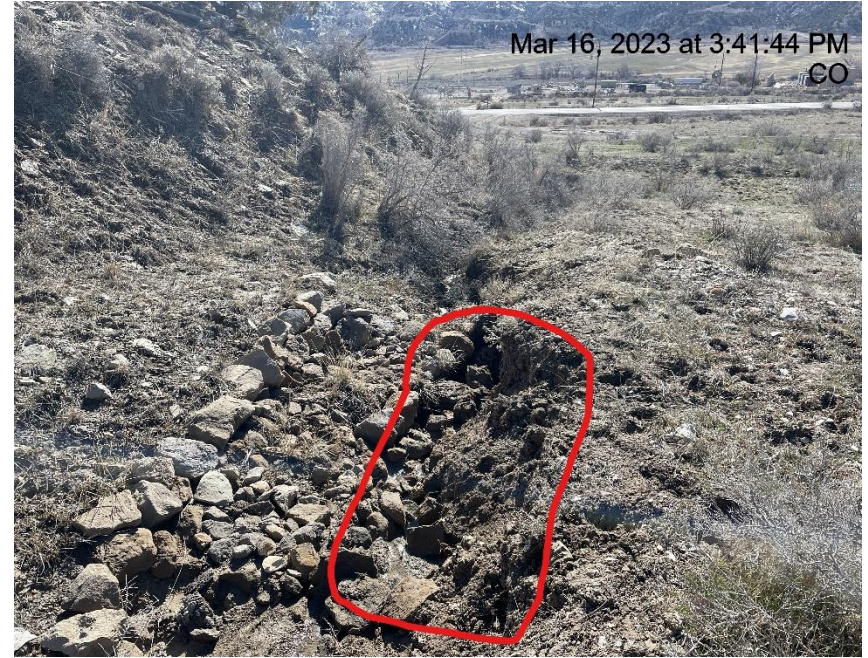
**Photo # 2555 Rip Rap needs maintenance (SW corner of location)**

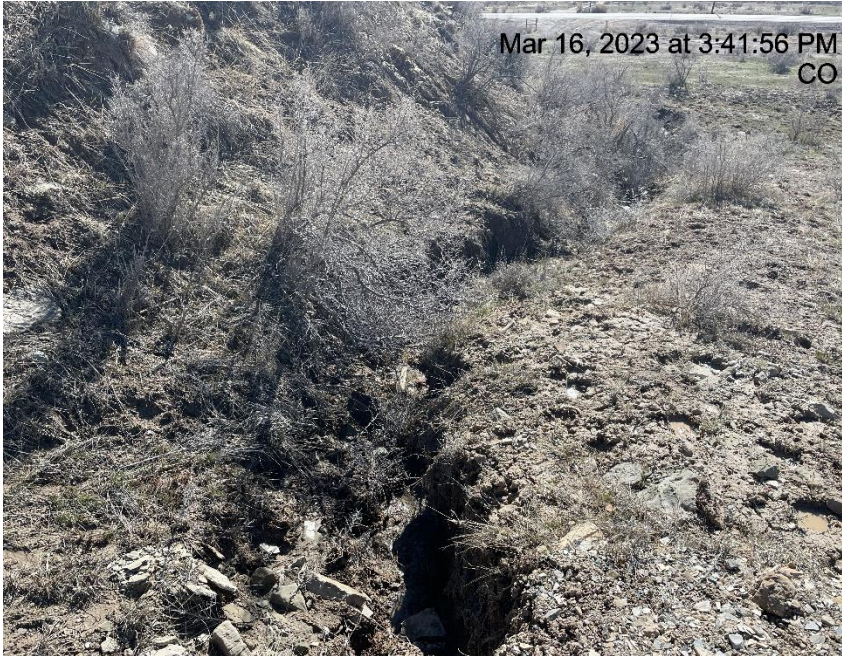
**Photo # 2556 Insufficient runoff controls/BMP's – Channel erosion (SW corner of location)**

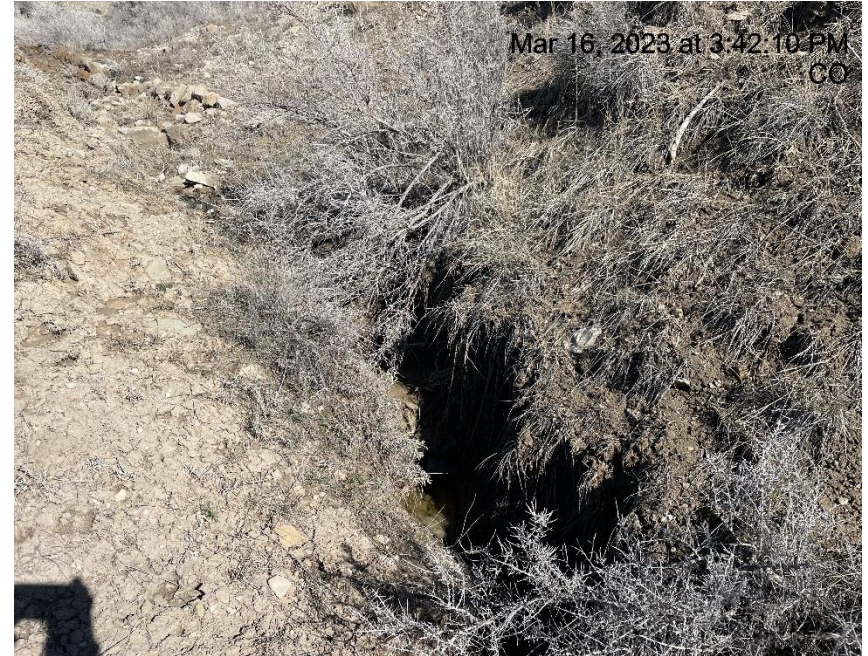
**Photo # 2557 Insufficient runoff controls/BMP's – Channel erosion (off SW corner of location)**

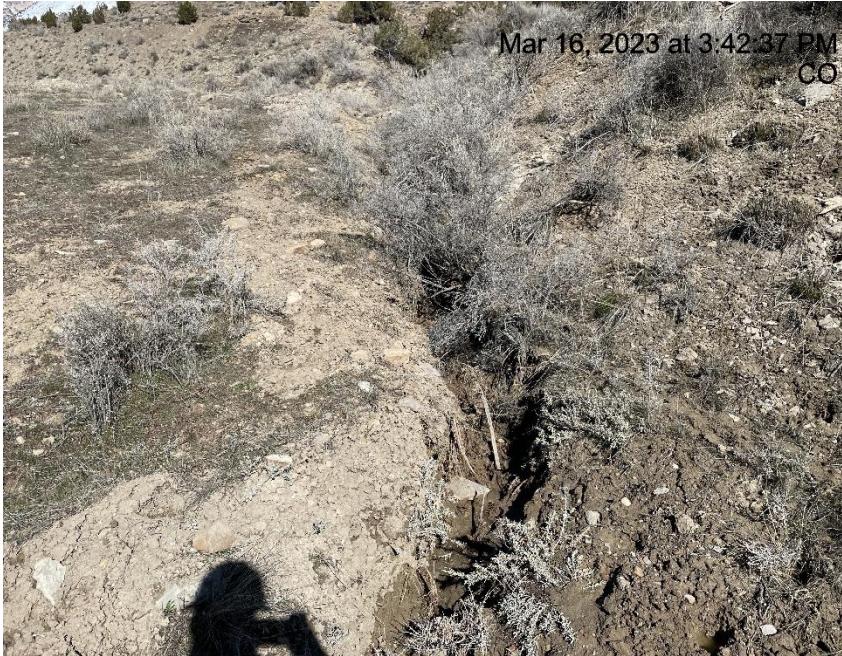
**Photo # 2559 Insufficient runoff controls/BMP's – Channel erosion (off SW corner of location)**

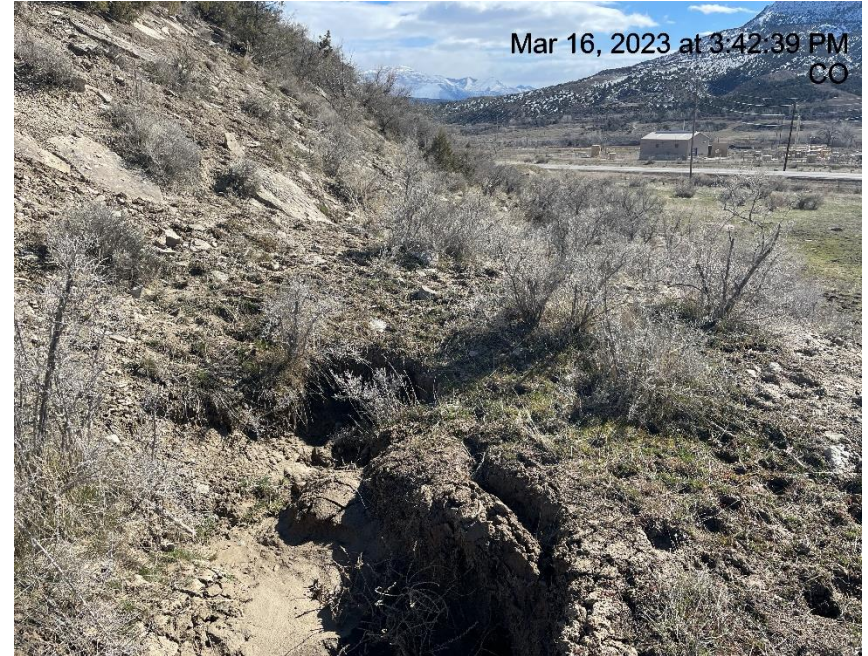
**Photo # 2560 Insufficient runoff controls/BMP's – Channel erosion & berm needs maintenance (off SW corner of location)**

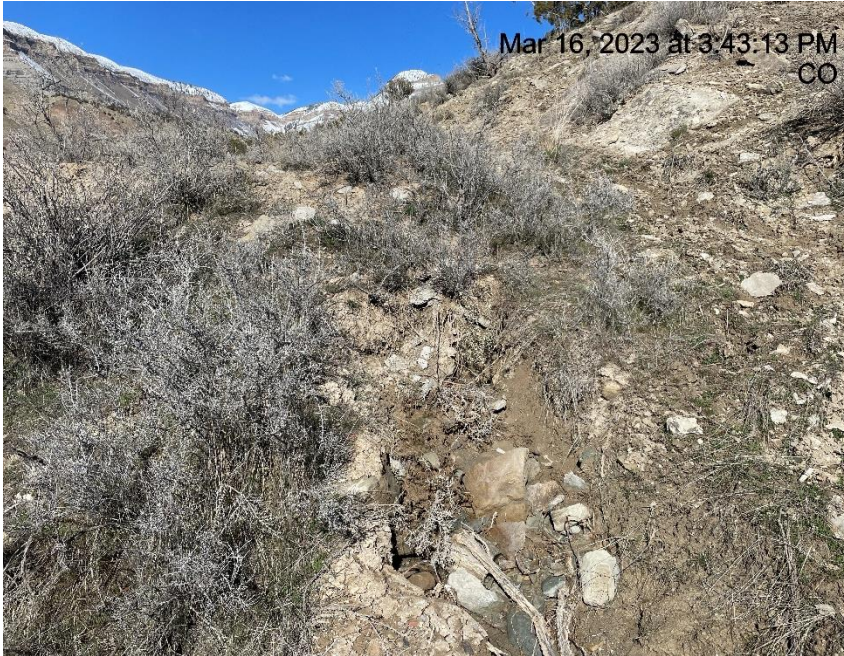
**Photo # 2561 Berm needs maintenance (Berm is off SW corner of location)**

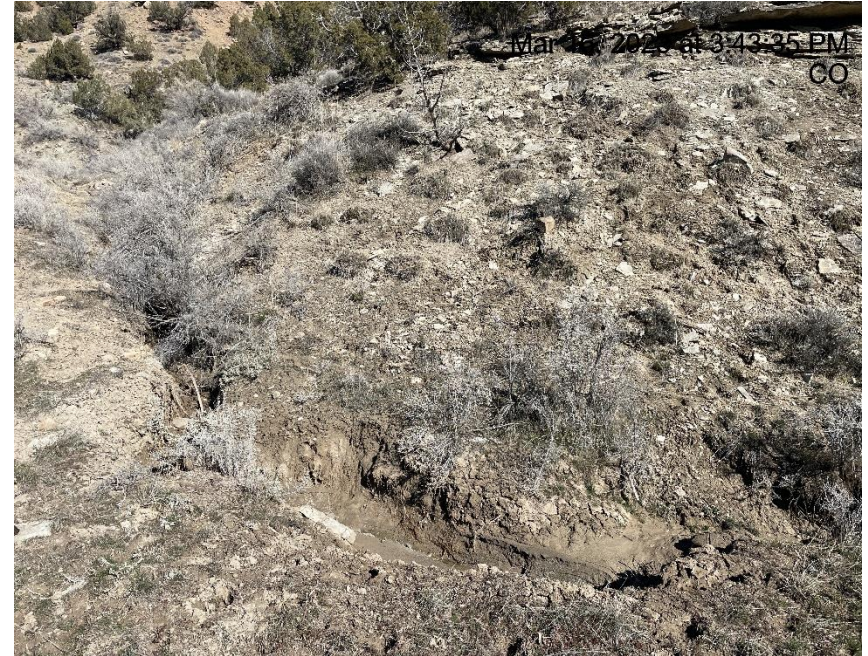
**Photo # 2562 Insufficient runoff controls/BMP's – Channel erosion (below berm off SW corner of location)**

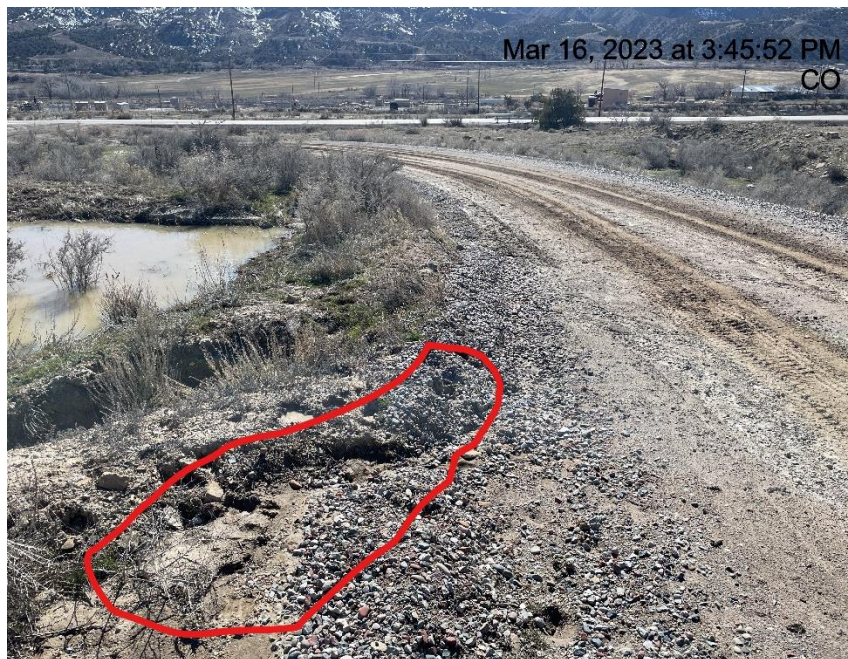
**Photo # 2564 Ditch needs maintenance (Access road)**

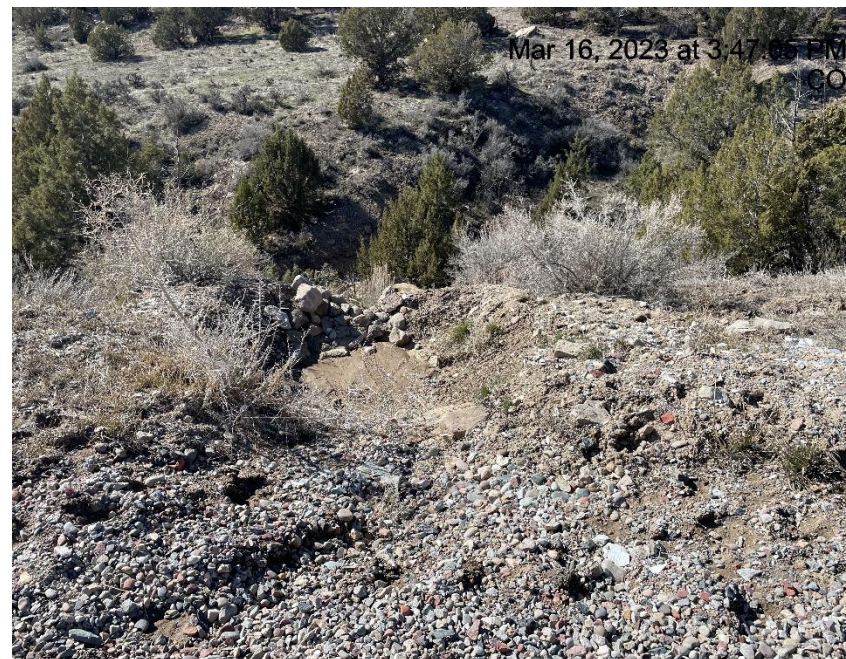
**Photo # 2565 Sediment Trap needs maintenance (N side of location off access road)**

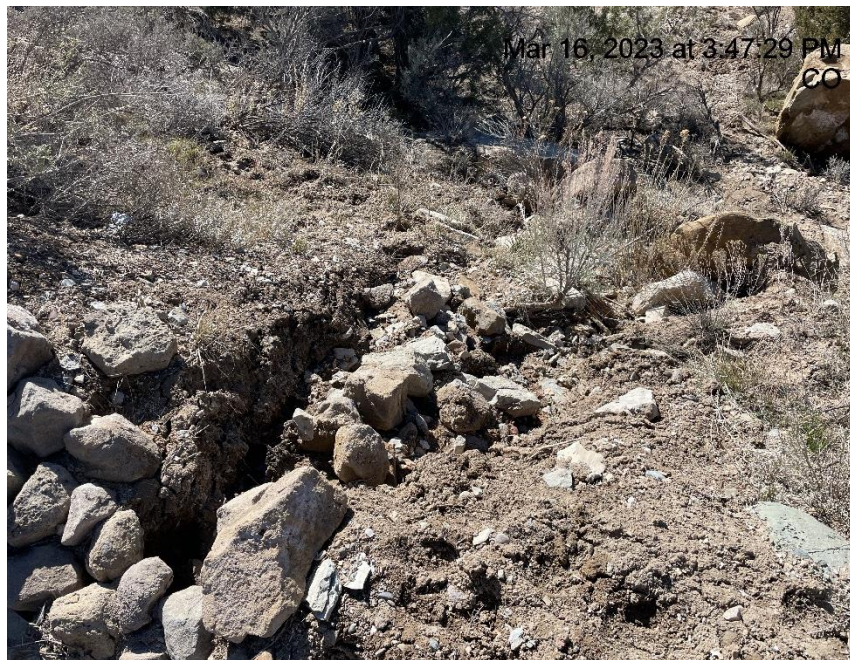
**Photo # 2567 Sediment Trap needs maintenance (N side of location off access road)**

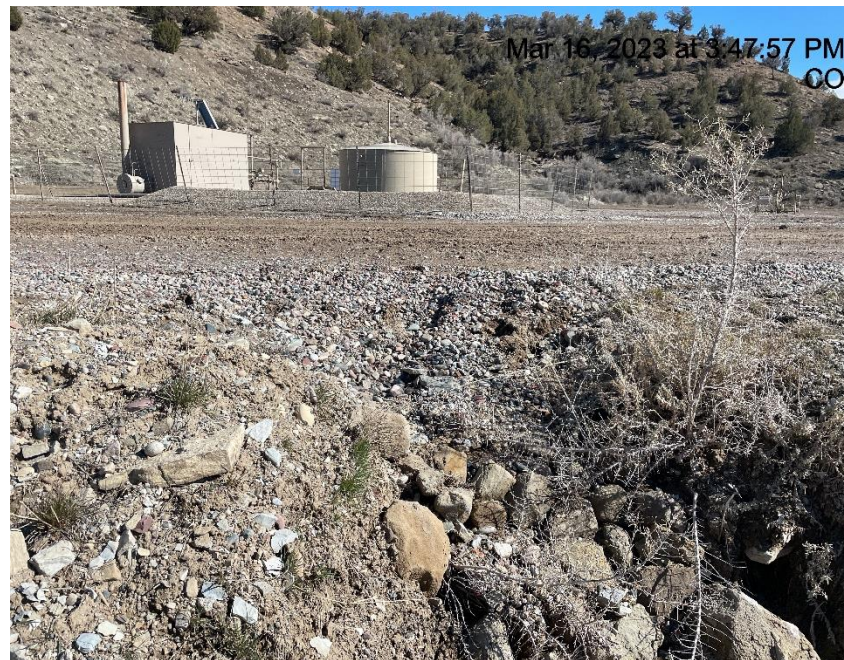
**Photo # 2569 Sediment Trap needs maintenance (N side of location off access road)**
