Inspection Photos

Location Name: TEP ROCKY MOUNTAIN LLC HOLL RWF 13-31 Pad

Location ID: 417582

COLORADO
Oil & Gas Conservation
Commission
Department of Natural Resources

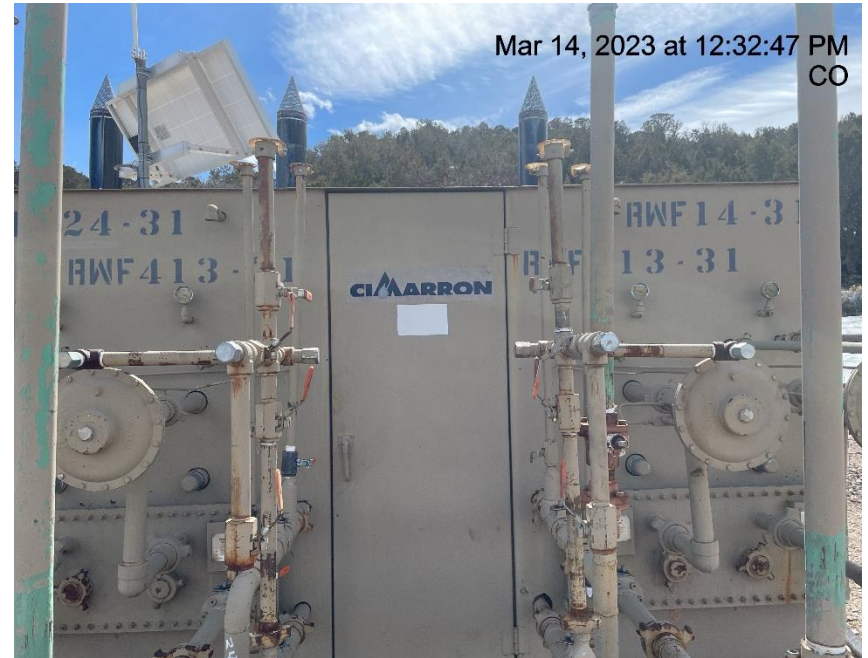
Photo # 2369 Calibration info not conspicuously posted

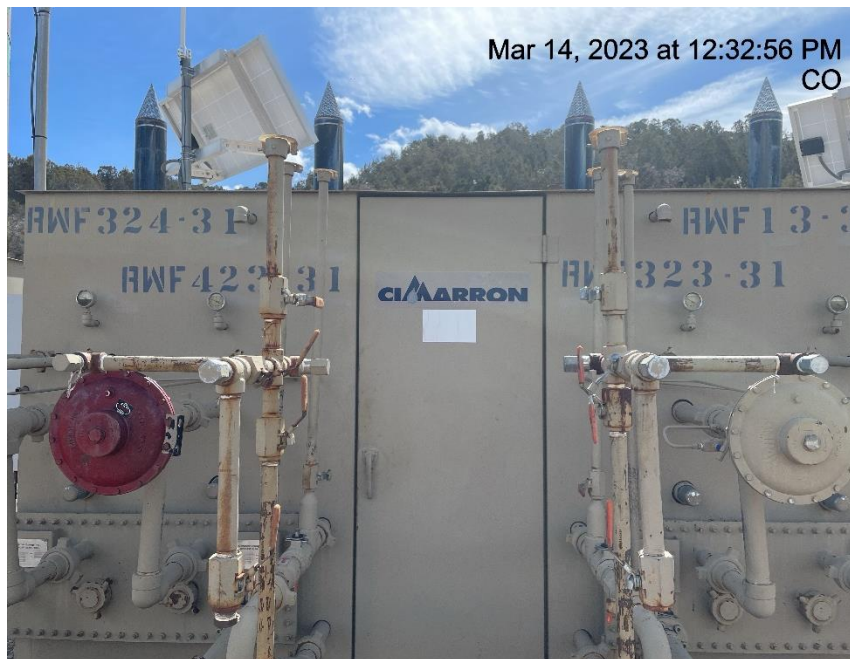
Photo # 2370 Calibration info not conspicuously posted

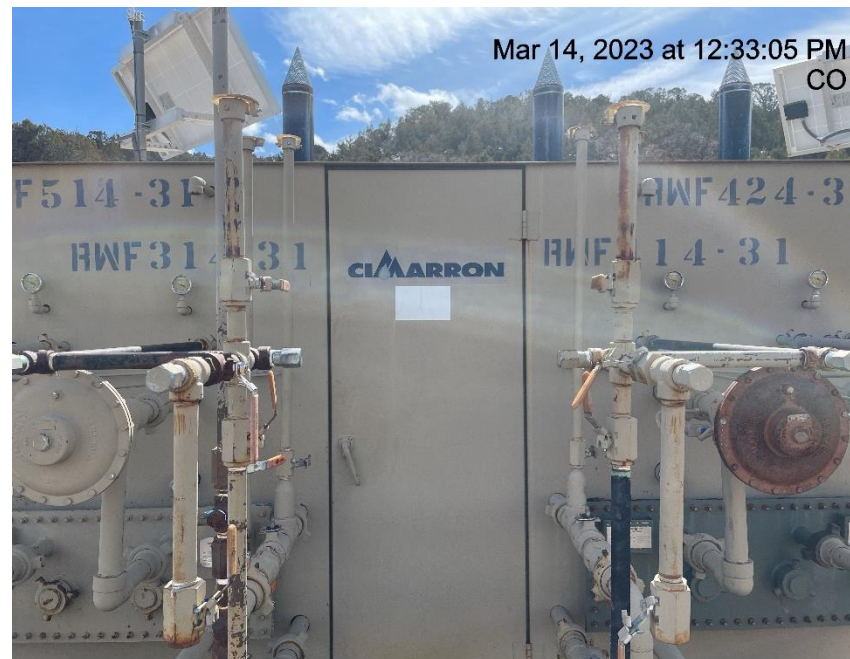
Photo # 2371 Calibration info not conspicuously posted

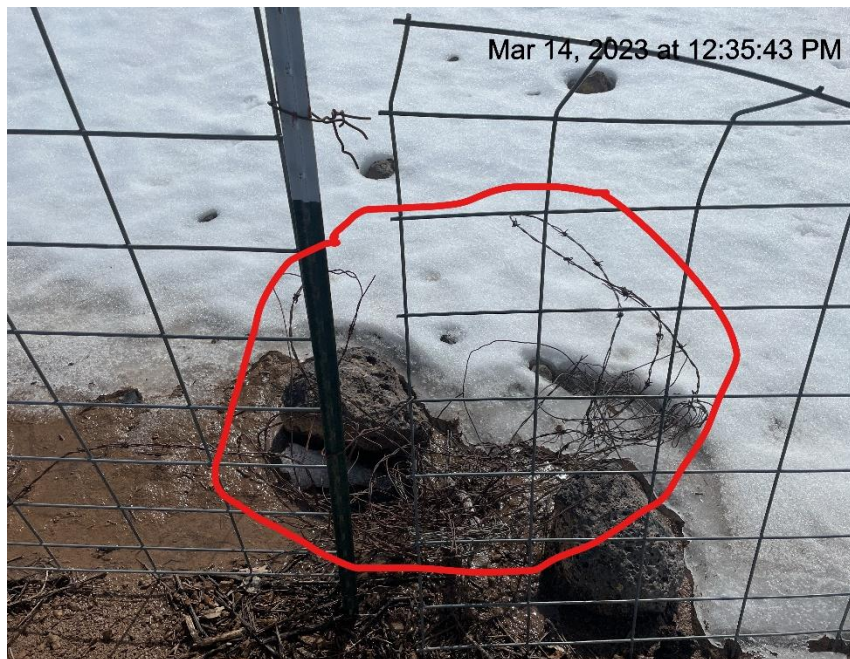
Photo # 2372 Debris - Barbed wire laying on ground/wildlife hazard

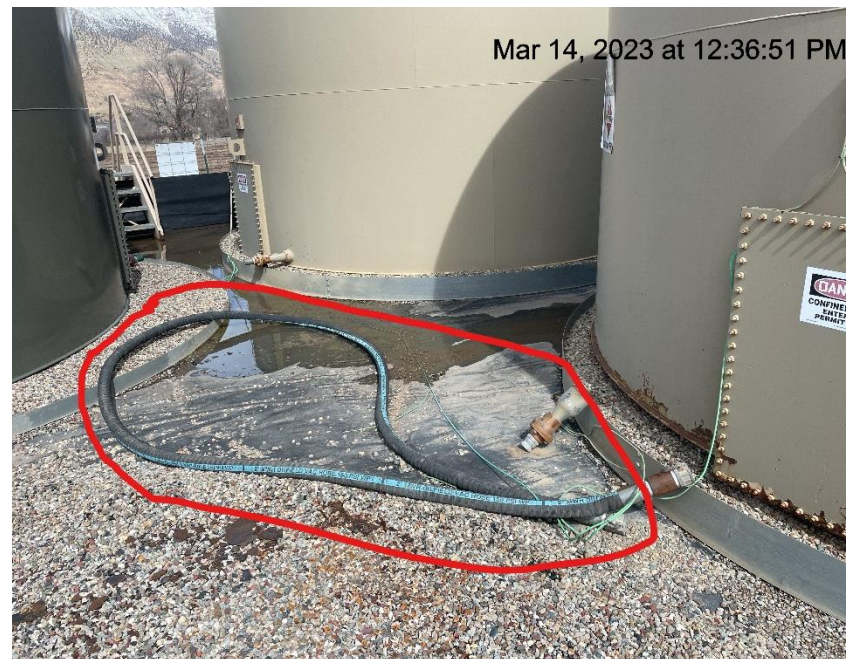
Photo # 2373 Unused equipment

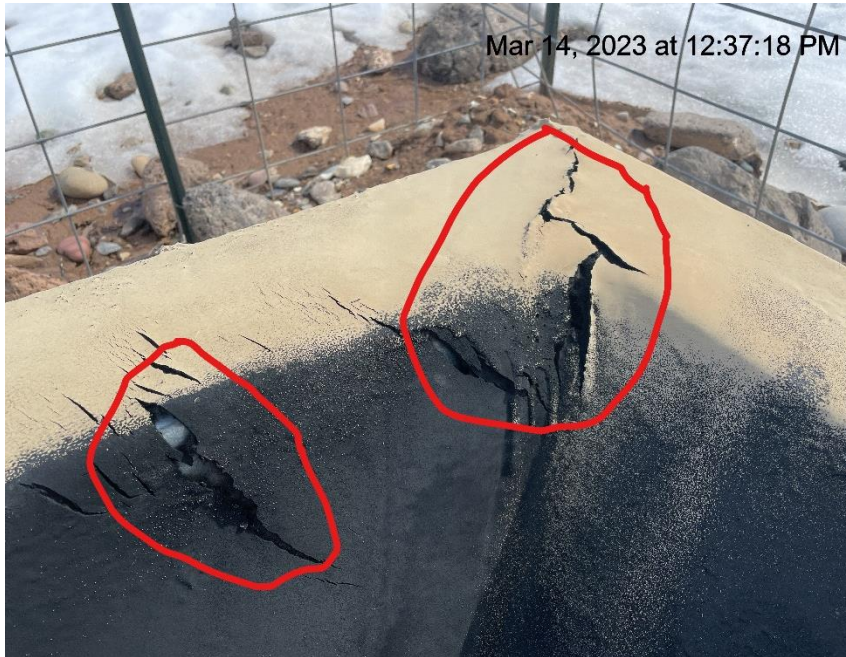
Photo # 2374 Containment needs maintenance

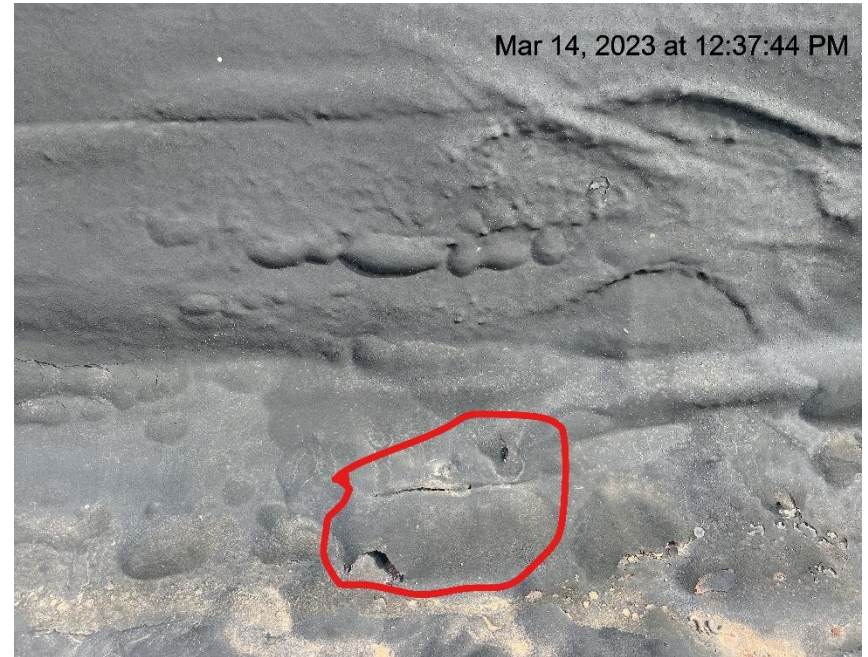
Photo # 2375 Containment needs maintenance

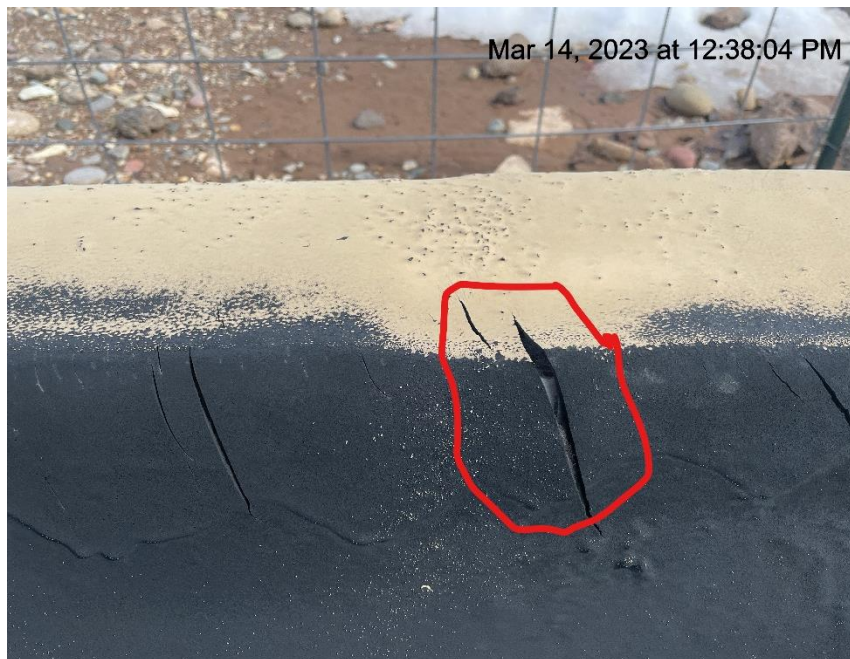
Photo # 2376 Containment needs maintenance

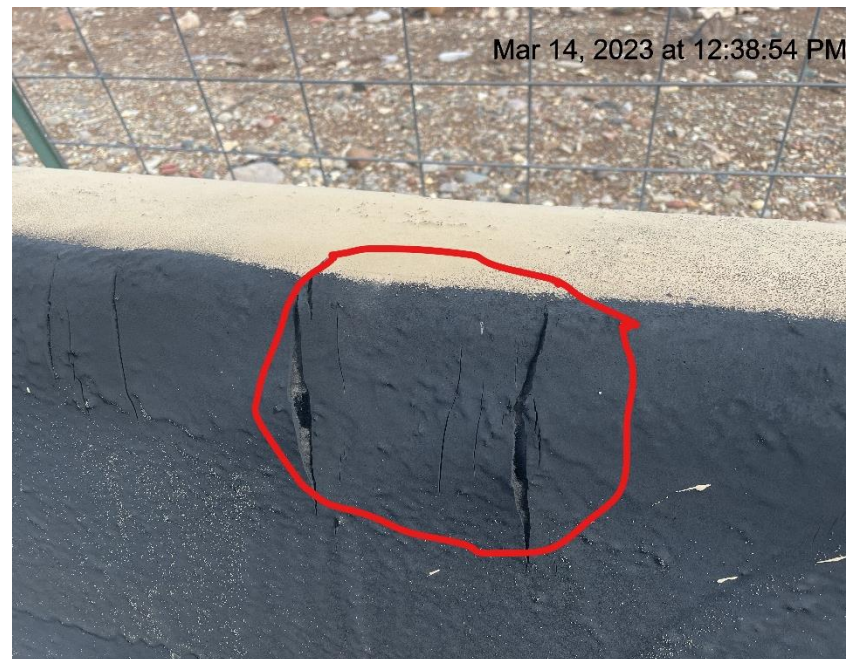
Photo # 2377 Containment needs maintenance

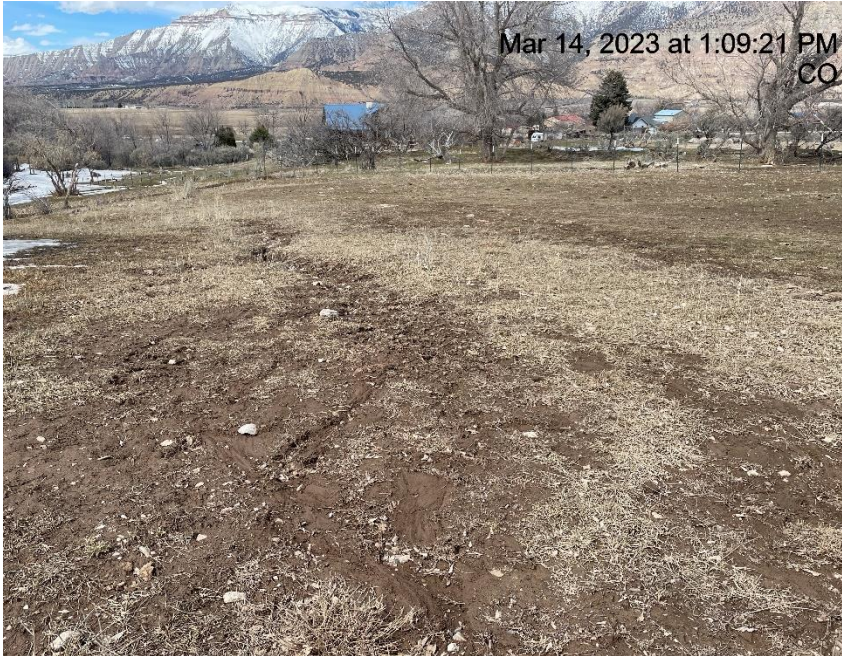
Photo # 2400 Gulley erosion off edge of pad

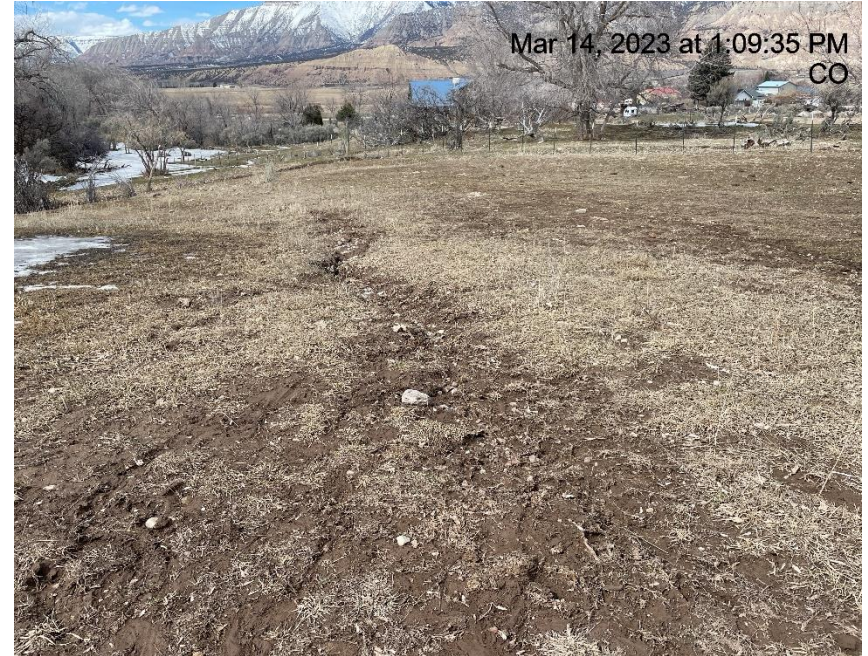
Photo # 2401 Gulley erosion off edge of pad

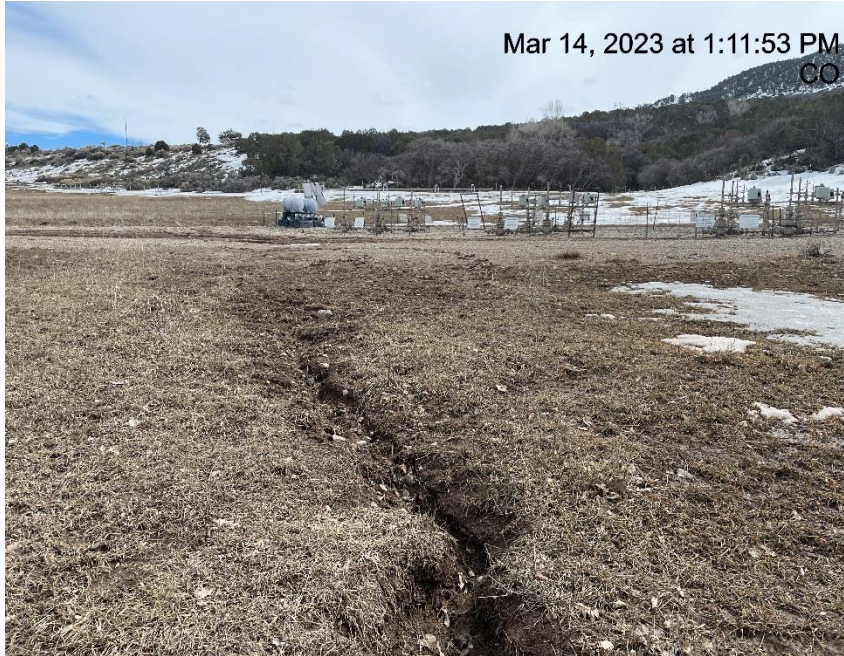
Photo # 2405 Gulley erosion off edge of pad

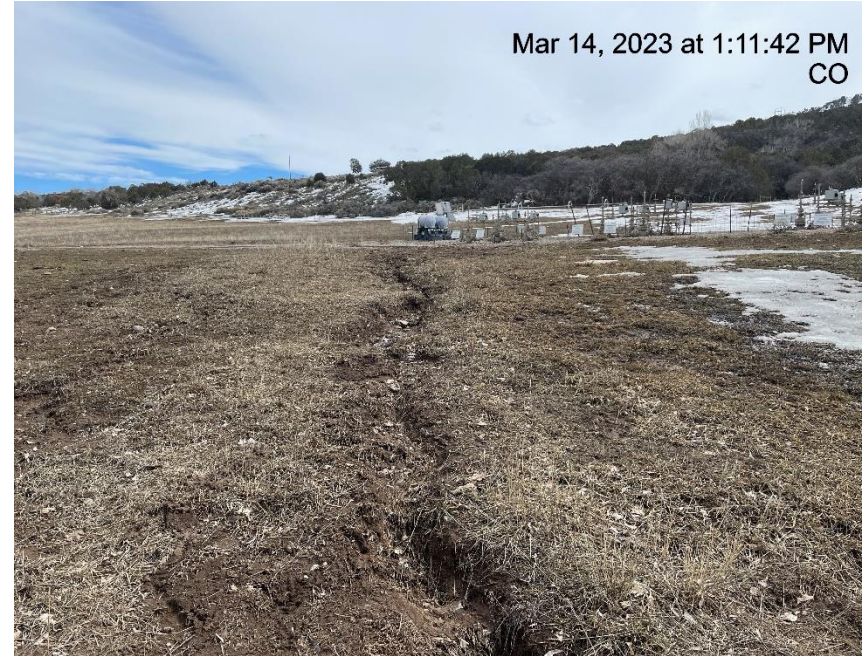
Photo # 2404 Gulley erosion off edge of pad

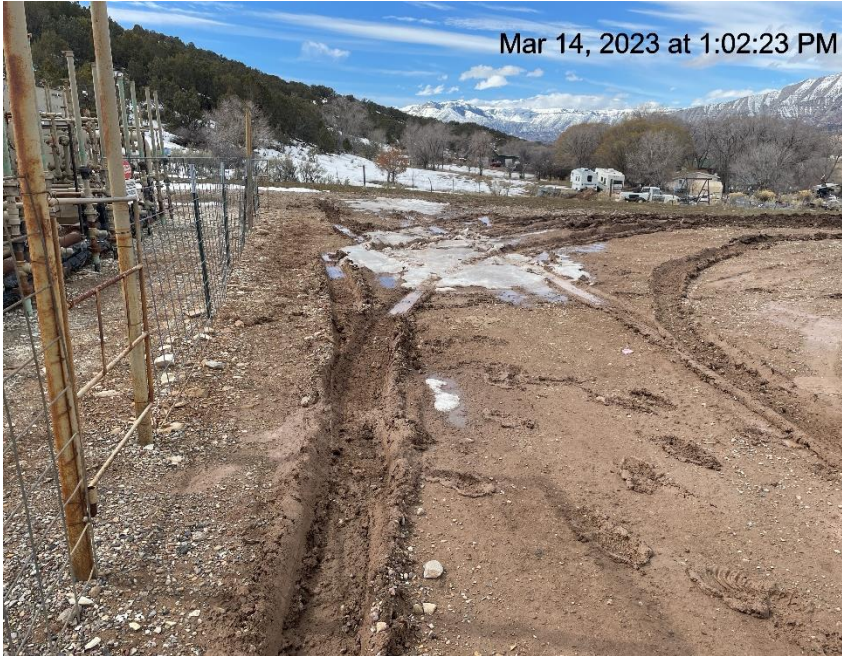
Photo # 2390 Lack of stabilization

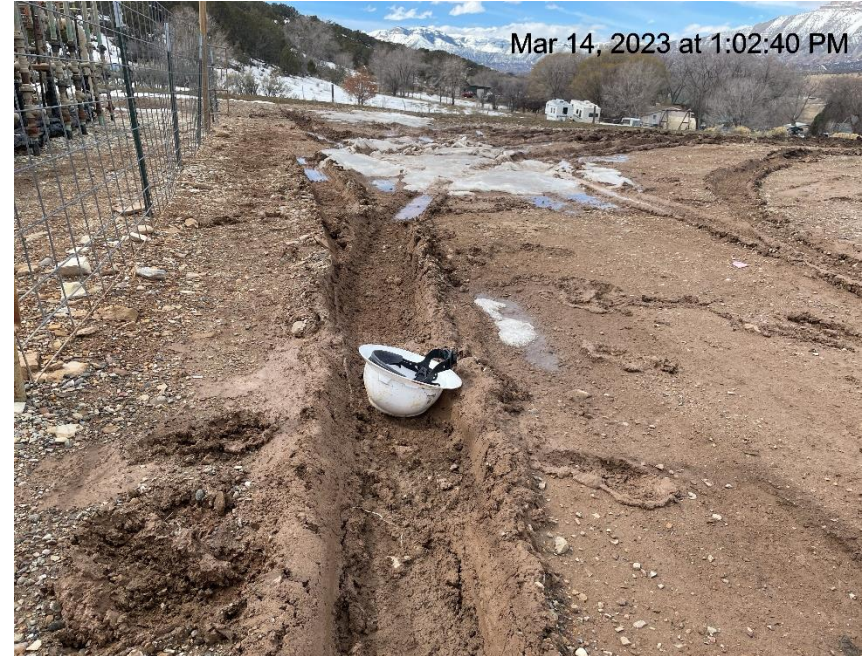
Photo # 2391 Lack of stabilization

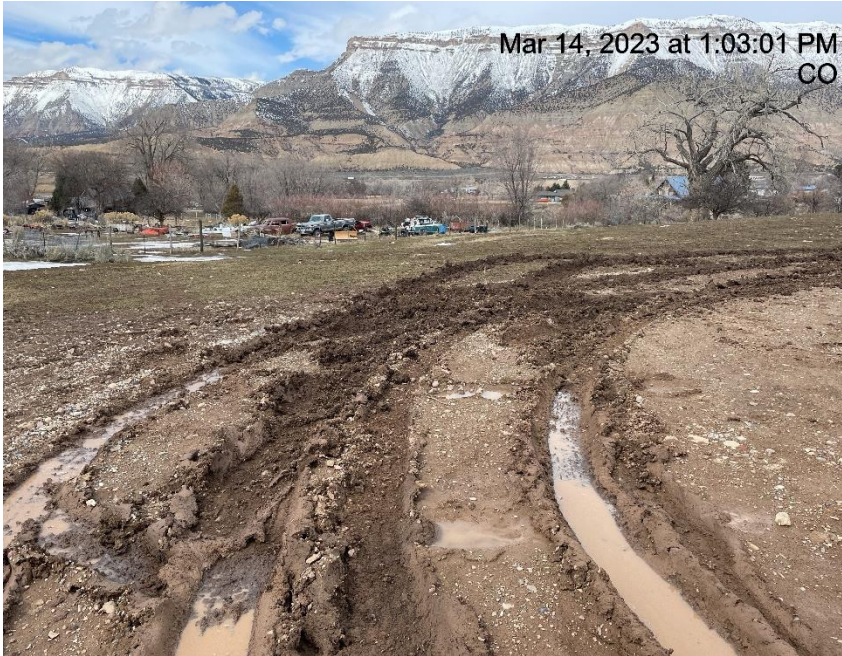
Photo # 2392 Lack of stabilization

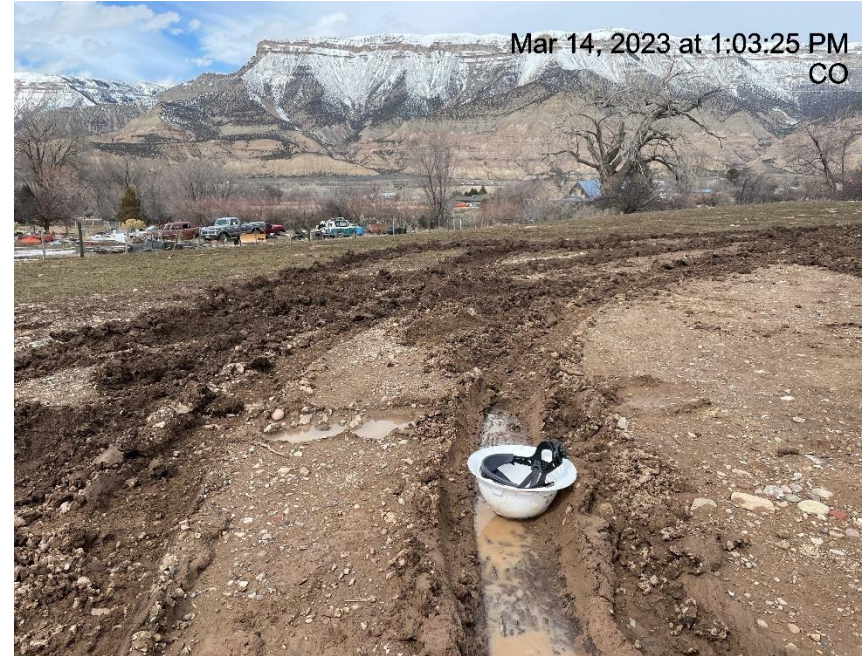
Photo # 2393 Lack of stabilization

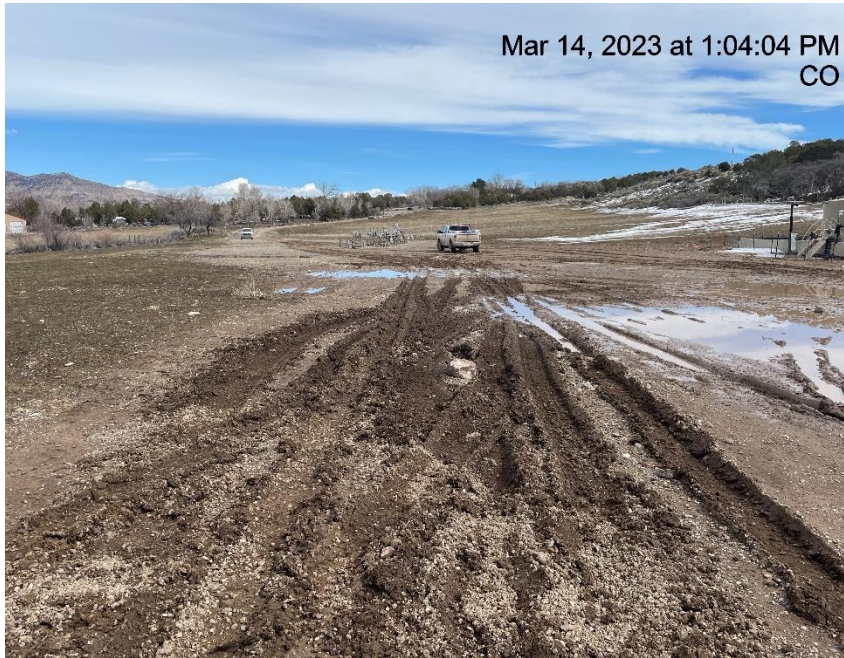
Photo # 2394 Lack of stabilization

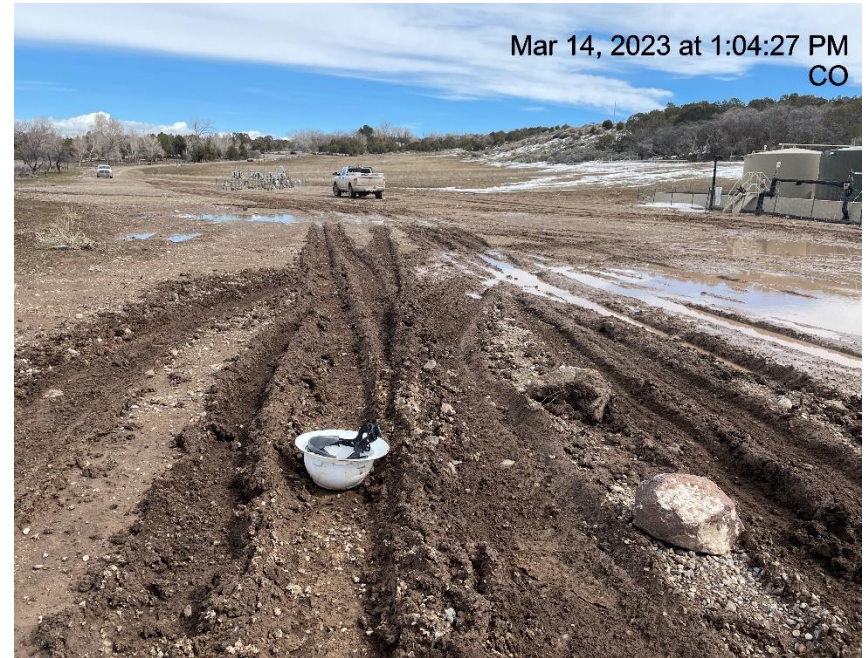
Photo # 2395 Lack of stabilization

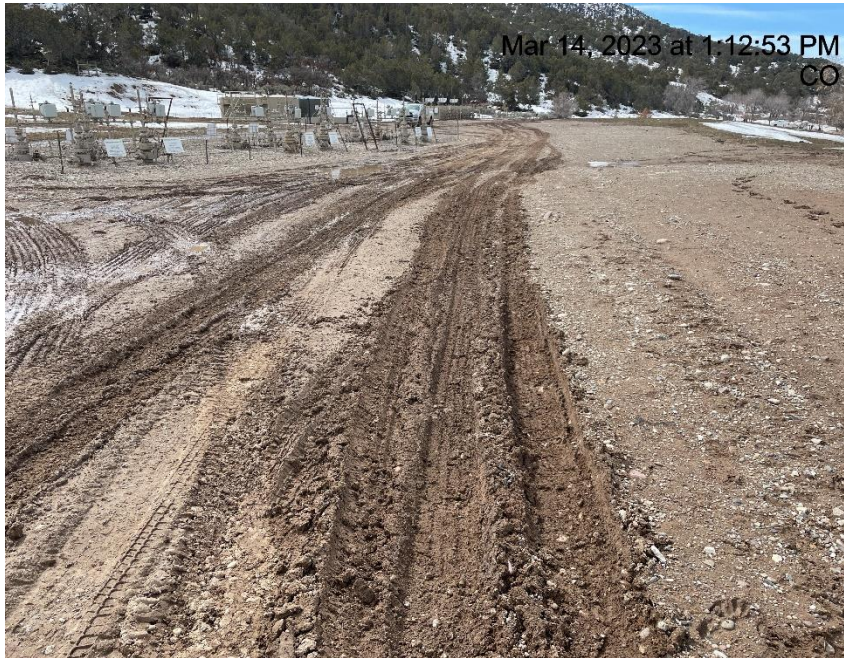
Photo # 2406 Lack of stabilization

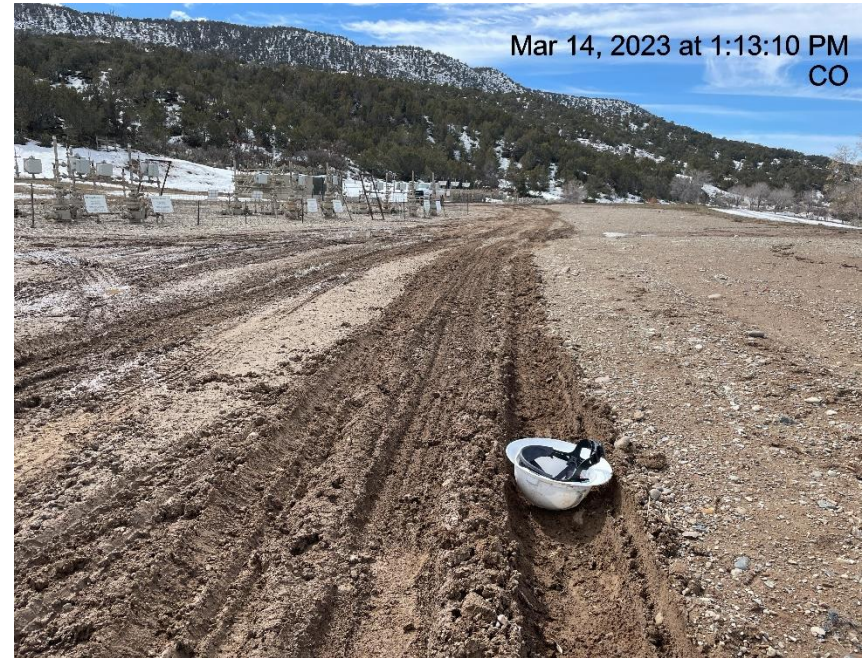
Photo # 2407 Lack of stabilization

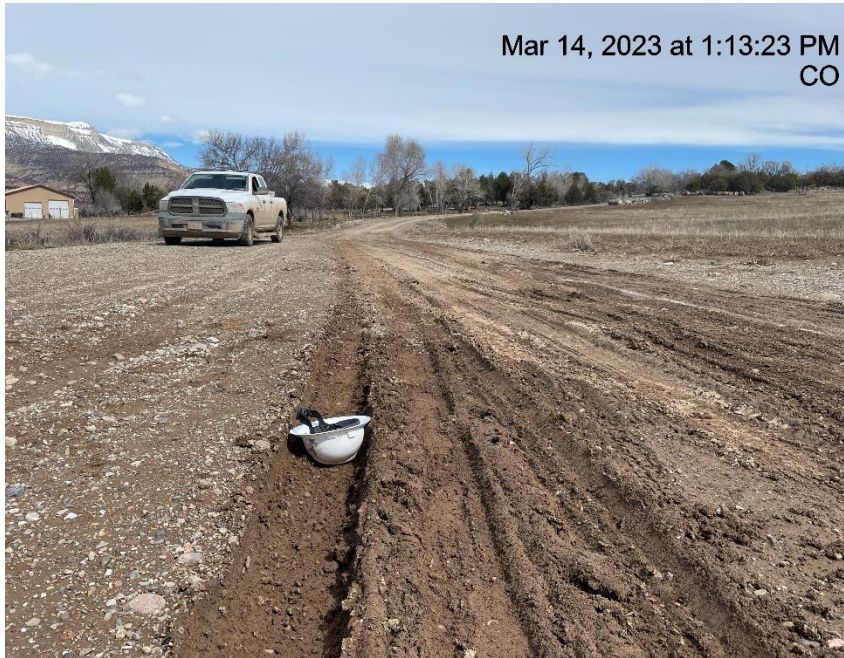
Photo # 2408 Lack of stabilization

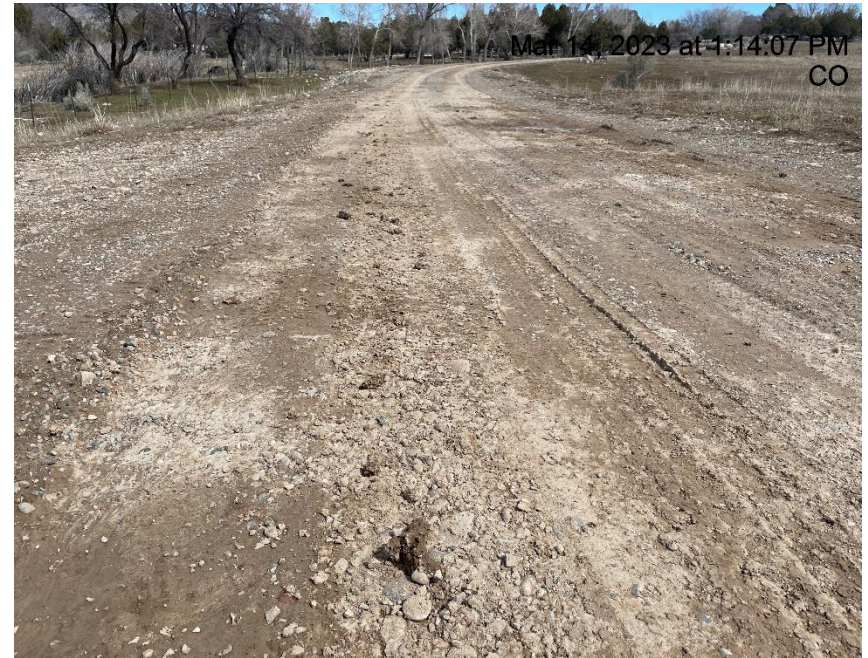
Photo # 2409 Insufficient tracking BMP/Vehicle Tracking onto lease road

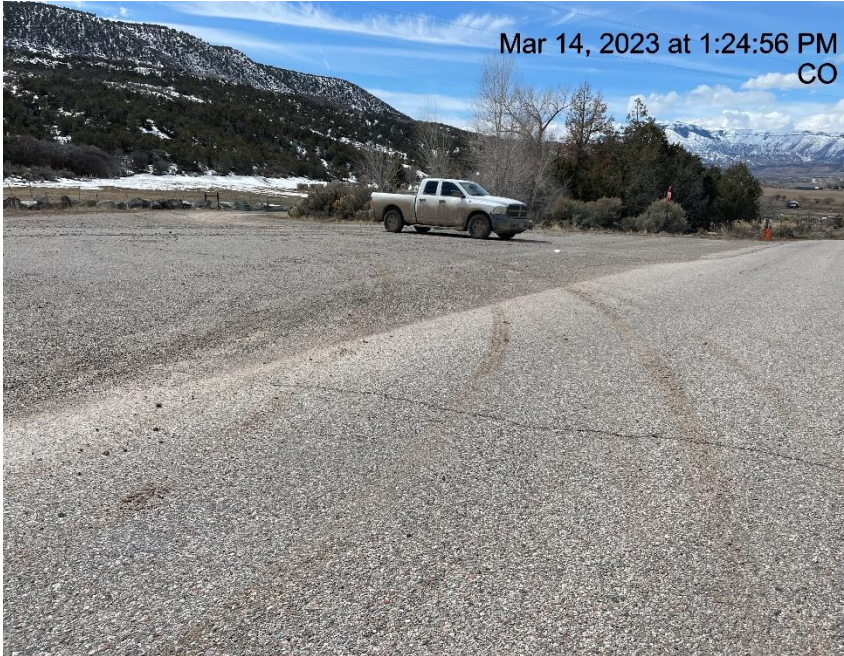
Photo # 2413 Insufficient tracking BMP/Tracking onto County Road 309

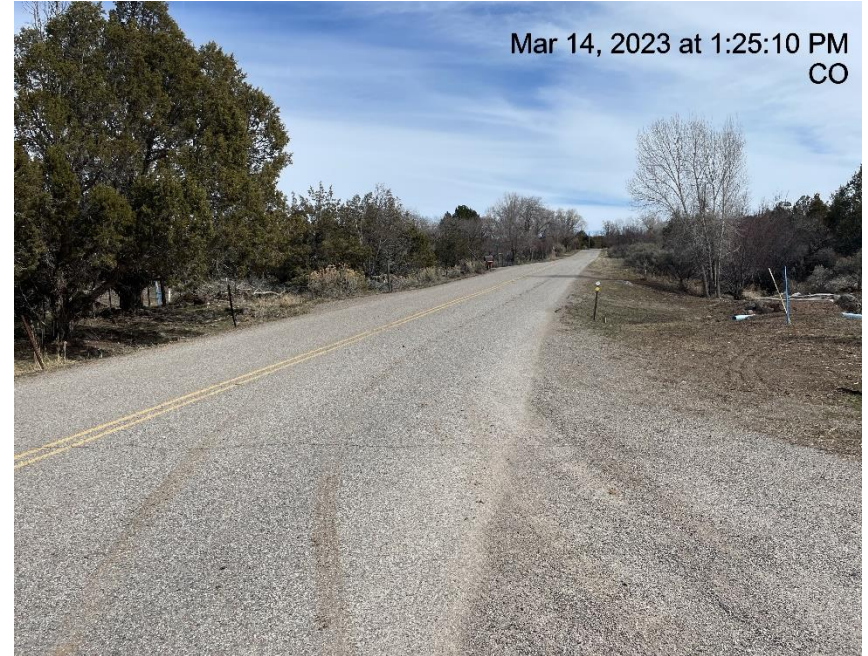
Photo # 2414 Insufficient tracking BMP/Tracking onto County Road 309

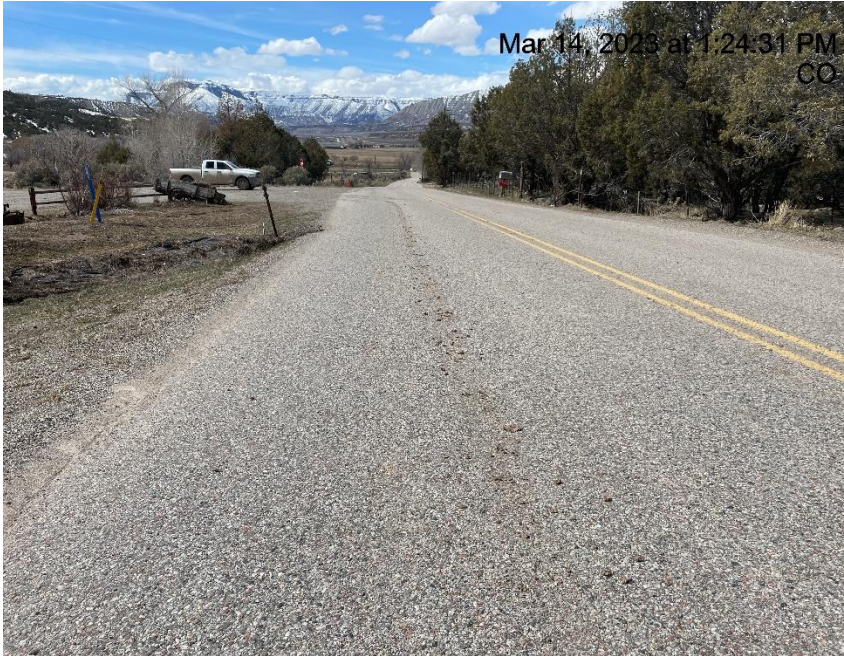
Photo # 2412 Insufficient tracking BMP/Tracking onto County Road 309

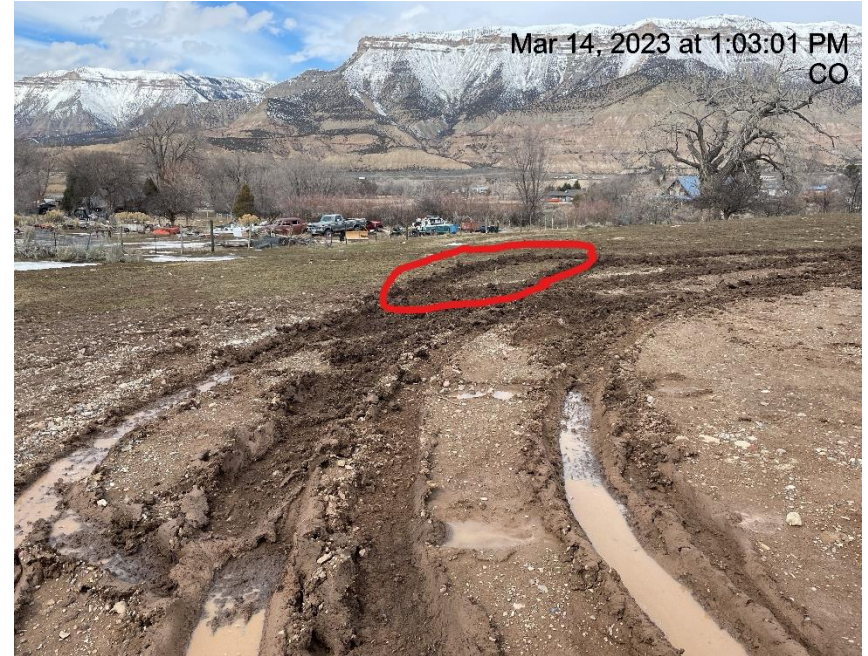
Photo # 2392 Failure to minimize surface disturbance

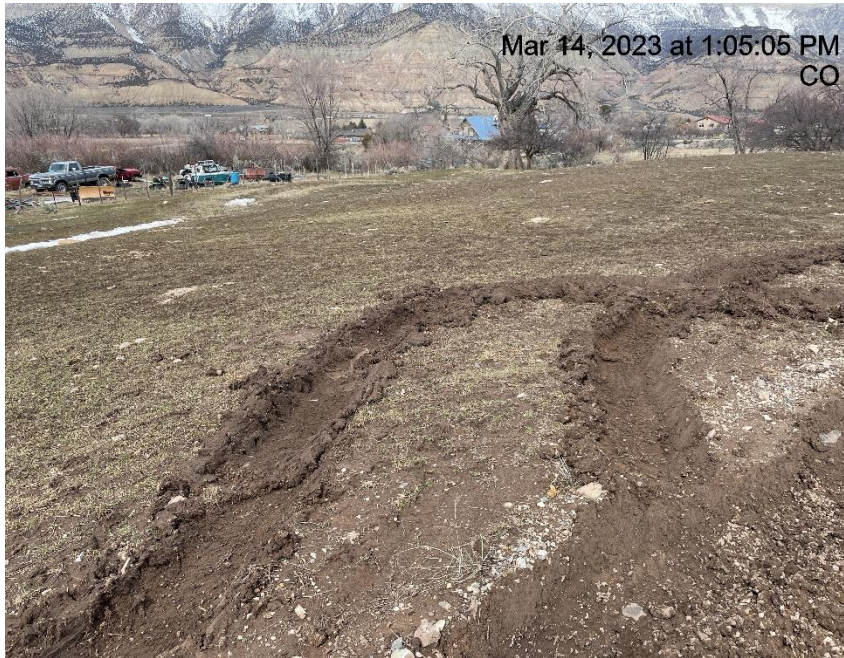
Photo # 2396 Failure to minimize surface disturbance

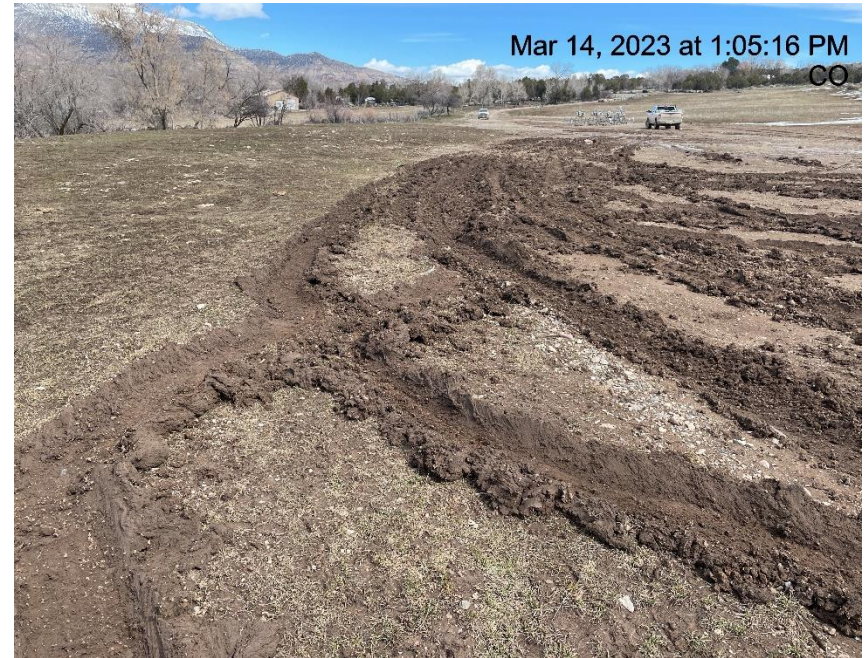
Photo # 2397 Failure to minimize surface disturbance

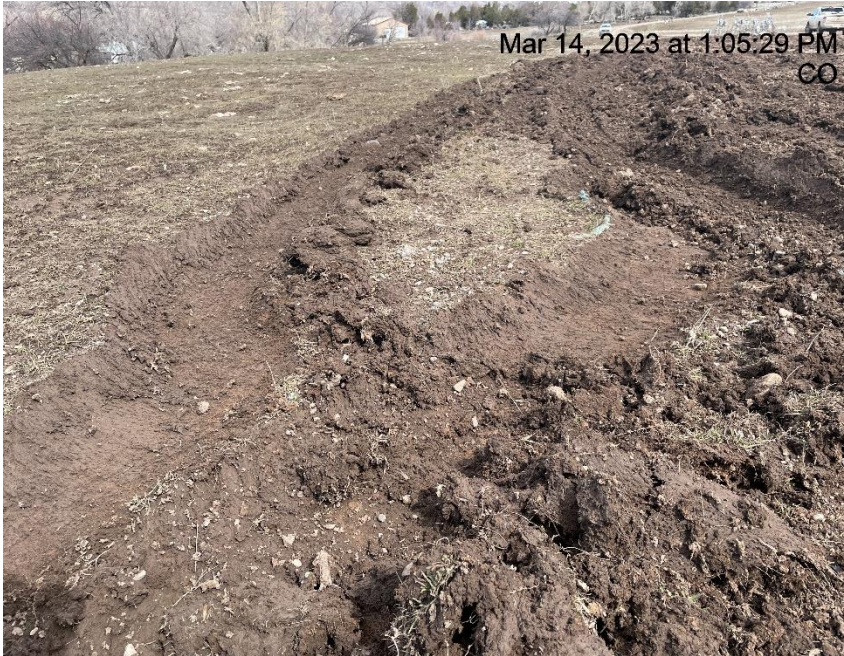
Photo # 2398 Failure to minimize surface disturbance
