Caerus Piceance LLC
Nolte 14-796
Location #435806

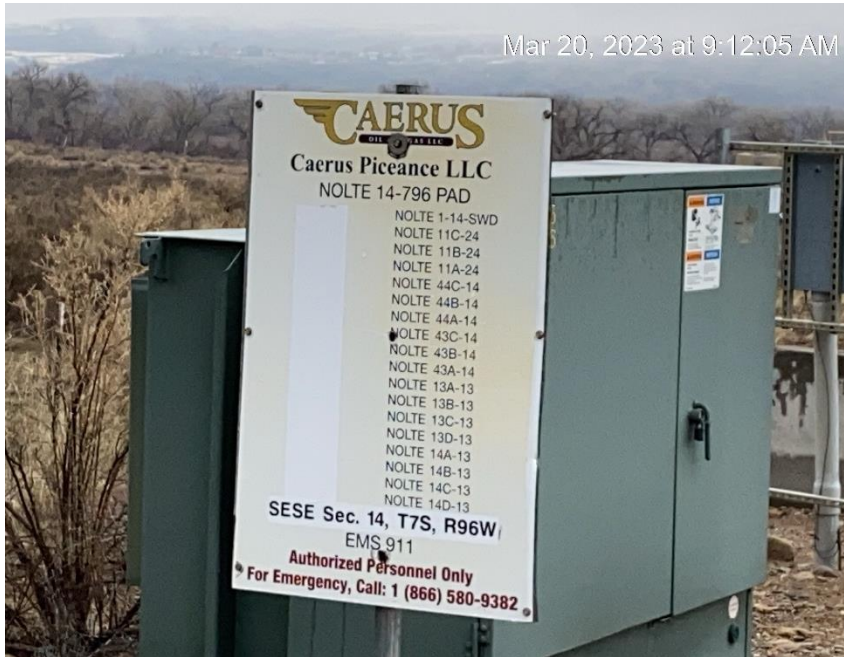
Sign at access road entrance off I70 frontage road

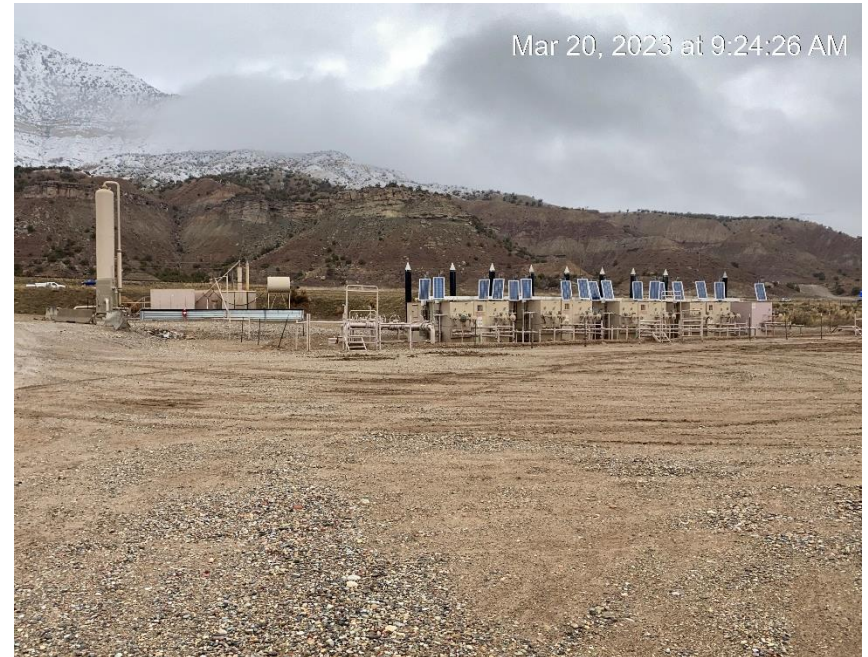
Middle of location looking North

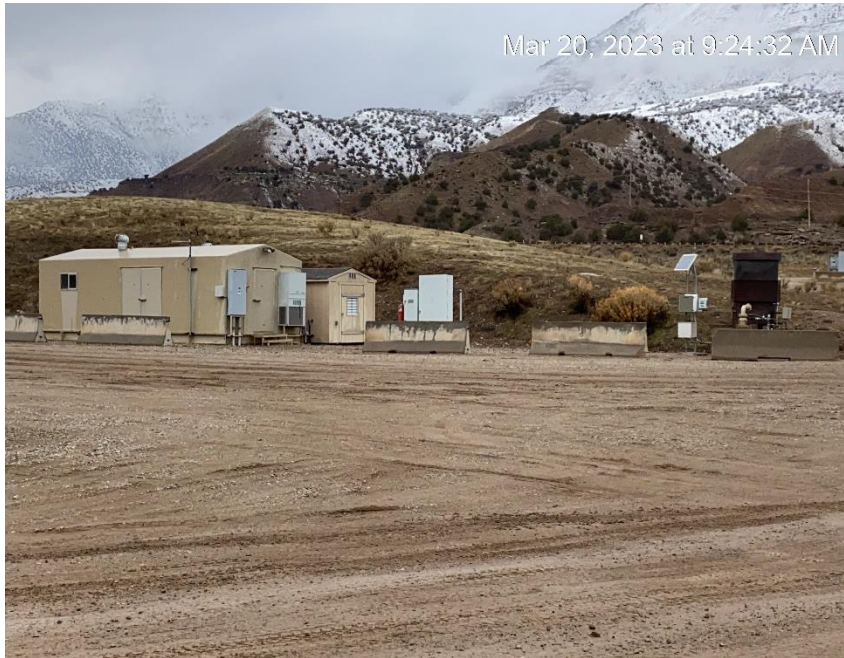
Middle of location looking Northwest

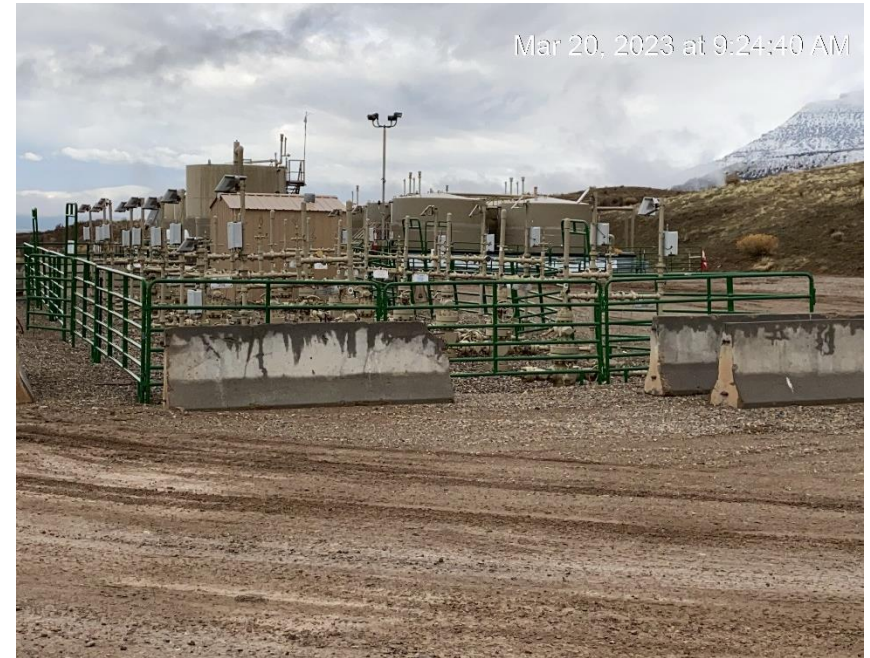
Middle of location looking West

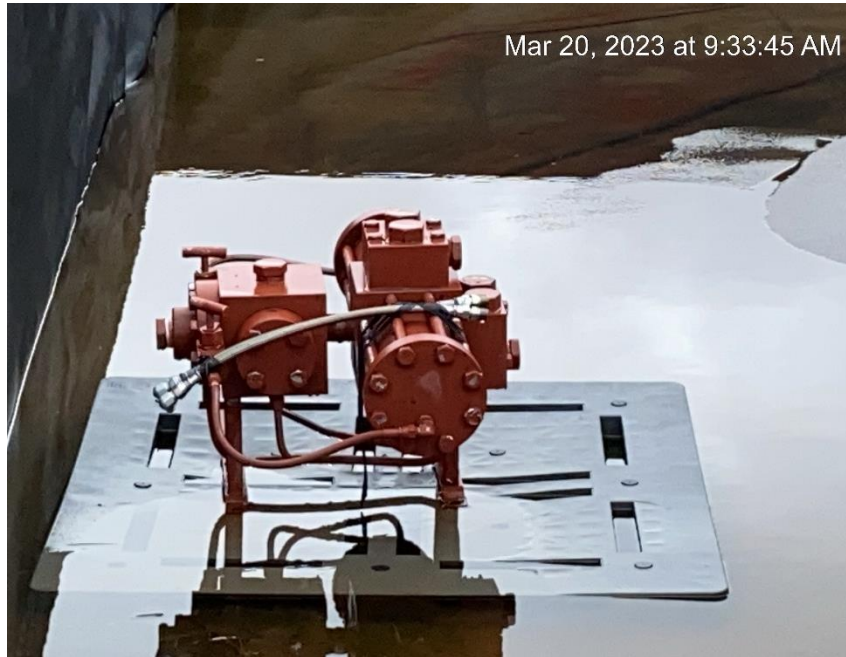
Unused equipment inside Dehy containment

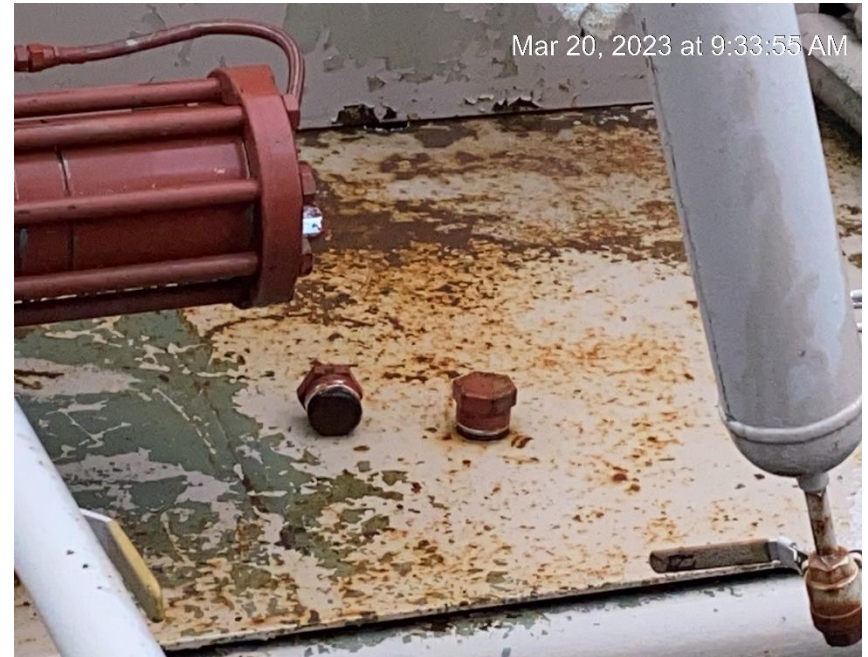
Debris on Dehy skid

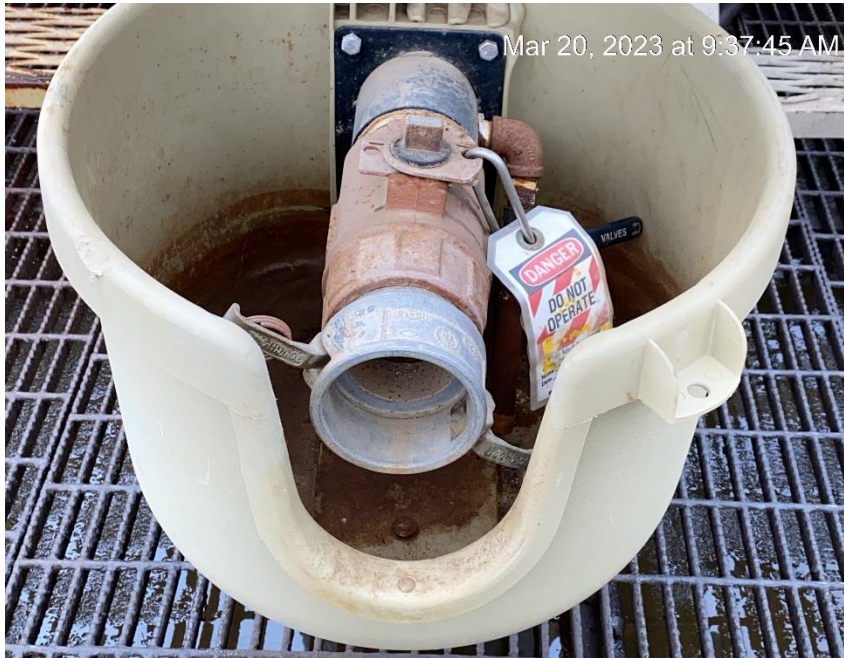
Open end loadline

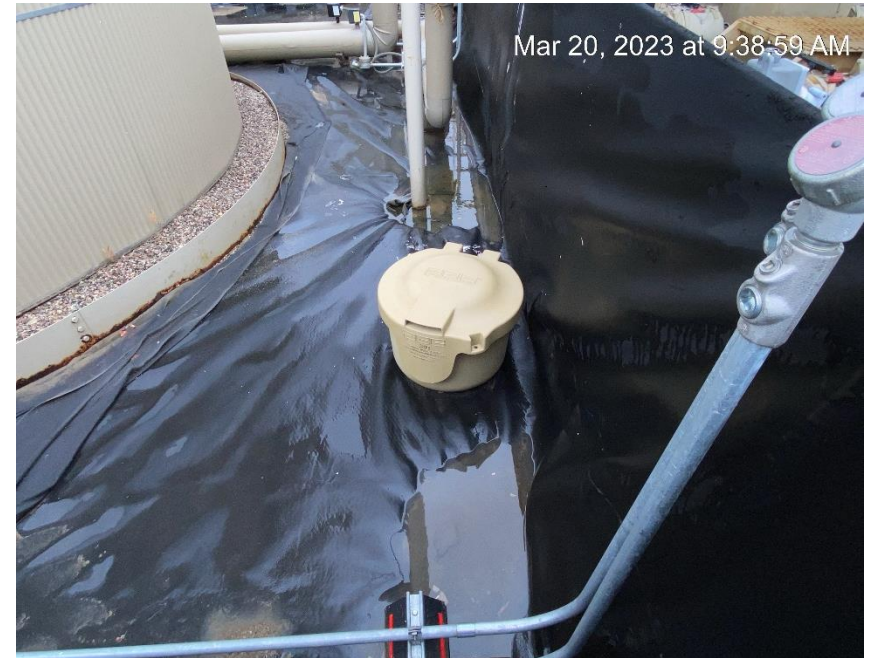
Unused equipment inside tank battery

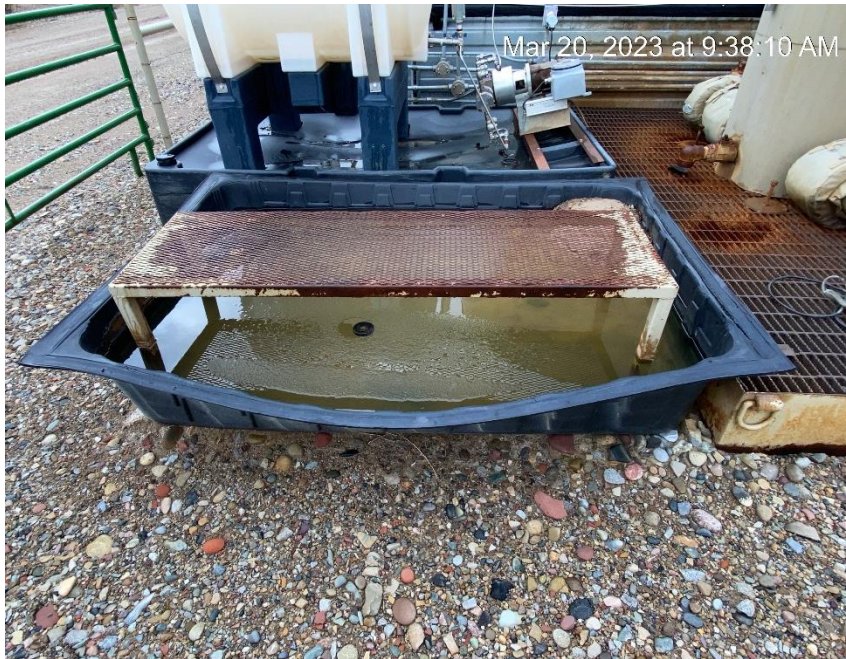
Unused equipment. Containment open to wildlife.

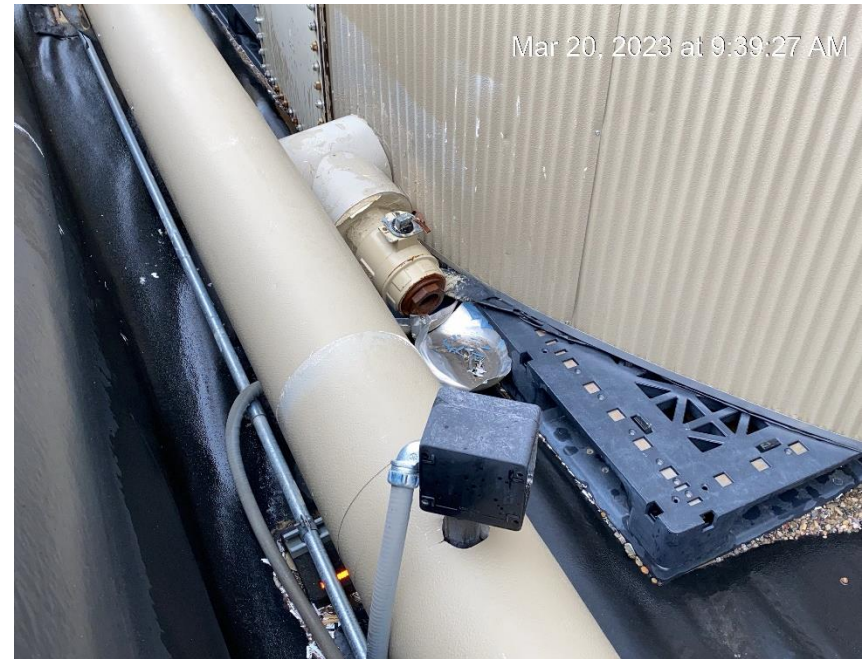
Debris. Open end tank valve.

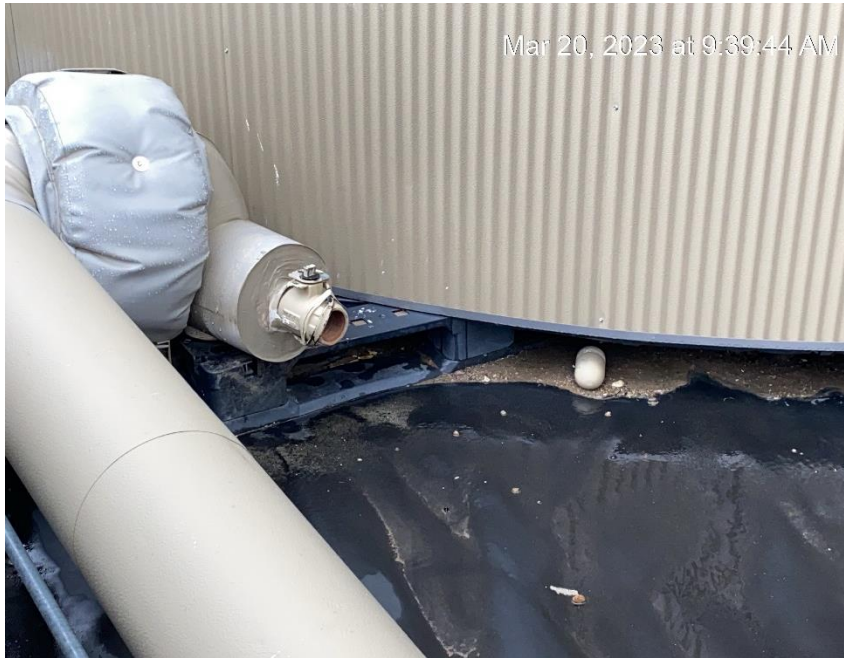
Debris. Open end tank valve.

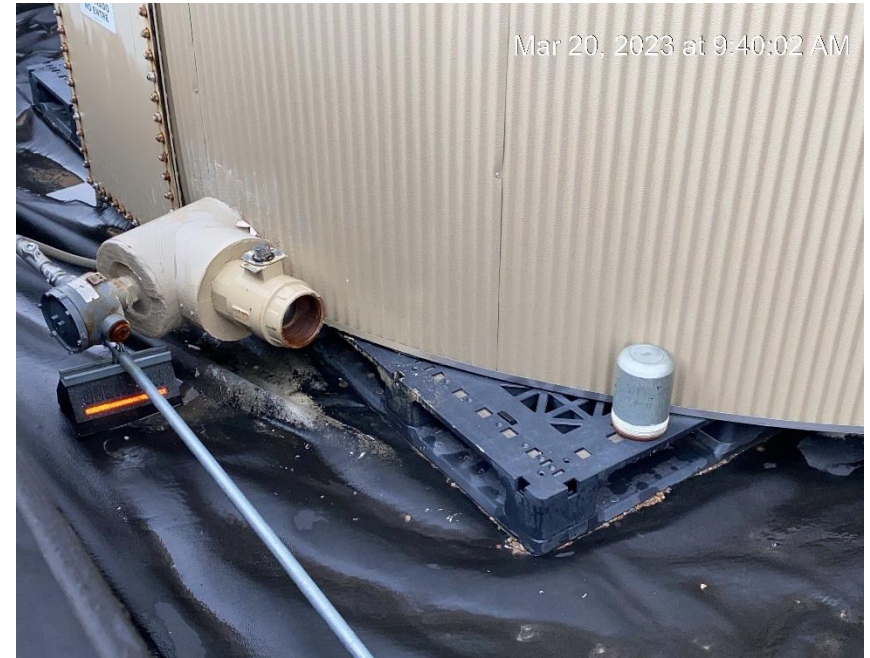
Debris. Open end tank valve.

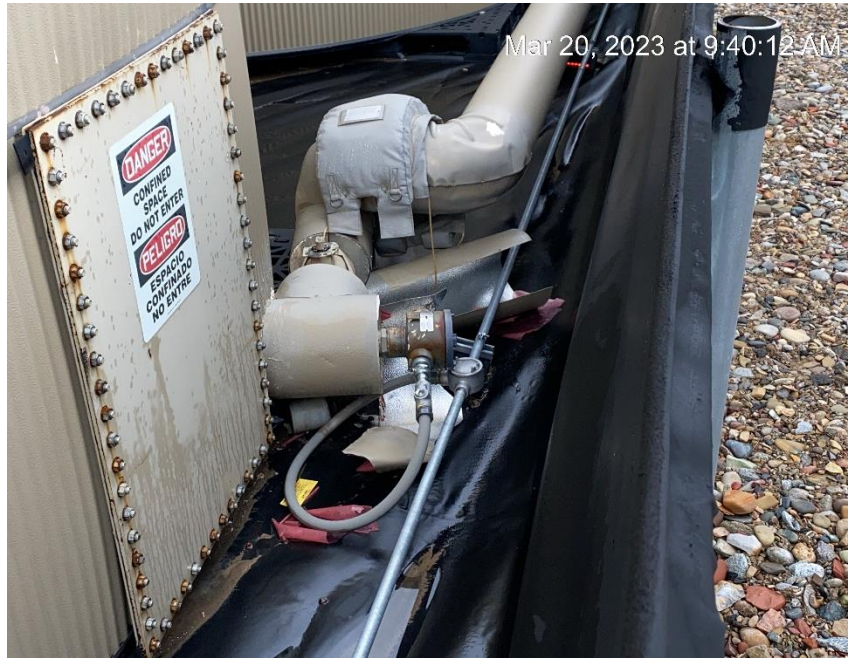
Debris inside tank containment

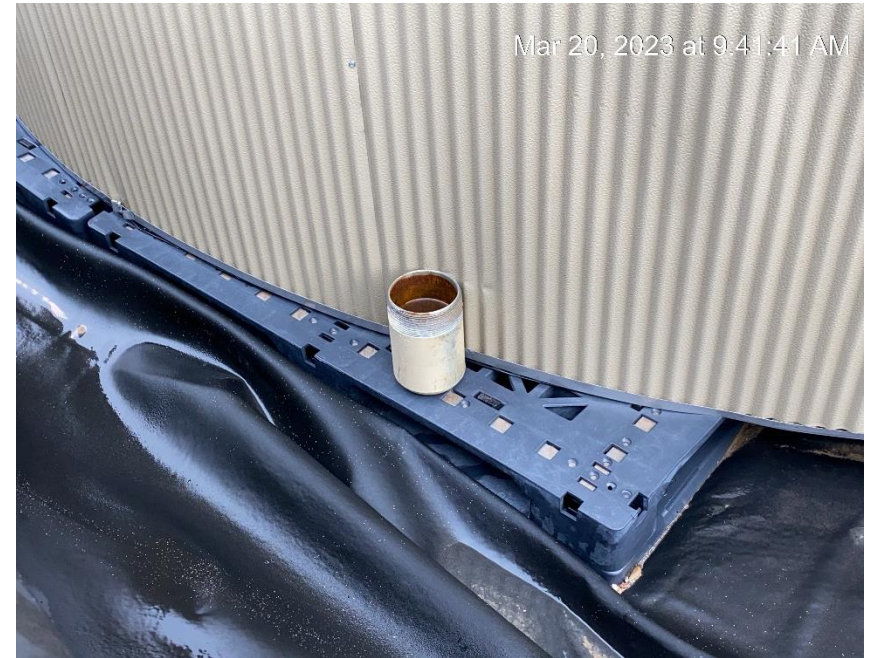
Debris inside tank containment

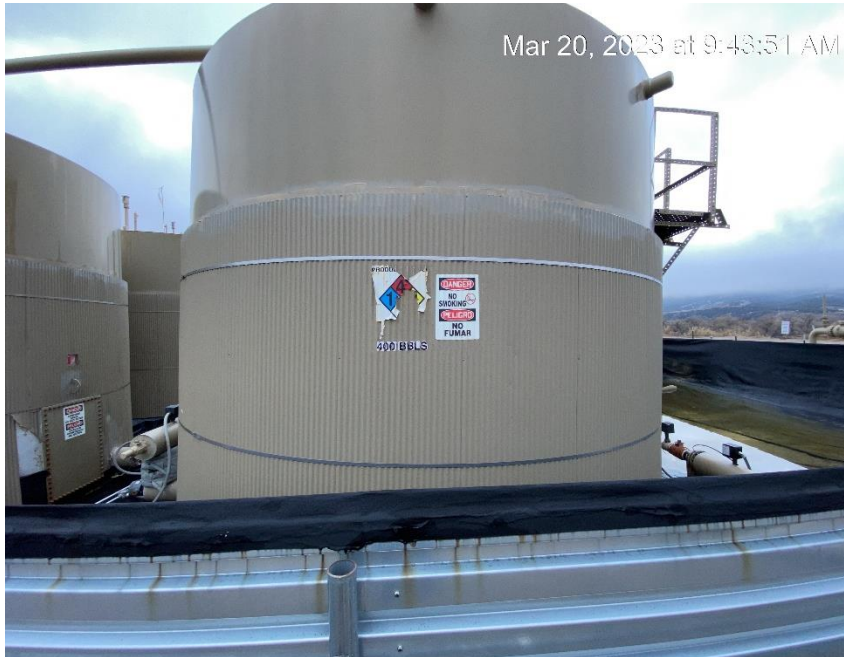
Peeled label. Lacking Name of Operator and Operator emergency contact information.

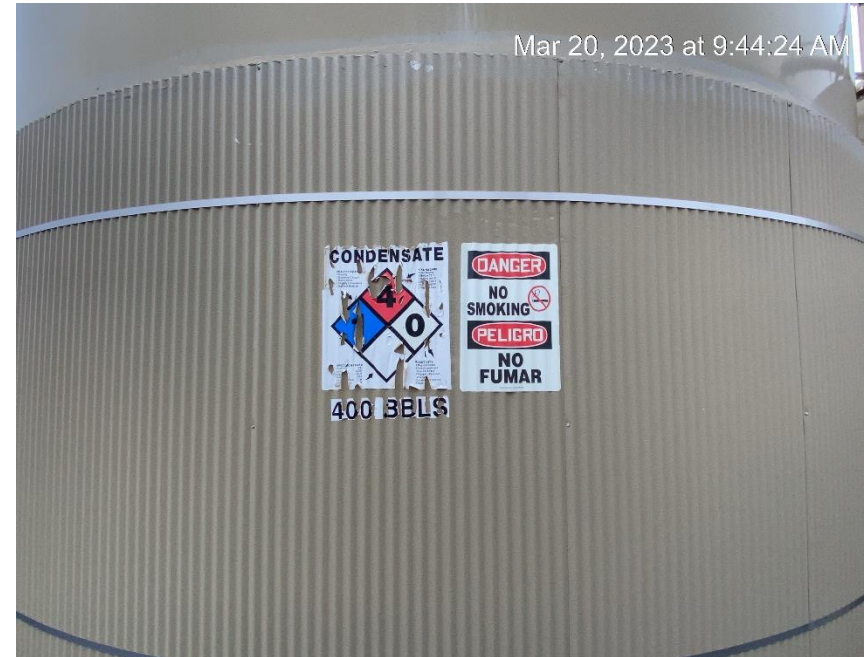
Peeled label. Lacking Name of Operator and Operator emergency contact information.

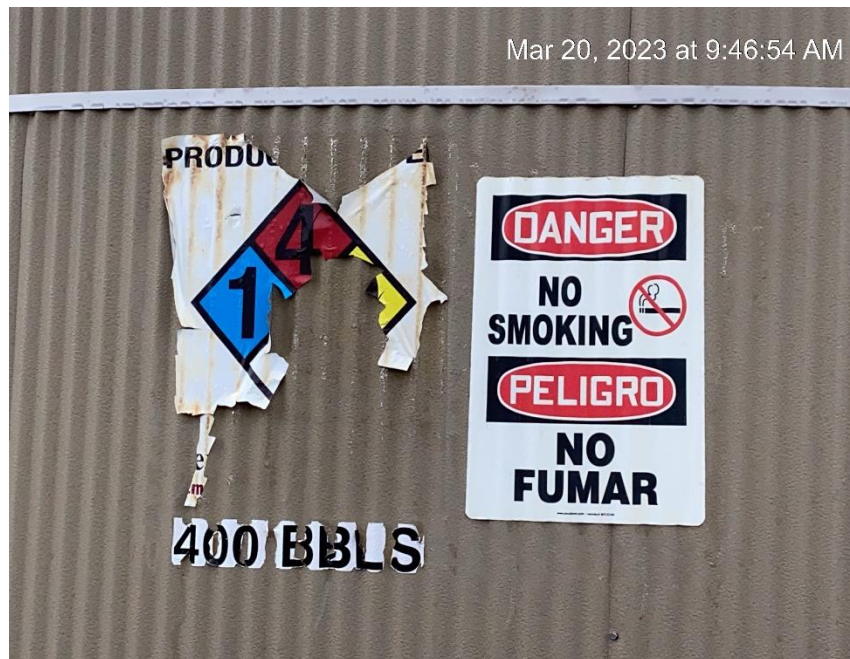
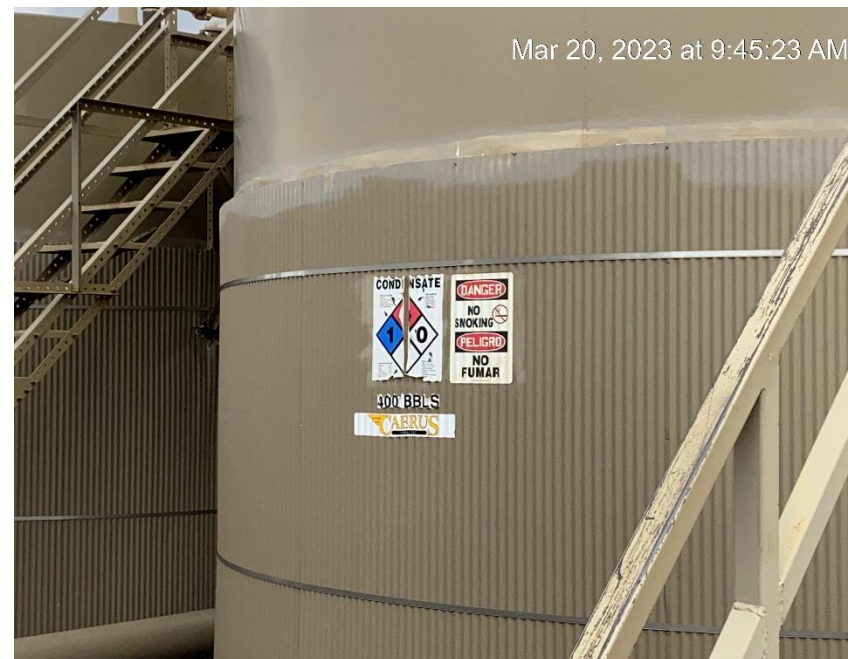
**Peeled label. Lacking Name of Operator and
Operator emergency contact information.**

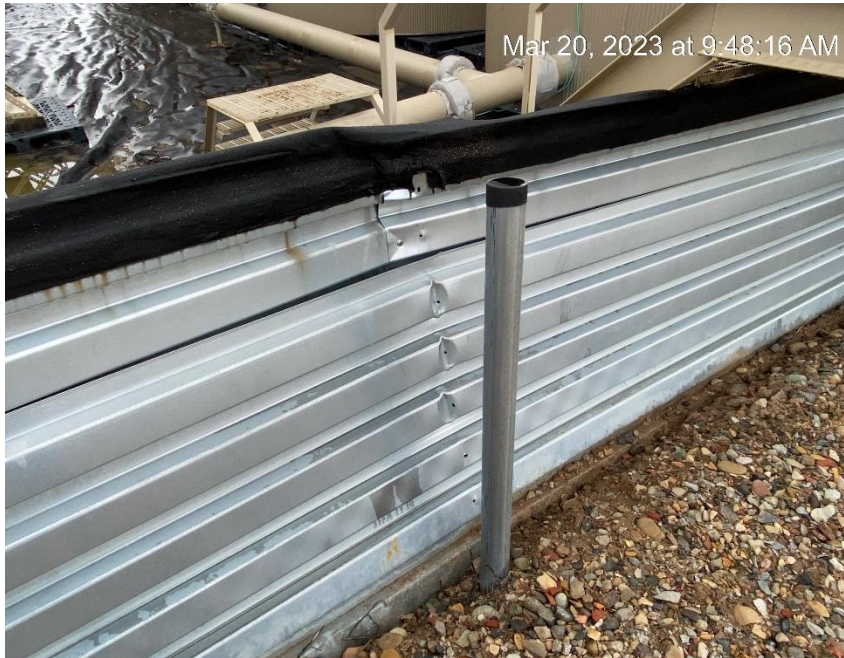
Containment pulled from anchor post

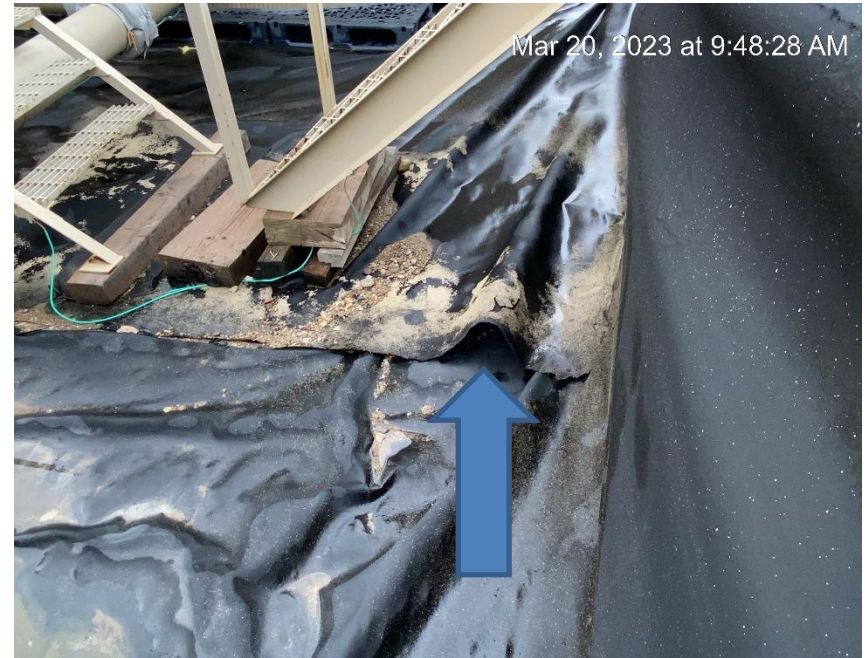
Liner pulled apart inside of containment

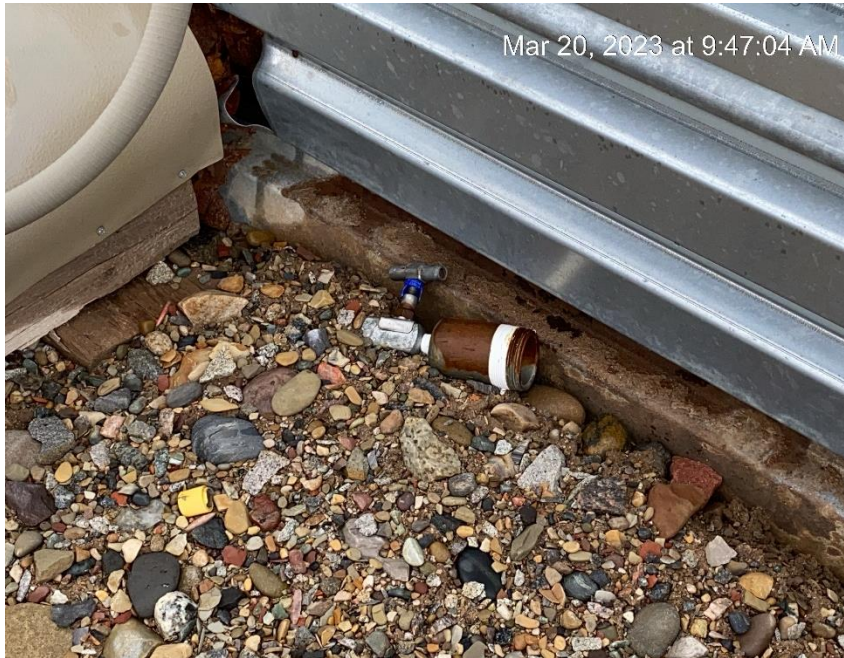
Debris outside tank containment

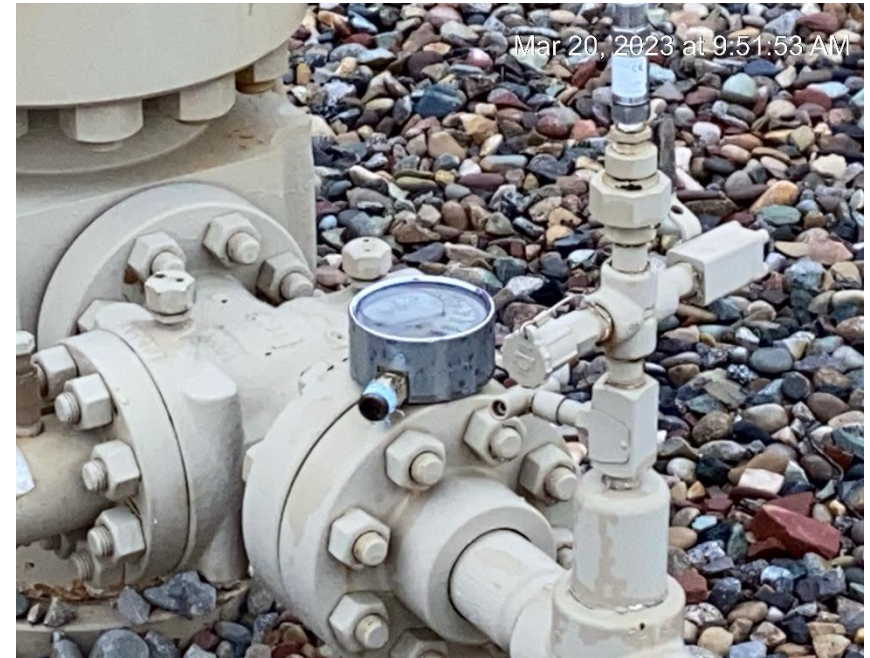
Debris at wellhead

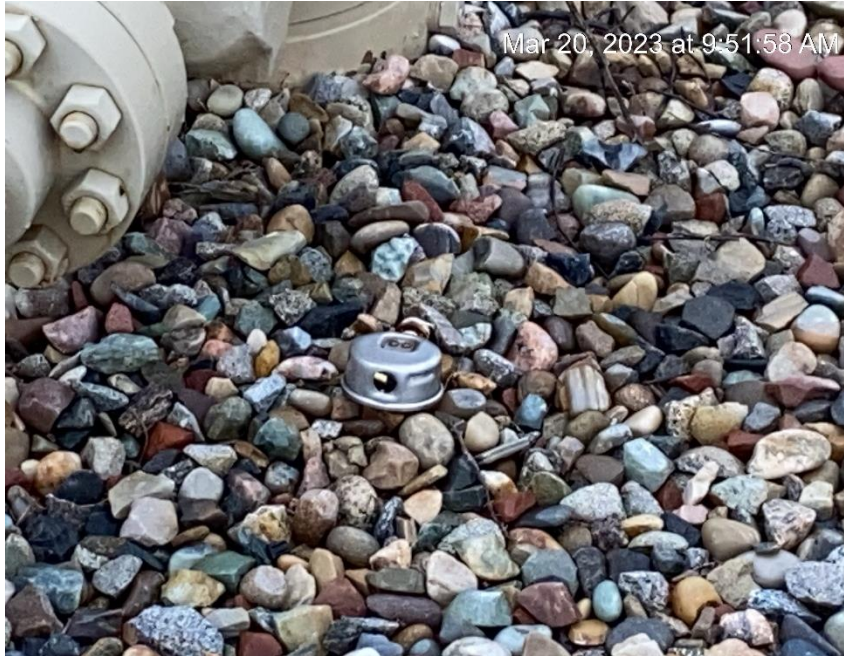
Debris at wellhead

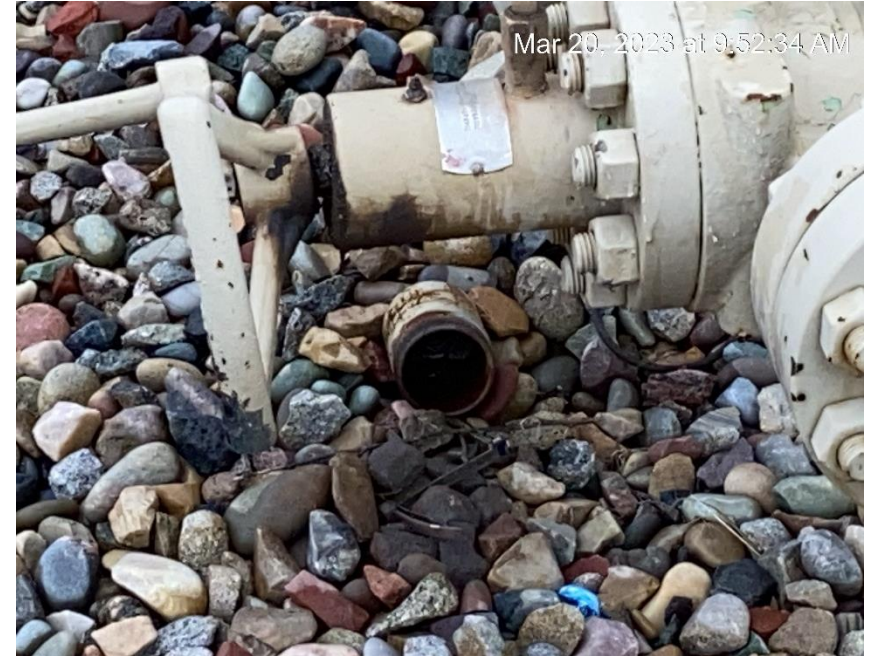
Debris at wellhead

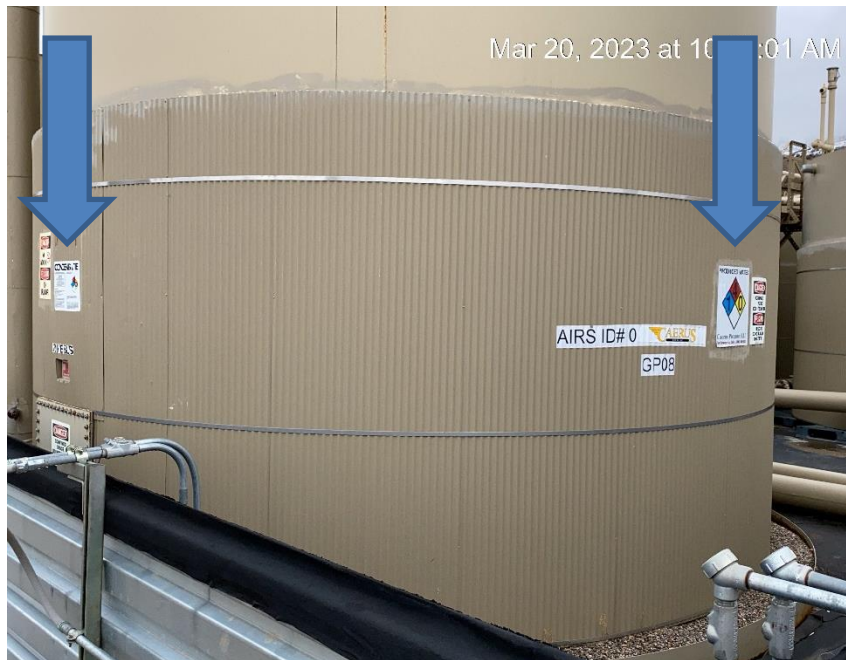
Condensate or Produced Water? Conflicting labels

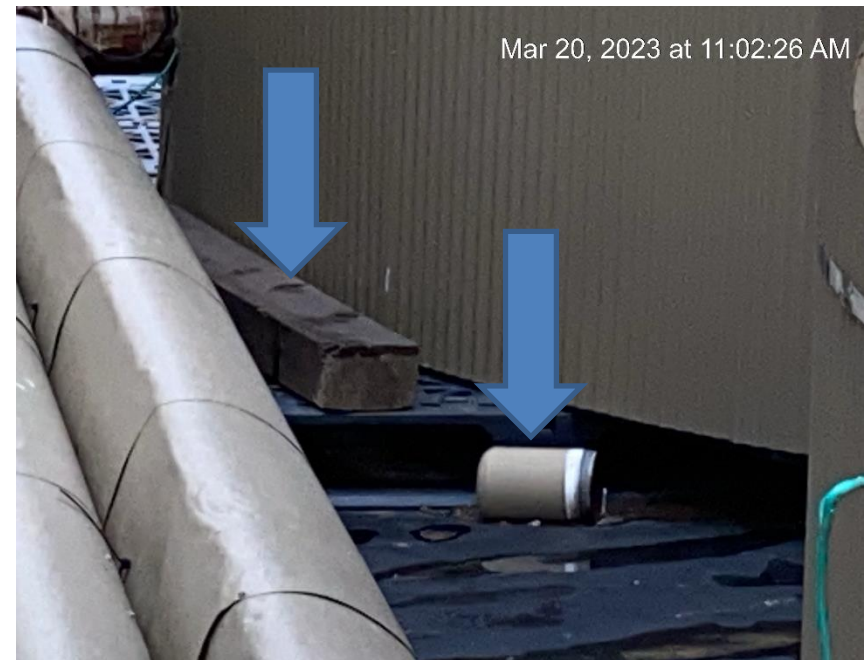
Debris inside tank containment

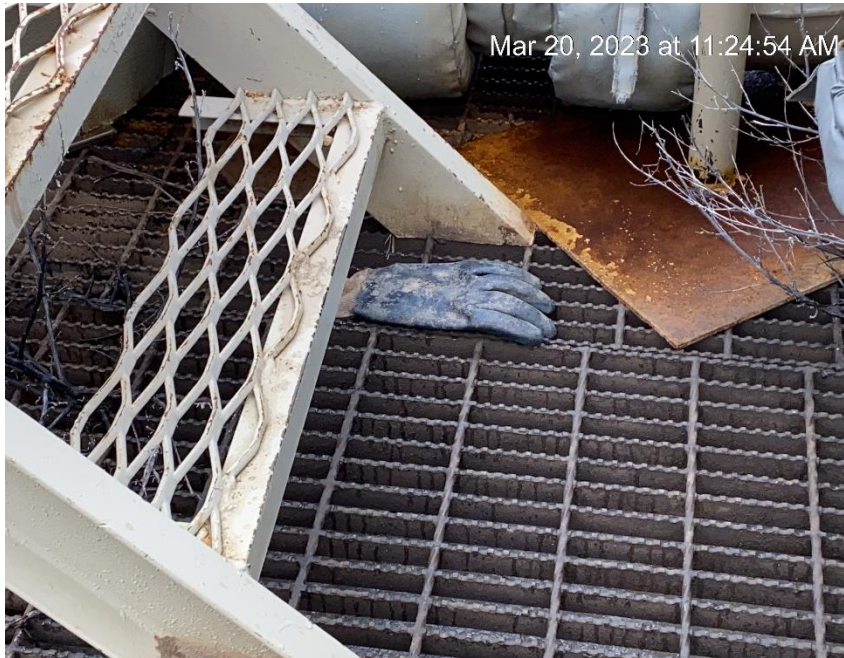
Debris at filter skid.

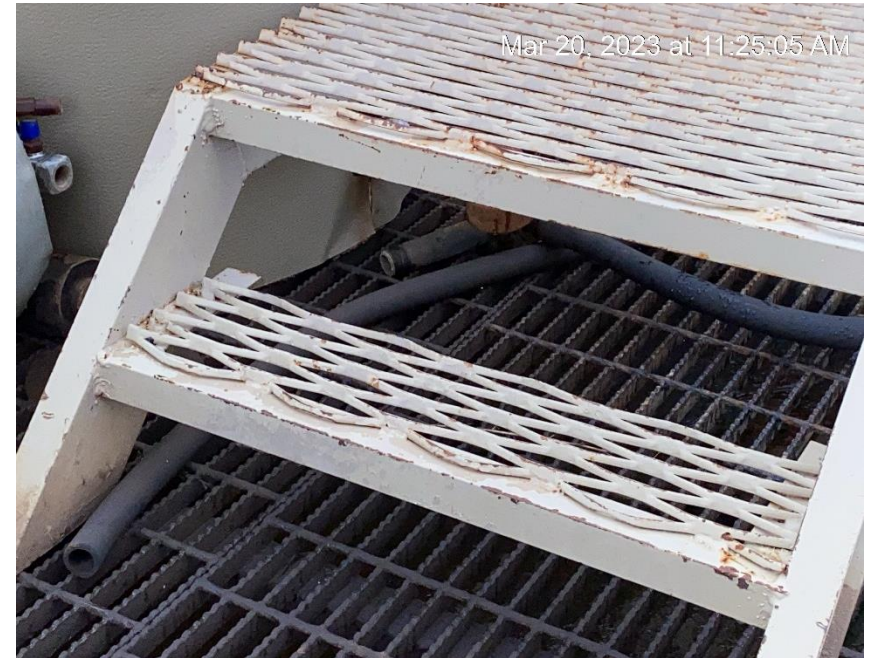
Debris at filter skid.
