Inspection Photos

Location Name: TEP ROCKY MOUNTAIN LLC CLOUGH RWF 533-22 pad

Location ID: 335367

COLORADO
Oil & Gas Conservation
Commission
Department of Natural Resources

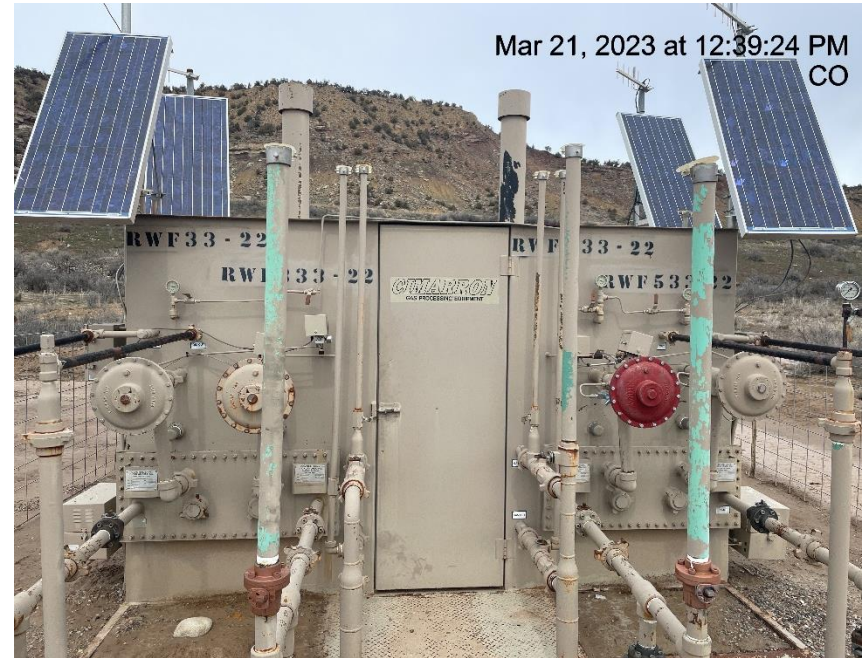
Photo # 2750 Meter calibration info not conspicuously posted

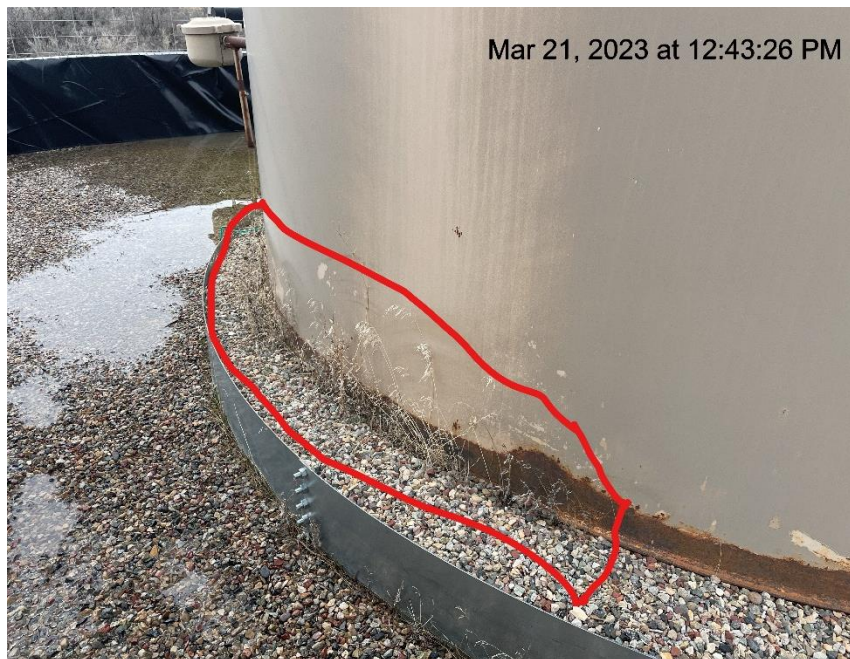
Photo # 2755 Undesirable plant species

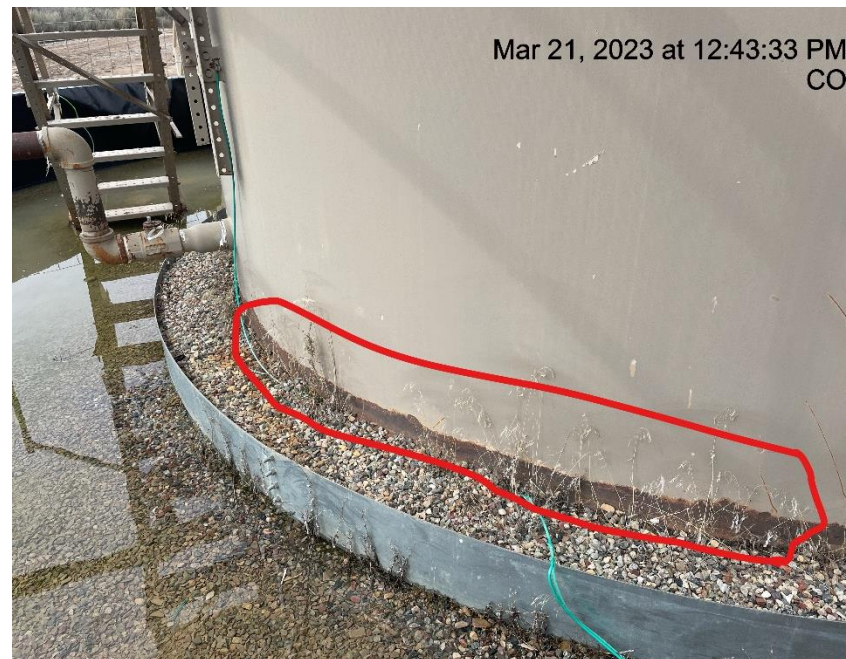
Photo # 2756 Undesirable plant species

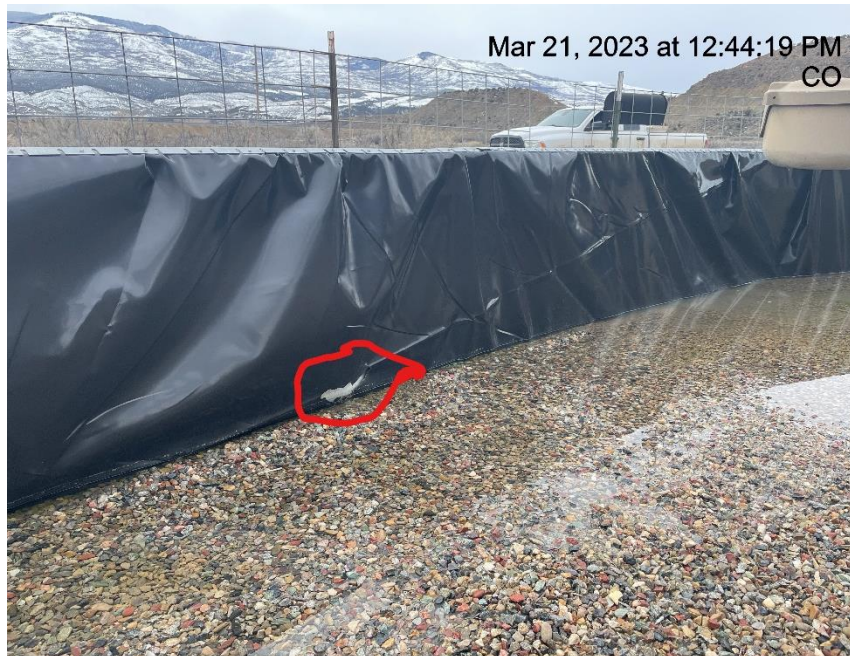
Photo # 2758 Containment liner needs maintenance

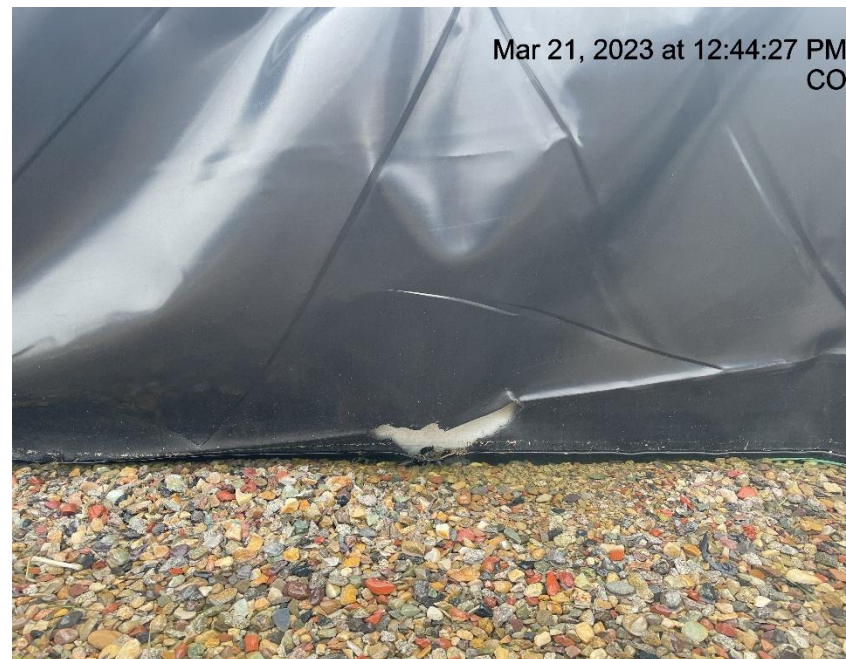
Photo # 2759 Containment liner needs maintenance

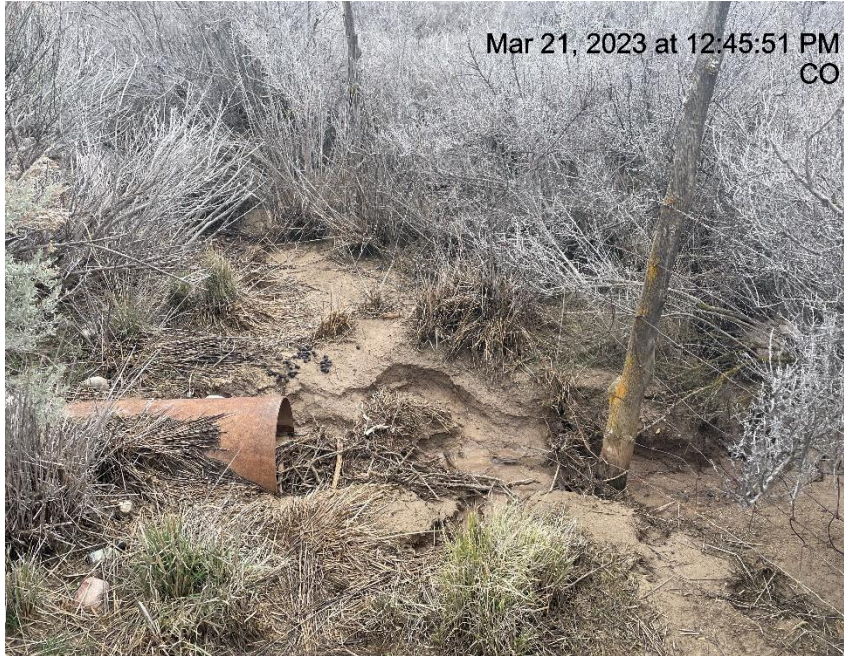
Photo # 2761 Culvert needs maintenance (Culvert is near entrance to location)

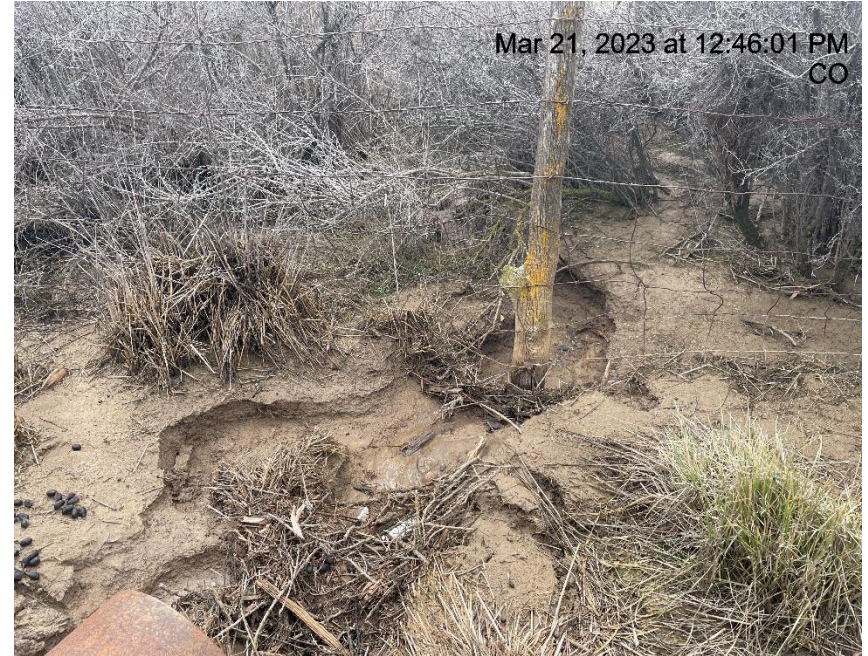
Photo # 2762 Gully erosion at culvert insufficient BMP's (Culvert is near entrance to location)

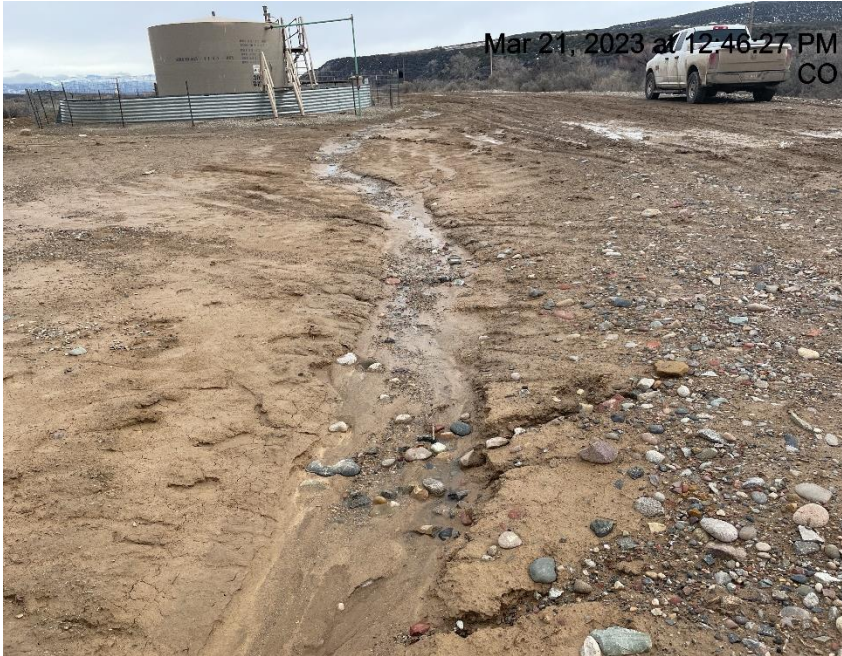
Photo # 2763 – Rill erosion/ditch needs maintenance

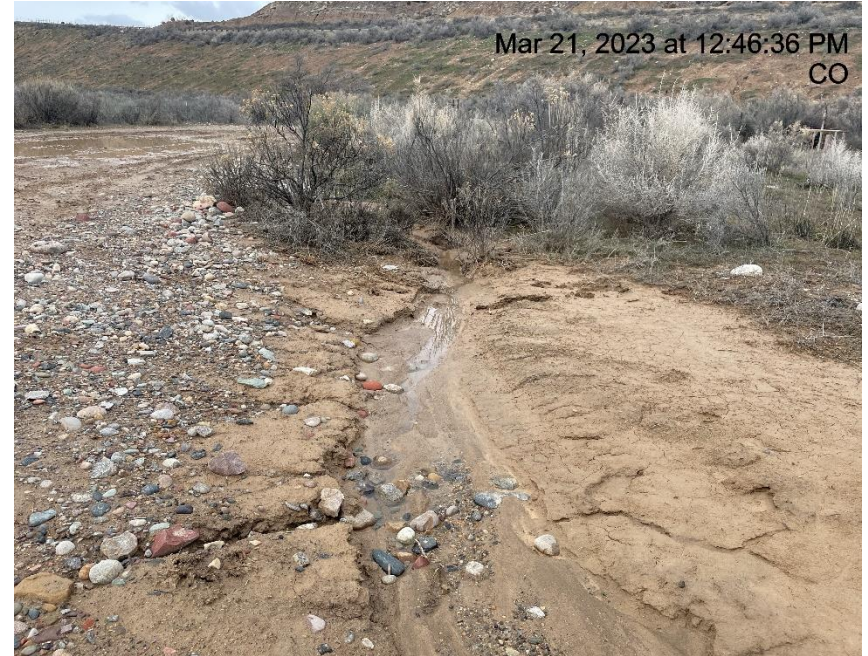
Photo # 2764 Rill erosion/ditch needs maintenance

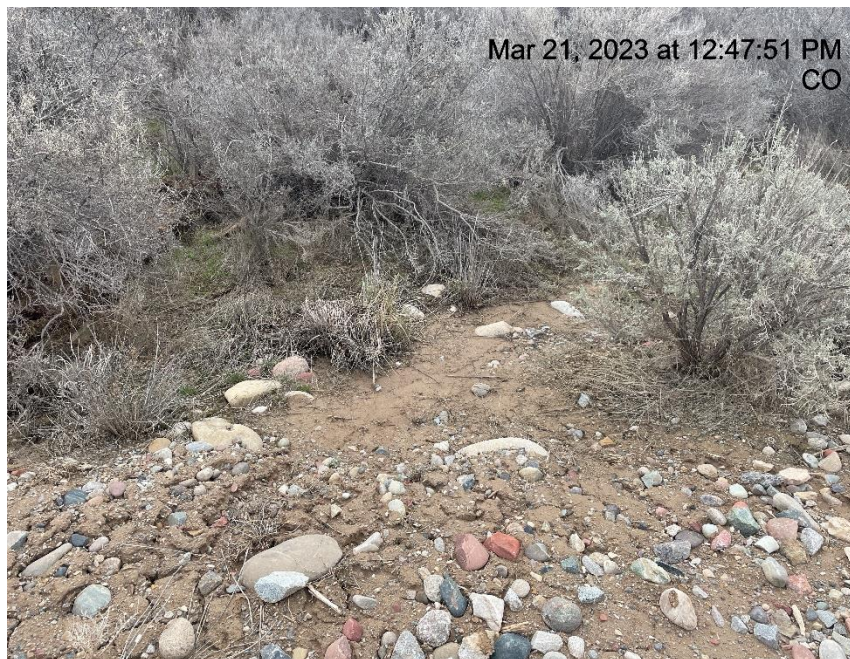
Photo # 2767 Rill erosion/transport of sediment off location

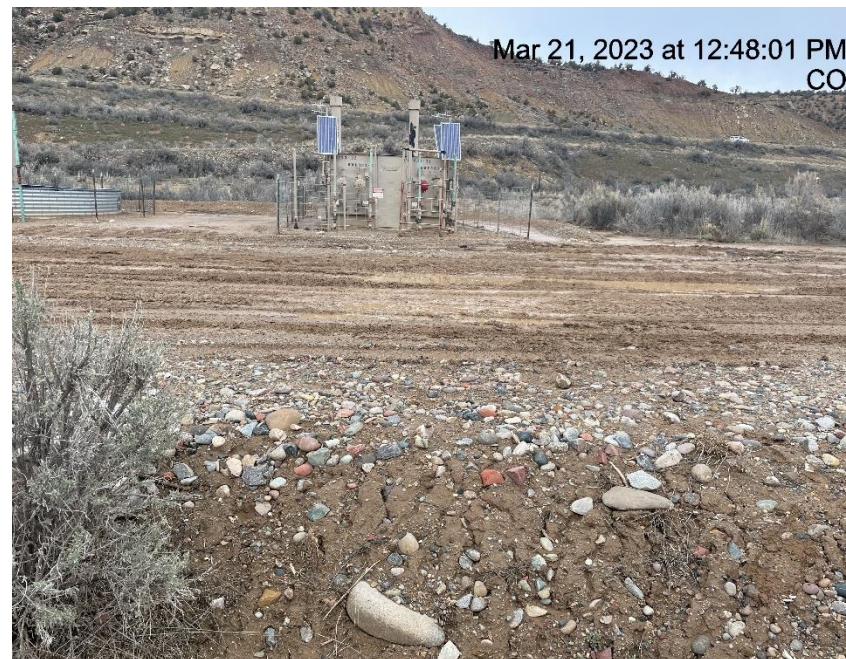
Photo # 2768 Rill erosion

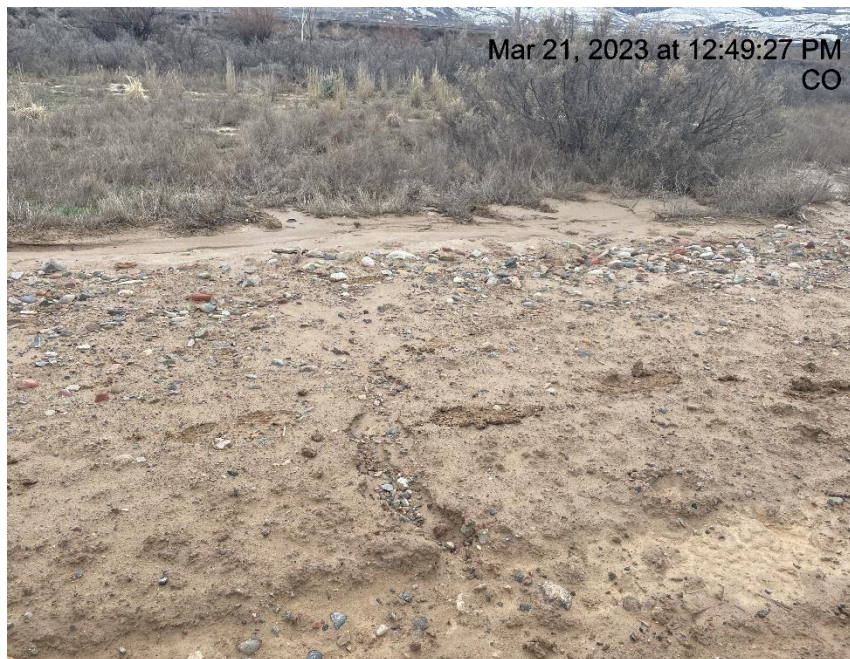
Photo # 2770 Rill erosion & transport of sediment off location (south side of location)

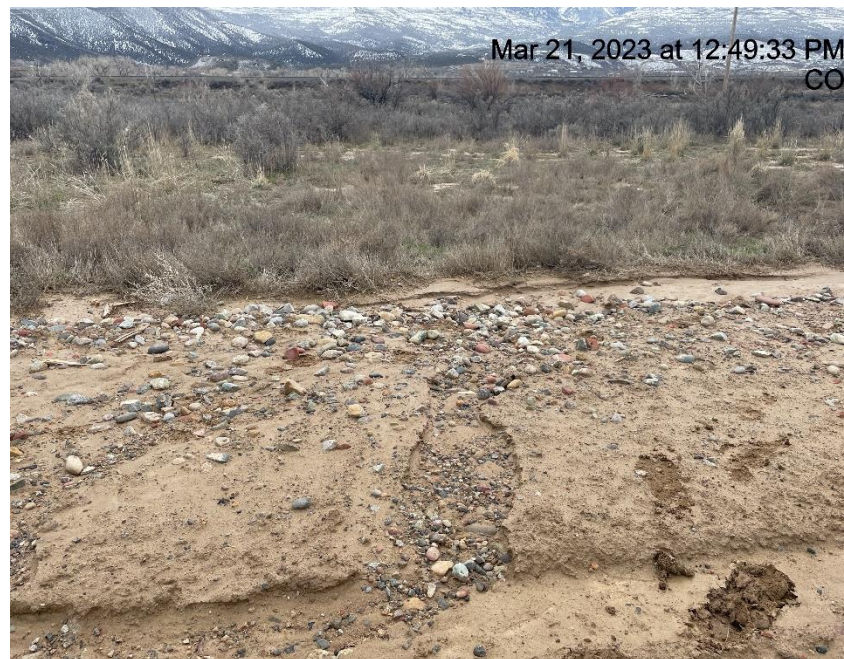
Photo # 2771 Rill erosion (south side of location)

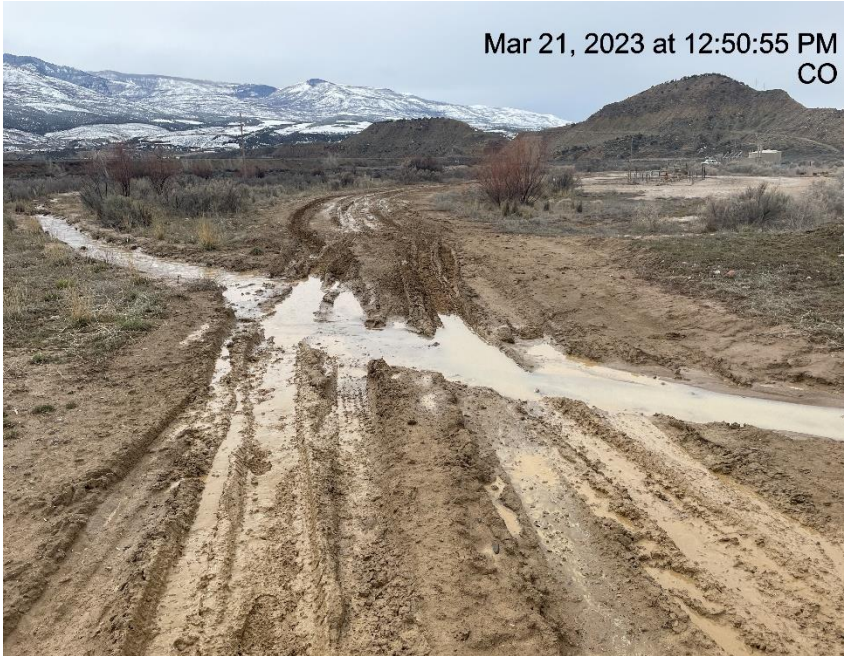
Photo # Degradation of roadway/insufficient BMP's (east side of location)

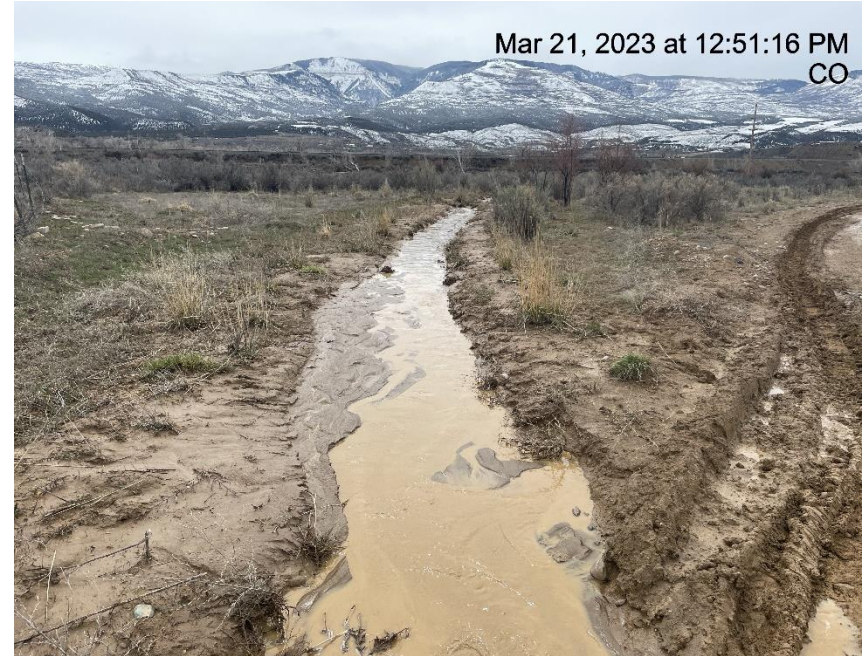
Photo # 2774 Ditch needs maintenance (E/SE side of location)

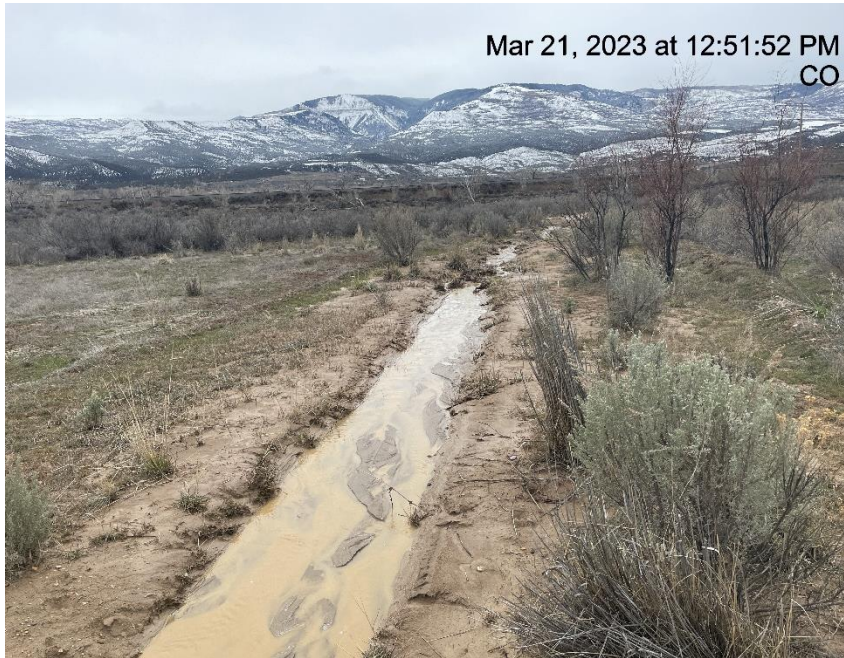
Photo # 2776 Ditch needs maintenance (E/SE side of location)

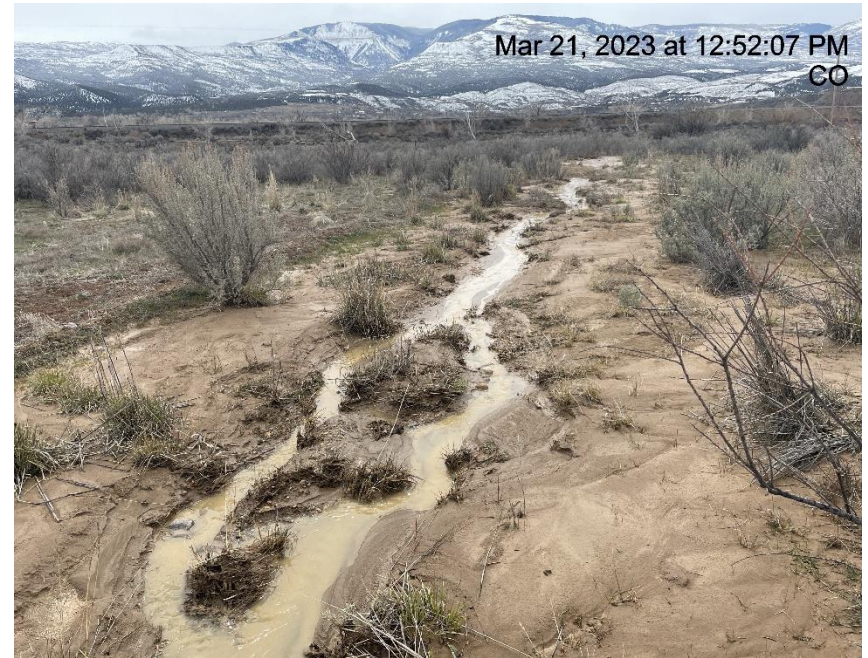
Photo # 2777 Ditch needs maintenance (E/SE side of location)

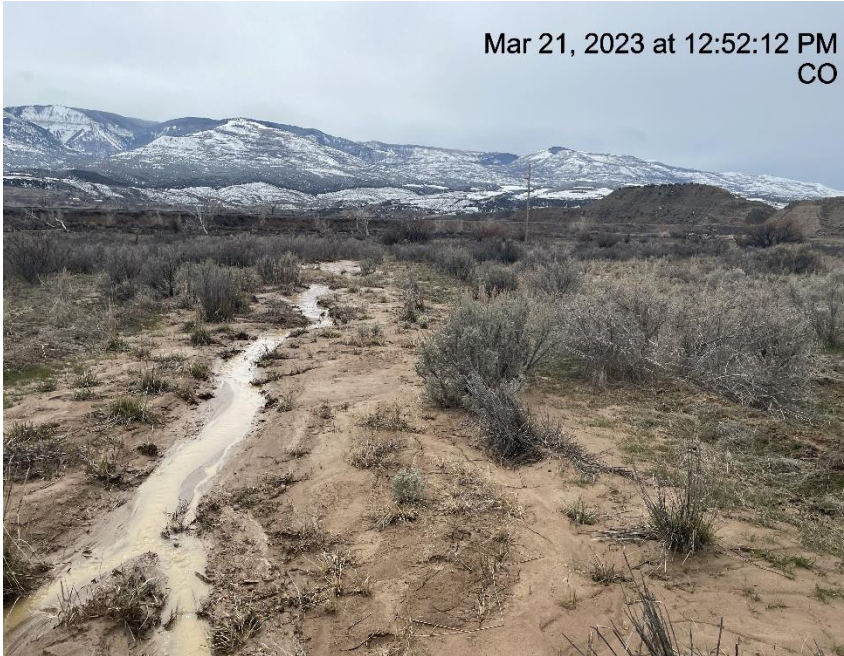
Photo # 2778 Ditch needs maintenance (E/SE side of location)

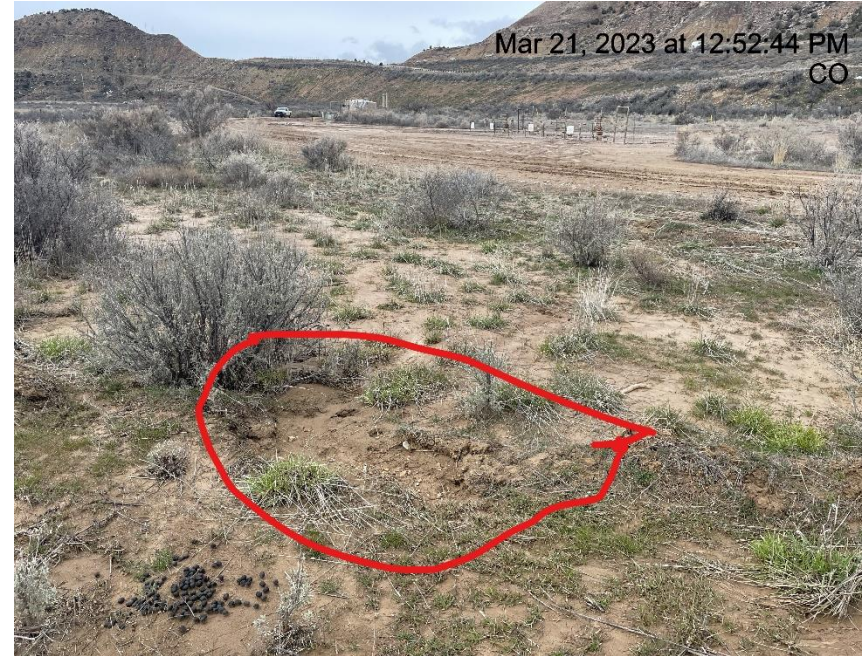
Photo # 2780 Berm needs maintenance/sediment encroaching on & choking off vegetation (S/SE area of location)

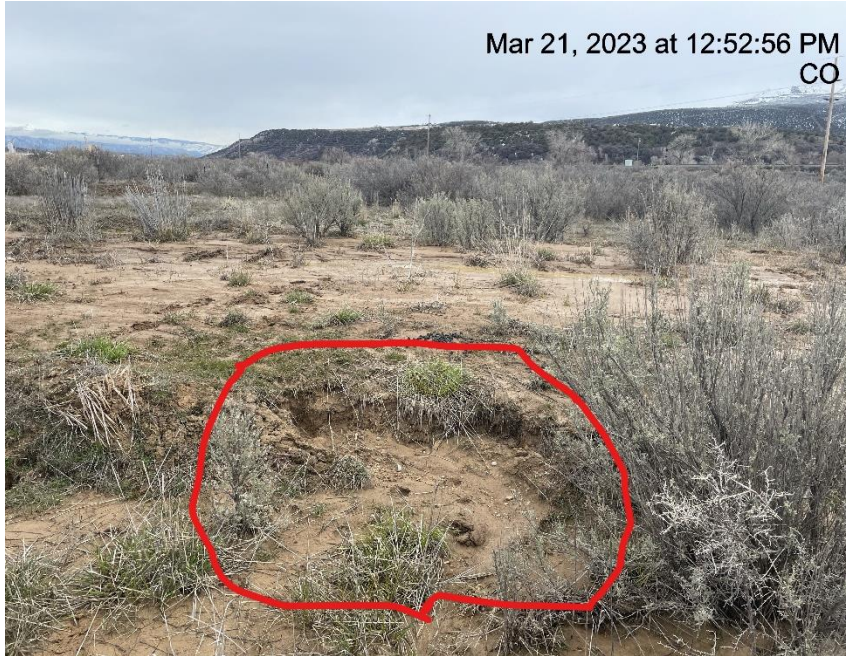
Photo # 2781 Berm needs maintenance/sediment encroaching on & choking off vegetation (S/SE area of location)

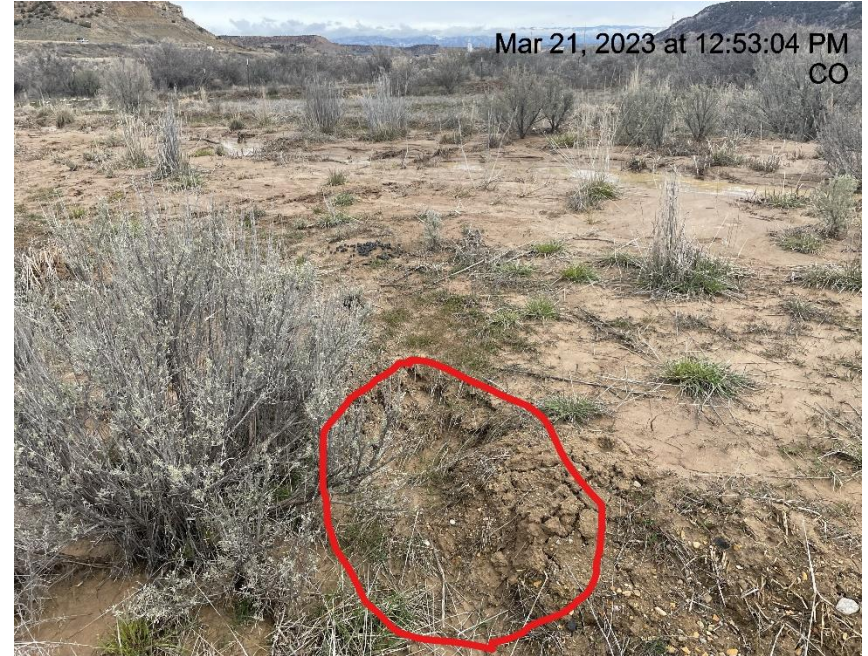
Photo # 2782 Berm needs maintenance/sediment encroaching on & choking off vegetation(S/SE area of location)

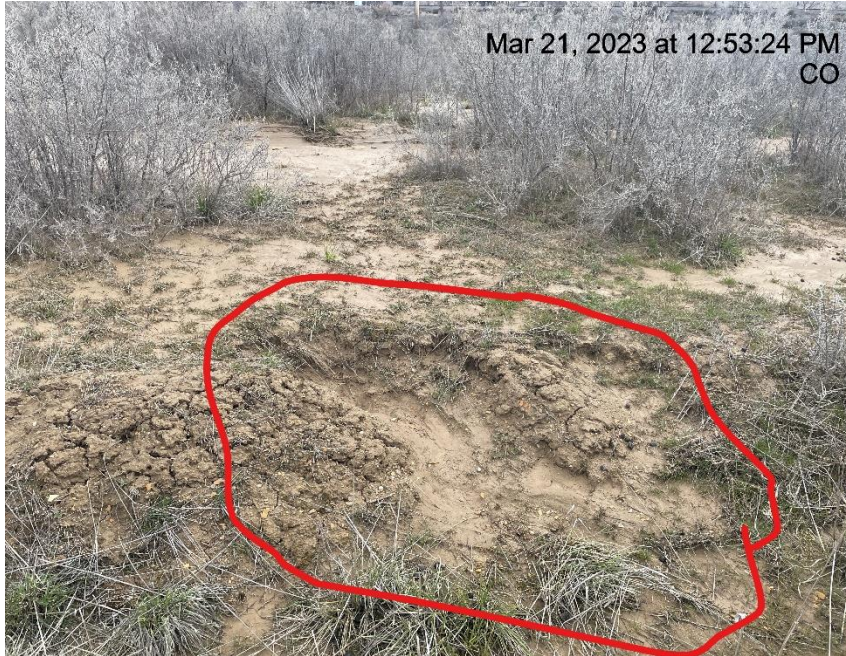
Photo # 2784 Berm needs maintenance/sediment encroaching on & choking off vegetation (S/SE area of location)

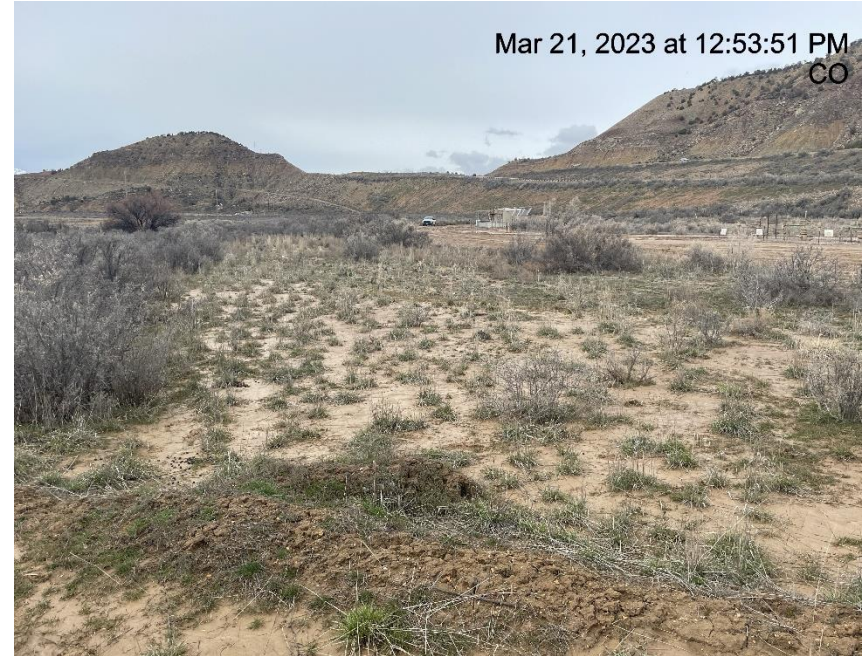
Photo # 2786 Berm needs maintenance/sediment encroaching on & choking off vegetation (S/SE area of location)

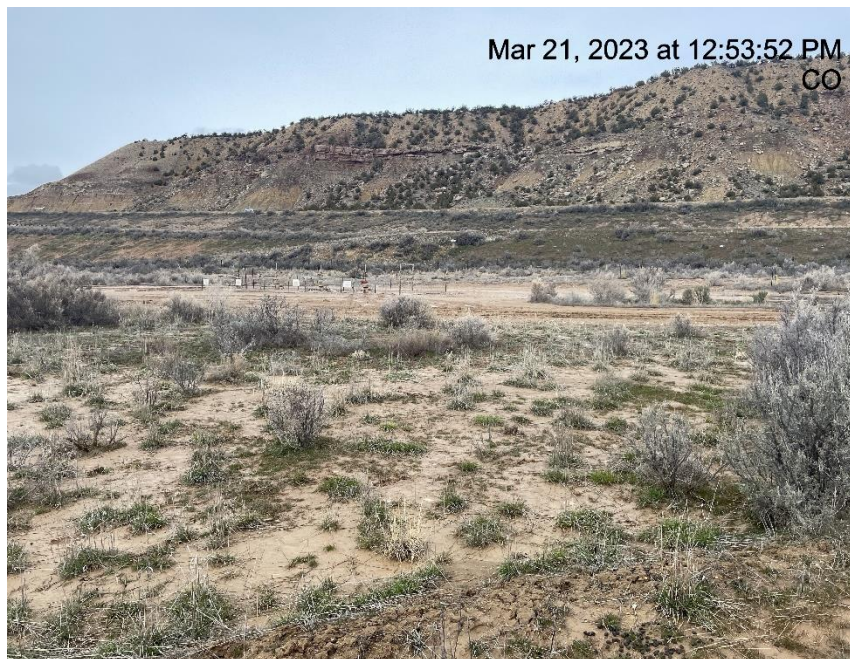
Photo # 2787 Sediment encroaching on & choking off vegetation (S/SE area of location)

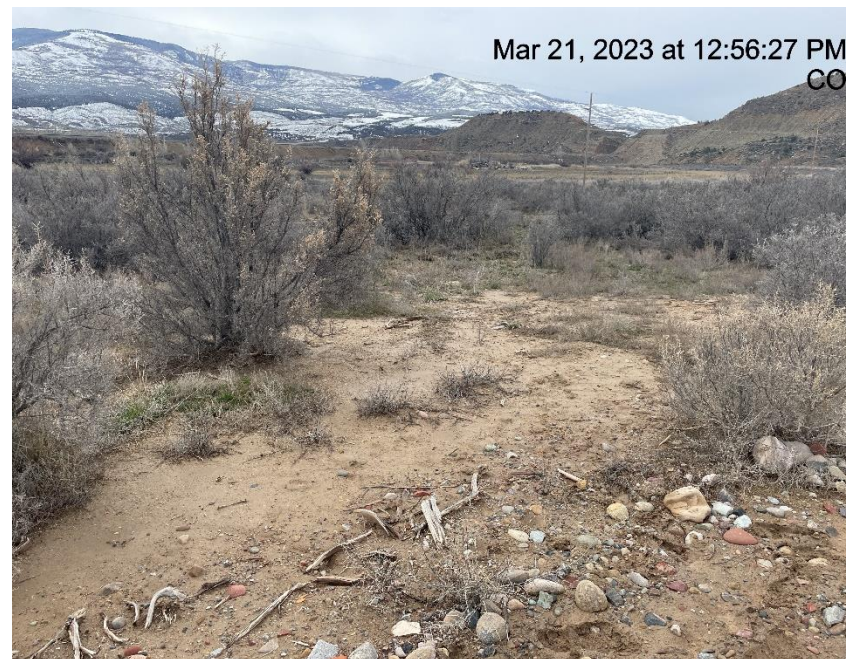
Photo # 2796 Sediment encroaching on & choking off vegetation

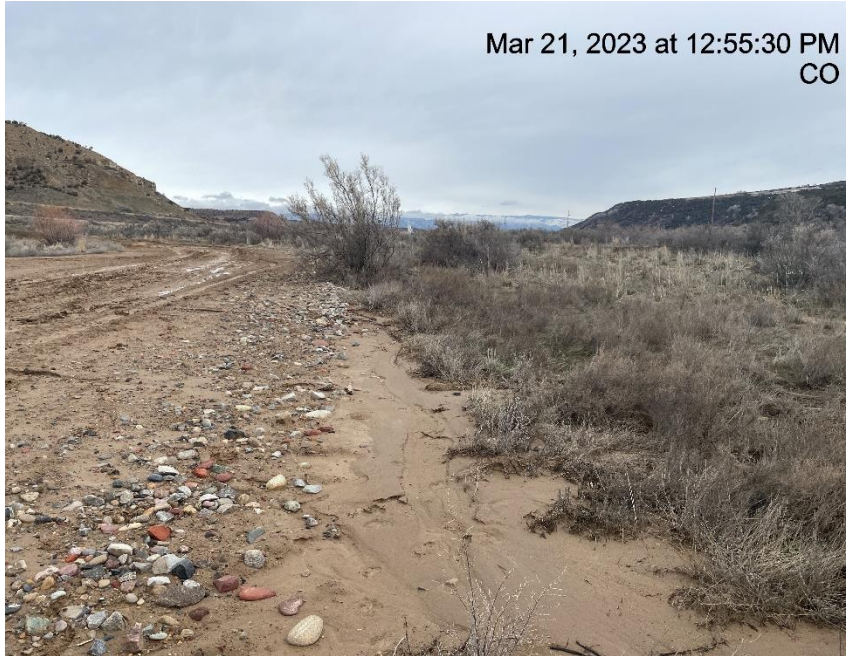
Photo # 2792 Rill erosion & transport of sediment off location (South side of location)

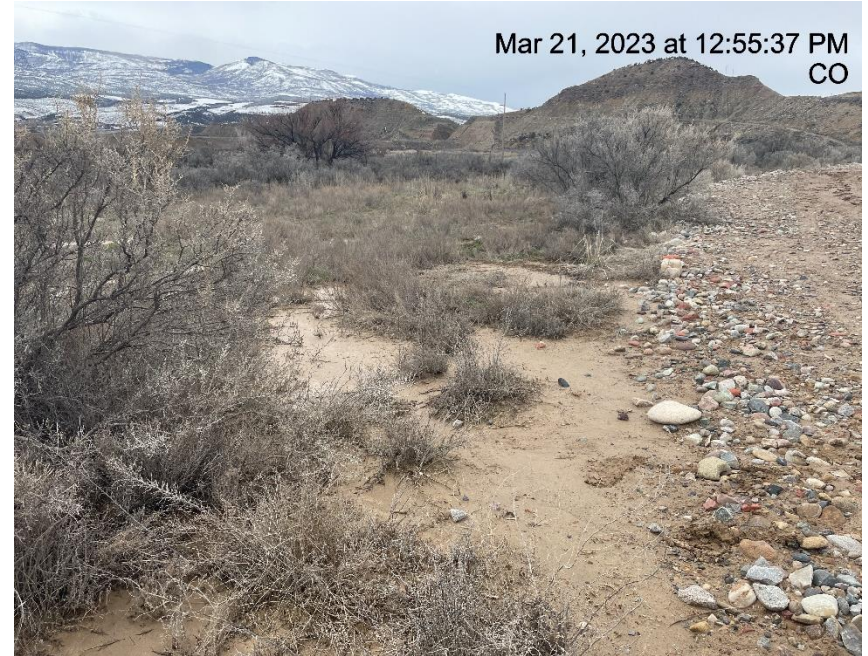
Photo # 2793 Transport of sediment off location/encroaching on & choking off vegetation (south side of location)

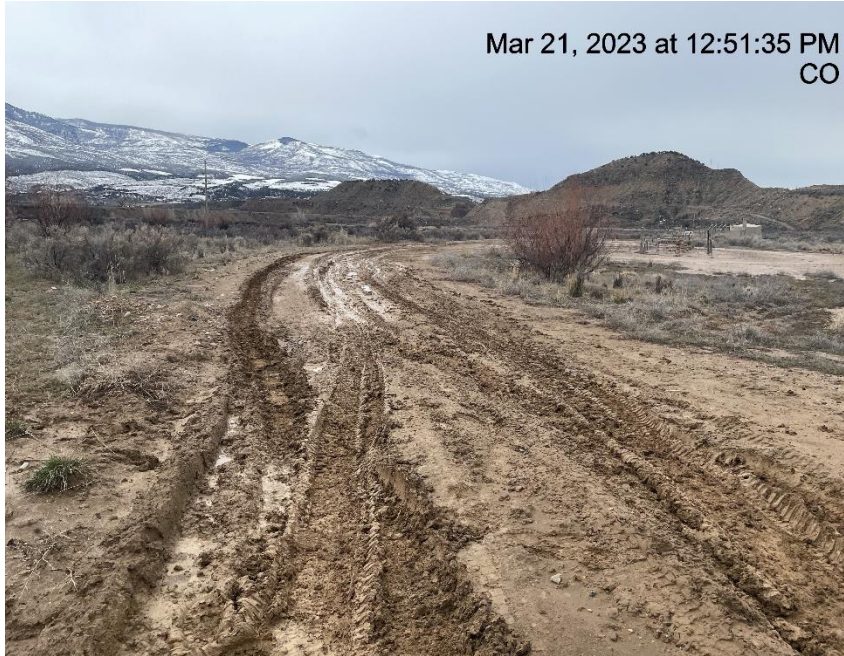
Photo # 2775 Lack of stabilization

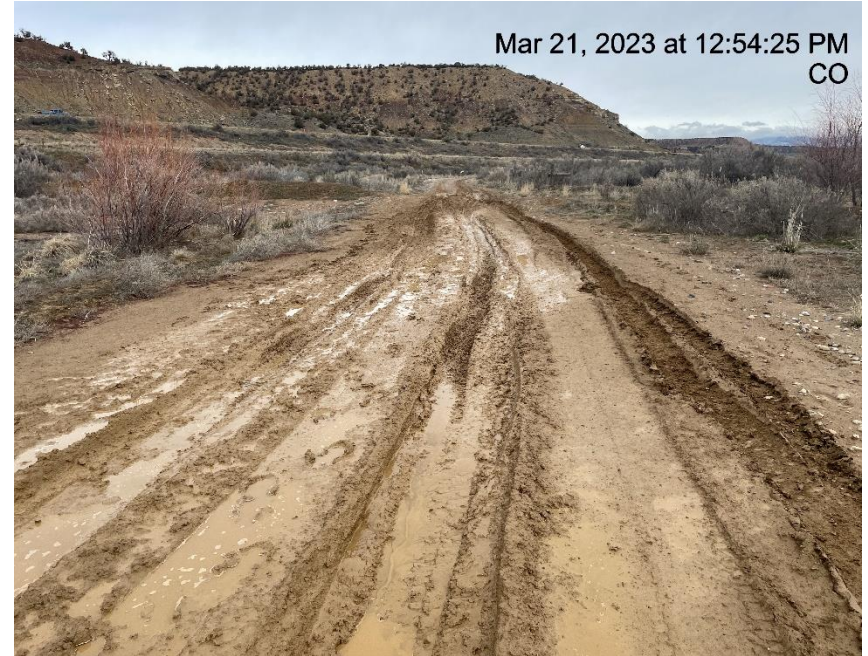
Photo # 2788 Lack of stabilization

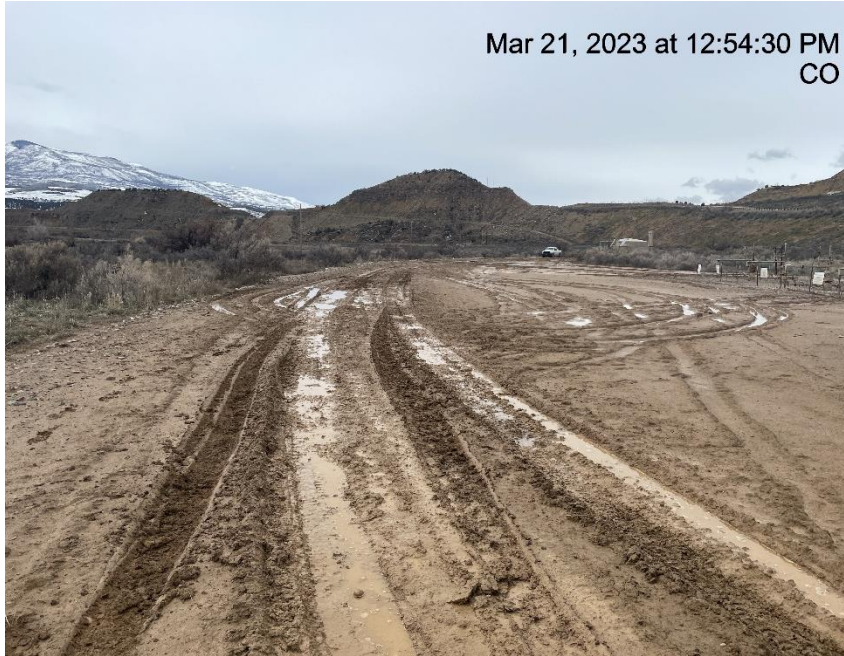
Photo # 2789 Lack of stabilization

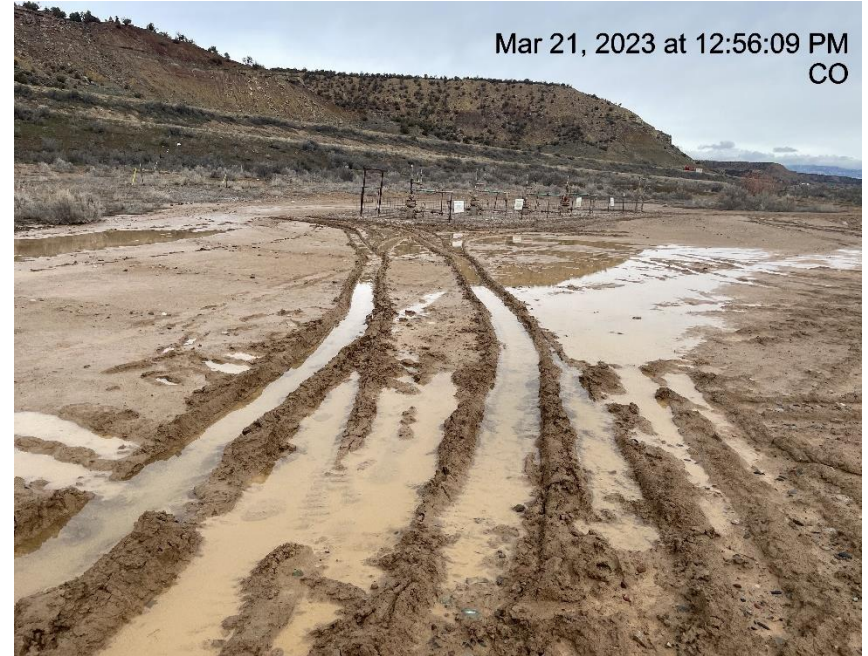
Photo # 2795 Lack of stabilization

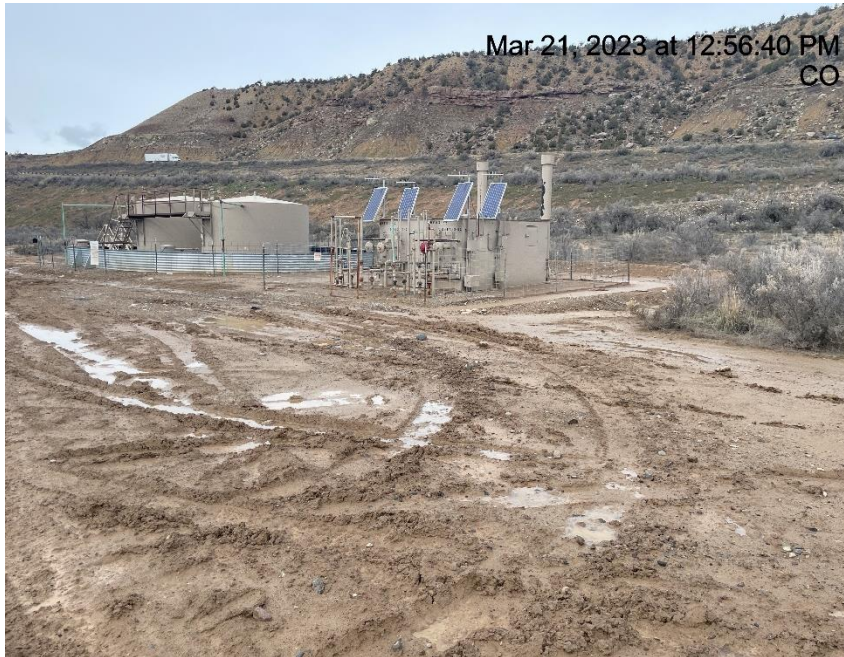
Photo # 2797 Lack of stabilization
