Storm Water Management and Erosion control

Location Name: McPhearson A

Location #: 335539

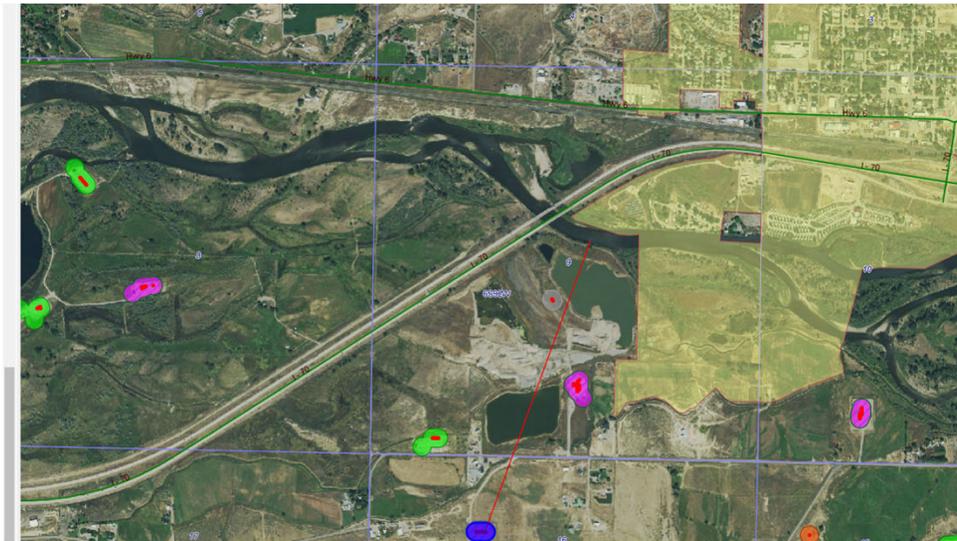
Location Overview : Location is approximately 8/10ths of a mile from the Colorado river.

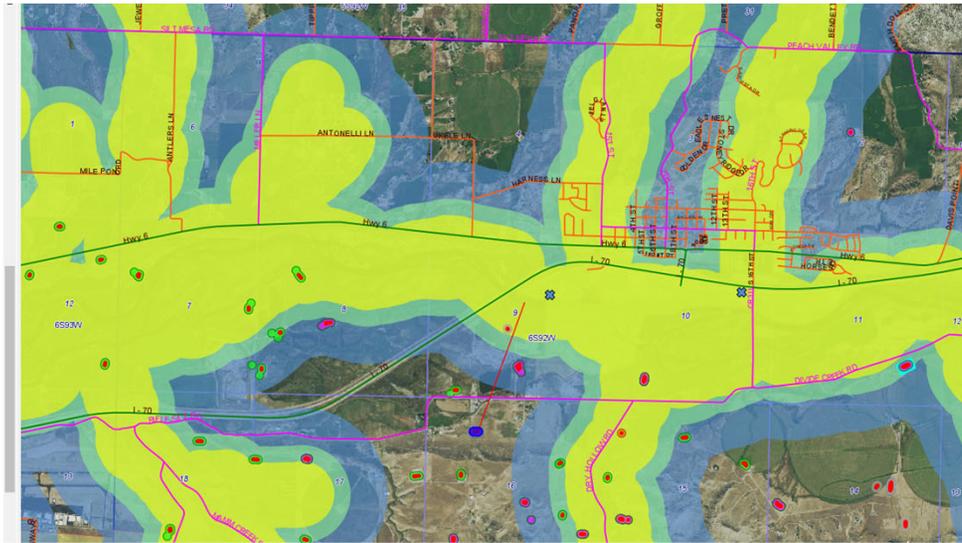
Location Overview : Location is with close proximity to the
411 Public Water System Protection

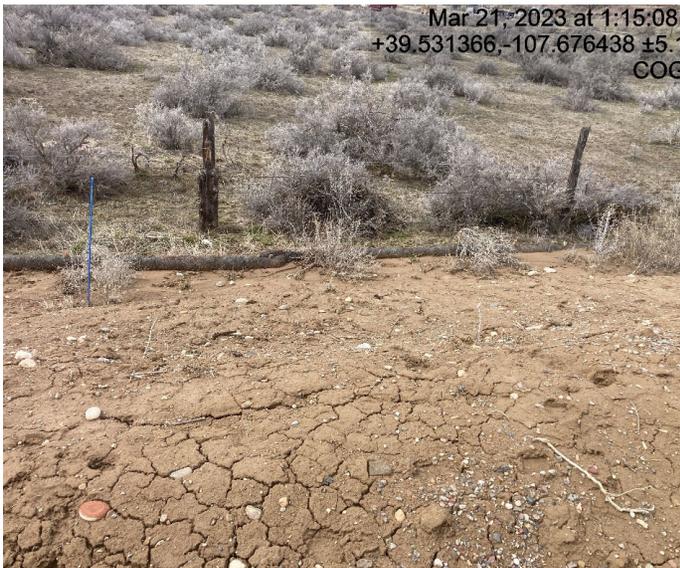
Fill slope shows lack of stabilization

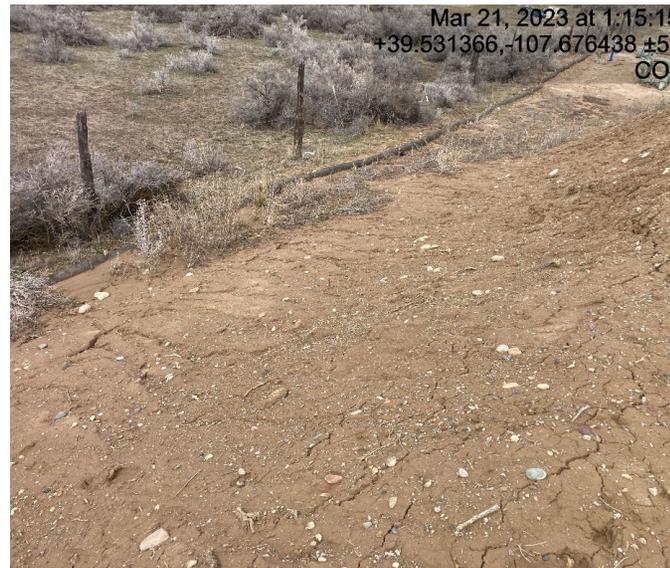
Fill slope shows lack of stabilization

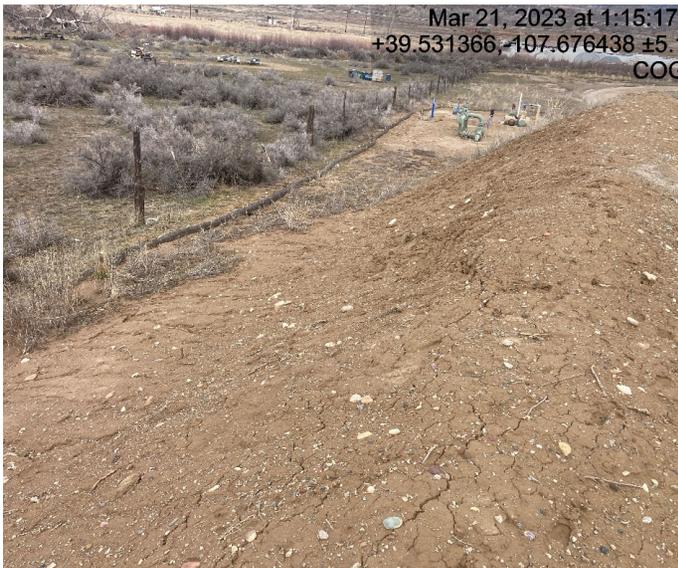
Fill slope shows lack of stabilization

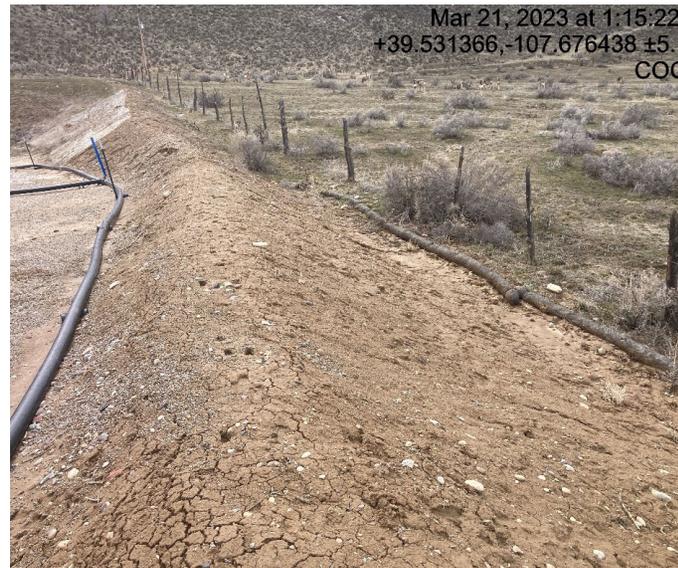
Fill slope shows lack of stabilization

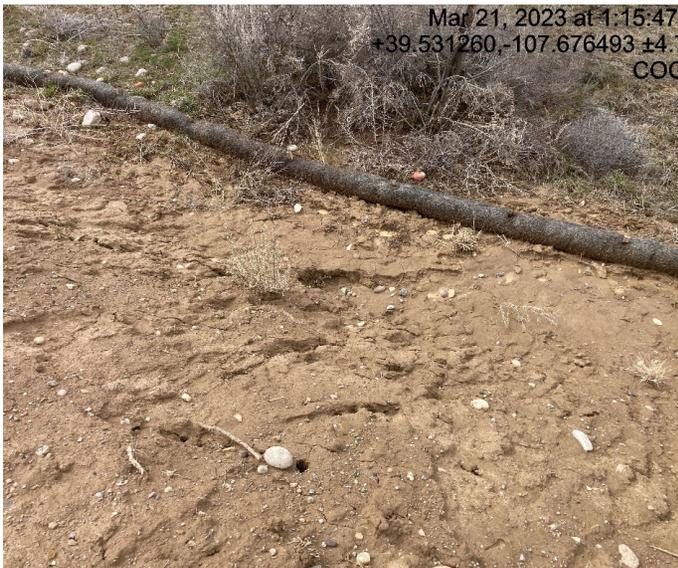
Erosion is undermining location berm coming out of fill slope

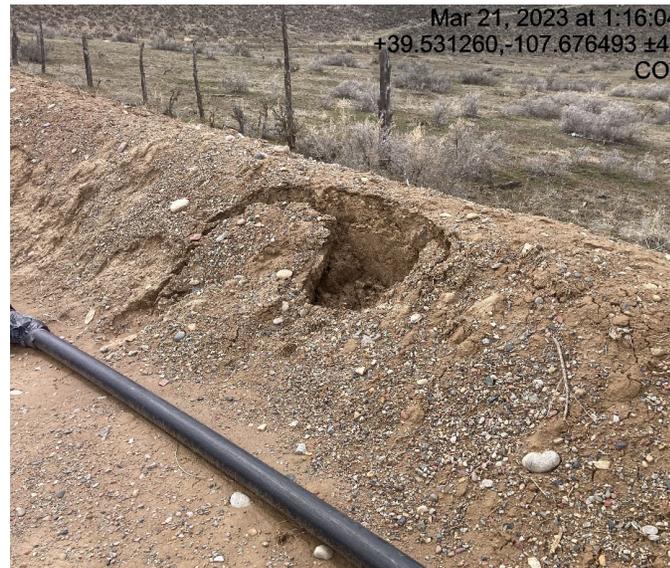
Erosion is undermining location berm coming out of fill slope

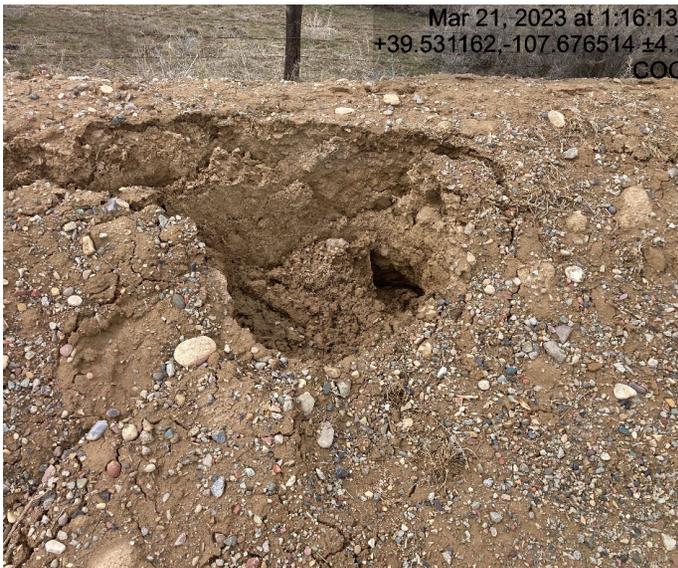
Erosion is undermining location berm coming out of fill slope

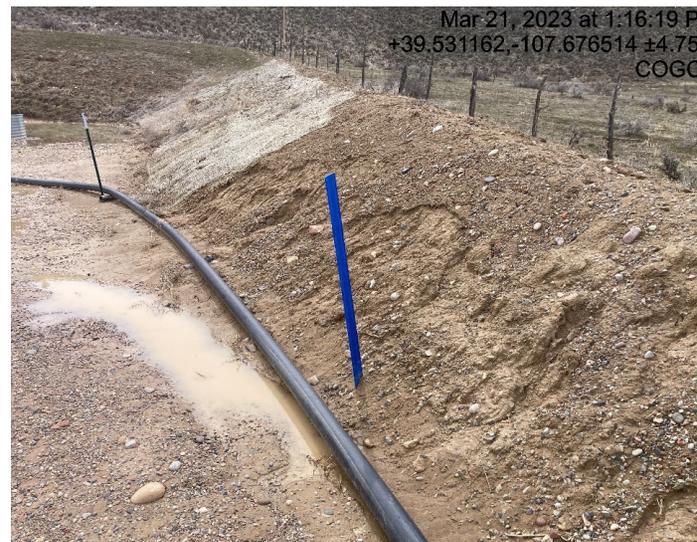
Cut slope shows signs of erosion, Blankets have been installed in areas.

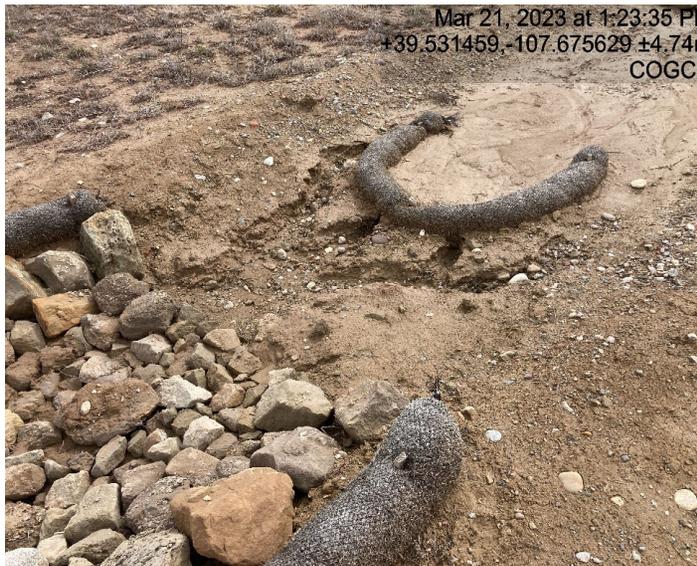
Erosion under waddles

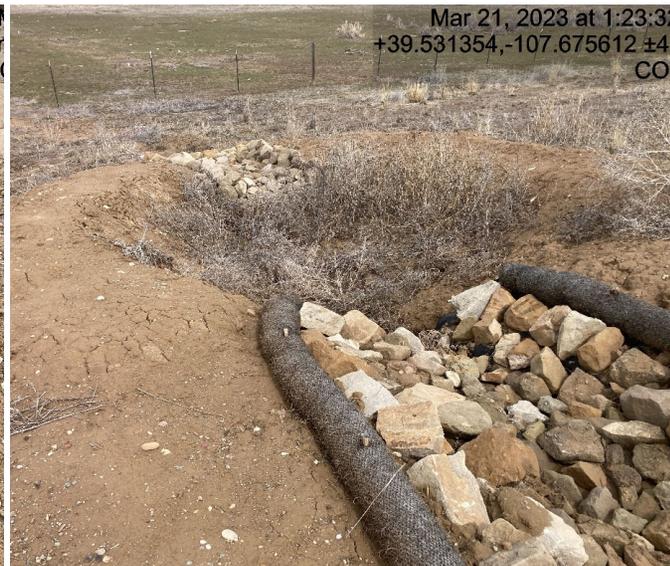
Sediment trap full of weeds

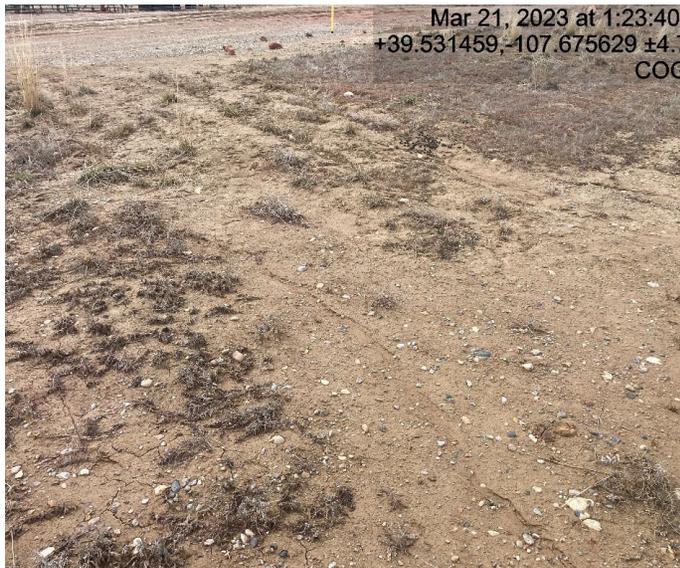
Sediment migration is choking out vegetation

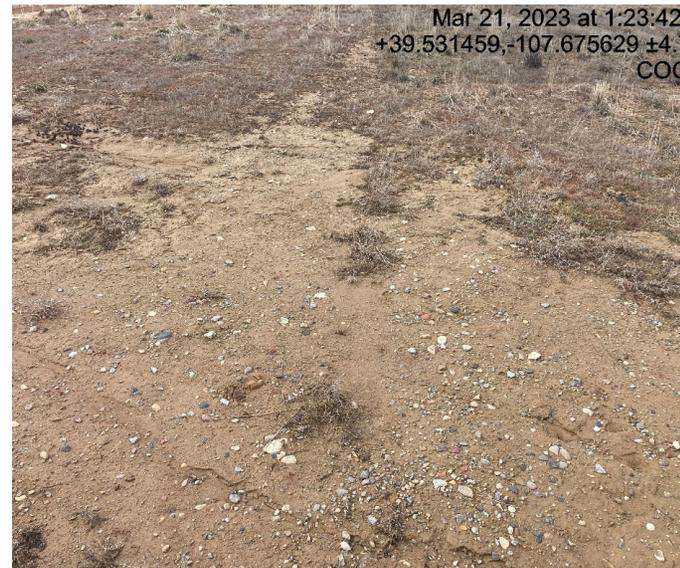
Sediment migration is choking out vegetation

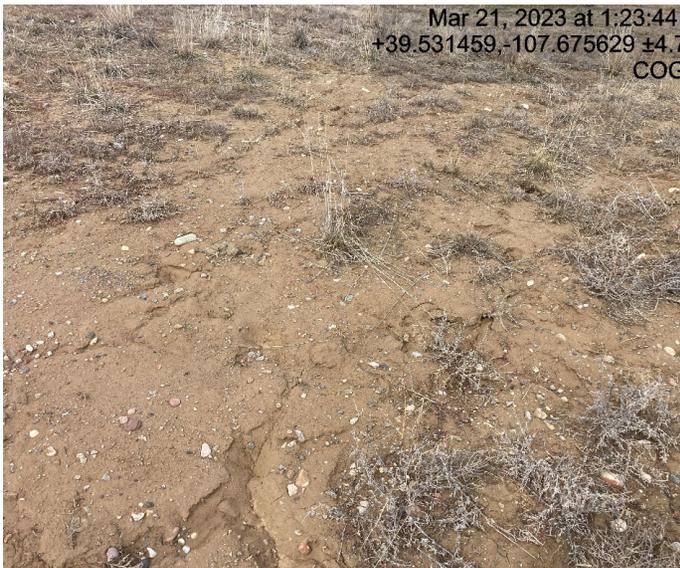
Sediment migration is choking out vegetation

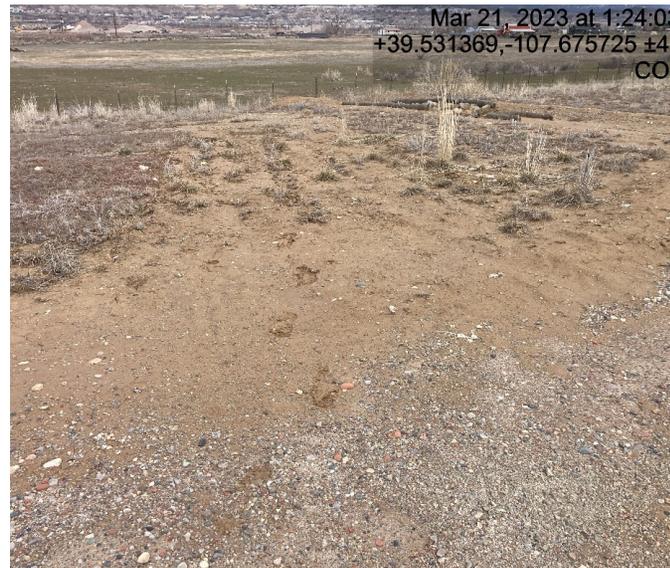
Sediment migration is choking out vegetation

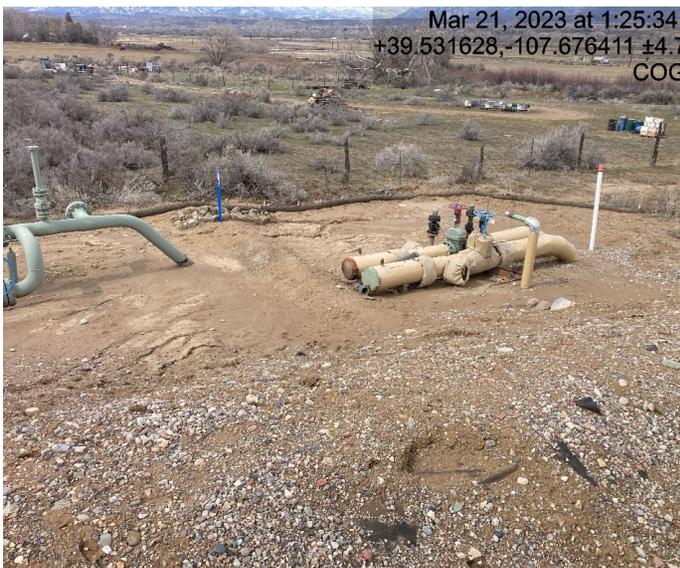
Multiple areas of erosion next to access road with BMP's failing

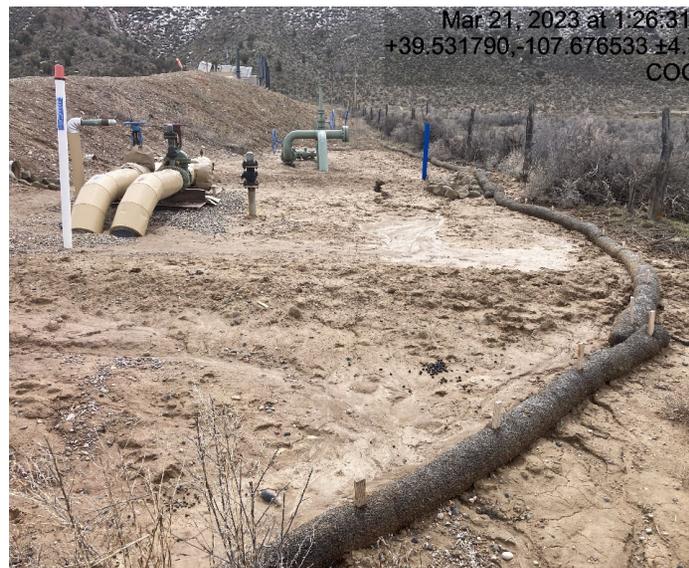
Multiple areas of erosion next to access road with BMP's failing

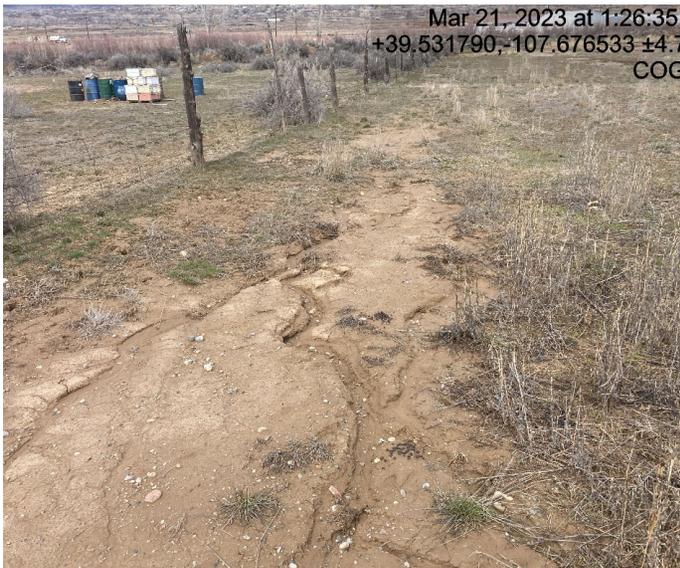
Sediment migration choking out vegetation

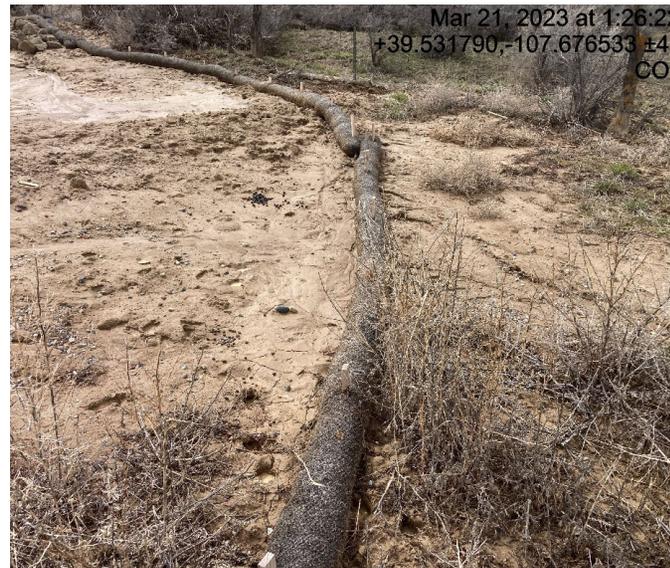
BMP's failing

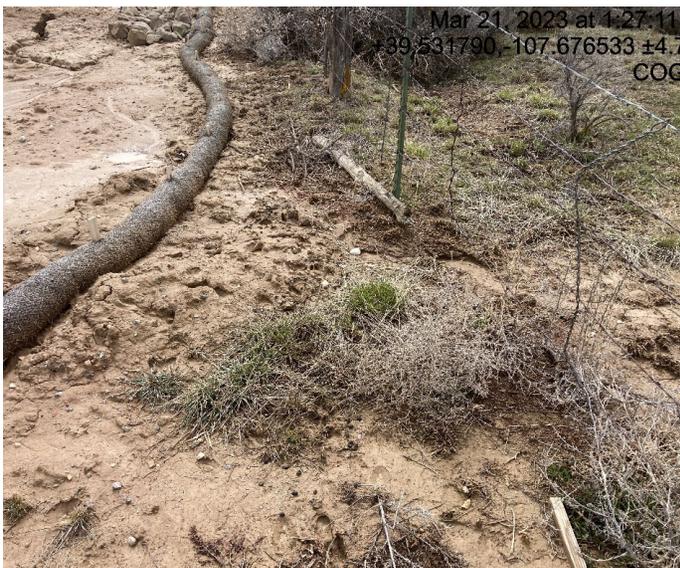
Sediment migration choking out vegetation

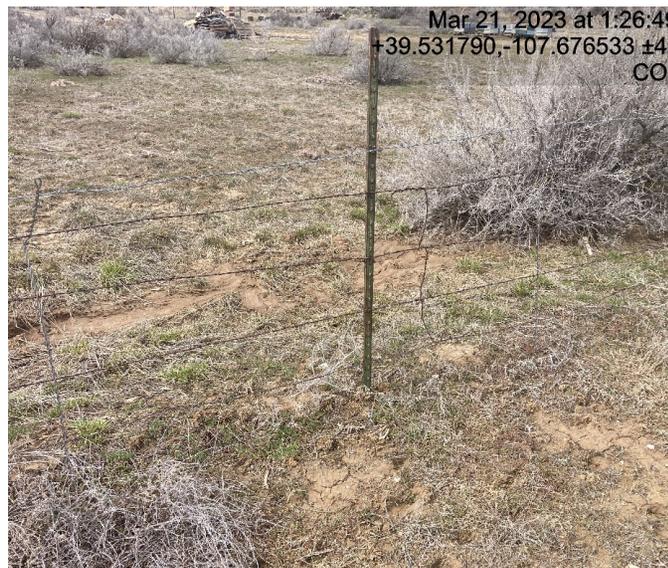
Sediment migration choking out vegetation has left location on adjacent property.

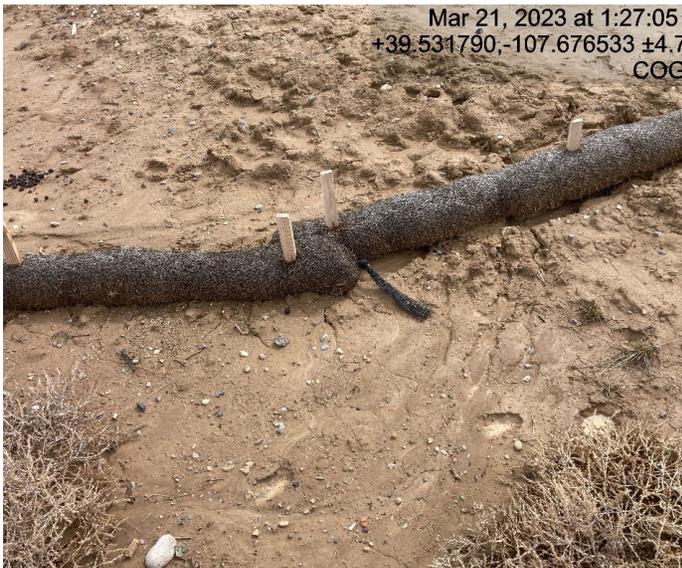
BMP's failing

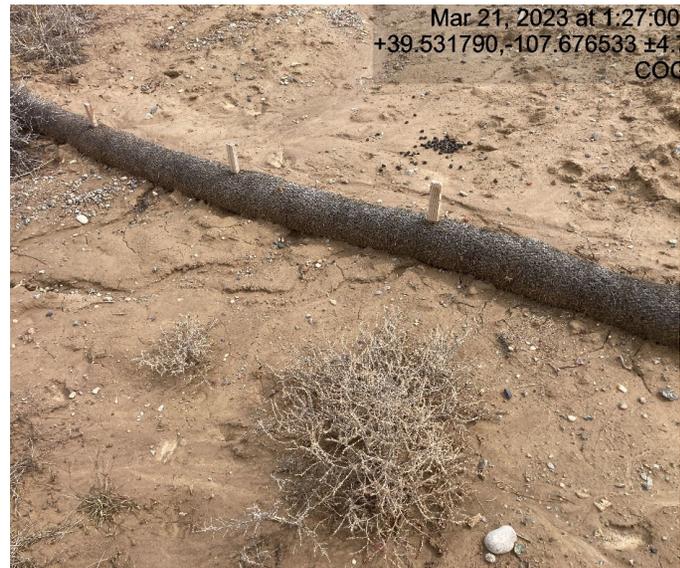
BMP's failing
