Inspection Photos
Location Name: Dechant State #1
Location ID: 336321

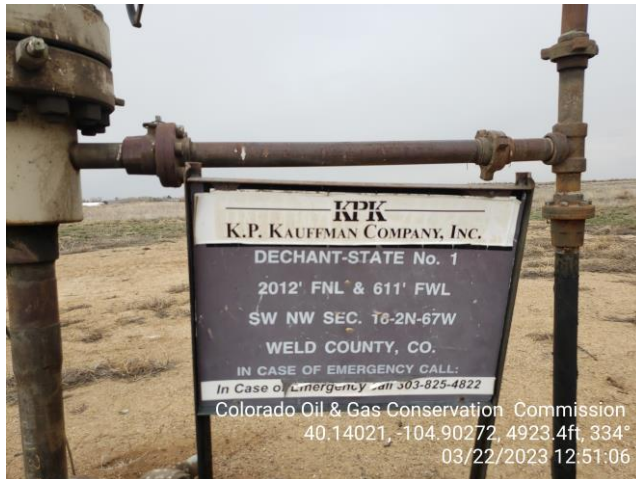
Photo 1 WH sign.

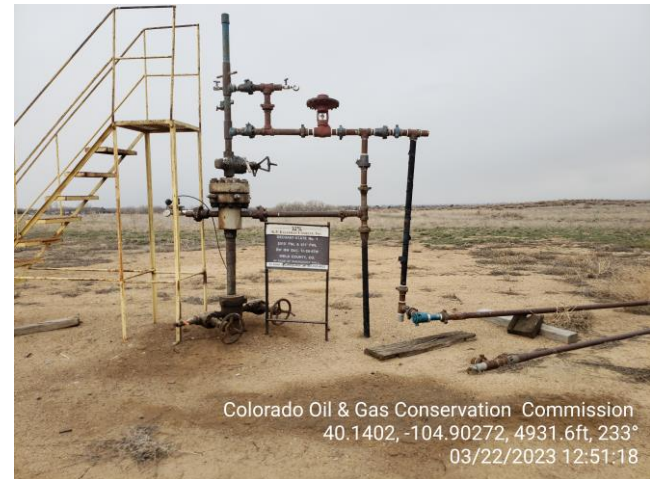
Photo 2 WH, stained soil

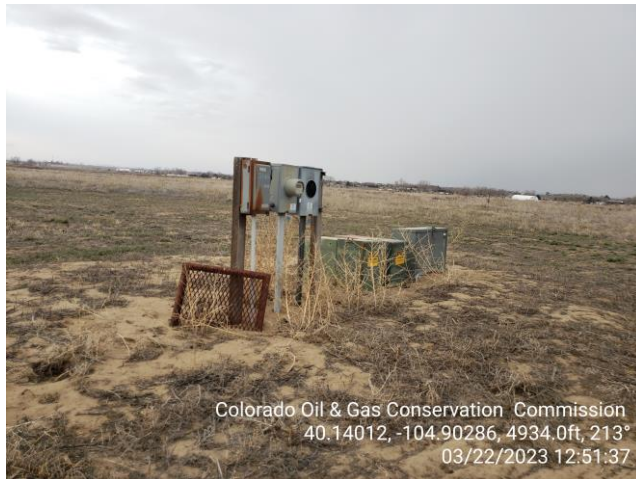
Photo 3 Ancillary equip.

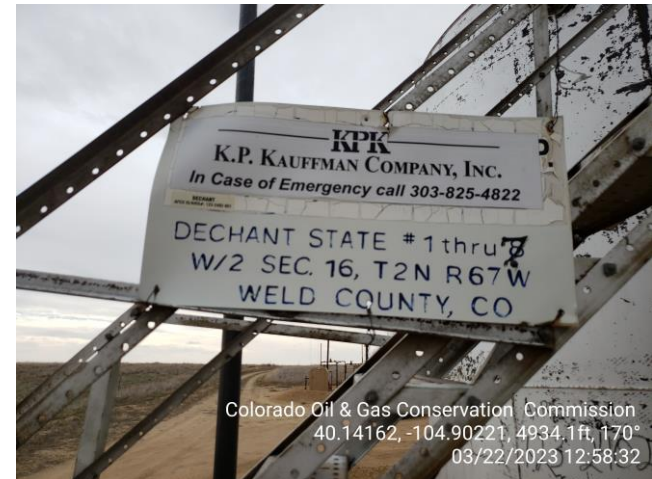
Photo 4 TB sign.

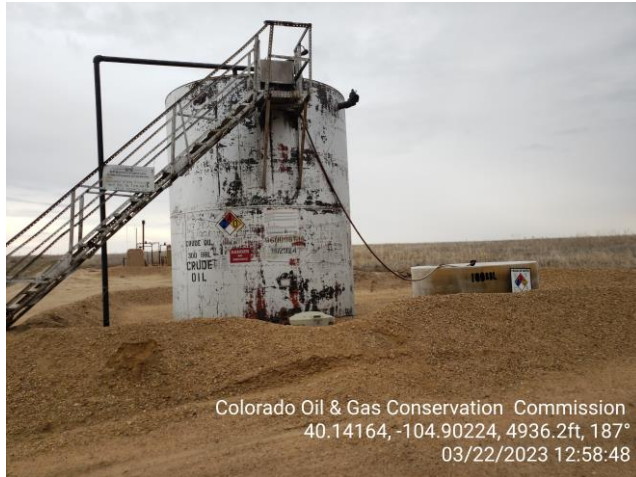
Photo 5 TB, Paint is faded and peeling making it hard to see the labels and placards even though they are new.

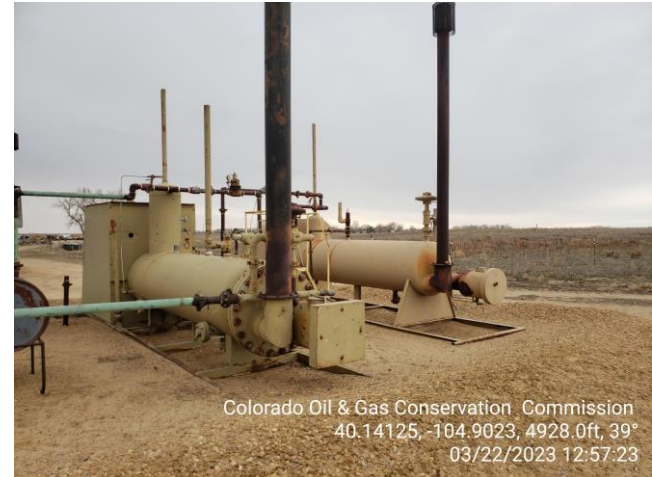
Photo 6 Horizontal Heated Separators.

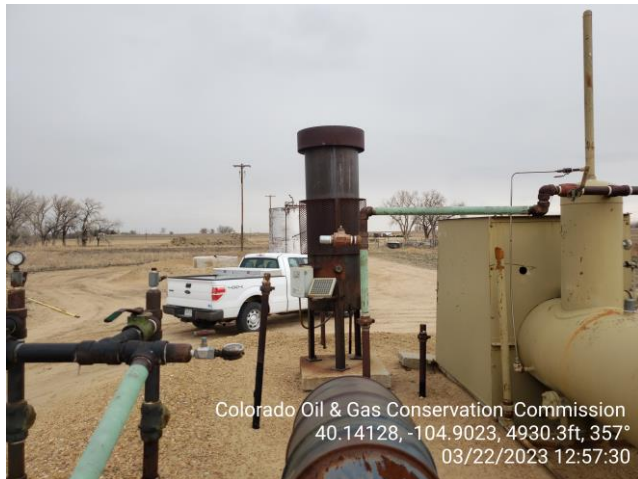
Photo 7 ECD.

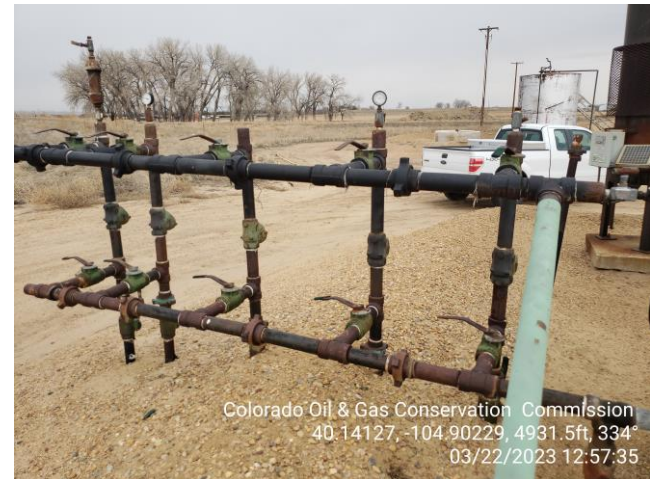
Photo 8 Flow line manifold.

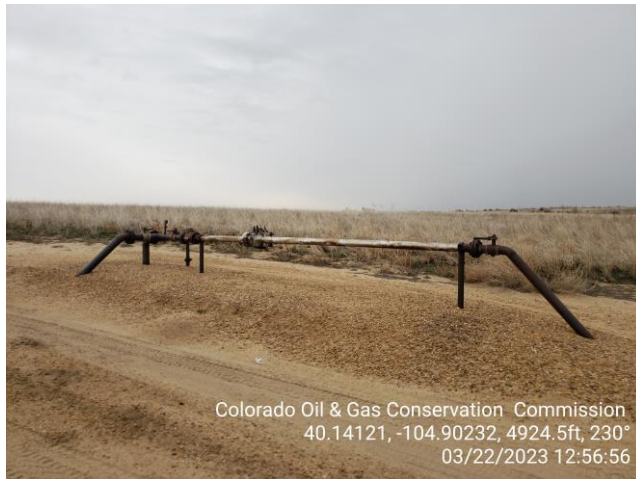
Photo 9 Flow line.

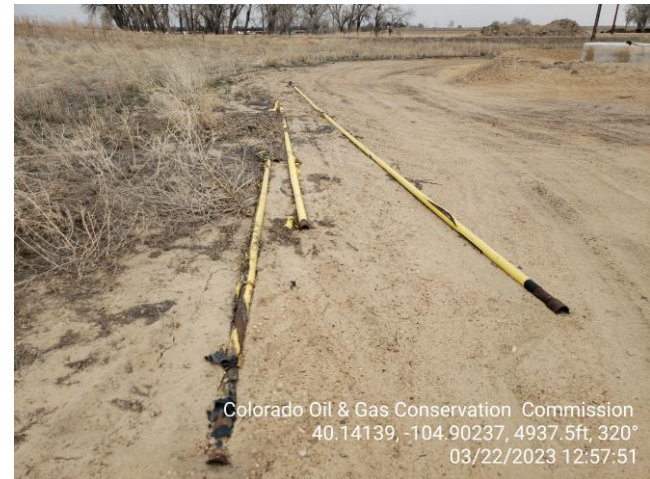
Photo 10 Unused pipe by TB.

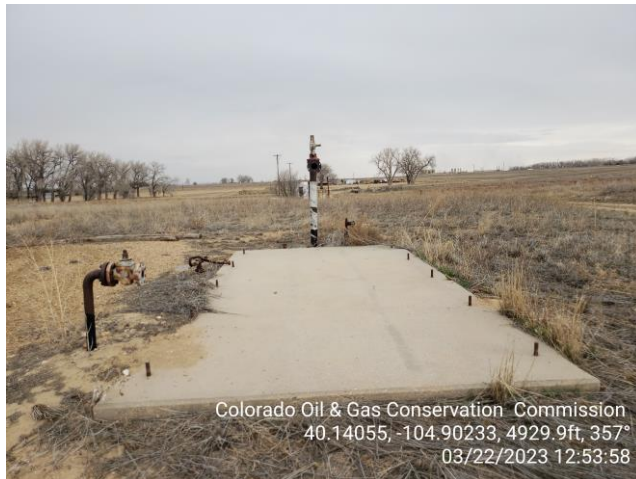
Photo 11 Unused Flow lines not LOTO and cement pad.

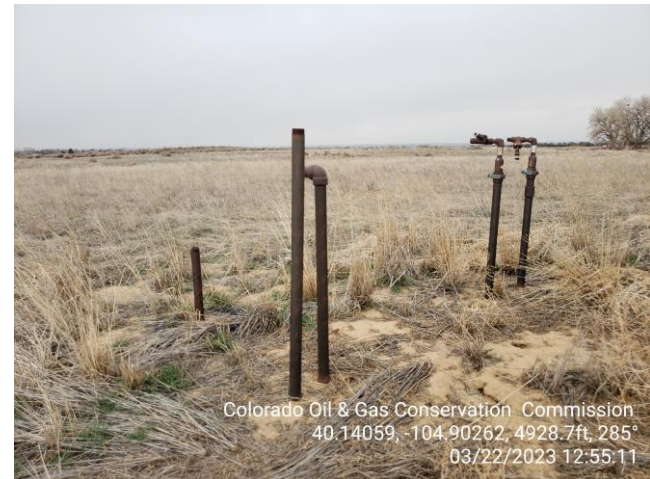
Photo 12 Unused flow lines not LOTO.

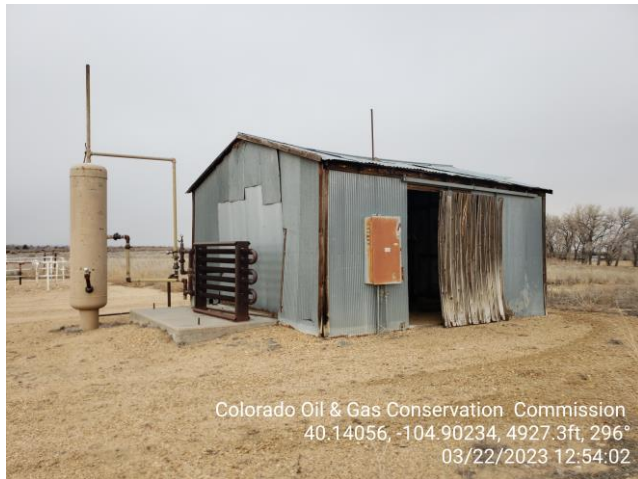
Photo 13 Compressor house.

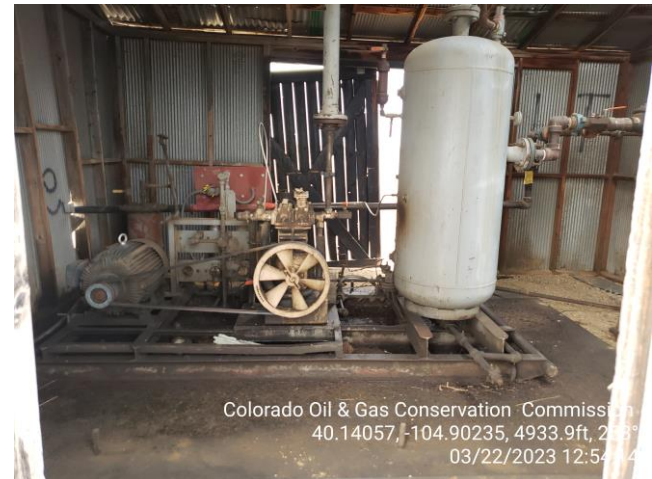
Photo 14 inside of the compressor house.

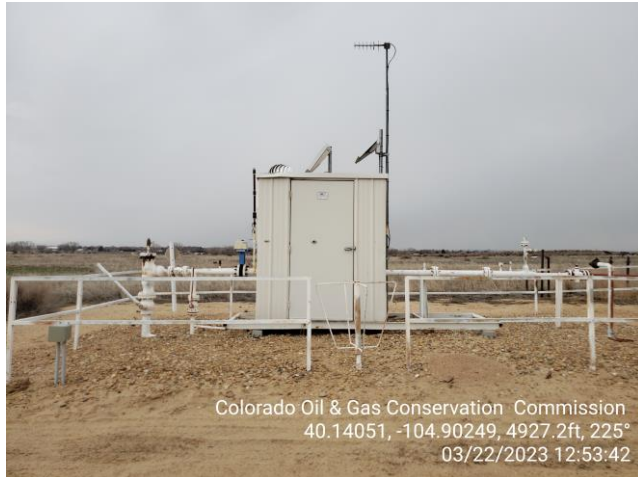
Photo 15 Gas meter Run.
