Construction and Stormwater Inspection

Operator: SUMMIT OIL & GAS LLC - 10774

Location ID: 468847

Inspection Photos
Location Name: Castor 7-59 11
Location ID: 468847

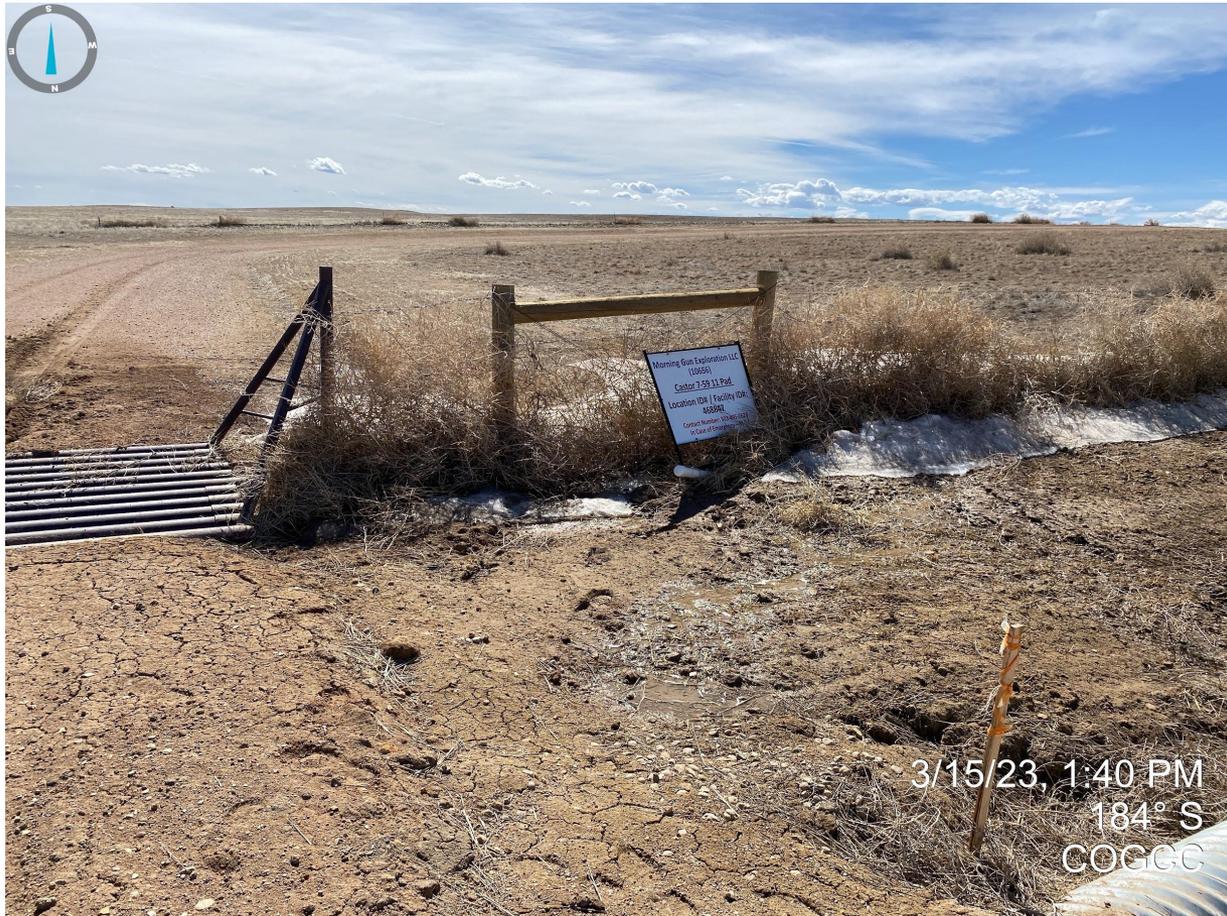
Photo 1. Facing south from the location. An approved copy of the Form 2A was posted on location. The location sign lists a different operator and the sign will need to be updated to reflect the change in operatorship. (See comment in Photo 12)

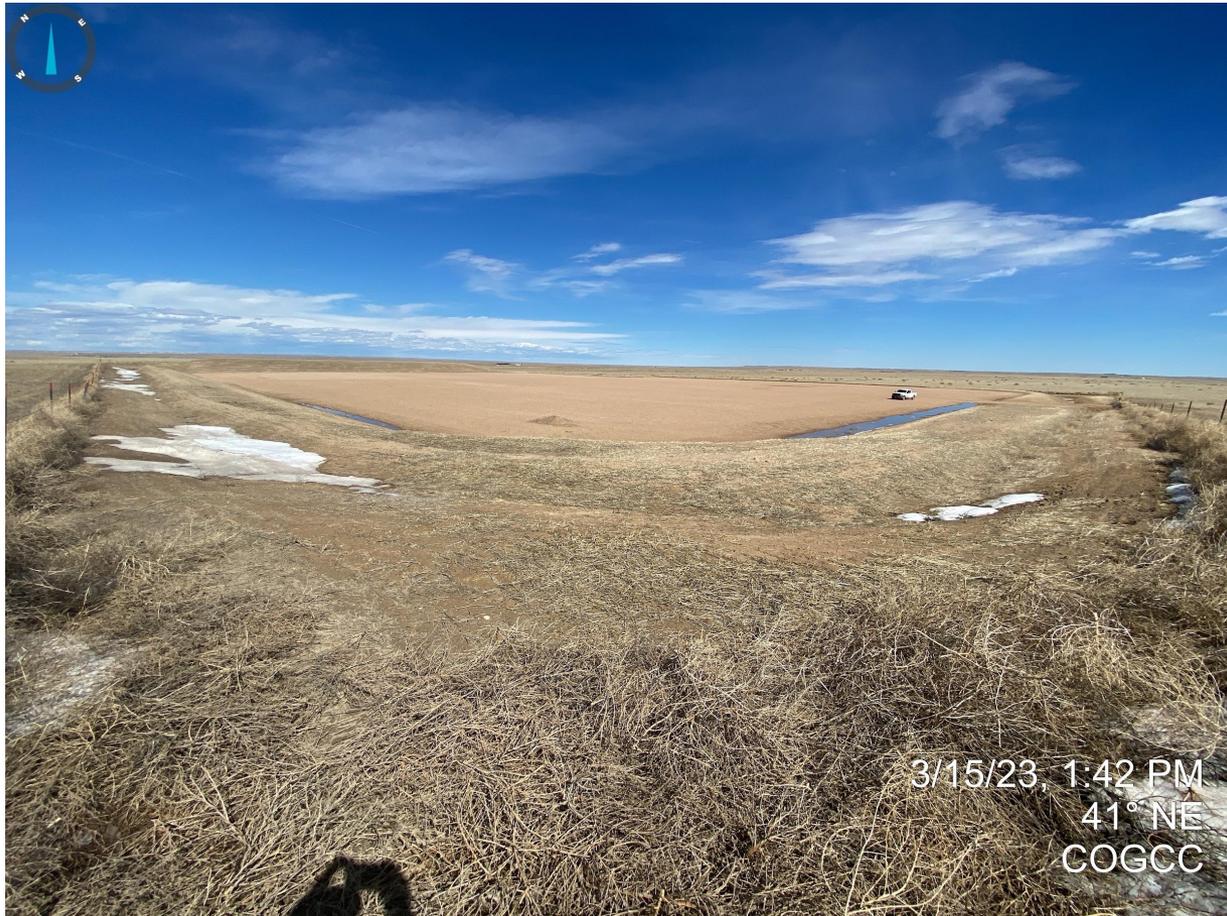
Photo 2. Facing northeast from the southwest corner of the location. Perimeter ditch and berm has been installed during the construction phase of the location. These areas appeared to have been stabilized as crimped straw mulch and drill rows were evident.

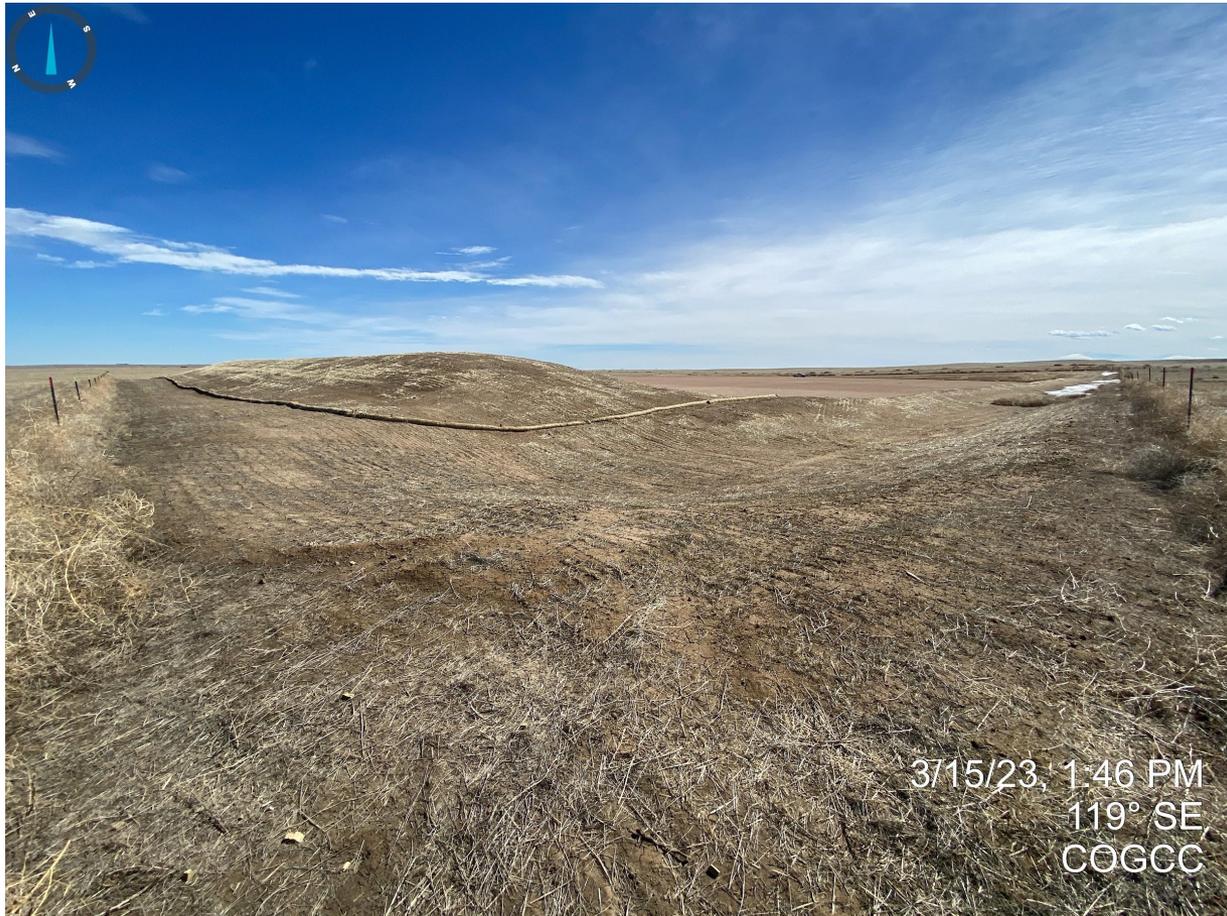
Photo 3. Facing southeast from the northwest corner of the location. See comments in Photo 2.

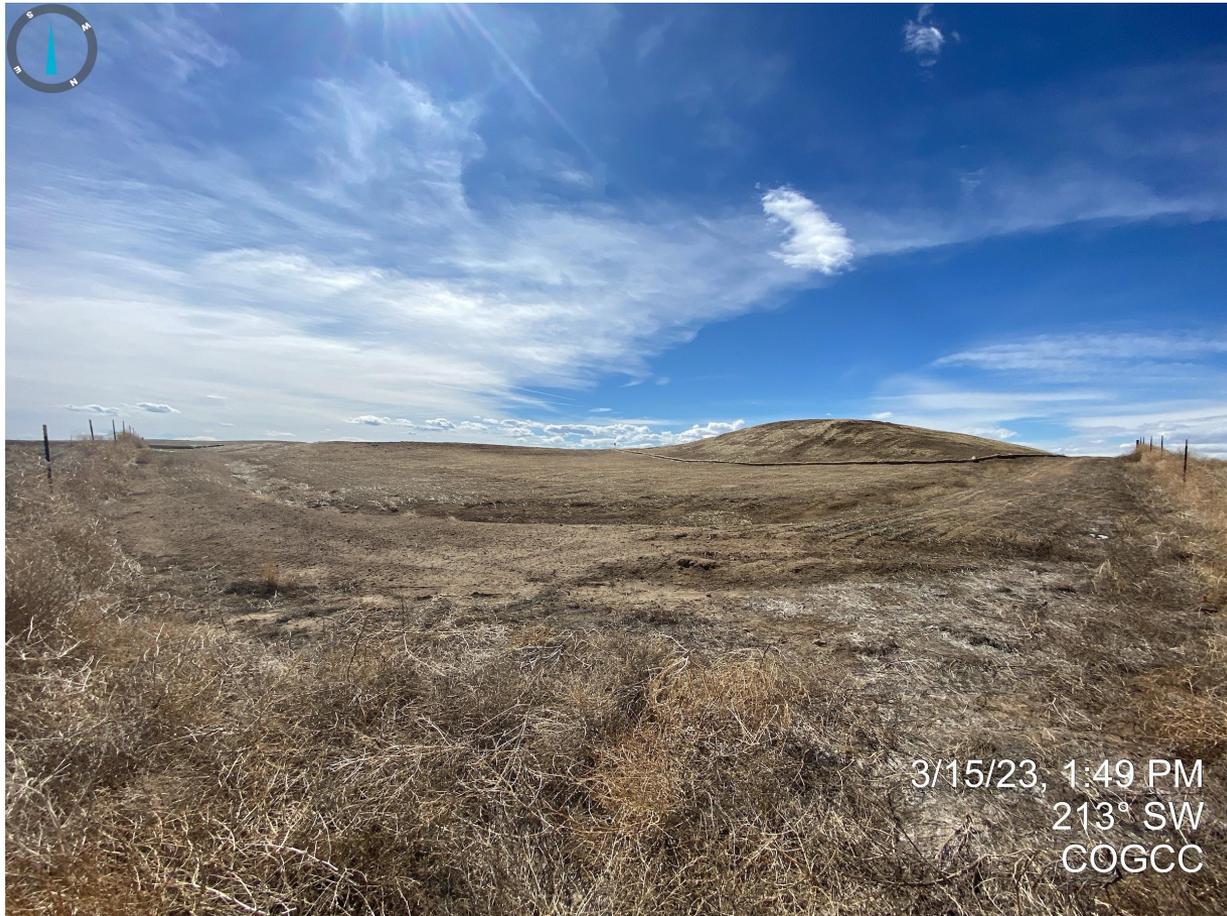
Photo 4. Facing southwest from the northeast corner of the location. See comments in Photo 2.

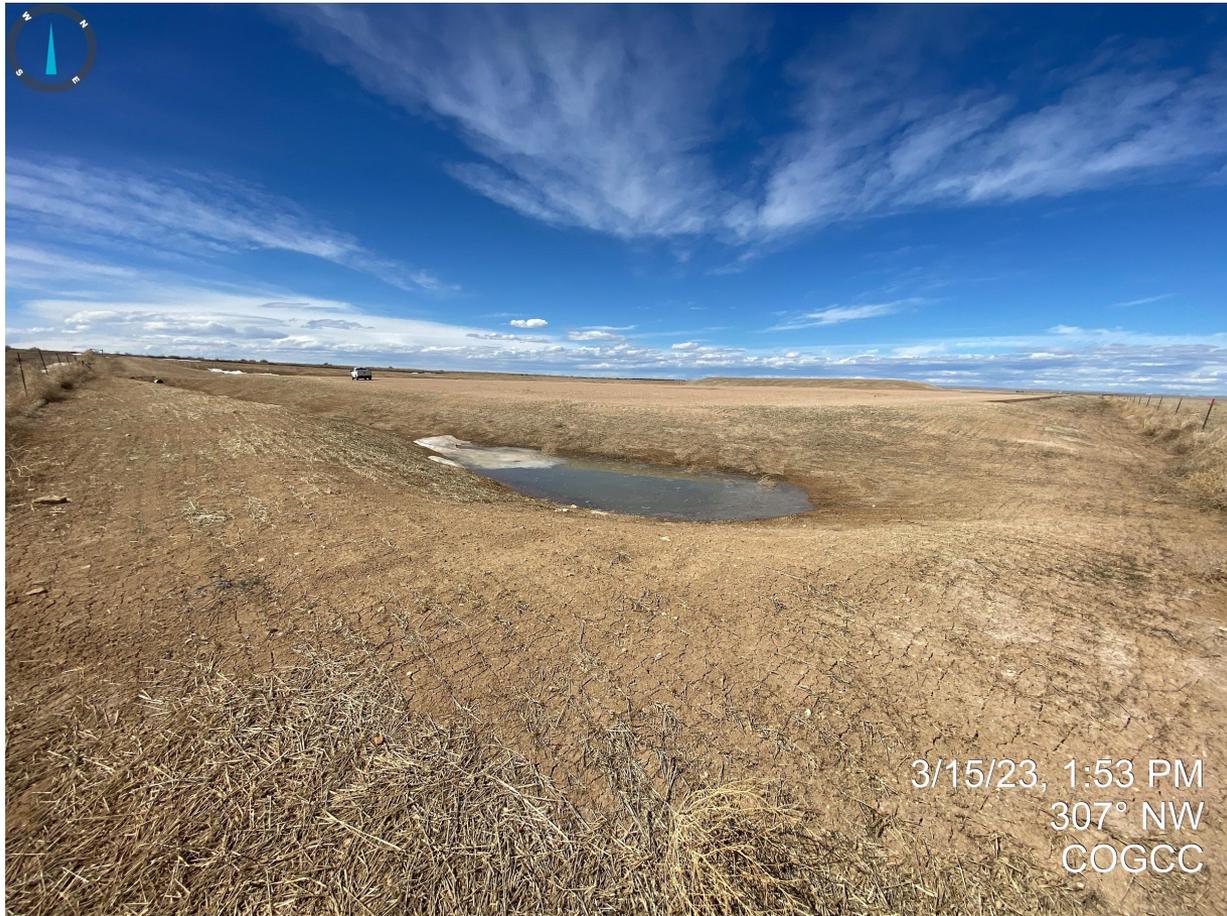
Photo 5. Facing northwest from the southeast corner of the location. See comments in Photo 2.

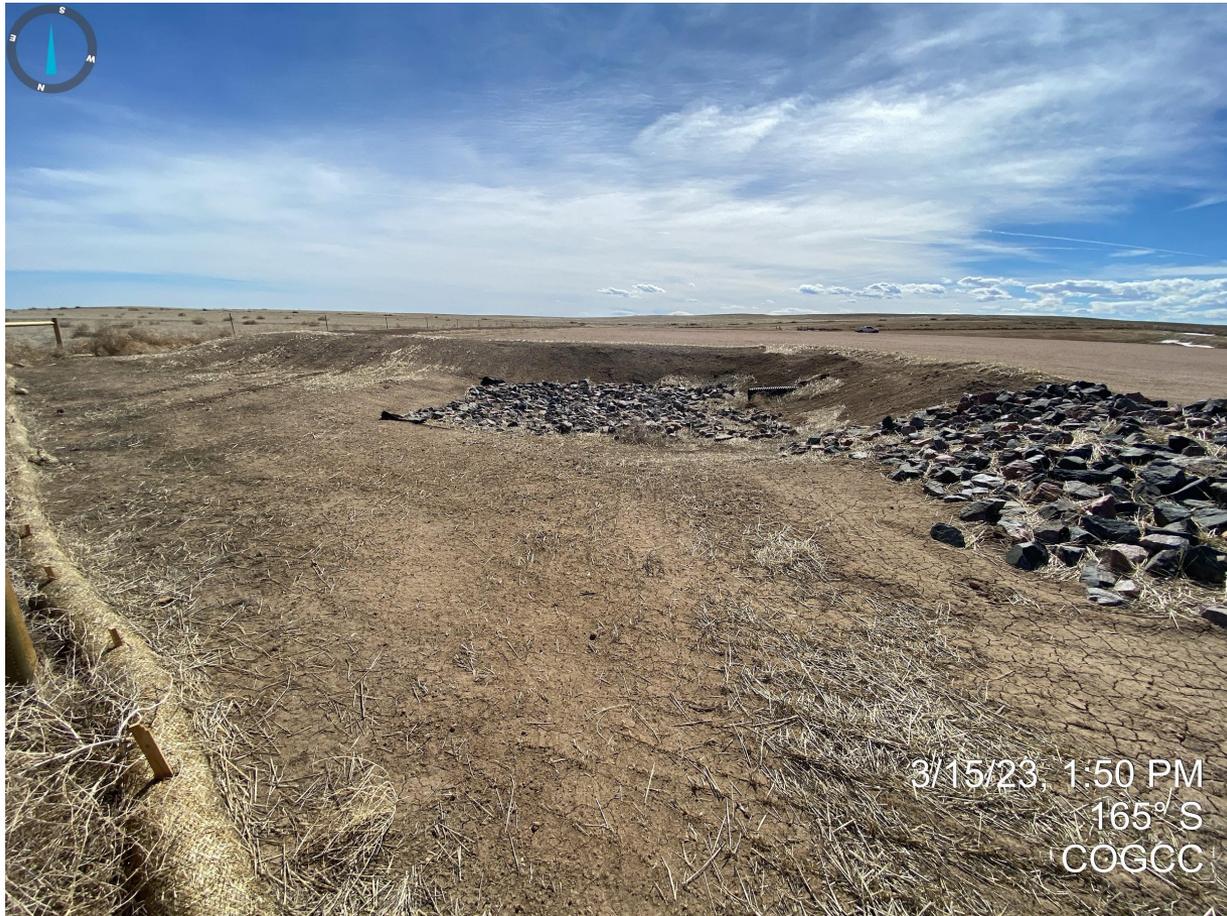
Photo 6. Facing south from the eastern/center portion of the location. Operator installed a sediment trap with a rip-rap structure to stabilize the outlets and protect against erosion. Straw wattles were also observed around the entire perimeter of the location and appear to be properly installed per good engineering practices.

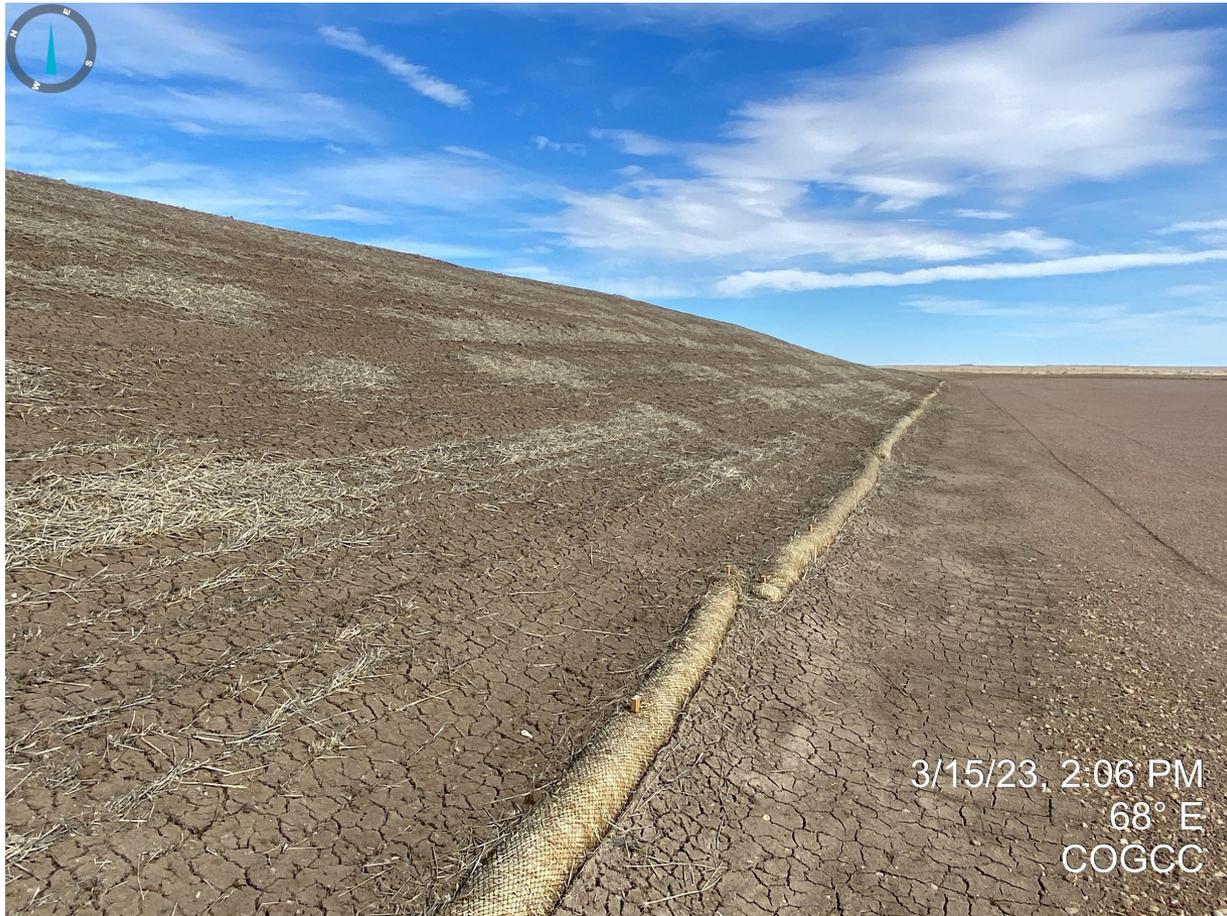
Photo 7. Facing east near the topsoil stockpile. It appears the operator has salvaged all of the topsoil from the disturbance area and stored it on the northern end of the location. Straw wattles were observed around the entire perimeter of the stockpile.

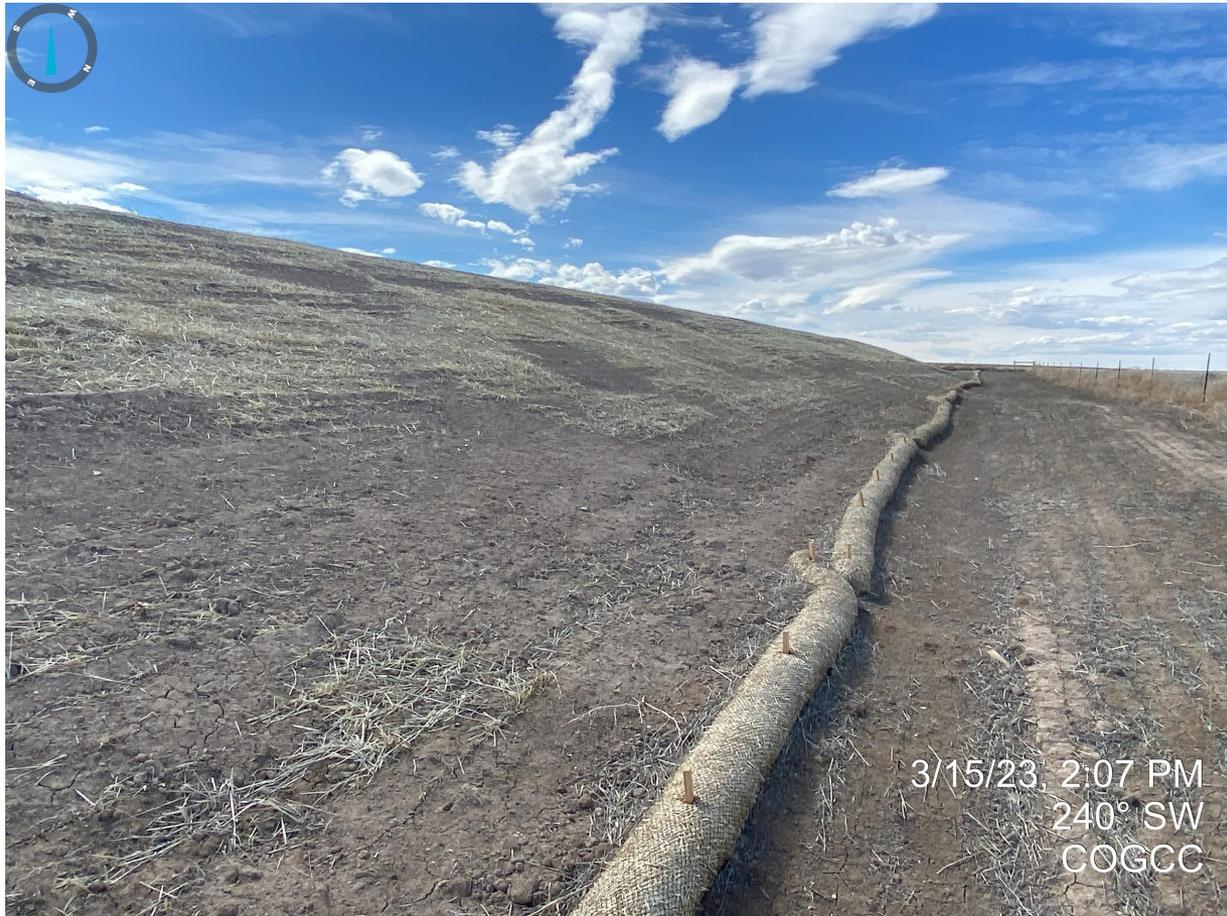
Photo 8. Facing southwest from the center/northern portion of the topsoil stockpile. See comments in Photo 7.

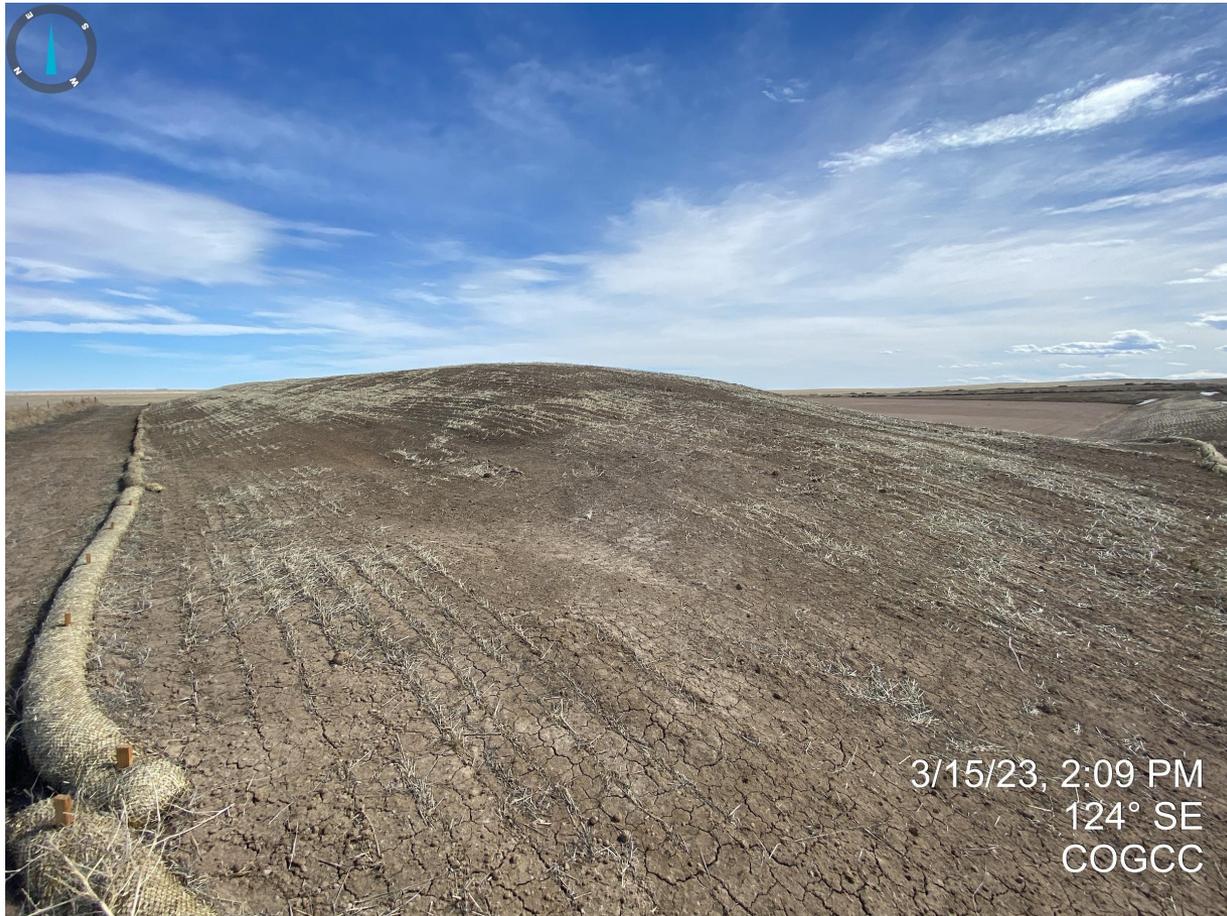
Photo 9. Facing southeast from the northwest corner of the topsoil stockpile. See comments in Photo 9.

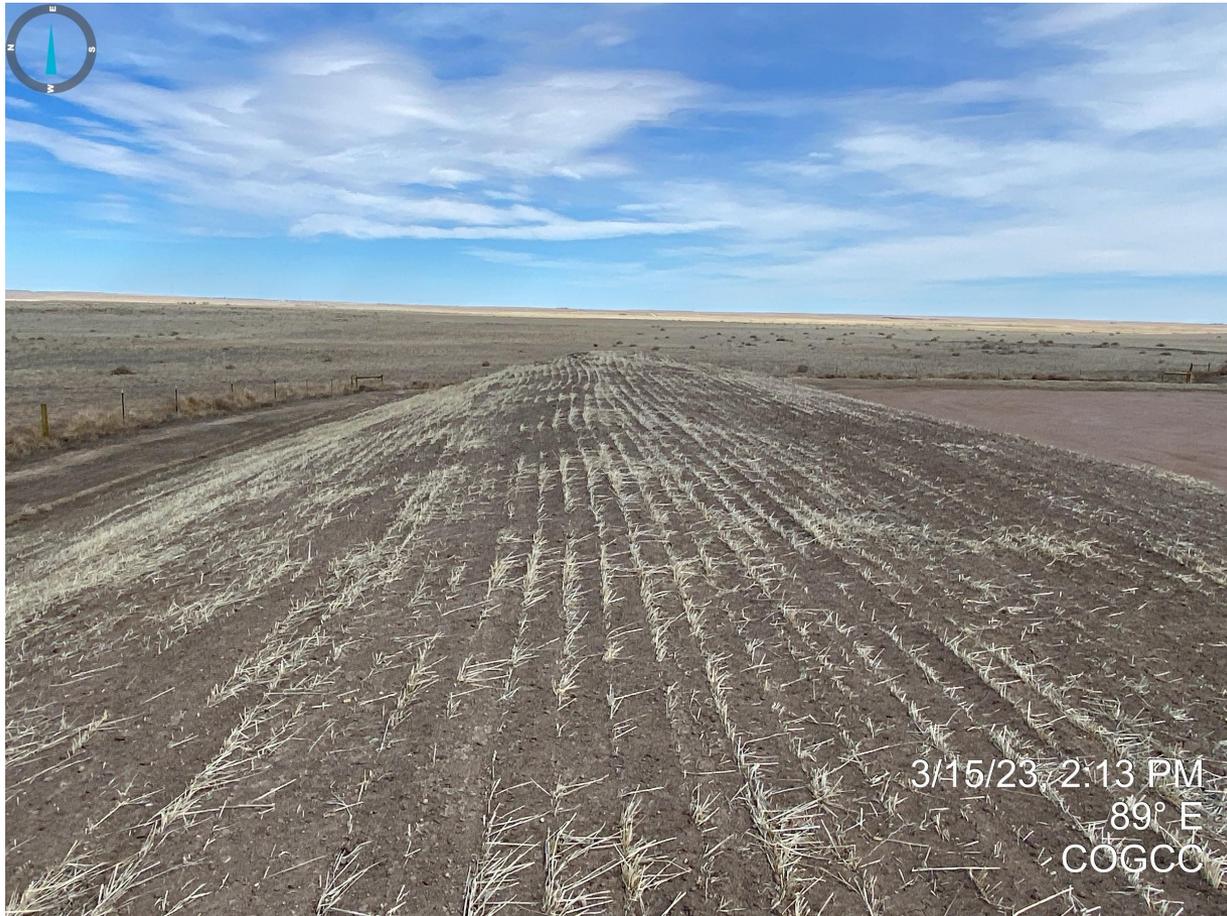
Photo 10. Facing east from the top of the stockpile. See comments in Photo 7.

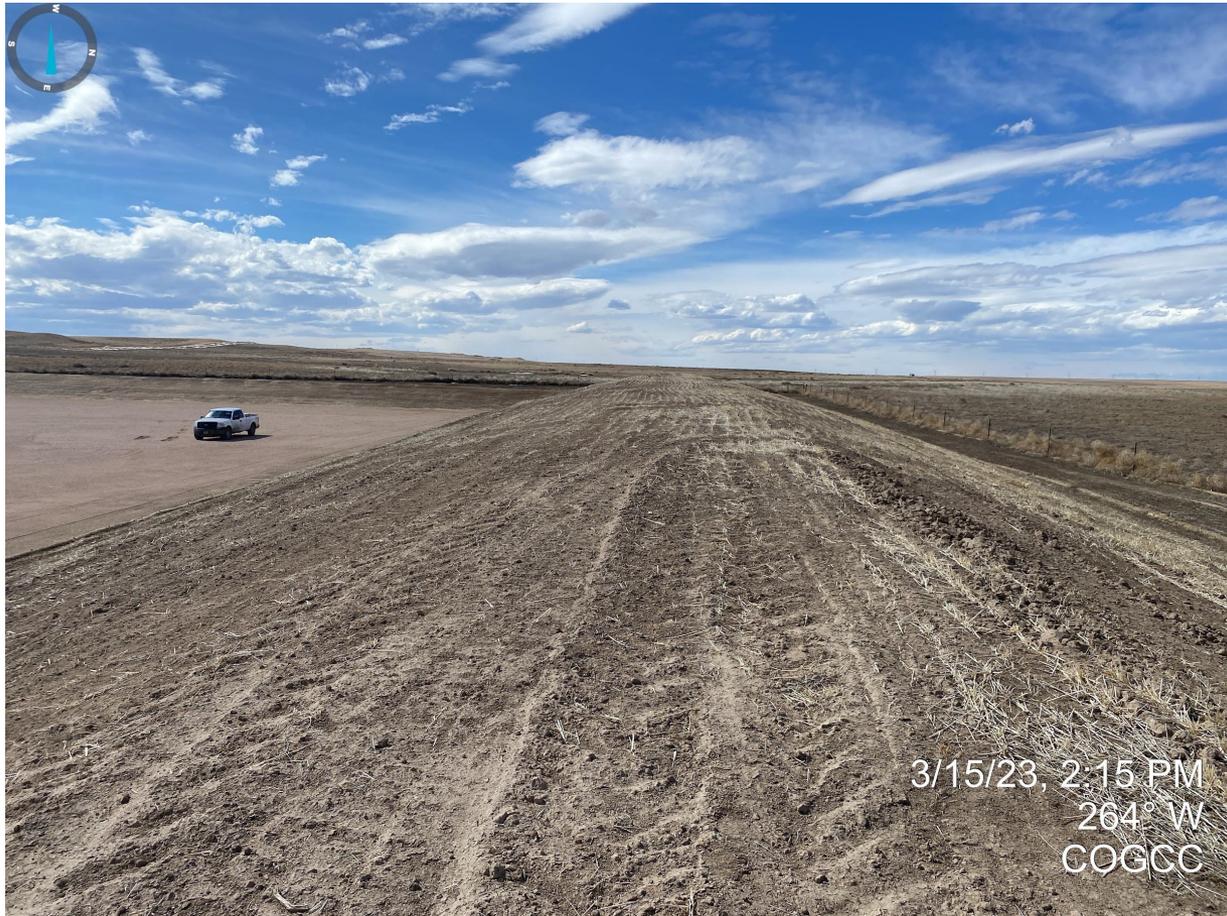
Photo 11. Facing west from the top of the stockpile. See comments in Photo 7.

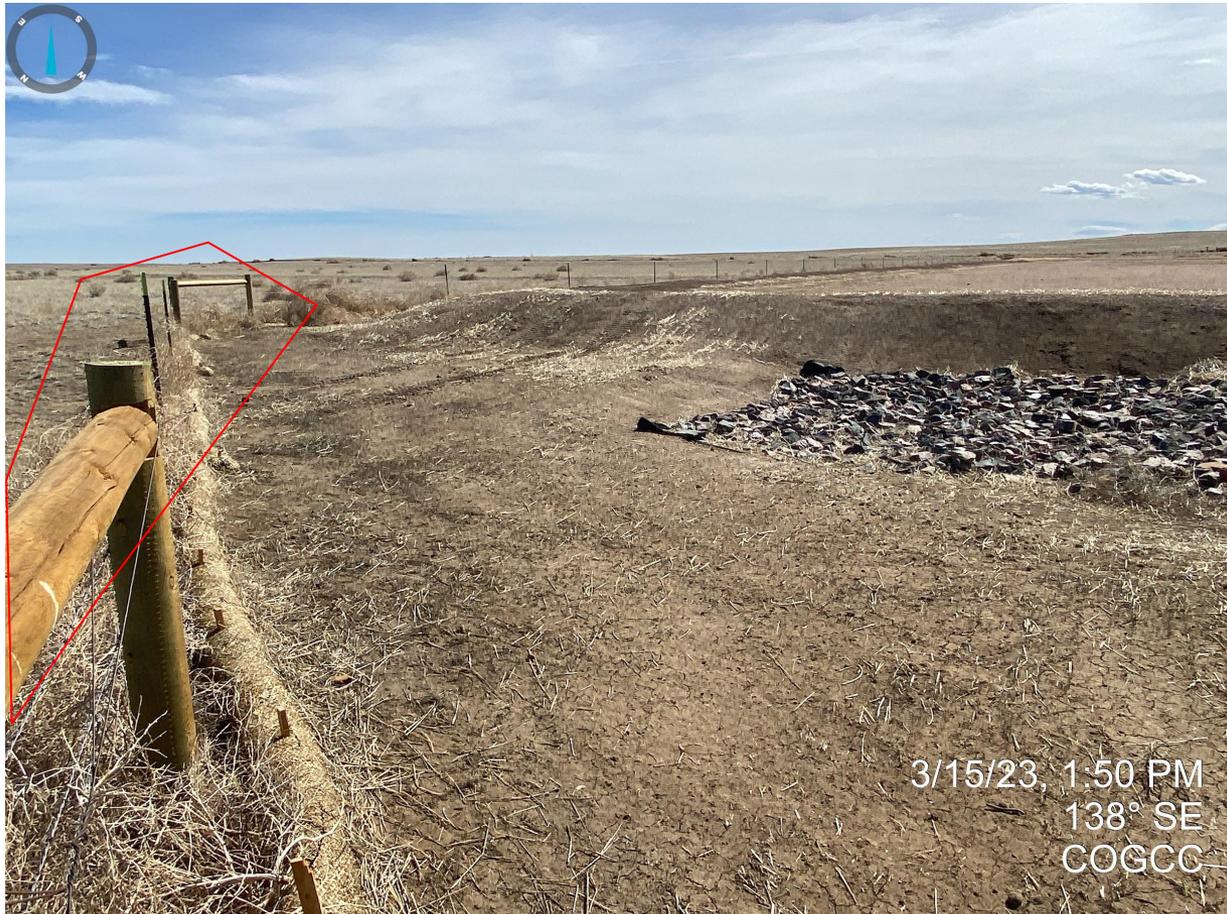
Photo 12. Facing southeast from the sediment trap on the east side of the location. Per Wildlife BMP/COA #16 on the Approved Form 2A (Doc #401891544) "The operator agrees to install raptor perch deterrents on equipment, fences, cross arms and pole tops in plains sharp-tailed grouse habitat". During this inspection, Staff did not observe any raptor perch deterrents on the perimeter fences; this photo illustrates one example.
