Inspection Photos

API: 071-07915

Operator: WAPITI OPERATING LLC

Inspection Date: 3/22/2023

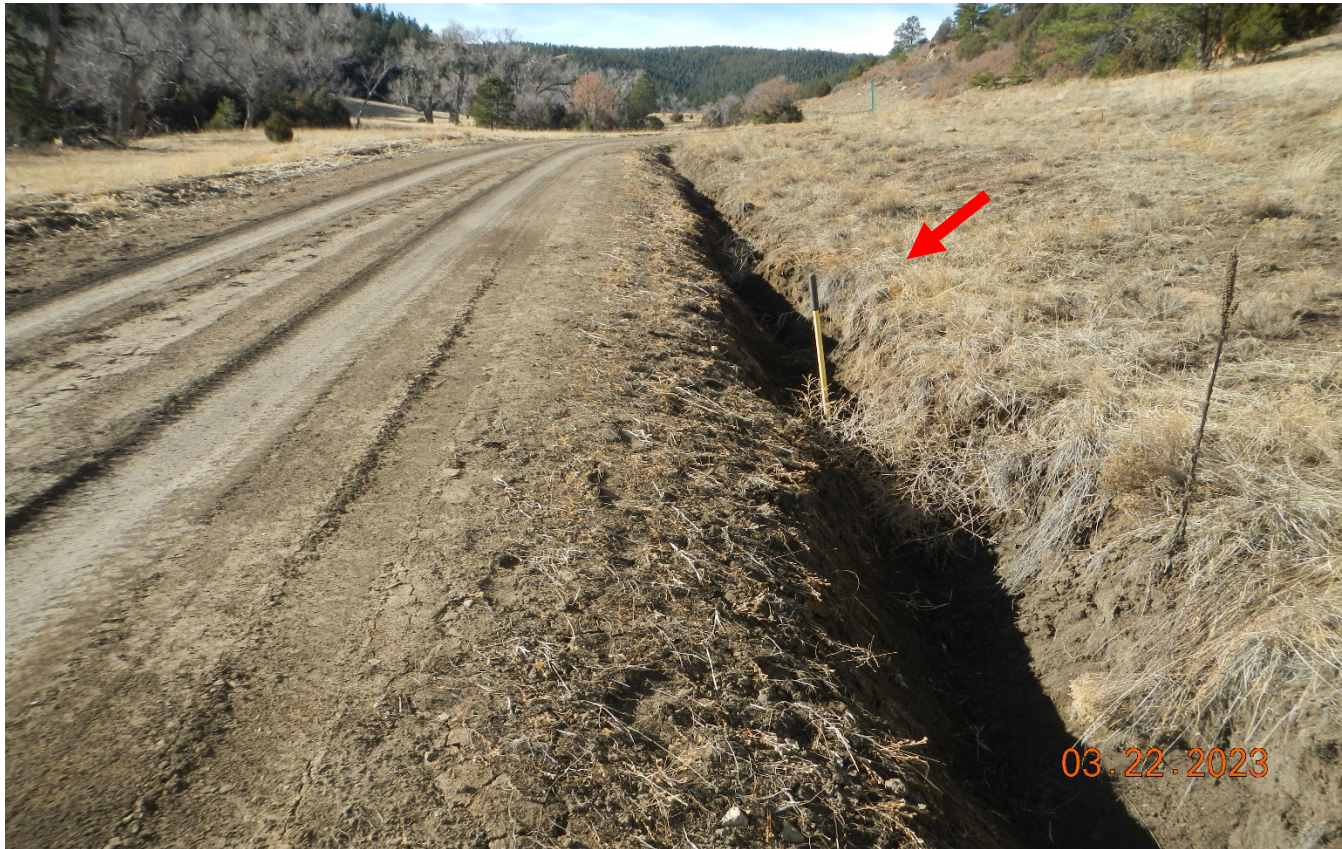
Photo 1. Facing south along the main road. There is erosion occurring along the road side. BMP's need to be installed to prevent erosion. Red arrow points to 4.5' shovel. Previous corrective action not completed.

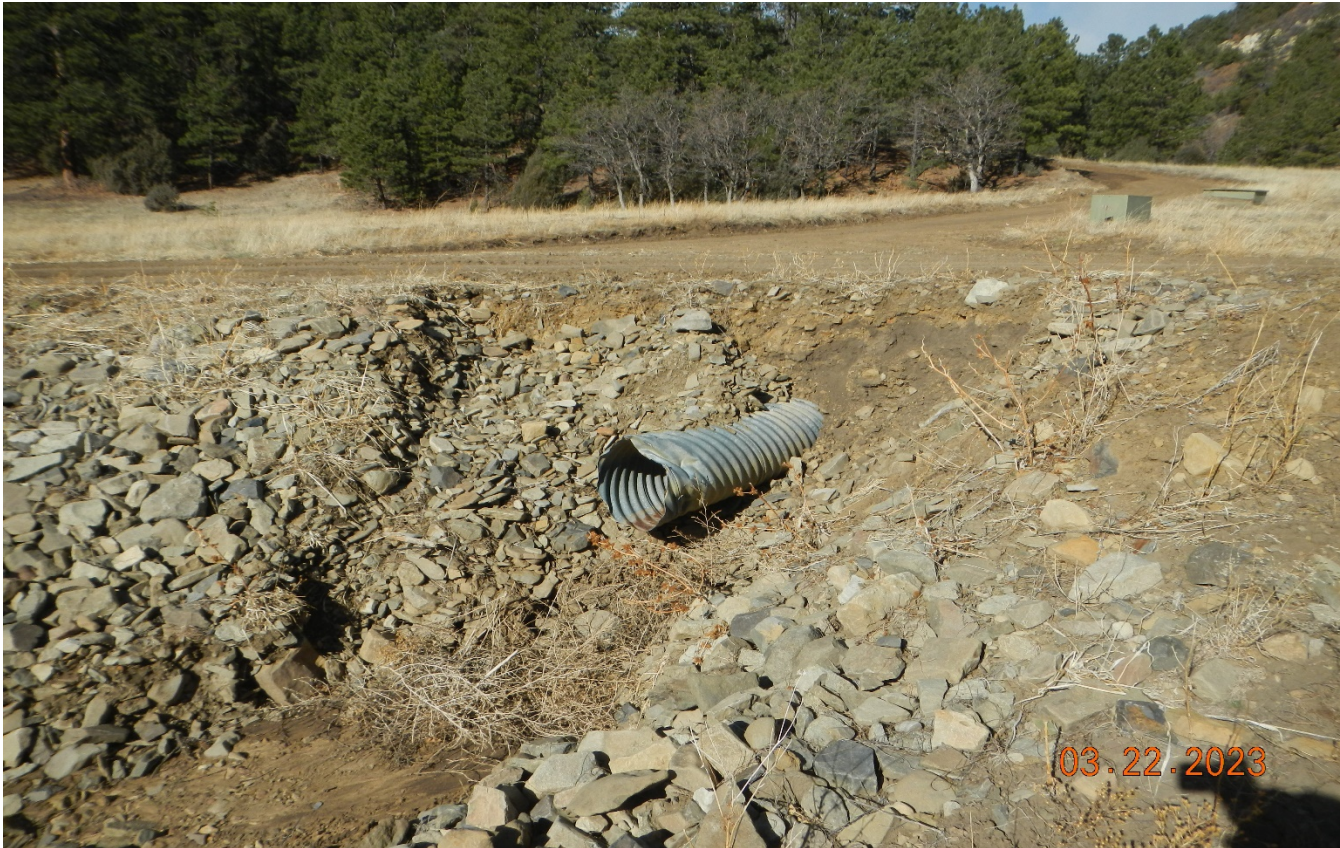
Photo 2. Facing west toward near the access road ascending the hillside. The culvert outlet has been washed out from recent storm event. It appears a larger culvert is needed along with larger rock rip/rap outlet protection. Previous corrective action not completed.

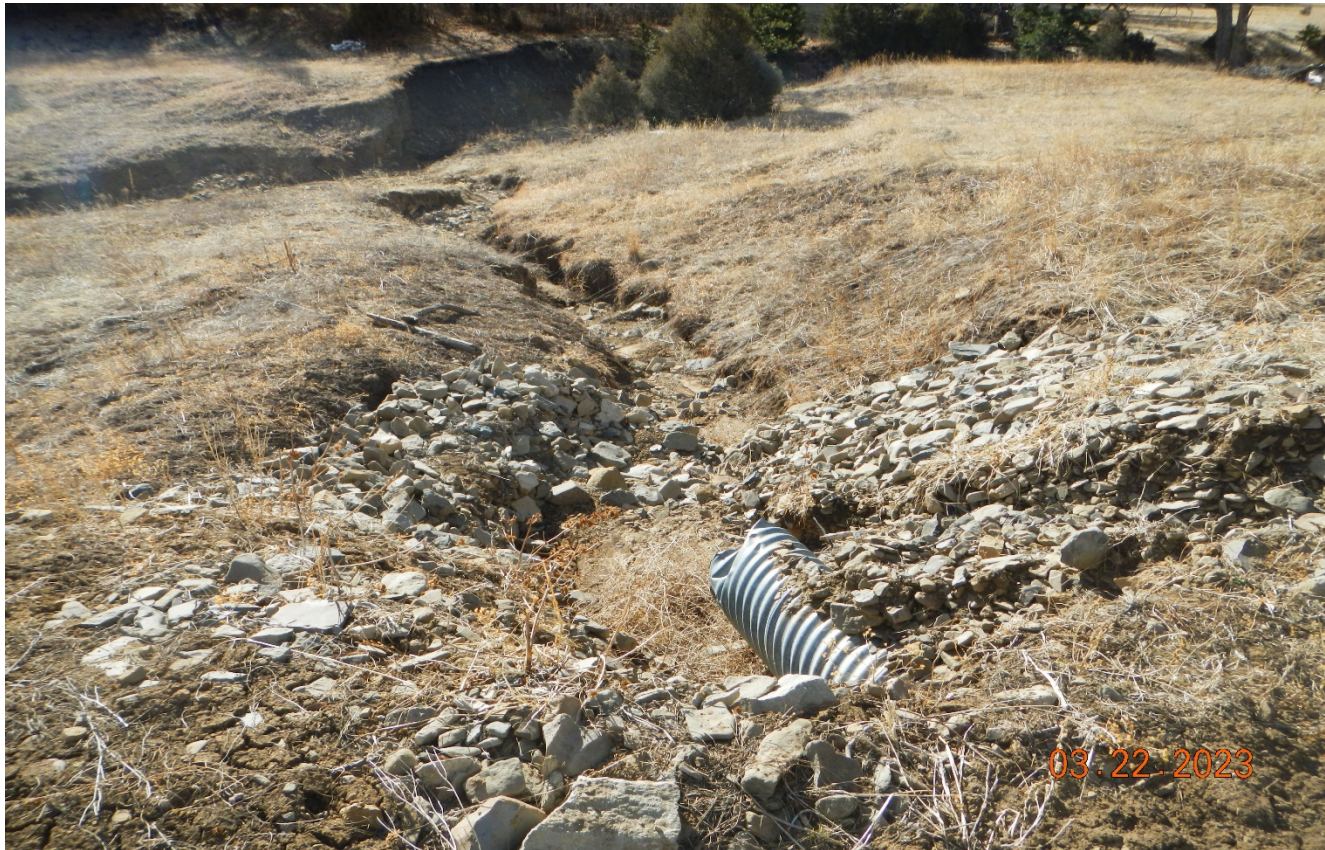
Photo 3. The culvert inlet is filled in with sediment and debris. It appears a larger culvert is needed at this area to handle stormwater coming off the road and drainage. Previous corrective action not completed.

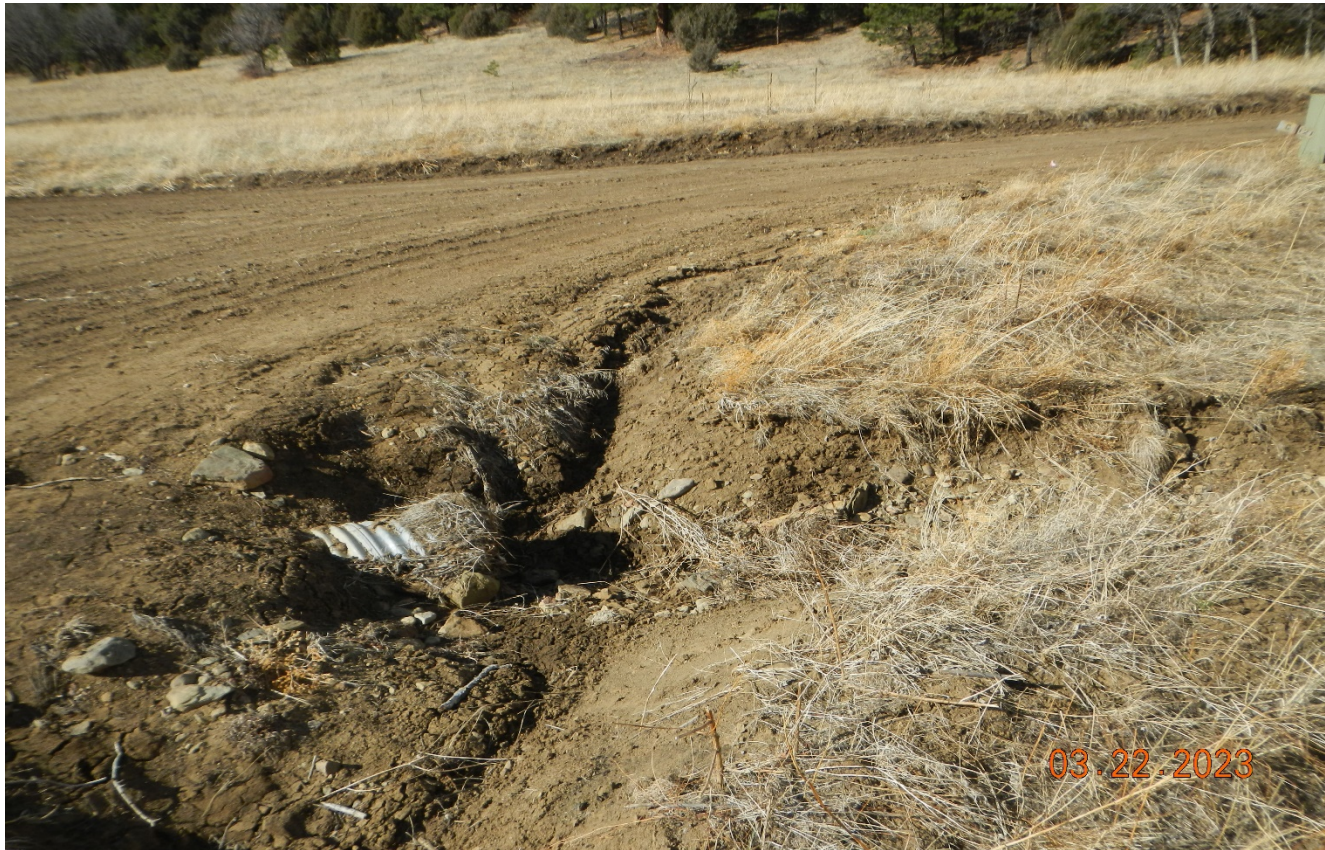
Photo 3. The culvert inlet is filled in with sediment and debris. It appears a larger culvert is needed at this area to handle stormwater coming off the road and drainage. Previous corrective action not completed.

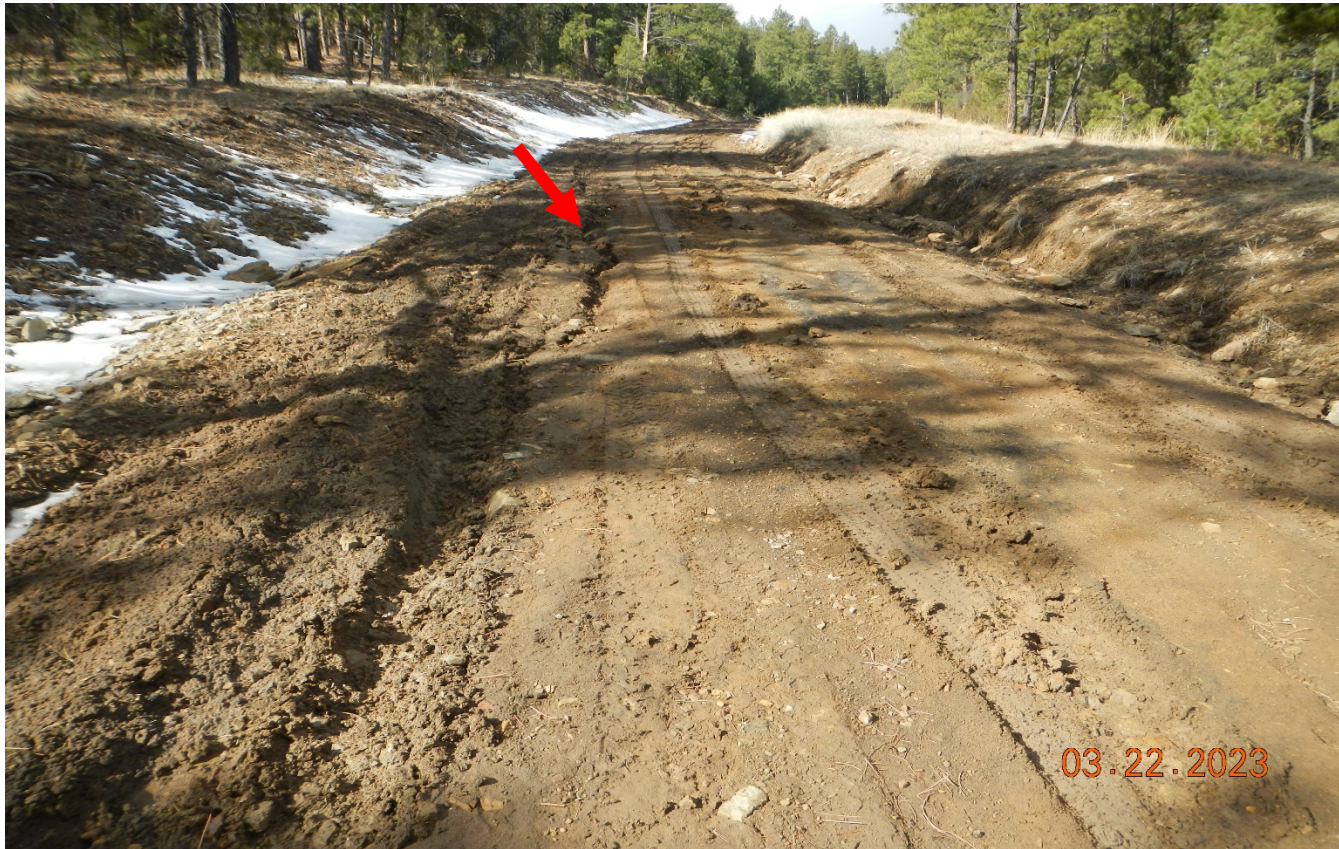
Photo 4. There are signs stormwater is flowing down the road causing erosion. This area has been a problem before and needs to be stabilized. Stormwater is not being properly diverted off the road. Additionally the road is very slick and vehicle rutting is occurring.

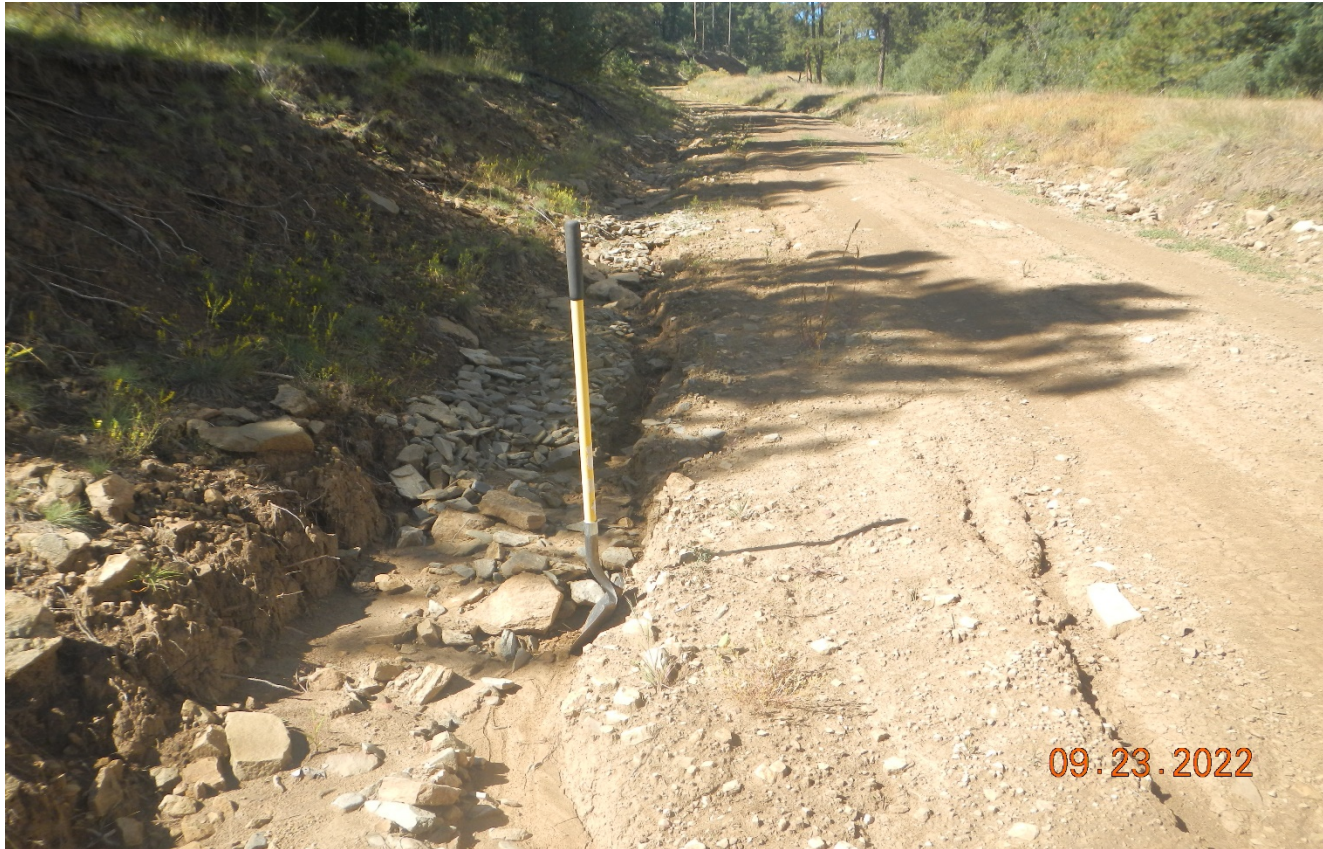
Photo 5. Facing west along the access road. Some of the rock check dams previously installed have washed out. Larger rock was likely needed. A 4.5 ft. shovel shows scale of erosion. Photo taken during previous inspection on 9/23/22.

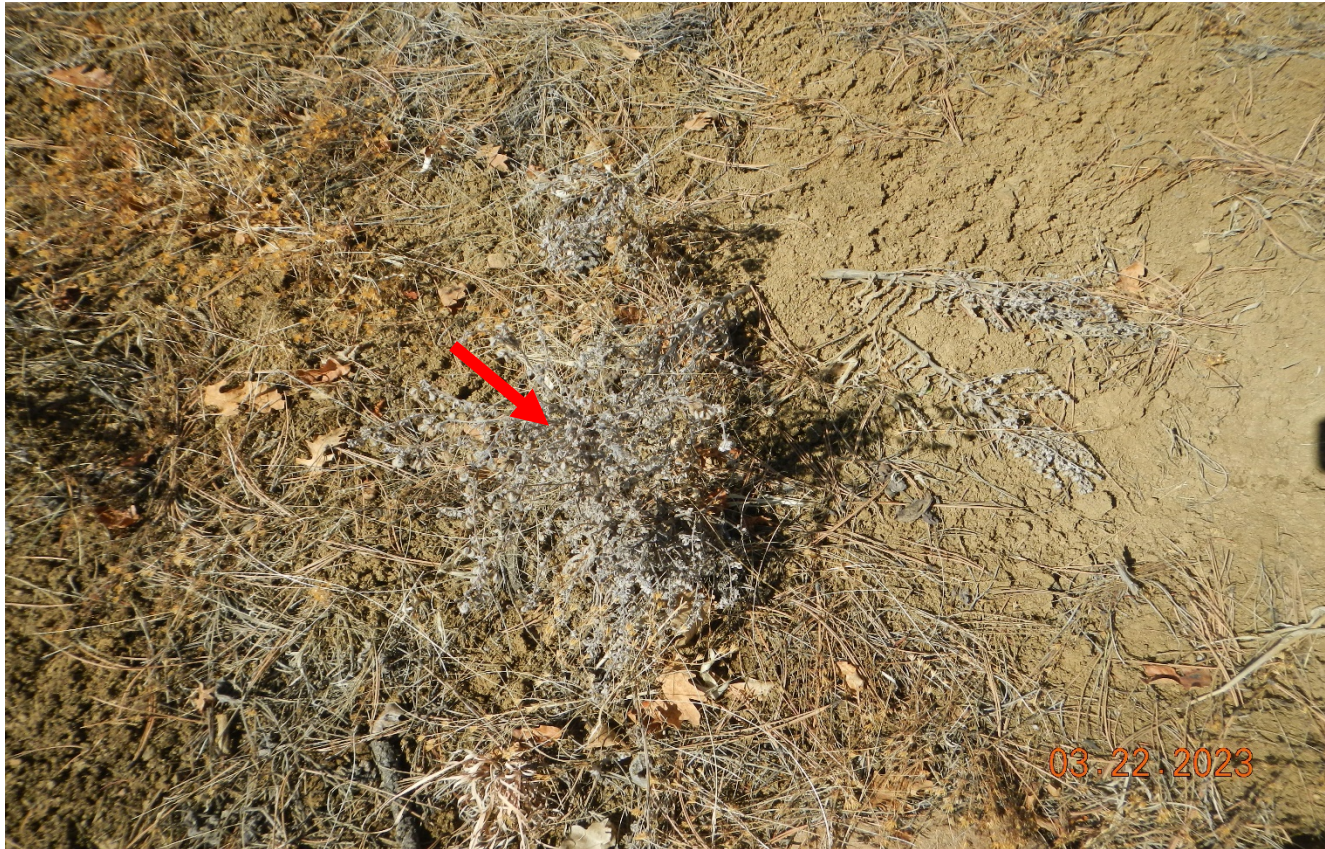
Photo 7. There are still noxious weeds Hounds tongue and Canada thistle which have not been controlled. The noxious weeds have produced seed so the weeds should have been bagged and removed. Red arrow points to Hounds tongue List B noxious weed.
