# Inspection Photos

3/21/2023

Operator: CAERUS PICEANCE LLC #10456

Location #335780

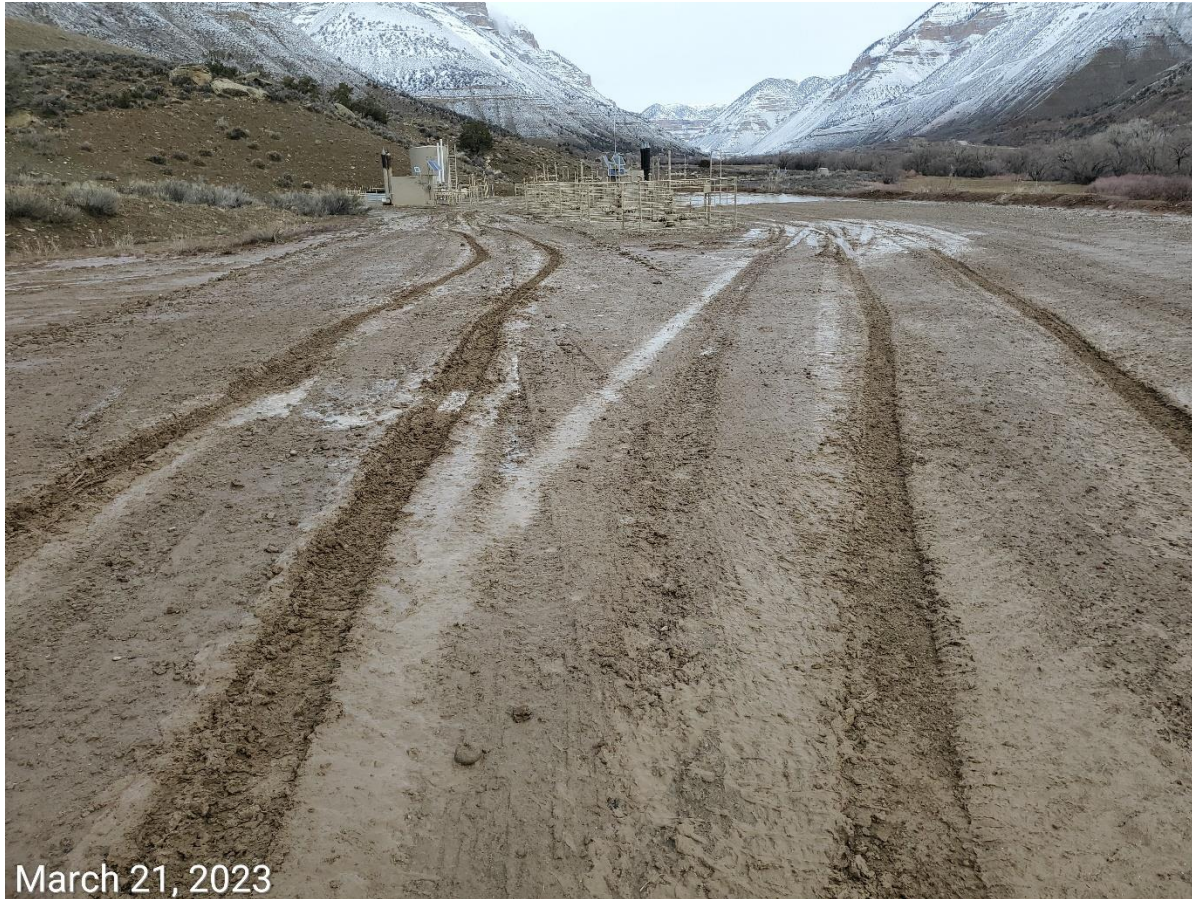
**Photo 1:** Photos 1-4 taken from the working pad area of the Location. Photos examples showing BMPs, including vehicle tracking control measures, remain missing or insufficient to minimize erosion, degradation, tracking and sediment transport during wet conditions. Regrading alone is inadequate to address tracking and stabilization issues. 6 foot measuring stick for reference.

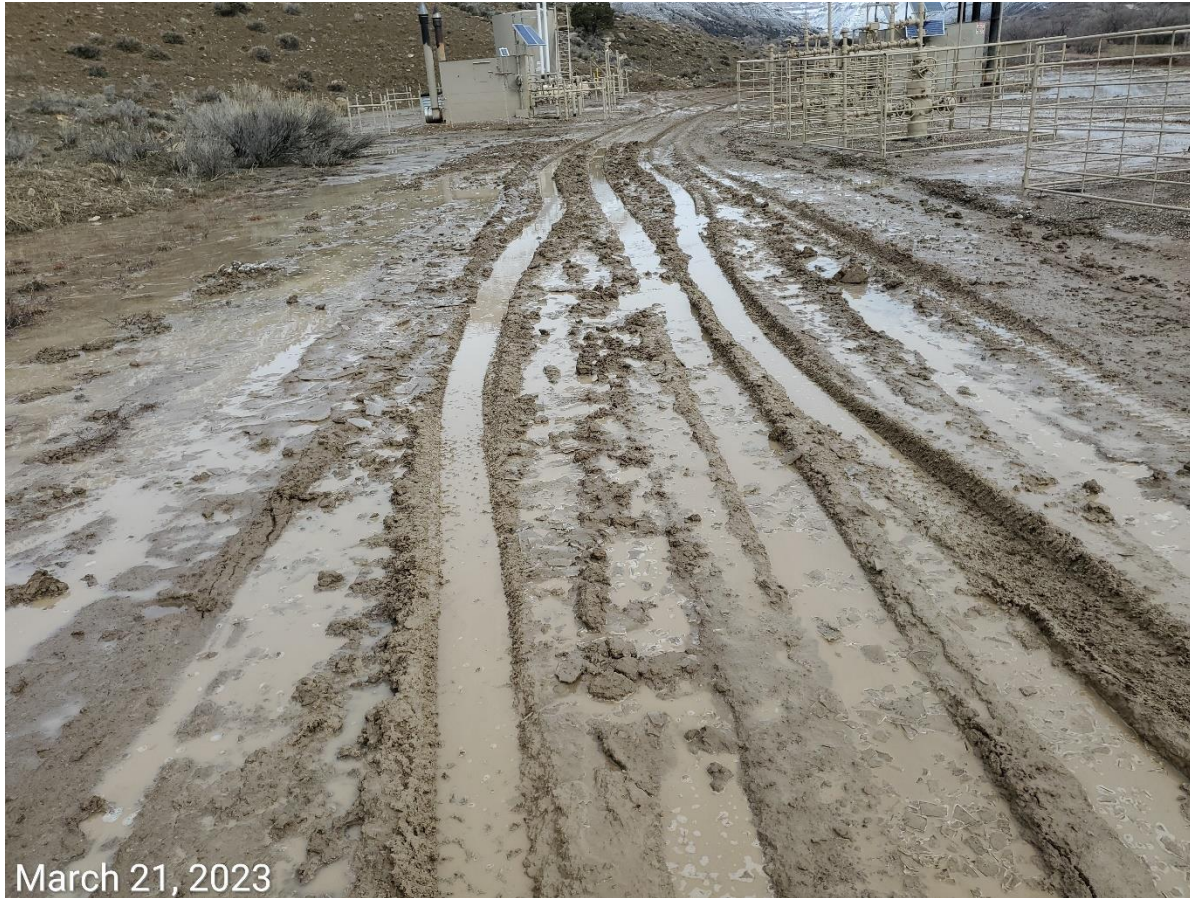
**Photo 2:** See comments under photo 1.

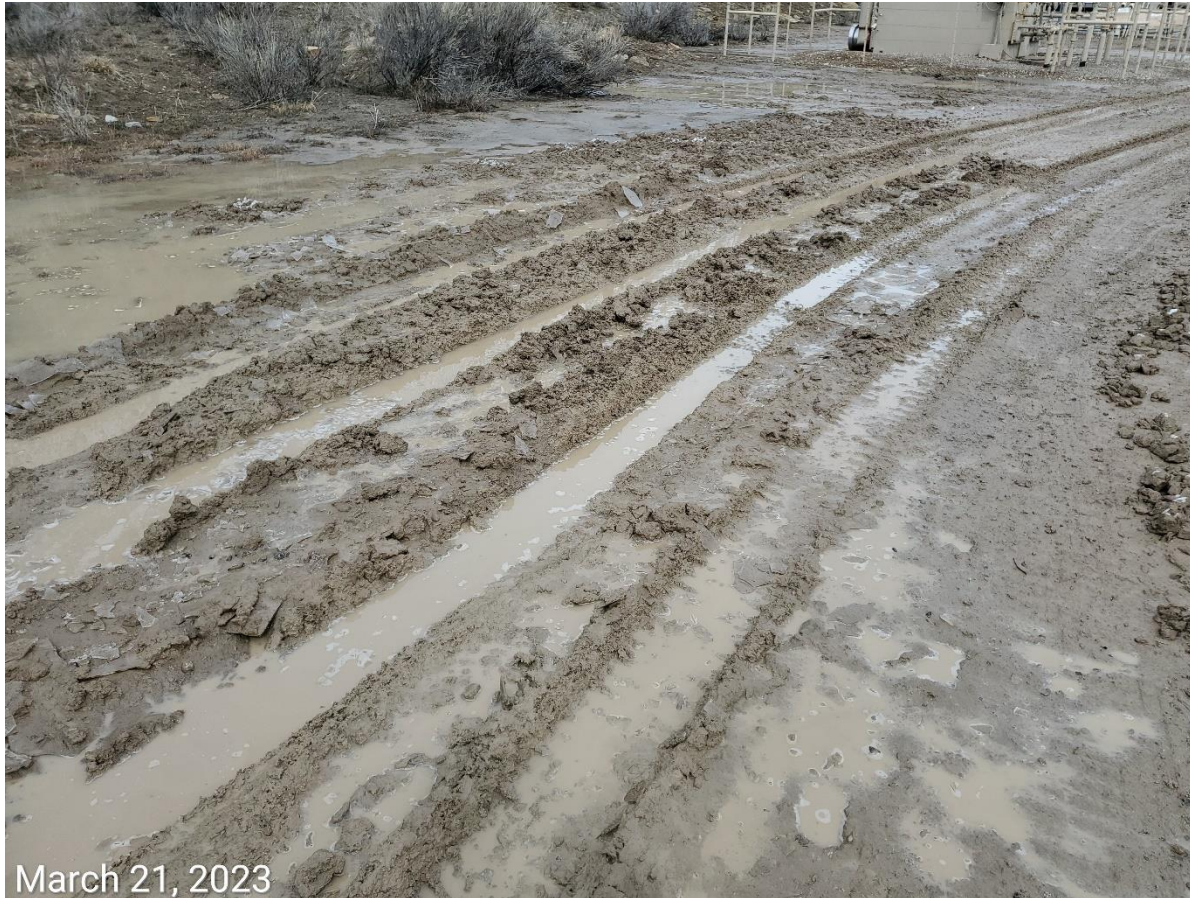
**Photo 3:** See comments under photo 1.

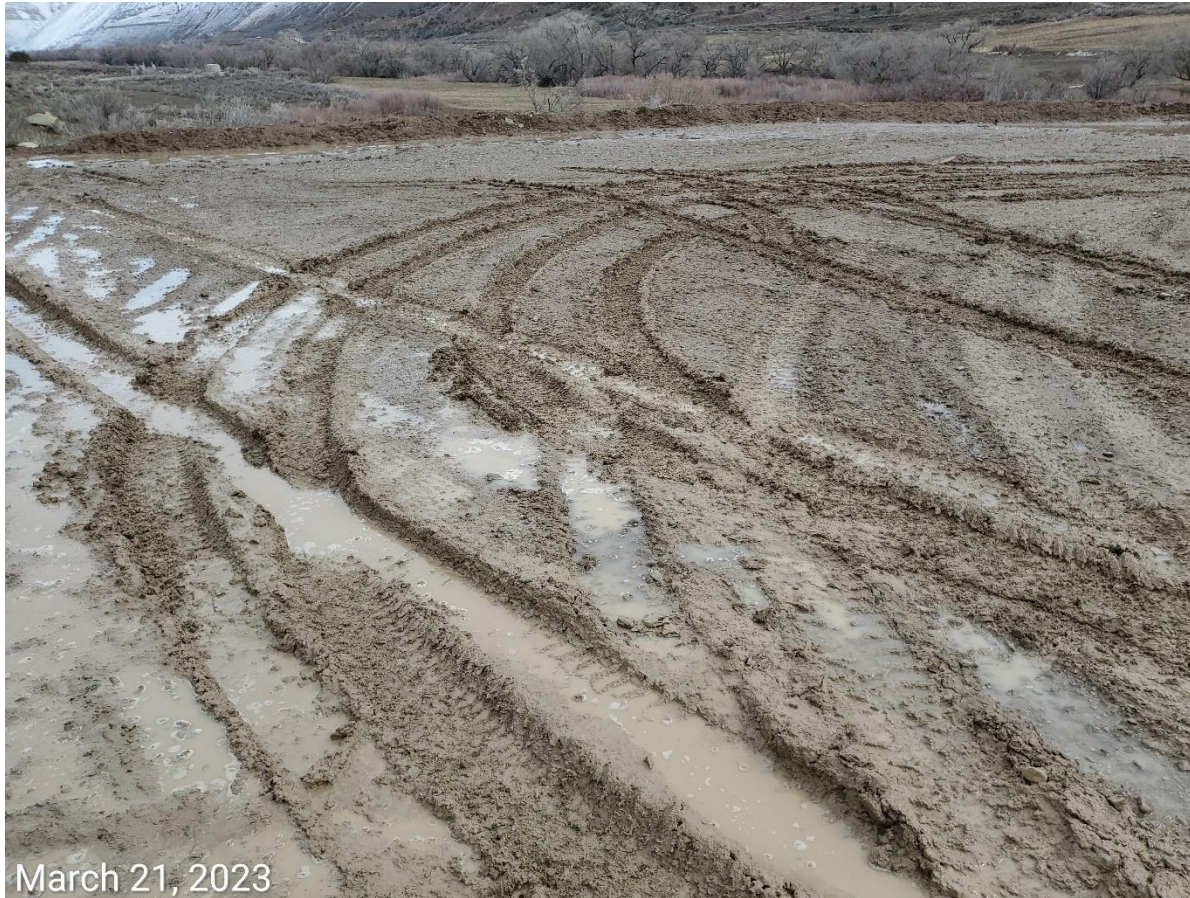
**Photo 4:** See comments under photo 1.

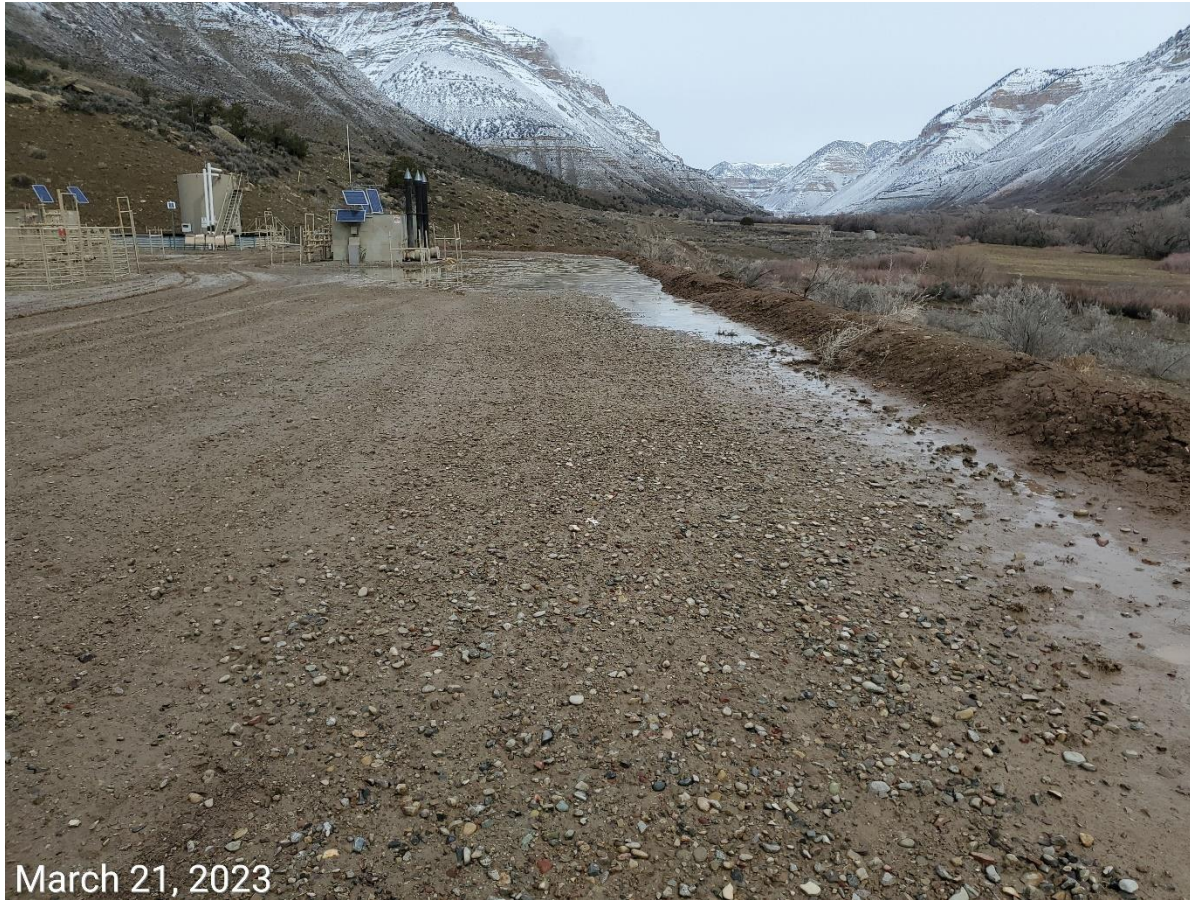
**Photo 5:** Photo taken from the east end of the Location. Photo shows areas where stormwater is ponding on the east end of the Location. There are several areas where stormwater has blown out the perimeter berm, resulting erosion, degradation, and sediment deposition on top of vegetation of the interim slopes of the Location; Location has not been constructed with an appropriate engineered outlet to allow for proper stormwater discharge.

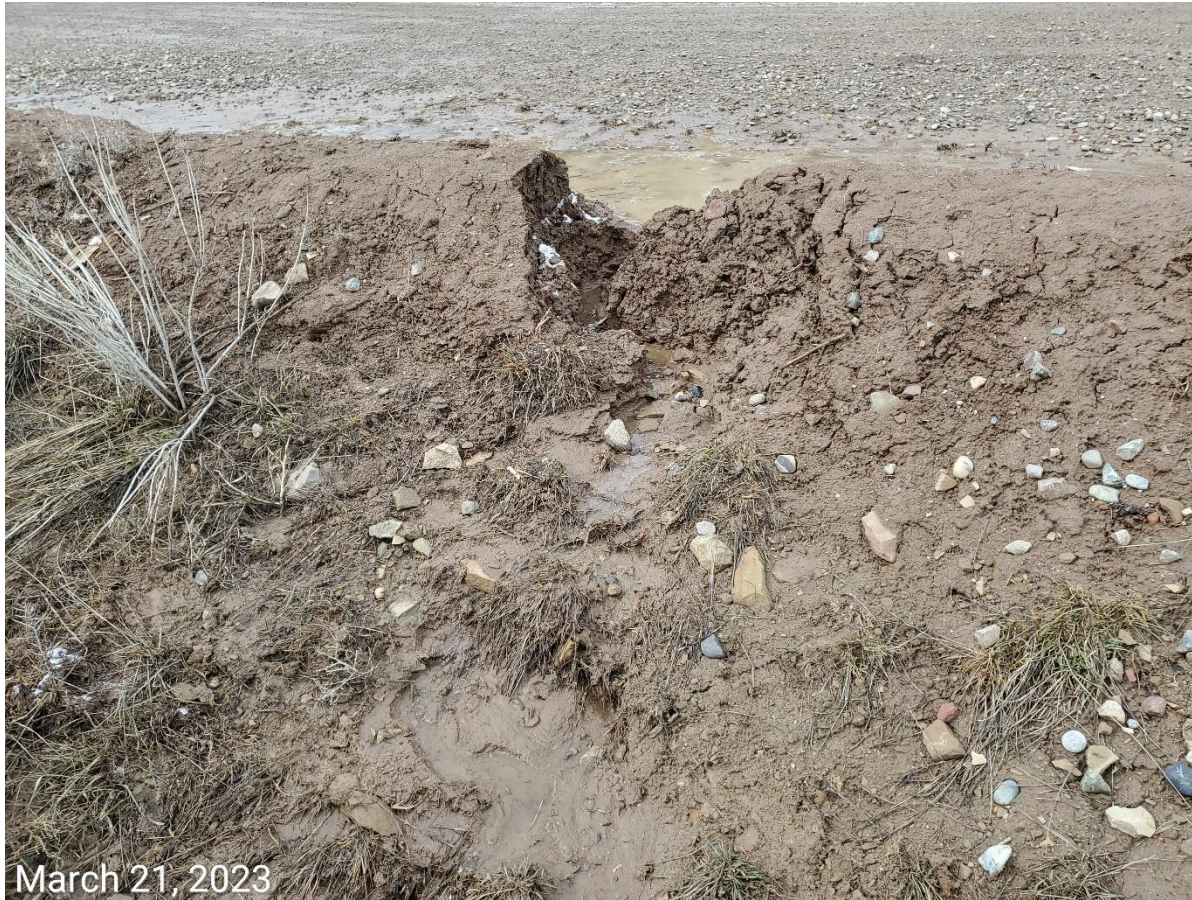
**Photo 6:** See comments under photo 5. Photo shows areas where stormwater has blown out the perimeter berm, resulting erosion and degradation the interim slopes of the Location; Location has not been constructed with an appropriate engineered outlet to allow for proper stormwater discharge.

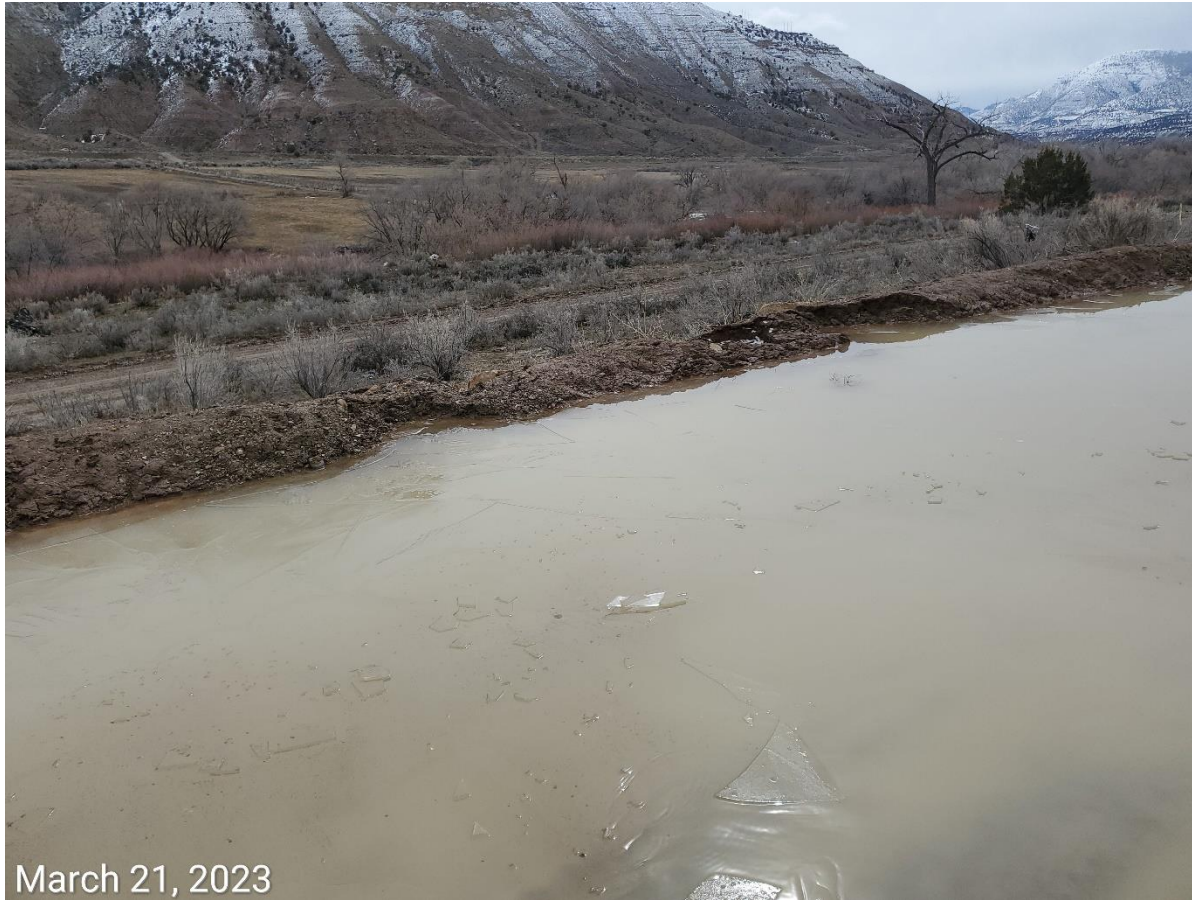
**Photo 7:** See comments under photo 5. Photo shows areas where stormwater has blown out the perimeter berm, resulting erosion and degradation the interim slopes of the Location; Location has not been constructed with an appropriate engineered outlet to allow for proper stormwater discharge.

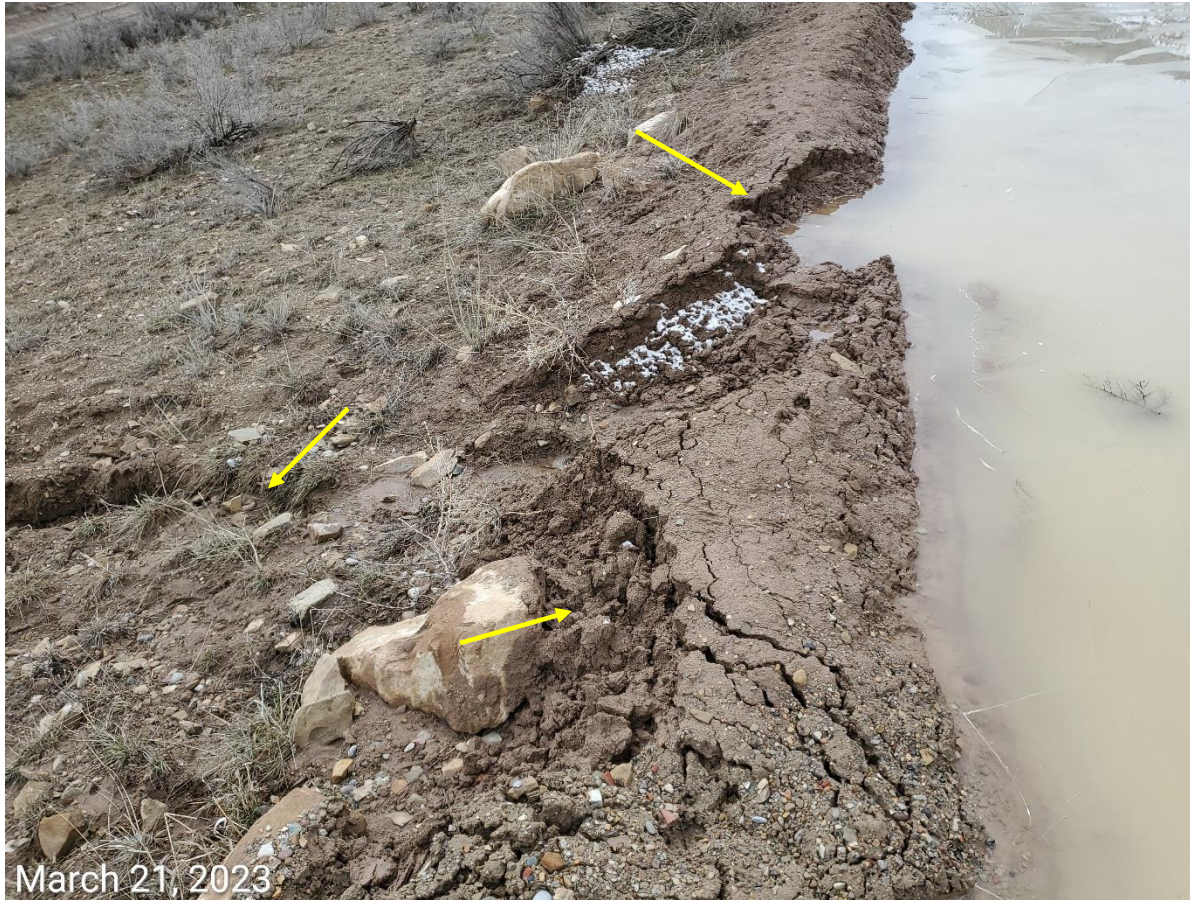
**Photo 8:** See comments under photo 5. Photo shows areas where stormwater has blown out the perimeter berm, resulting erosion and degradation the interim slopes of the Location; Location has not been constructed with an appropriate engineered outlet to allow for proper stormwater discharge.

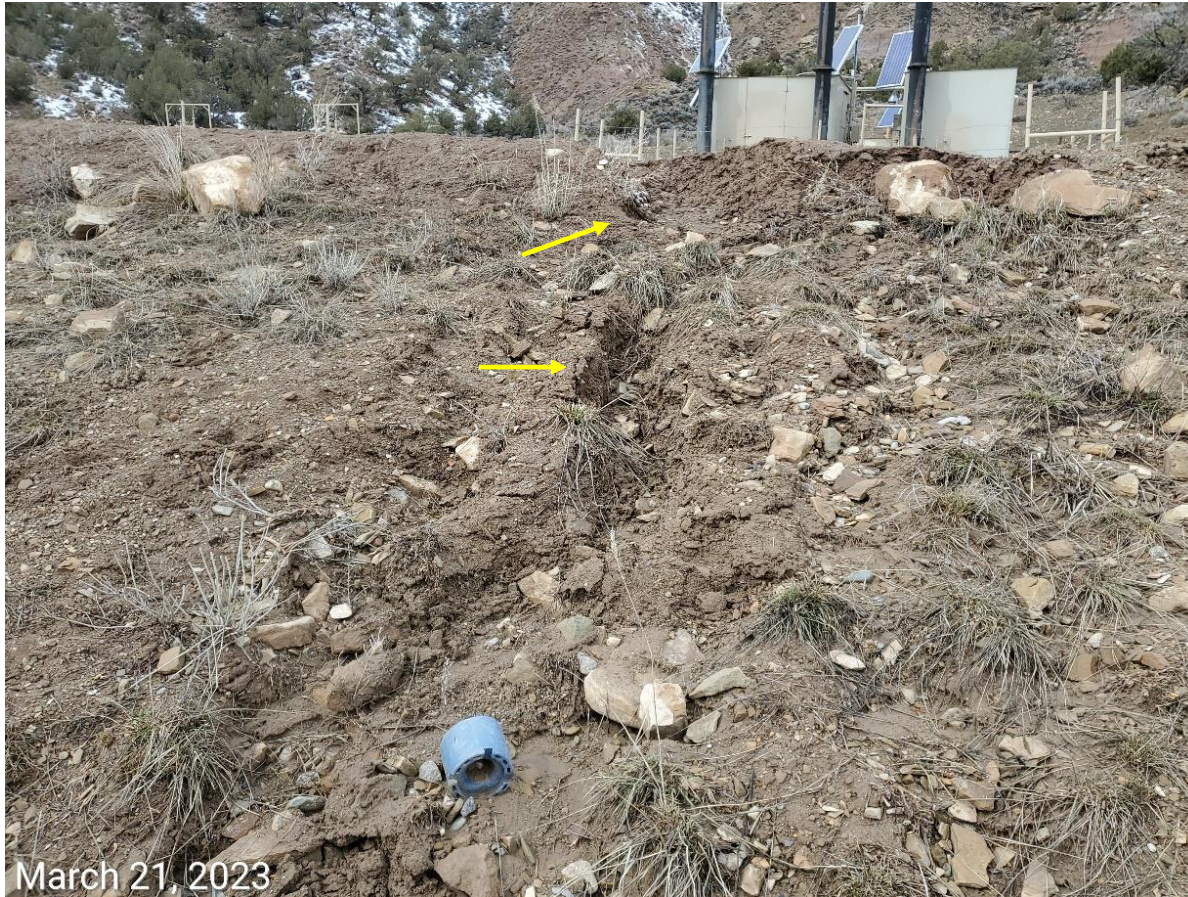
**Photo 9:** Photo shows stormwater erosion and degradation at the eastern interim slopes of the Location. Location has not been constructed with an appropriate engineered outlet to allow for proper stormwater discharge.

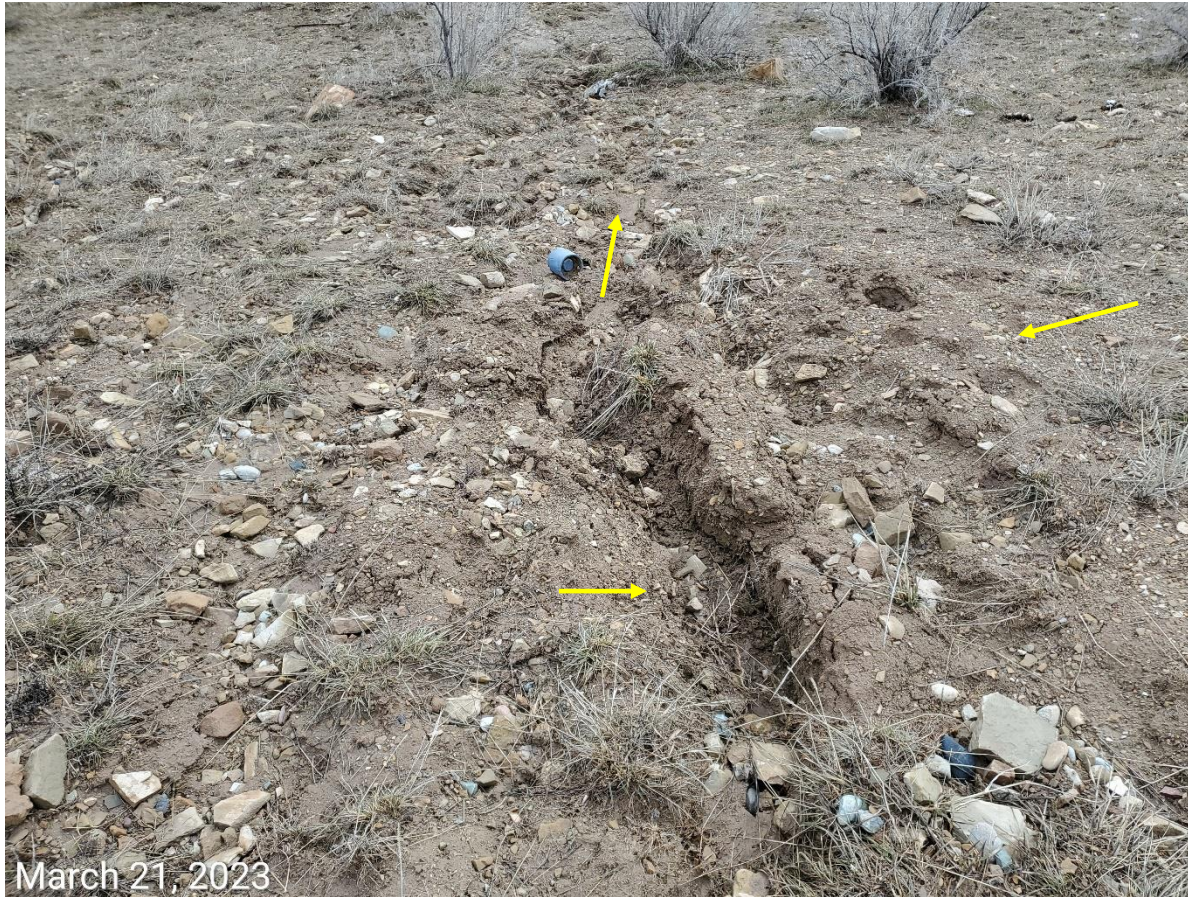
**Photo 10:** See comments under photo 9.

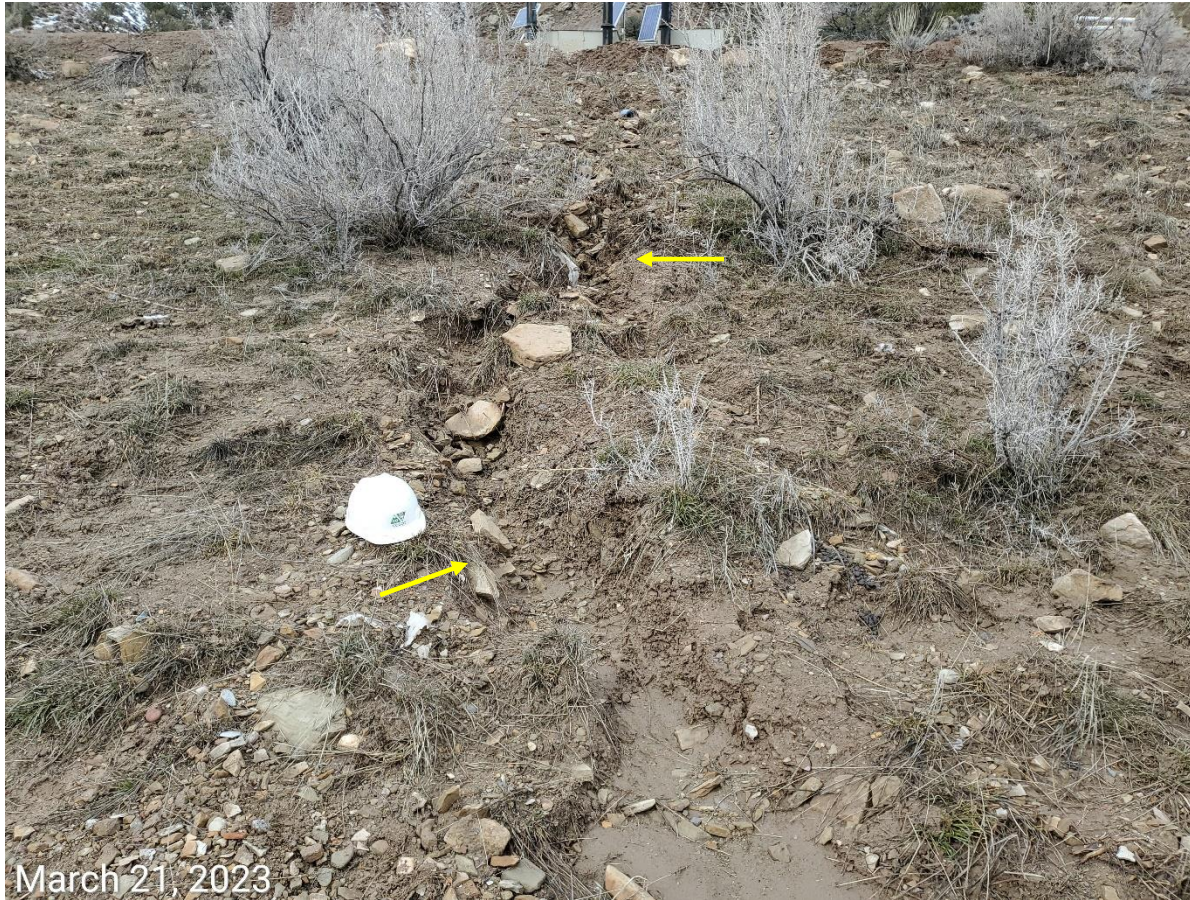
**Photo 11:** See comments under photo 9. Hardhat used for reference

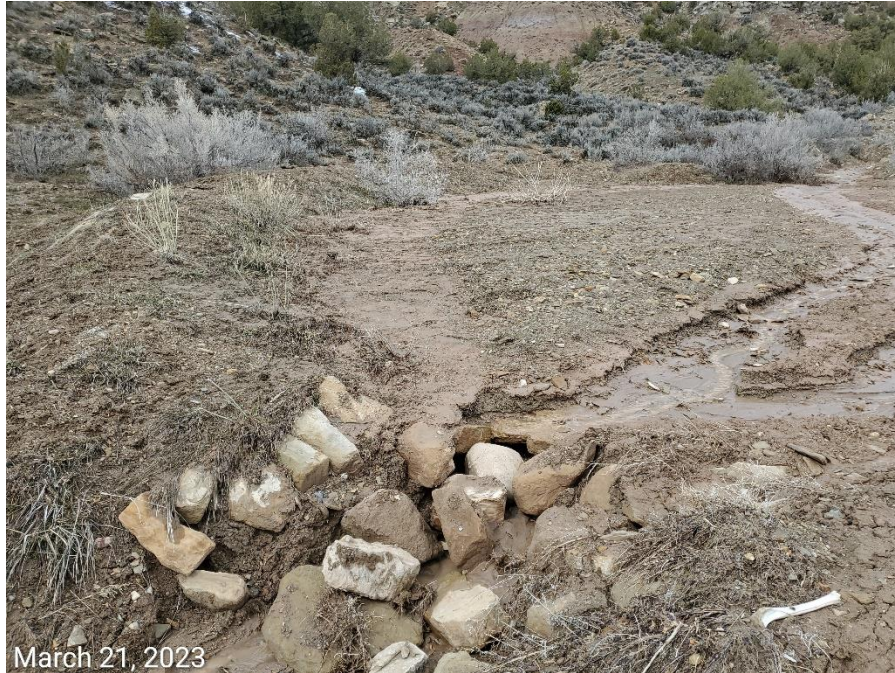
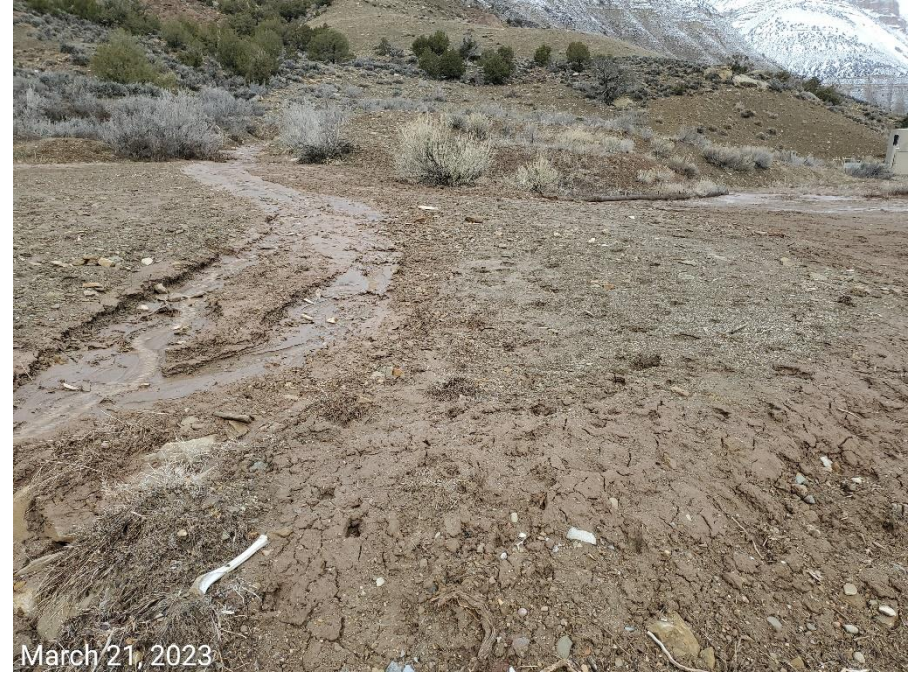
**Photo 12:** Photos taken from the sediment trap on the west end of the Location. Photo shows BMP appears to have filled with sediment.

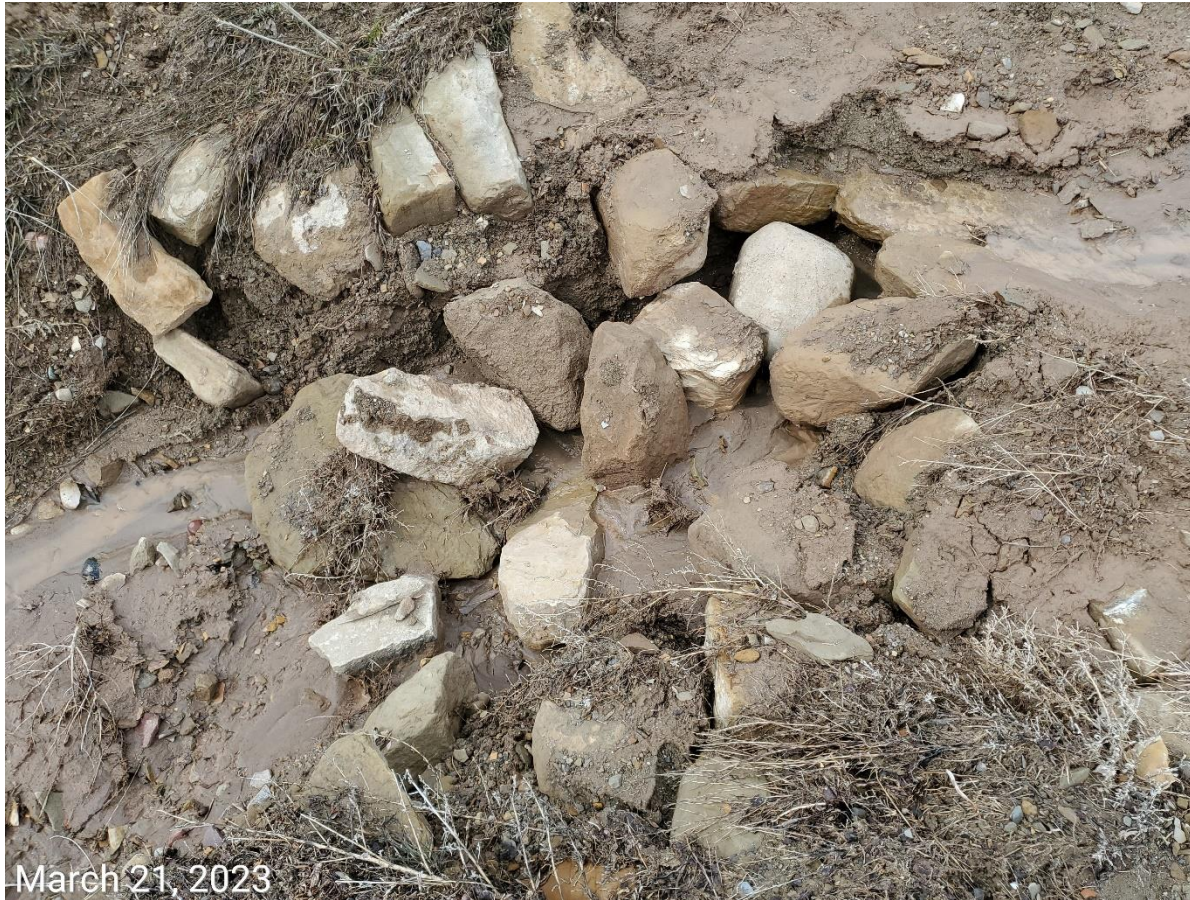
**Photo 13:** Continued from photo 12. Photo shows outlet at the sediment trap in disrepair. BMP also does not appear to have been constructed in accordance with good engineering practices; geotextile lining not observed beneath armoring.

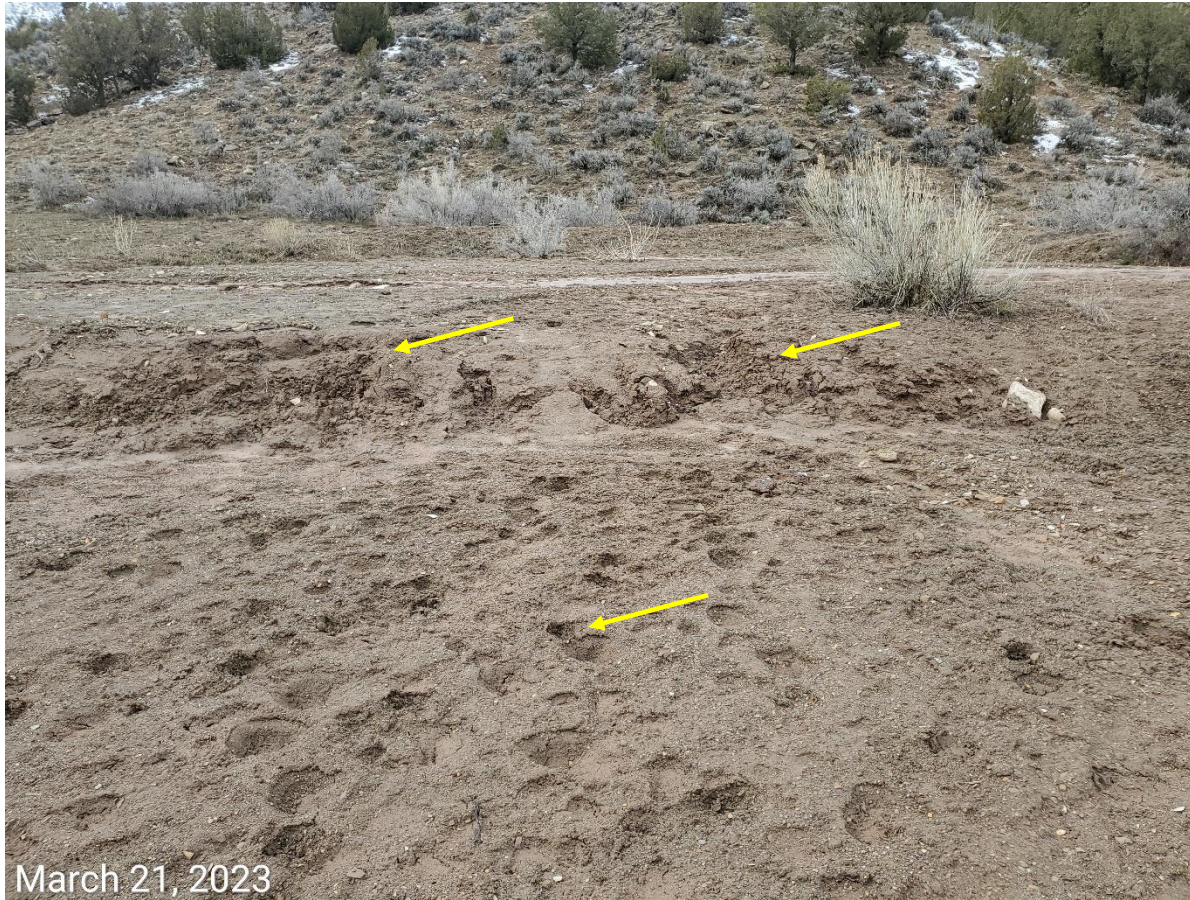
**Photo 14:** Photo shows areas where stormwater appears to have blown out a section of the sediment trap, resulting in runoff onto the working pad area and sediment deposition.

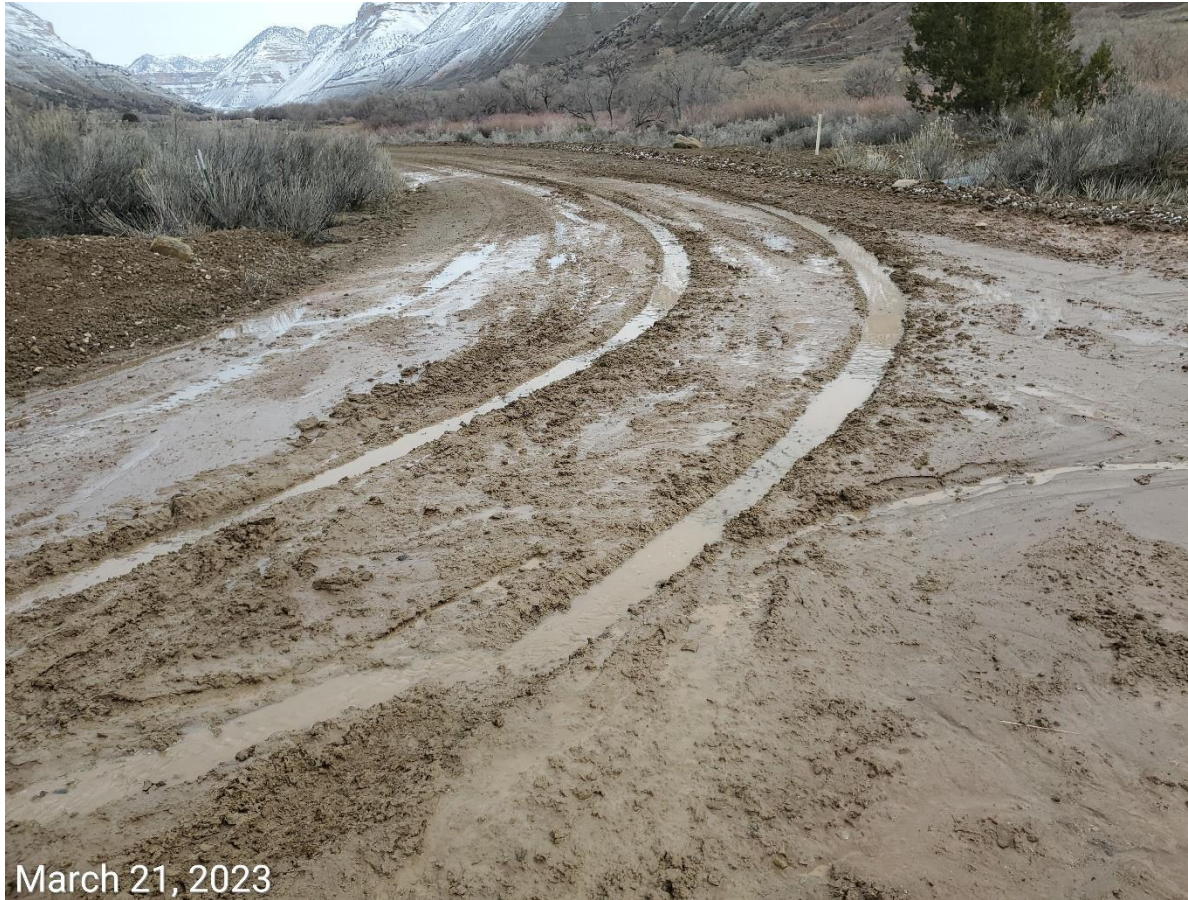
**Photo 15:** Photos 15-16 show BMPs to minimize erosion, degradation, tracking and sediment transport remain missing or insufficient at the access road. Degradation/tracking and sediment transport observed throughout many sections of the main north/south access road. Stormwater does not appear to be being adequately diverted, or discharging from the road. Grading alone is inadequate to address tracking and stabilization issues.

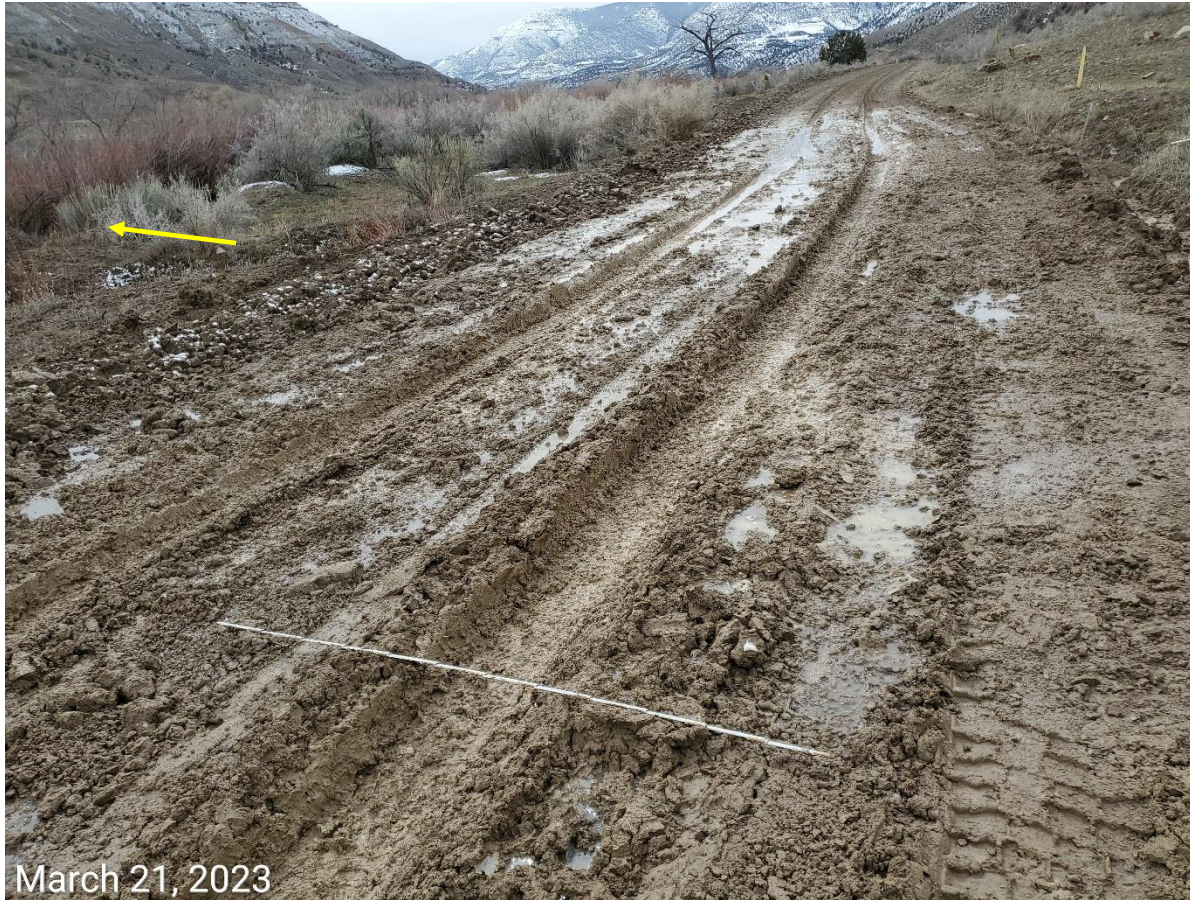
**Photo 16:** Photo taken example of sections along the main North/South access road, where BMPs to minimize erosion, degradation, tracking and sediment transport remain missing or insufficient. Stormwater does not appear to be being adequately diverted, or discharging from the road. Regrading alone is inadequate to address tracking and stabilization issues. 6 foot measuring stick for reference. Riparian area for Parachute Creek visible in the left of the photo.
