Construction and Stormwater Inspection

Date: 03/23/2023

Operator: NAVEX RESOURCES LLC - 10360

Location ID: 483129

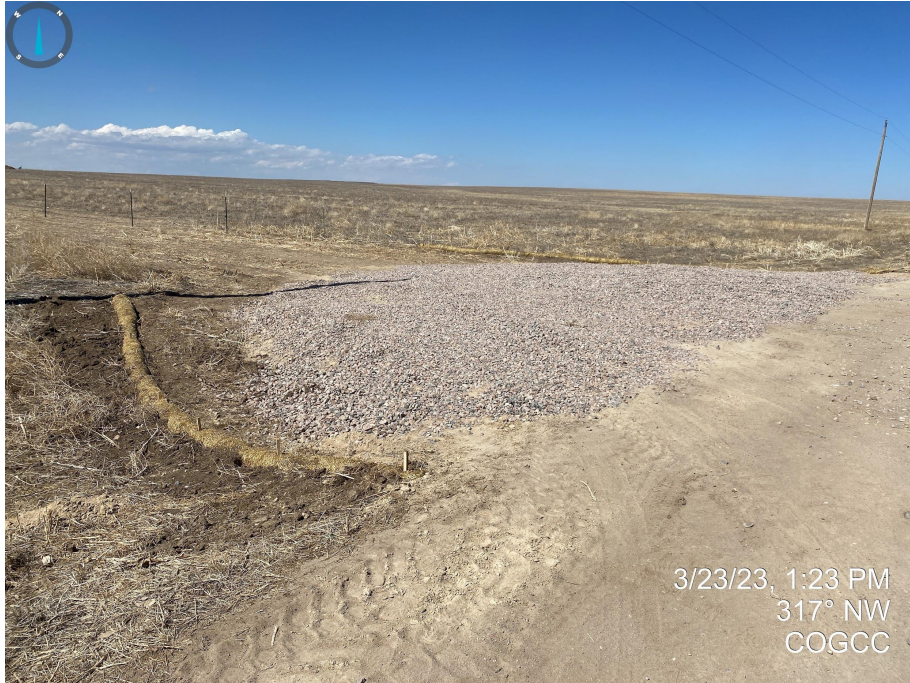
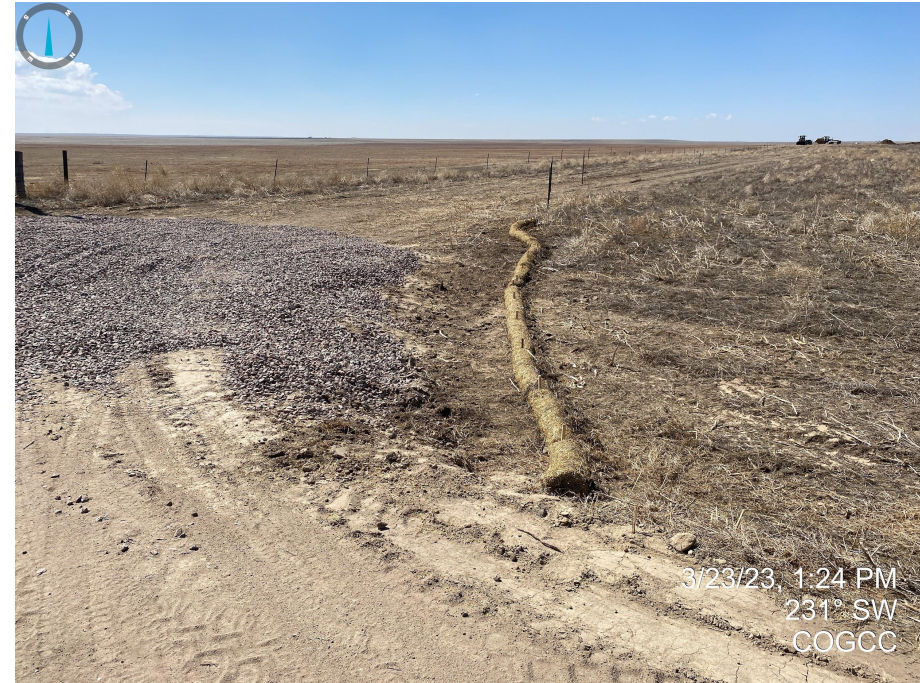
Photos 1 & 2. Facing northwest and southwest at the location entrance. Vehicle track out pad and stormwater BMPs installed. Location signage was not observed at the entrance as required by Rule 406.d.

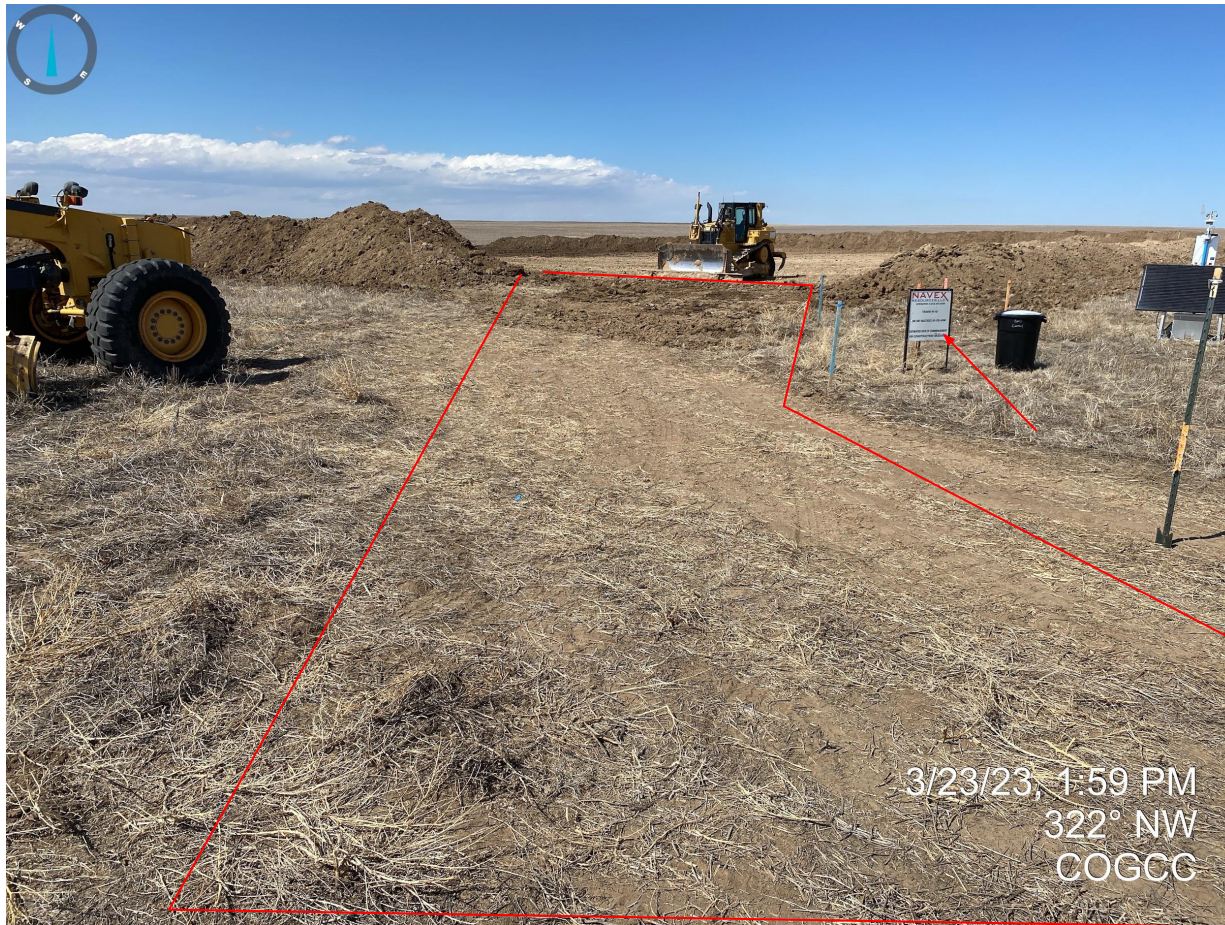
Photo 3. Facing northwest at the construction pad entrance. Photo illustrates that the approach to the pad, and the access road (both outlined in red), have not been salvaged for topsoil and will be required Per Rule 1002.b. Red arrow illustrates location signage that needs to be moved to the entrance for the access road.

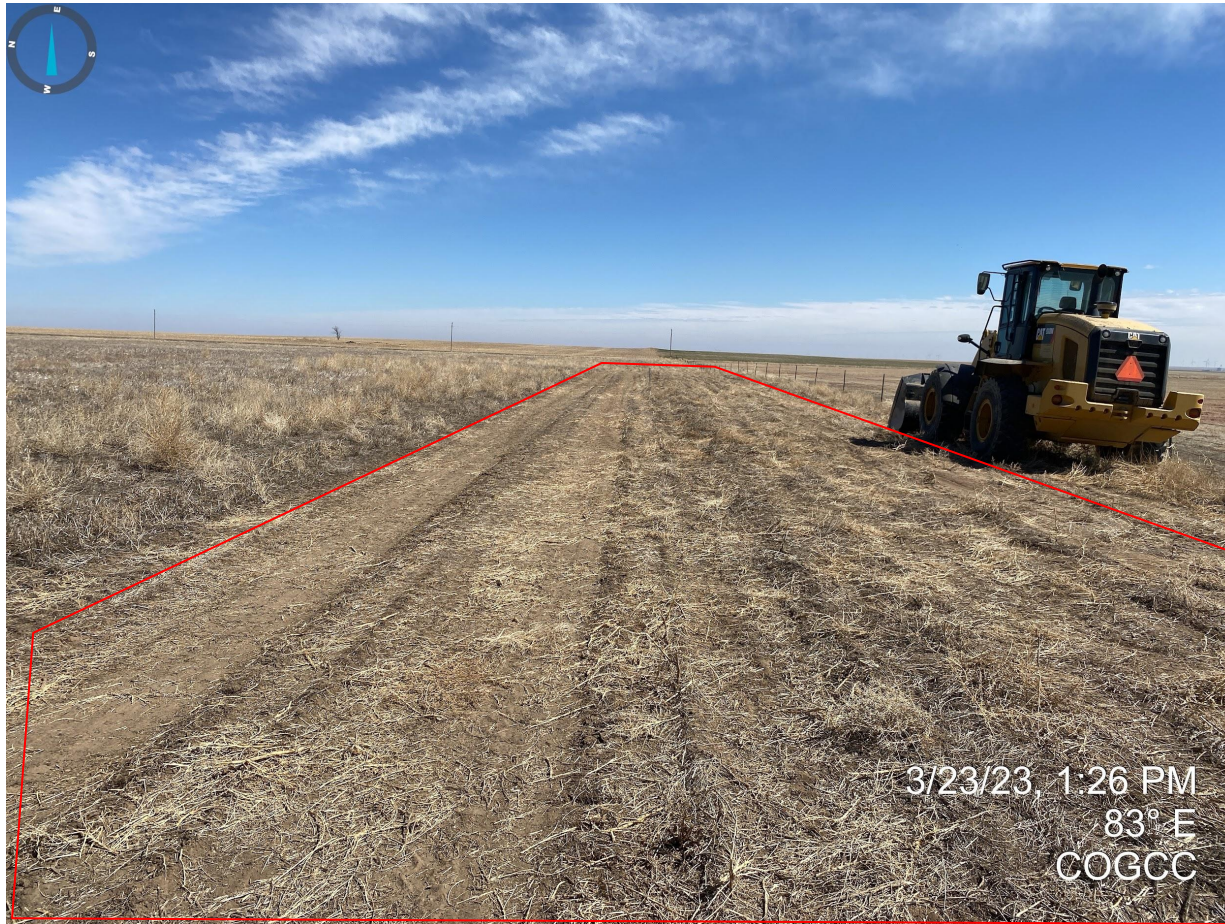
Photo 4. Facing east along access road. Topsoil from the access road has not been salvaged at the time of this inspection.

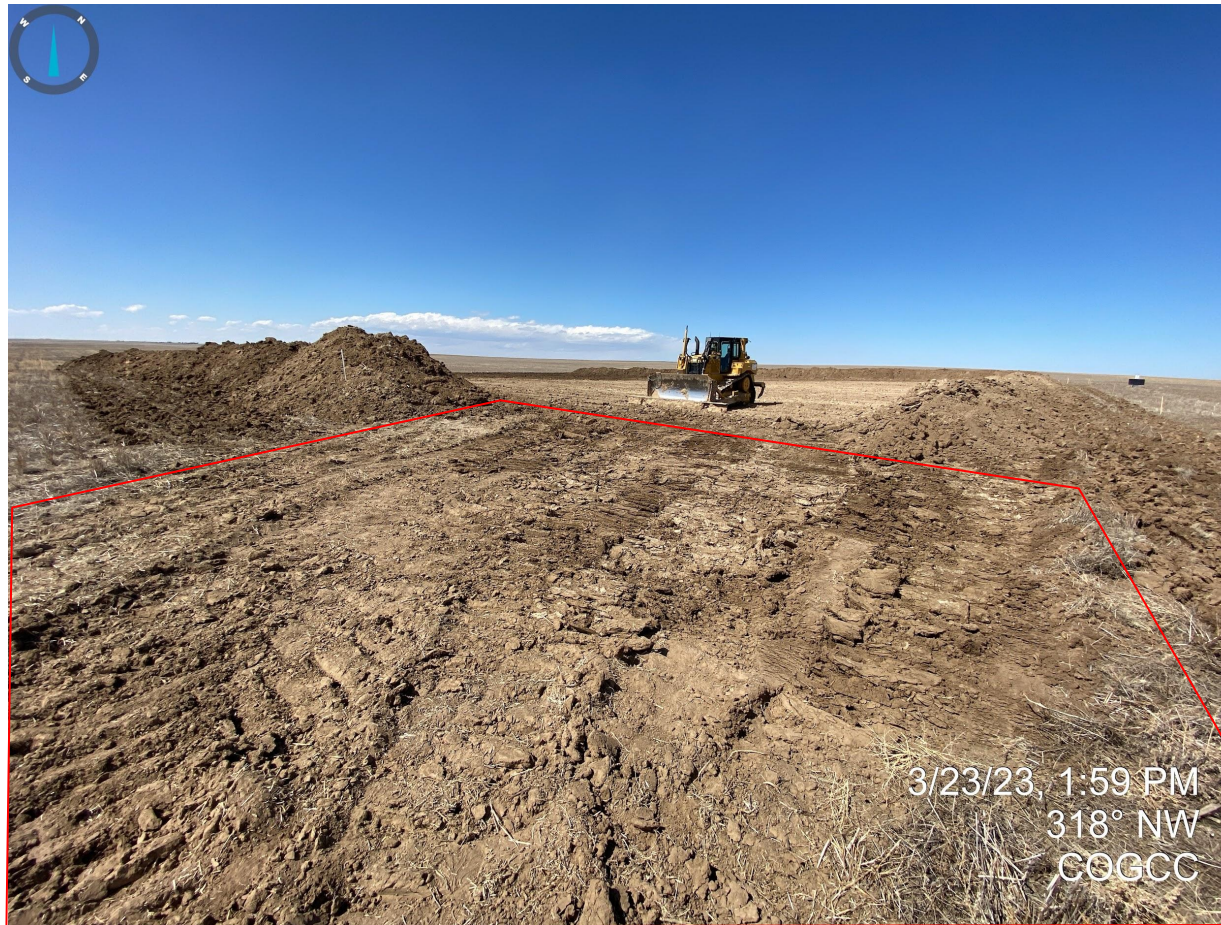
Photo 5. Facing northwest from the southeast corner of the construction pad; see comments in Photos 3 & 4.

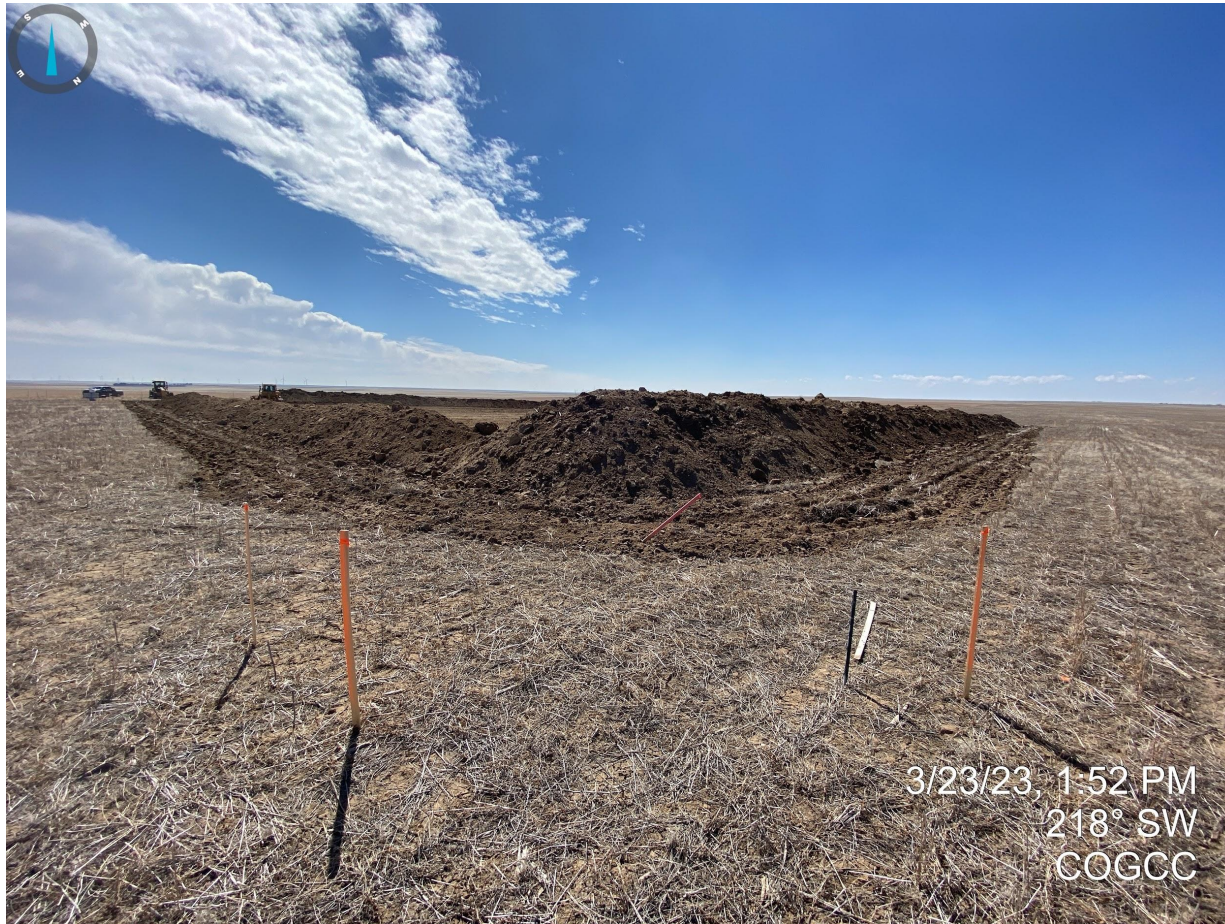
Photo 6. Facing southwest from the northeast corner of the construction. It appears temporary BMPs (surface roughening) have been installed during the initial site construction. On-site contractor advised that straw wattles would be installed at a later date. Some BMPs are still in-process (sediment traps, etc). More permanent stormwater BMPs should be selected after pad construction is completed. Topsoil stockpiles also pictured on the interior perimeter of the disturbance area.

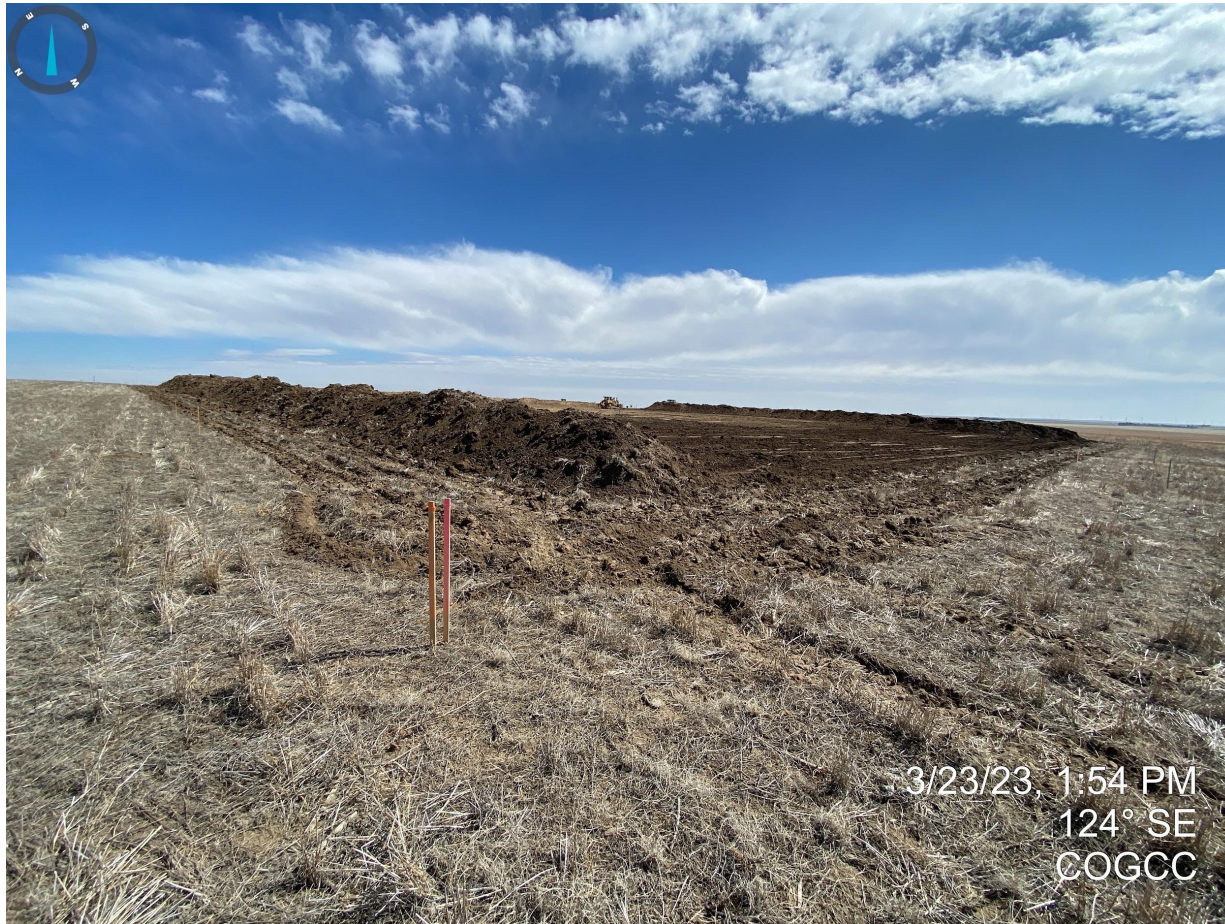
Photo 7. Facing southeast from the northwest corner; see comments in Photo 6.

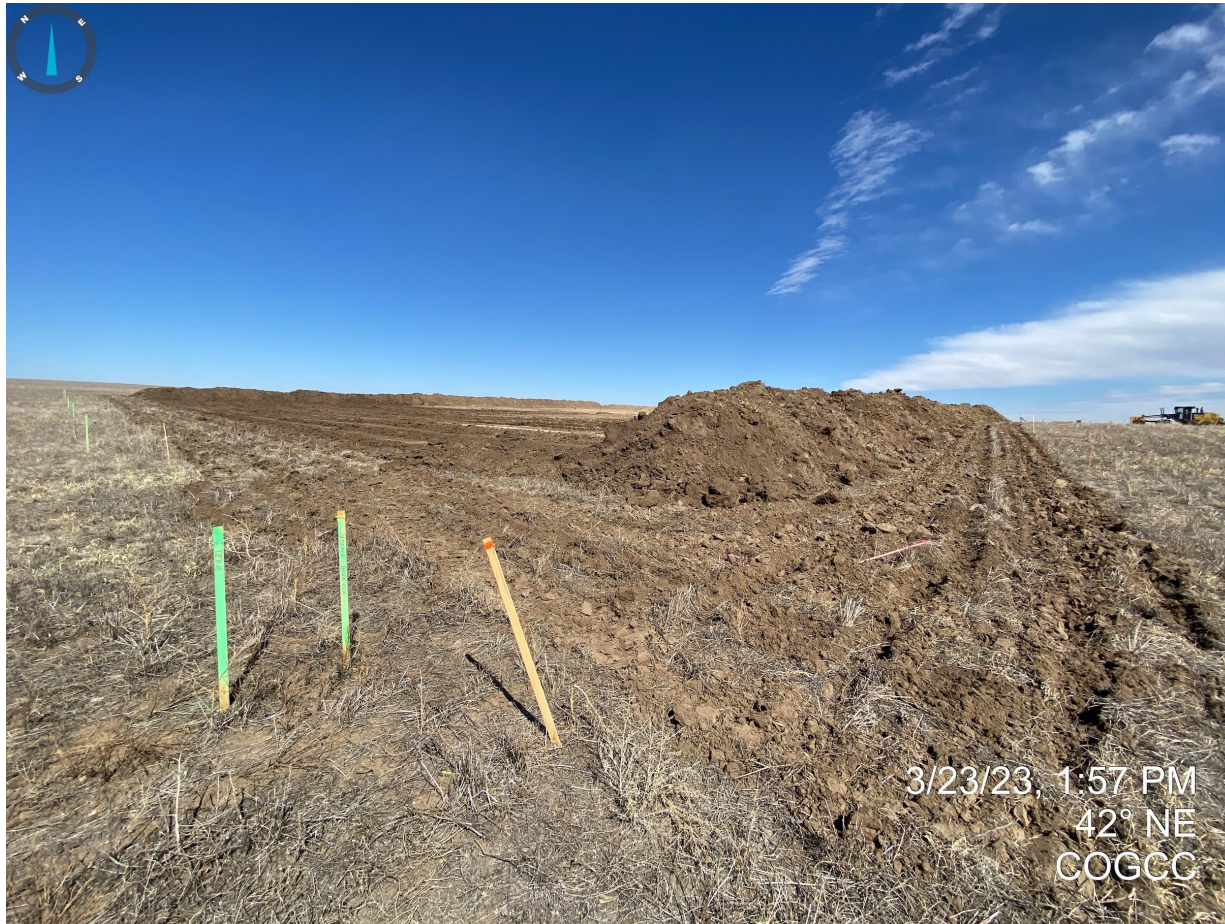
Photo 8. Facing northeast from the southwest corner of the location, near the proposed sediment trap location. See comments in Photo 6.

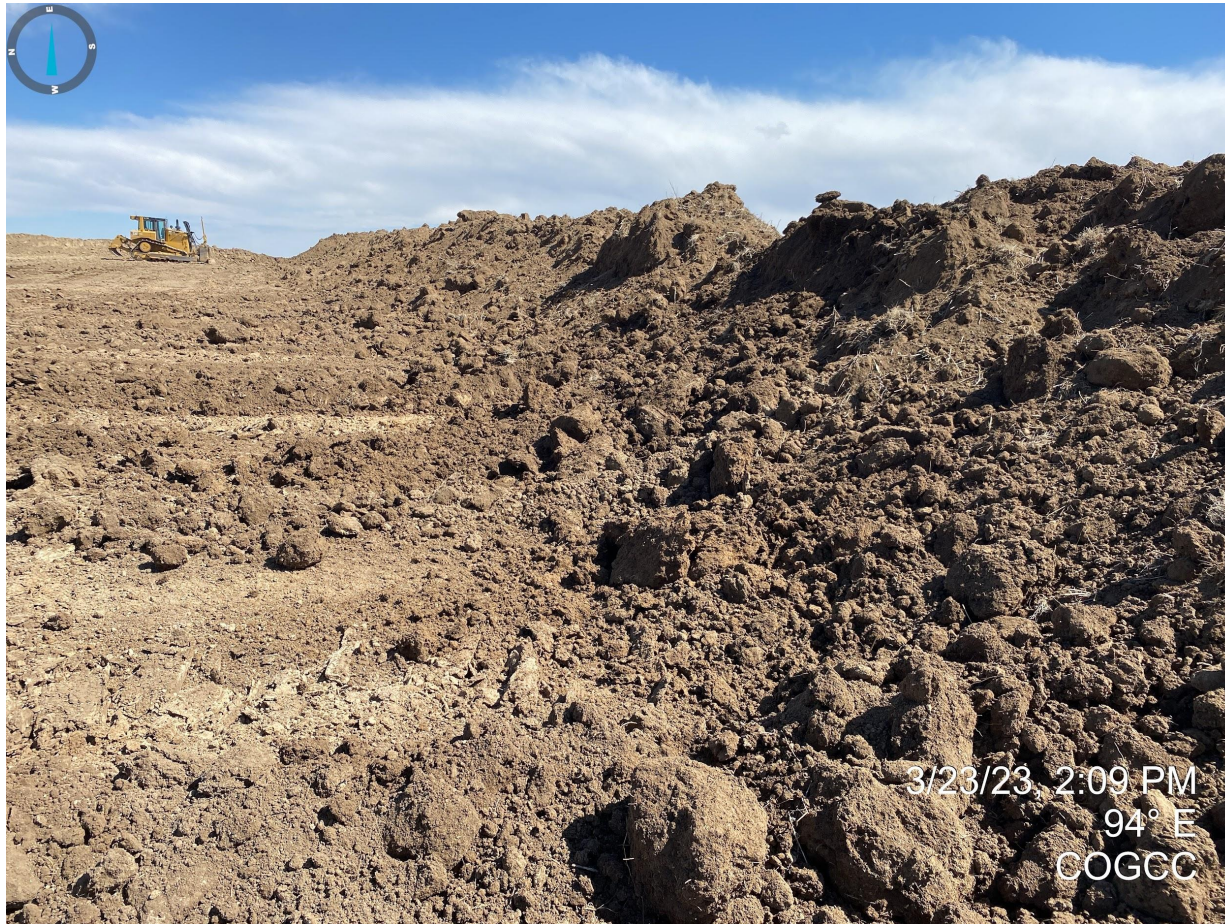
Photo 9. Facing east at the southern topsoil stockpile. Appears the topsoil has been segregated and stockpiled and will need to be stabilized from wind and water erosion. Construction was still on going during this inspection; a follow-up inspection will be conducted to document the topsoil stockpiles for Rule 1002.c compliance.

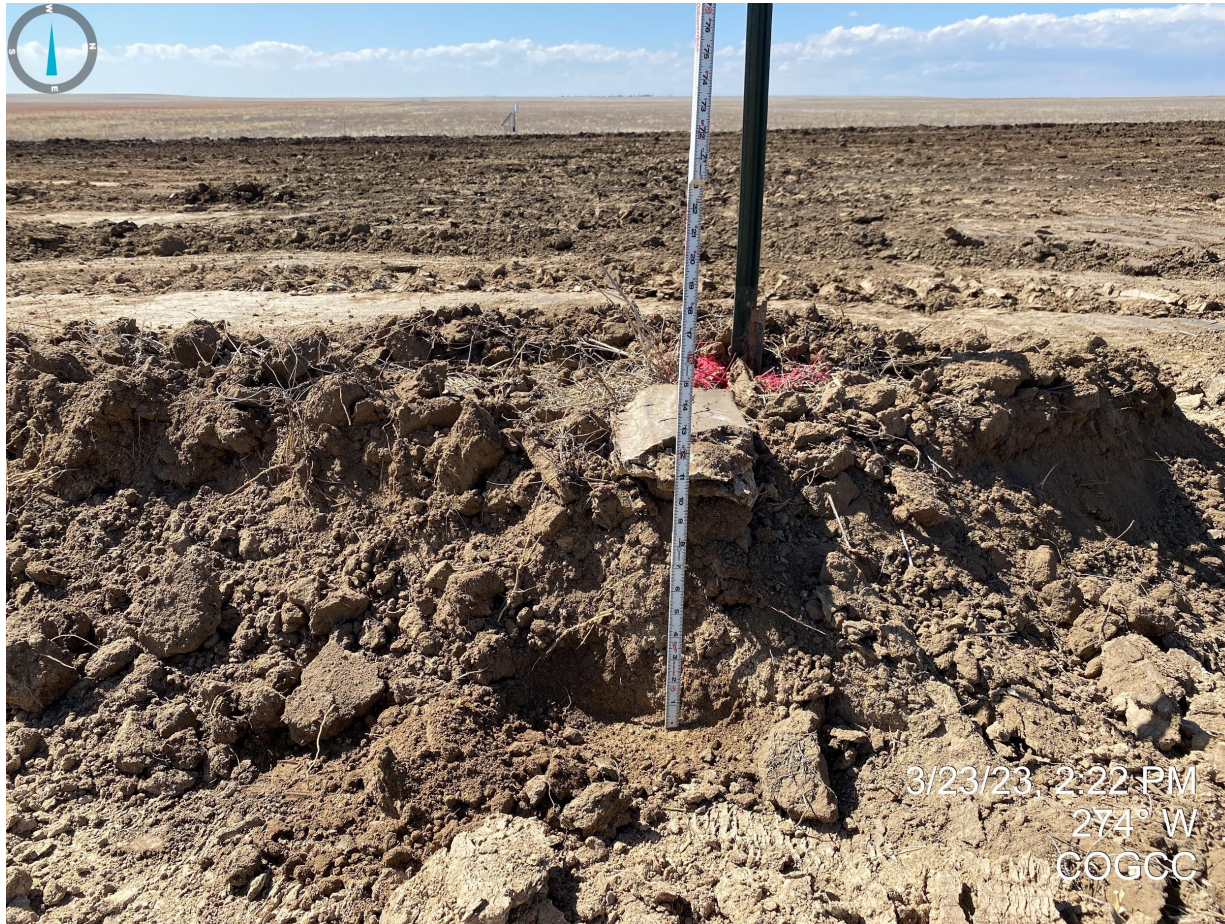
Photo 10. Facing west from the proposed well location; photo illustrates topsoil salvage with rule for scale.

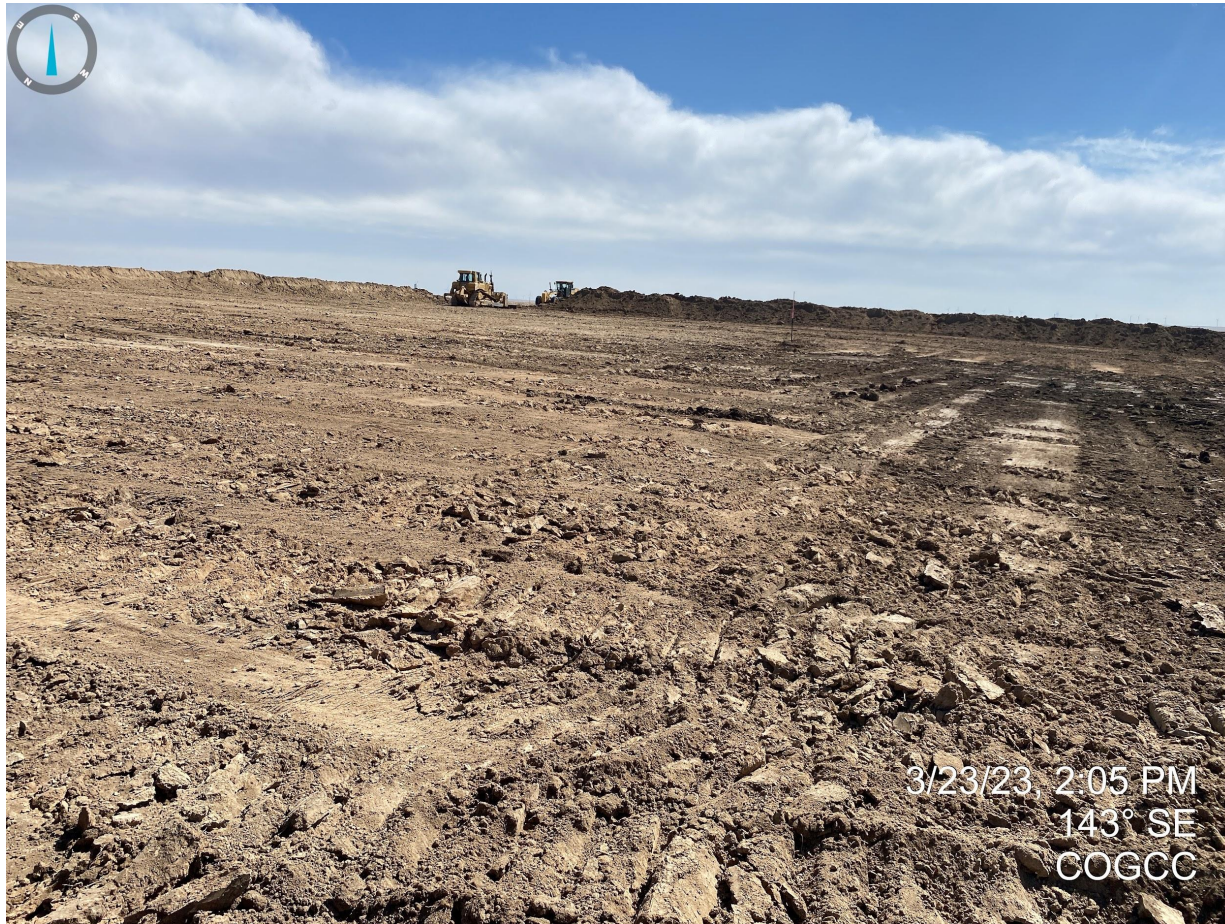
Photo 11. Facing southeast from the northern portion of the location. It appears that topsoil has been salvaged from the location in accordance with Rule 1002.b.

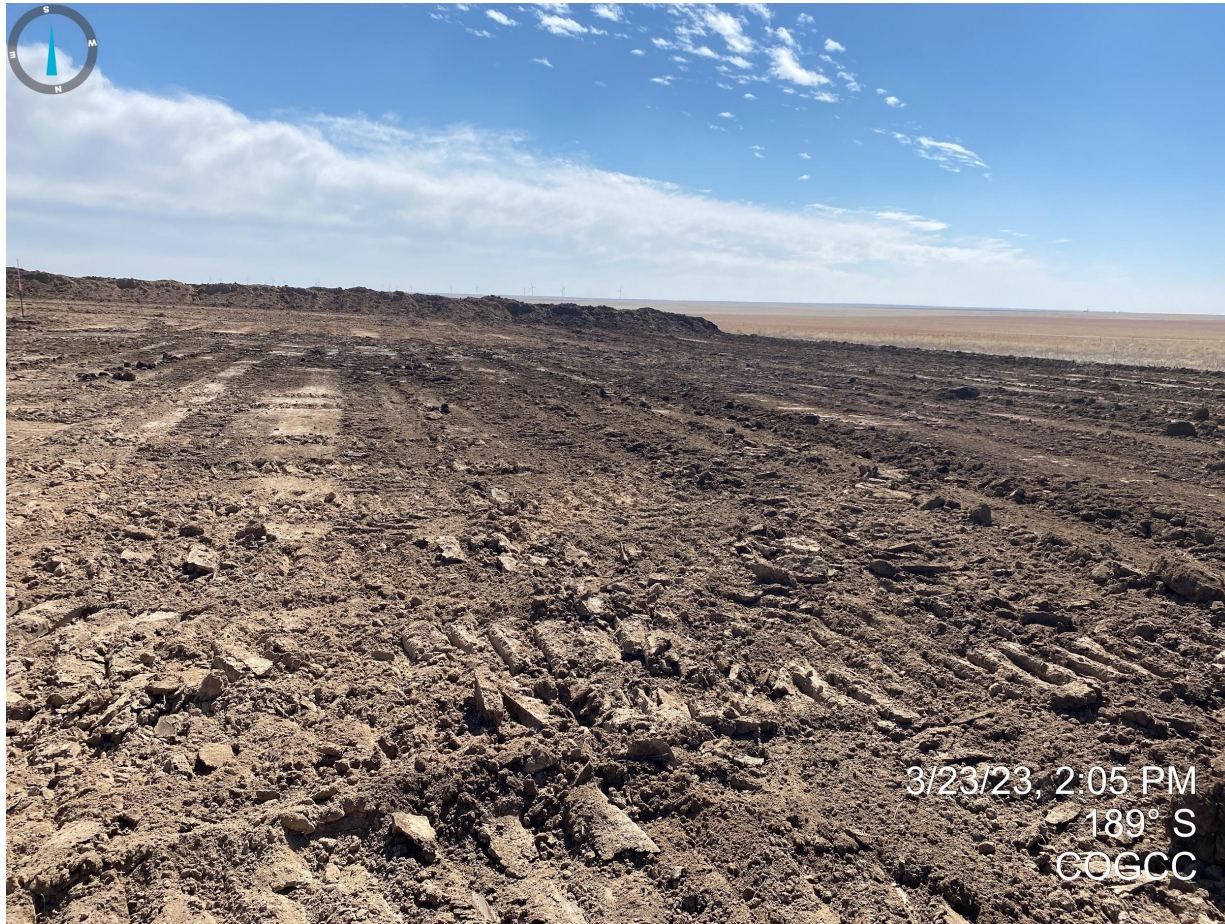
Photo 12. Facing south from the northern part of the location; see comments in Photo 11.
