## Inspection Photos

Location Name: TEP ROCKY MOUNTAIN LLC FEDERAL SG 43-28 Pad

Location ID: 334978

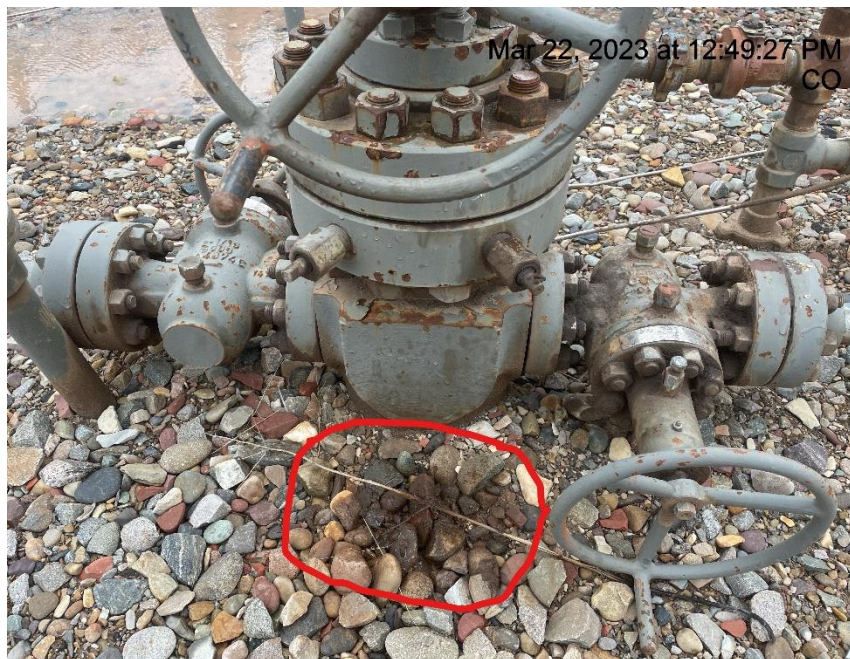
**Photo # 2808 Stained soils & gravel in front of SG 342-28 wellhead**

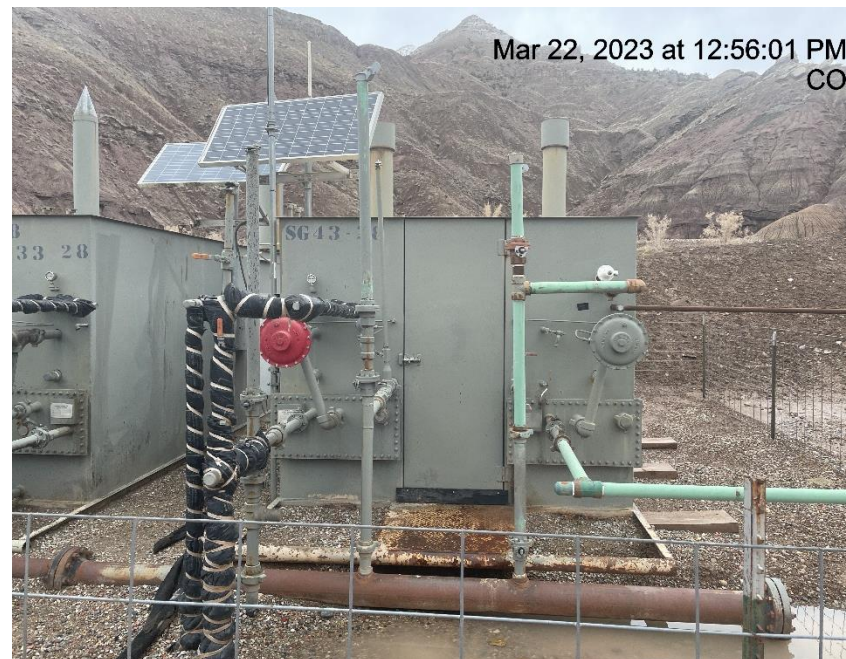
**Photo # 2814 Meter calibration info not conspicuously posted**

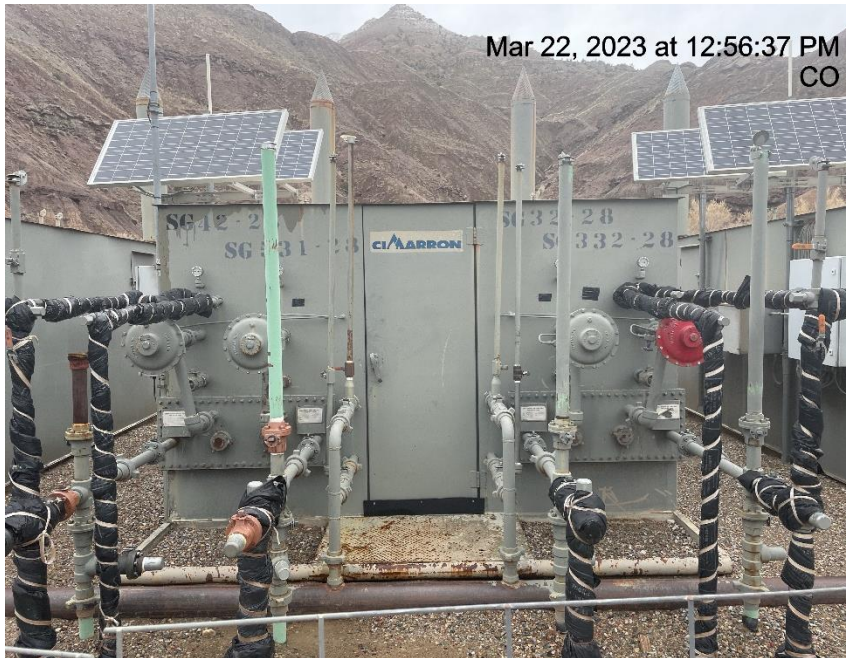
Photo # 2815 Meter calibration info not conspicuously posted

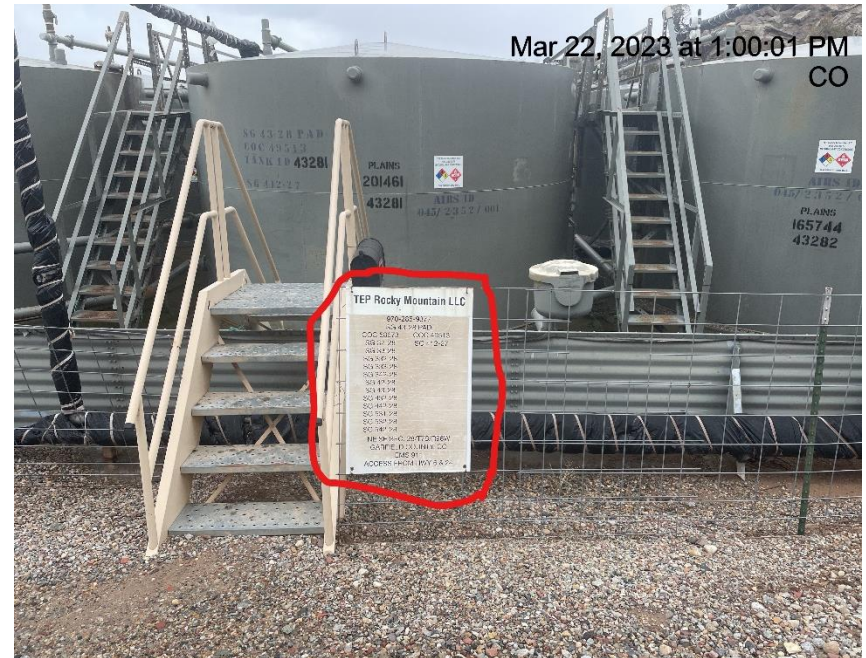
Photo # 2816 Battery sign missing required information

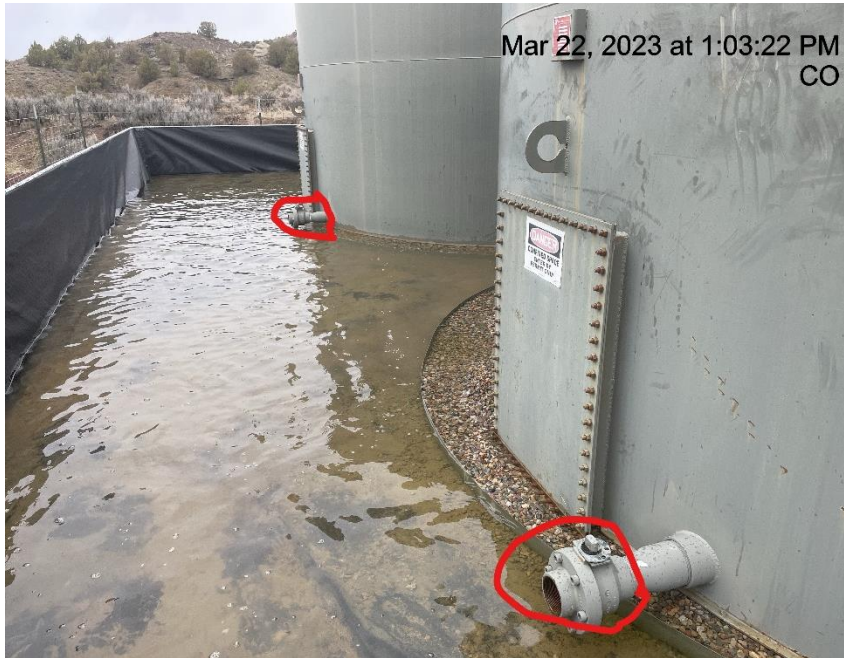
**Photo # 2821 Open ended load lines**

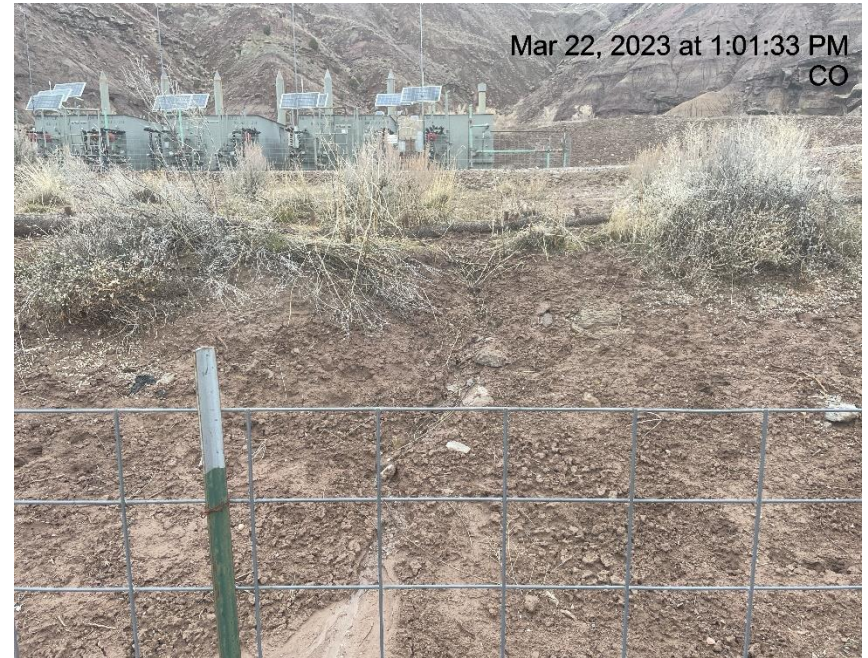
**Photo # 2818 Waddles need maintenance/rill erosion/sediment encroaching on equipment**

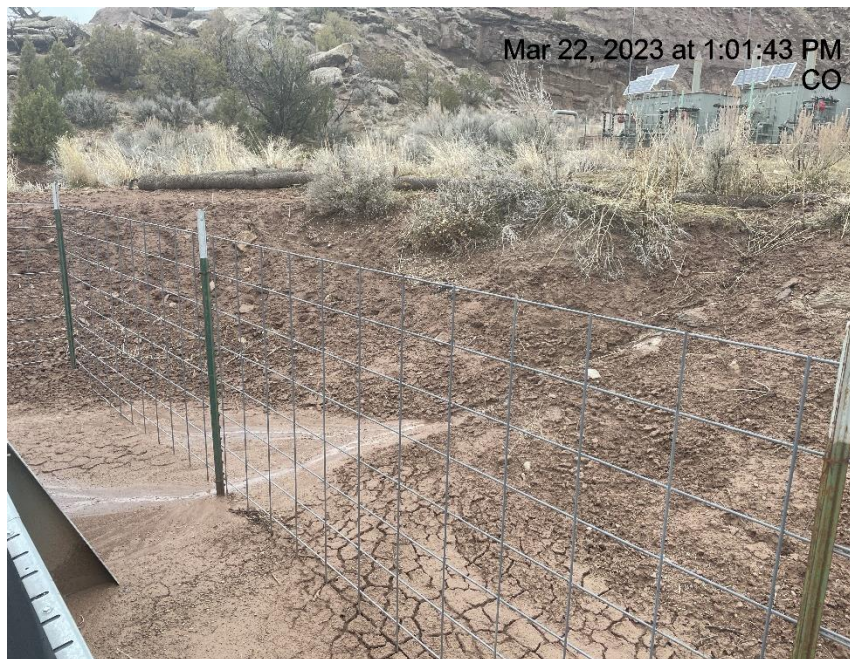
**Photo # 2819 Waddles need maintenance/rill erosion/sediment encroaching on equipment**

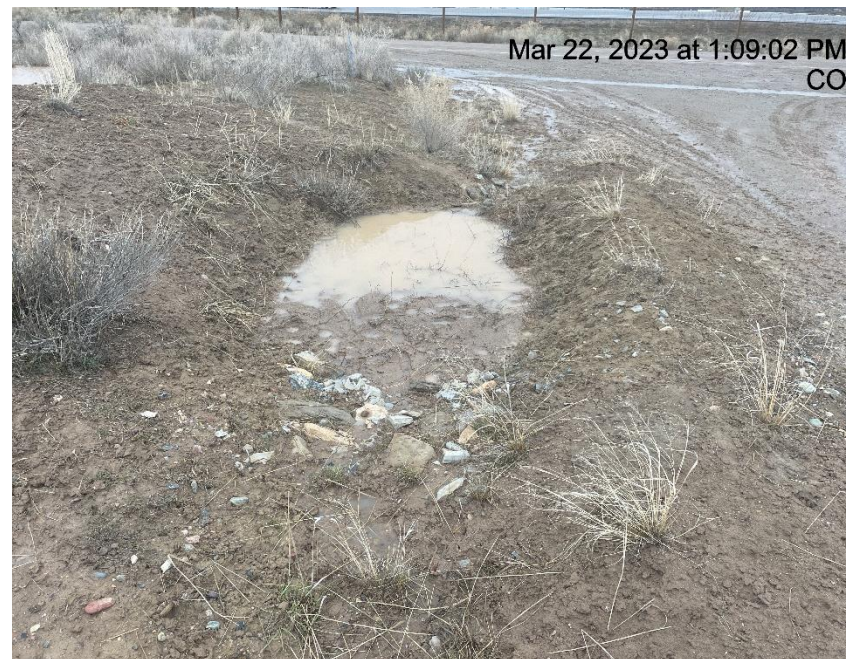
**Photo # 2822 Sediment trap needs maintenance (near entrance to spur road)**

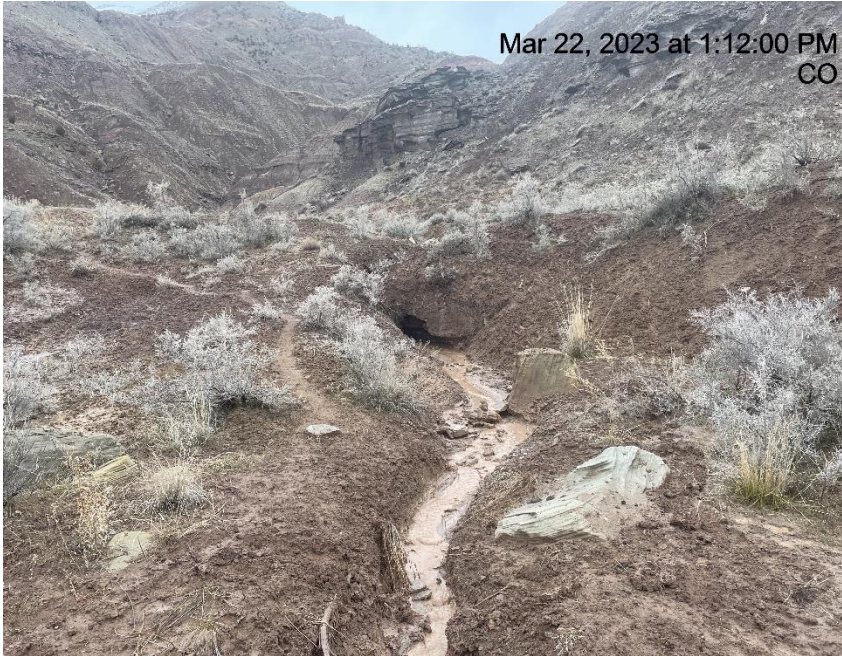
**Photo # 2825 Ditch needs maintenance (lower tier of pad east side)**

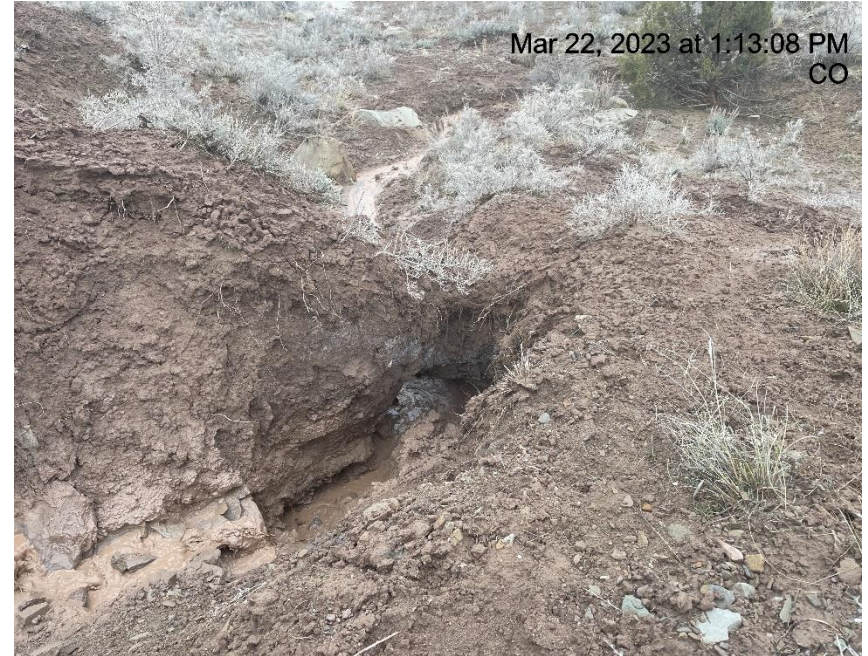
**Photo # 2828 Erosion/ditch needs maintenance (lower tier of pad east side)**

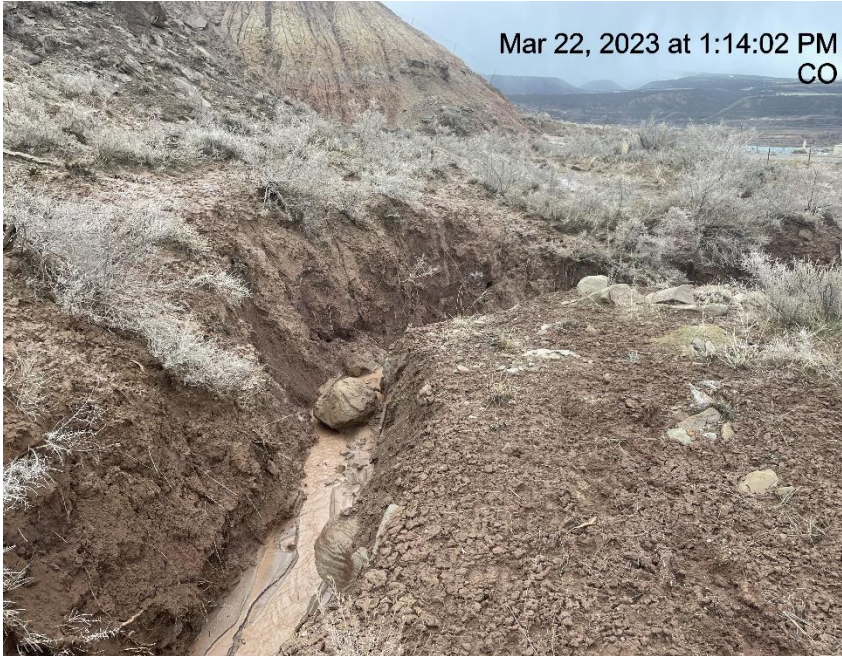
**Photo # 2831 Erosion/ditch needs maintenance (lower tier of pad east side)**

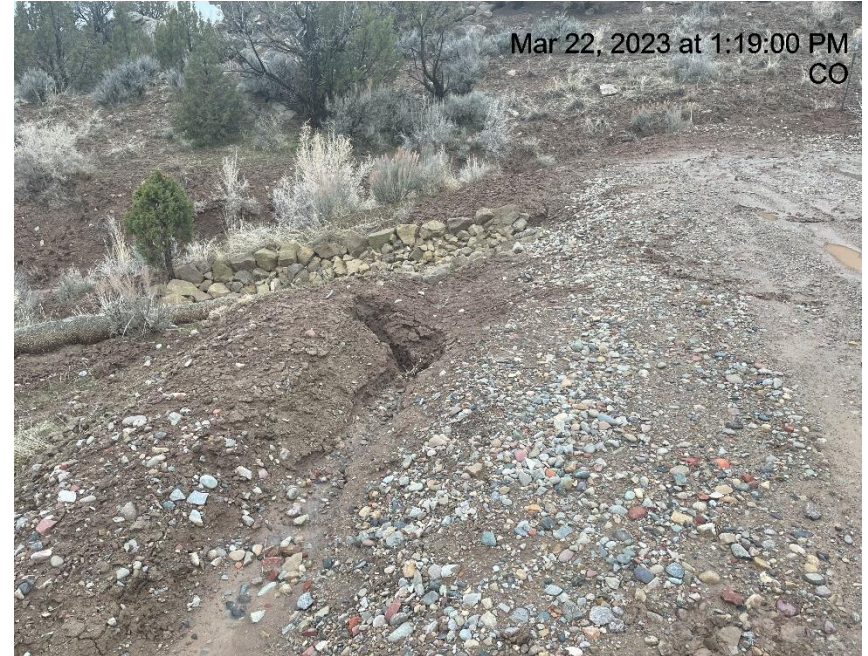
**Photo # 2836 Erosion/ditch needs maintenance (upper tier of pad, SW corner near rip rap run)**

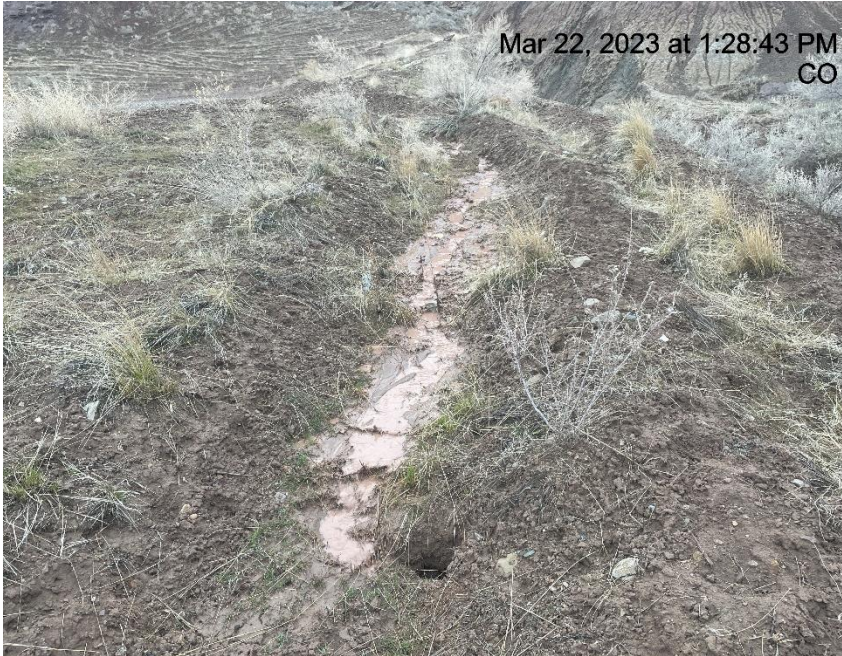
**Photo # 2845 Tunnel erosion/ditch needs maintenance  
(upper tier of pad, east side)**

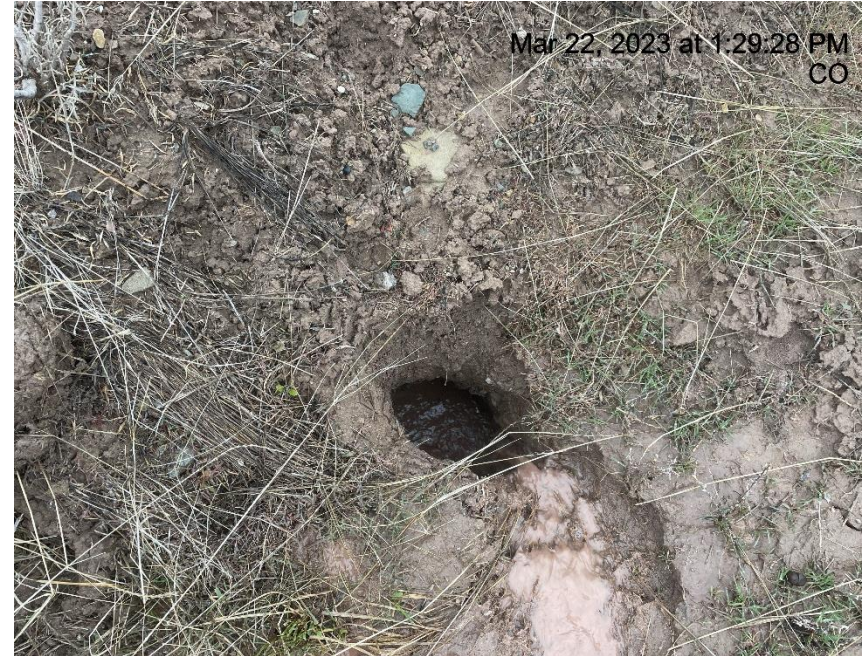
**Photo # 2849 Tunnel erosion/ditch needs maintenance  
(upper tier of pad, east side)**

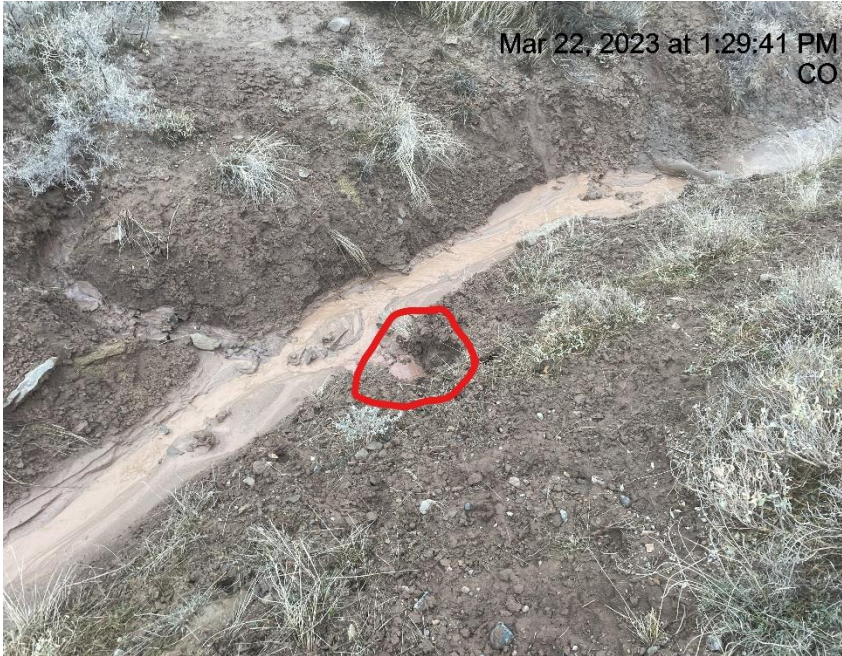
**Photo # 2850 Tunnel erosion/berm needs maintenance  
(upper tier of pad, east side)**

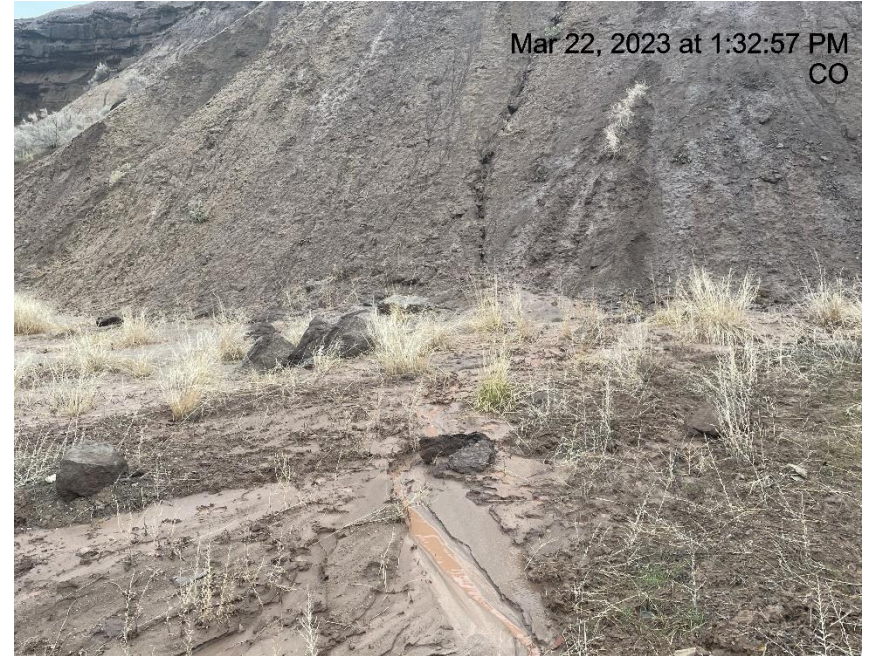
**Photo # 2858 Insufficient run on controls/BMP's**

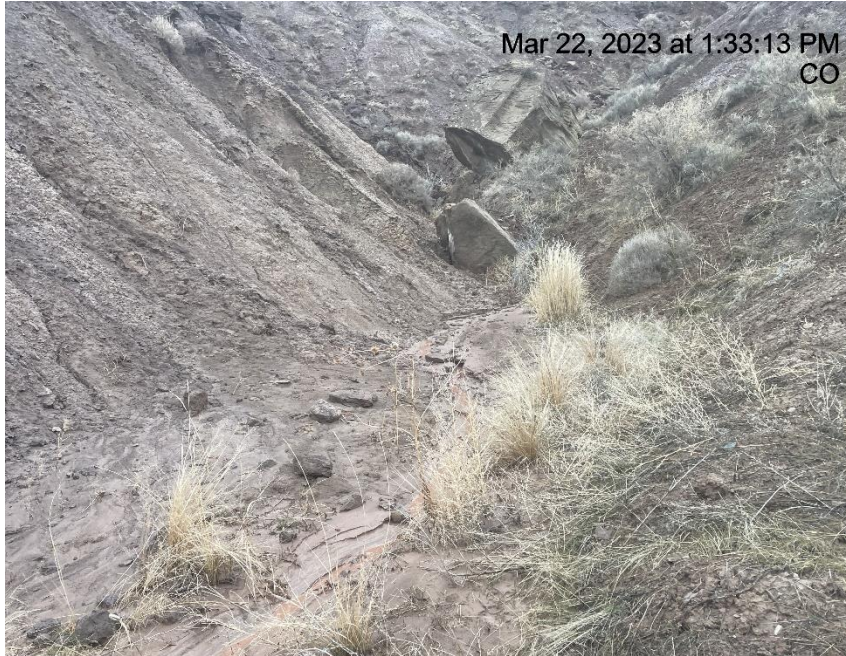
**Photo # 2859 Insufficient run on controls/BMP's**

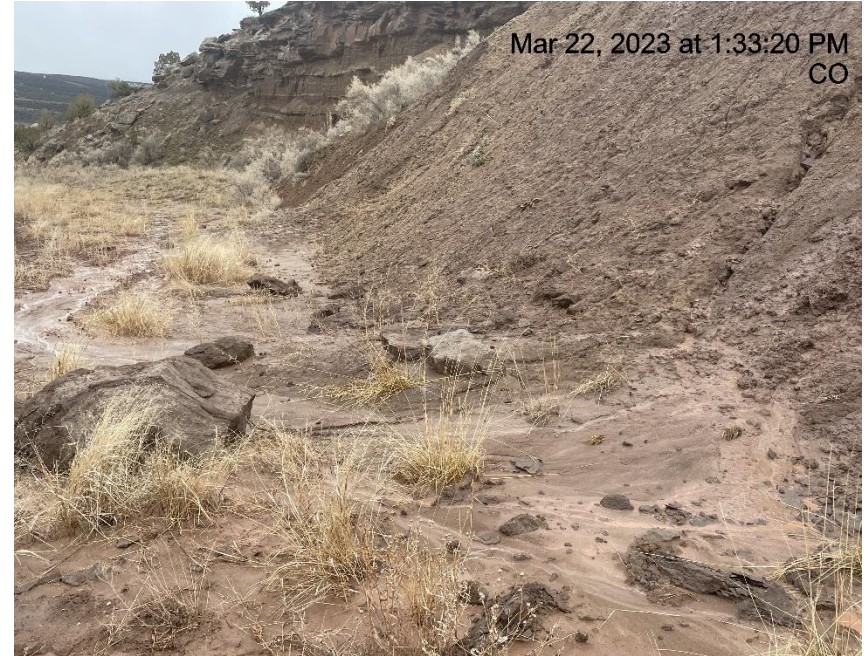
**Photo # 2860 Insufficient run on controls/BMP's/sediment encroaching on habitat & choking of vegetation**

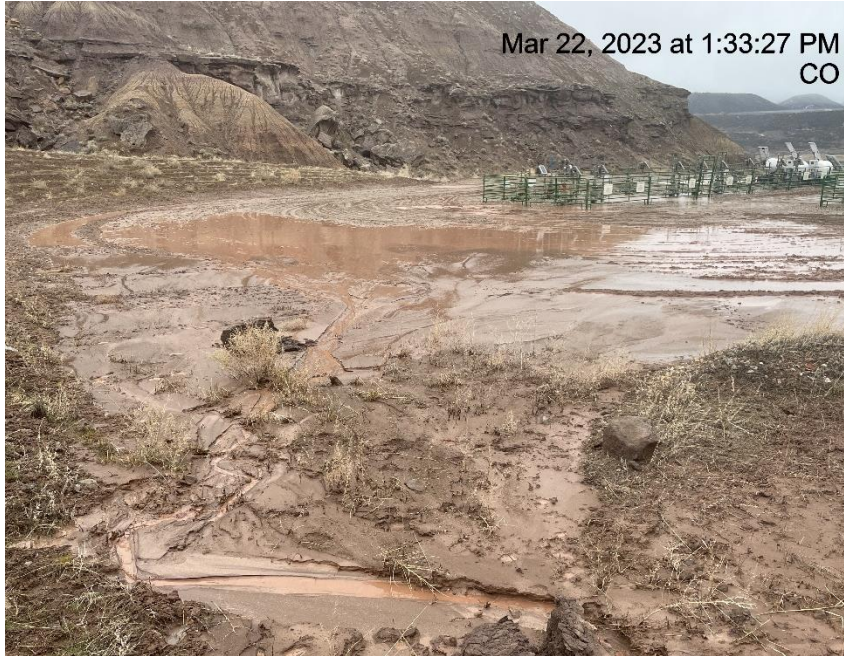
**Photo # 2861 Insufficient run on controls/BMP's**

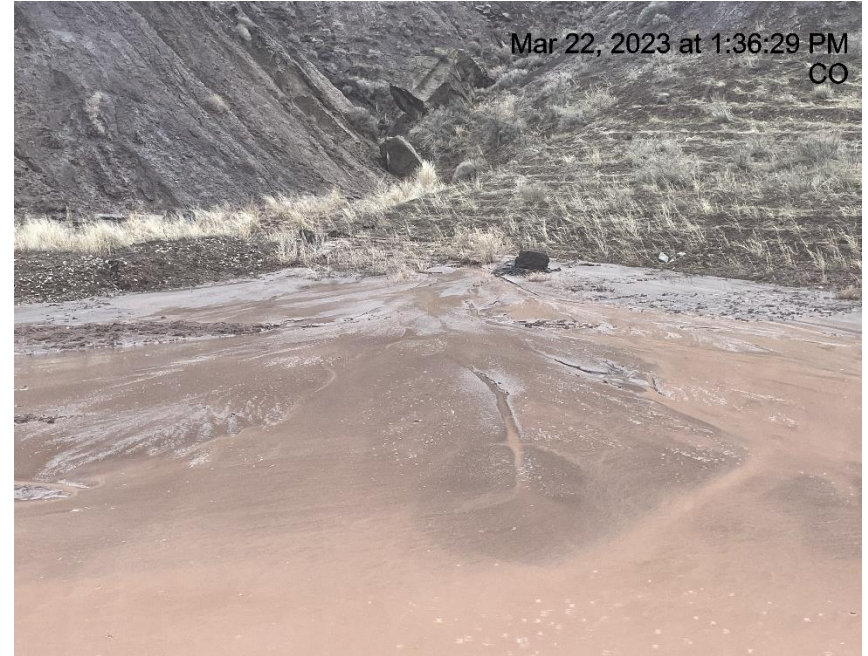
**Photo # Insufficient run on controls/BMP's**

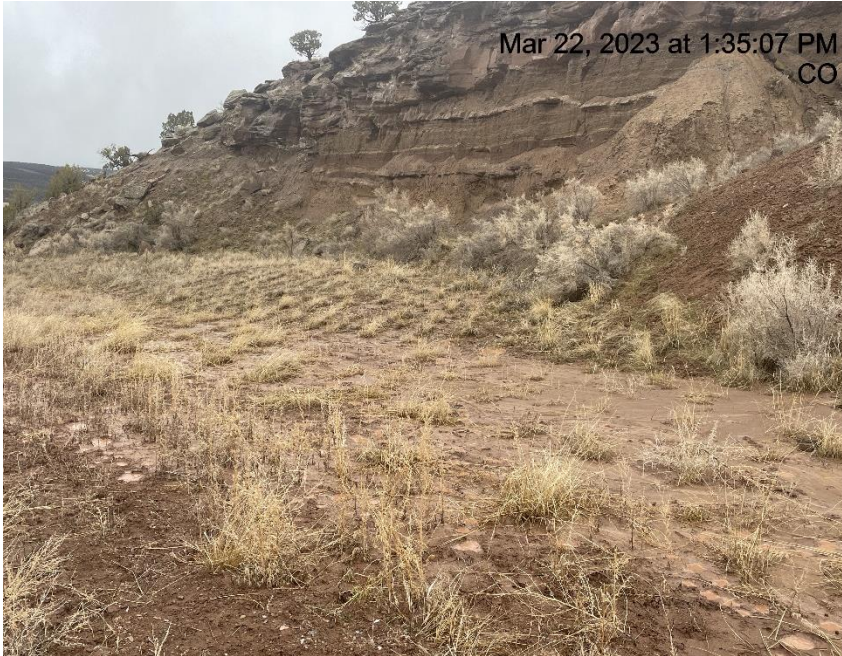
**Photo # 2868 Insufficient run on controls/BMP's/sediment encroaching on habitat & choking of vegetation**

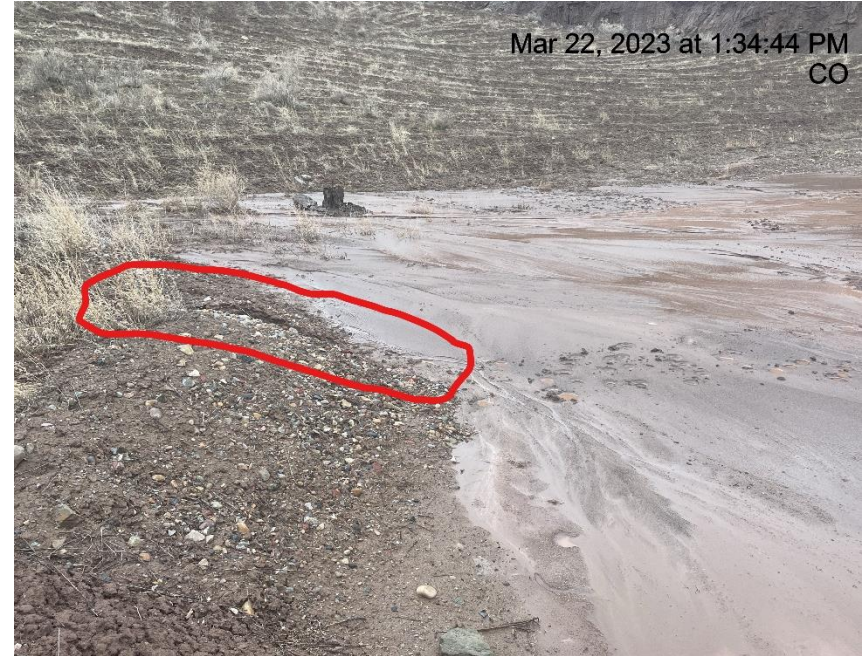
**Photo # 2865 Berm needs maintenance (upper tier of past NW side)**

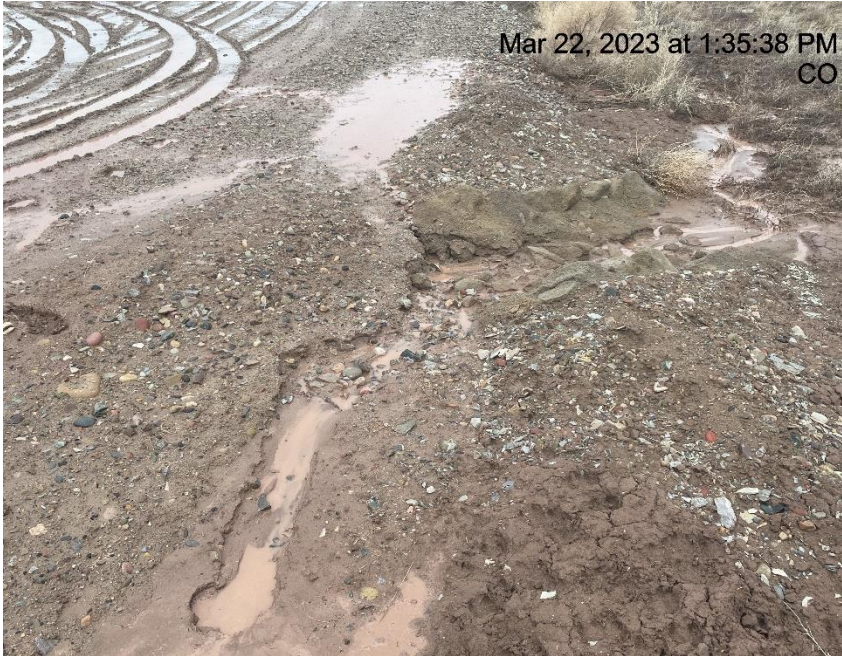
**Photo # 2871 Rill erosion/rip rap needs maintenance (upper tier, west side)**

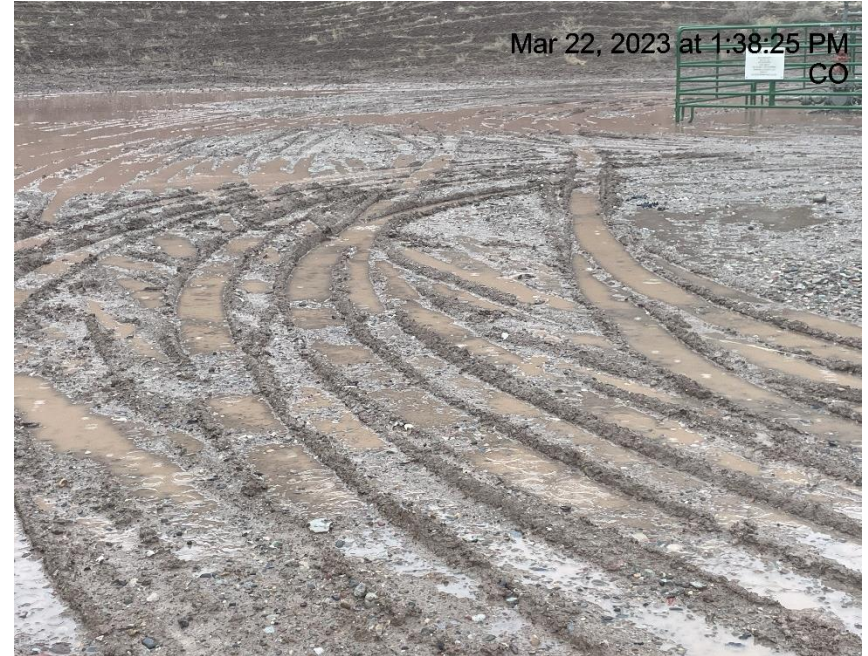
**Photo # 2878 Lack of stabilization**

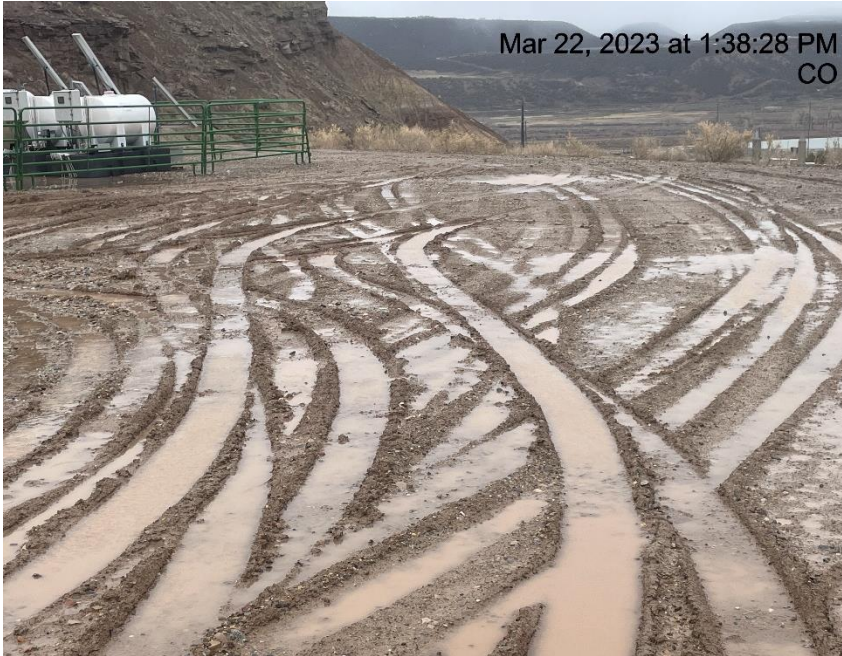
Photo # 2879 Lack of stabilization

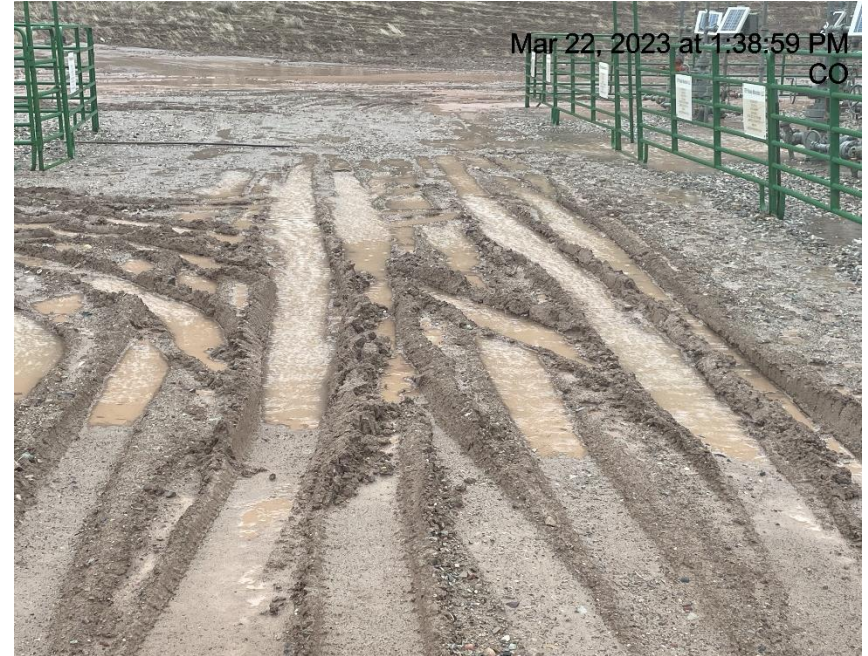
Photo # 2880 Lack of stabilization

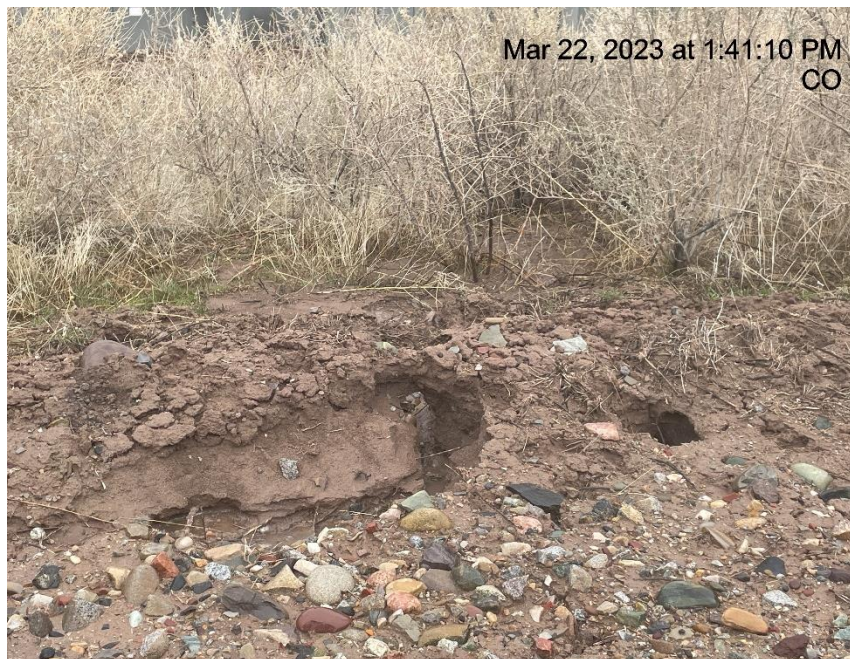
**Photo # 2887 Rill & tunnel erosion (upper tier of pad, south side)**

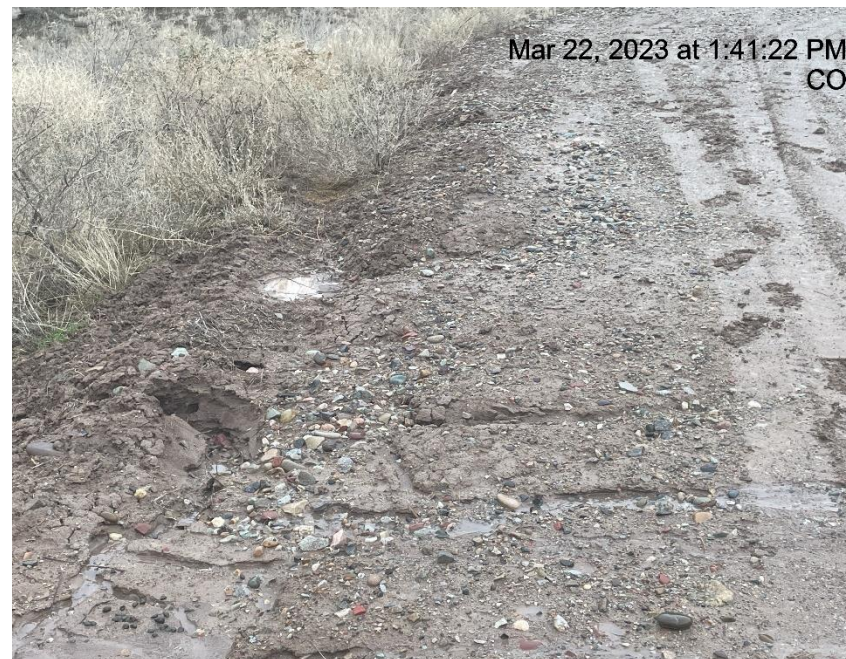
**Photo # 2888 Rill & tunnel erosion (upper tier of pad, south side)**

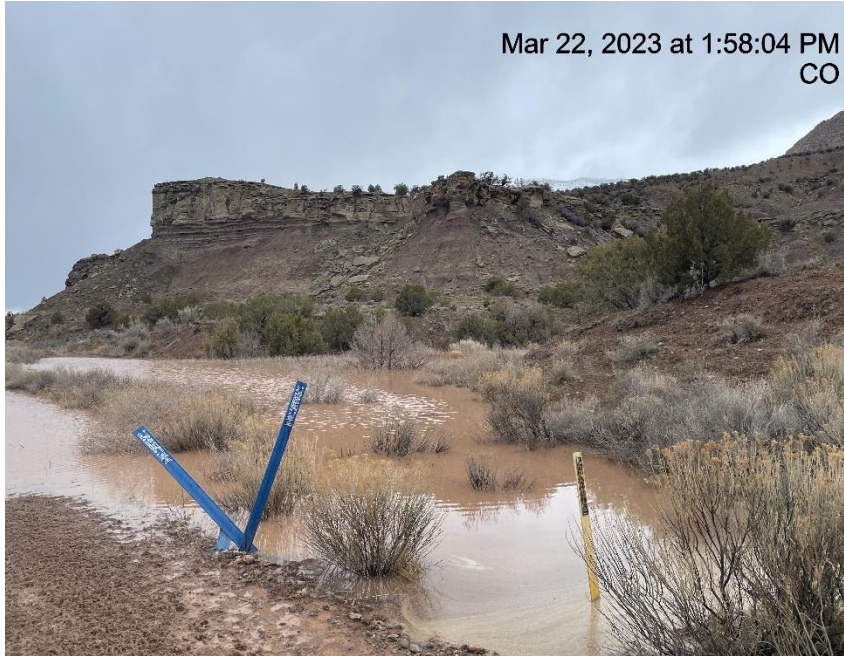
**Photo # 2889 Insufficient run on controls/BMP's/ & degradation of roadway (4/10<sup>th</sup> of a mile down lease road)**

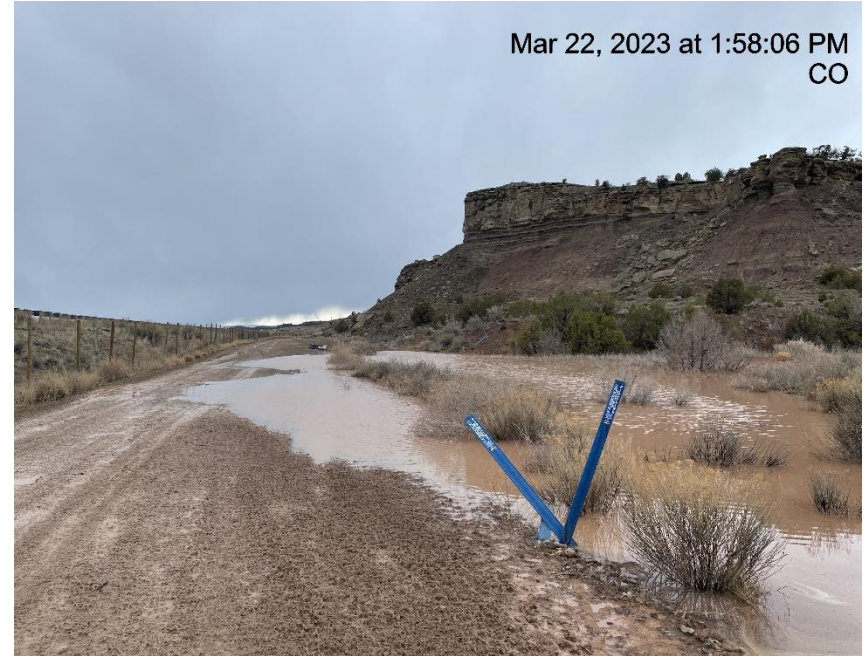
**Photo # 2890 Insufficient run on controls/BMP's/ & degradation of roadway (4/10<sup>th</sup> of a mile down lease road)**
