Inspection Photos

Location Name: TEP ROCKY MOUNTAIN LLC CLOUGH RMV 95-21 Pad

Location ID: 324053

COLORADO
Oil & Gas Conservation
Commission
Department of Natural Resources

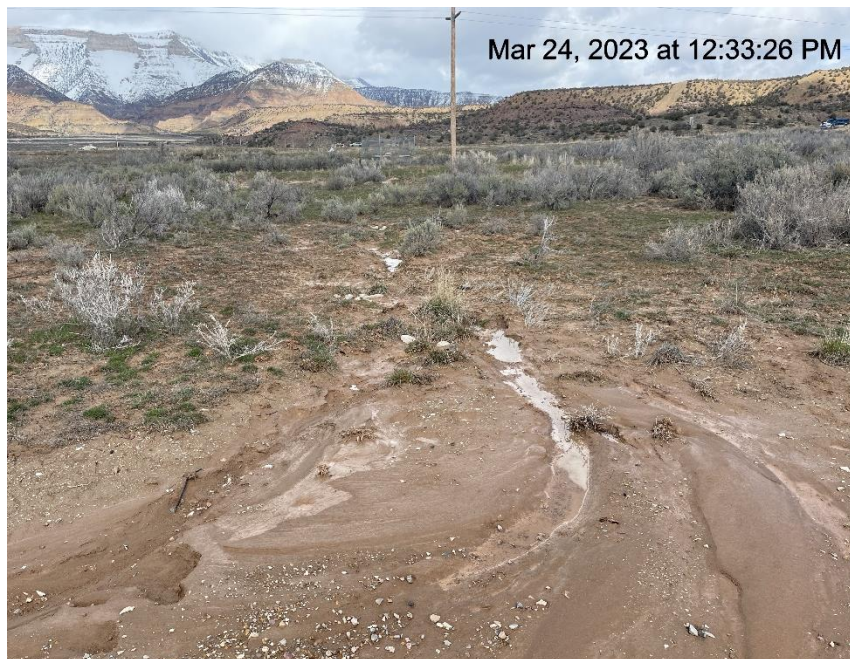
Photo # 3226 Rill erosion/transport of sediment off location/insufficient BMP's

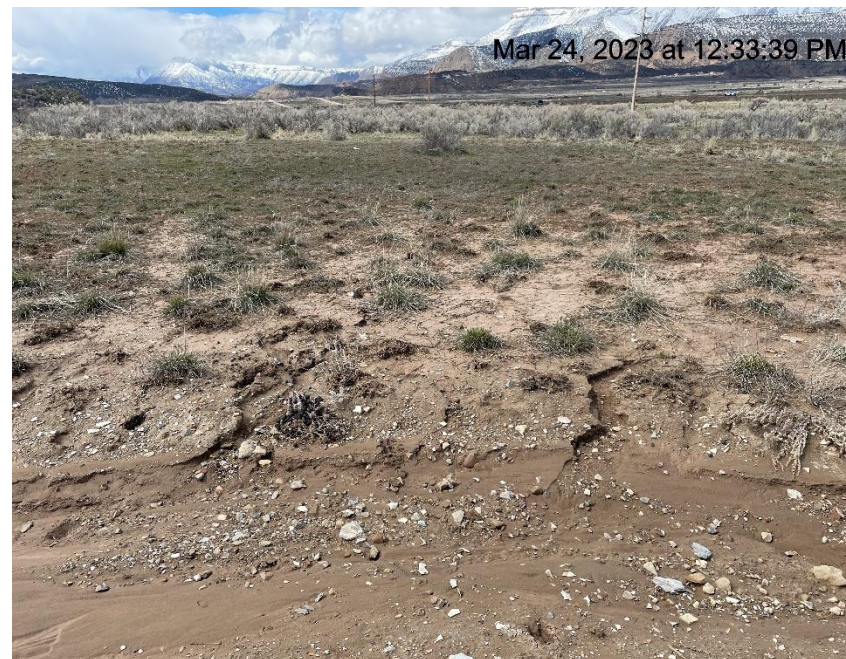
Photo # 3227 Rill erosion on location

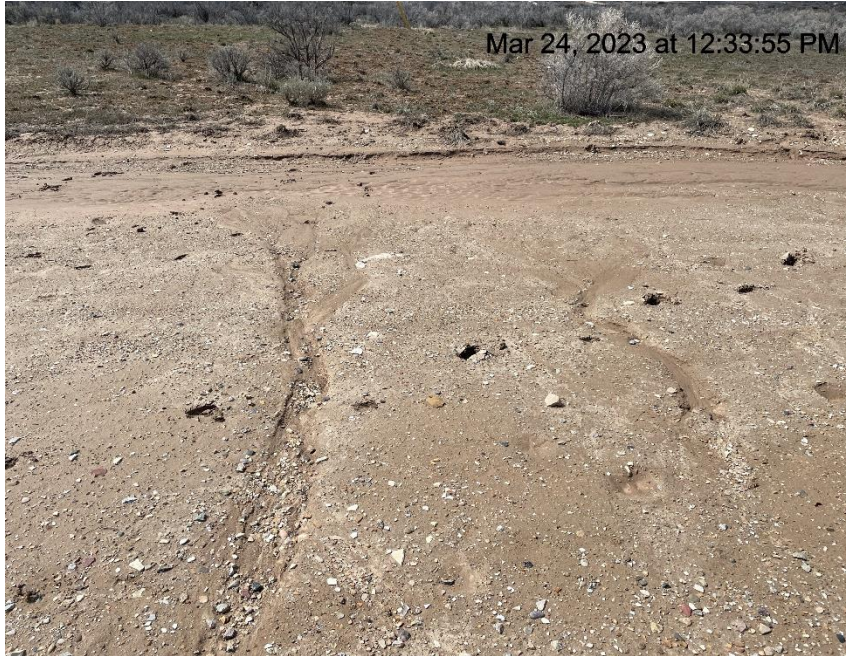
Photo # 3228 Rill erosion on spur road

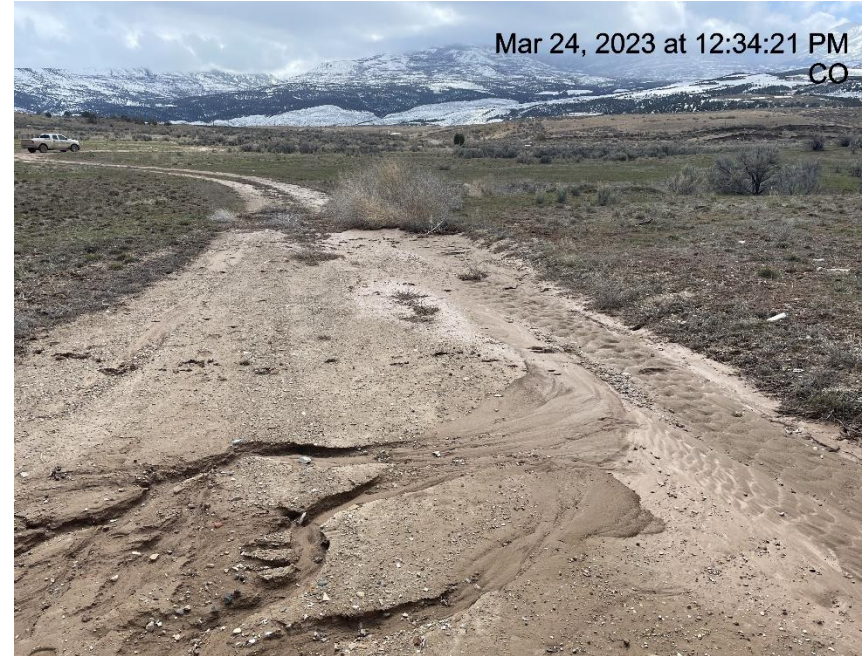
Photo # 3230 Rill erosion on spur road

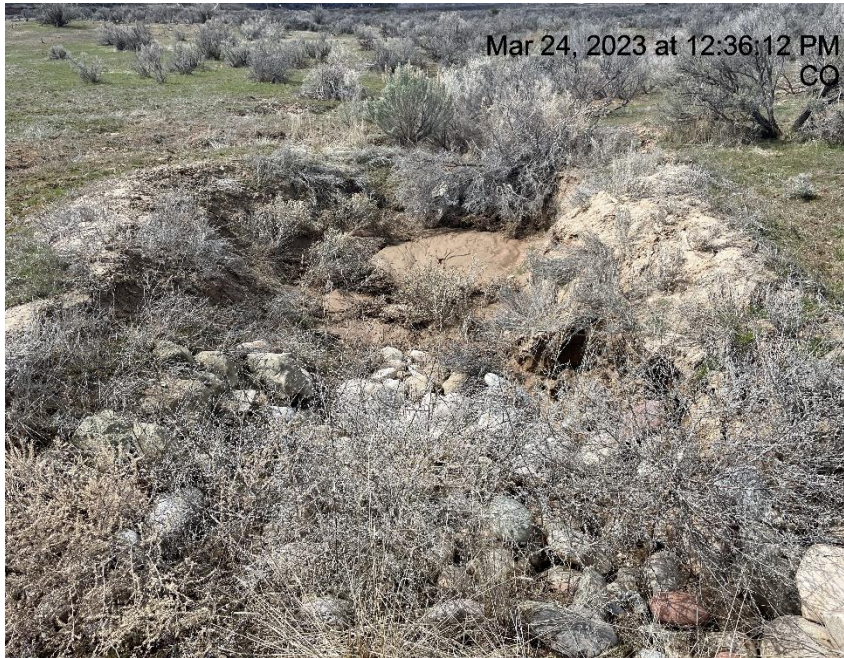
Photo # 3232 Sediment trap needs maintenance

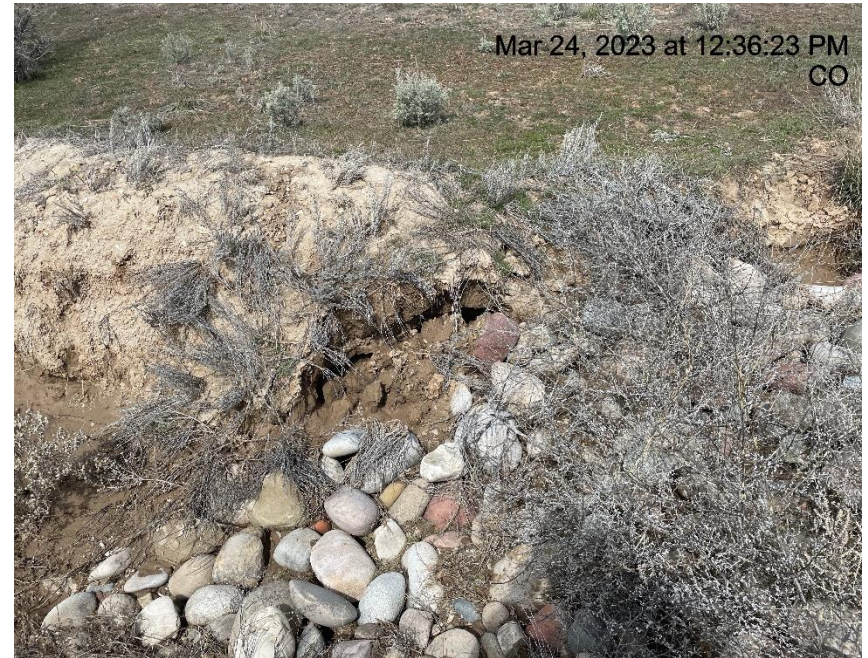
Photo # 3233 Sediment trap needs maintenance

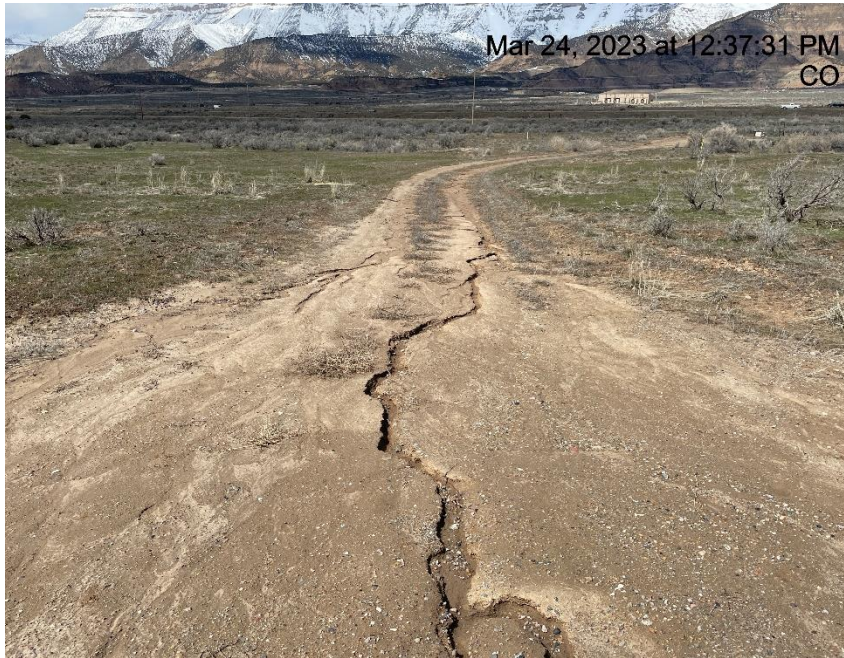
Photo # 3234 Rill erosion on spur road

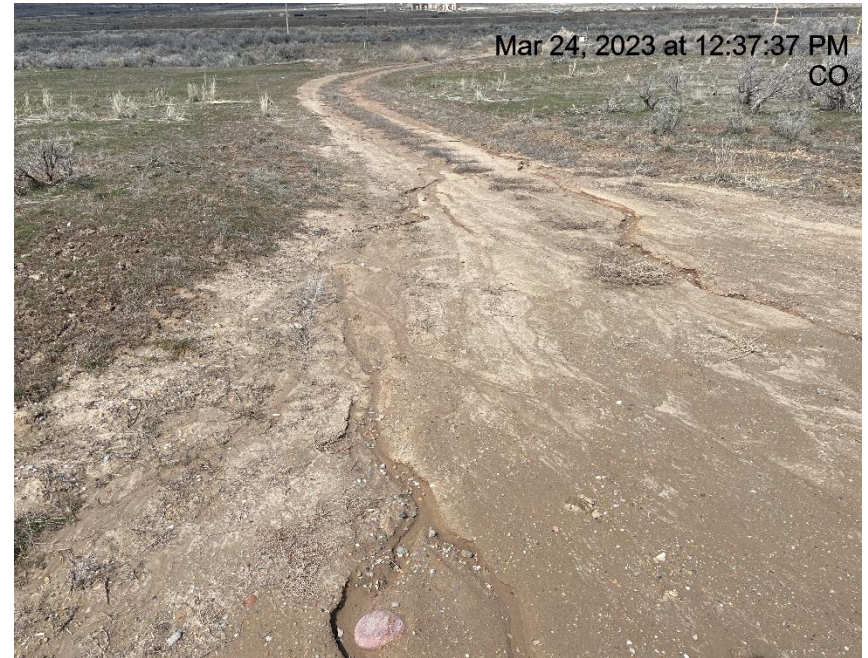
Photo # 3235 Rill erosion on spur road

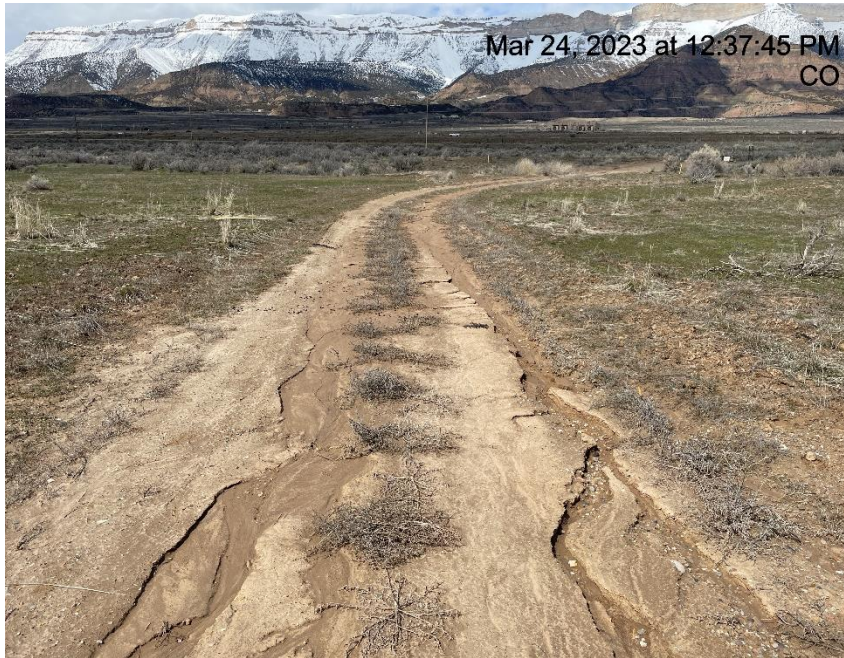
Photo # 3236 Rill erosion on spur road
