Inspection Photos

Location Name: TEP ROCKY MOUNTAIN LLC CLOUGH 31-23H Pad

Location ID: 323919

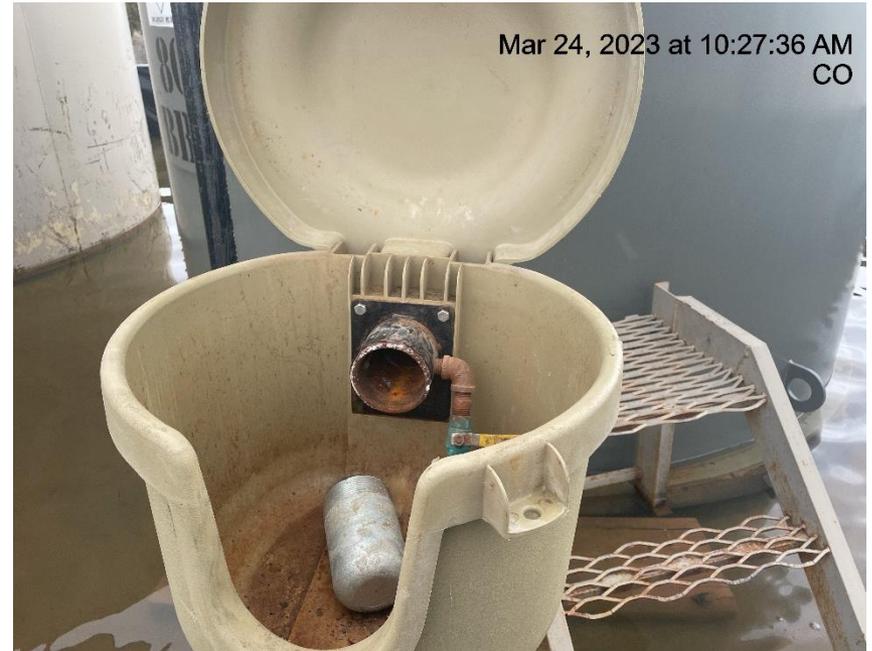
Photo # 3116 Open ended load line

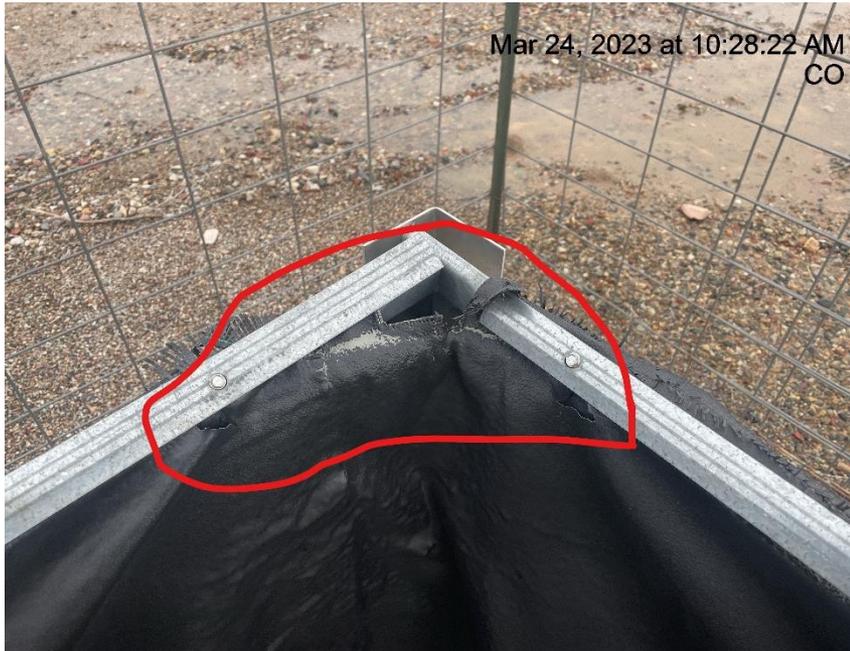
Photo # 3119 Containment needs maintenance

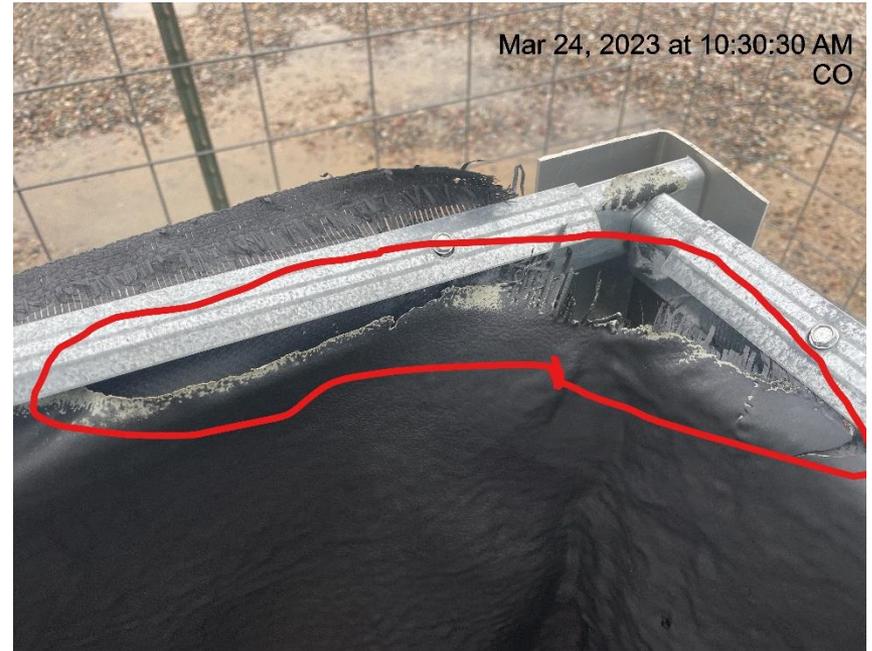
Photo # 3120 Containment needs maintenance

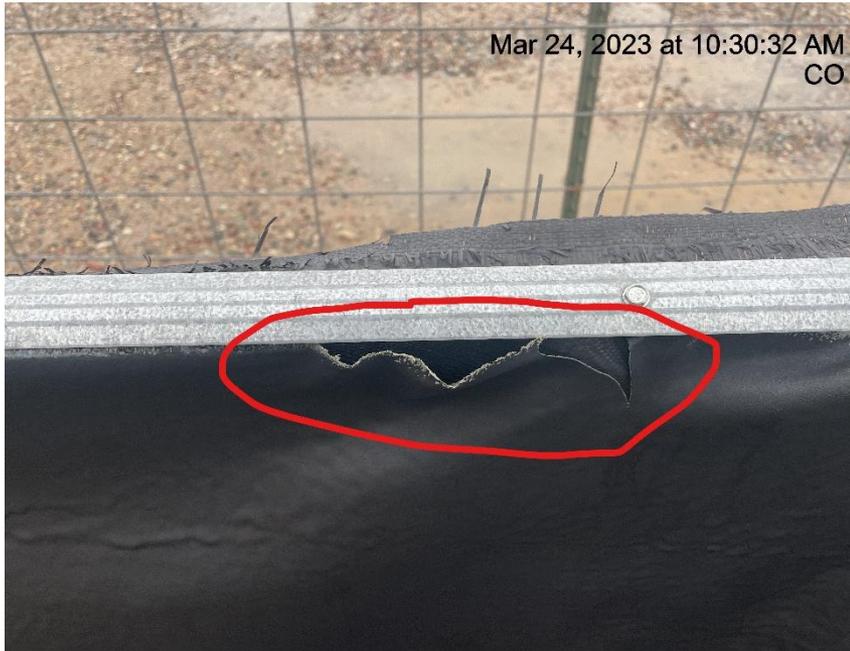
Photo # 3121 Containment needs maintenance

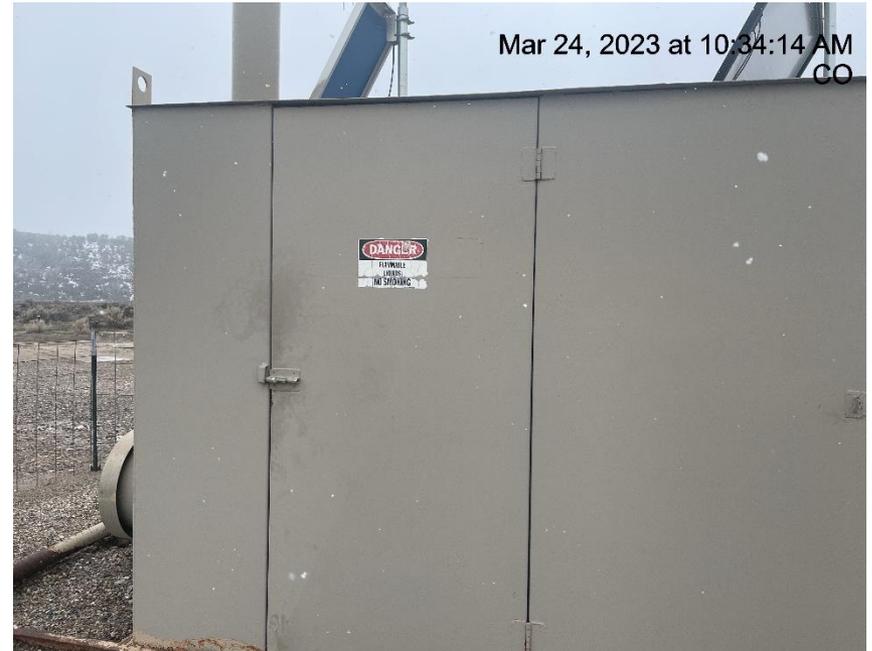
Photo # 3124 Meter calibration info not conspicuously posted

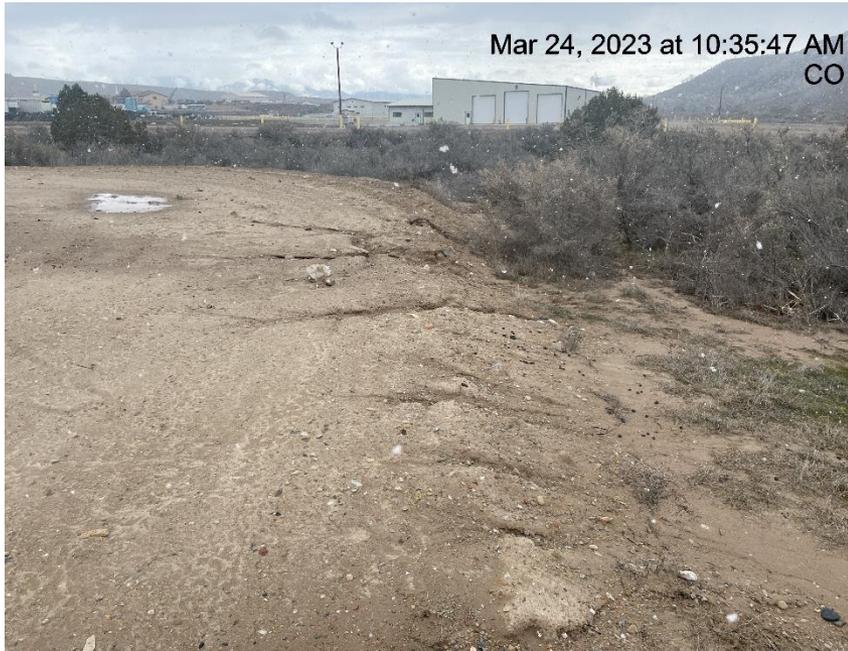
Photo # 3127 Rill erosion/transport of sediment off location (south side of pad)

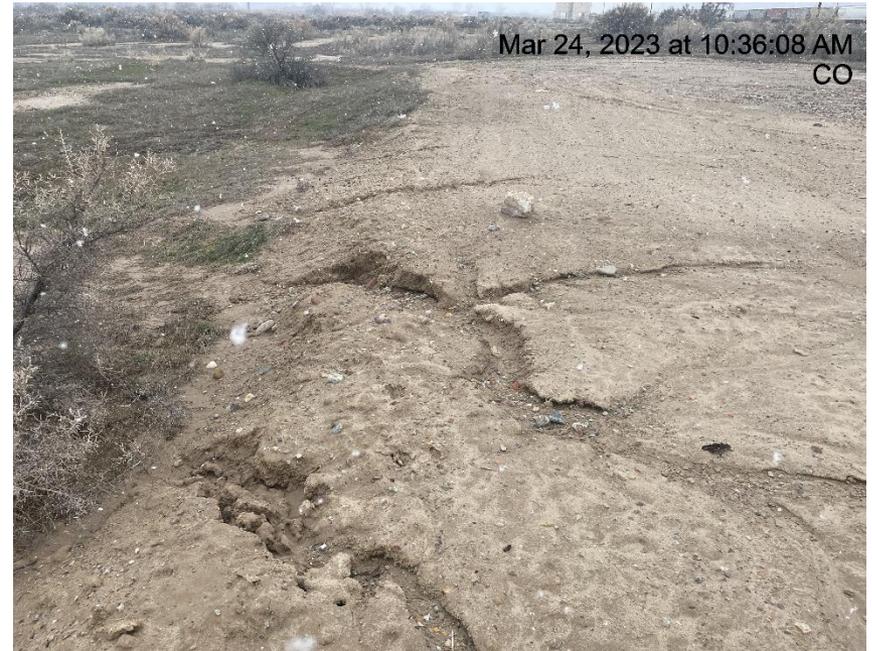
Photo # 3128 Rill erosion/transport of sediment off location (south side of pad)

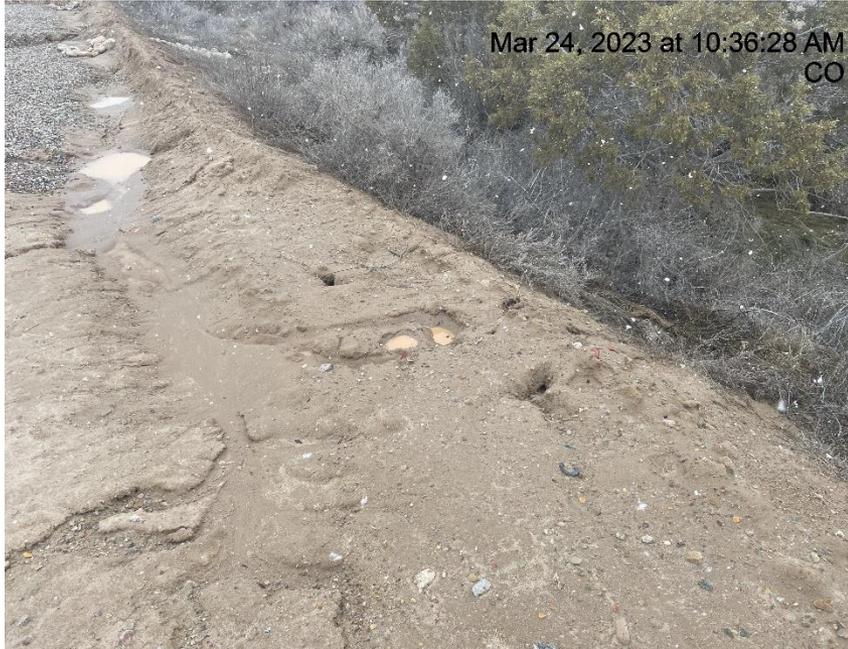
Photo # 3129 Tunnel & Rill erosion on location (east side of pad)

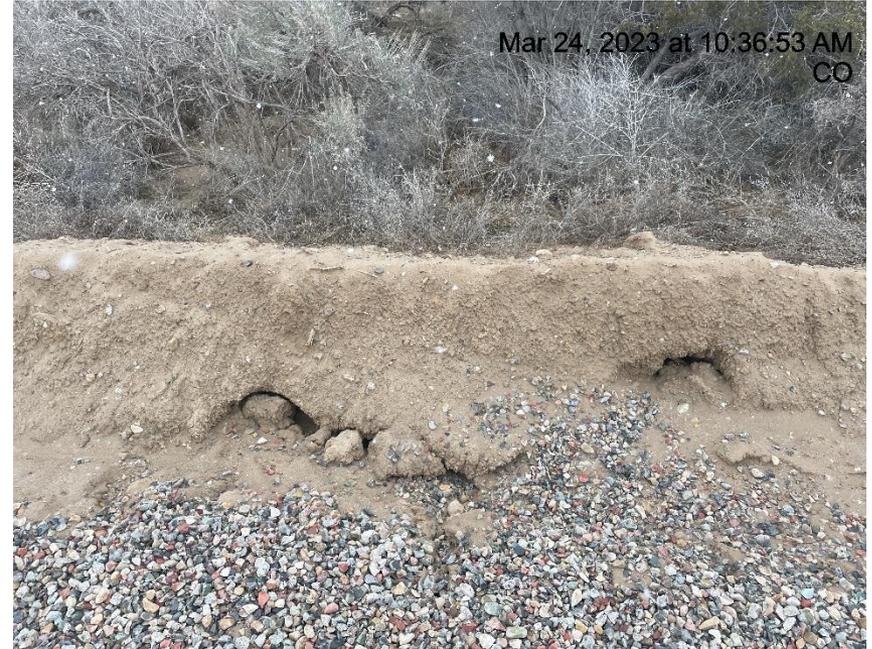
Photo # 3132 Tunnel erosion (east side of pad)

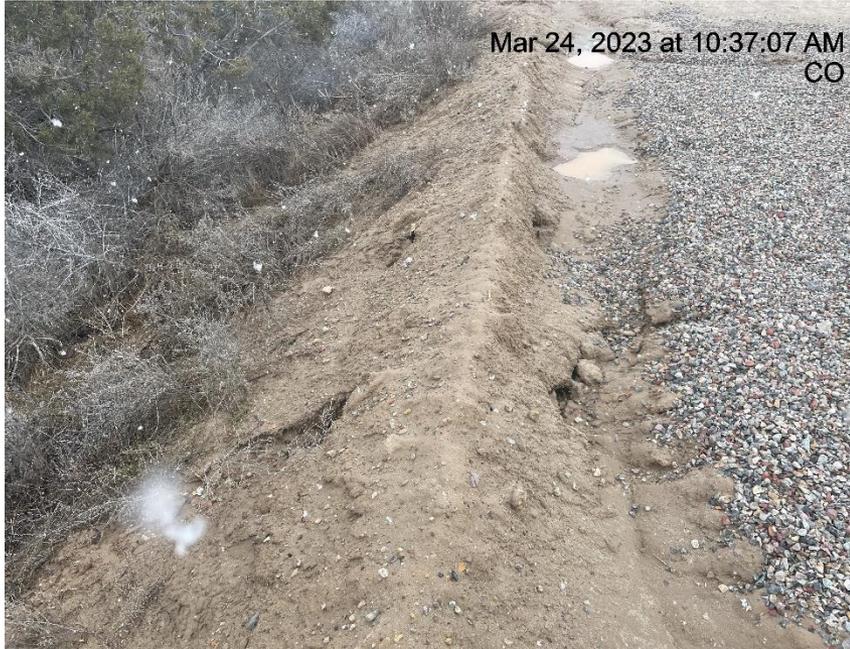
Photo # 3133 Tunnel erosion through berm (east side of pad)

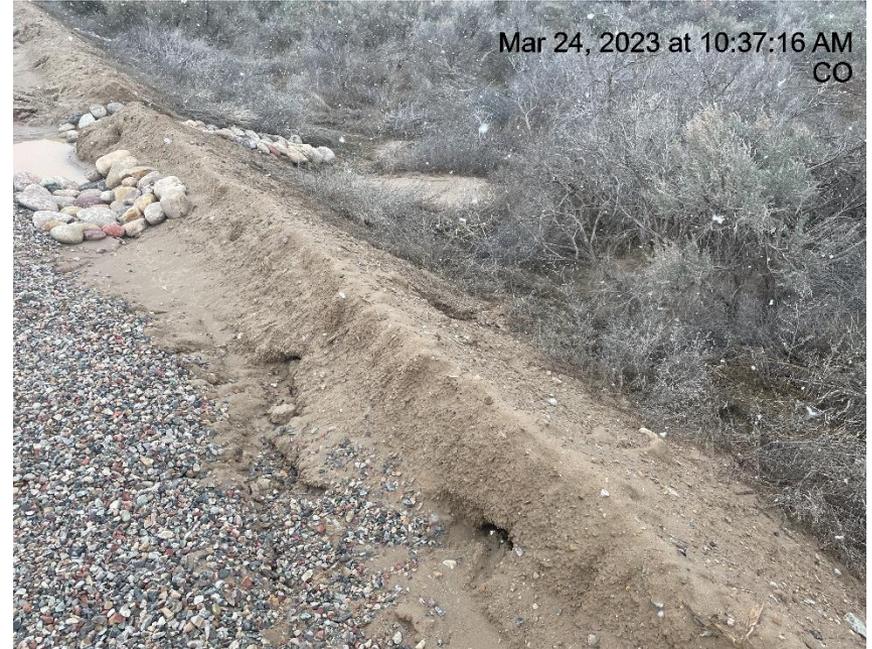
Photo # 3134 Tunnel erosion through berm (east side of pad)

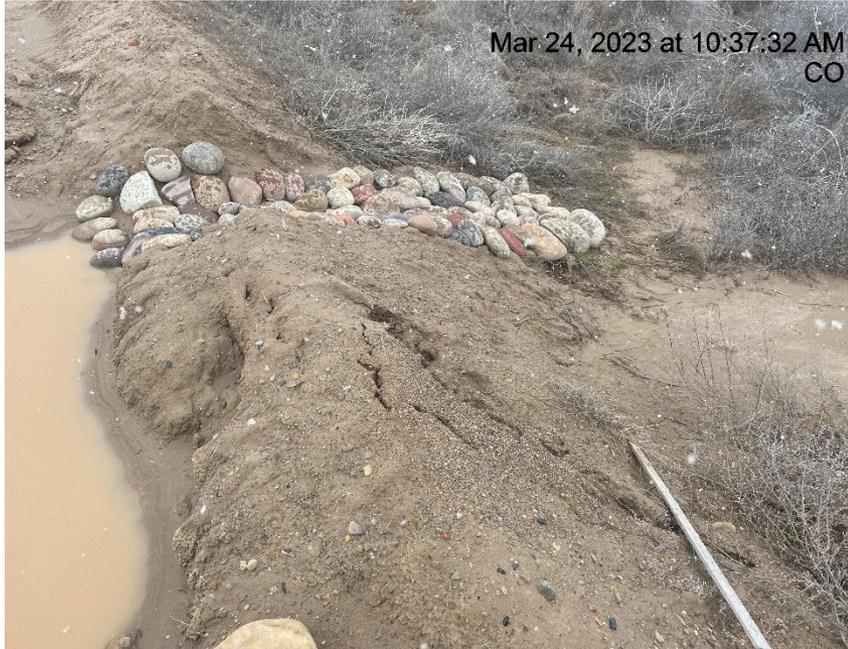
Photo # 3135 Tunnel erosion through berm & transport of sediment off location (east side of pad)

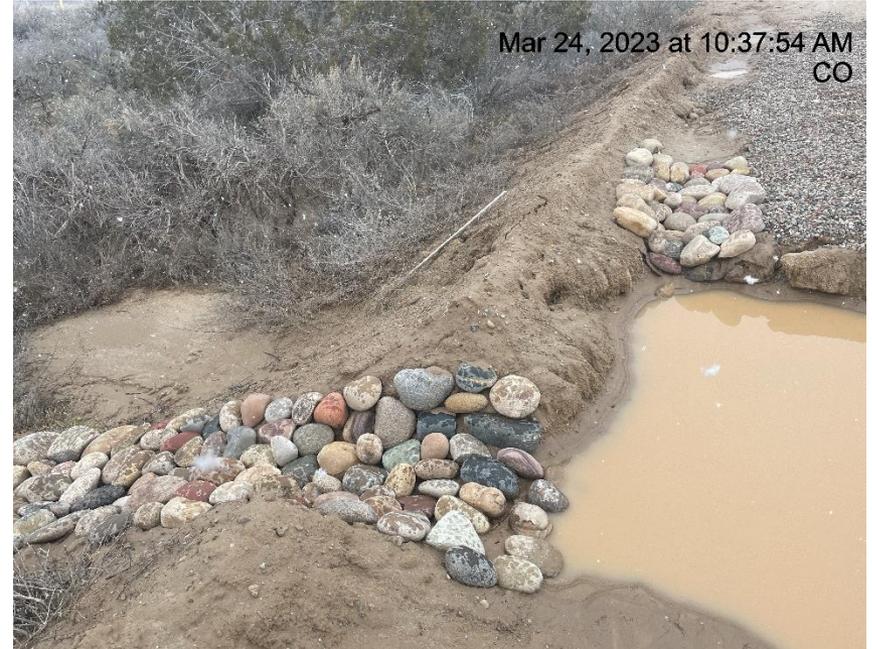
Photo # 3137 Tunnel erosion through berm & transport of sediment off location (east side of pad)

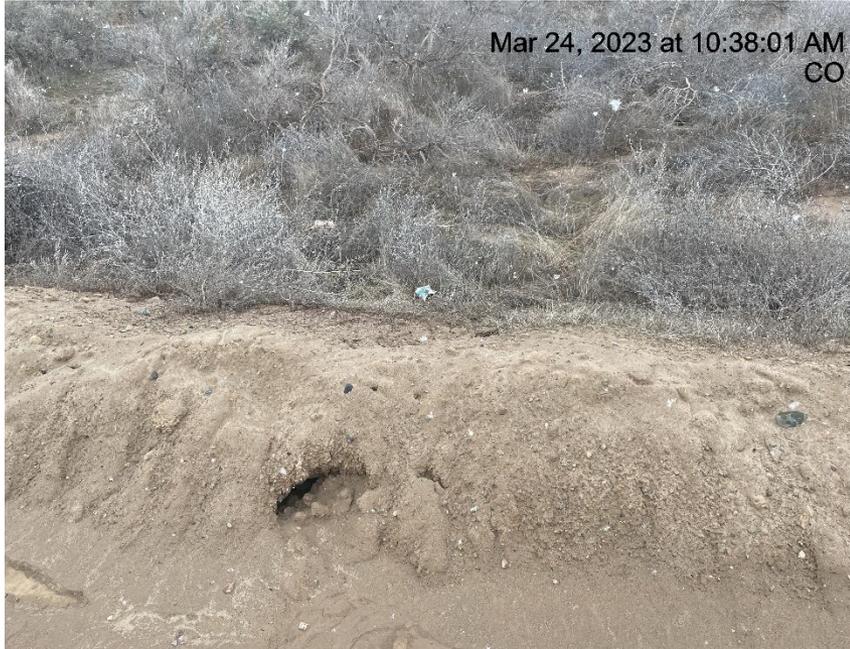
Photo # 3138 Tunnel erosion

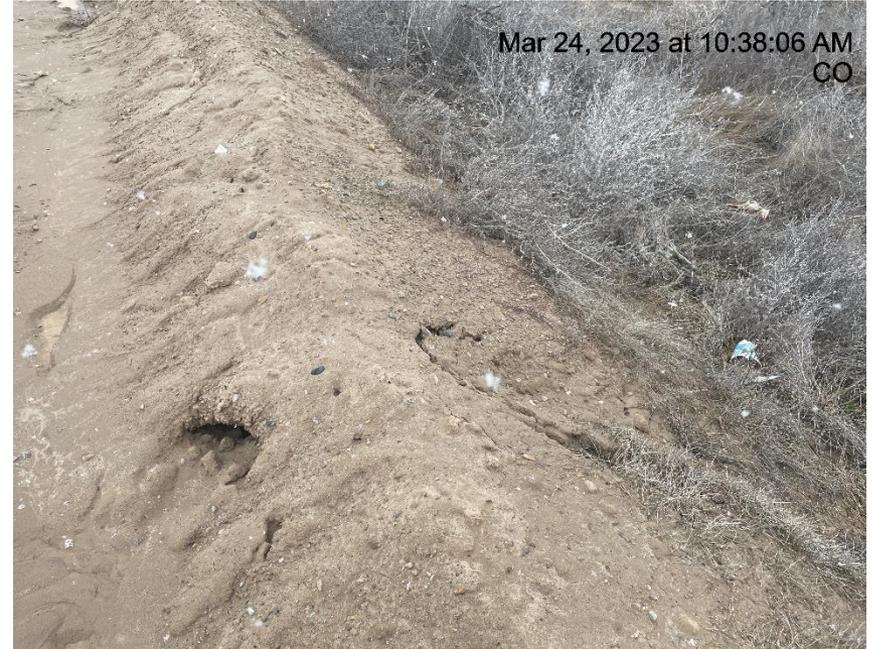
Photo # 3139 Tunnel erosion through berm & transport of sediment off location (east side of pad)

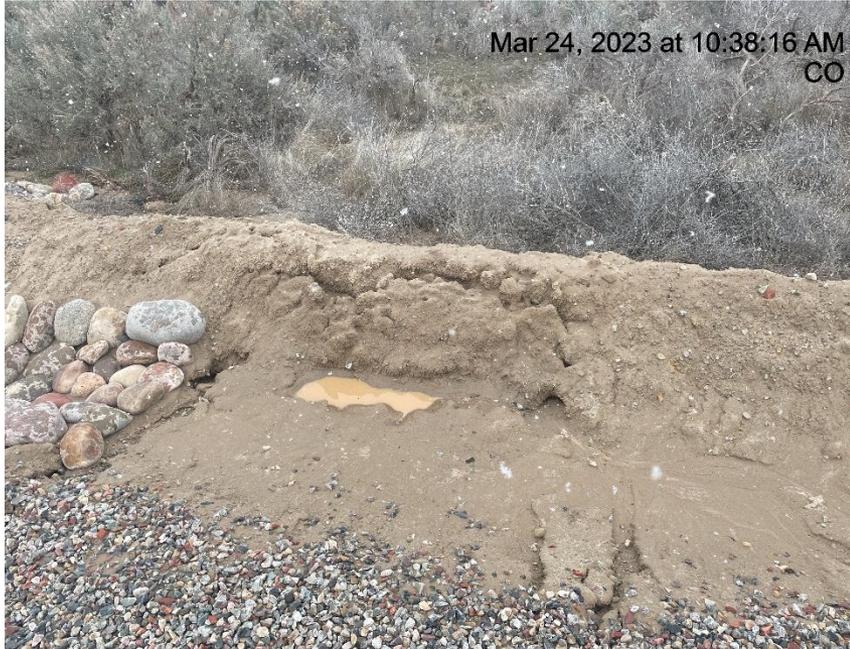
Photo # 3140 Tunnel erosion through berm (east side of pad)

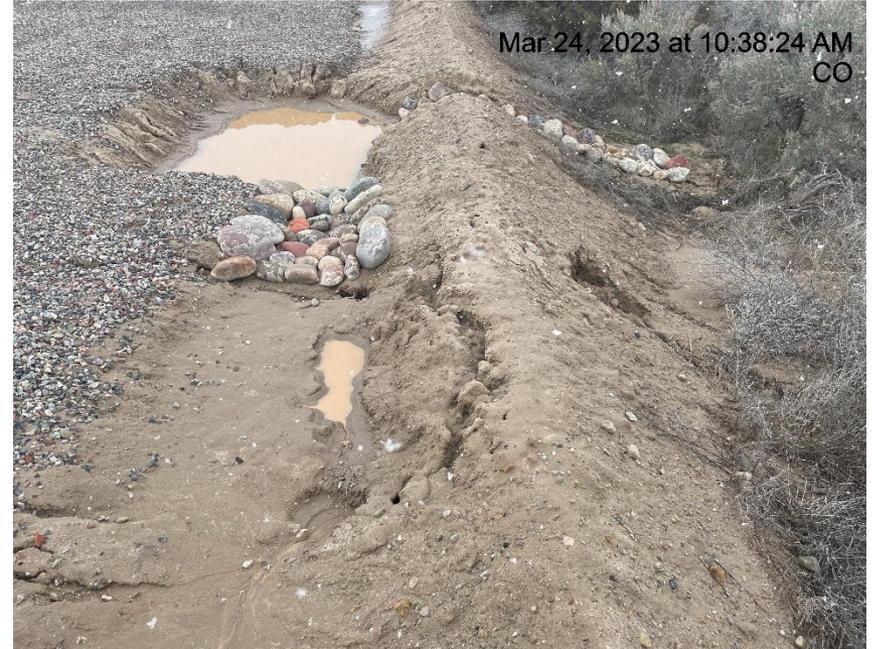
Photo # 3141 Tunnel erosion through berm & transport of sediment off location (east side of pad)

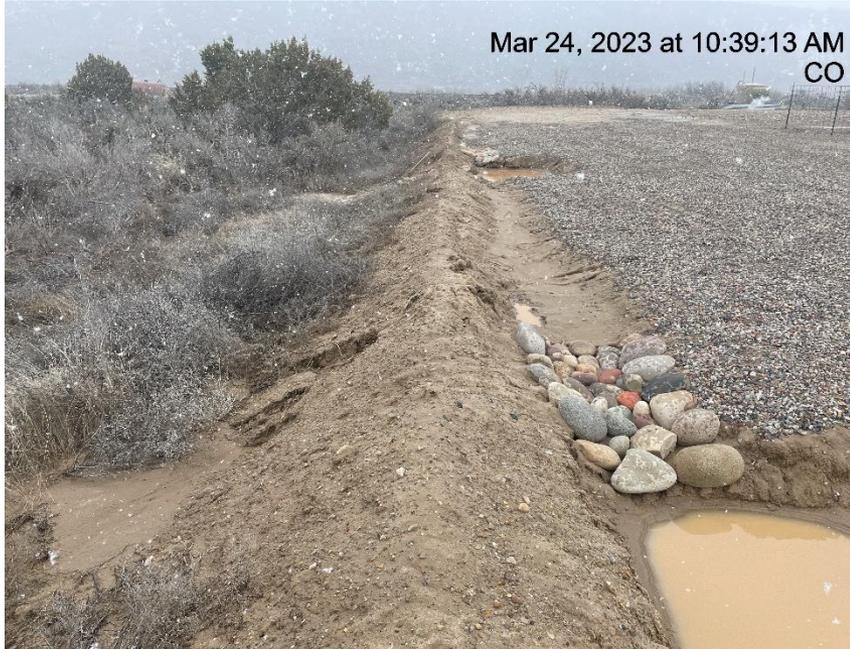
Photo # 3146 Tunnel erosion through berm & transport of sediment off location (east side of pad)

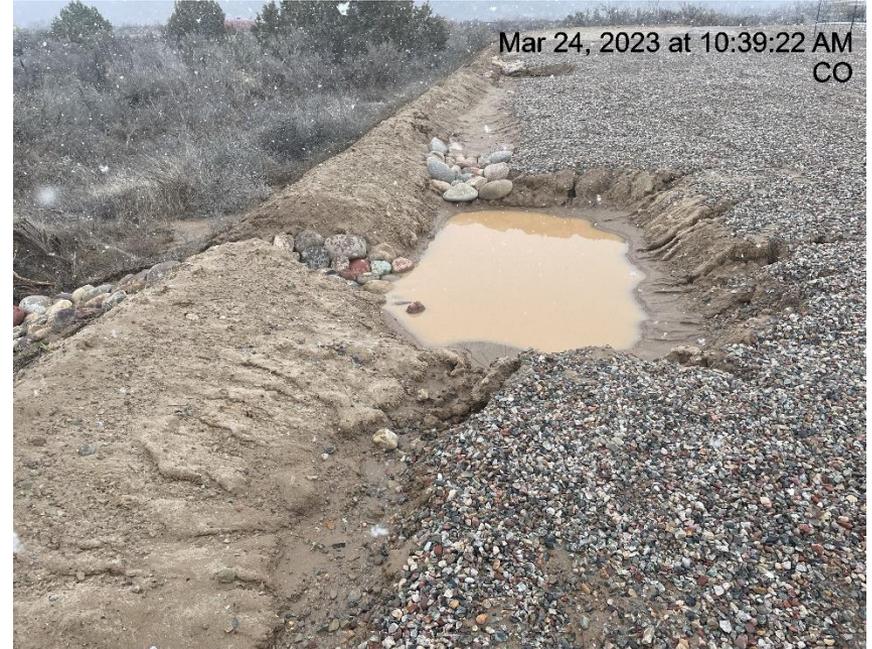
Photo # 3147 Sediment Trap needs maintenance (east side of location)

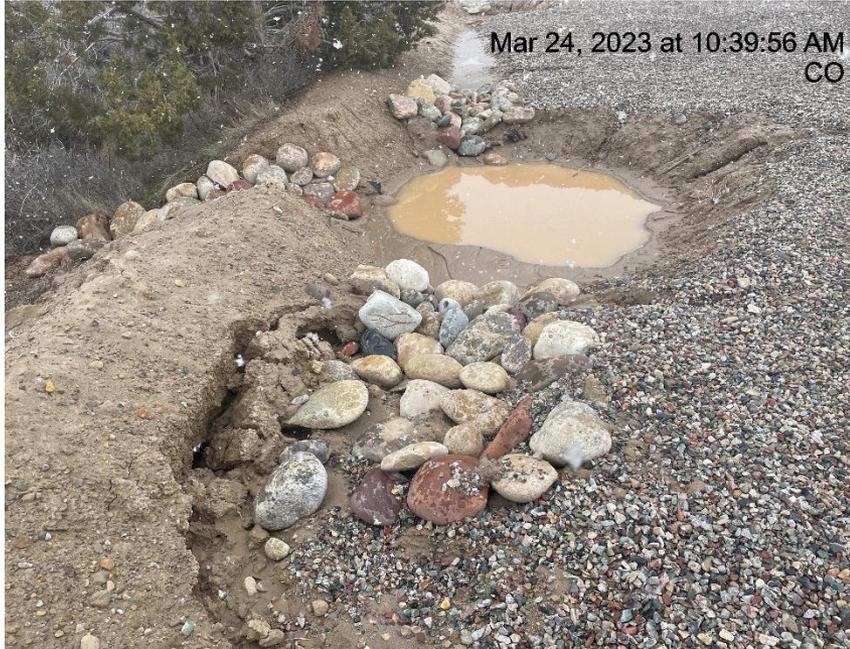
Photo # 3149 Sediment Trap needs maintenance (east side of location)

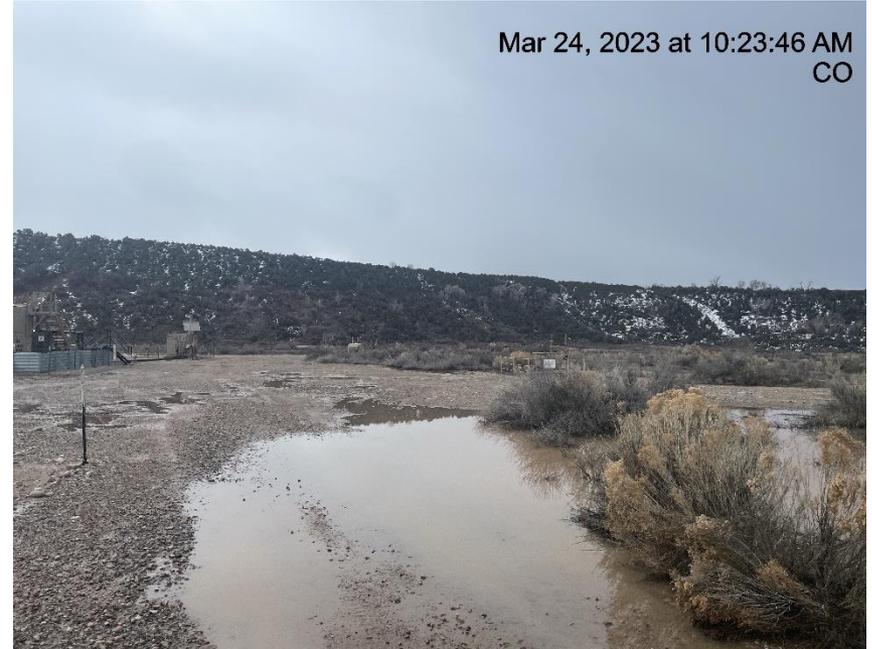
Photo # 3109 Insufficient run on controls/BMP's (Access road & entrance to location)
