Inspection Photos

Location Name: TEP ROCKY MOUNTAIN LLC CLOUGH RMV 26-21 Pad

Location ID: 323917

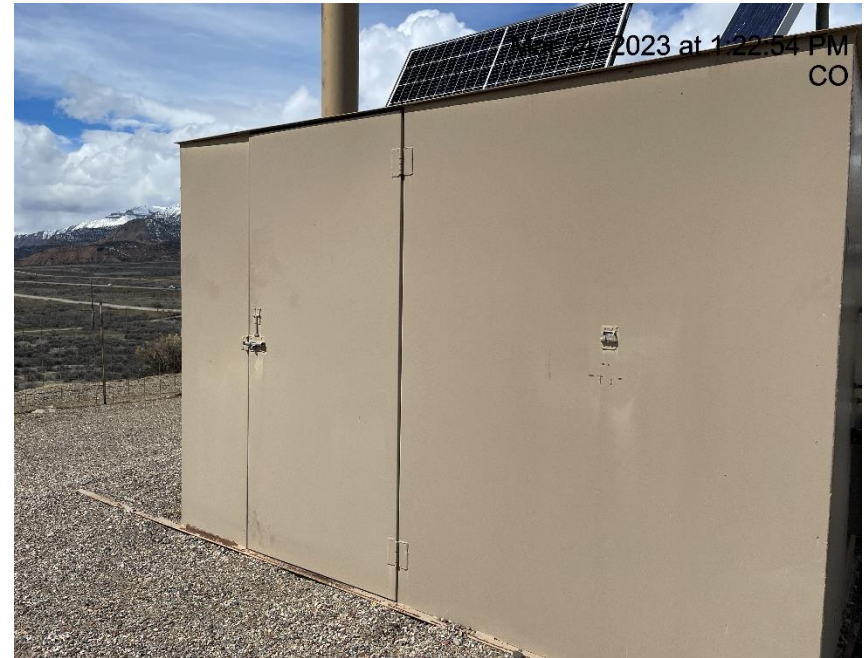
Photo # 3311 Meter calibration info not conspicuously posted

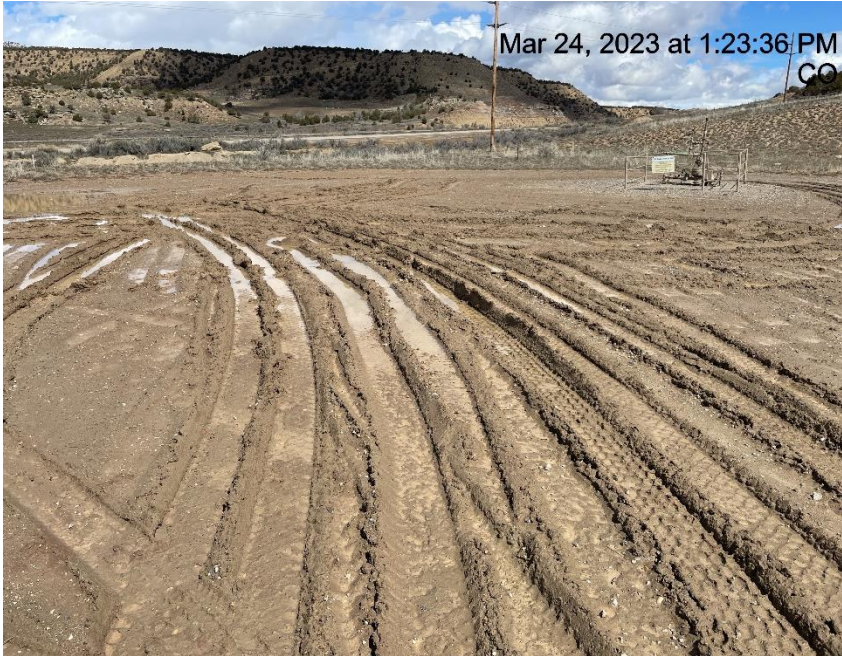
Photo # 3312 Lack of stabilization

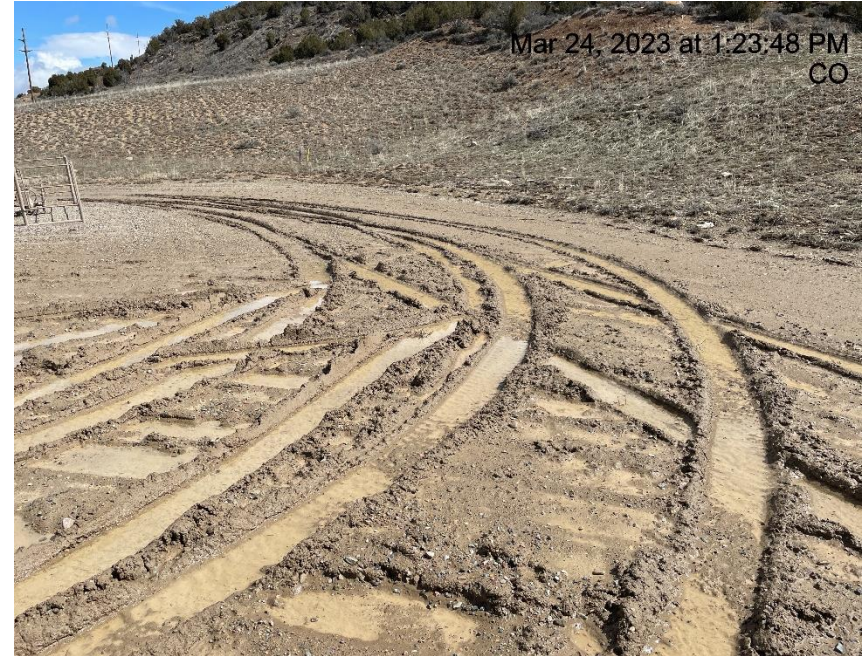
Photo # 3314 Lack of stabilization

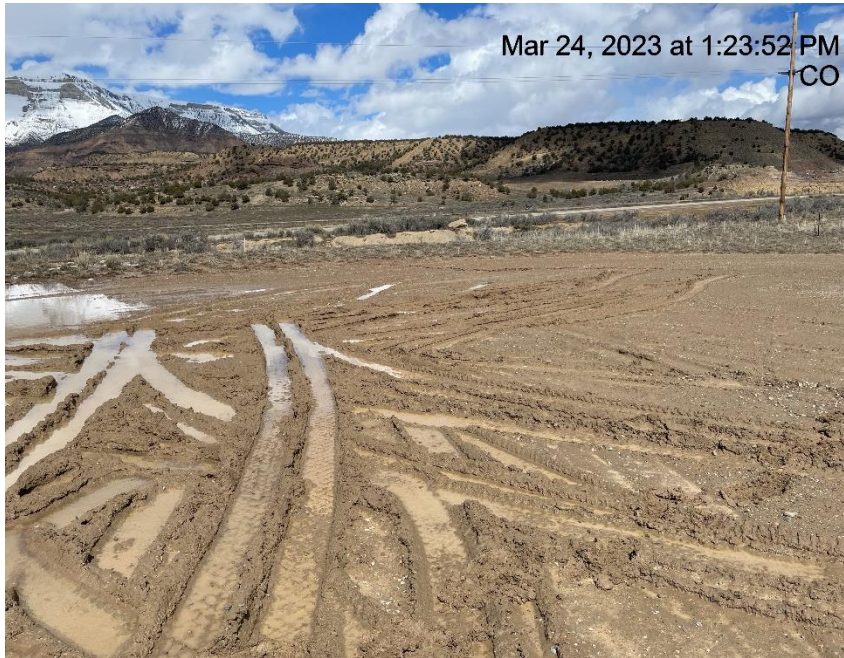
Photo # 3315 Lack of stabilization

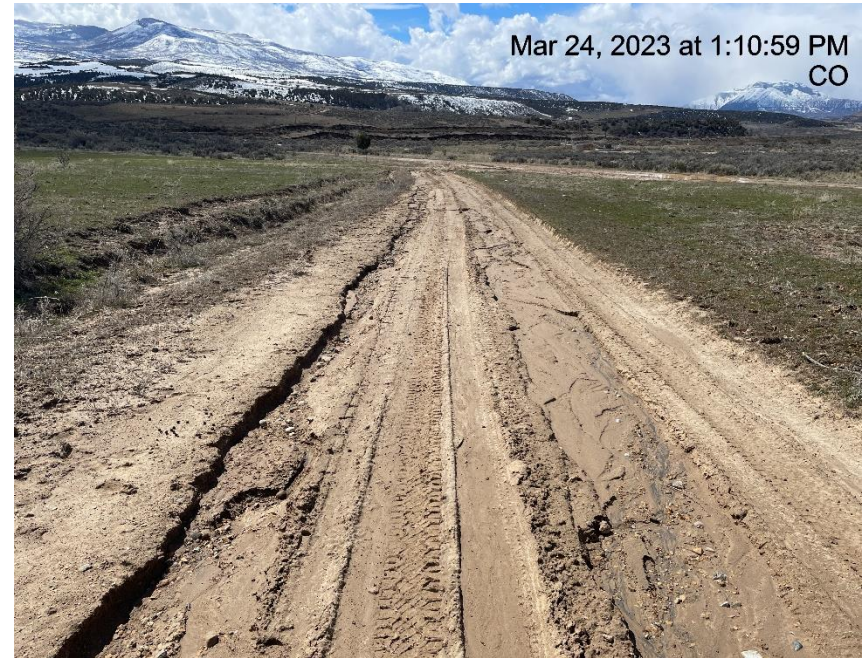
Photo # 3286 Rill erosion

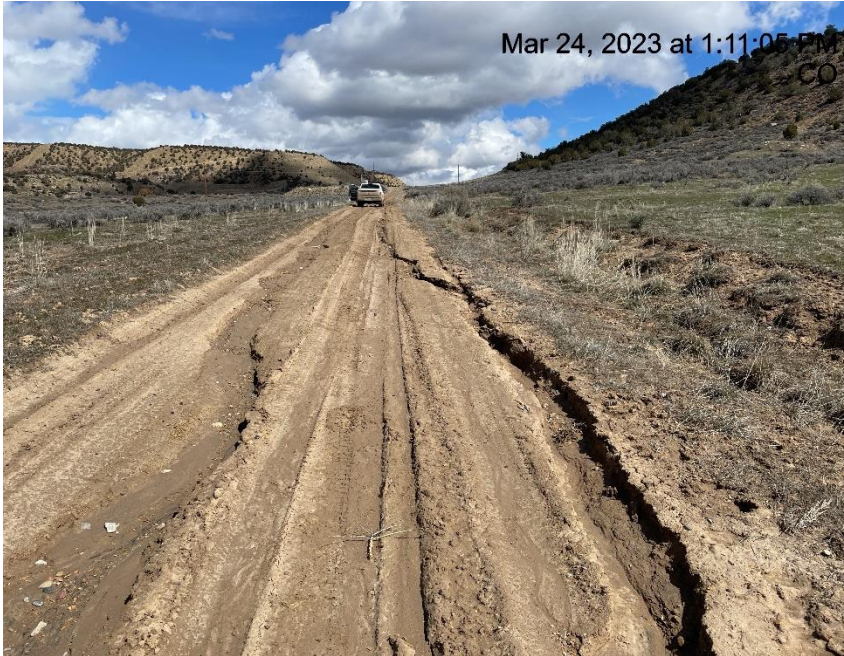
Photo # 3287 Rill erosion

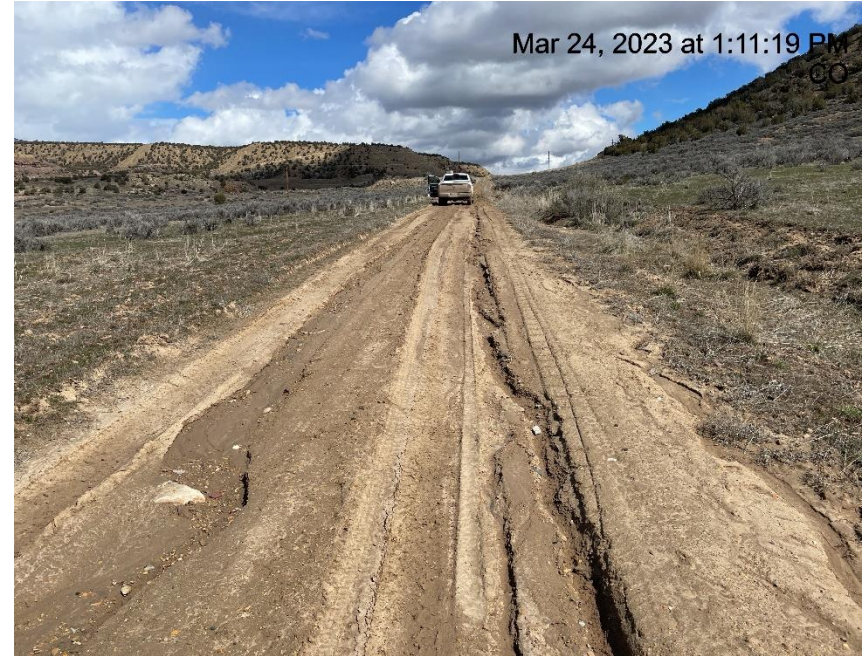
Photo # 3288 Rill erosion

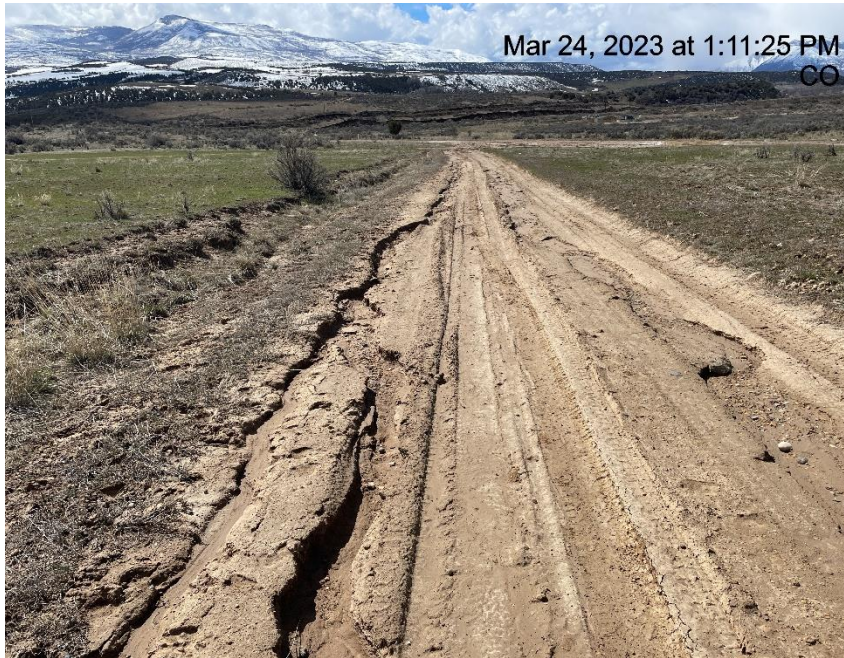
Photo # 3289 Rill erosion

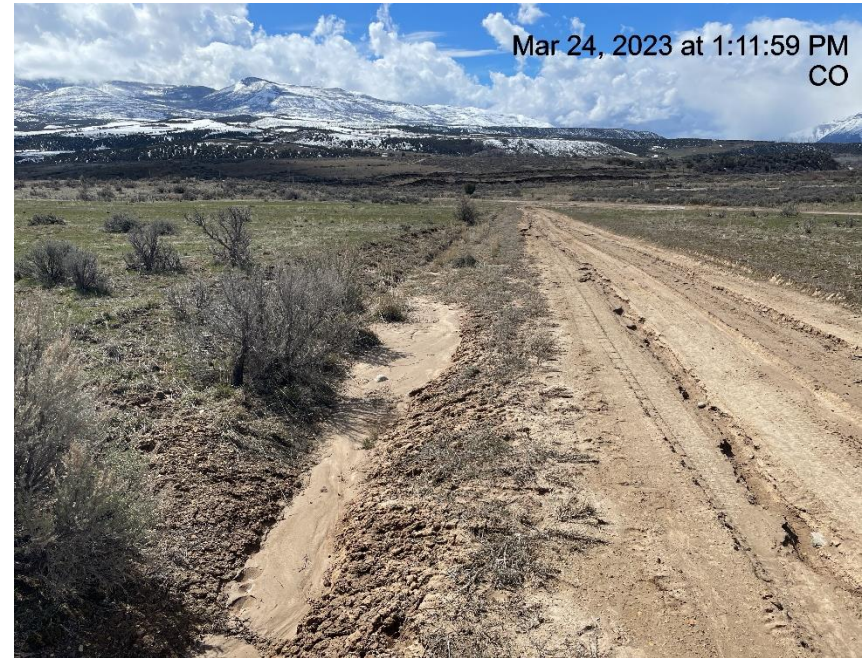
Photo # 3291 Ditch needs maintenance

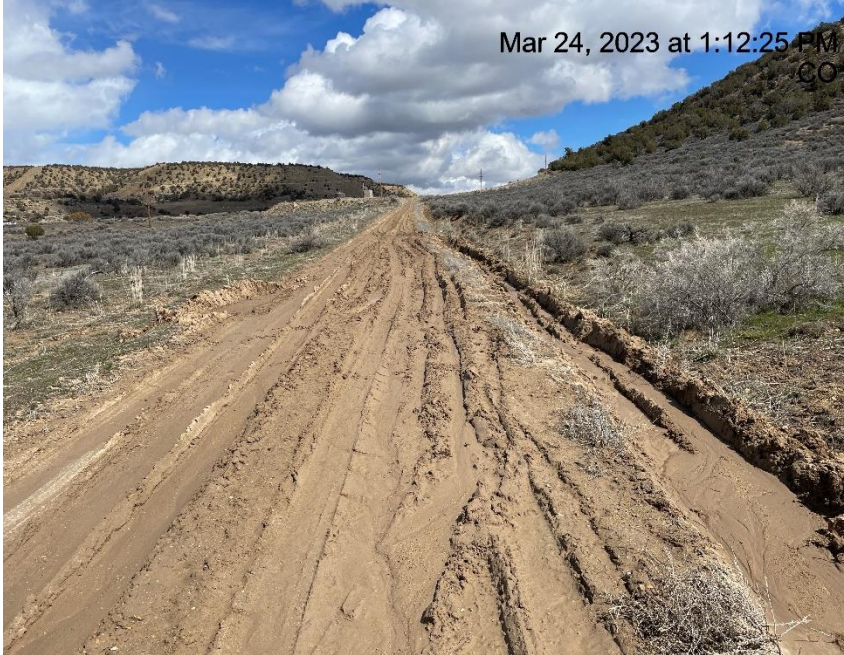
Photo # 3292 Ditch on spur road needs maintenance/light compaction & sparse gravel on road

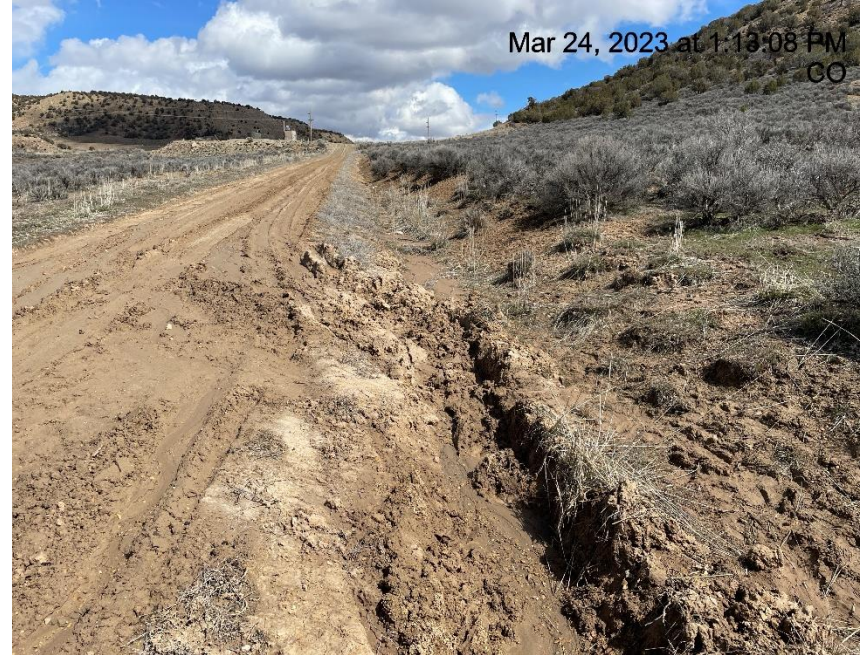
Photo # 3293 Ditch needs maintenance

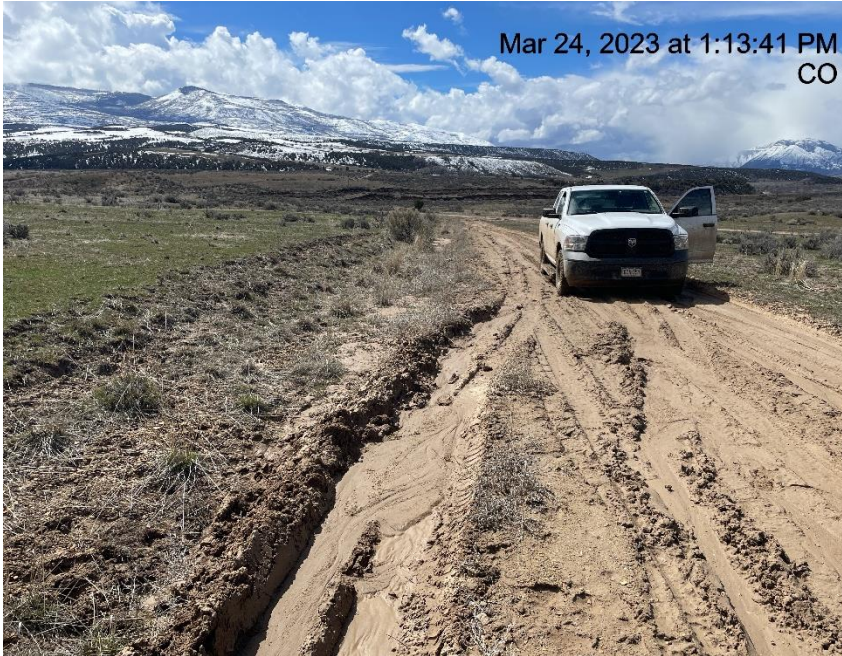
Photo # 3294 Ditch needs maintenance

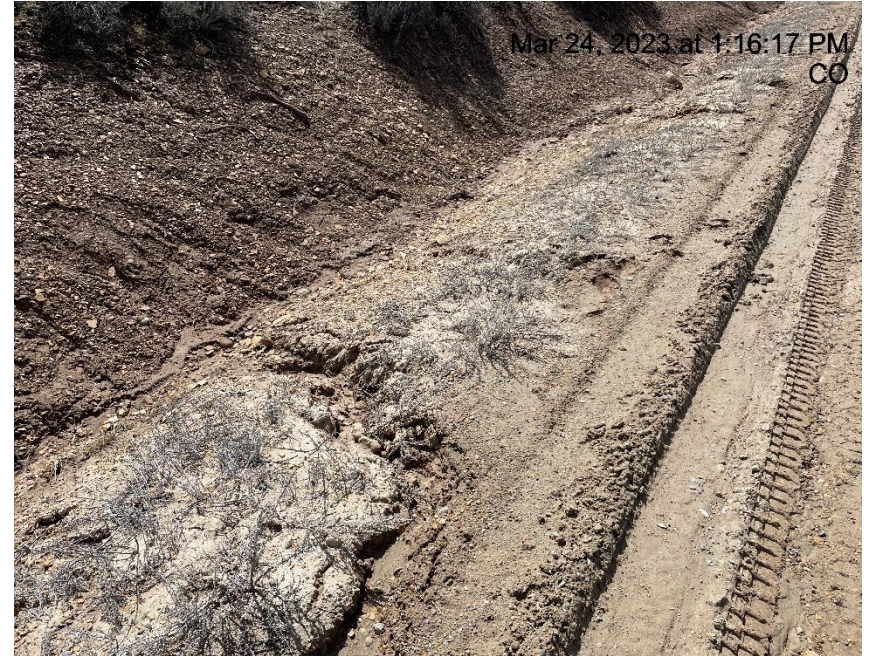
Photo # 3295 Rill erosion

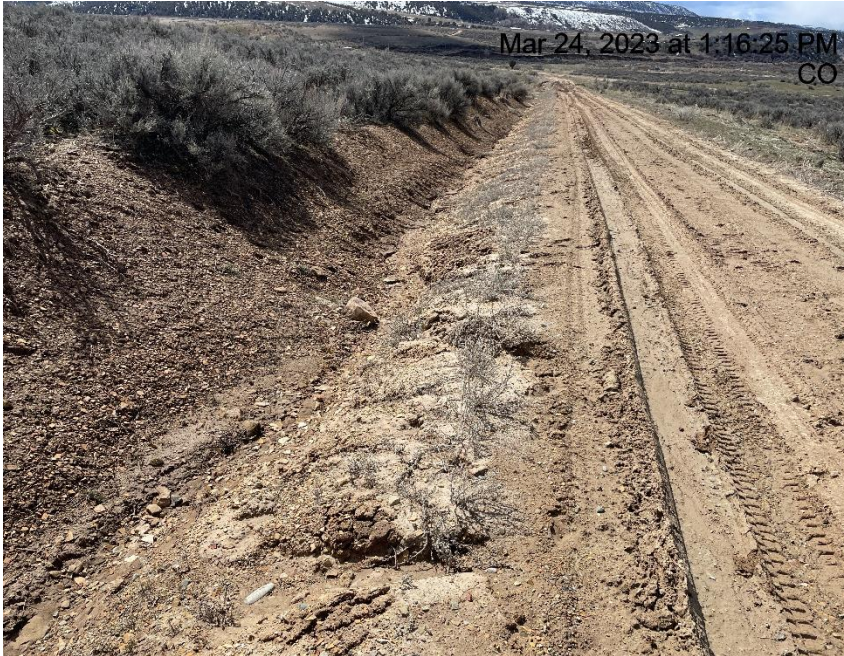
Photo # 3296 Rill erosion

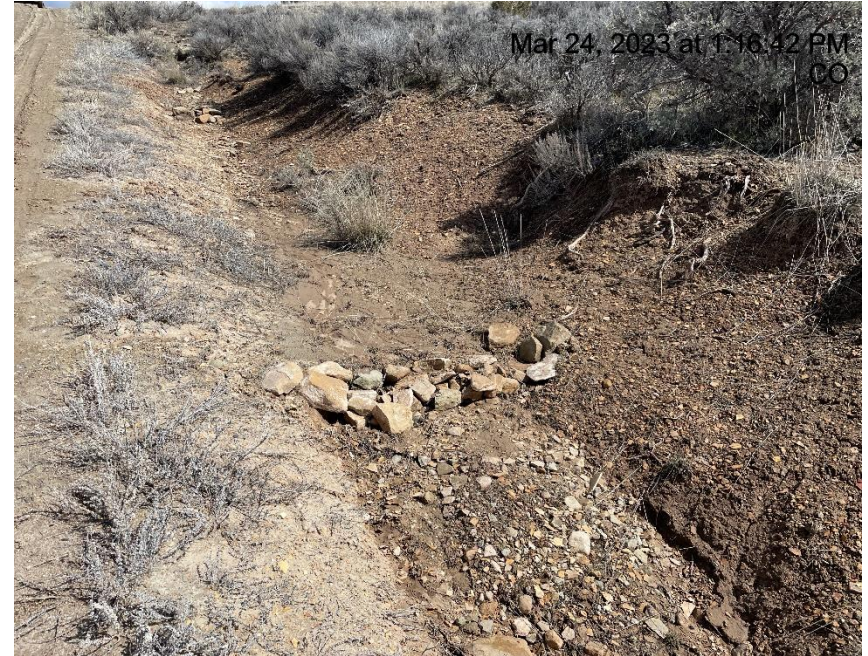
Photo # 3297 Check dam needs maintenance

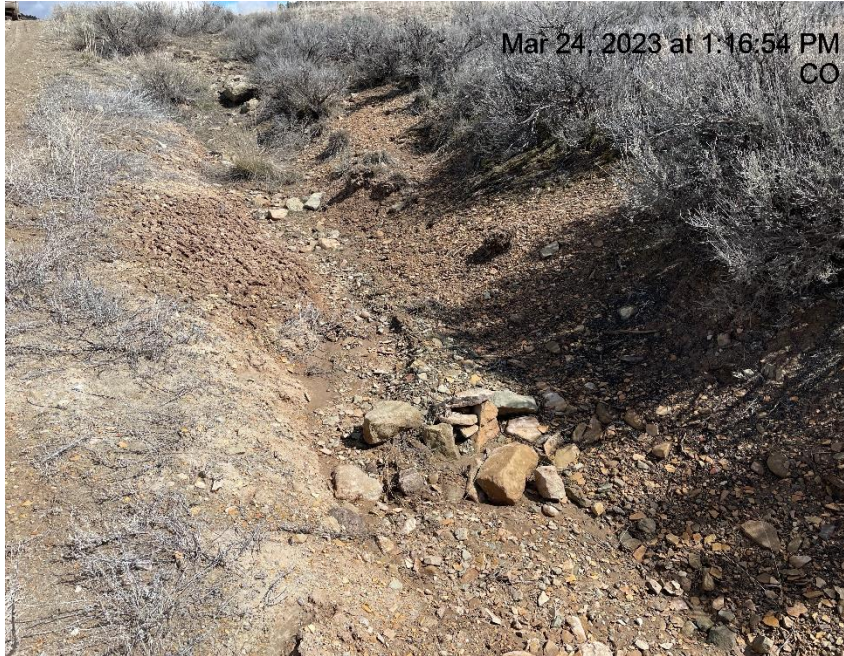
Photo # 3298 Check dam needs maintenance

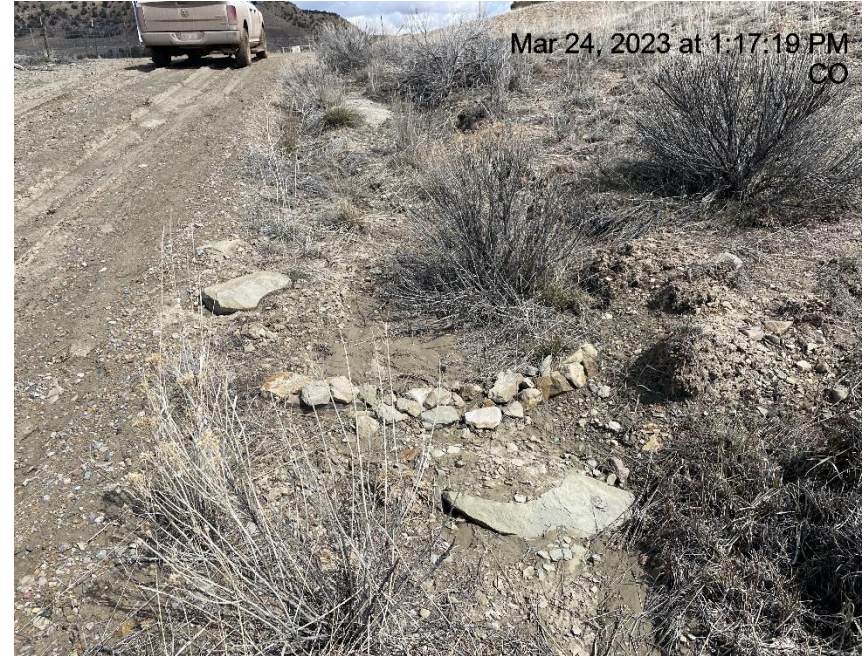
Photo # 3299 Check dam needs maintenance

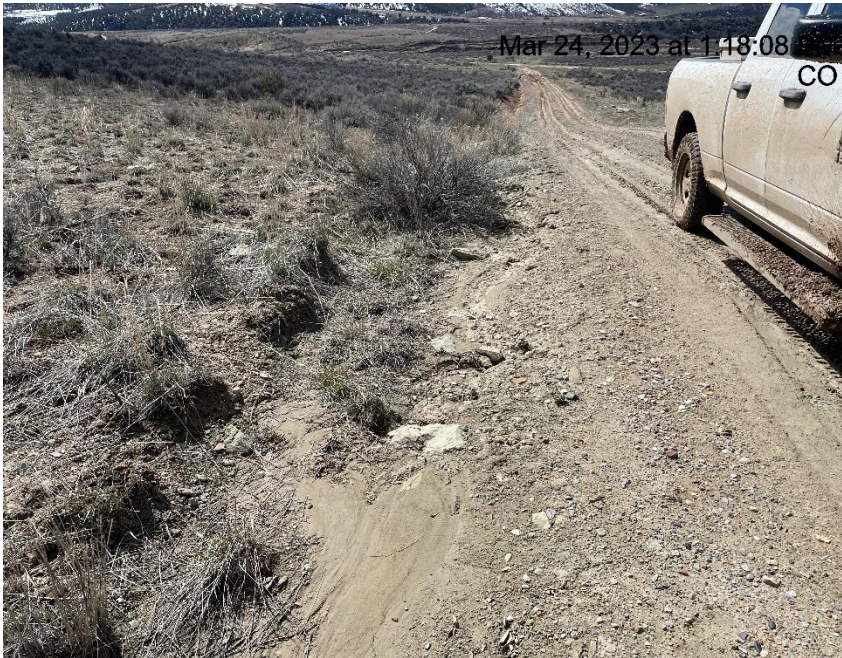
Photo # 3300 Ditch & Check dam need maintenance

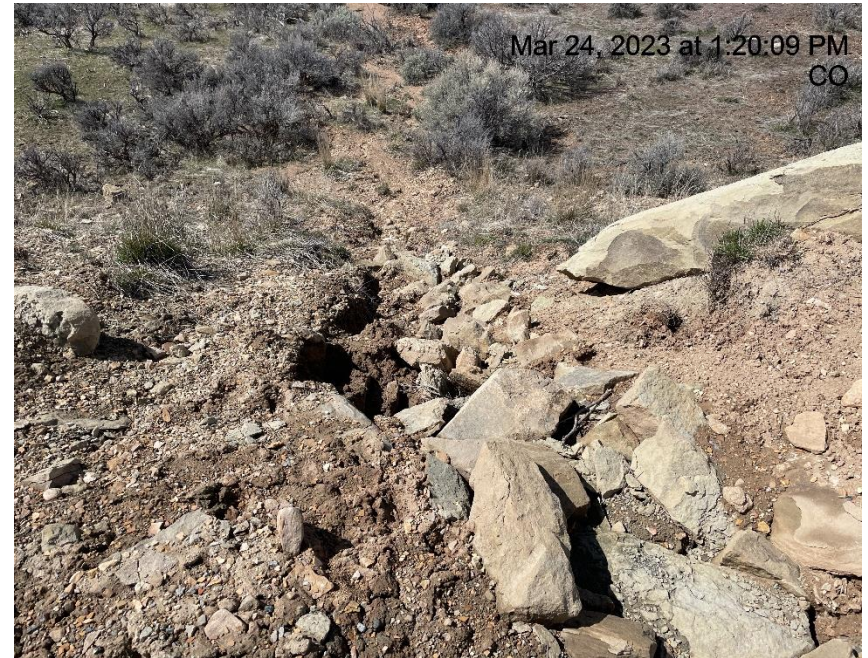
Photo # 3301 Rip Rap Run needs maintenance

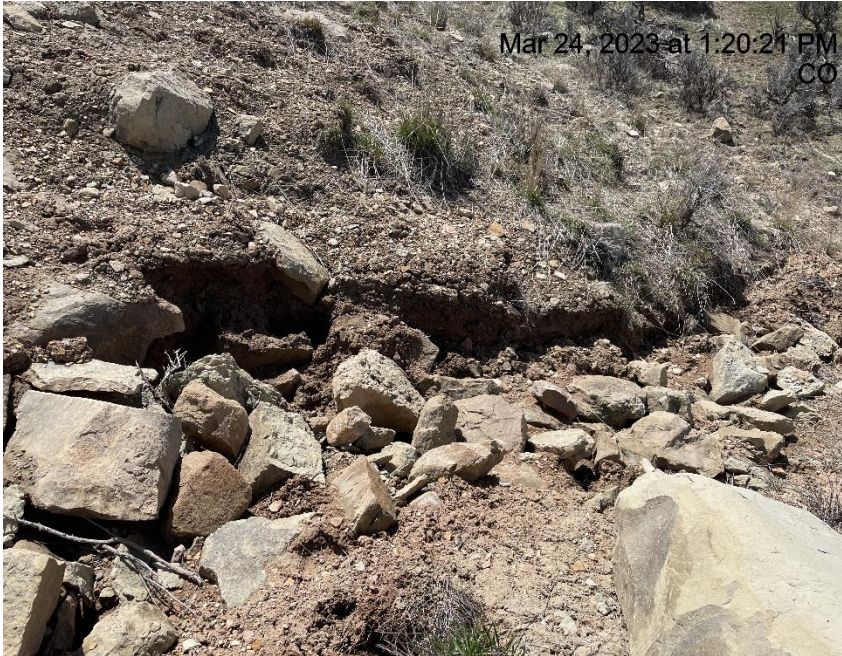
Photo # 3302 Rip Rap Run needs maintenance

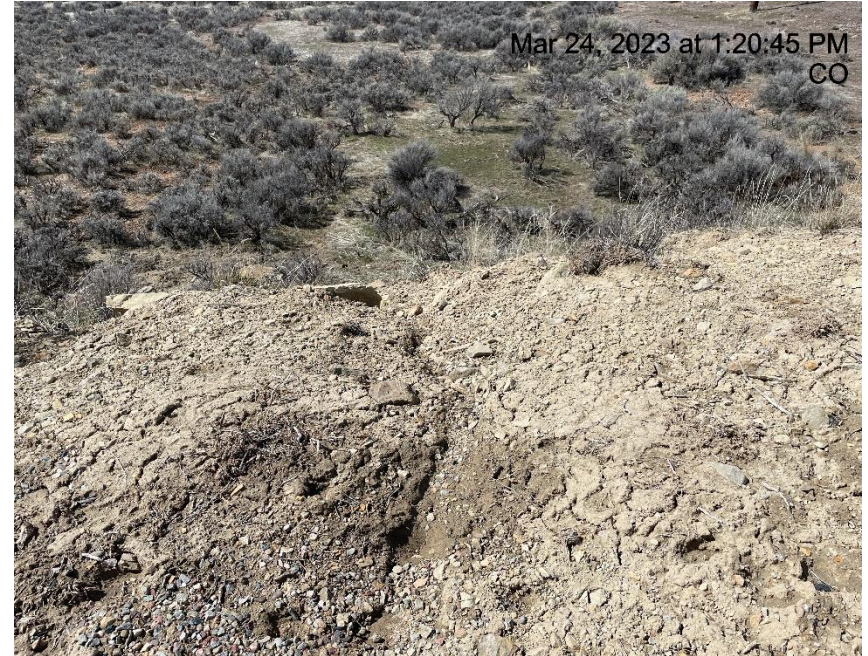
Photo # 3304 Rill erosion on edge of location
