Inspection Photos  
Location Name: Sack #44-31  
Spill ID 484022

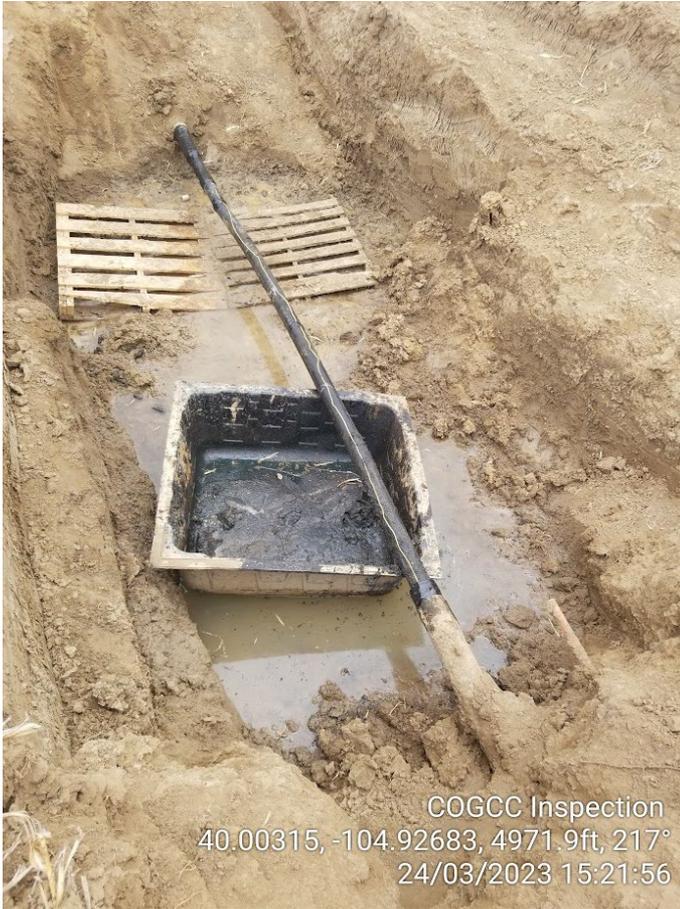
**Photo 1 – South Excavation groundwater visible with sheen and flecks of hydrocarbon material.**

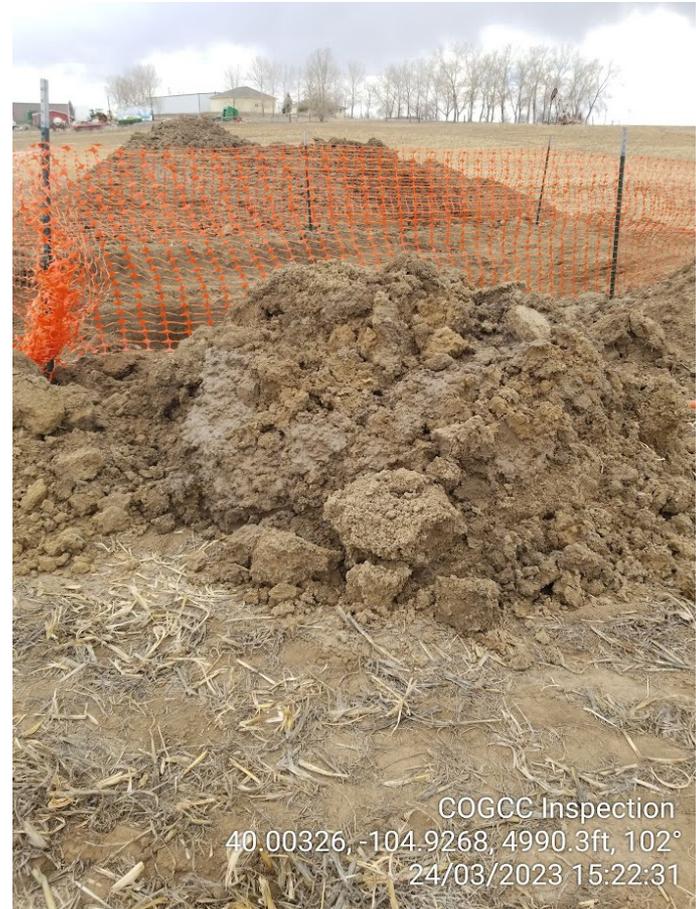
**Photo 2 – South Excavation, wet stockpile with hydrocarbon odor and no liner.**

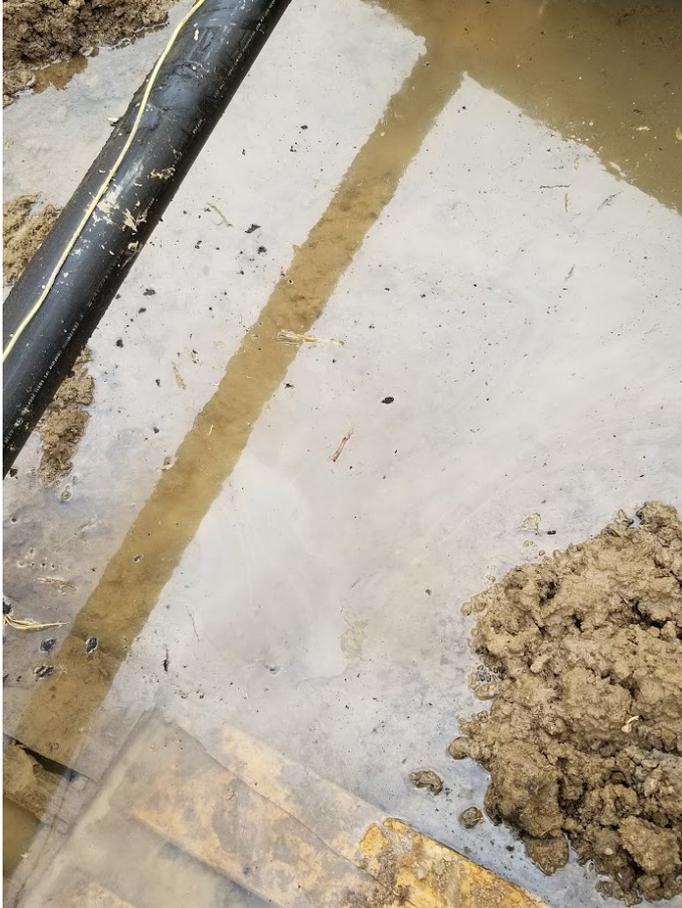
Photo 3 – South Excavation groundwater visible with sheen and flecks of hydrocarbon material.

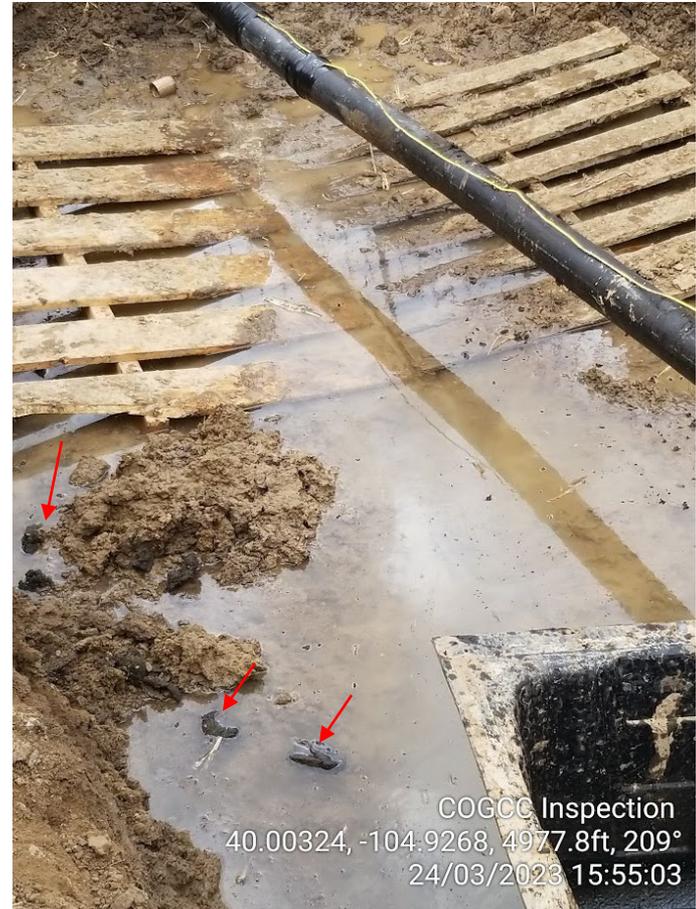
Photo 2 – South Excavation groundwater visible with sheen and flecks of hydrocarbon material. Arrows indicate heavily stained material.
