## Inspection Photos

Location Name: TEP ROCKY MOUNTAIN LLC VASSAR-HEATH 130 Pad

Location ID: 322425

**COLORADO**  
Oil & Gas Conservation  
Commission  
Department of Natural Resources

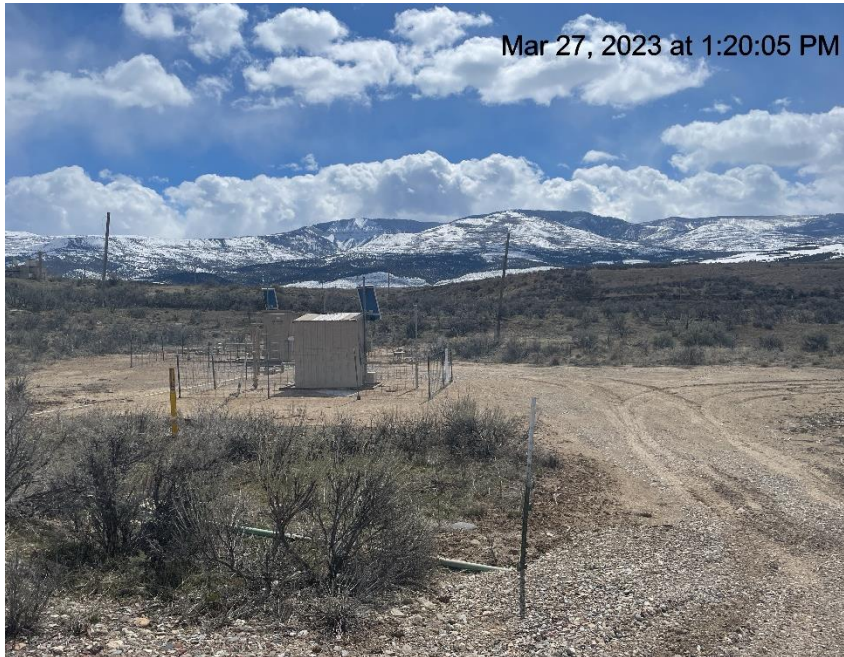
Photo # 3452 From entrance to location

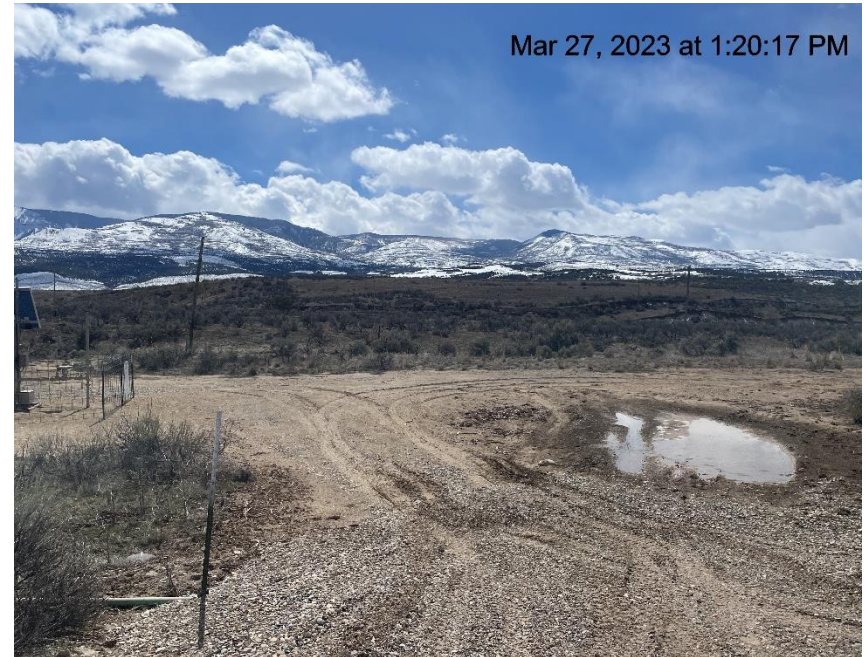
Photo # 3453 From entrance to location

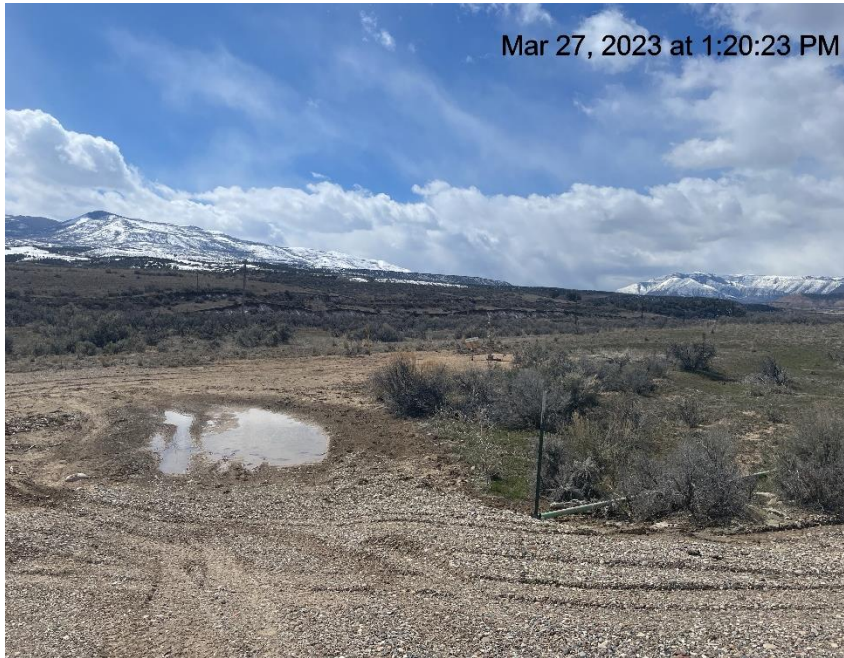
Photo # 3455 From entrance to location

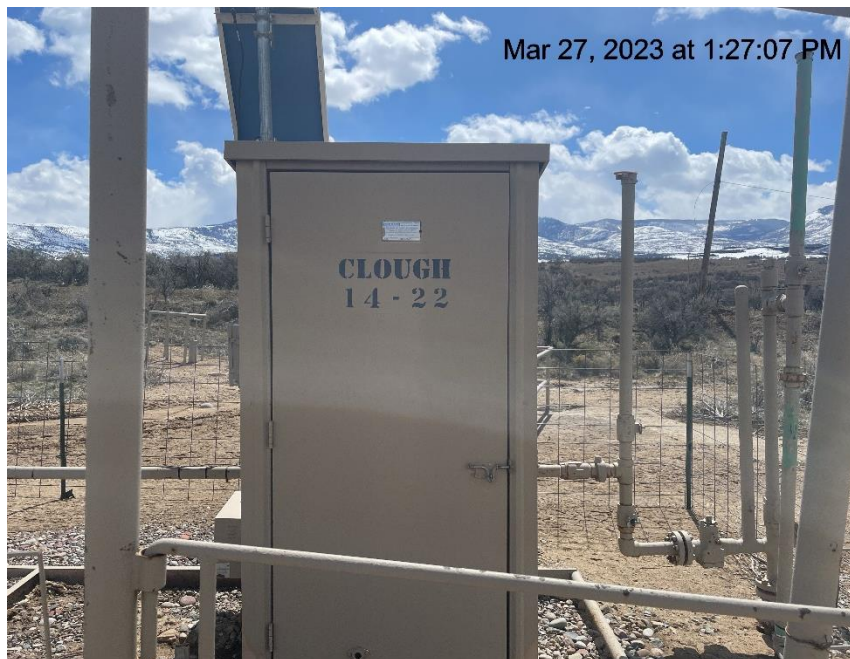
**Photo # 3477 Meter calibration info not conspicuously posted**

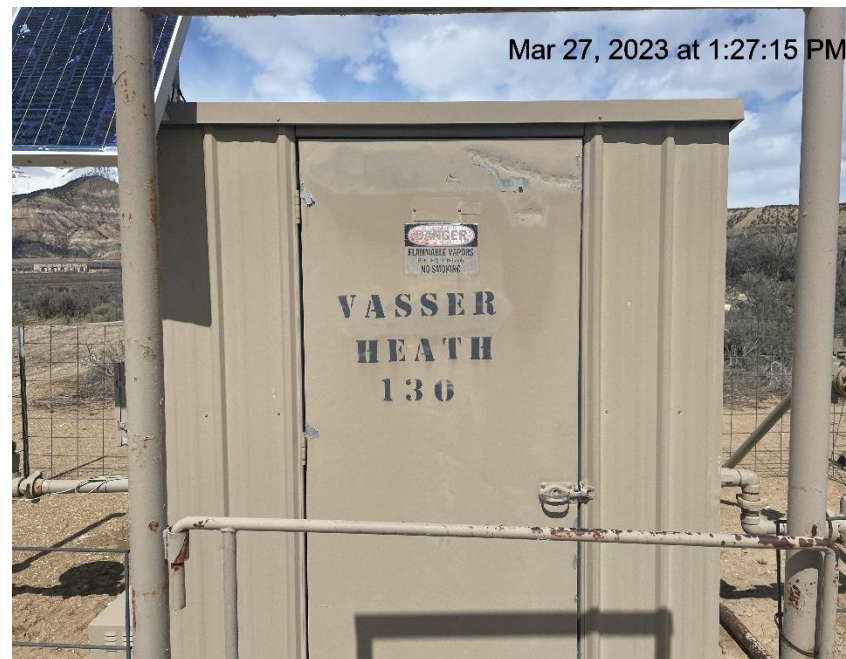
**Photo # 3478 Meter calibration info not conspicuously posted**

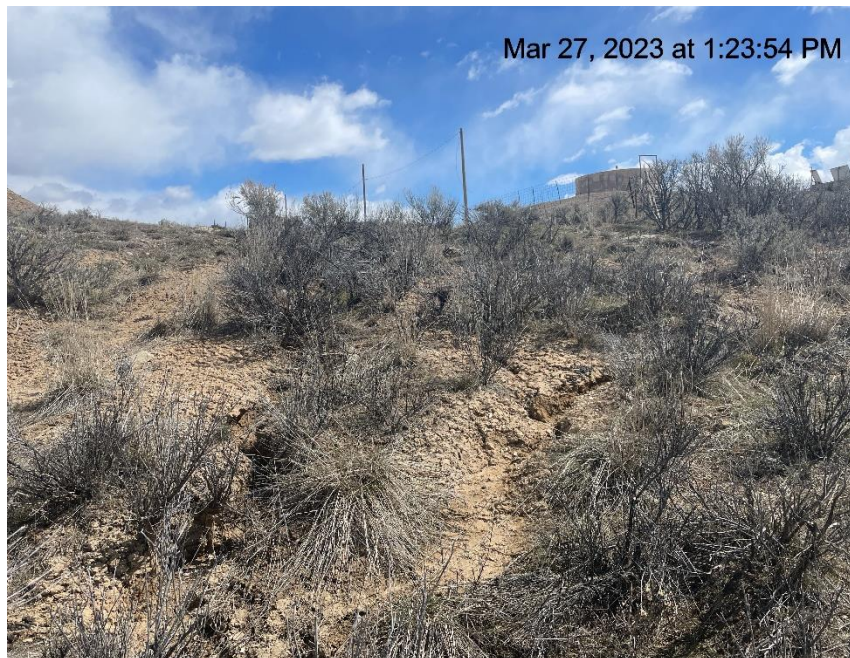
**Photo # 3460 Rill erosion**

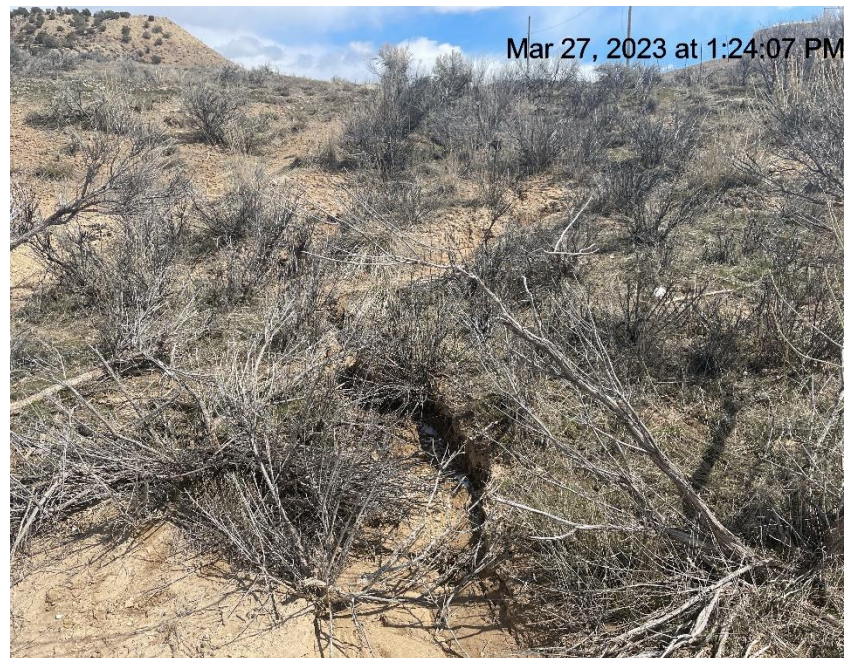
**Photo # 3461 Rill & Gully erosion**

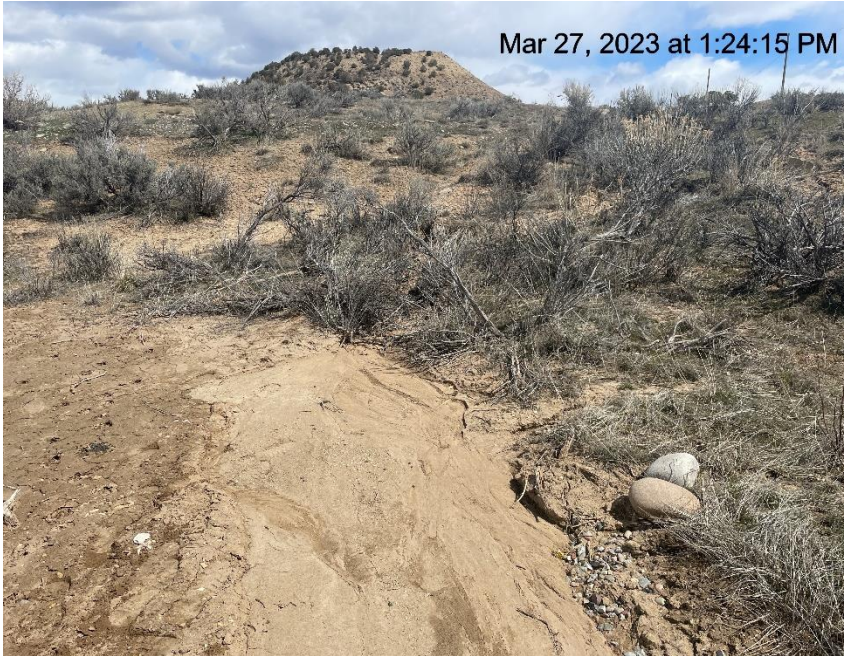
**Photo # 3462 Erosion & Transport of sediment/insufficient run on BMP's**

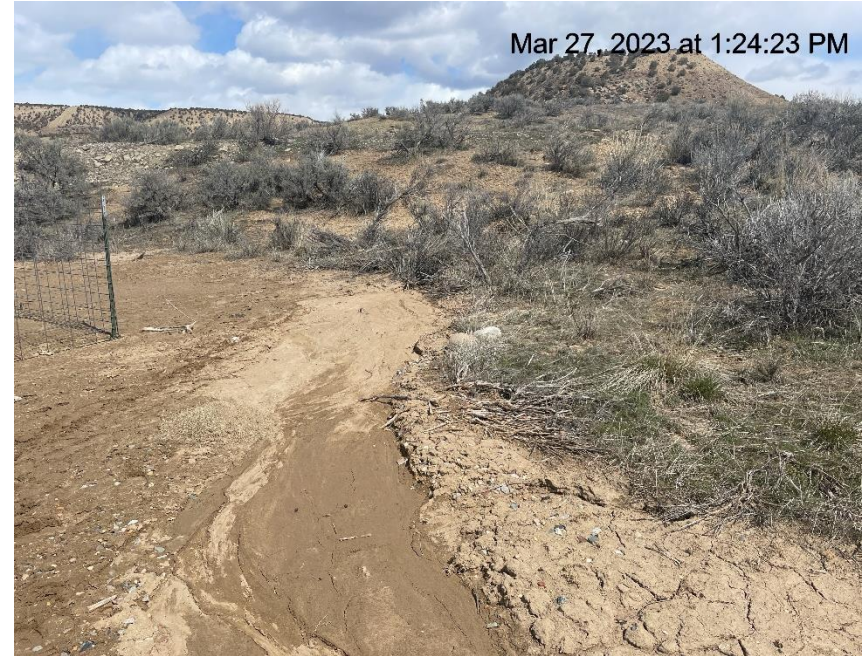
**Photo # 3463 Erosion & Transport of sediment/insufficient run on BMP's**

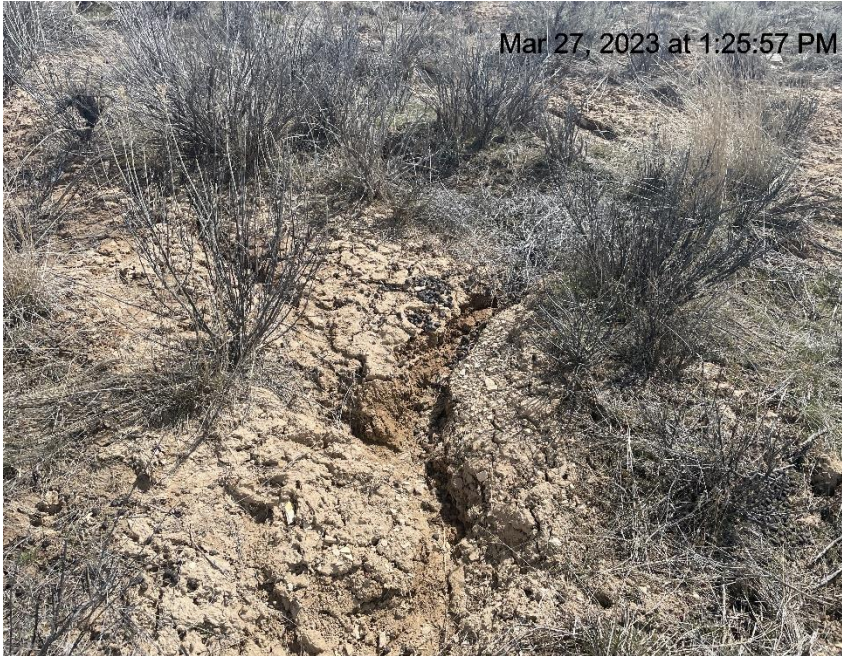
**Photo # 3470 Rill erosion on slope**

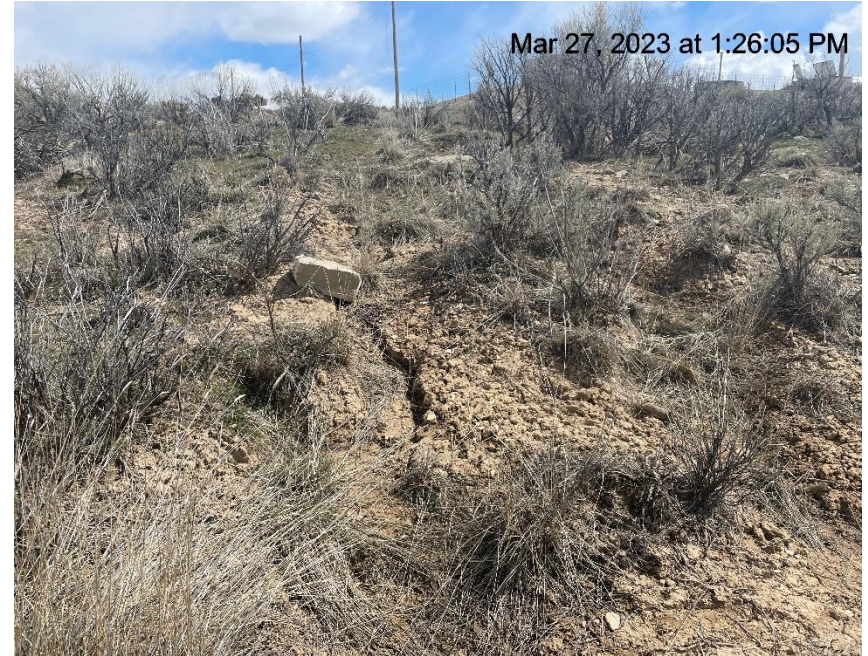
**Photo # 3471 Rill erosion on slope**
