## Inspection Photos

Location Name: TEP ROCKY MOUNTAIN LLC CLOUGH RMV 232-28 Pad

Location ID: 324163

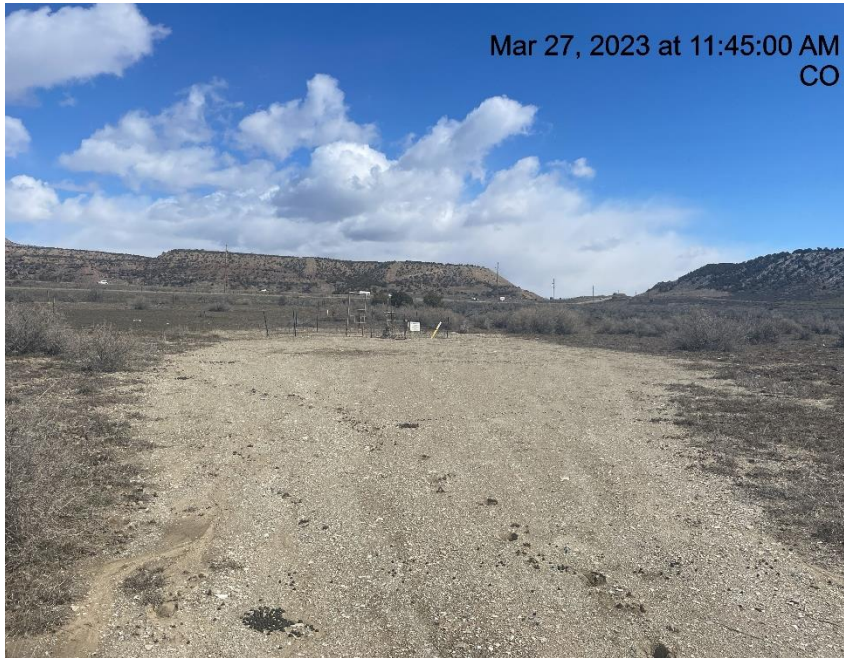
Photo # 3377 From entrance to location

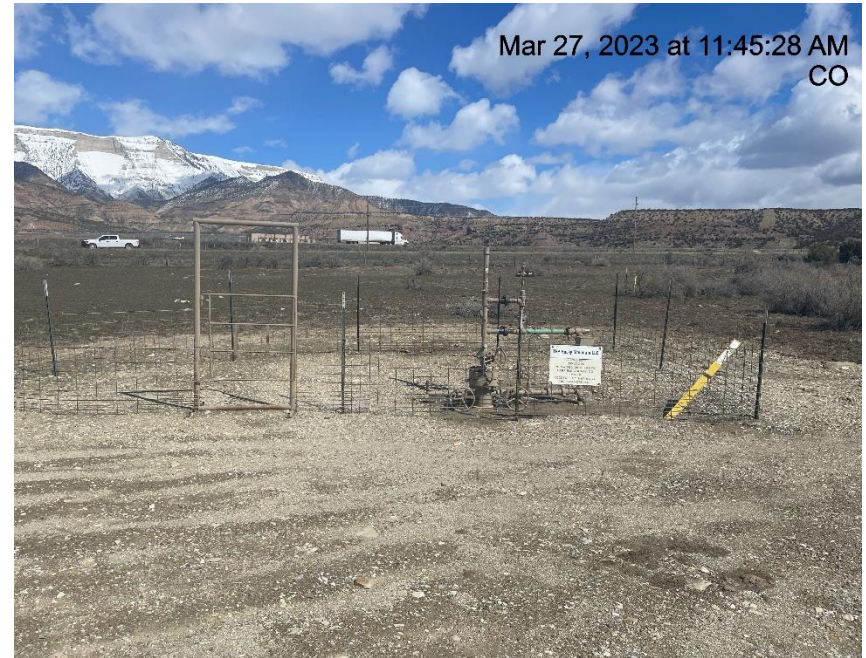
Photo # 3378 Location

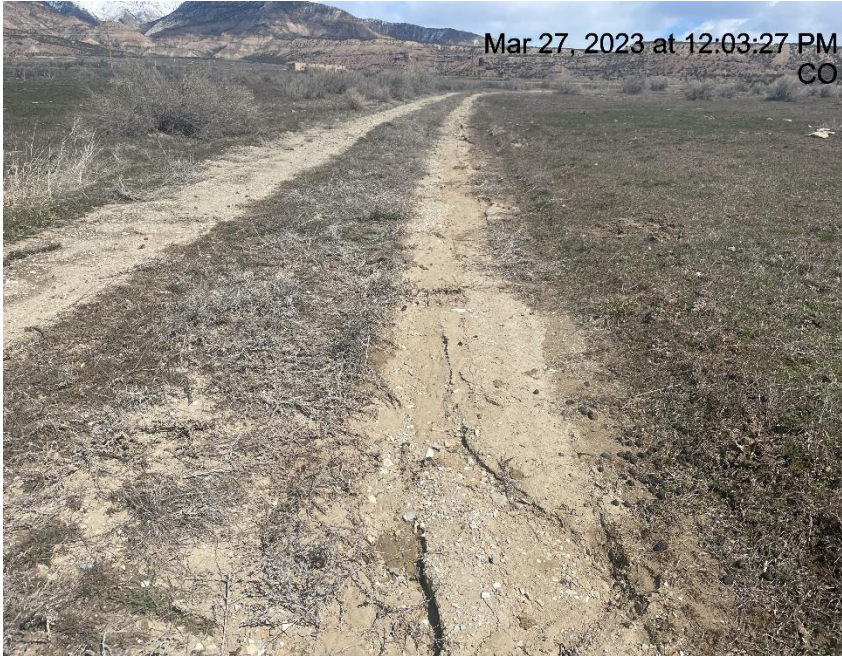
**Photo # 3382 Rill erosion on spur road**

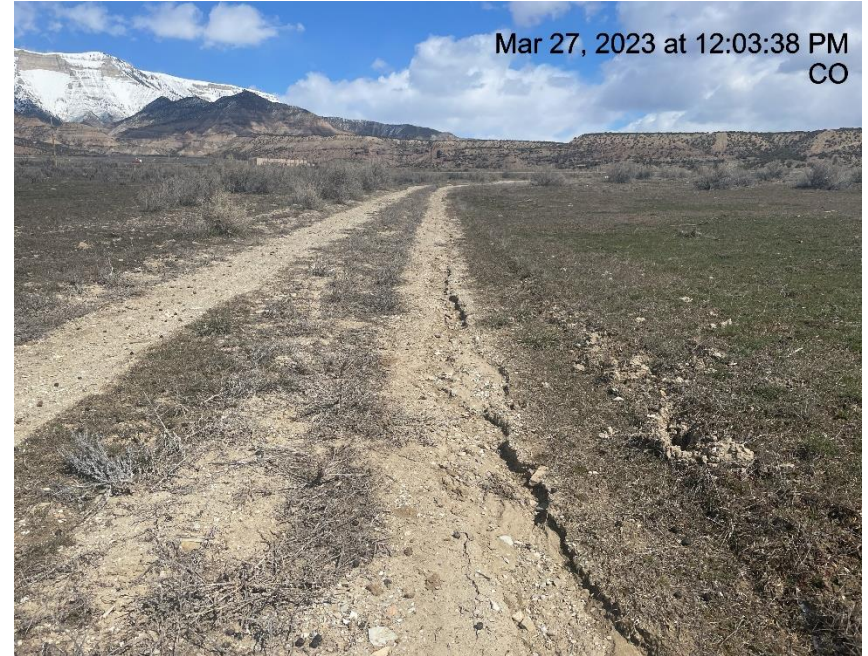
**Photo # 3383 Rill erosion on spur road**

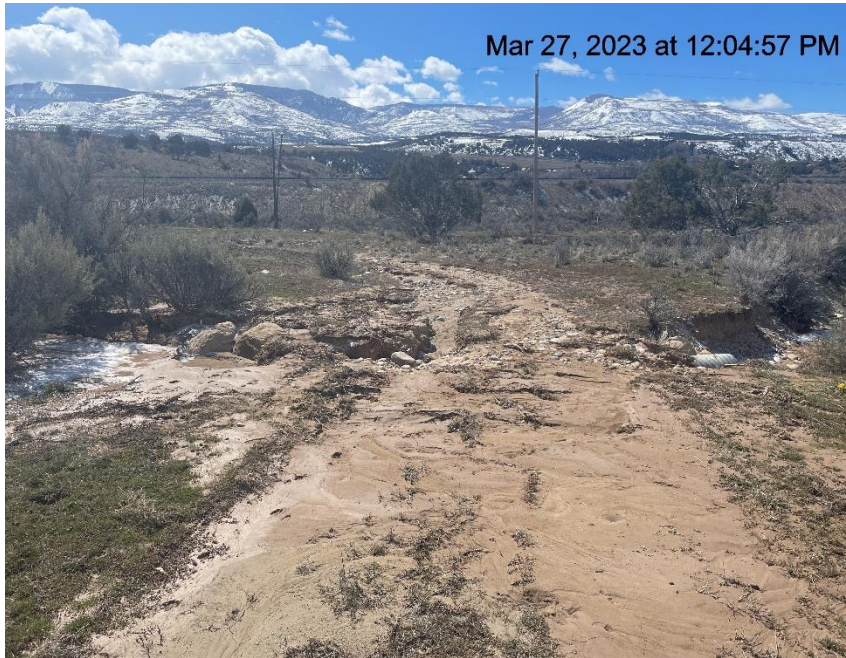
**Photo # 3384 Road degradation/transport of sediment**

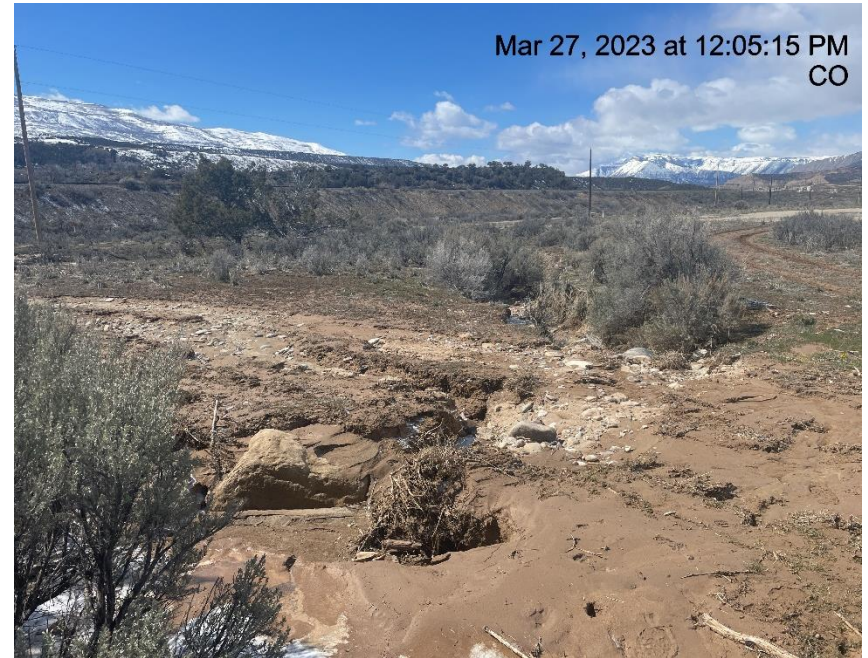
**Photo # 3385 Culvert needs maintenance/Insufficient run on BMP's/transport of sediment**

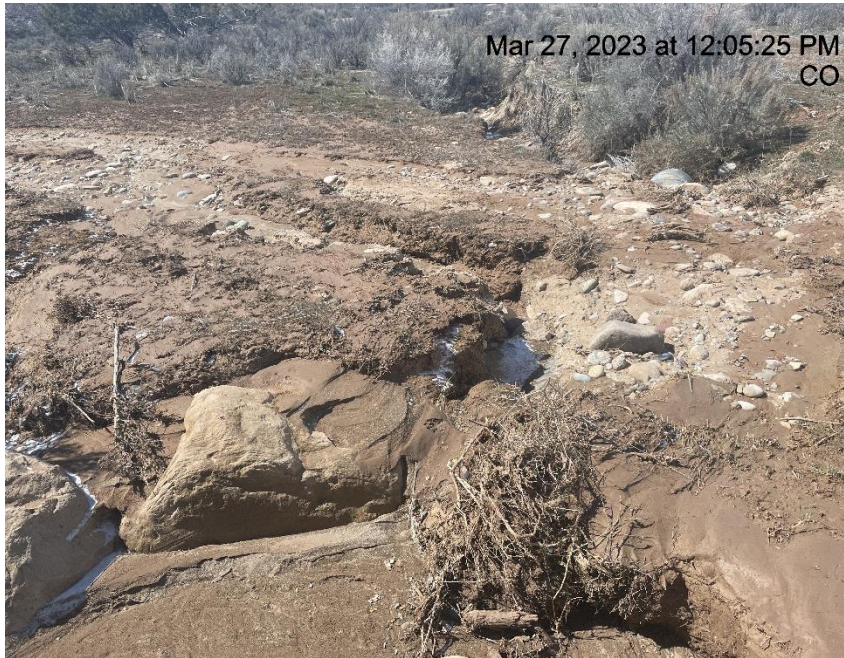
**Photo # 3386 Culvert needs maintenance/Insufficient run on BMP's**

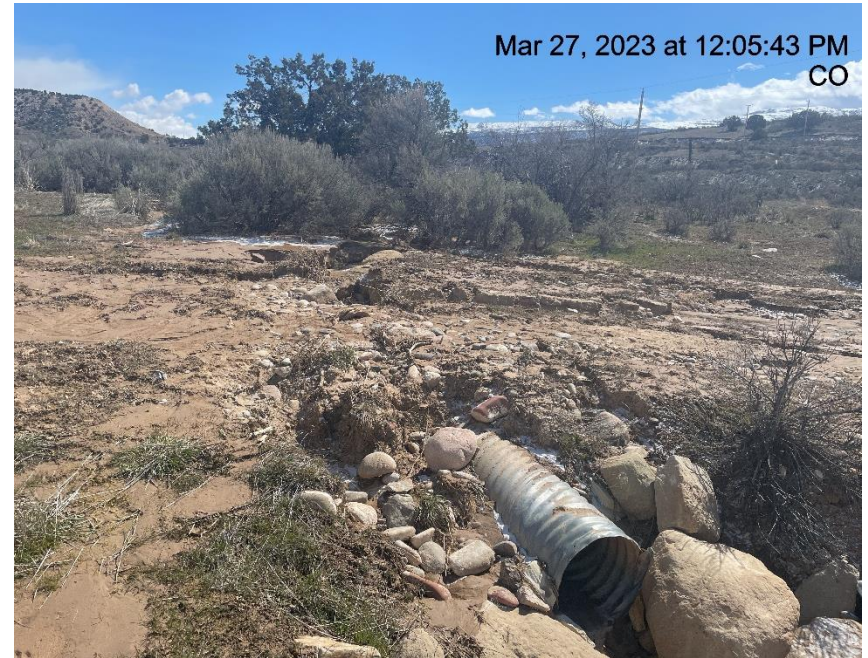
**Photo # 3387 Culvert needs maintenance/Insufficient run on BMP's**

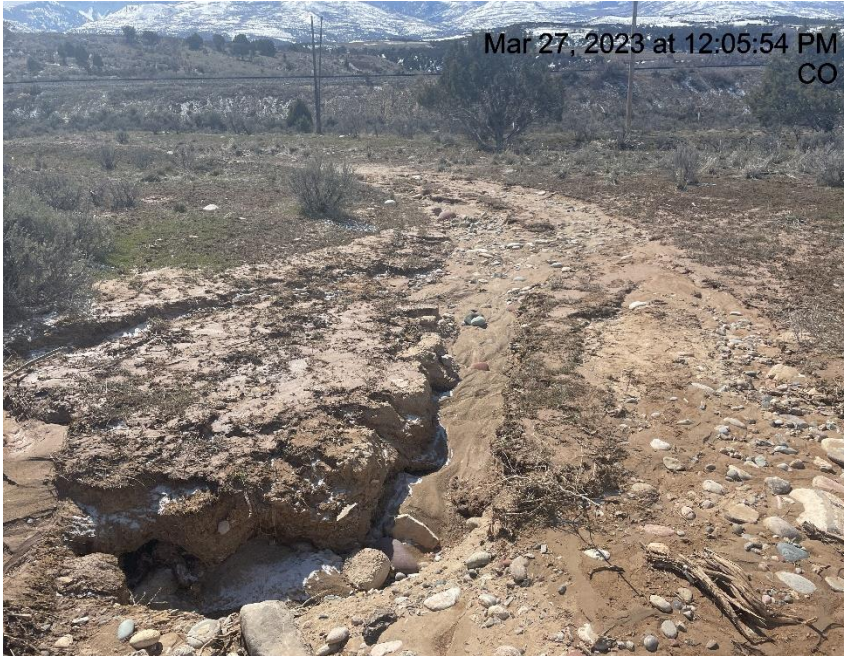
**Photo # 3388 Gully/Rill erosion/Transport of sediment on spur road/road degradation**

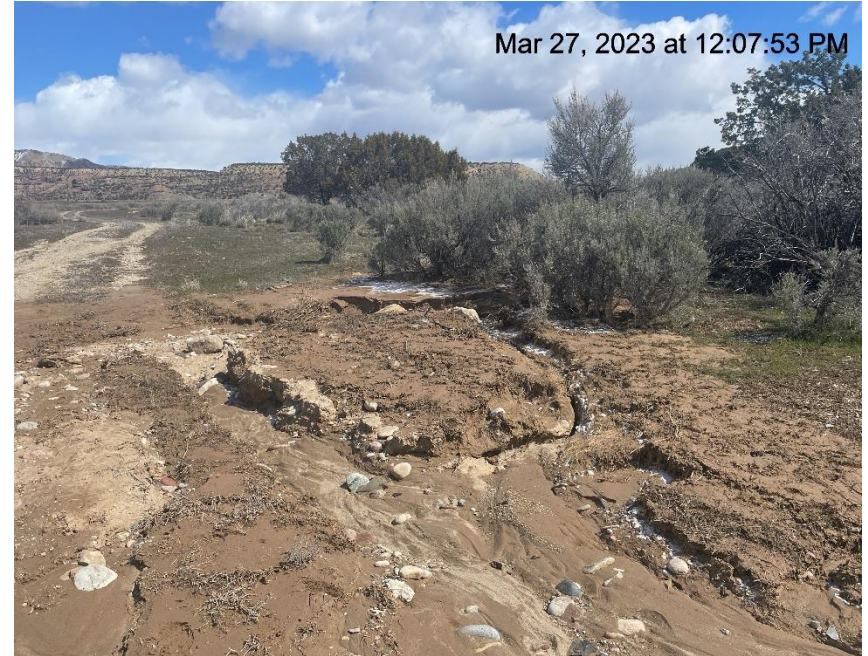
**Photo # 3389 Gully/Rill erosion/Transport of sediment on spur road/road degradation**

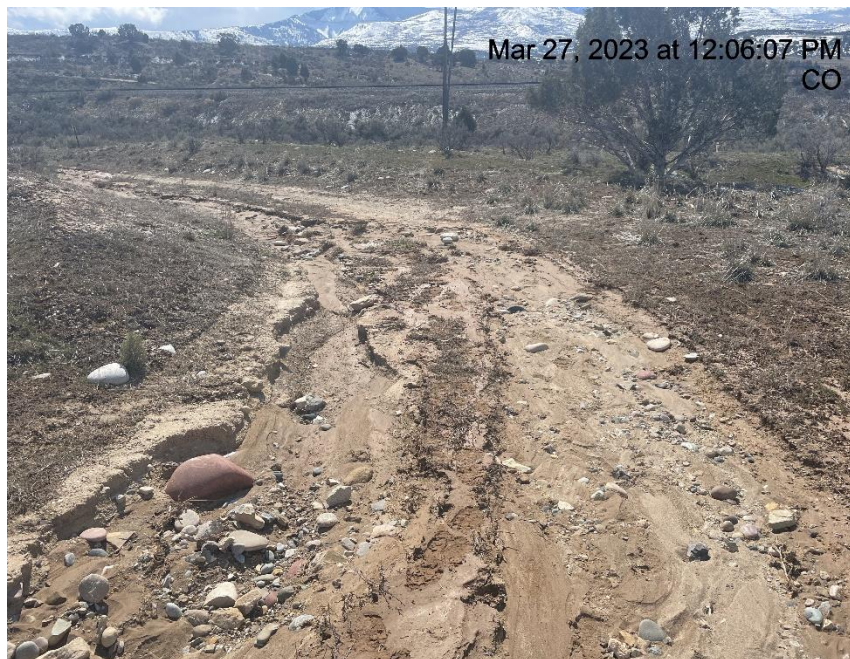
Photo # 3390 Rill erosion & transport of sediment on spur road

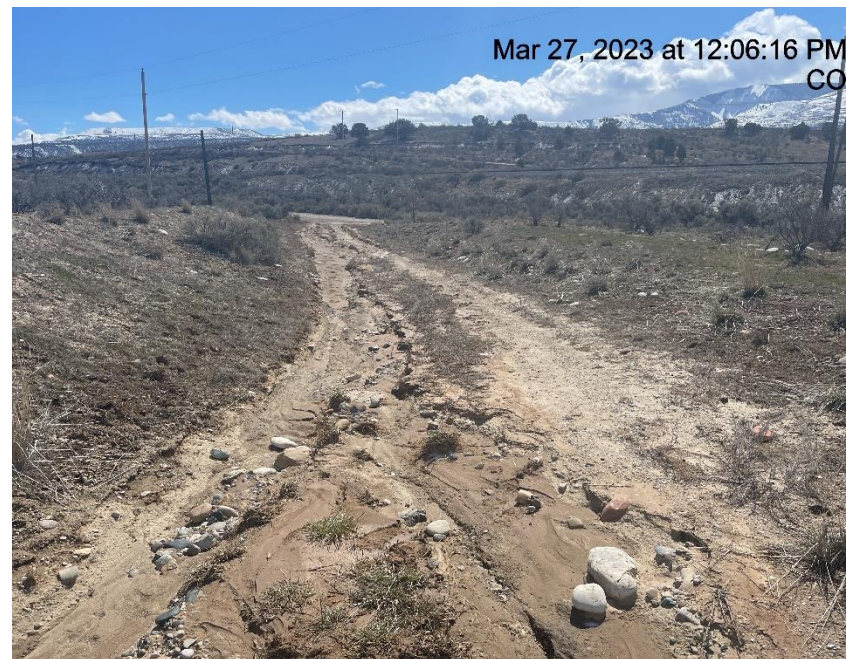
Photo # 3391 Rill erosion & transport of sediment on spur road

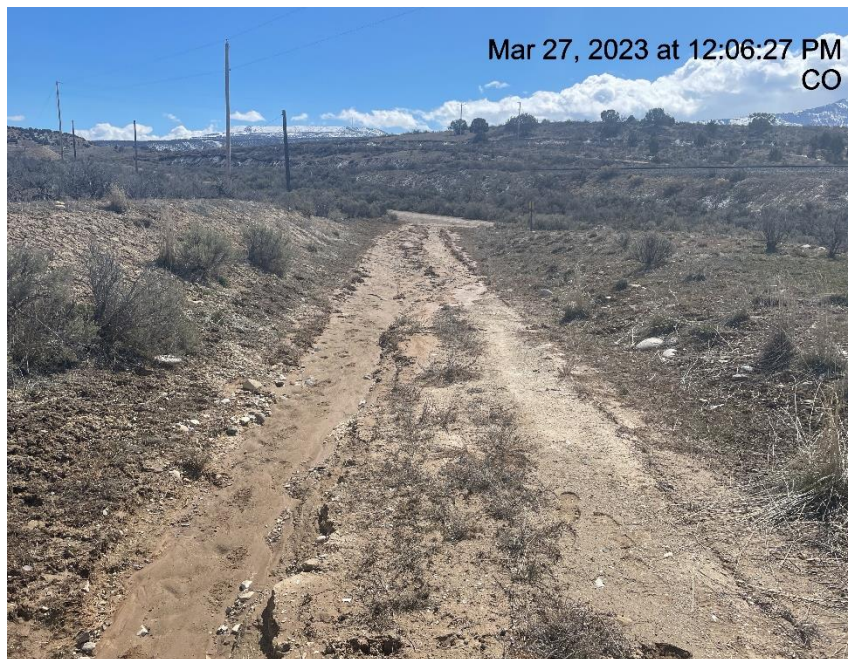
**Photo # 3392 Rill erosion & transport of sediment on spur road**

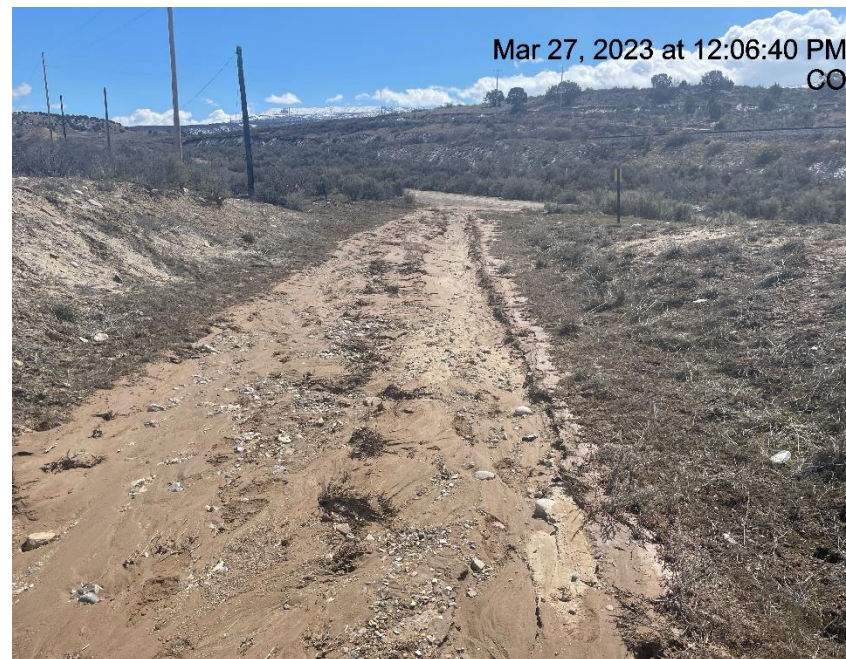
**Photo # 3393 Rill erosion & transport of sediment on spur road**

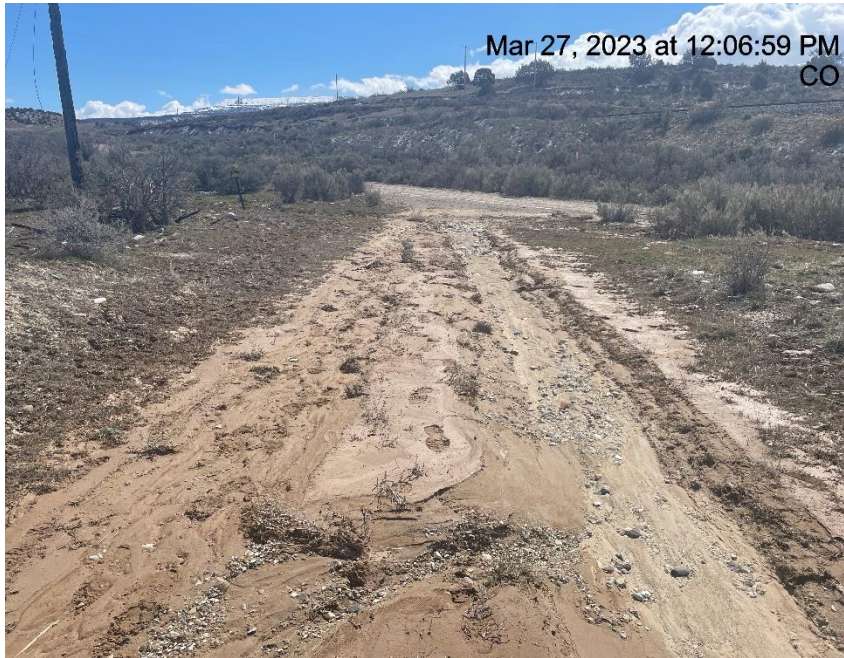
**Photo # 3394 Rill erosion & transport of sediment on spur road**
