Inspection Photos

API: 071-07085

Operator: EVERGREEN NATURAL RESOURCES

Inspection Date: 3/27/2023

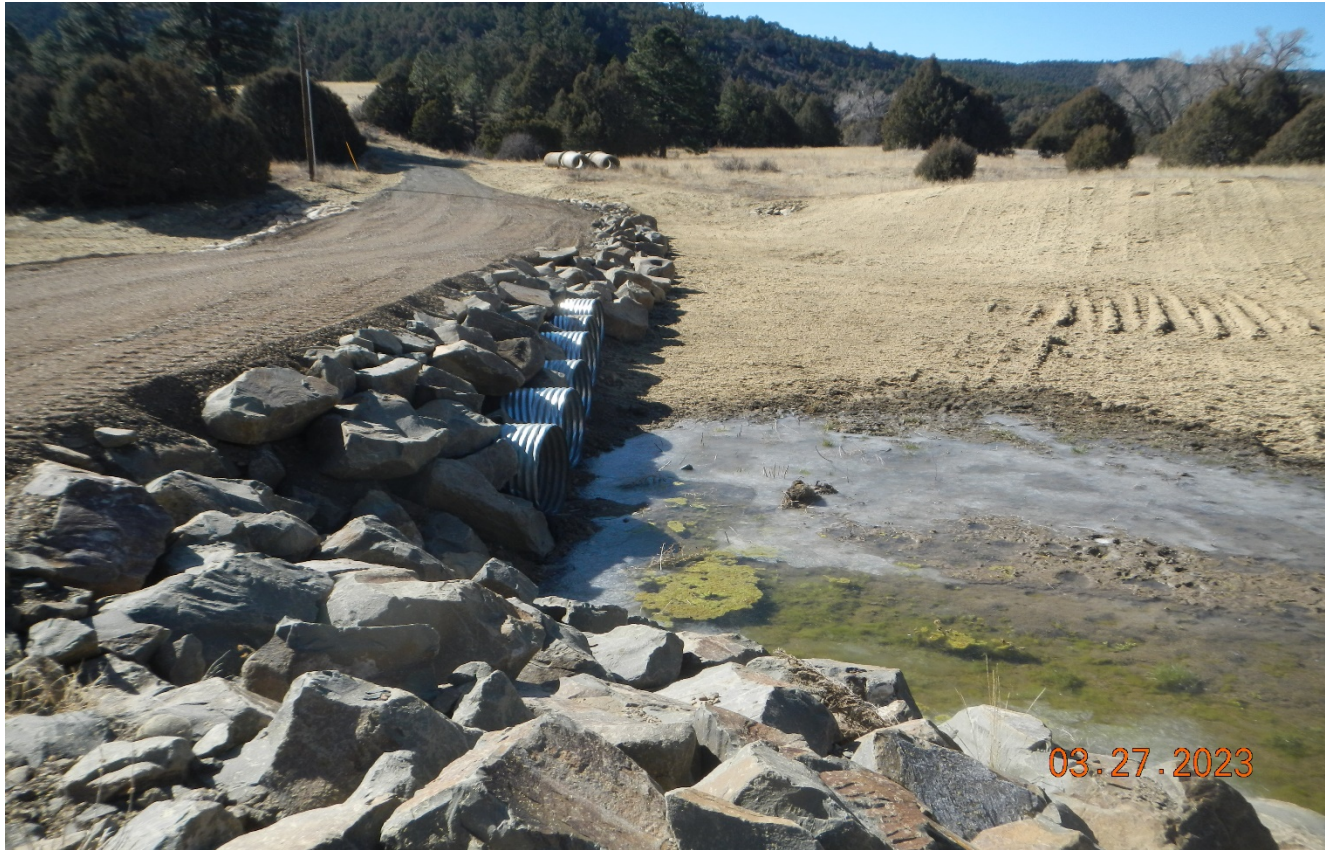
Photo 1. Facing south toward the access road stream crossing. There has been additional culverts installed and the embankment has been armored with rock rip/rap protection. Previous corrective action has been completed.

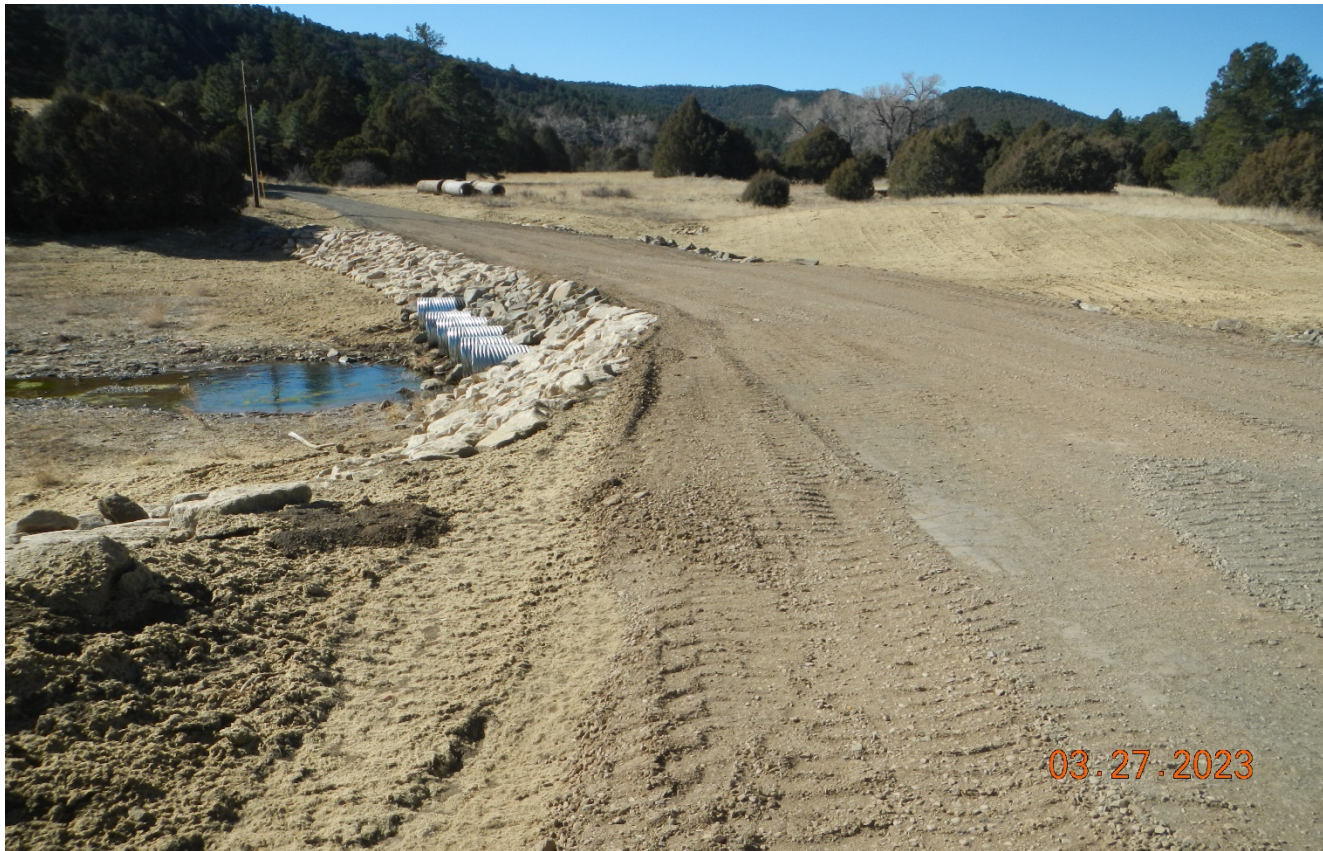
Photo 2. Facing south toward the access road stream crossing outlet side.

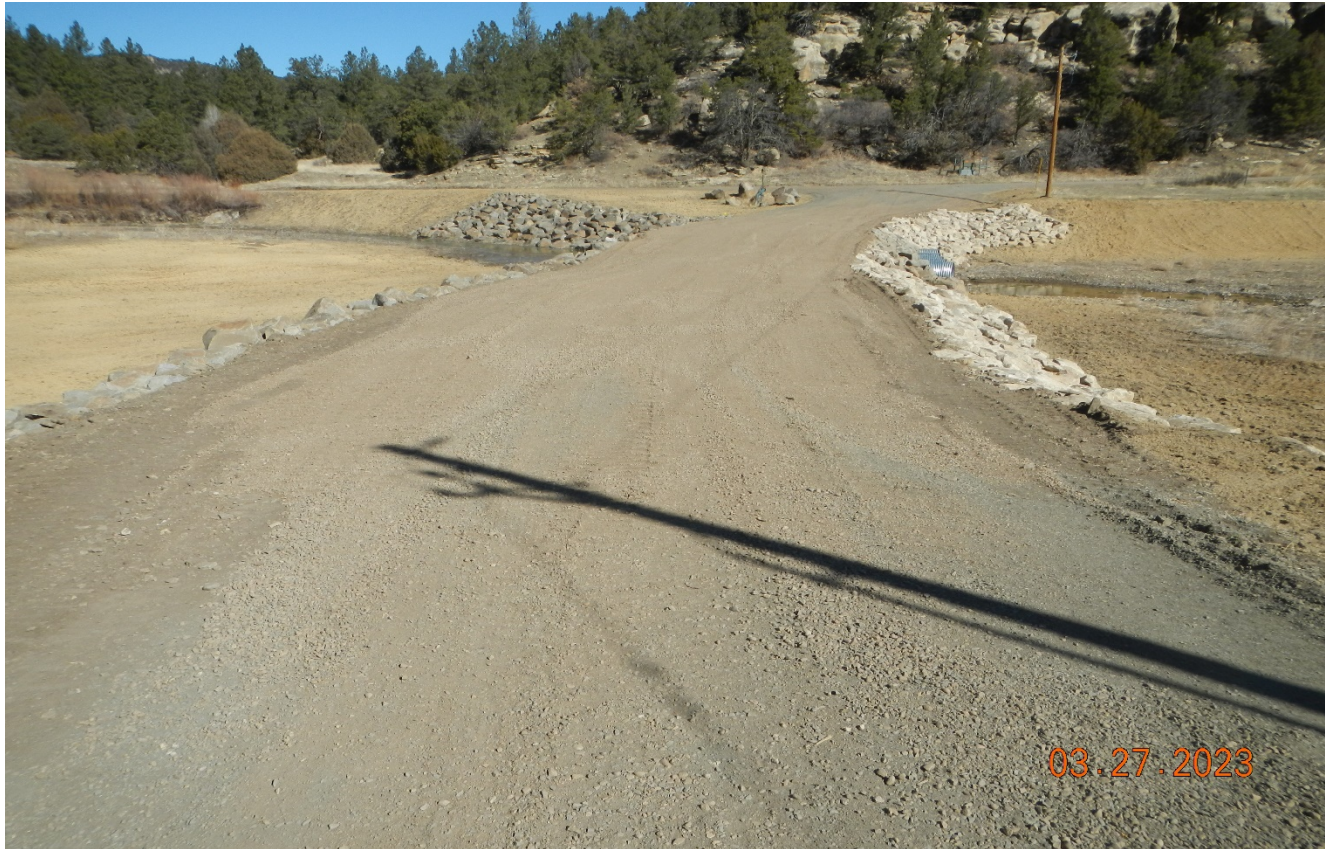
Photo 3. Facing northwest toward the access road stream crossing.

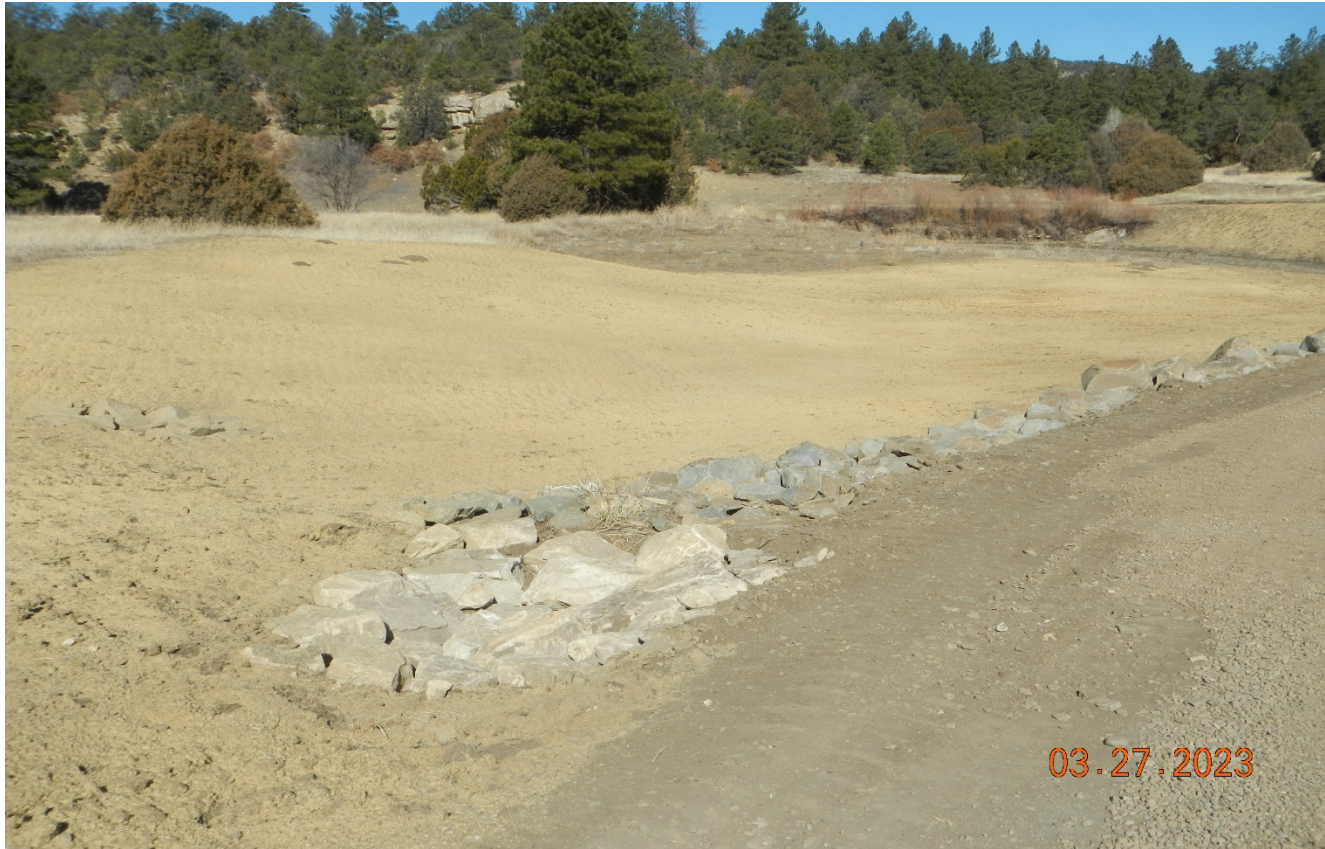
Photo 4. All disturbed areas along the road side have been seeded and stabilized.

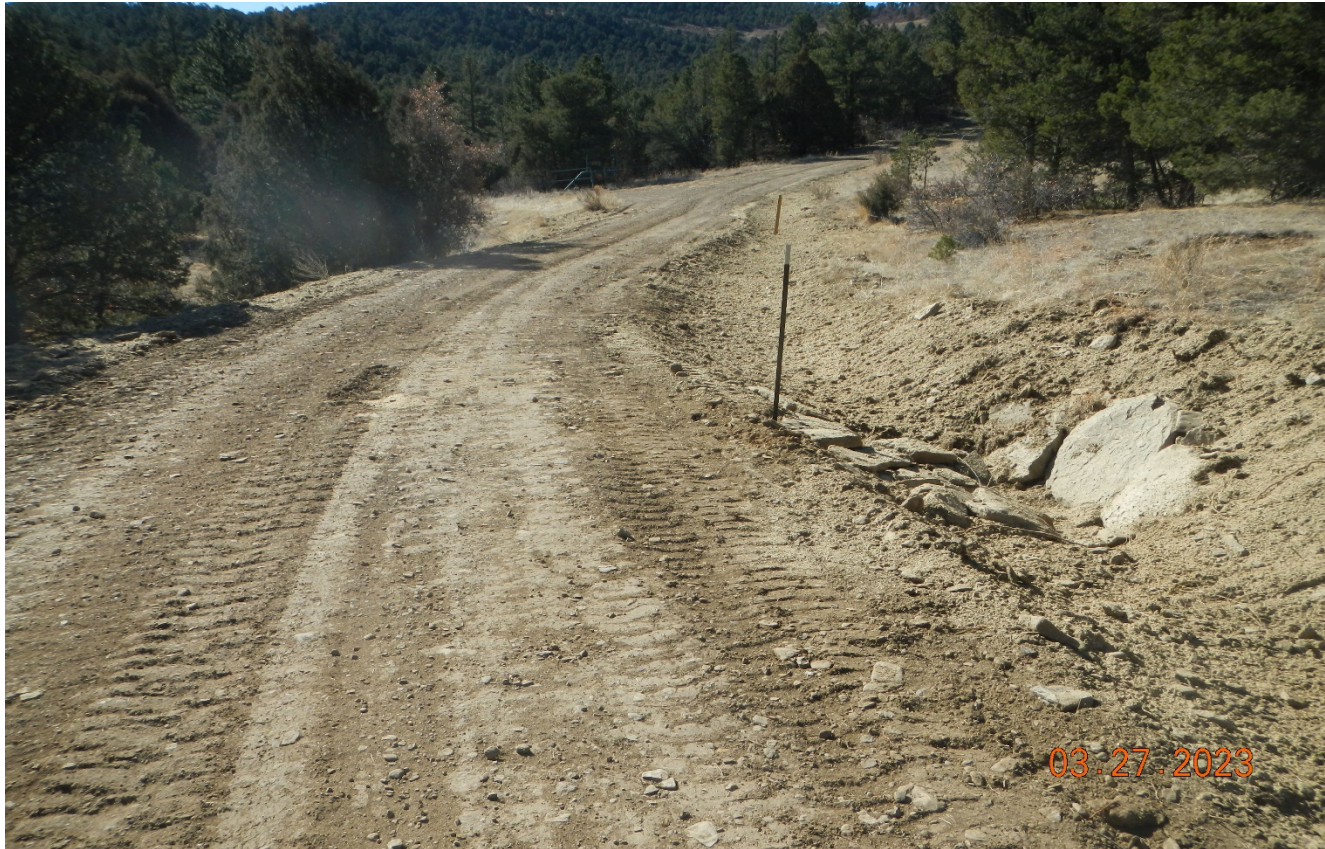
Photo 5. Facing southeast along the access road. The road side has been seeded and stabilized. The culverts are maintained.

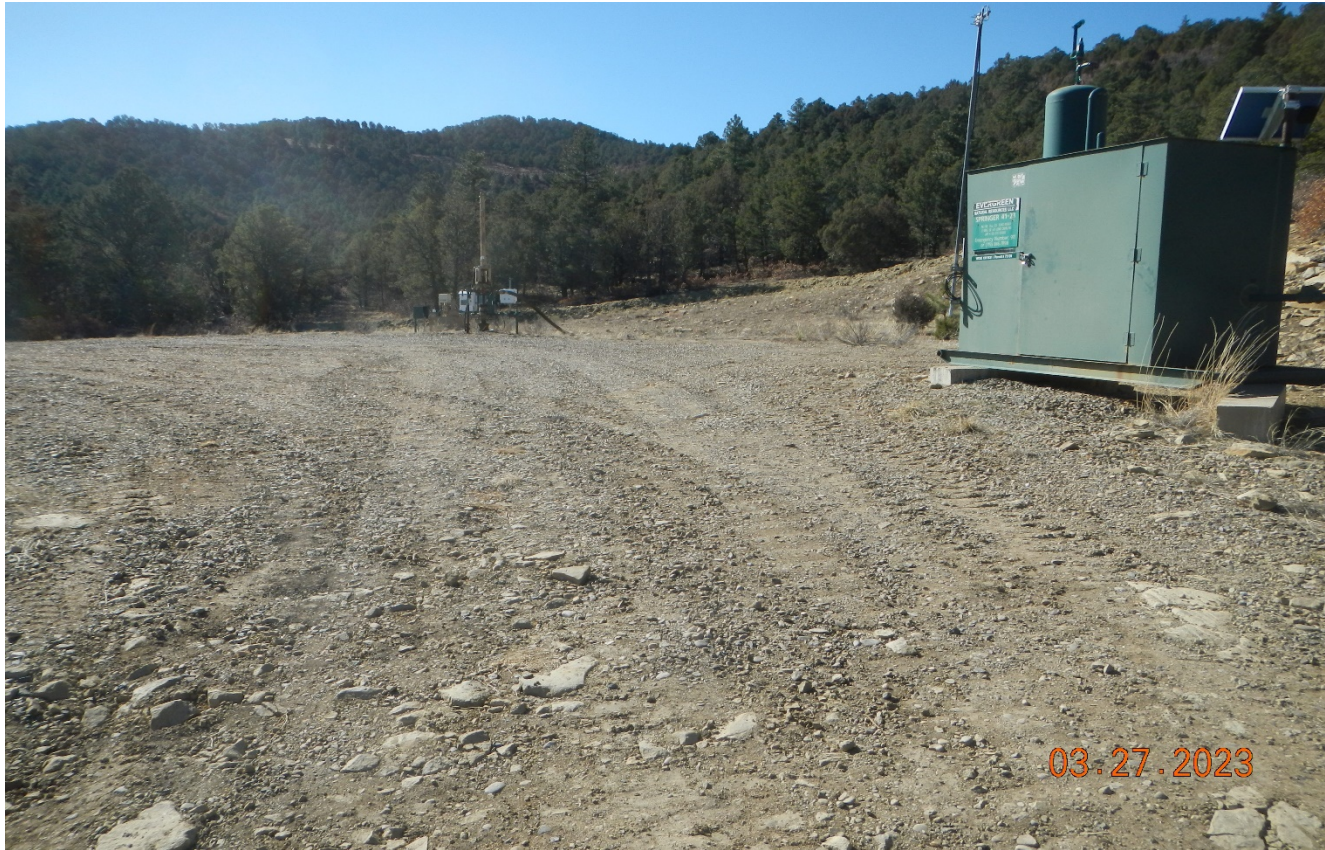
Photo 6. Facing southeast toward the well site.
