Inspection Photos
Location Name: Firecracker
Spill ID: 481413

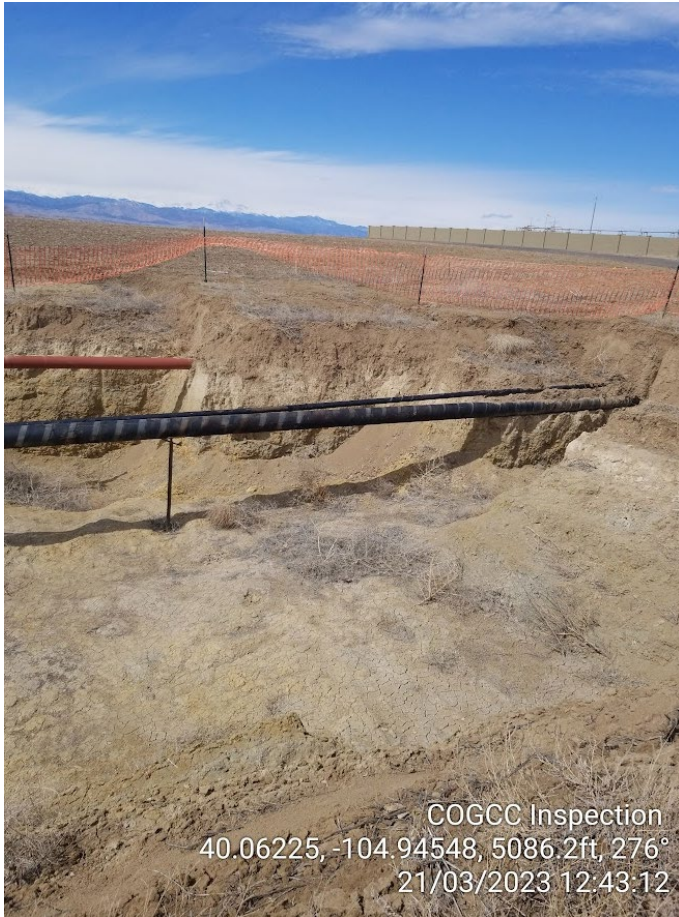
Photo 1 – Excavation- note fencing blowing in background

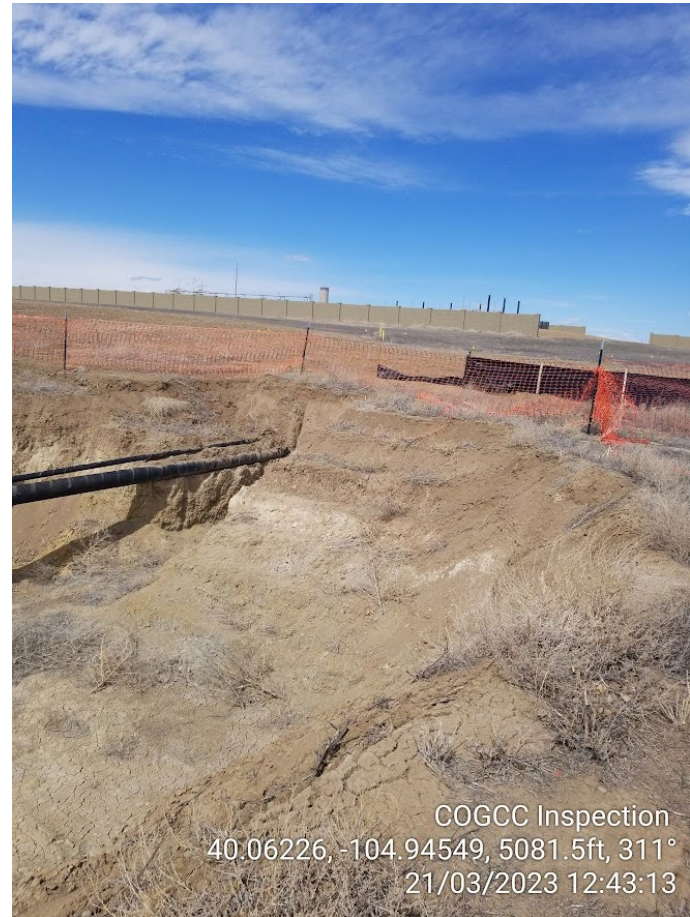
Photo 2 – Excavation- note silt fence failing in background

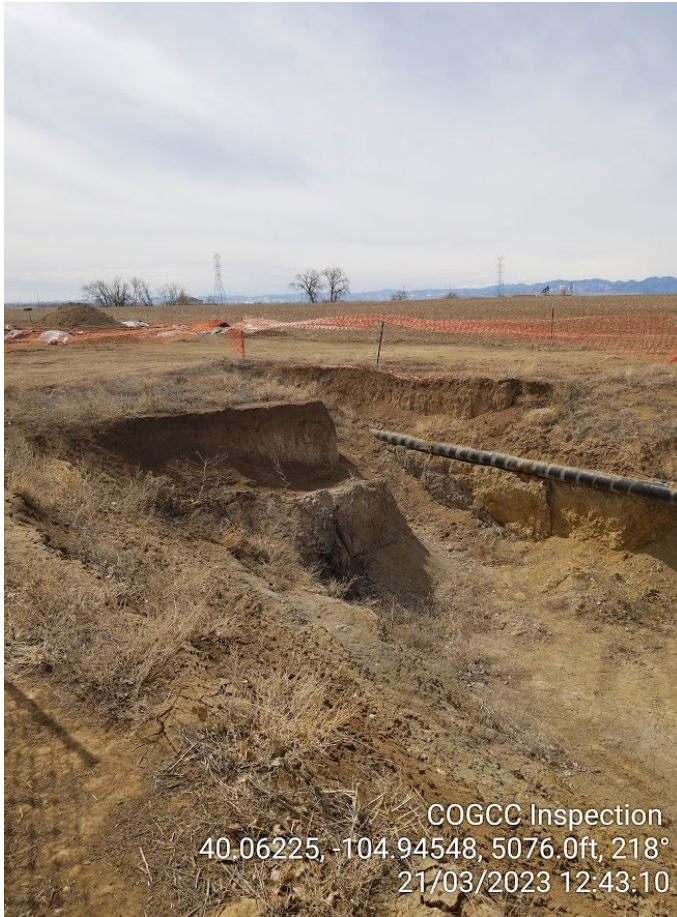
Photo 3 – Excavation- note fencing blowing in background

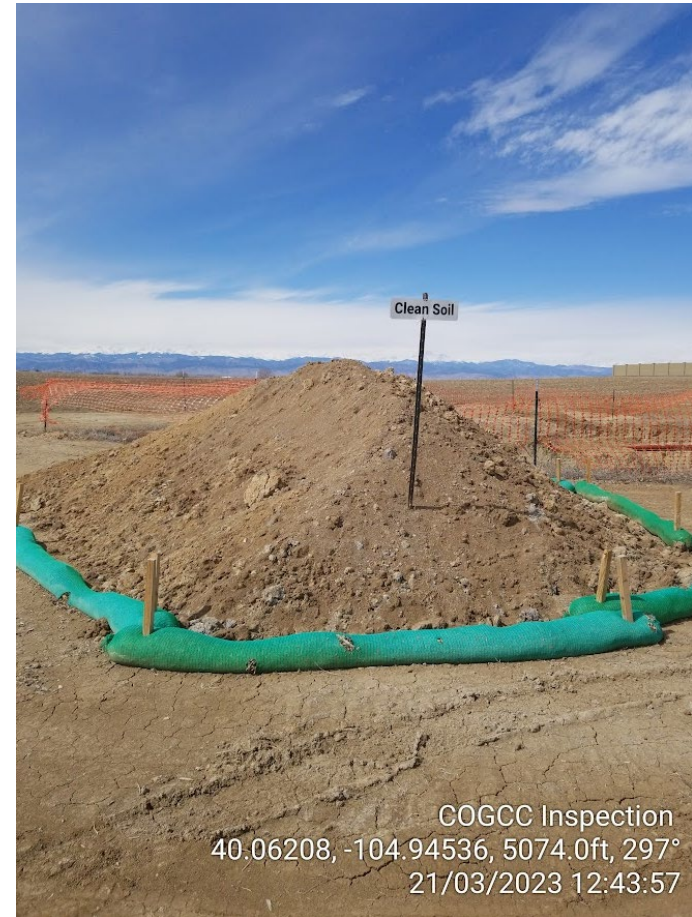
Photo 4 – Clean soil stockpile- note fencing blowing in background

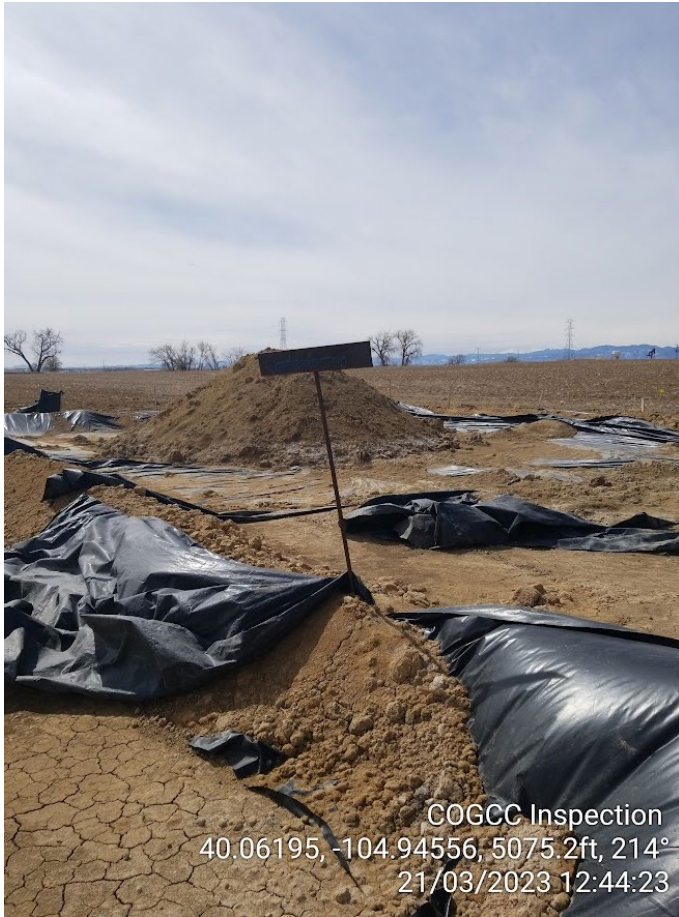
Photo 5 – Contaminated soils stockpile

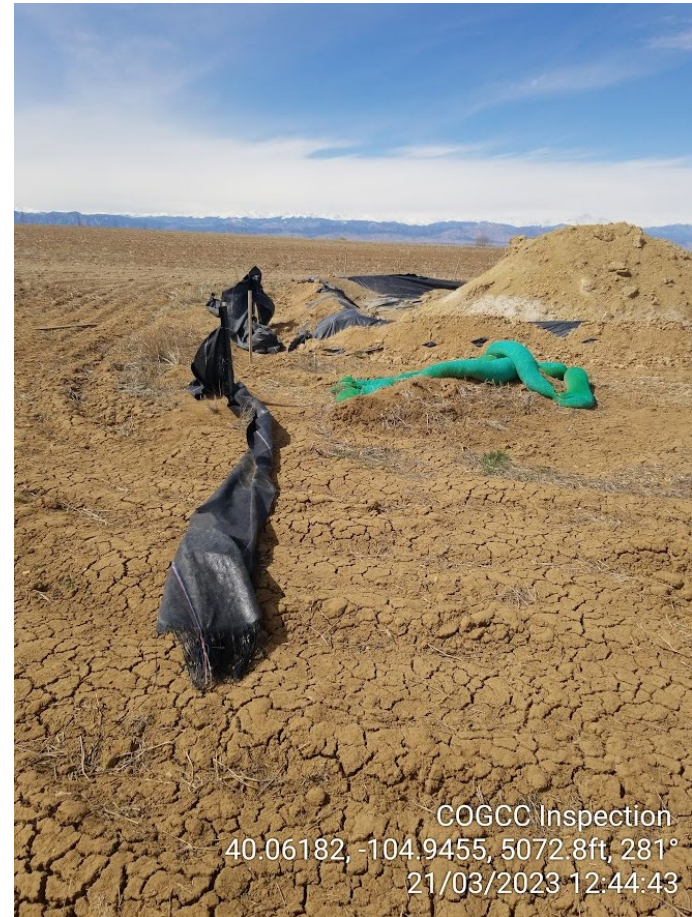
Photo 6 – Failed stormwater BMPs and trash

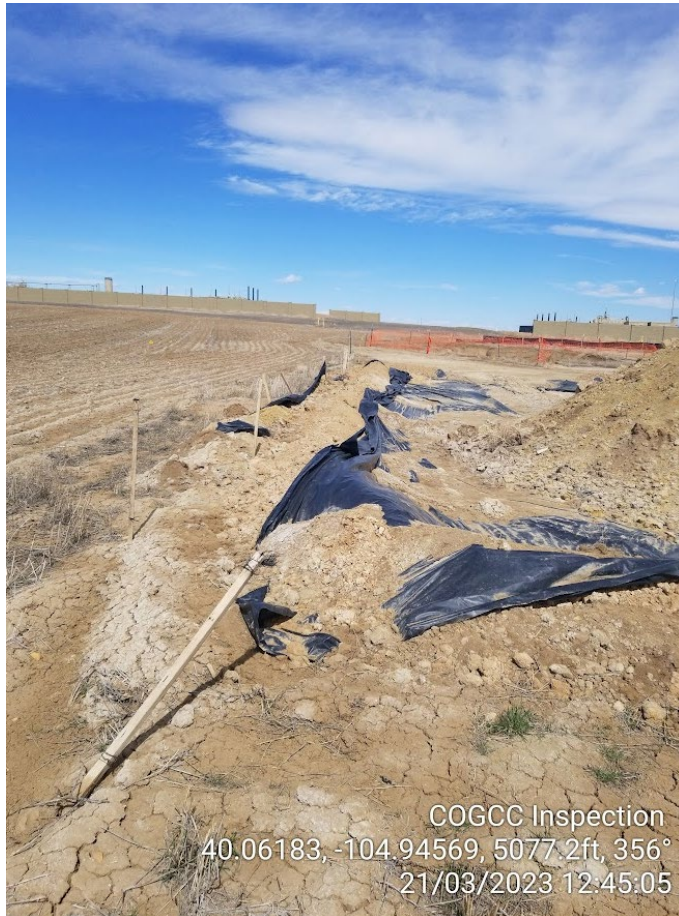
Photo 7 – South Excavation Failed stormwater BMPs and contaminated soils overtopping berm.

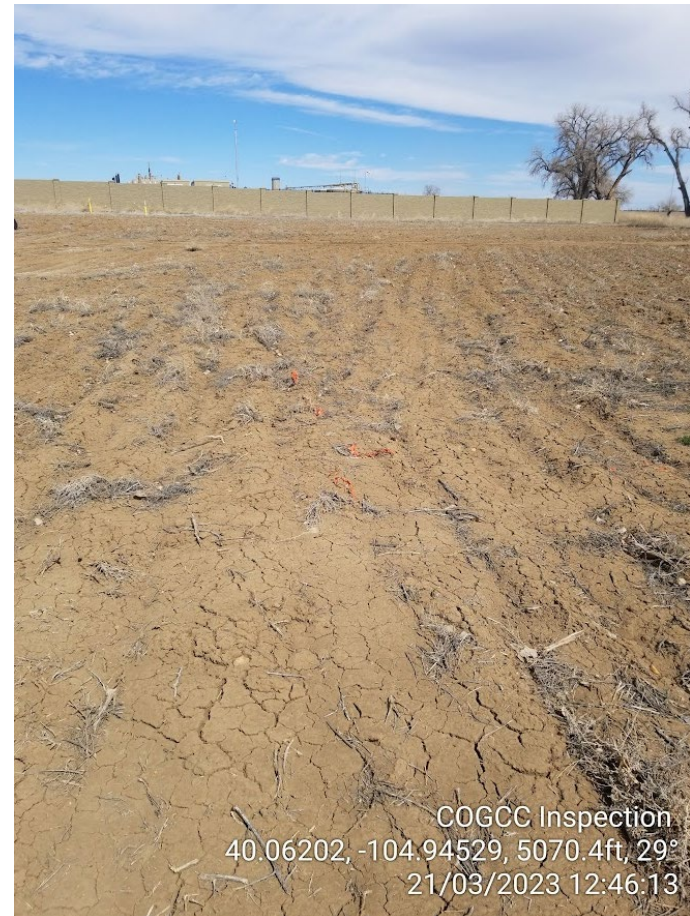
Photo 8 – Fencing has degraded and become windblown trash in neighboring fields.
