Inspection Photos

Location Name: TEP ROCKY MOUNTAIN LLC CLOUGH RMV 96-28 Pad

Location ID: 335122

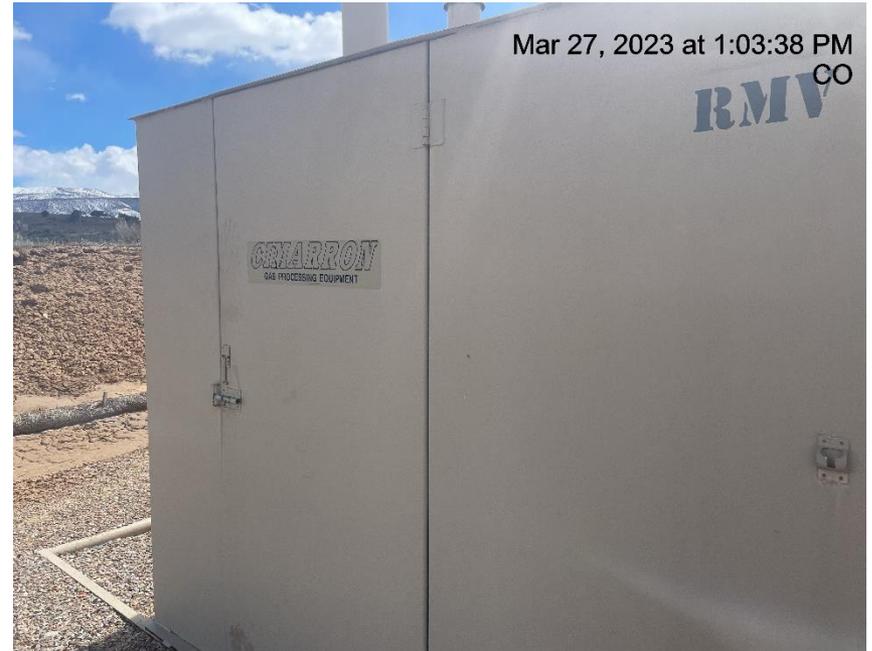
Photo # 3429 Meter calibration info not conspicuously posted

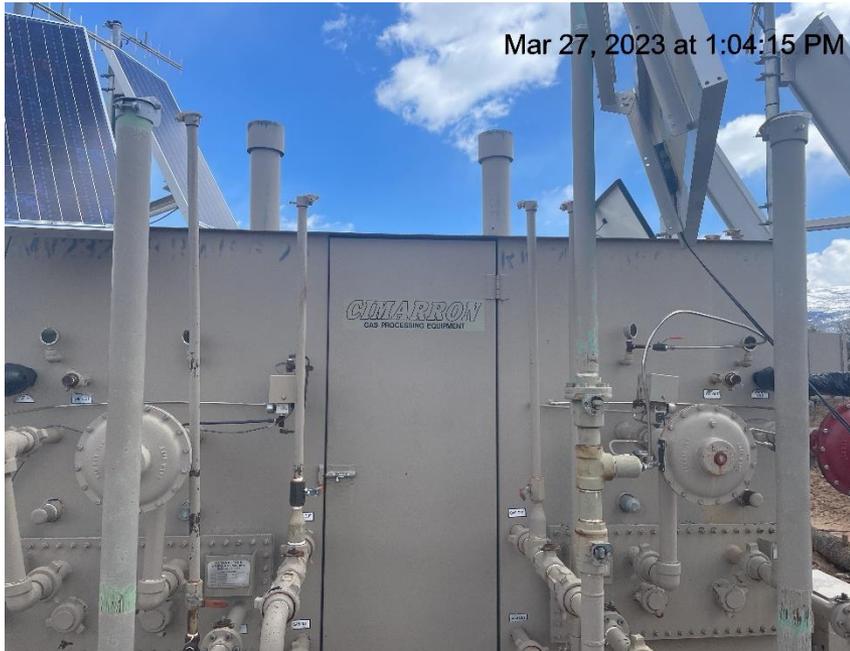
Photo # 3430 Meter calibration info not conspicuously posted

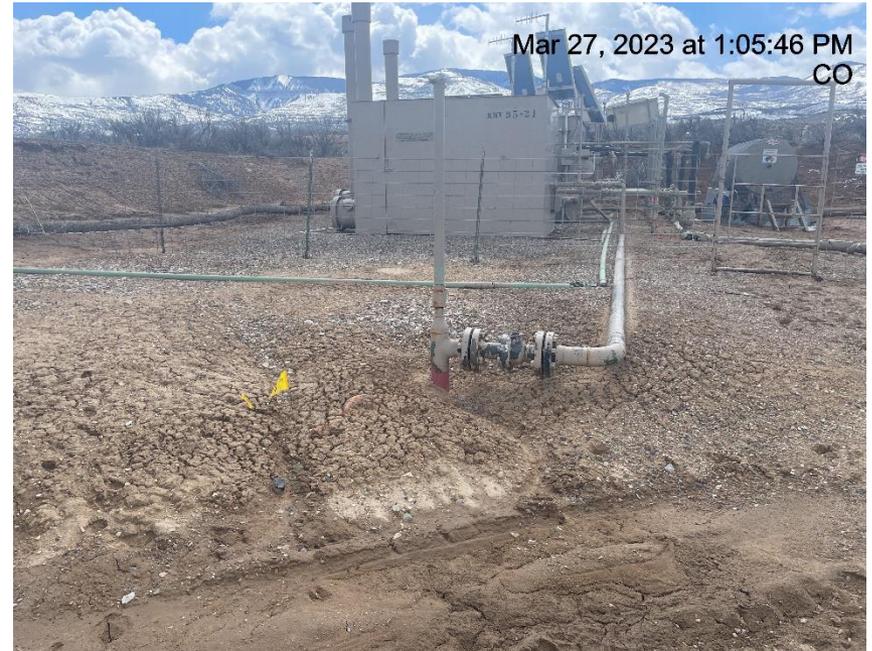
Photo # 3432 Rill erosion

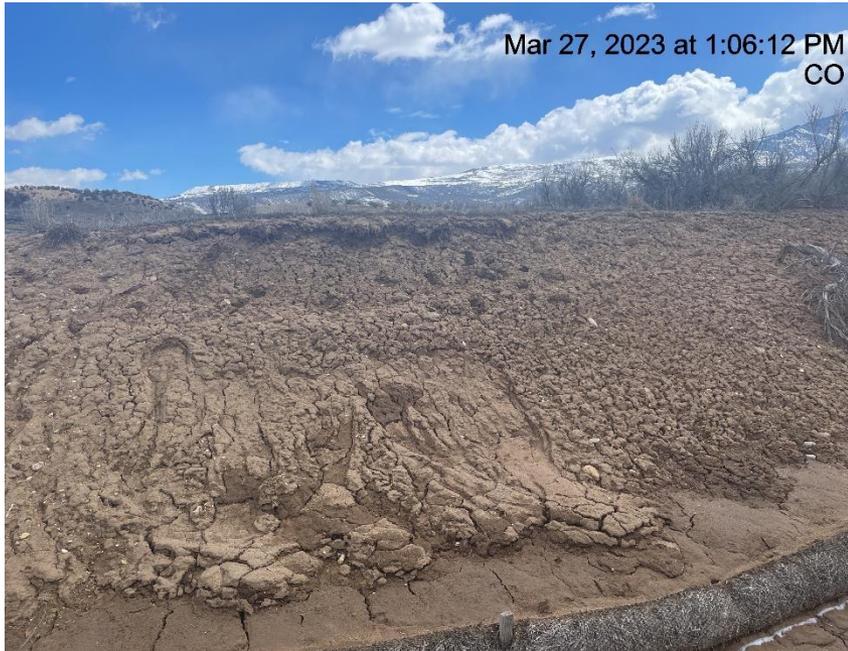
**Photo # 3433 Lack of stabilization & erosion of cut slope/
insufficient BMP's**

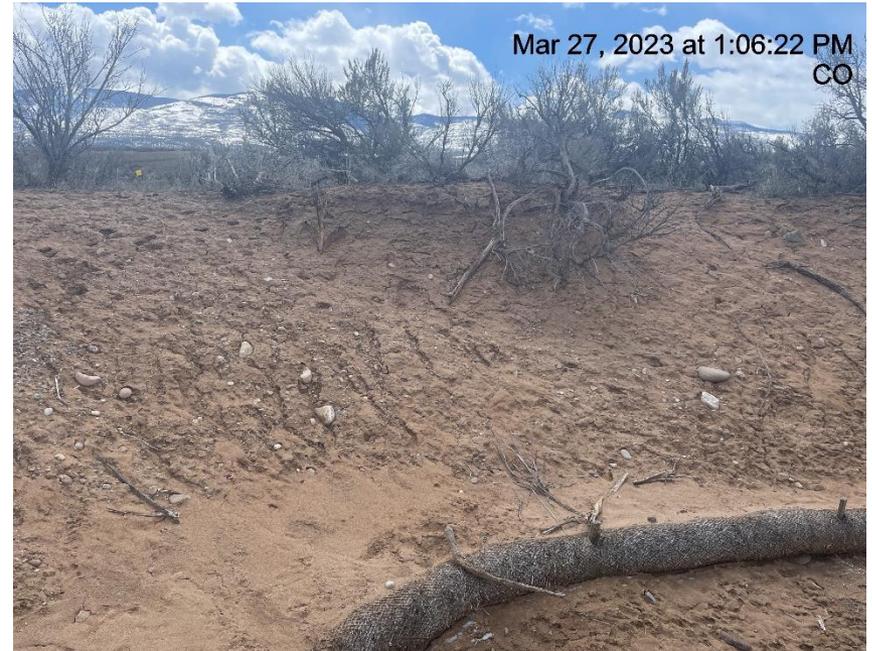
**Photo # 3434 Lack of stabilization & erosion of cut slope/
insufficient BMP's**

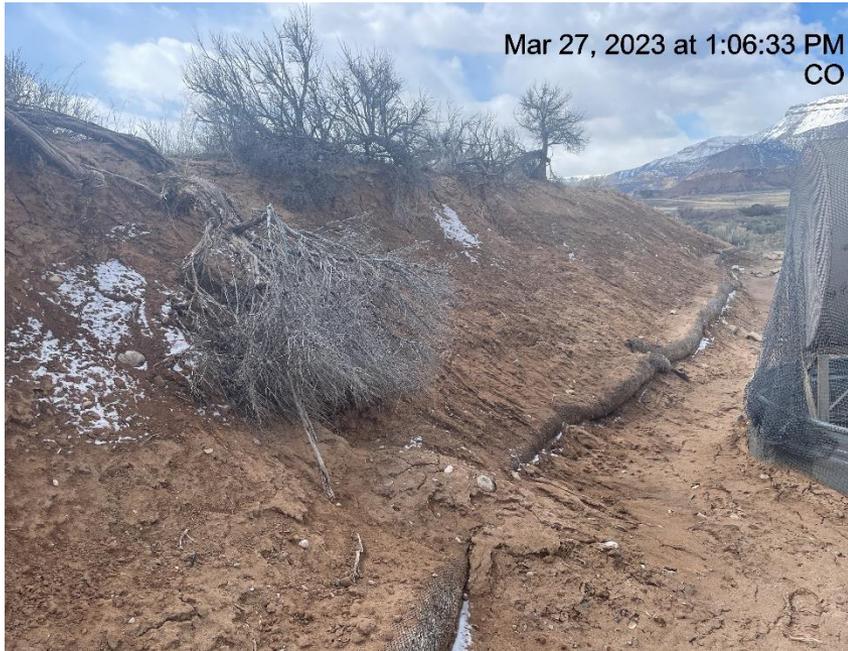
Photo # 3435 Lack of stabilization & erosion of cut slope /insufficient BMP's & insufficient run on controls/BMP's

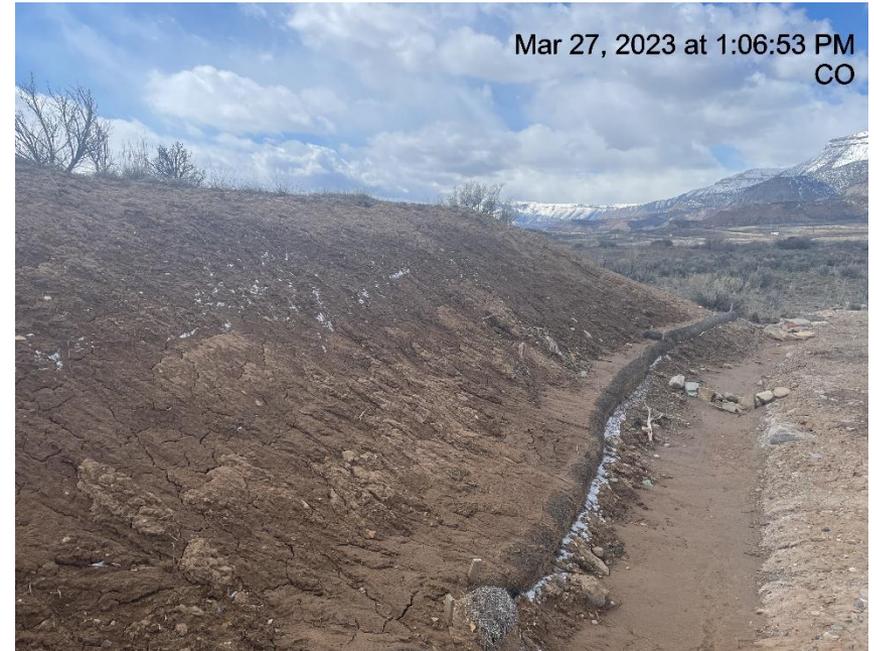
Photo # 3436 Lack of stabilization & erosion of cut slope/ insufficient BMP's & insufficient run on controls/BMP's

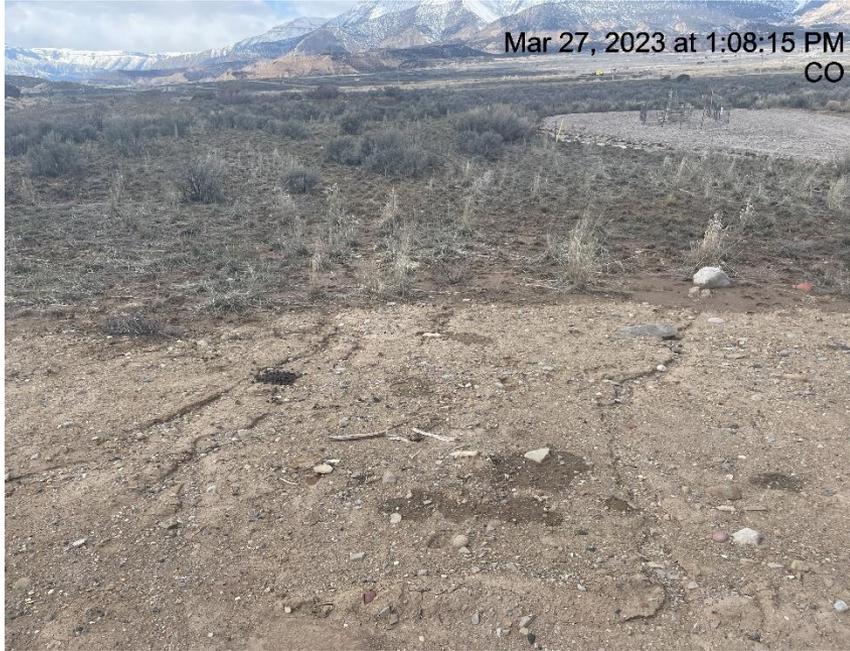
Photo # 3439 Rill erosion/transport of sediment off location

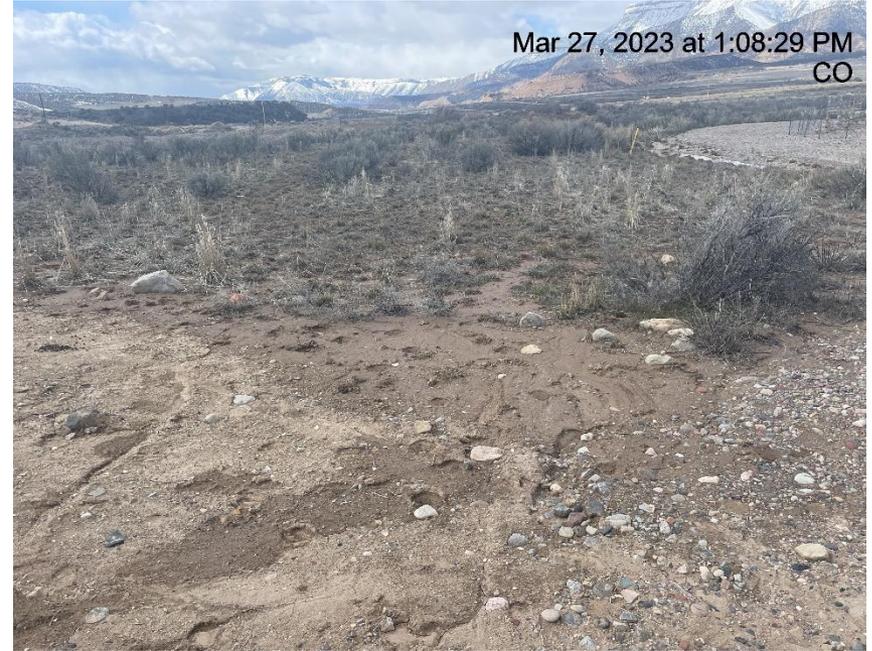
Photo # 3440 Rill erosion/transport of sediment off location

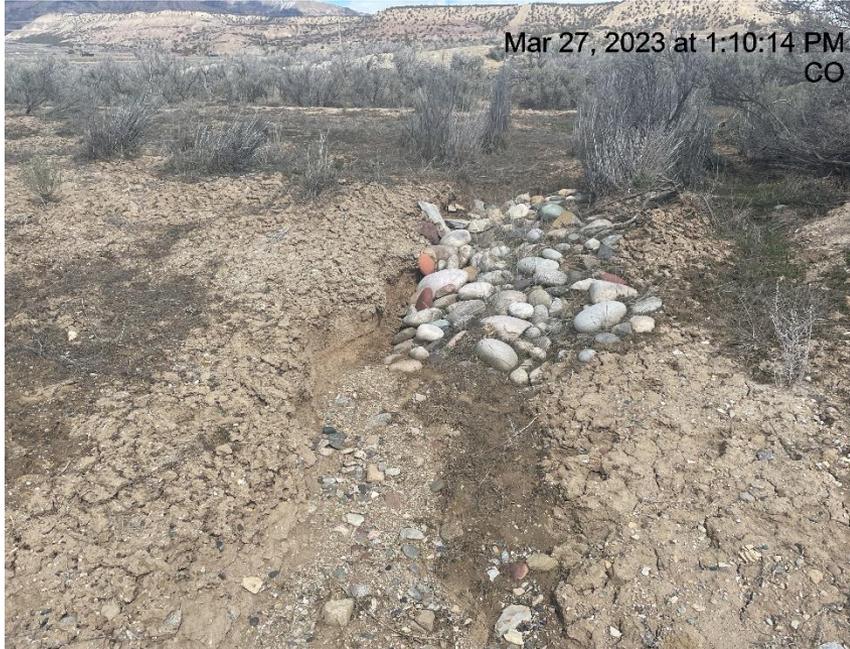
Photo # 3442 Rip Rap needs maintenance (NW area of location across from wellheads)

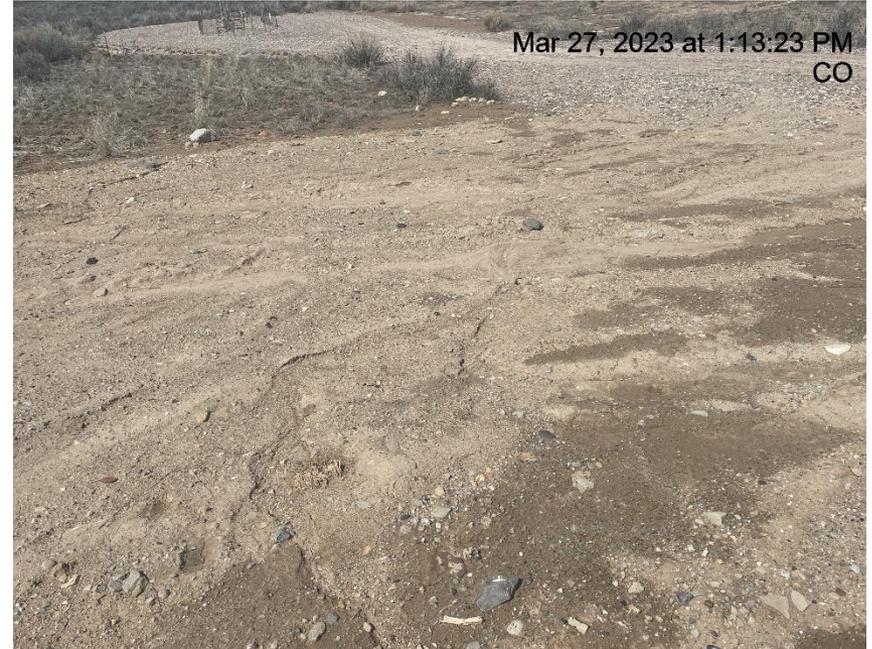
Photo # 3445 Rill erosion

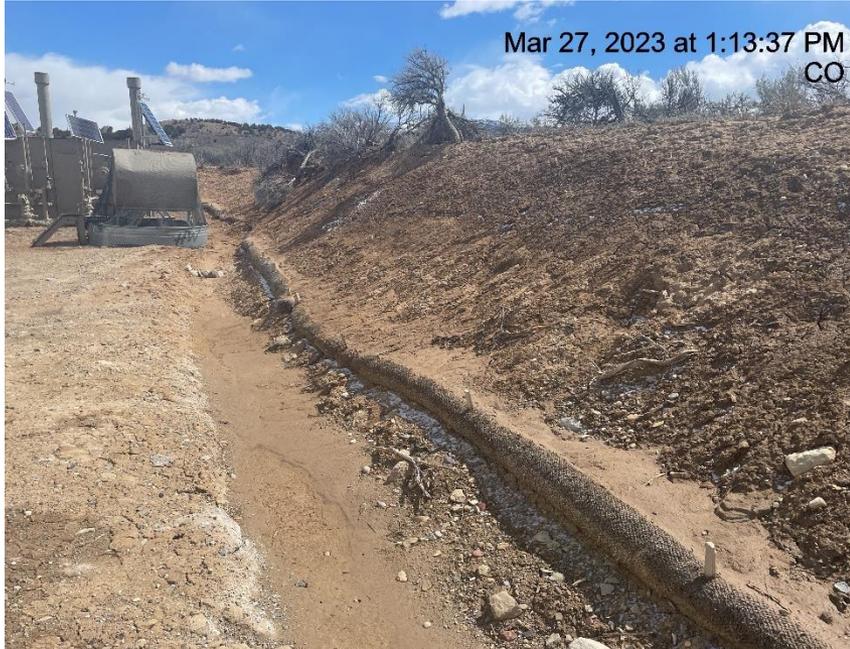
Photo # 3446 Insufficient run on controls/BMP's
