Final Reclamation and Stormwater Inspection

Operator: P O & G OPERATING LLC - 10634

Location ID: 324938 & 463250

Inspection Document #: 708200072

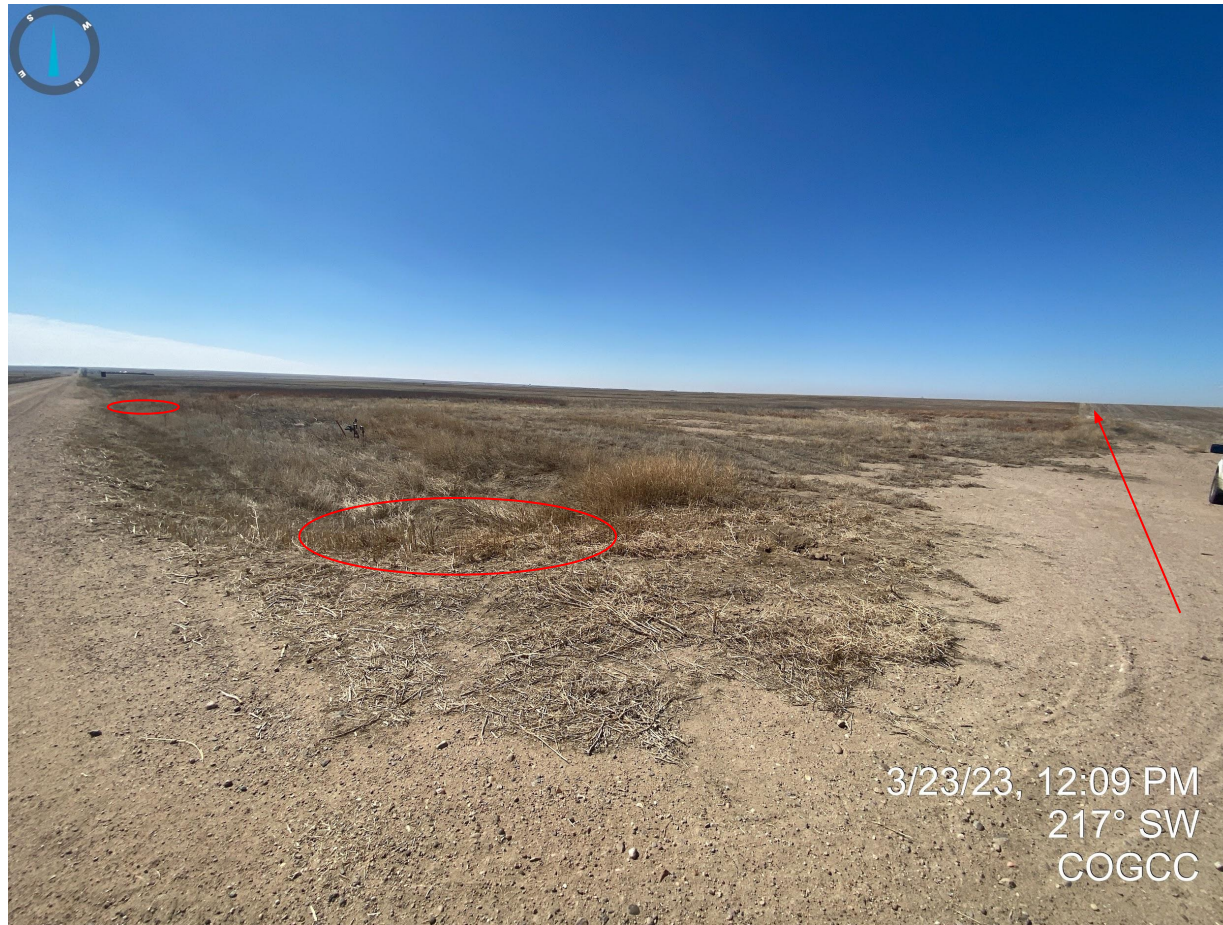
Photo 1. Facing southwest at location entrance. Photo provides an overview of the location in its present state, at the time of inspection. It does not appear any reclamation work has been attempted since the last inspection on 08/28/2019 (Doc #696200704). Culvert and access road remain, highlighted in red.

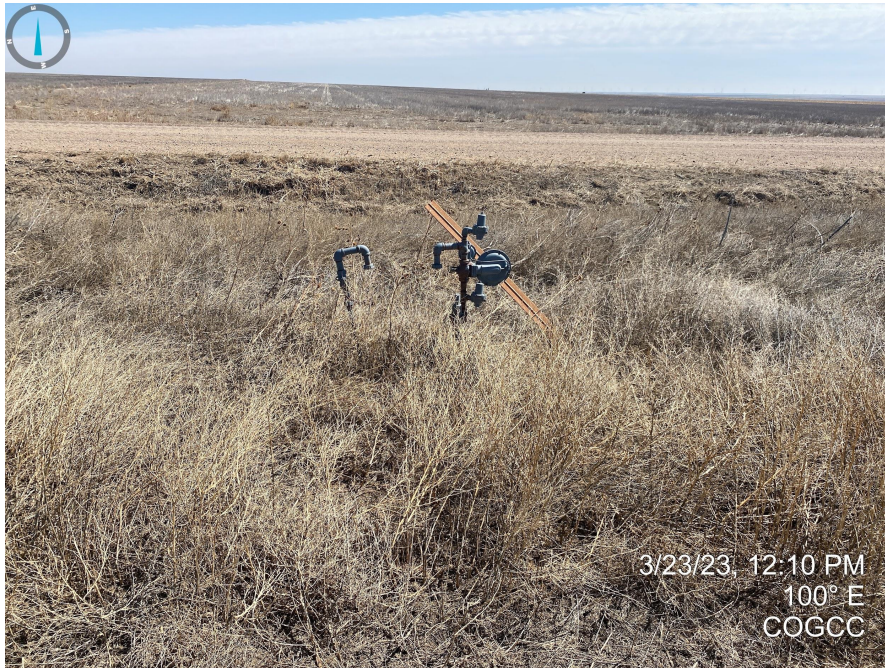
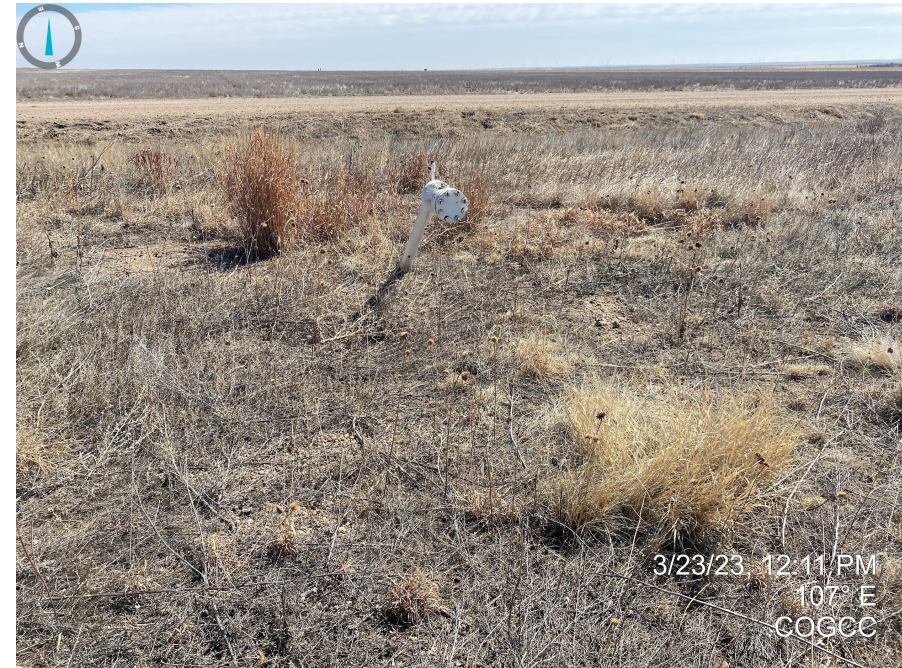
Photos 2 & 3. Facing east from the eastern portion of the location. Photo illustrates that equipment remains on location and has not been removed as part of the reclamation process, as mentioned in previous inspections. The equipment needs to be removed regardless of ownership.

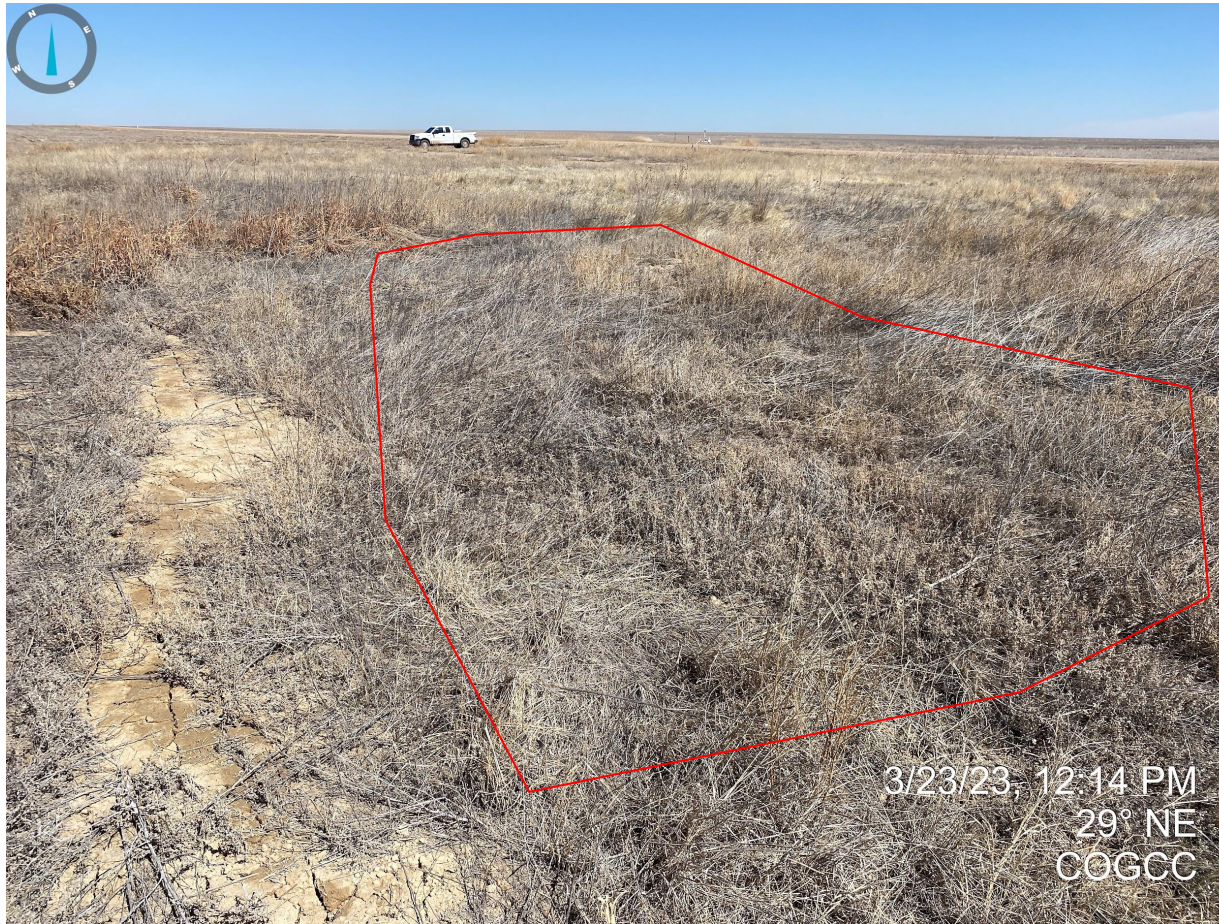
Photo 4. Facing northeast from the southwestern portion of the location. Photo illustrates subsidence (red) and presence of undesirable vegetation (e.g. kochia) observed near the former tank location.

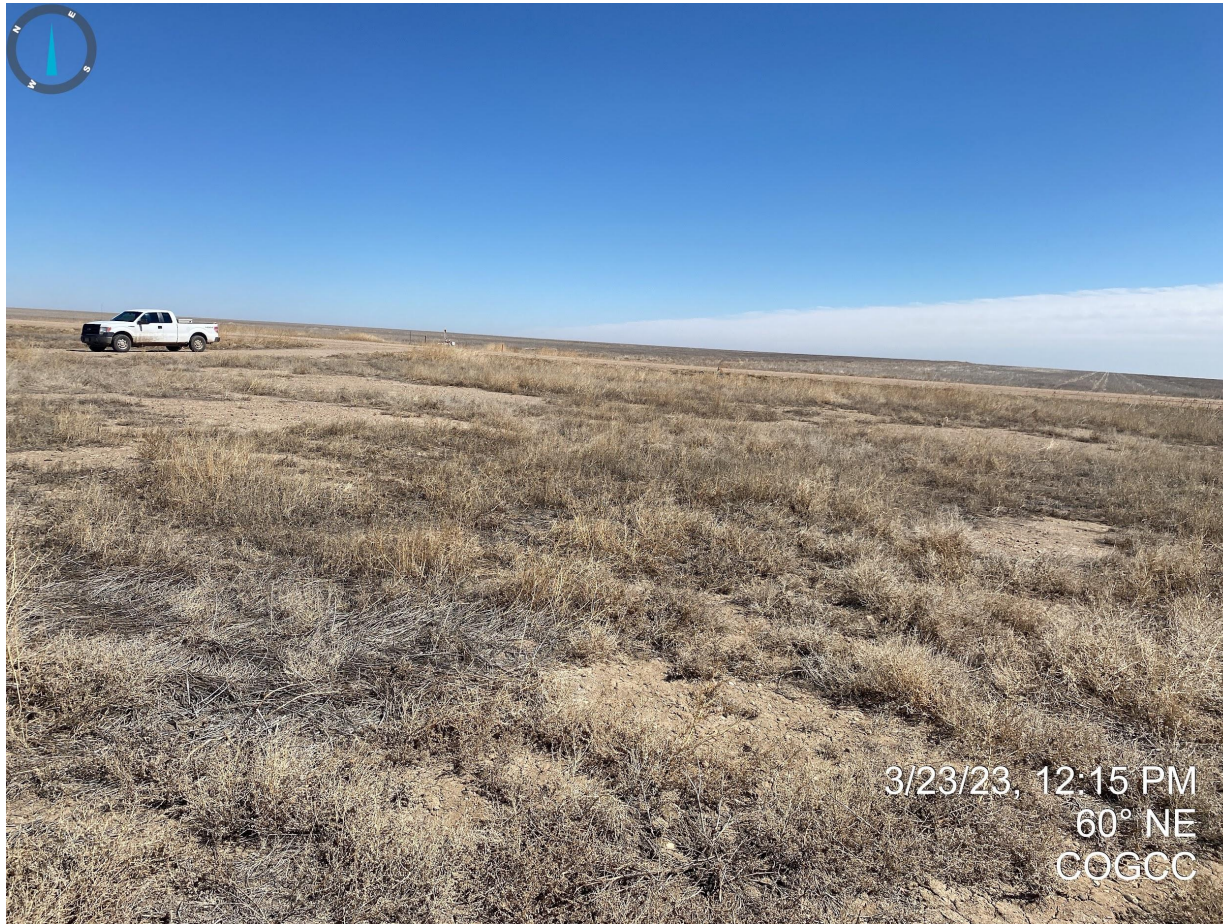
Photo 5. Facing northeast from the center/western portion of the location. Overview of location with presence of undesirable vegetation and bare areas where road base/gravel remains.

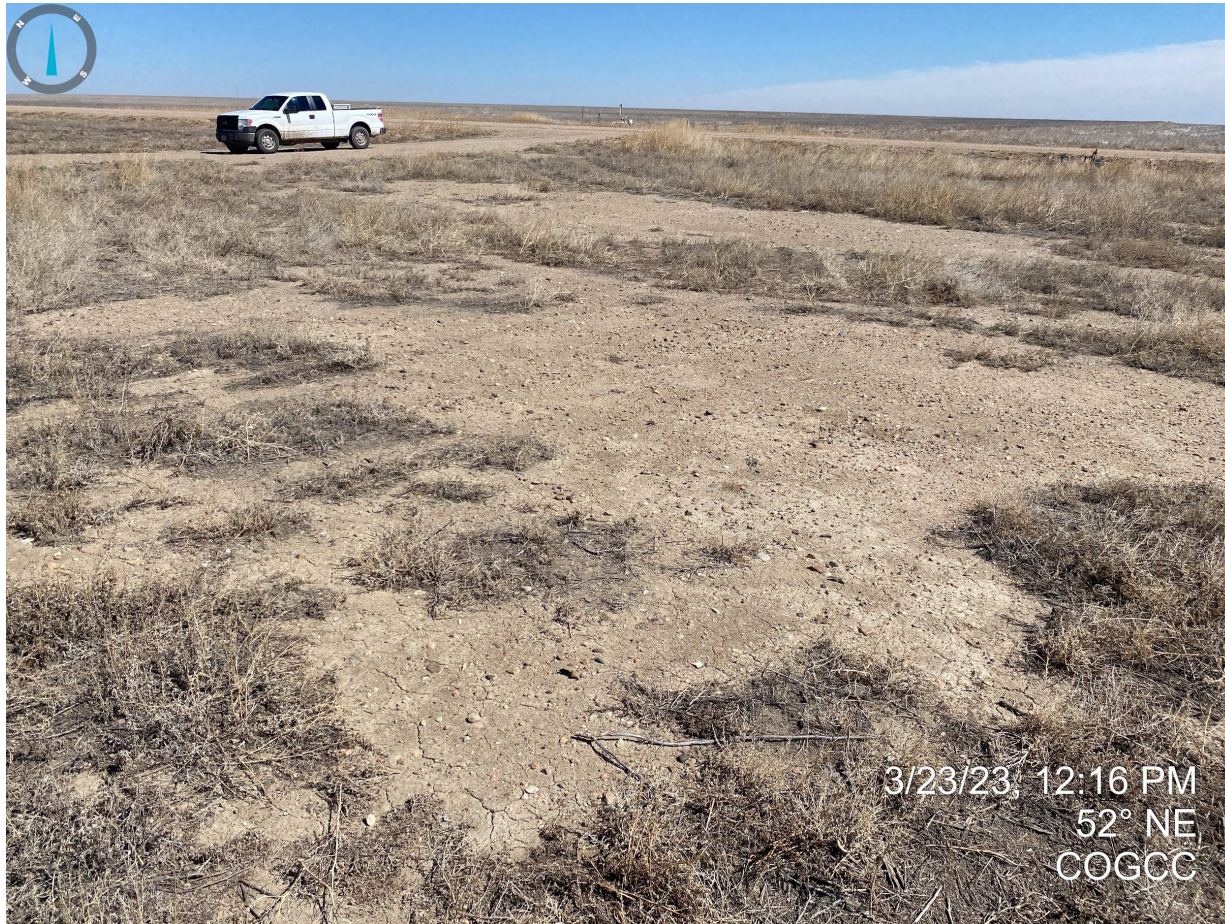
Photo 6. See comments in Photo 5.

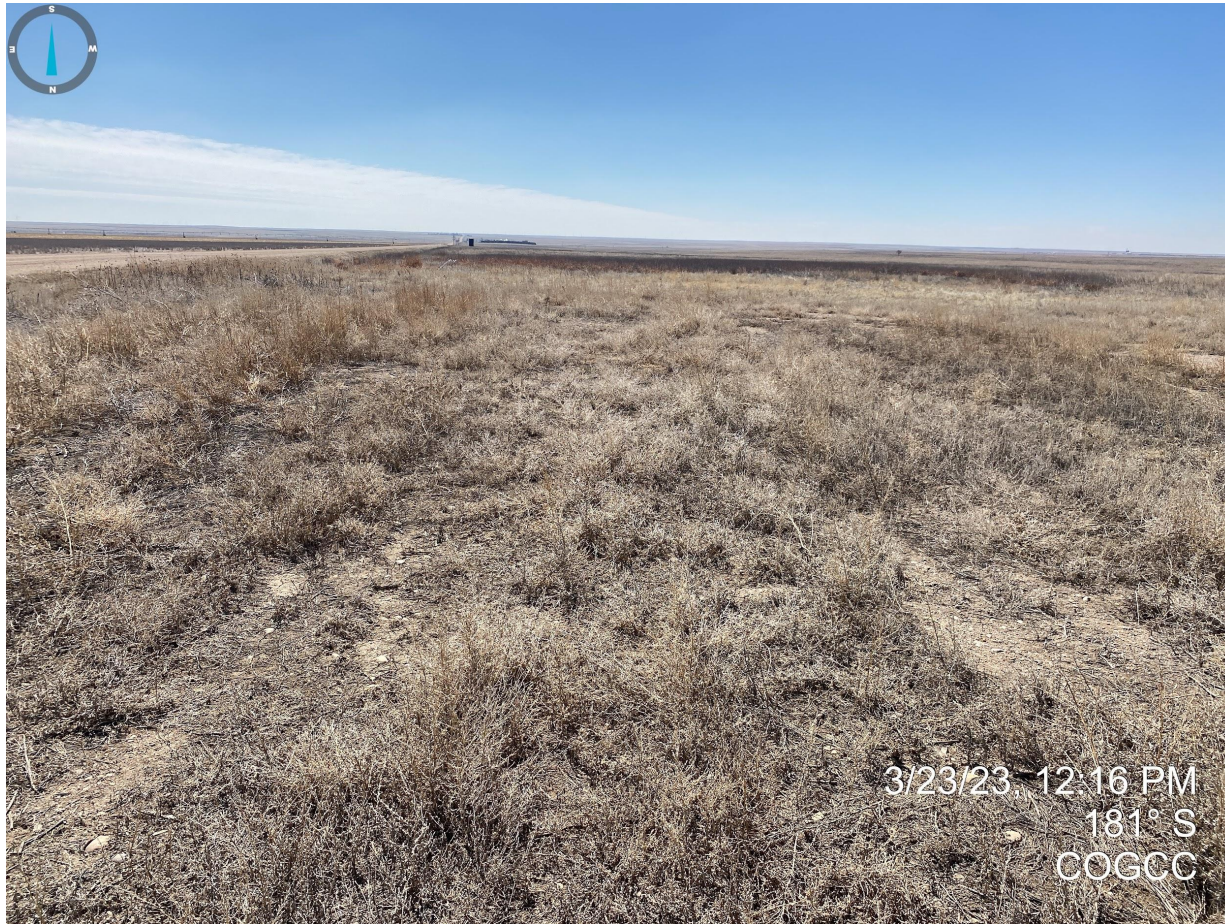
Photo 7. Facing south from approximate center of location. Location is predominantly undesirable vegetation (e.g. kochia).

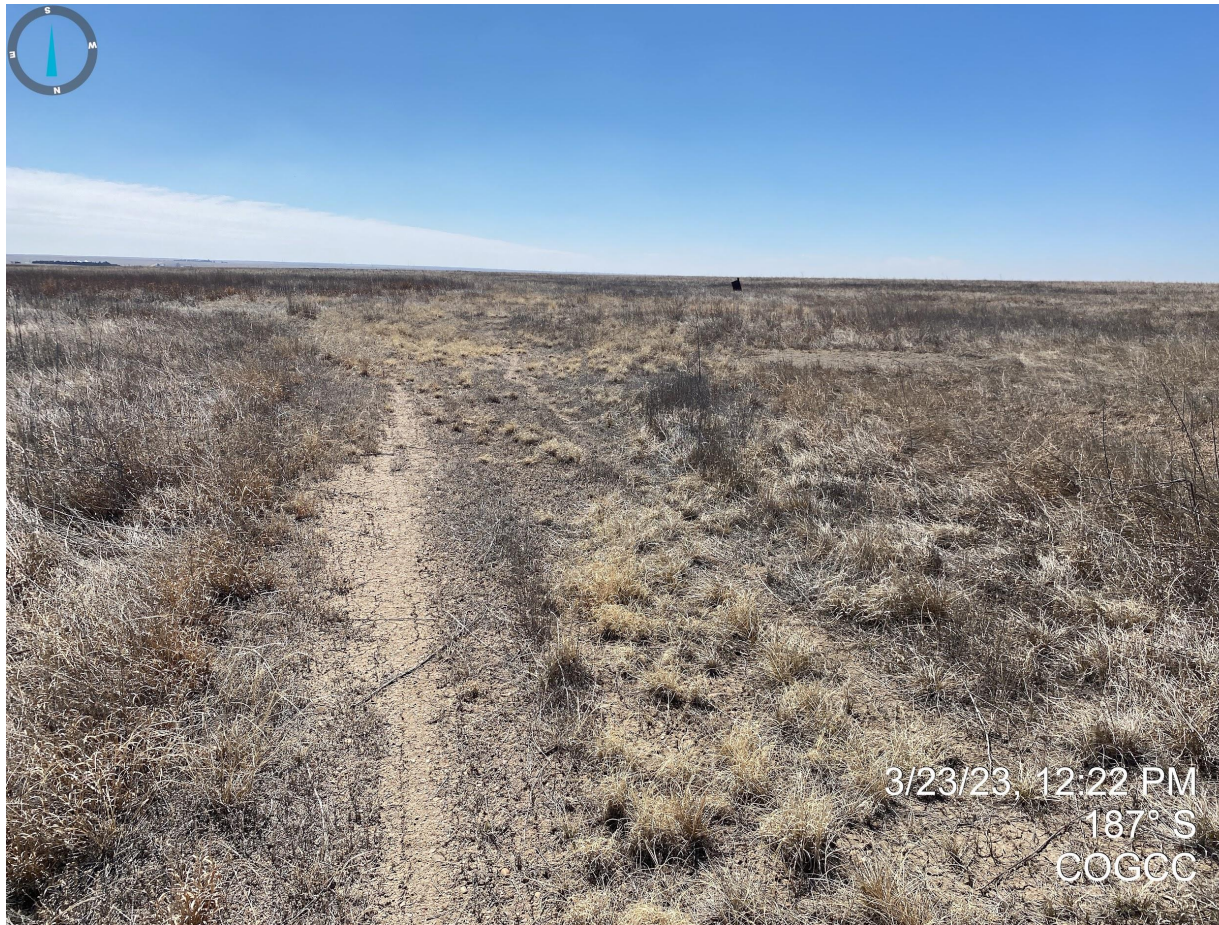
Photo 8. Facing south near PA well API 063-06192. Photo illustrates that the access road to the well has not been reclaimed with the presence of road base and gravel throughout.

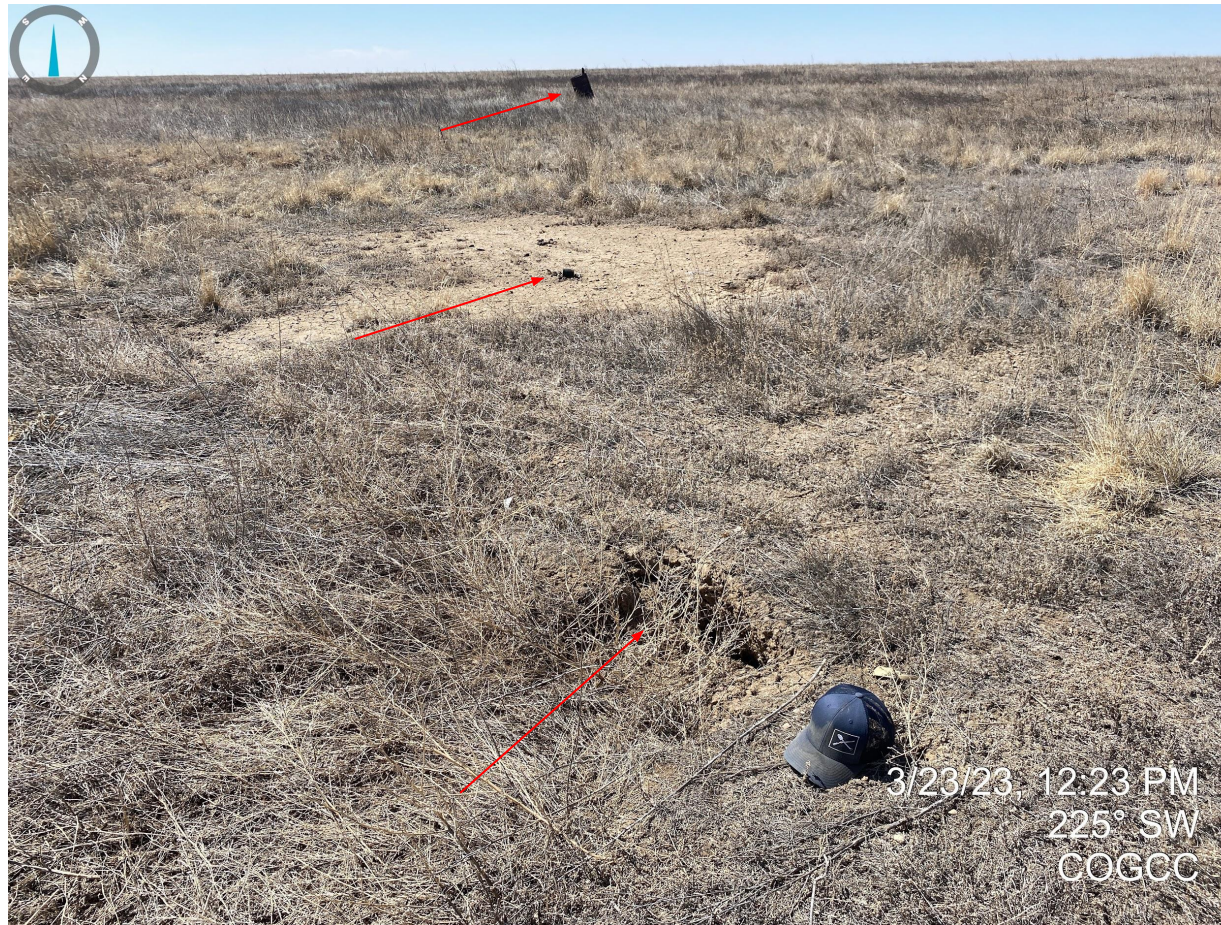
Photo 9. Facing southwest near the PA well. Subsidence (red) was observed in addition to undesirable vegetation, debris, road base/gravel, and equipment. It does not appear any additional reclamation work has been performed since the last inspection on 08/28/2019 (Doc #696200704).

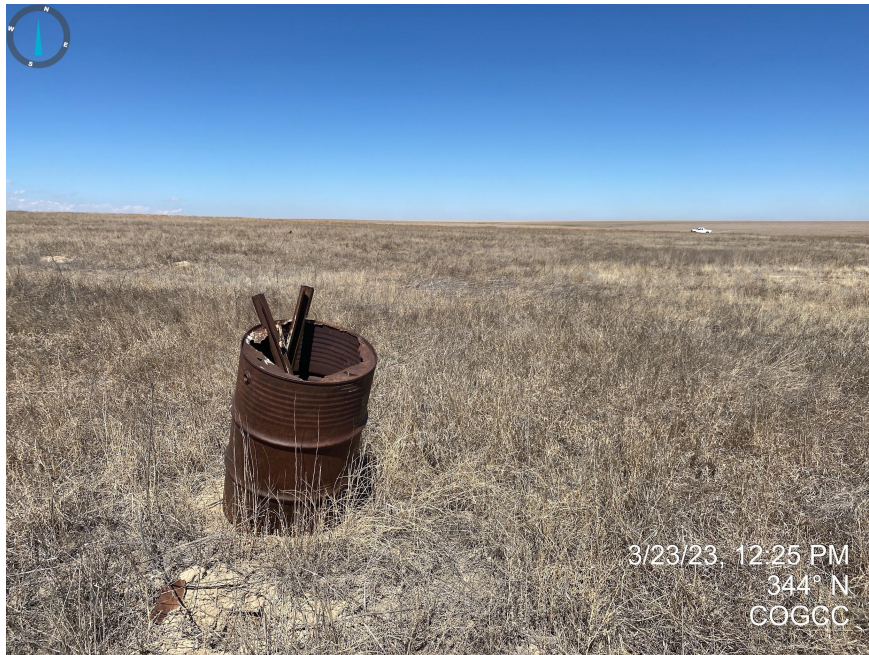
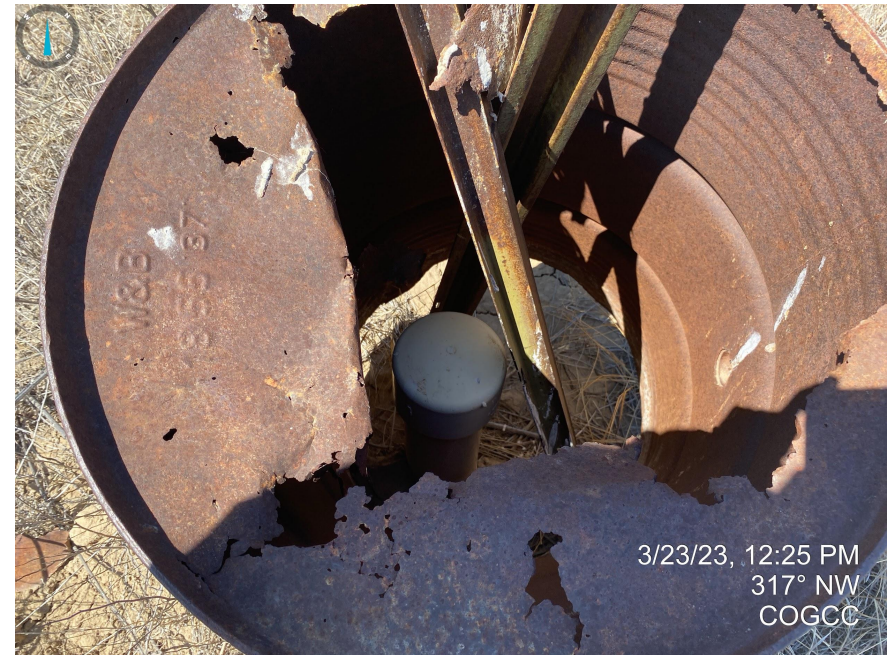
Photos 10 & 11. Equipment and debris observed on location that will need to be removed in addition to final reclamation activities.

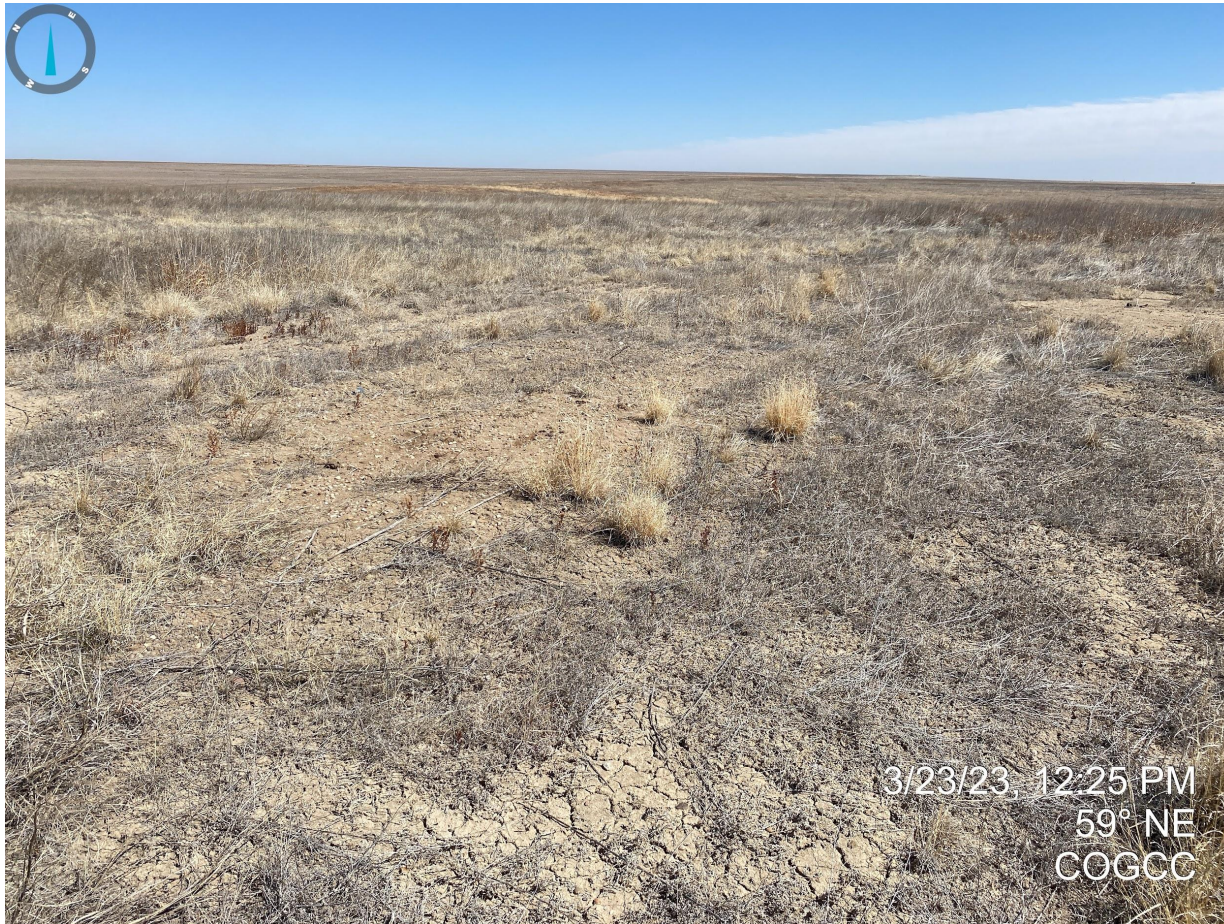
Photo 12. Facing northeast from the PA well. Photo illustrates that road base/gravel remain on location and presence of undesirable vegetation (e.g. kochia).

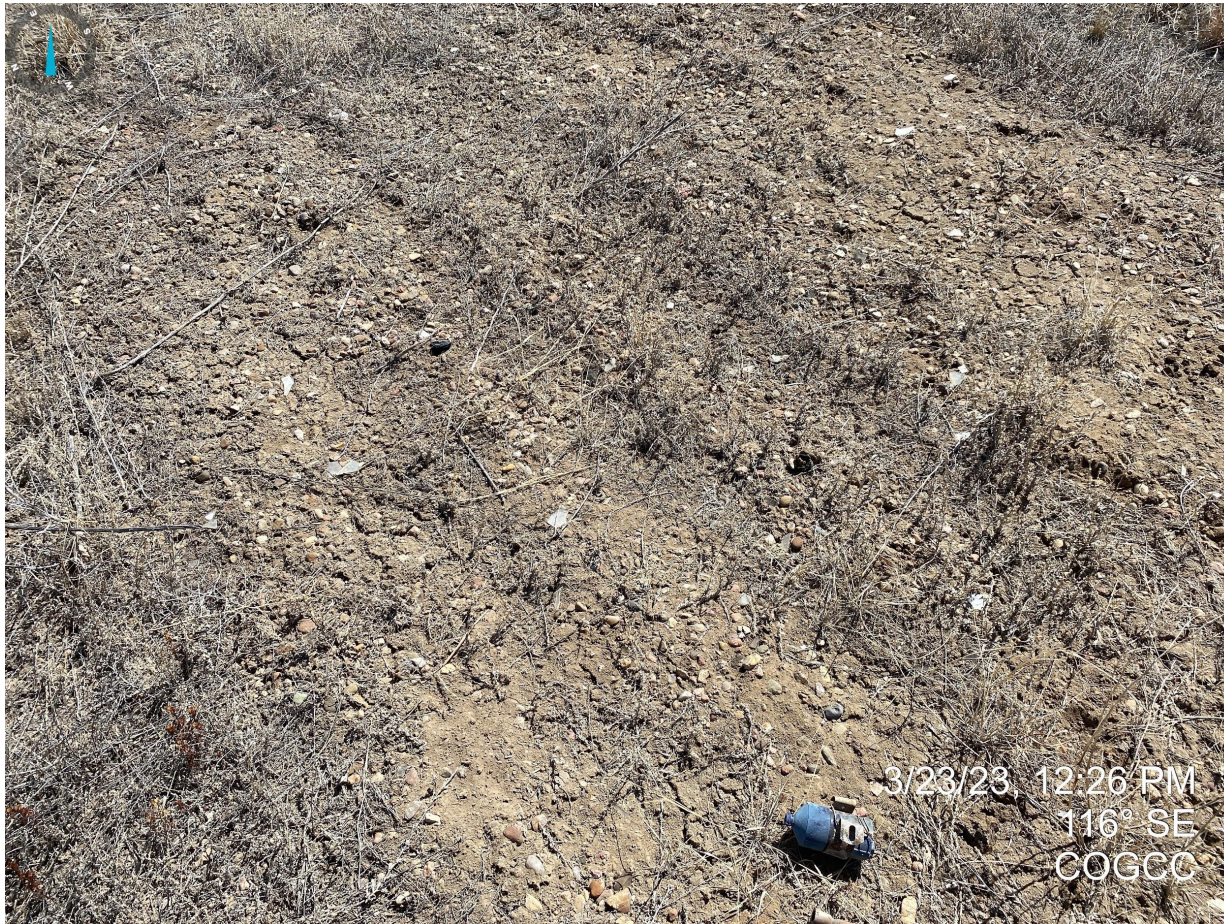
Photo 13. Close up photo of Photo 12.

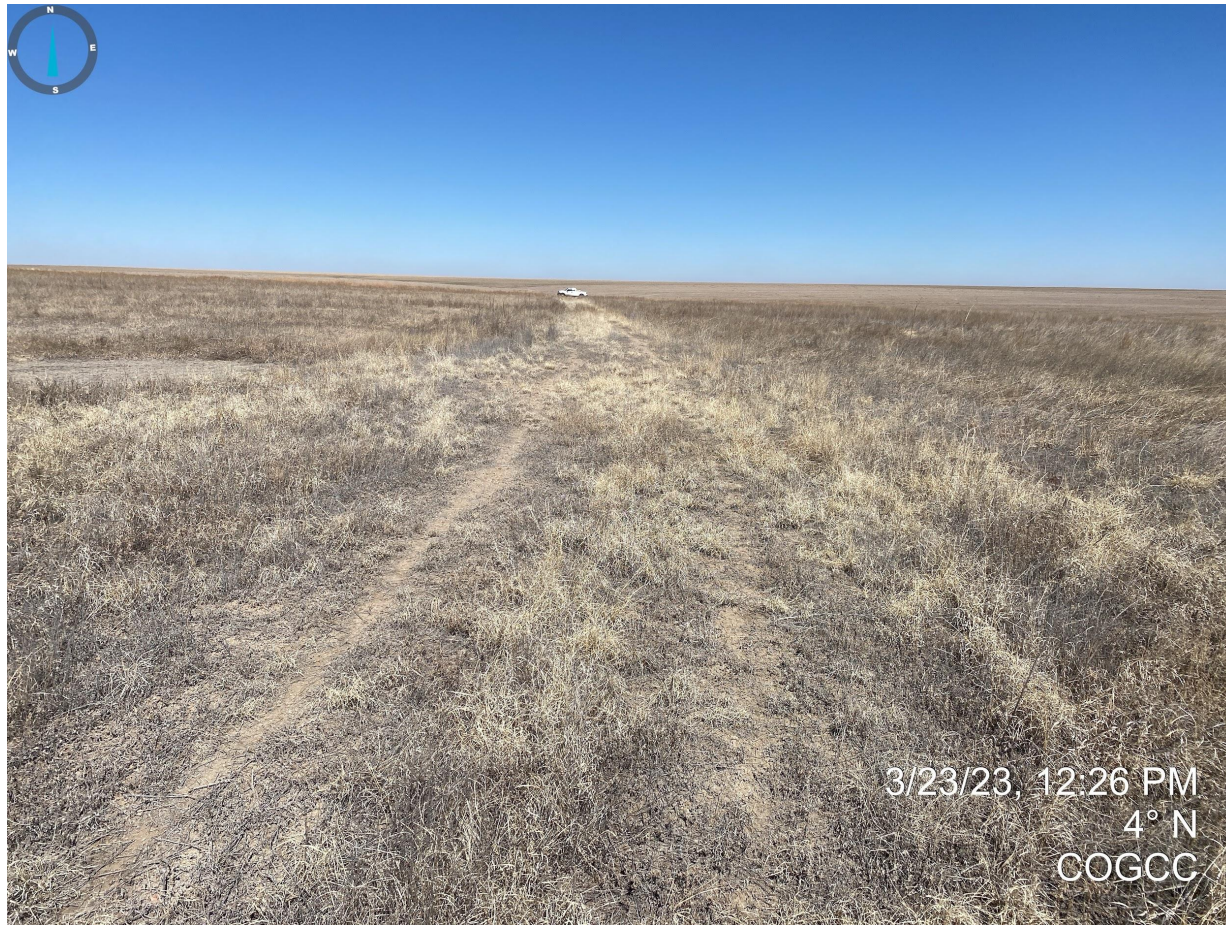
Photo 14. Facing north from PA well; access road has not been reclaimed.

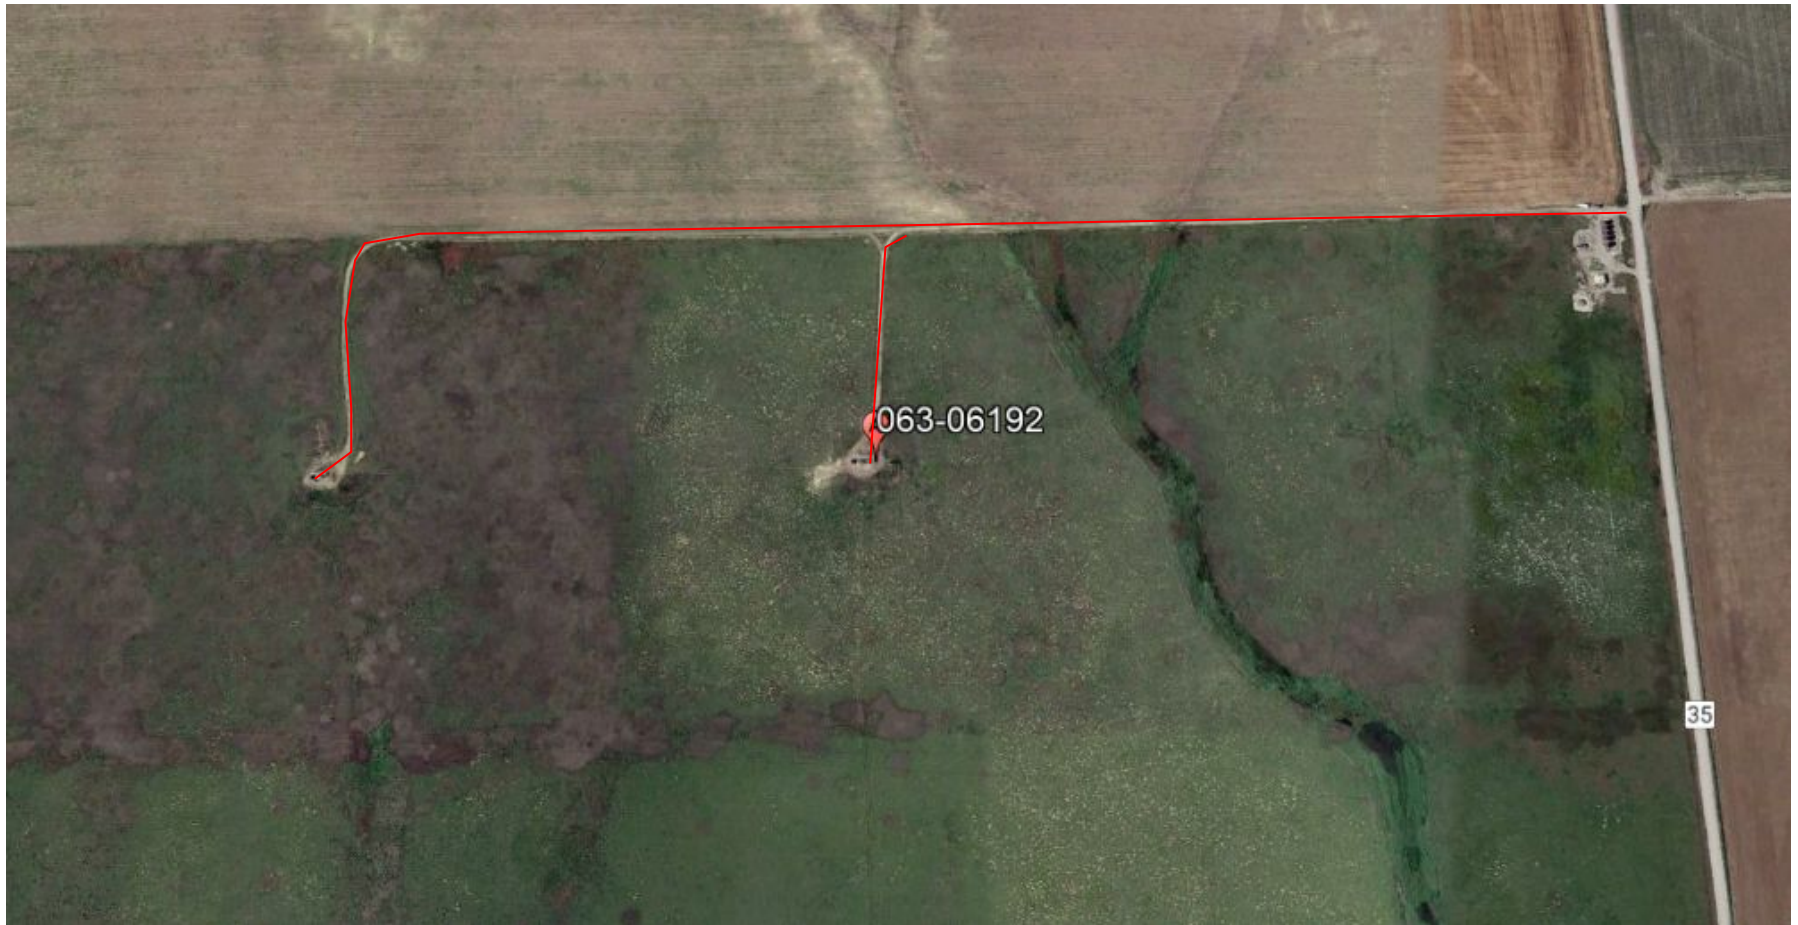
Photo 15. Google Earth aerial imagery illustrating the access roads (red) that remain and will need to be reclaimed per Rule 1004. Previous inspection (Doc #696200704) provided photos showing that the lease/access road did not exist pre-oil and gas development.
