# Storm Water Management and Erosion control

**Location Name: TEP ROCKY MOUNTAIN LLC DERE-66S95W /35SWSW**

**Location #: 334772**

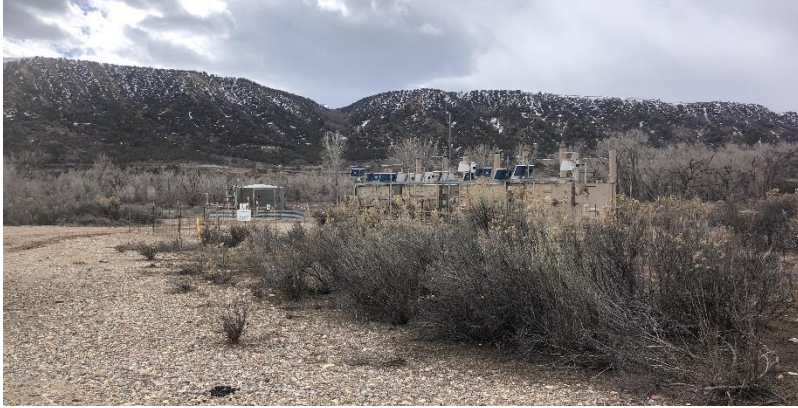
**North West corner of location.**

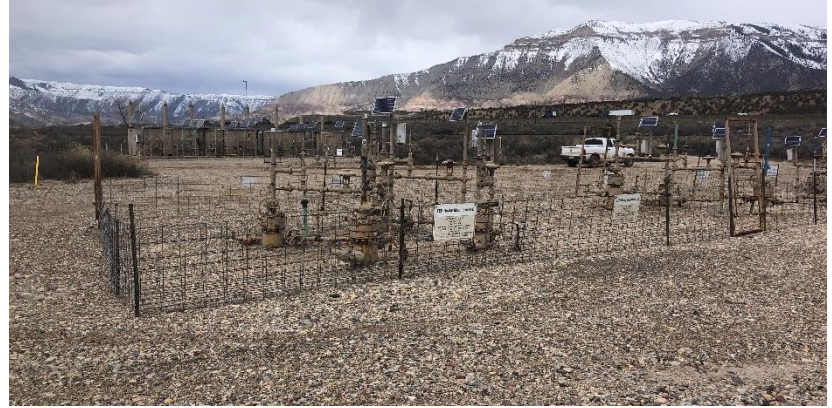
**North East corner of location.**

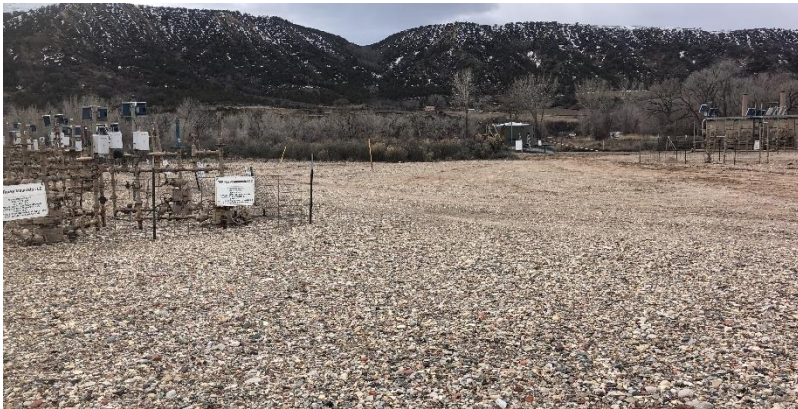
**South West corner of location.**

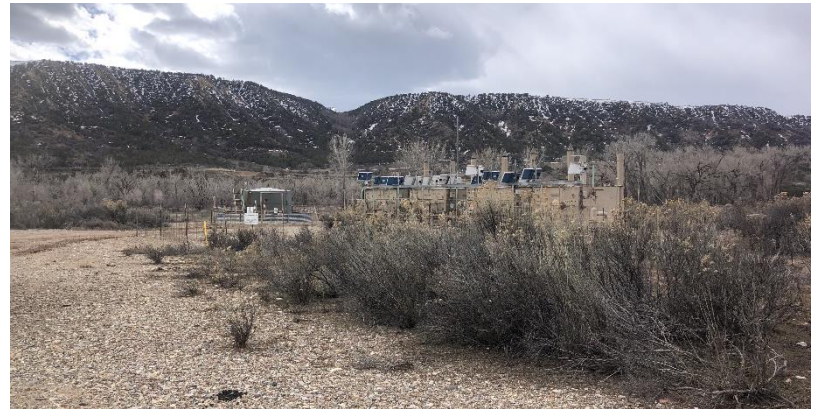
**South East corner of location.**

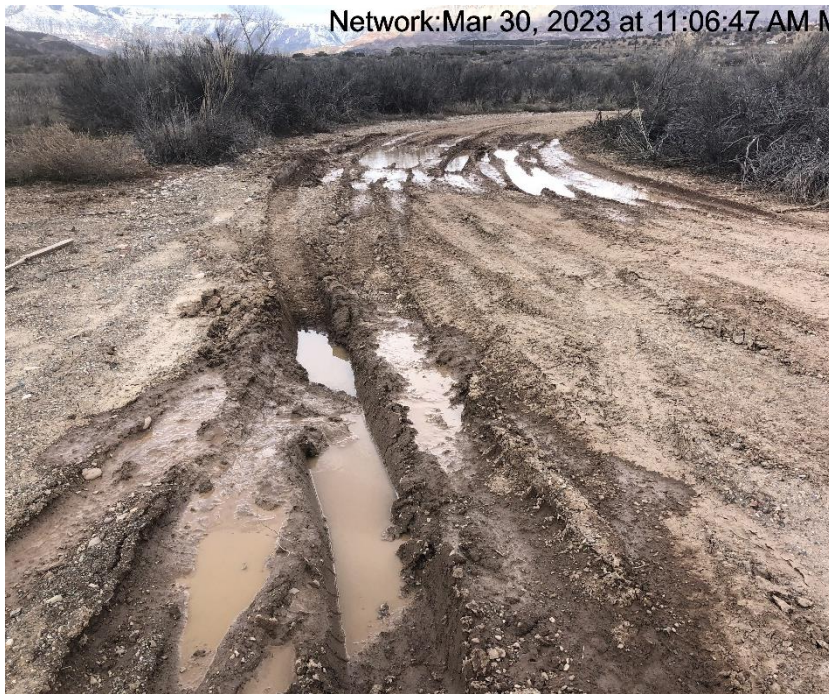
**Photo #9415 Location lacks stabilization.**

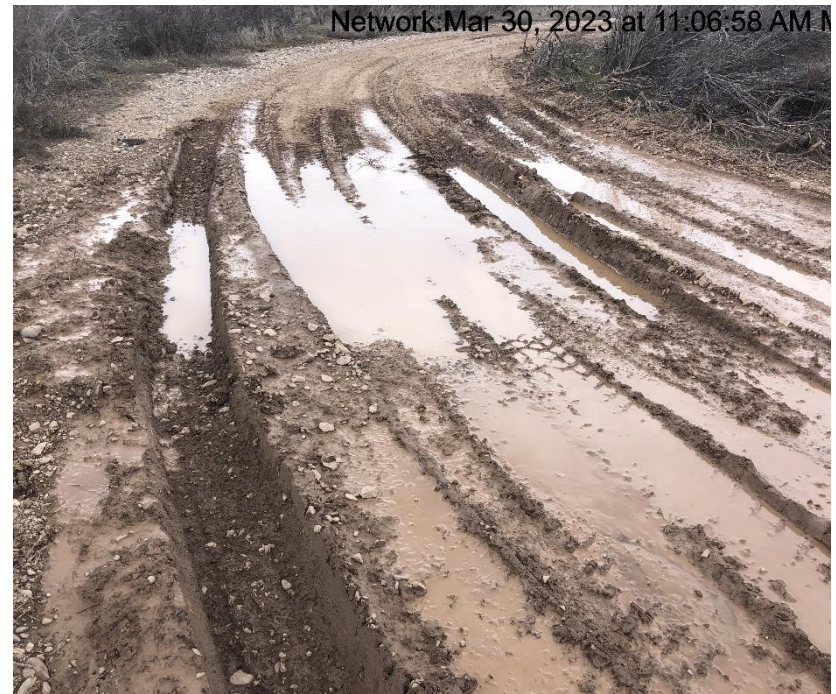
**Photo #9416 Location lacks stabilization.**

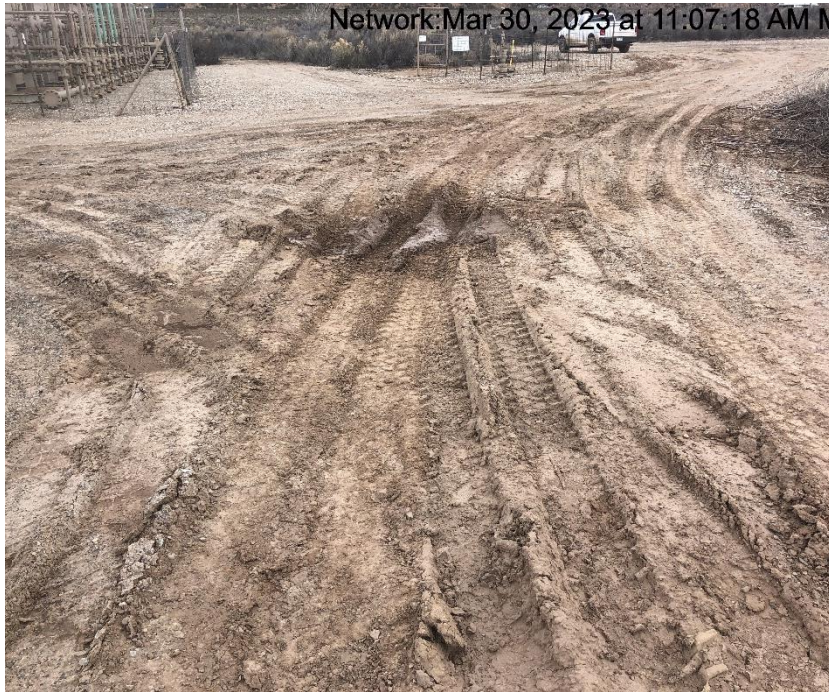
**Photo #9417 Location lacks stabilization.**

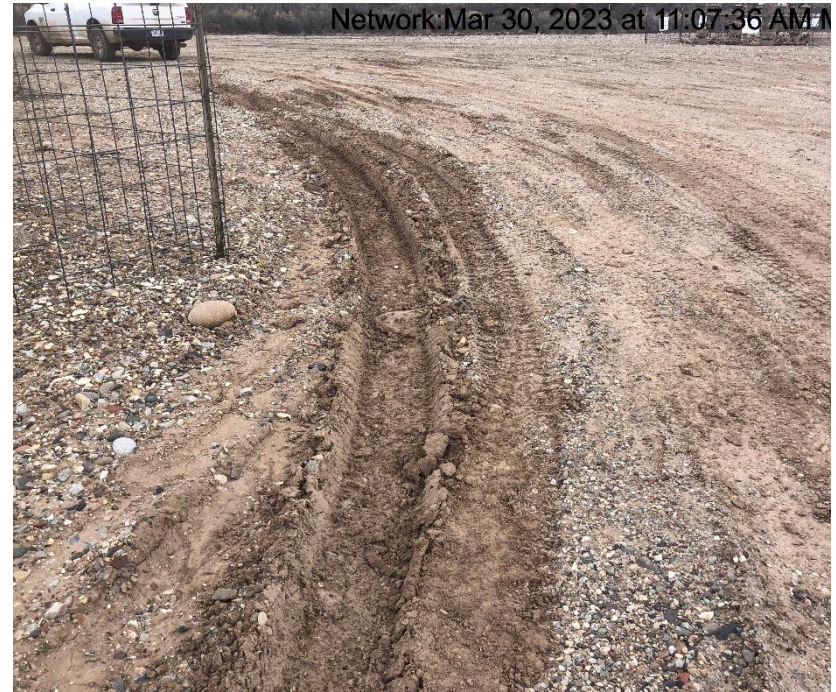
**Photo #9418 location lacks stabilization.**

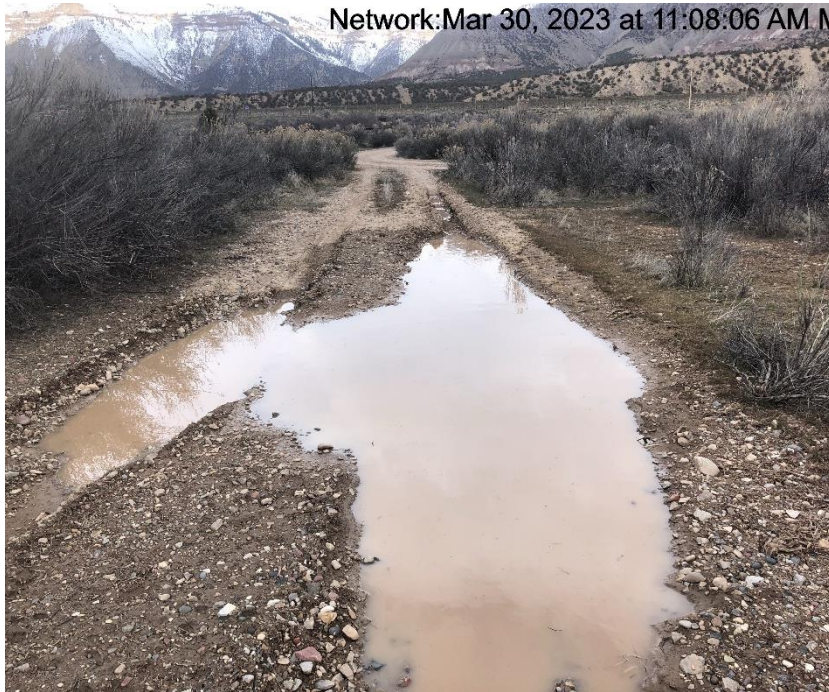
**Photo #9419 Location lacks stabilization.**

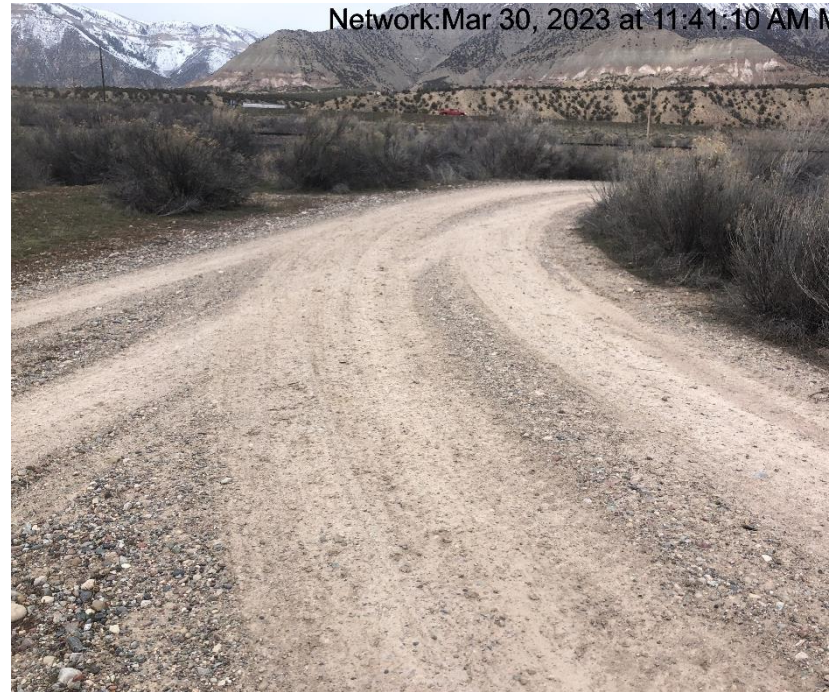
**Photo #9425 Insufficient tracking BMP at entrance to location.**

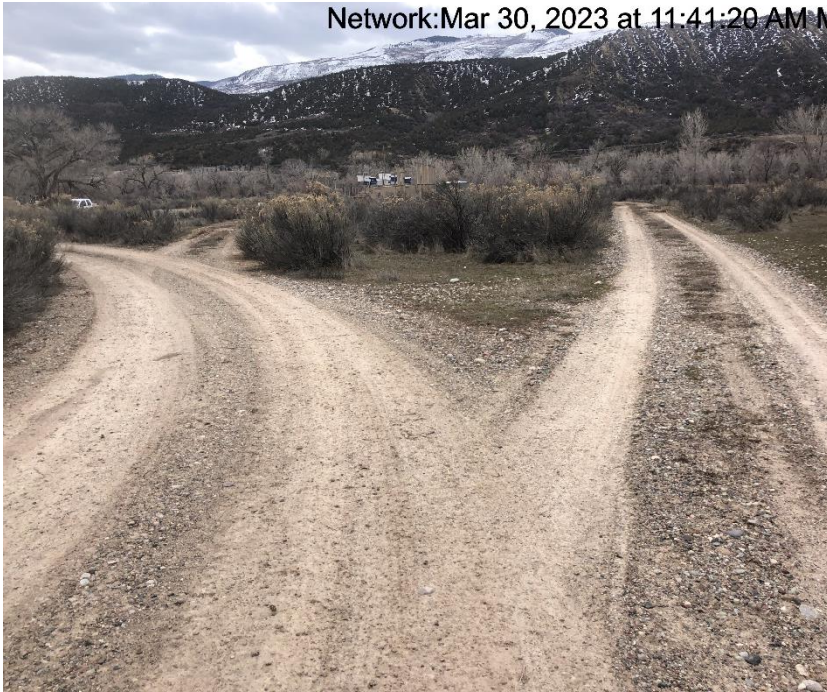
**Photo #9426 Insufficient tracking BMP at entrance to location.**
