Inspection Photos

Location Name: TEP ROCKY MOUNTAIN LLC CLOUGH RWF 434-20 pad

Location ID: 335342

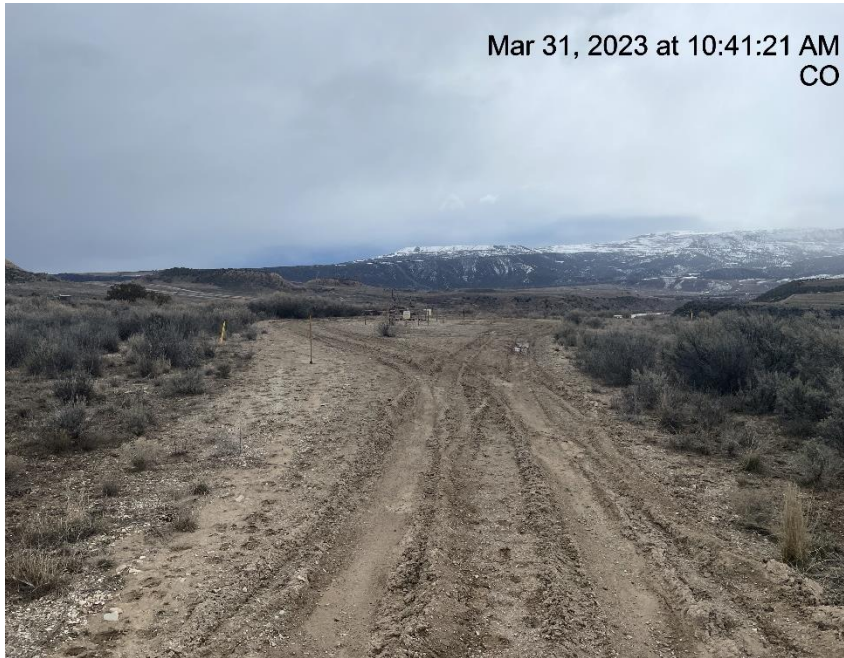
Photo # 3957 From entrance to location

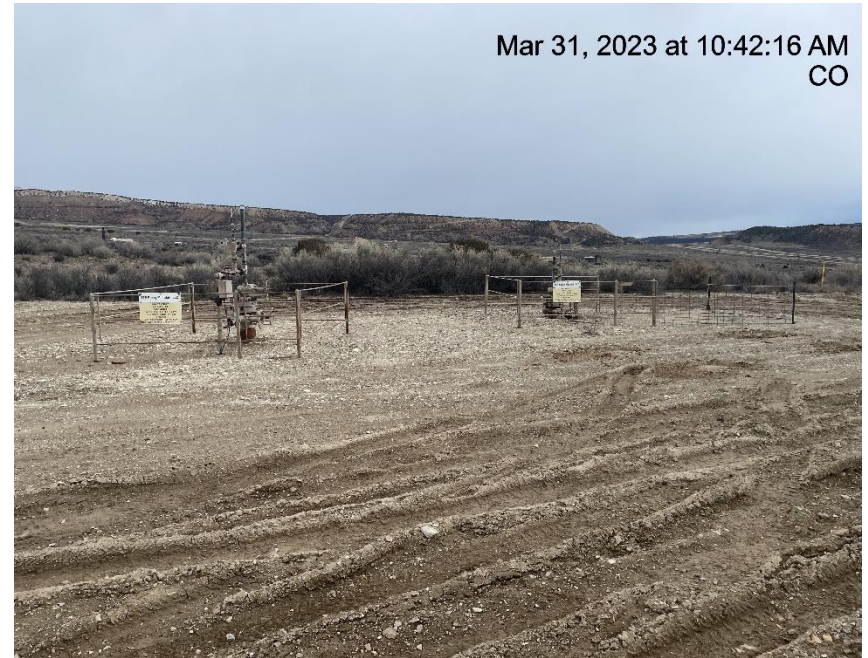
Photo # 3958 Location

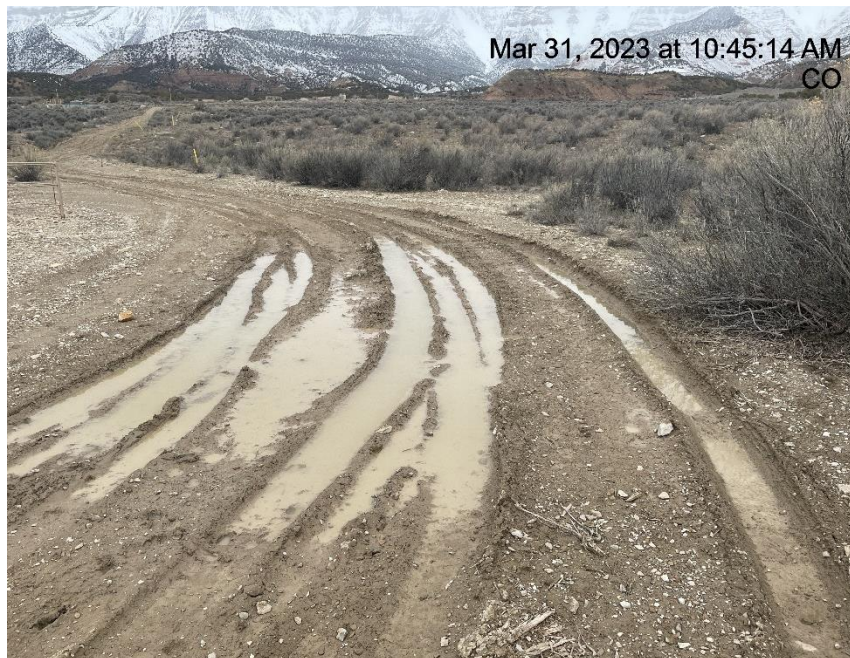
Photo # 3965 Lack of stabilization/compaction/insufficient tracking BMP's

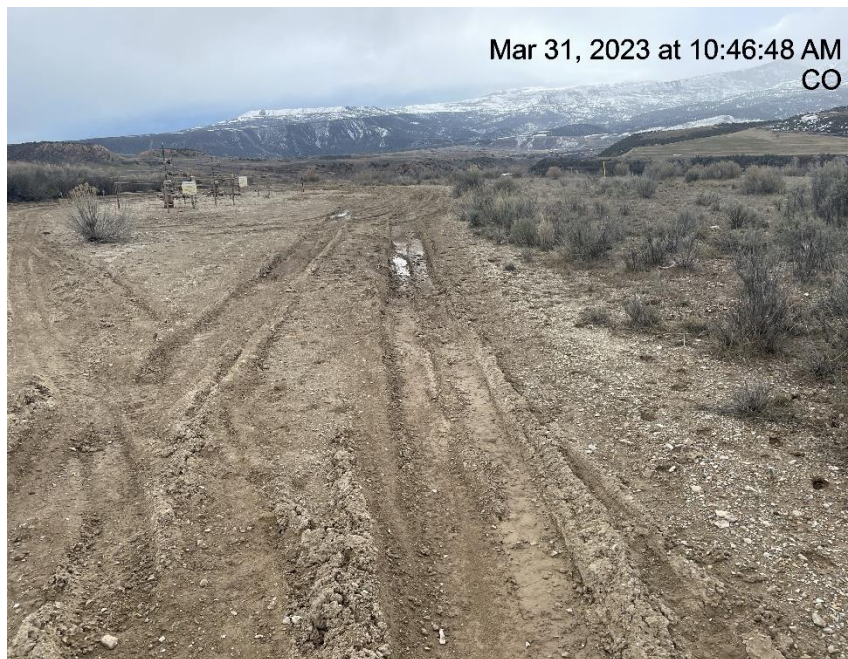
Photo # 3970 Lack of stabilization/compaction/insufficient tracking BMP's

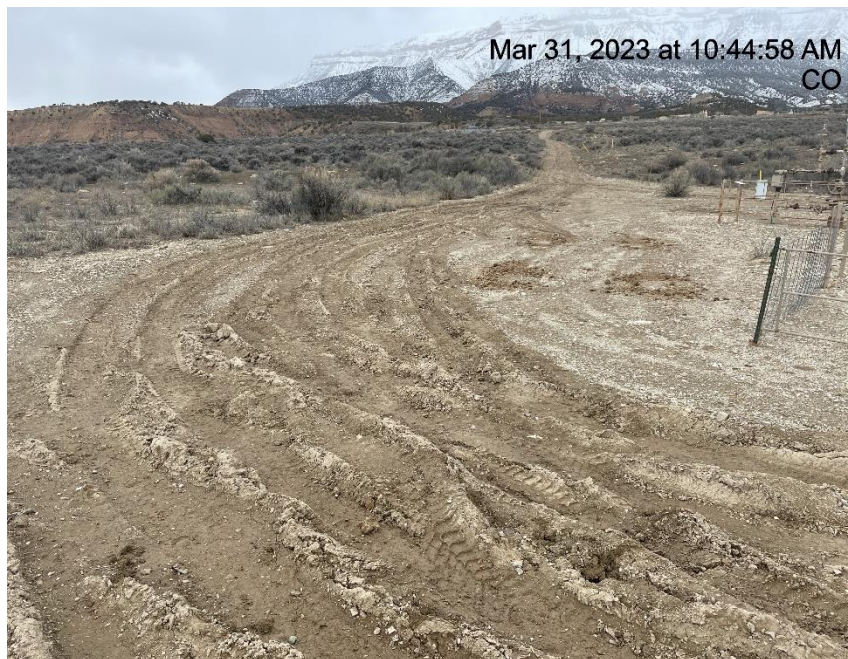
Photo # 3964 Lack of stabilization/compaction/insufficient tracking BMP's

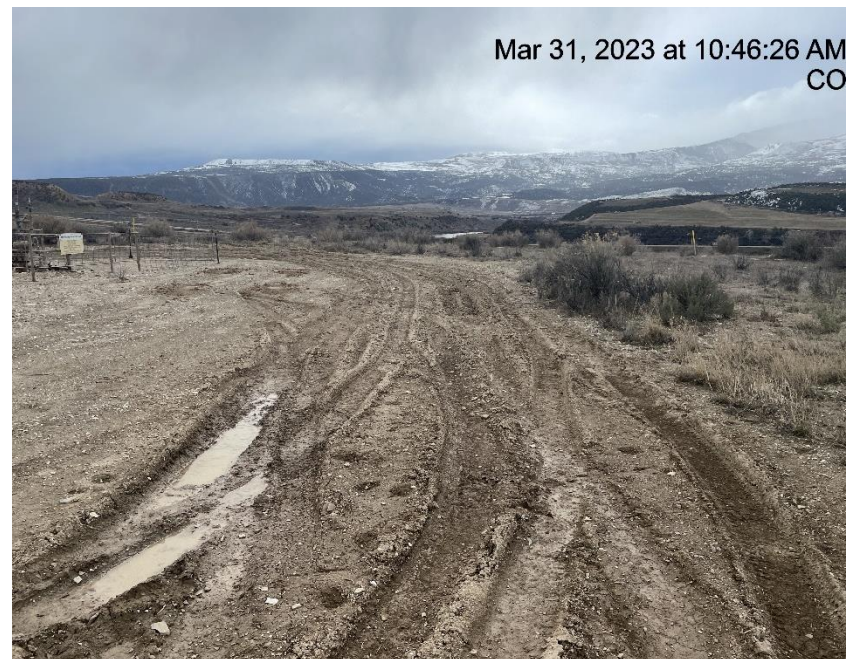
Photo # 3969 Lack of stabilization/compaction/insufficient tracking BMP's

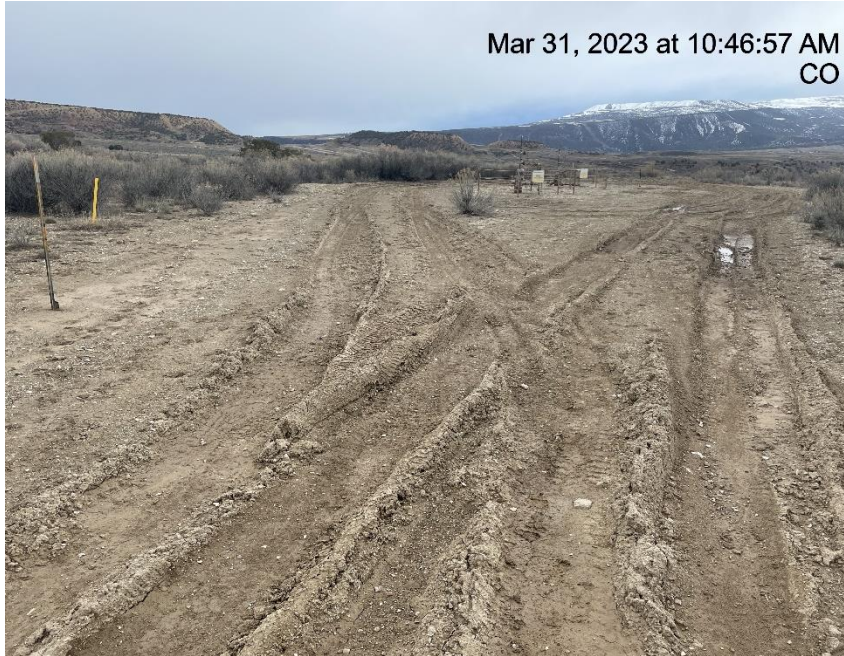
Photo # 3971 Lack of stabilization/compaction/insufficient tracking BMP's

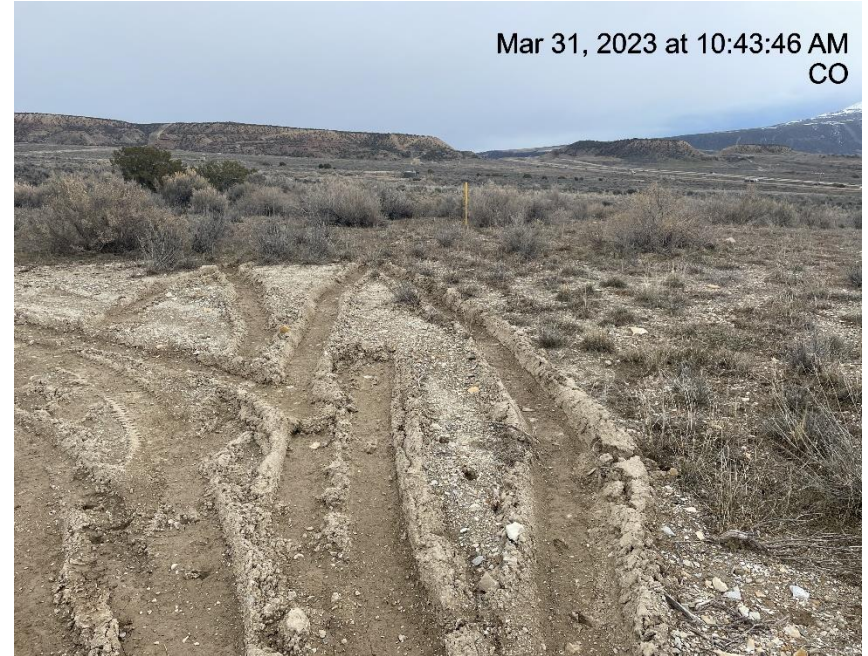
Photo # 3959 Failure to minimize surface disturbance

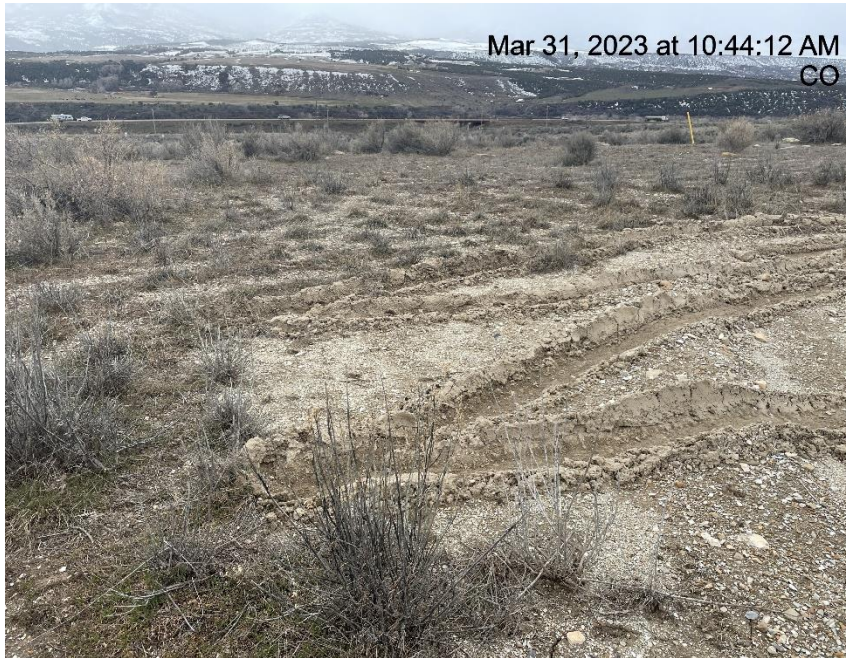
Photo # 3960 Failure to minimize surface disturbance

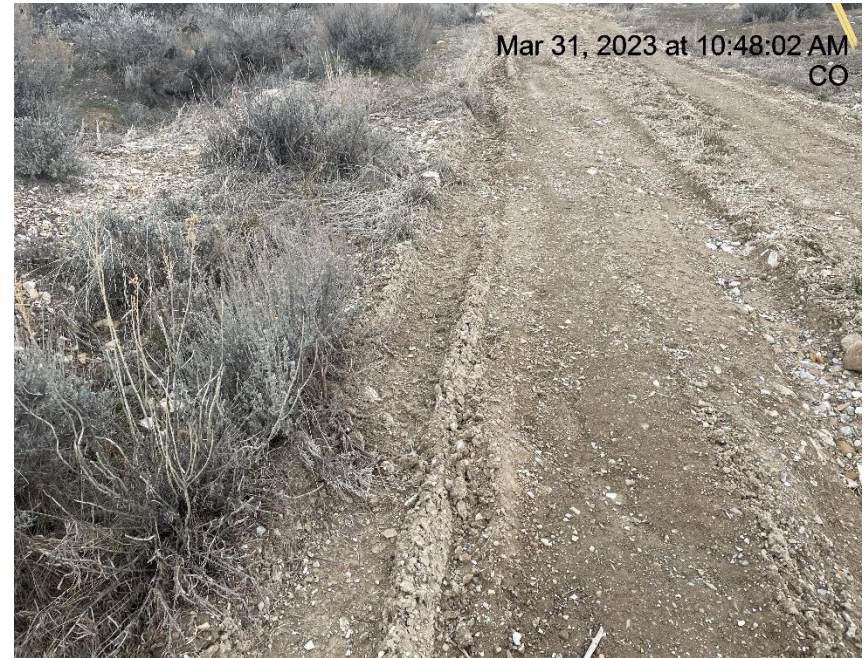
Photo # 3977 Failure to minimize surface disturbance

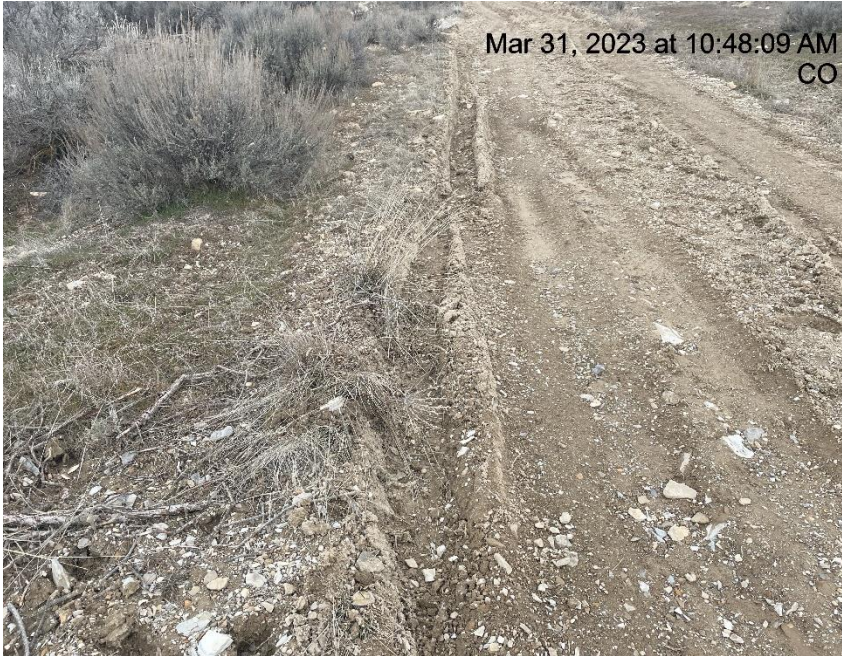
Photo # 3978 Failure to minimize surface disturbance
