Inspection Photos

API: 043-06122

Operator: JAVERNICK OIL

Inspection Date: 3/31/2023

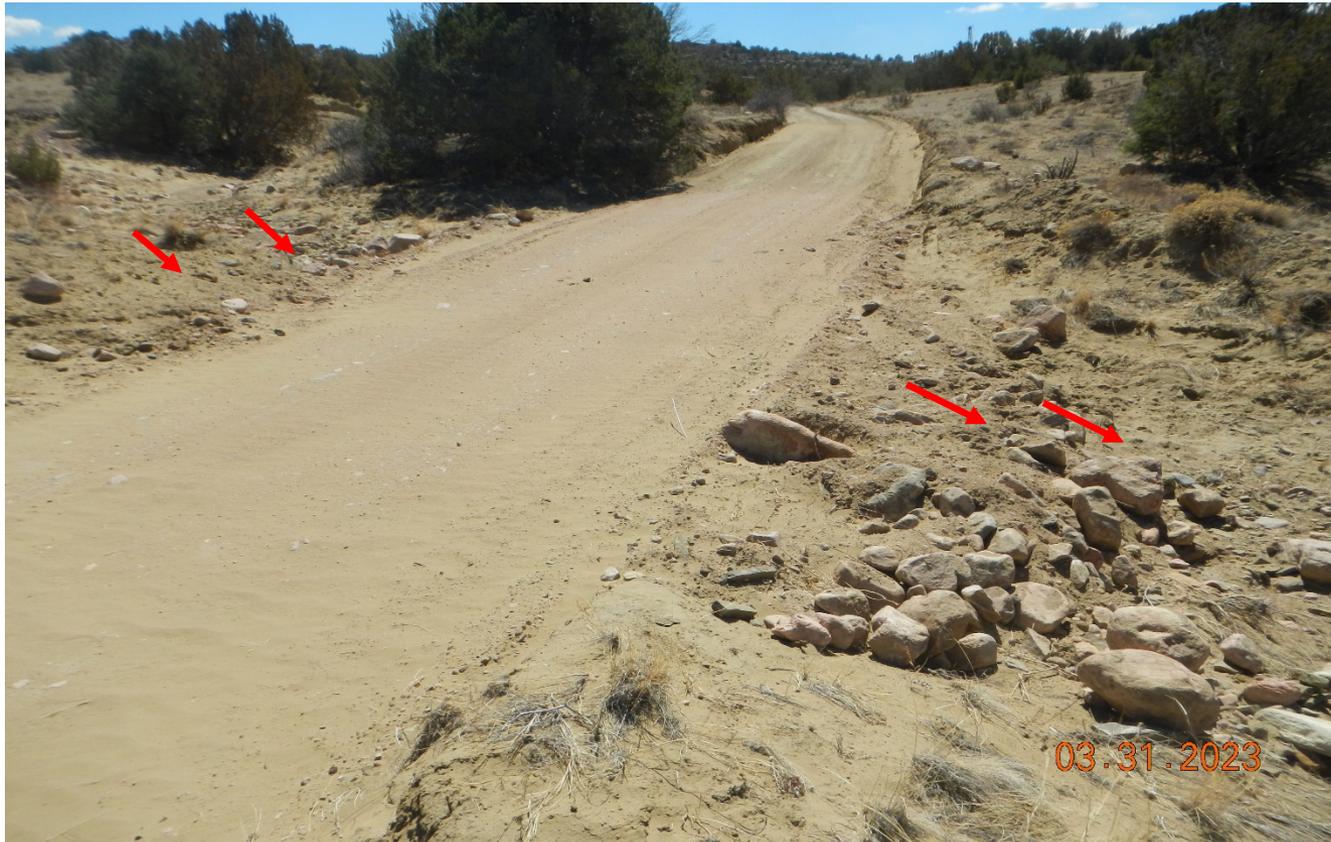
Photo 1. Facing southeast long the access road. This drainage crossing must have BMP's installed to accommodate seasonal storm event to prevent material from washing out. BMP may include culvert, rip/rap, ect. Previous corrective action not completed. Red line shows direction of drainage flow.

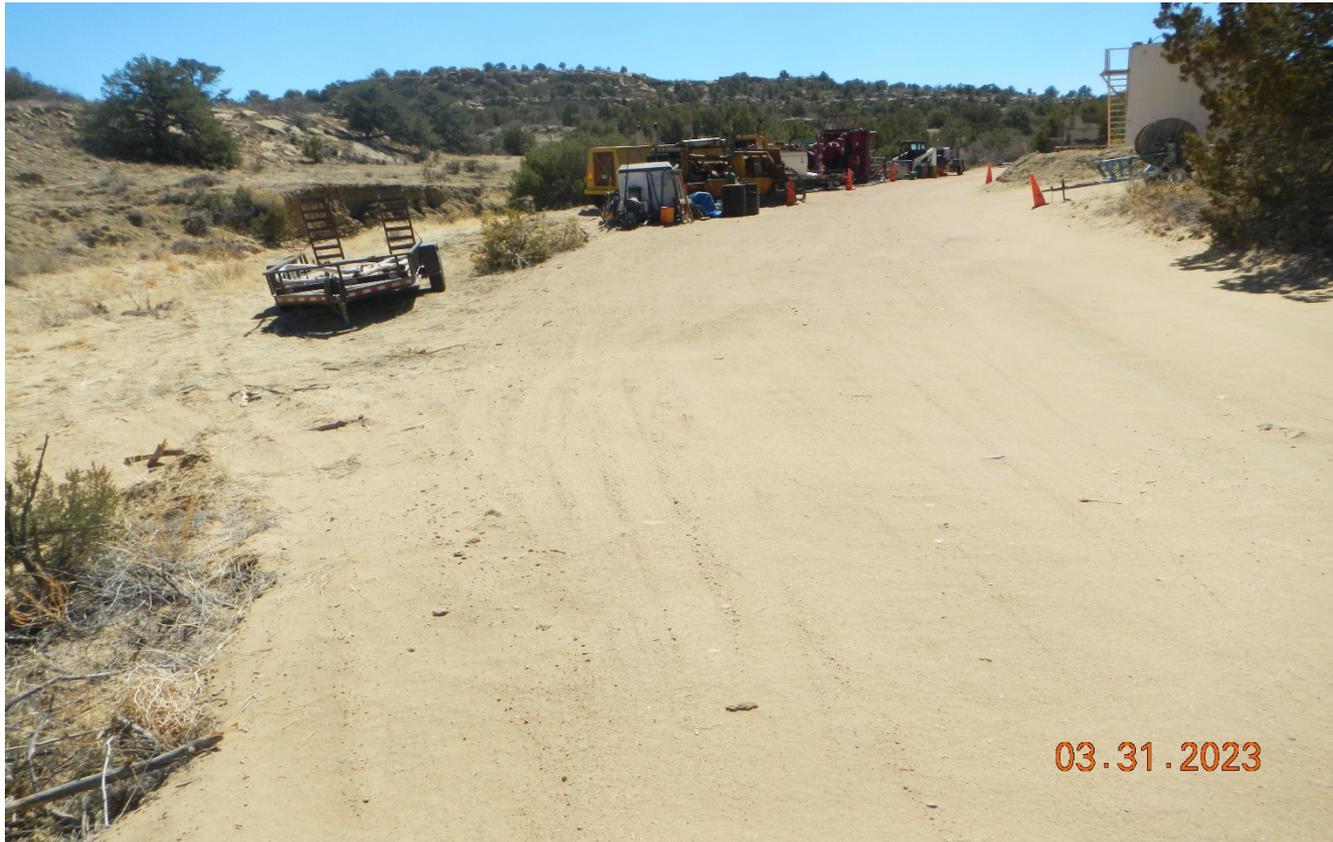
Photo 2. Facing southeast long the access road at the tank battery site. The trailer is being parked off the access road creating additional disturbance. The loose soils along the road are susceptible to erosion.

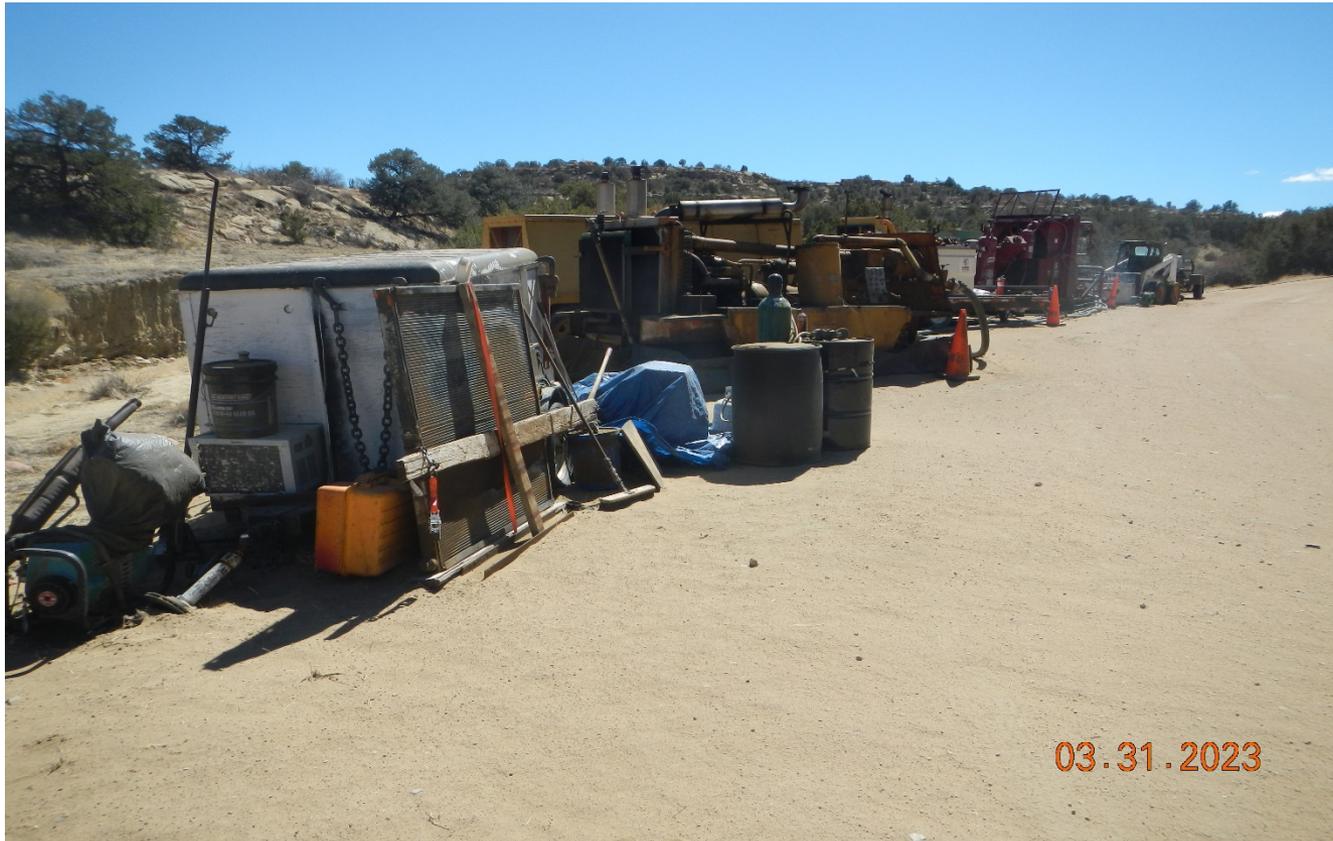
Photo 3. Facing southeast long the access road at the tank battery site. There are equipment and supplies being stored in this area documented since at least 12/1/2022.

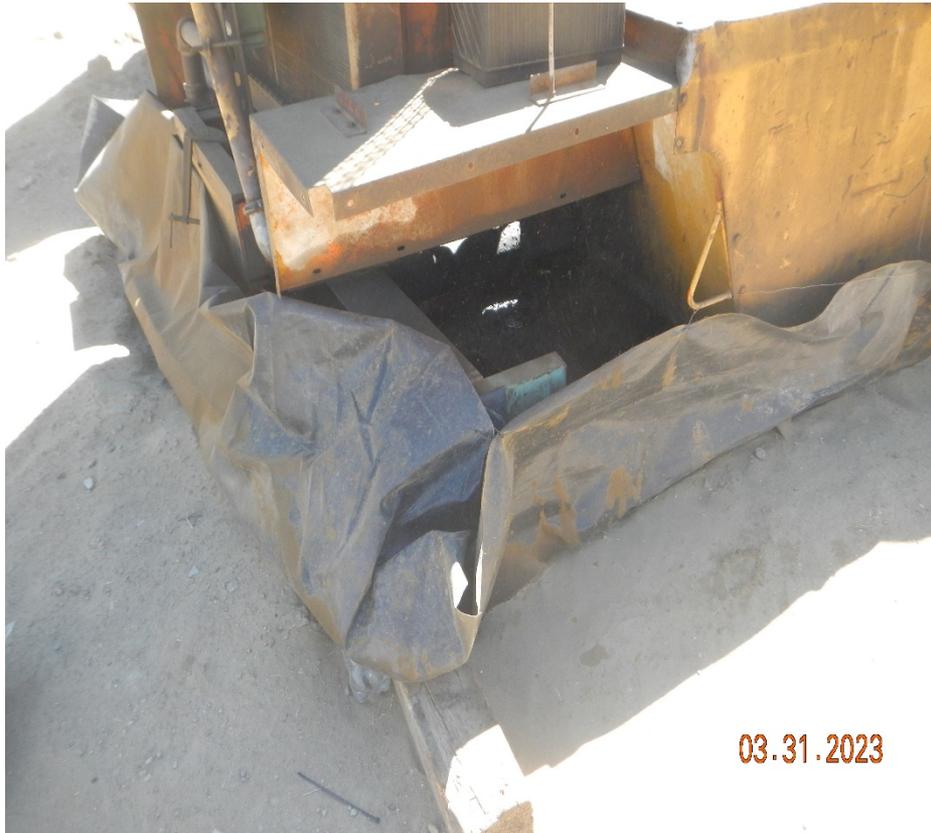
Photo 5. The equipment which is leaking fluids has liner that has been wired up but this is not adequate for containment and fluids in the liner need to be cleaned up.

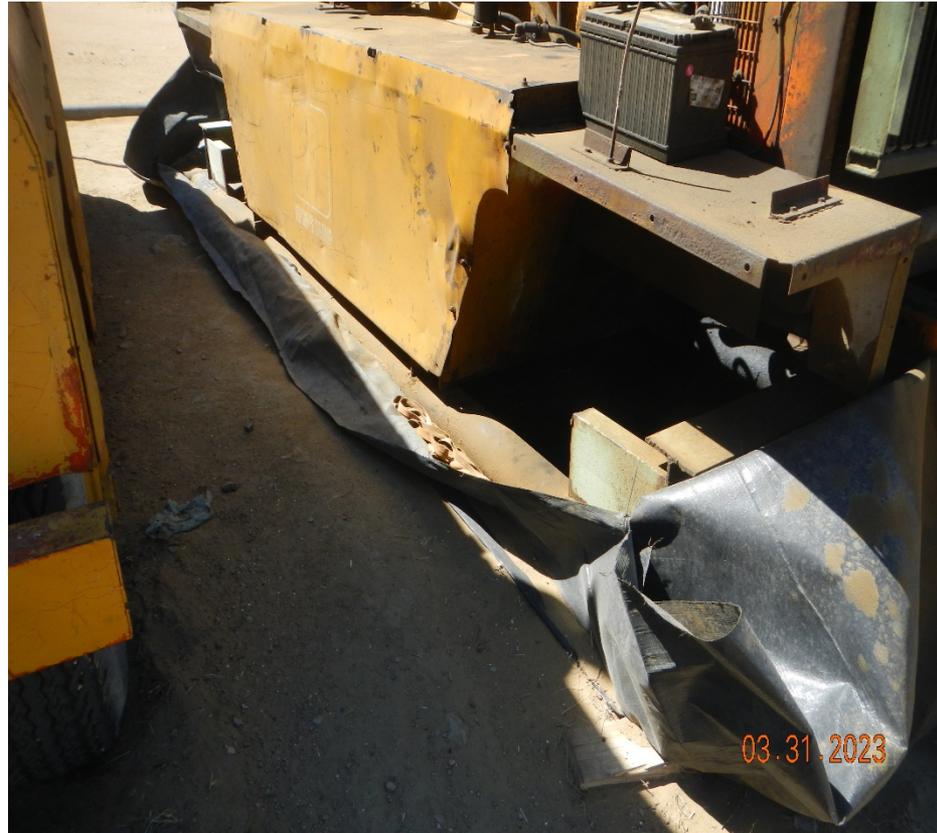
Photo 6. The liner on the other side of the equipment is laying on the ground and stormwater could easily wash out oily fluids onto the ground..

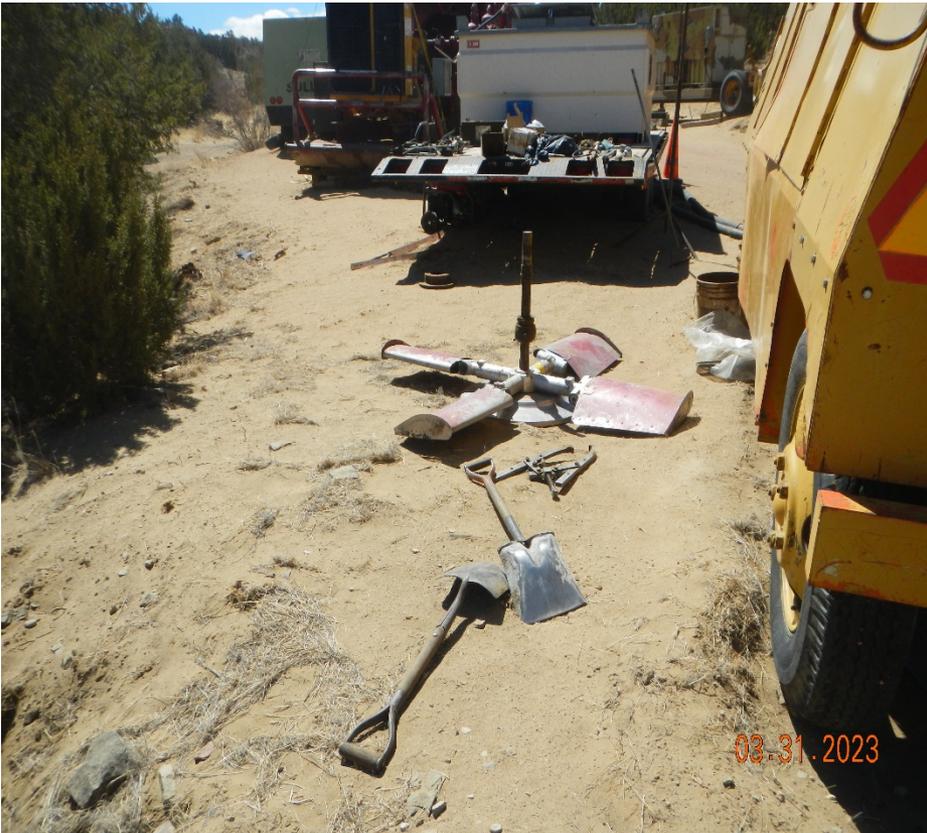
Photo 7. There are parts and shovel laying on the ground not stored in a workman like manner.

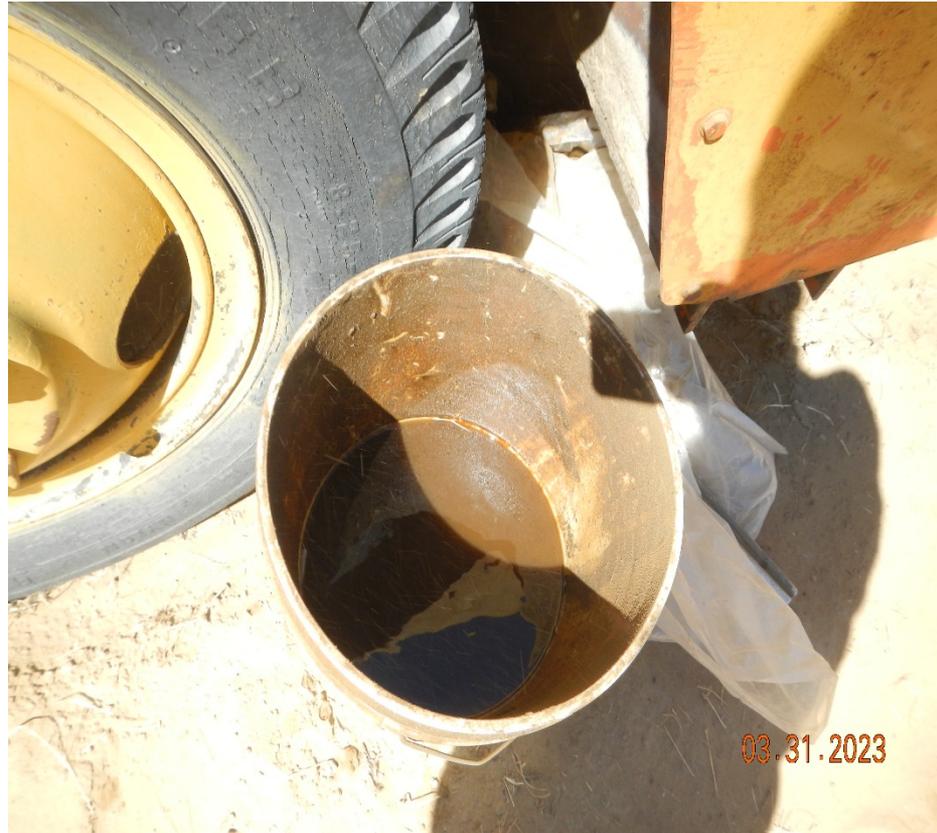
Photo 8. There is a bucket with oily fluid which could easily spill over or can be a problem for wildlife.

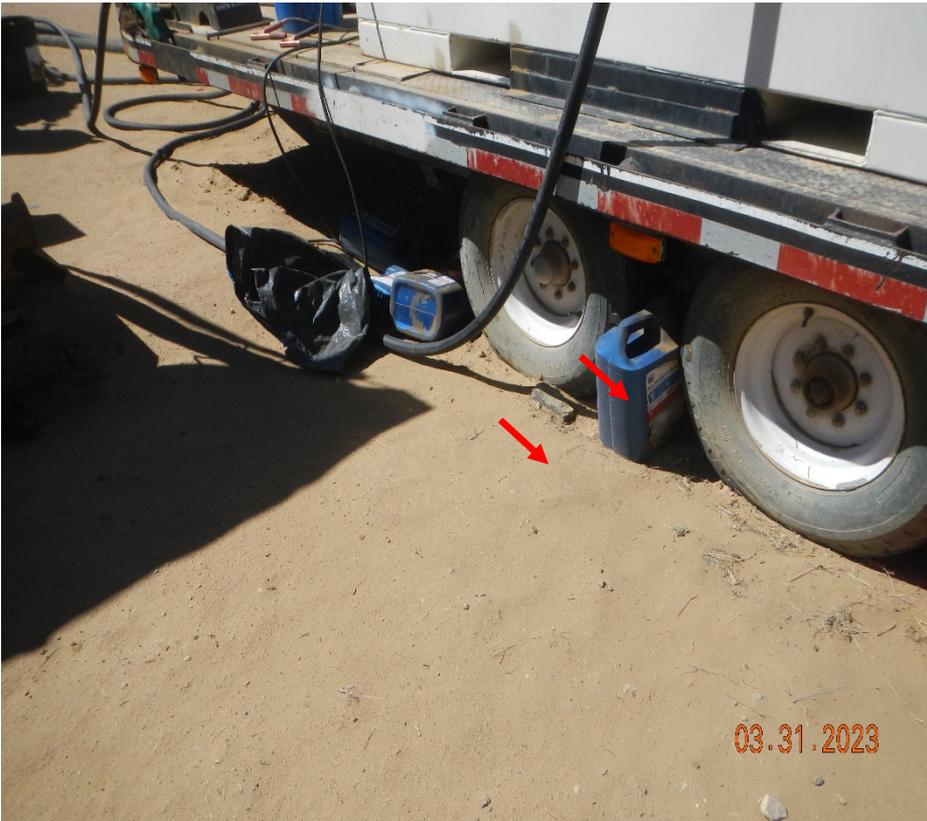
Photo 9. There are numerous buckets and containers laying on the ground that are not properly stored.

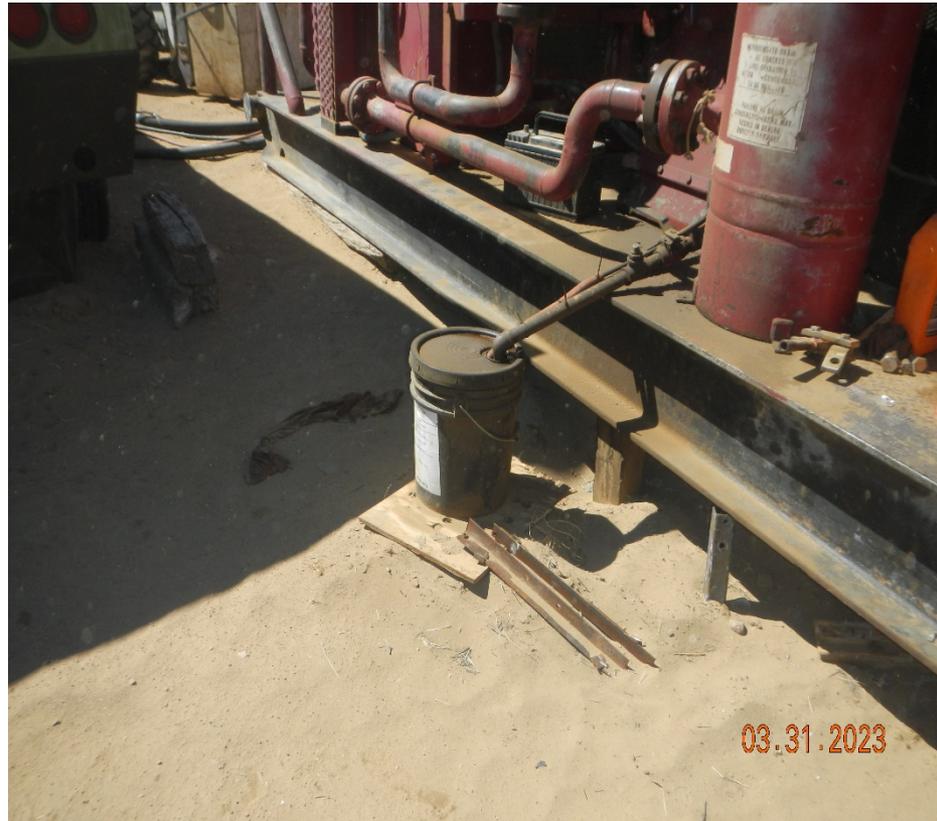
Photo 10. There is oil leaking out of the equipment being captured by buckets which could easily tip over and spill.

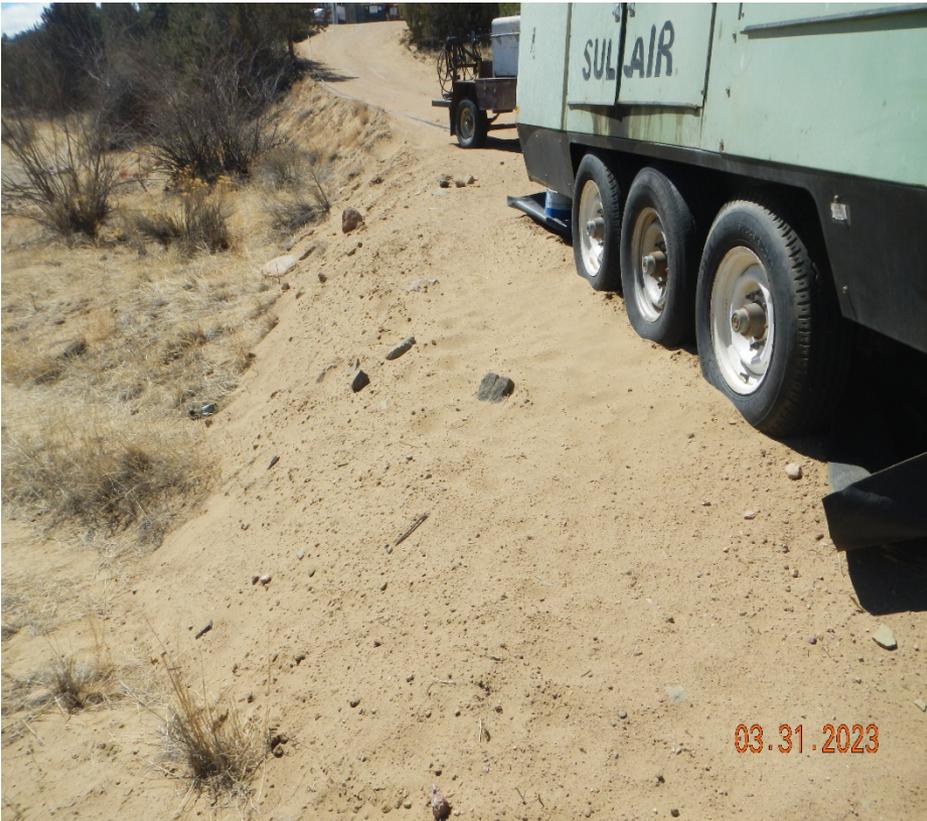
Photo 11. Facing south at the east side of the tank battery where equipment is being stored. There are no stormwater controls to prevent erosion of loose soils.

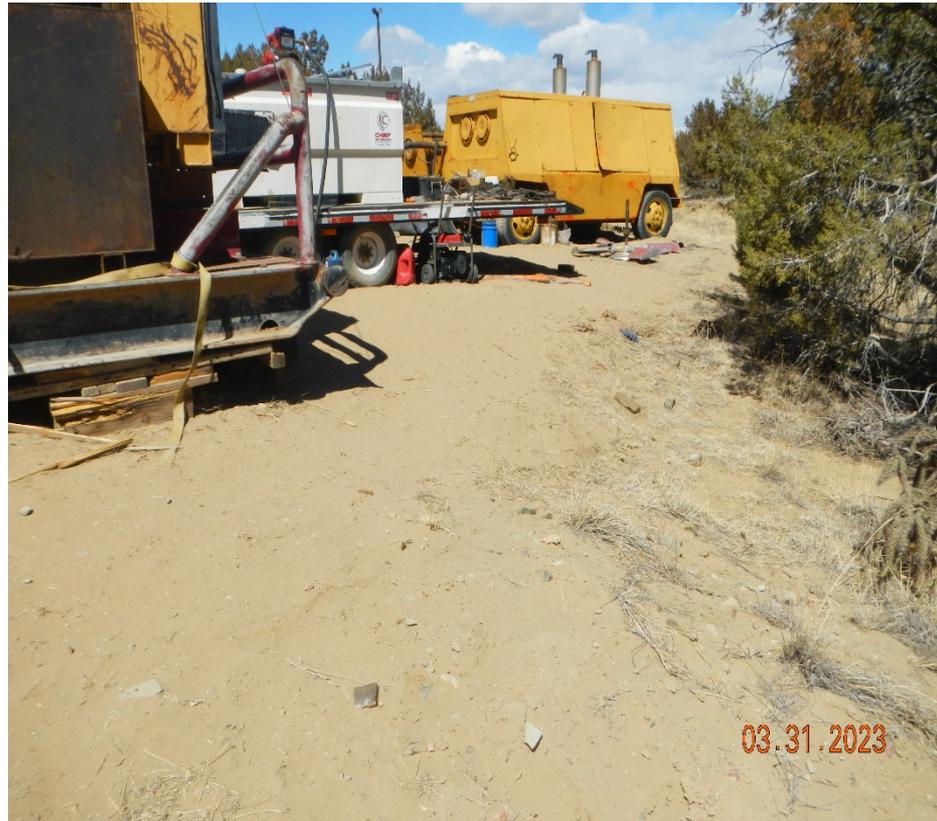
Photo 12. Facing north at the east side of the tank battery where equipment is being stored. There are no stormwater controls to prevent erosion of loose soils.

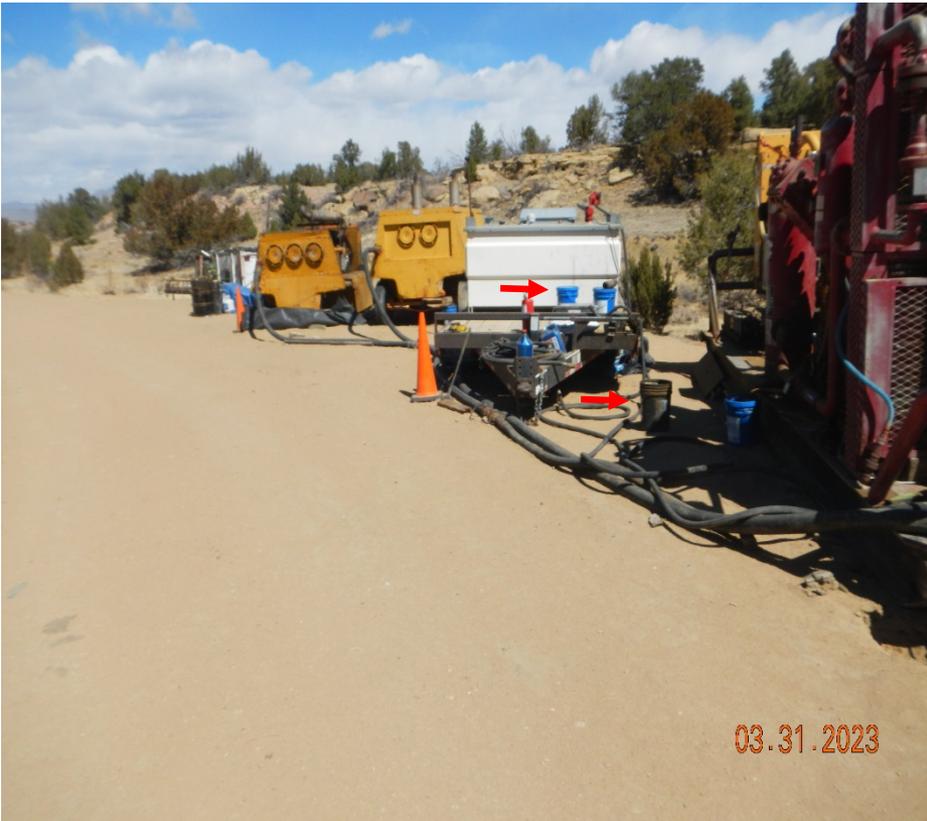
Photo 13. Facing north at the tank battery site where equipment is being stored. There are numerous buckets and containers laying not properly stored.

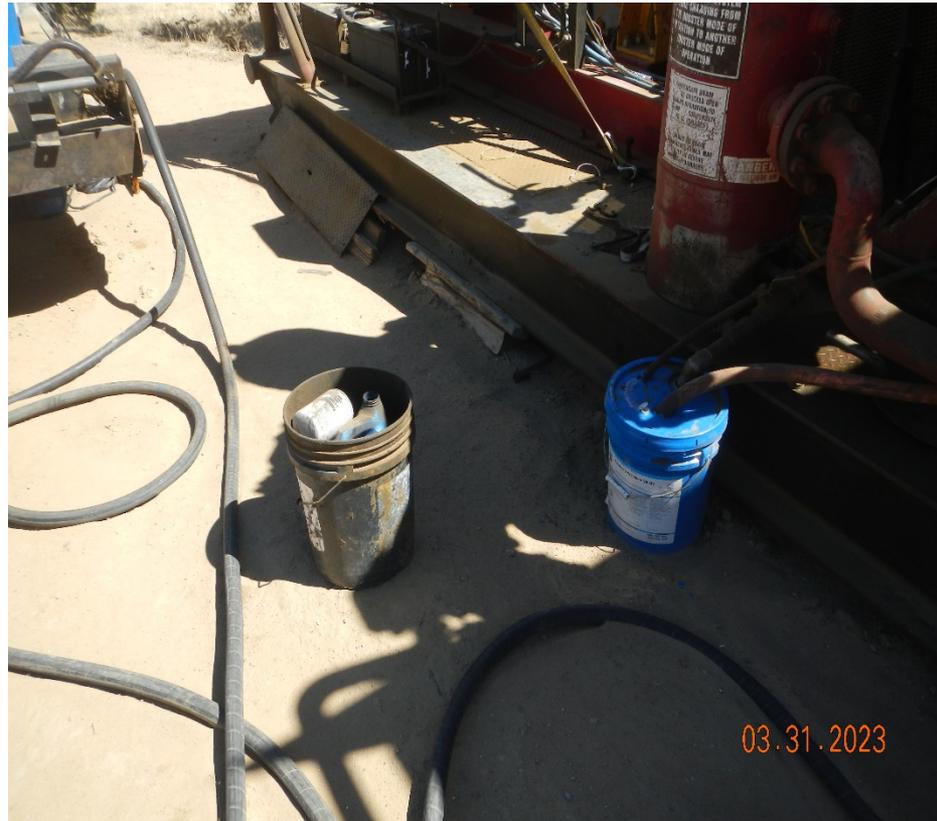
Photo 14. There is oil leaking out of the equipment being captured by buckets which could easily tip over and spill.

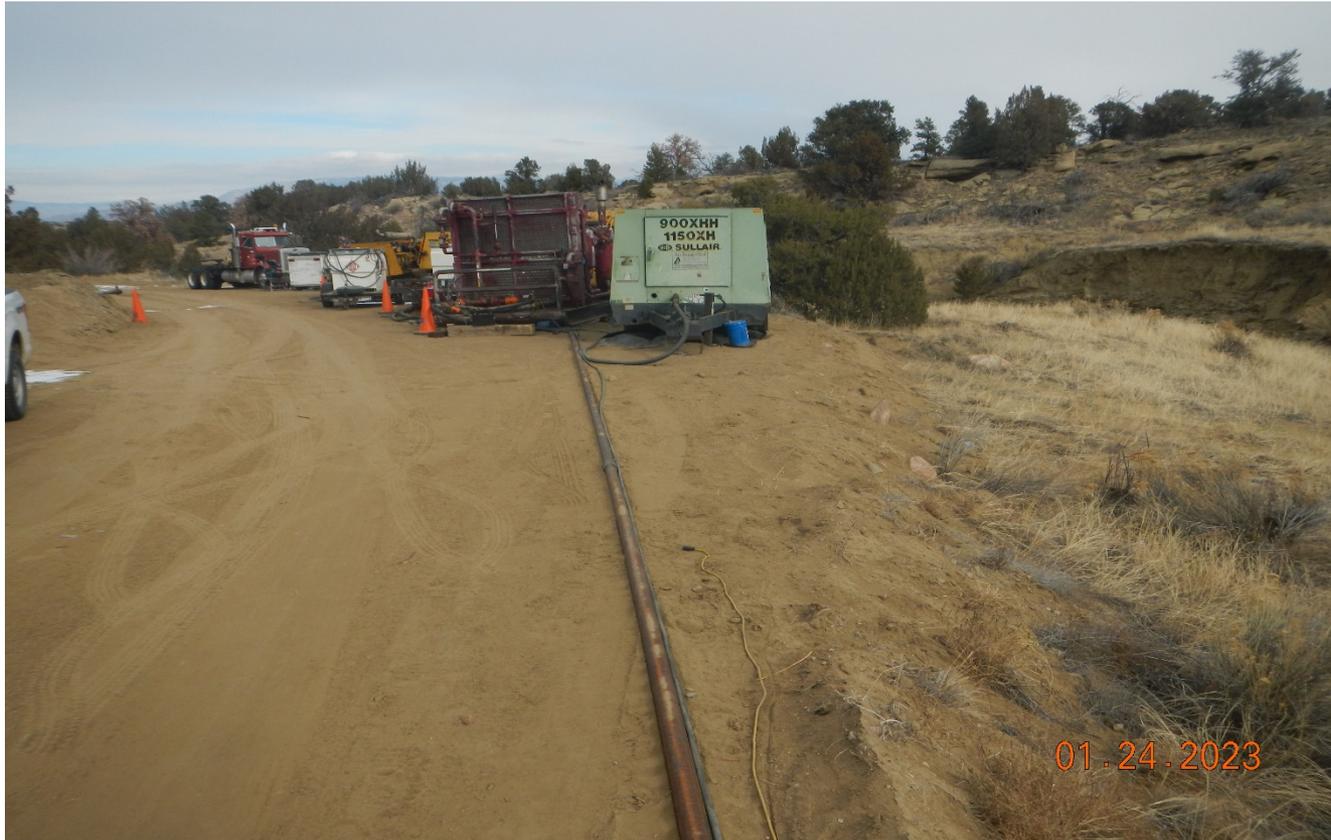
Photo 15. Facing north at the tank battery site where equipment is being stored. There are no perimeter stormwater controls down gradient toward the stream drainage at right side of photo which previous inspection also cited.

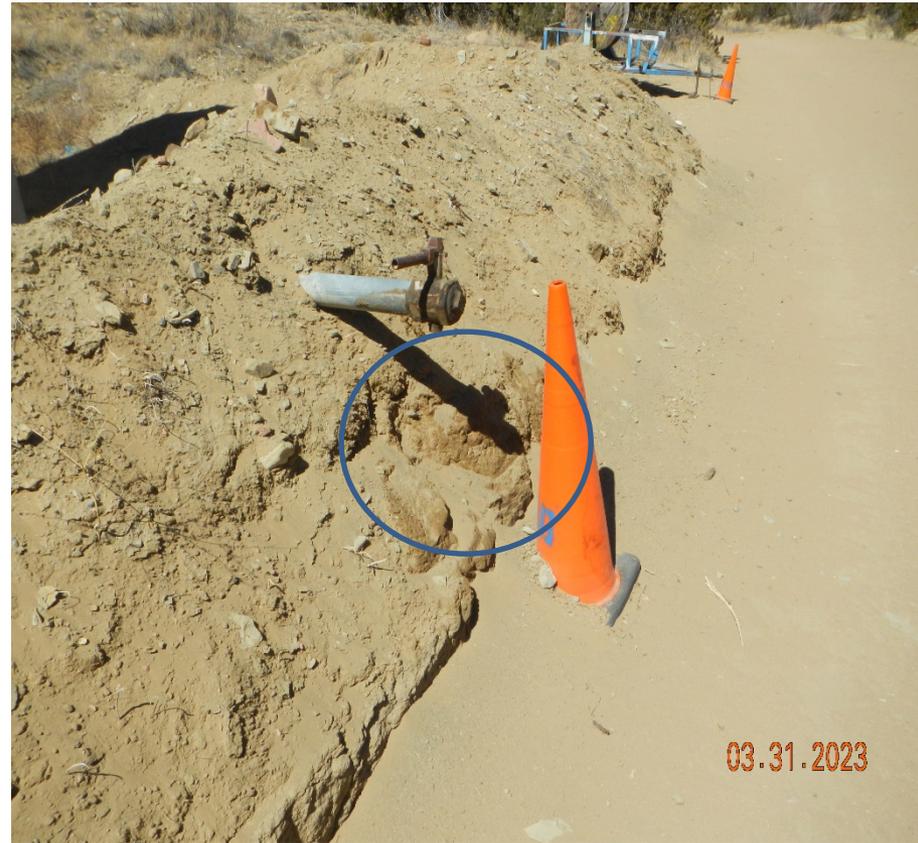
Photo 17. There is still oil stained soils at the tank pipe outlet shown at circled area of darkened soil..

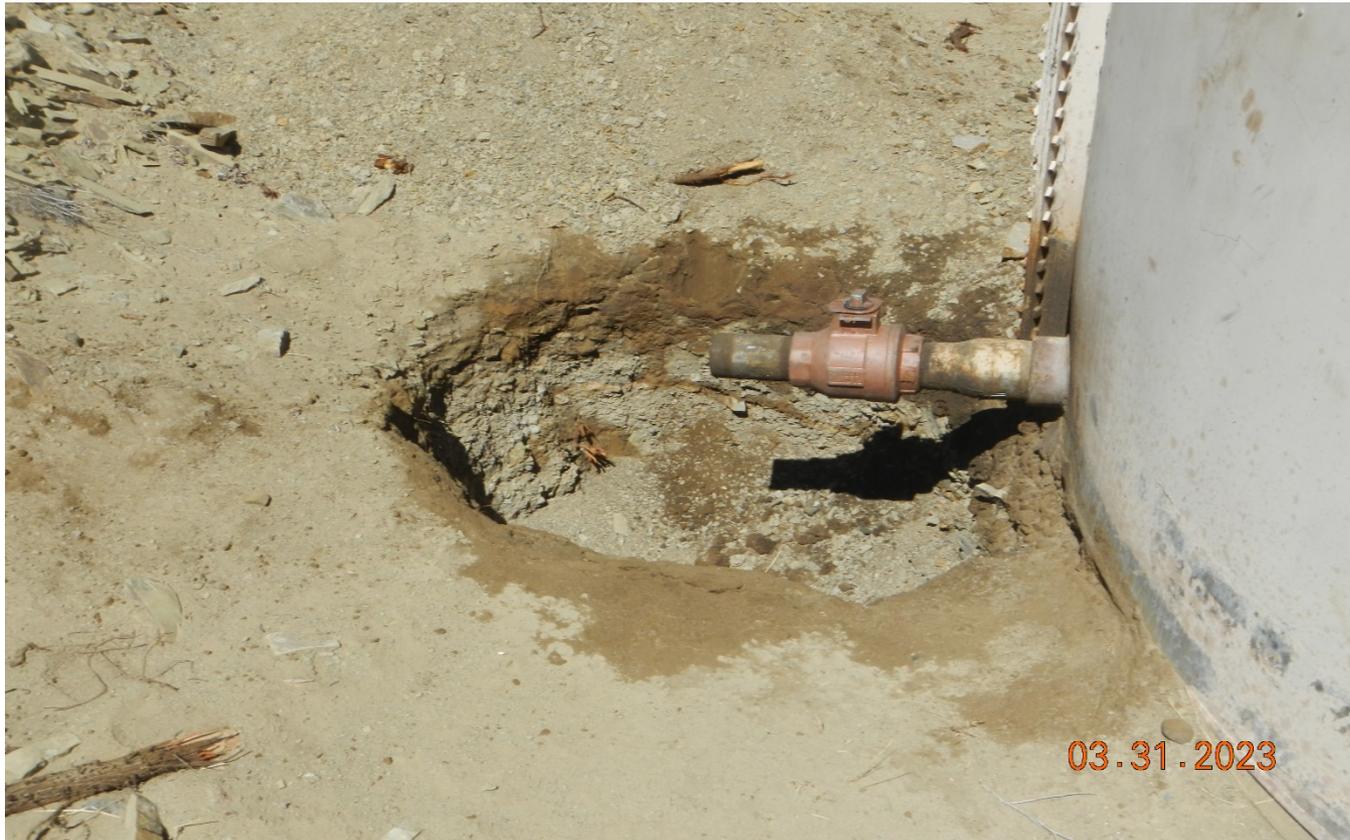
Photo 18. The dripping leak appears to have been fixed or fluids have been drained from the tank. There is still oil stained soils at the outlet area. Tank may need to be removed to cleanout the contaminated soils. This needs to be cleaned up immediately.

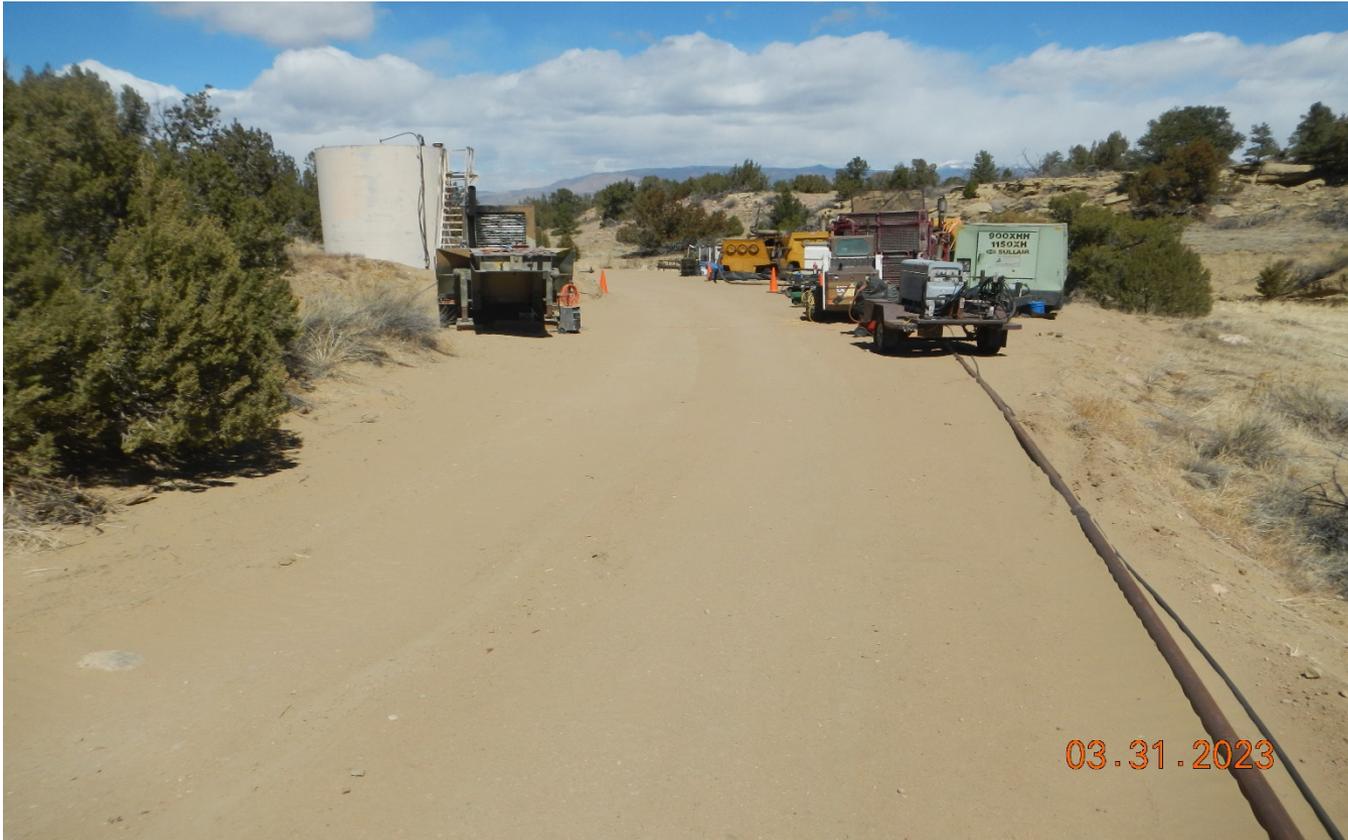
Photo 19. Facing back north toward the tank battery and where equipment is being stored. All unused equipment needs to be removed.

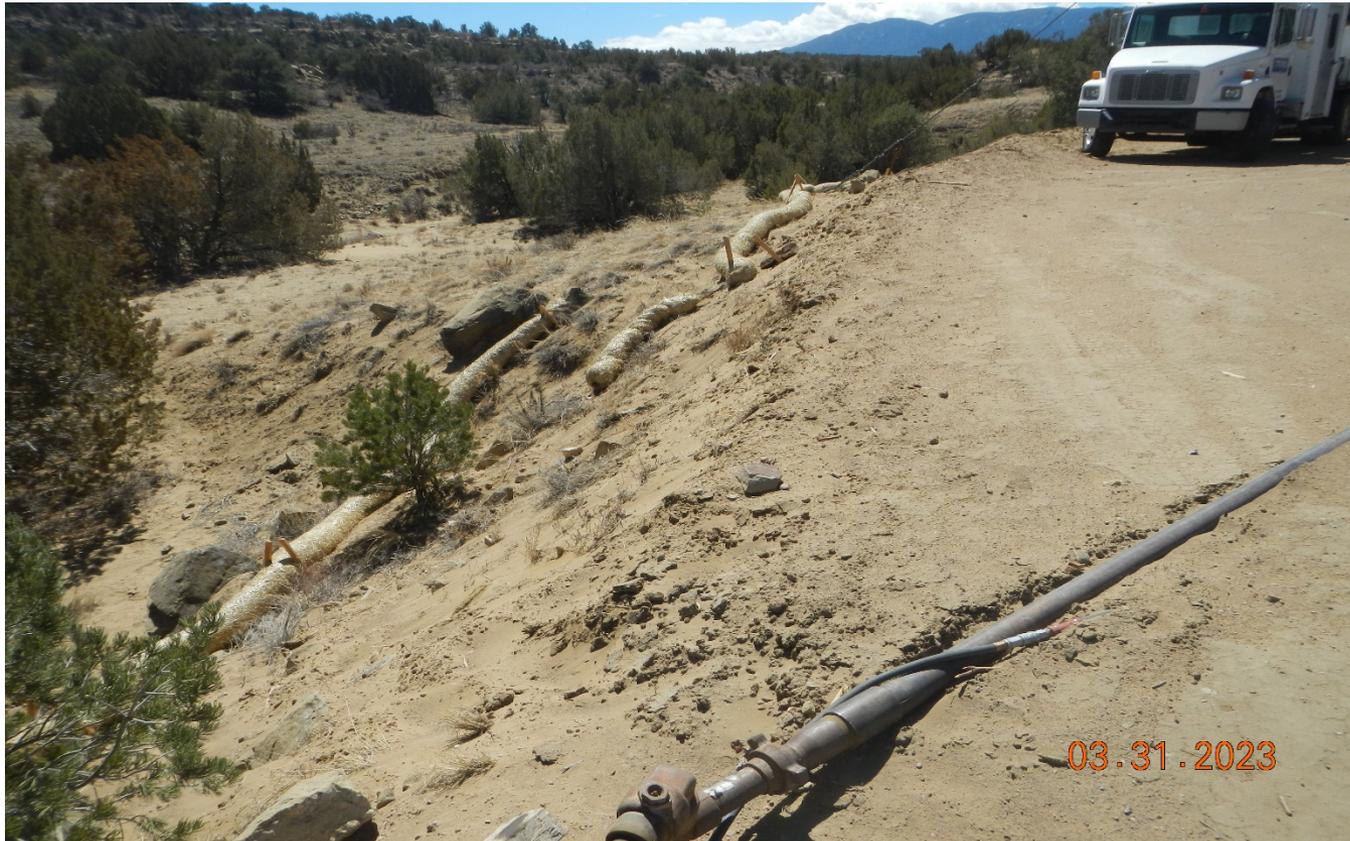
Photo 21. Facing southeast along the fill slope of the pad. There are wattles installed however they are not properly installed per good engineering practice. Wattles are not properly positioned, trenched, or staked down.

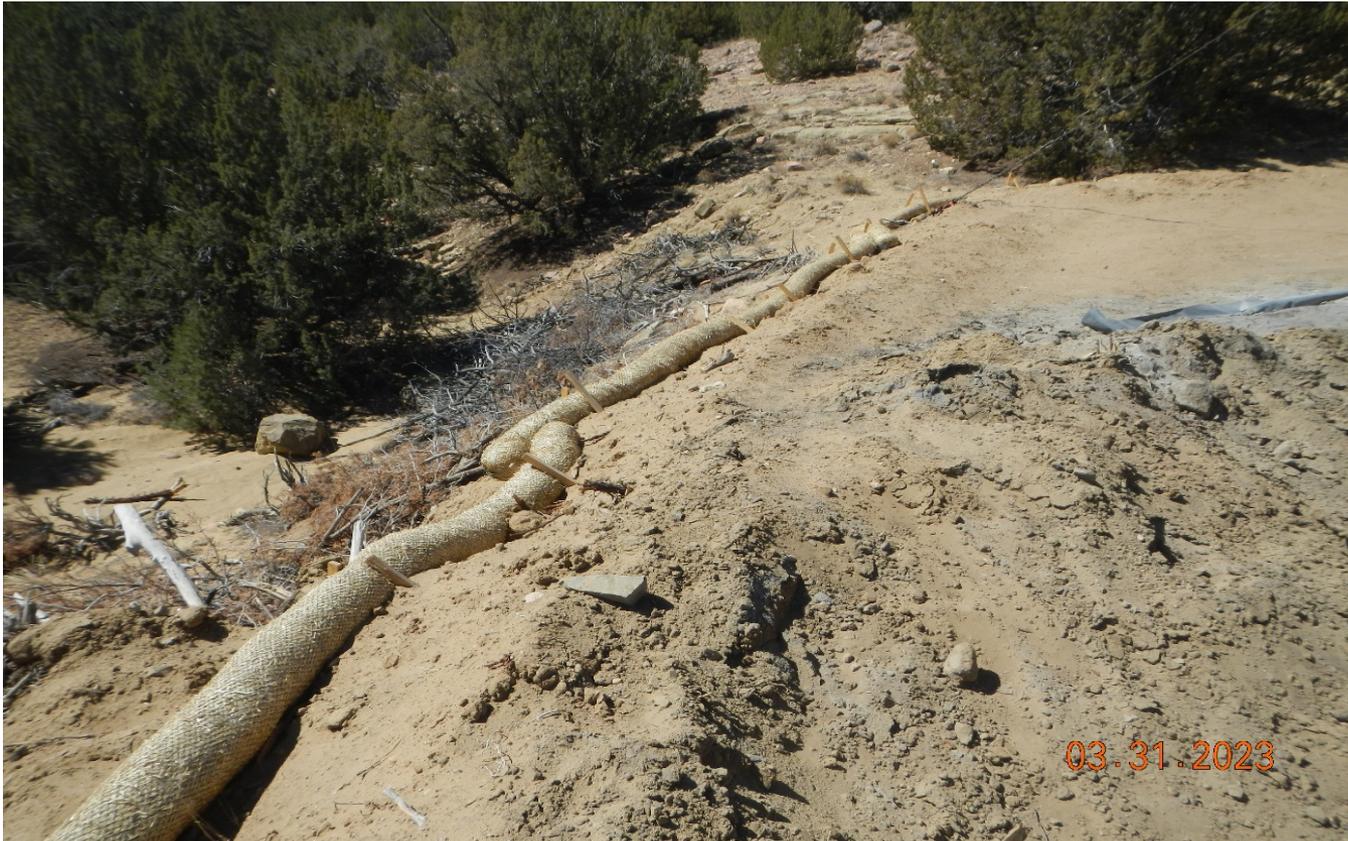
Photo 22. The wattle installed at the southern perimeter should have been positioned at the bottom of the slope to contain all loose soils that were pushed out and disturbed. BMP's need to be properly installed per good engineering practice.

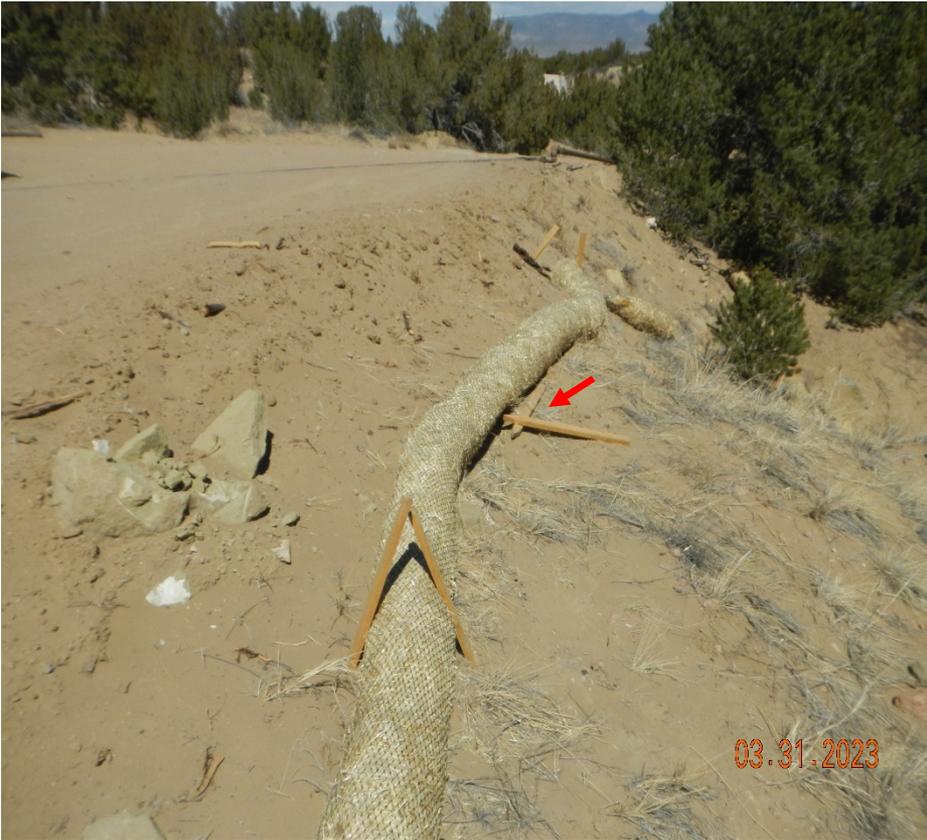
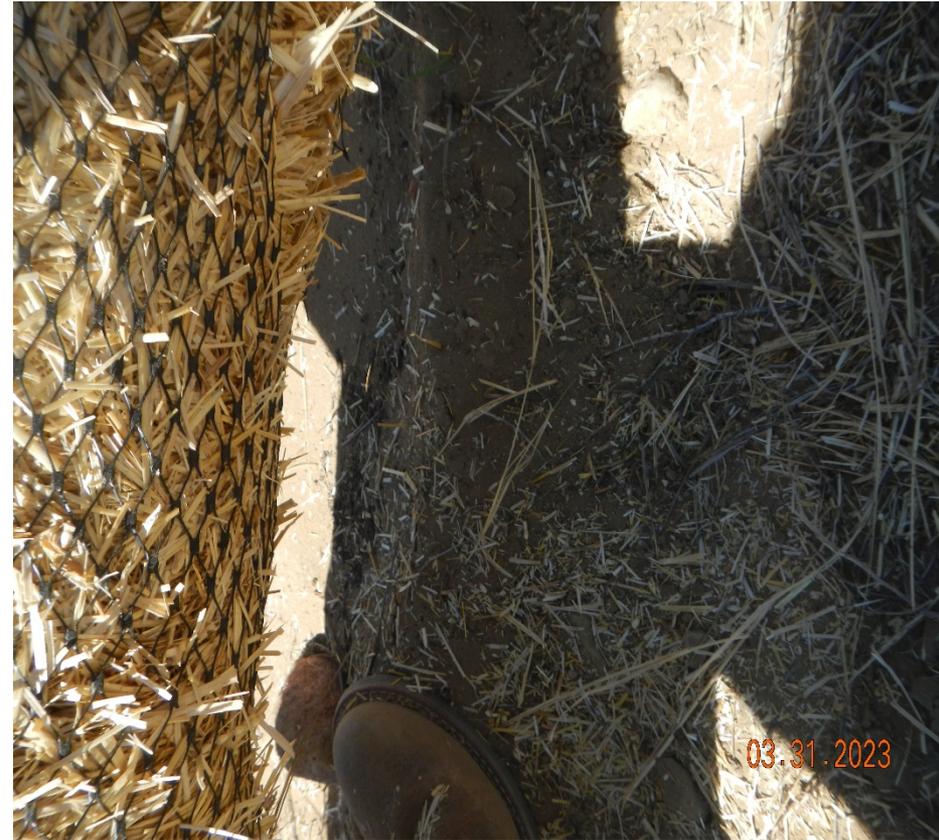
Photo 23 & 24. There is daylight underneath the wattles which shows in- proper installation. Wattles need to be trenched in and pack so stormwater wont undercut the wattles. The wattles are not properly staked down and stakes have fallen over at red arrow.

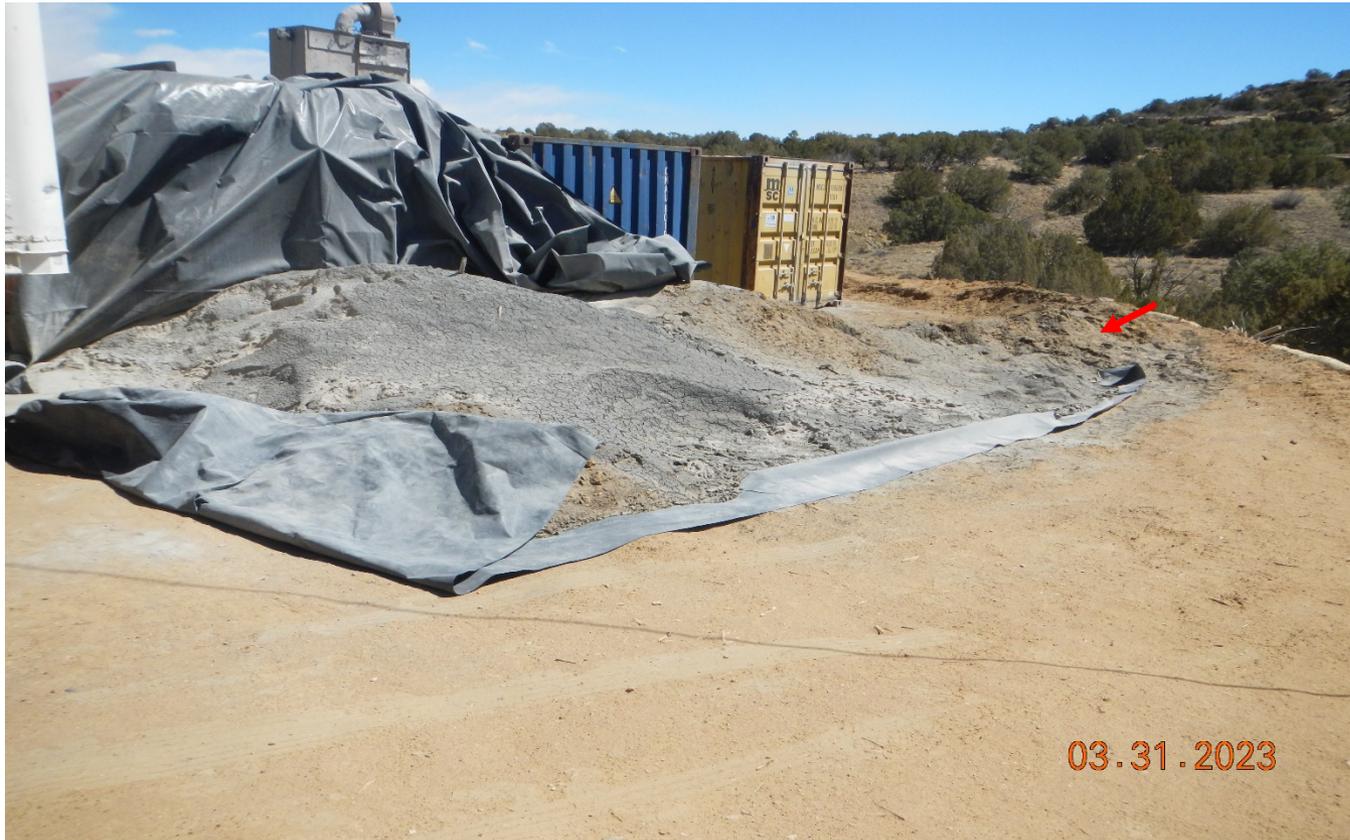
Photo 25. There is drill cuttings on the surface not properly stored and contained. The plastic liner does not contain the drill cutting from stormwater run-off and part of the cuttings at red arrow is not even off the edge of the liner.

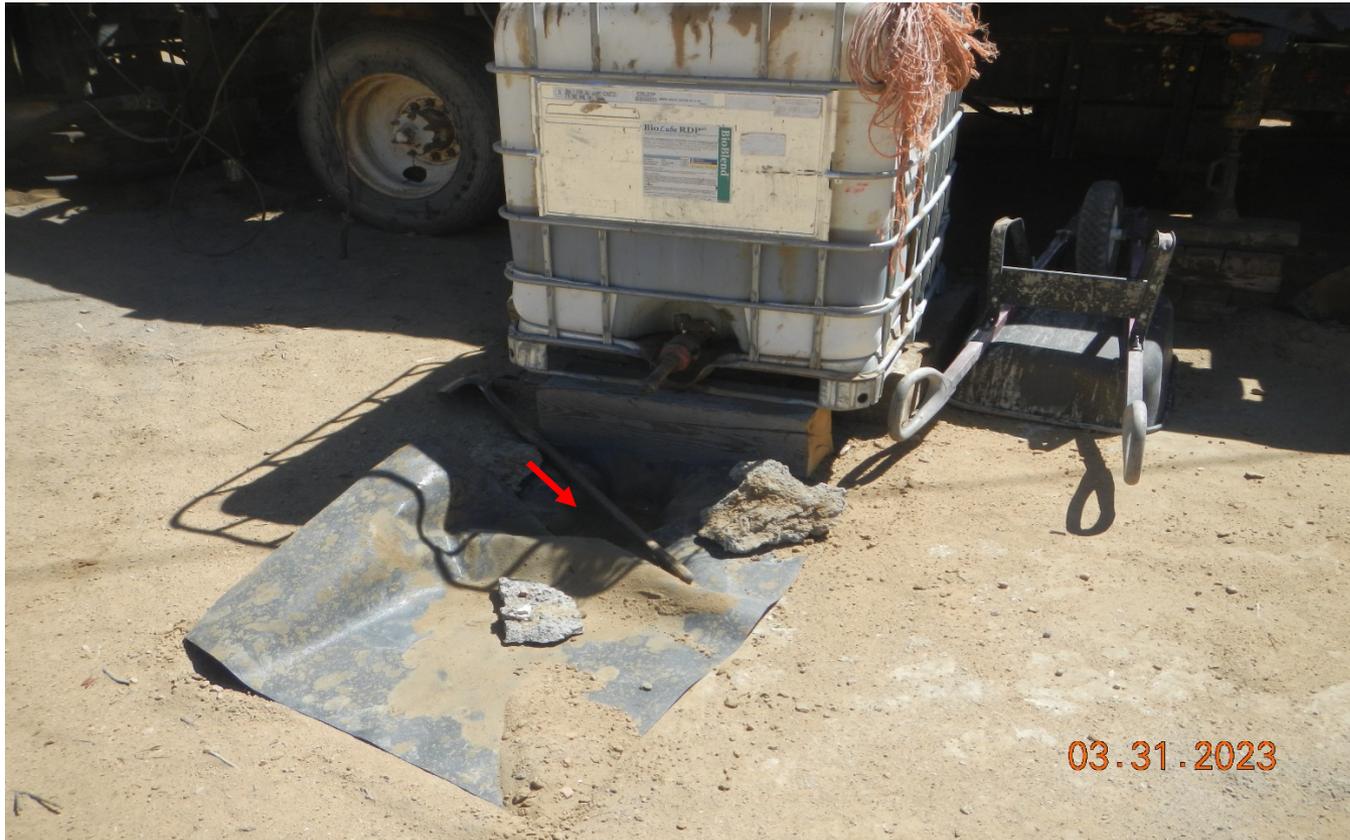
Photo 26. There is no containment for this chemical tote. A plastic liner was placed out the outlet which will not control a potential spill. Additionally there is a puddle of oily fluid at the outlet shown at red arrow.
