Inspection Photos

API: 043-06122

Operator: JAVERNICK OIL

Inspection Date: 3/31/2023

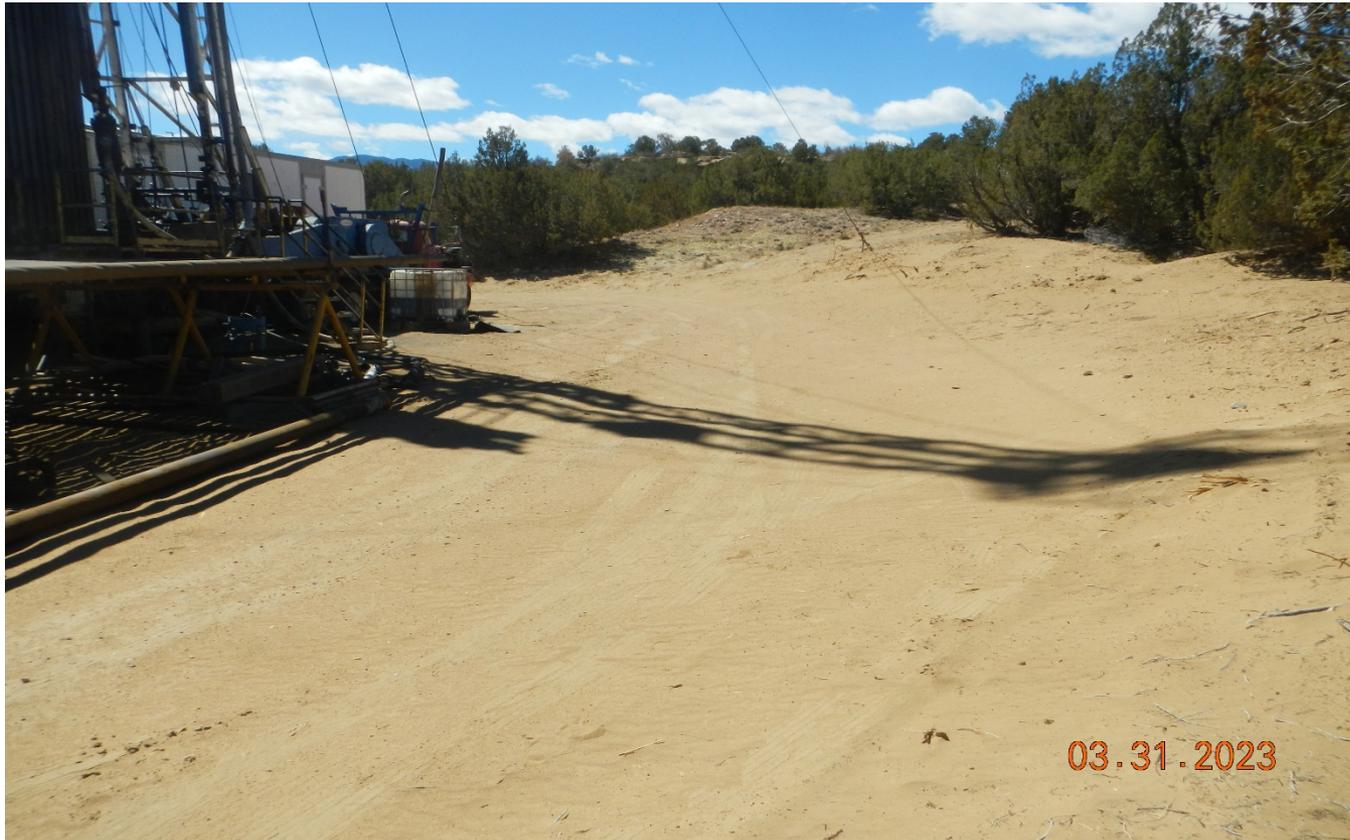
Photo 27. Facing southwest at the location. There are no stormwater run-on controls along the west side of the location.
