Inspection Photos

Location Name: TEP ROCKY MOUNTAIN LLC BATTLEMENT MESA-67S95W /5NWSE

Location ID: 334825

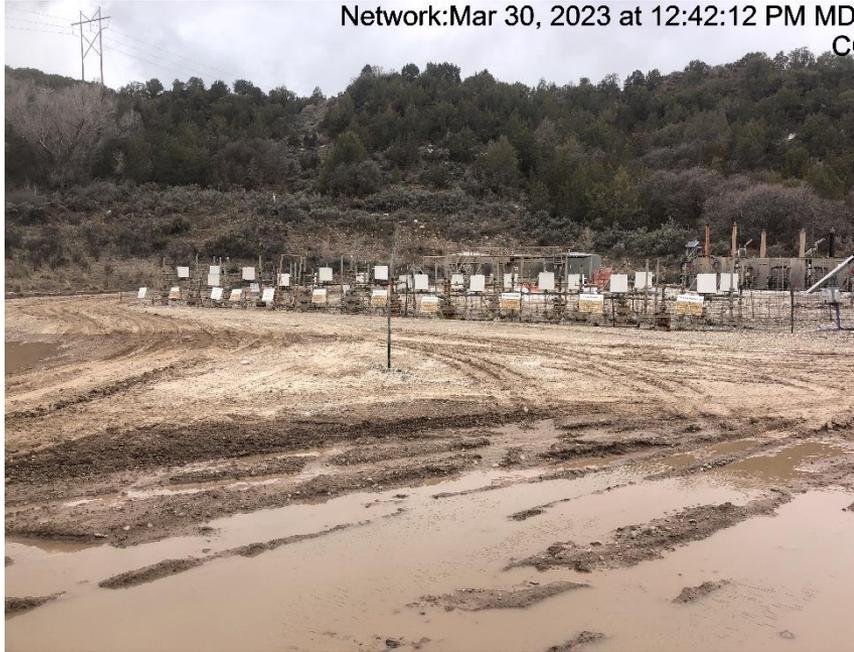
Photo #9432 From entrance to location.

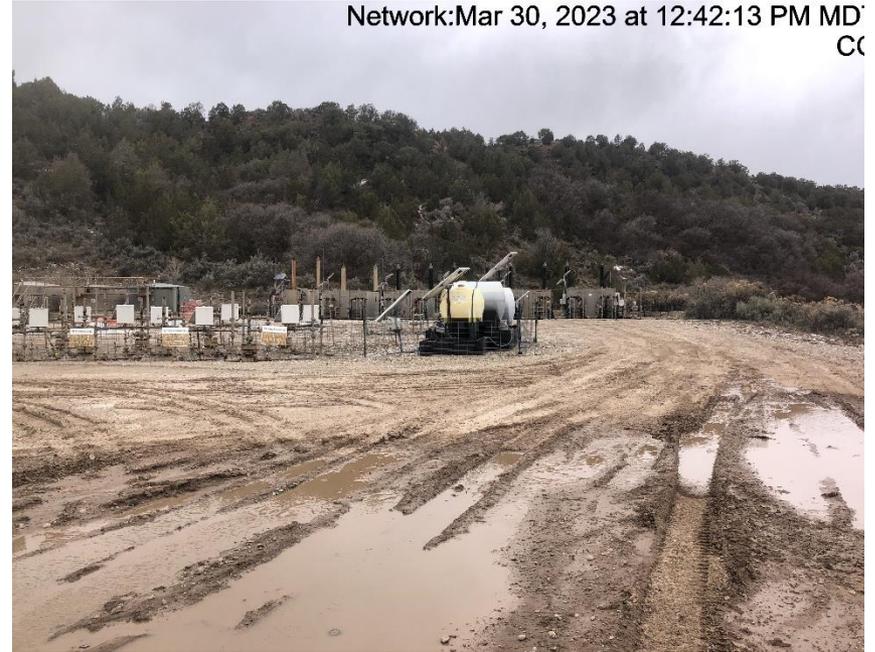
Photo #9433 From entrance to location

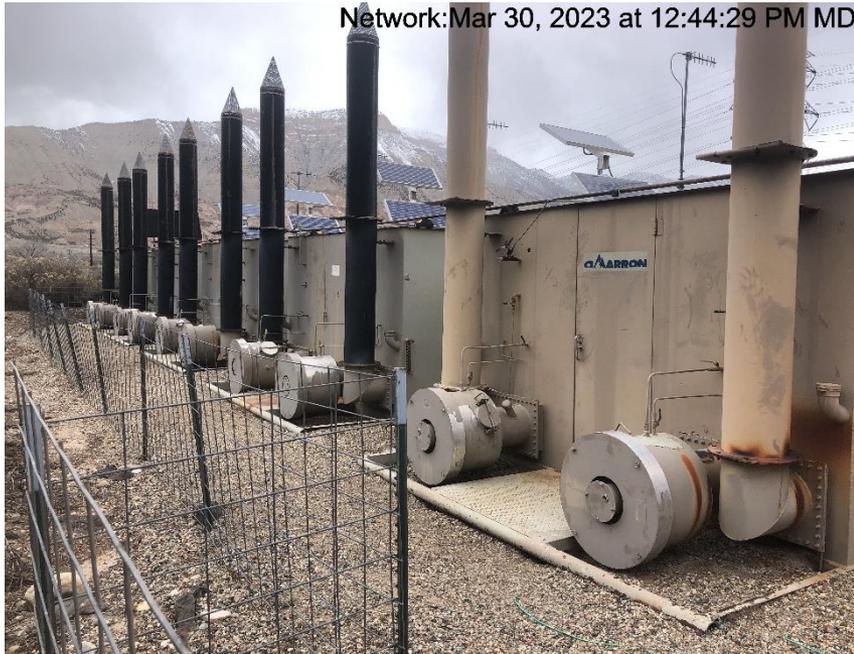
Photo #9435 Calibration cards not conspicuously posted

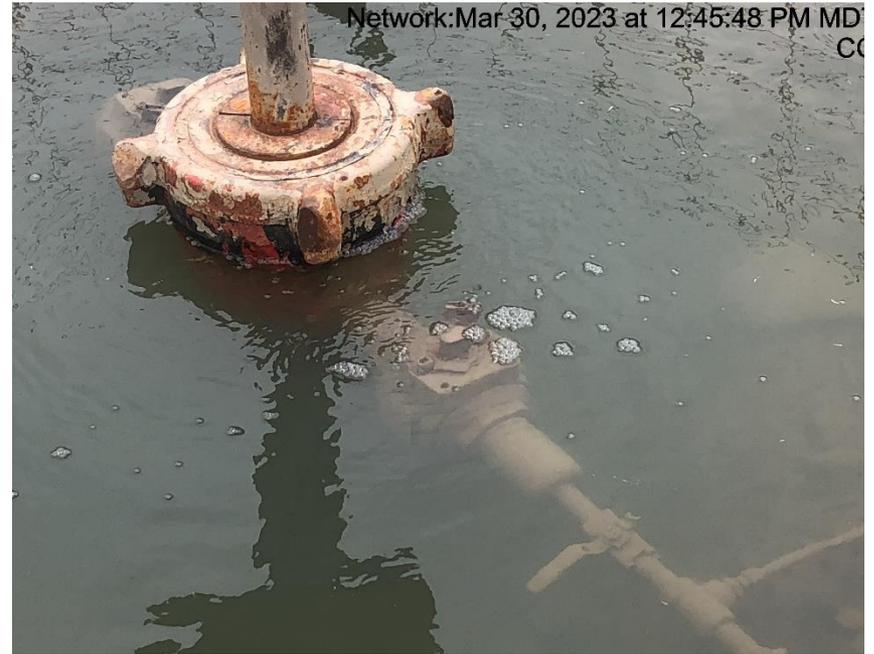
Photo #9444 Well W 15-5 wellhead leaking.

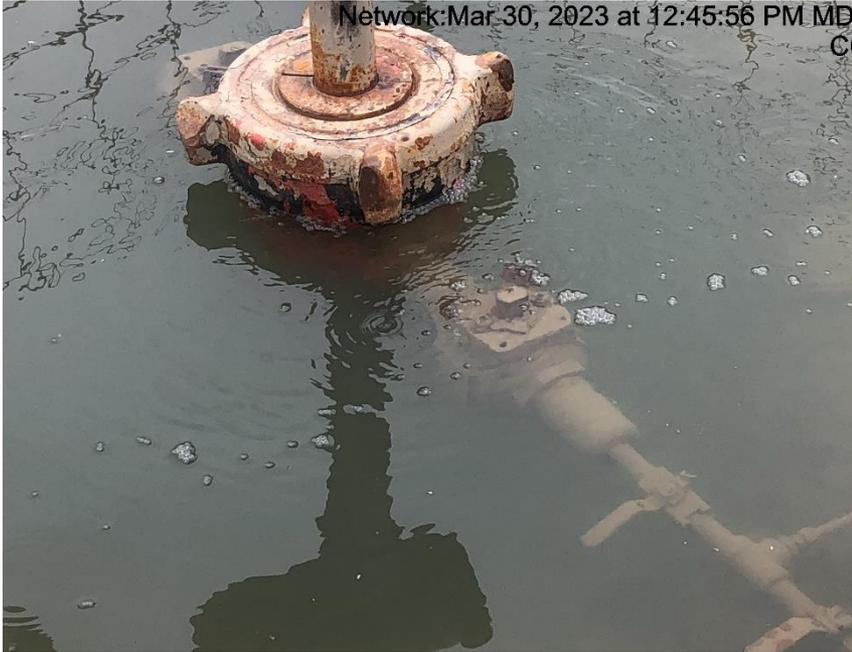
Photo #9445 Well W 15-5 wellhead leaking
