## Inspection Photos

Location Name: TEP ROCKY MOUNTAIN LLC CLOUGH RMV 137-27 pad

Location ID: 324122

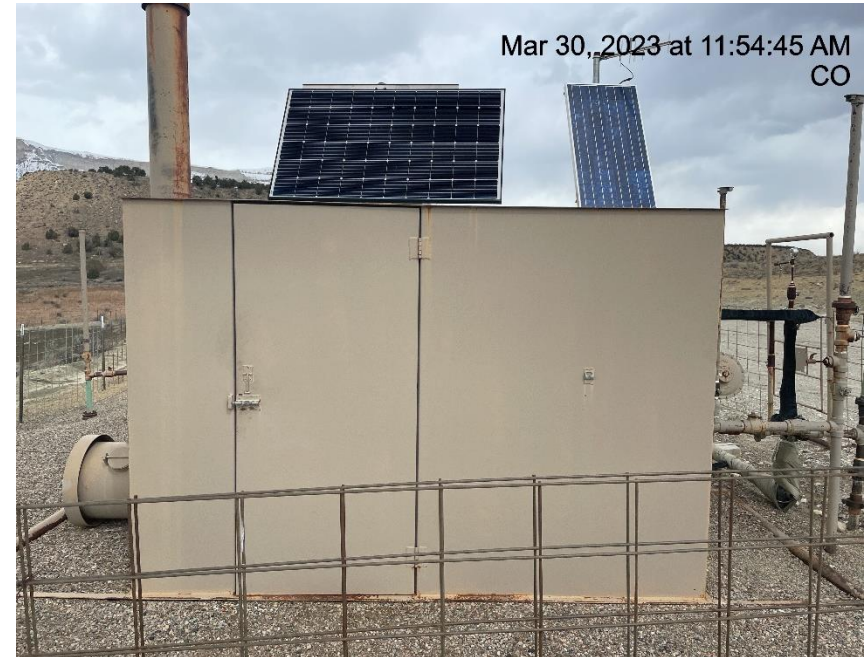
Photo # 3737 Meter calibration info not conspicuously posted

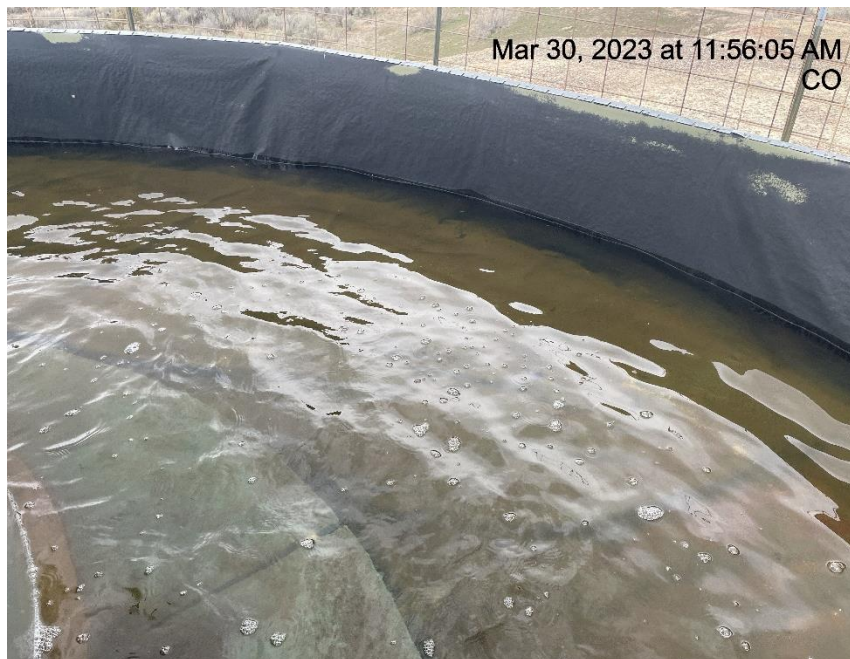
**Photo # 3738 Containment capacity inadequate**

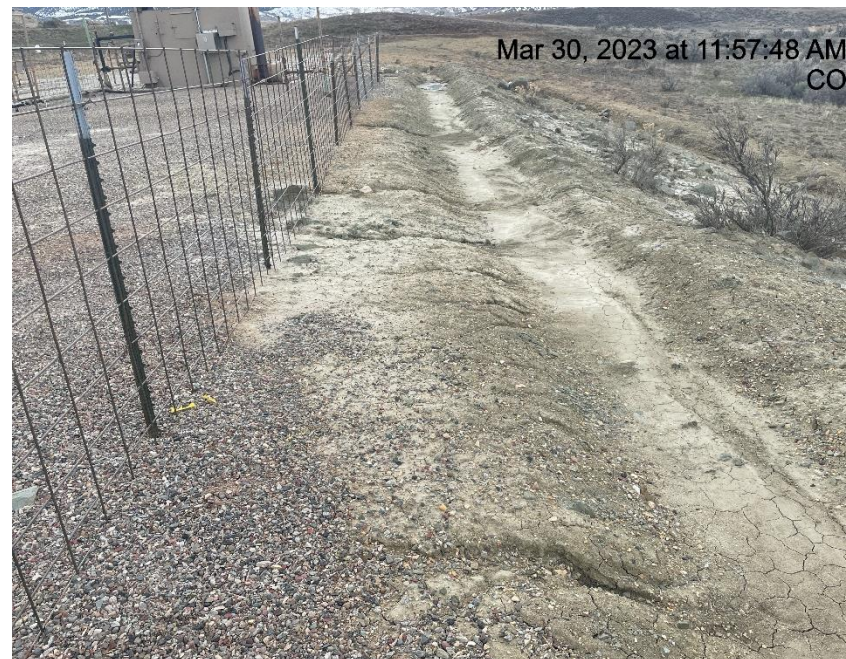
**Photo # 3739 Rill erosion & transport of sediment (NW area of location near production tank containment)**

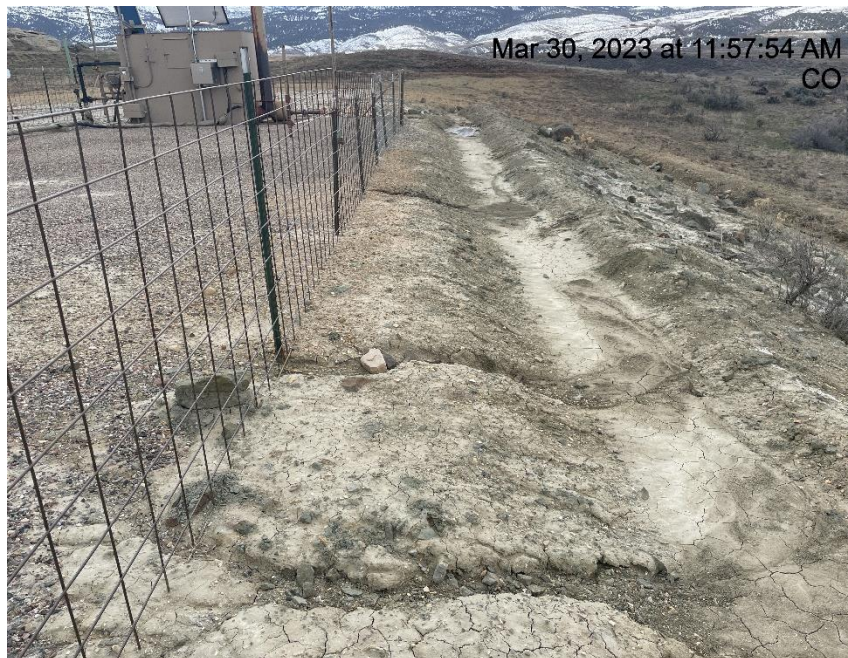
**Photo # 3740 Rill erosion & transport of sediment (NW area of location near production tank & containment)**

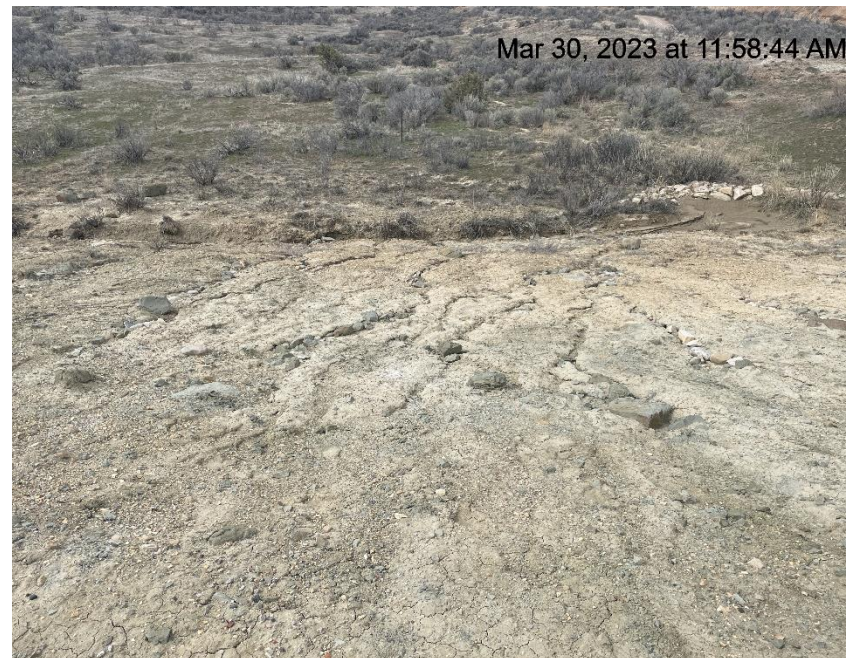
**Photo # 3742 Rill erosion & transport of sediment (NW area of location)**

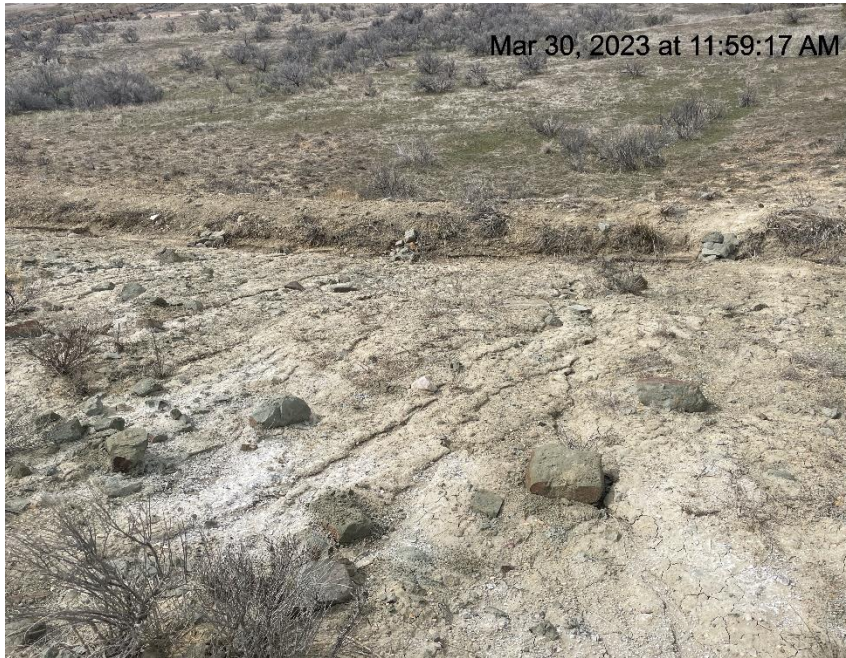
**Photo # 3745 Rill erosion & transport of sediment (NW area of location)**

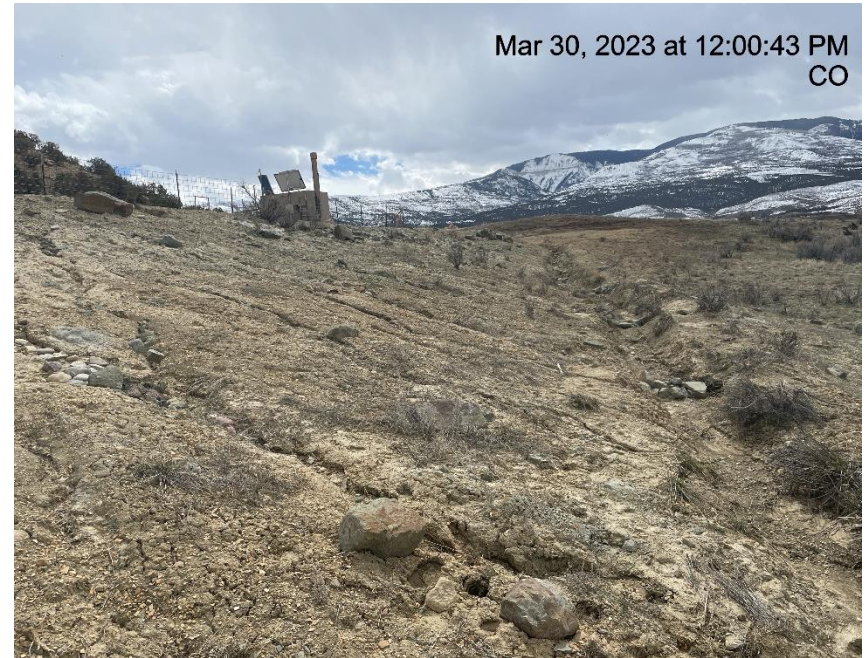
**Photo # 3746 Rill erosion & transport of sediment (NW area of location)**

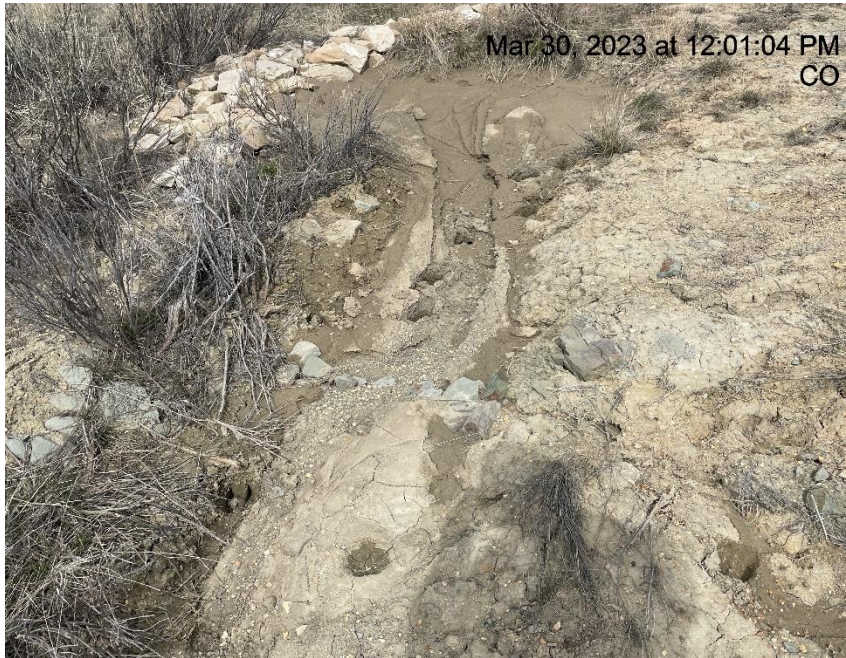
**Photo # 3748 Sediment Trap needs maintenance (NW area of location)**

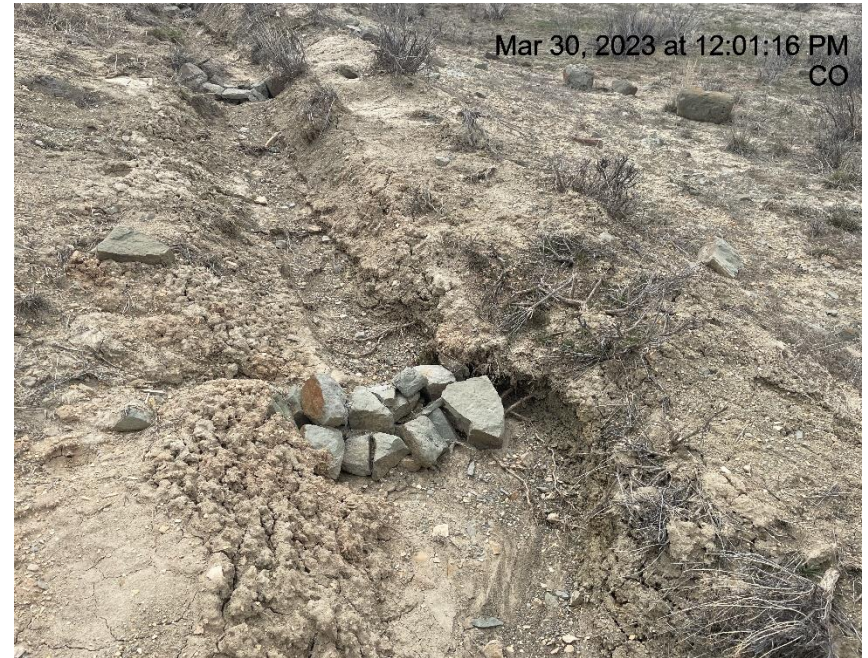
**Photo # 3749 Check dam needs maintenance (NW area near sediment trap)**

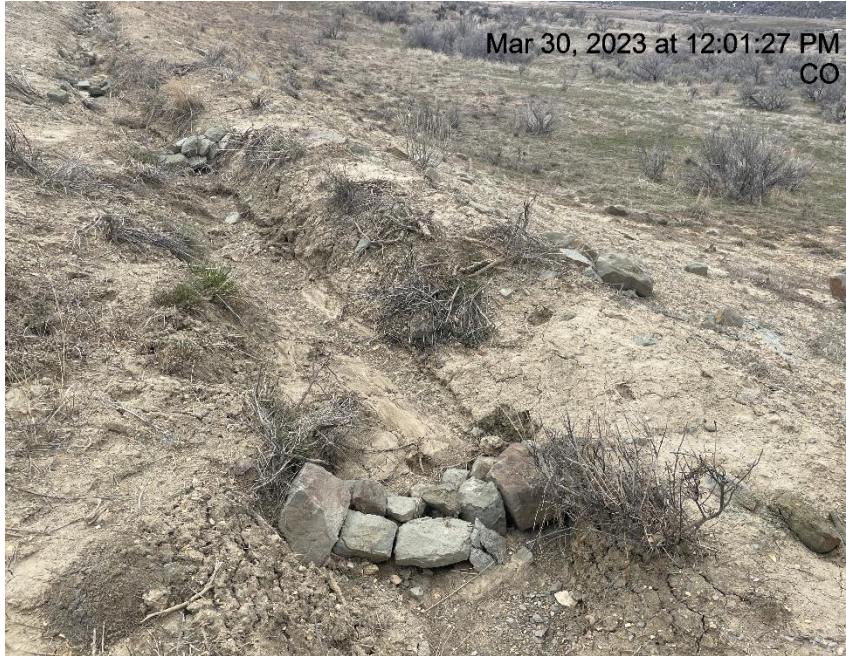
**Photo # 3750 Check dam needs maintenance (NW area near sediment trap)**

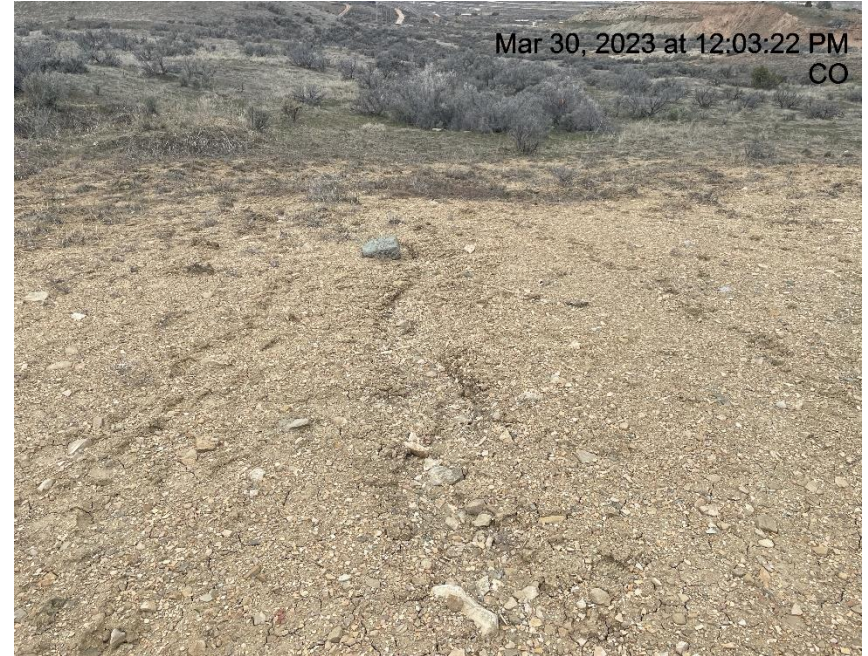
**Photo # 3753 Rill erosion & transport of sediment (SW area of location)**

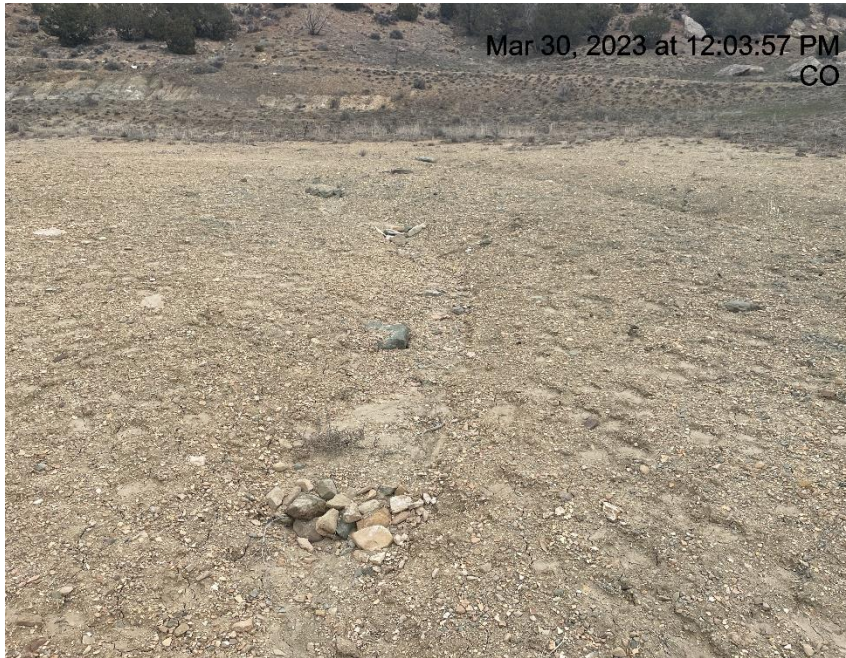
**Photo # 3754 Check dam needs maintenance**

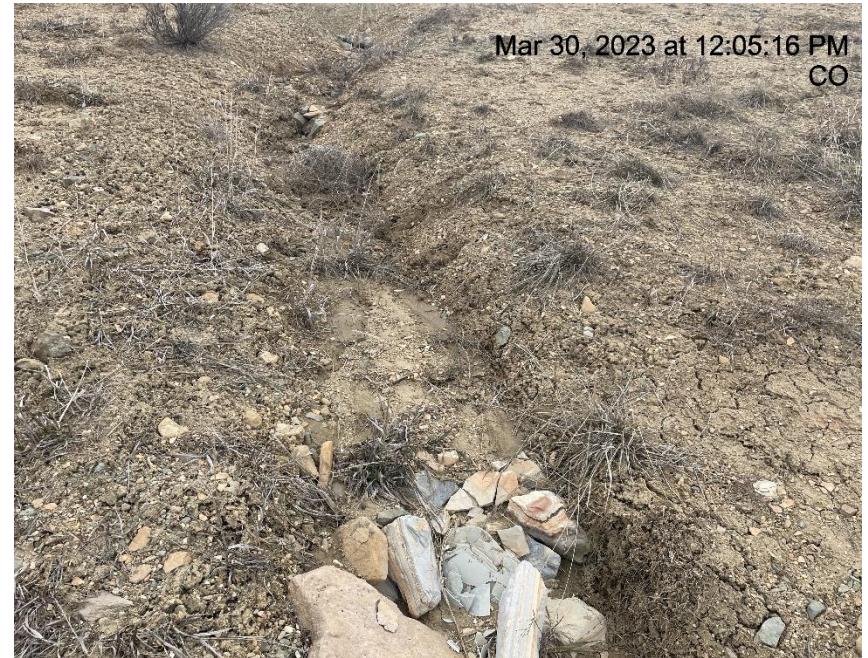
**Photo # 3758 Check dam needs maintenance (SW area of location)**

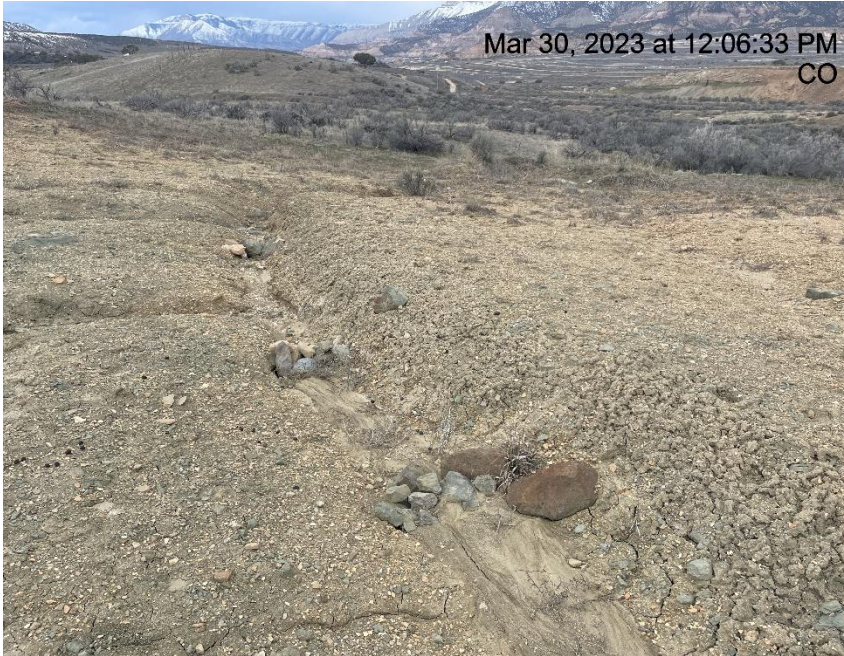
**Photo # 3760 Check dam needs maintenance (SW area of location)**

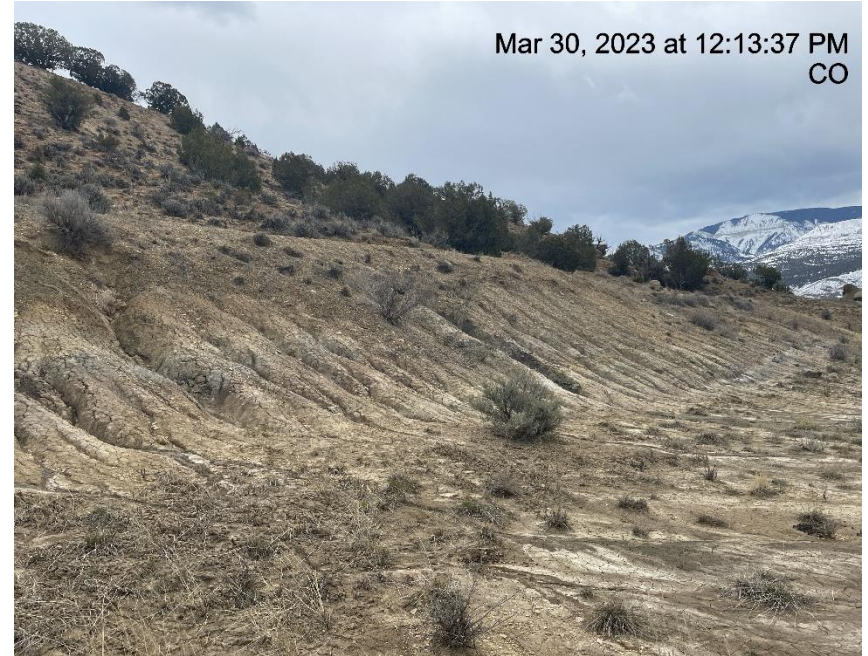
**Photo # 3763 Lack of stabilization/Rill & Gully erosion/transport of sediment onto location/insufficient run on controls/BMP's (East side of location on slope)**

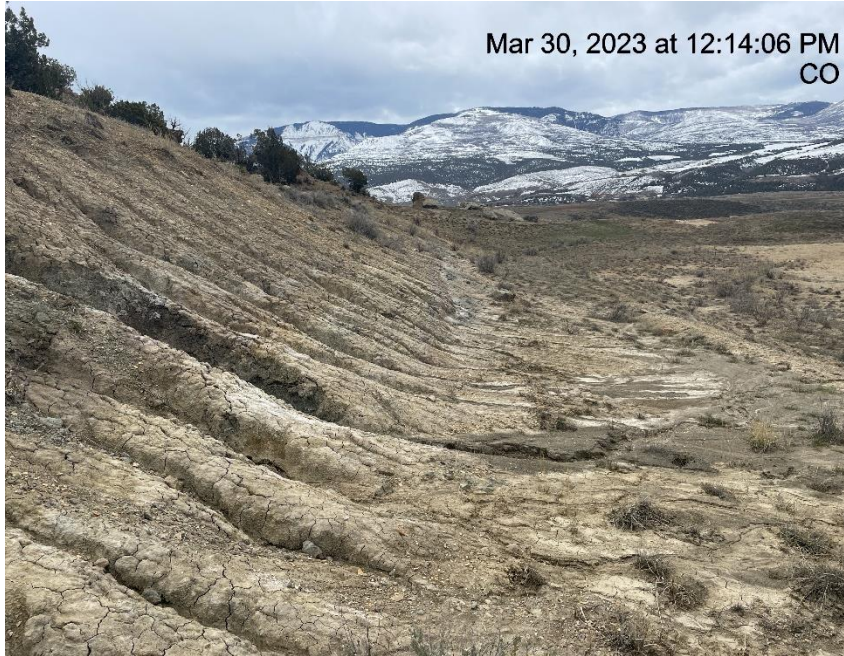
**Photo # 3764 Lack of stabilization/Rill & Gully erosion/transport of sediment onto location/insufficient run on controls/BMP's (East side of location on slope)**

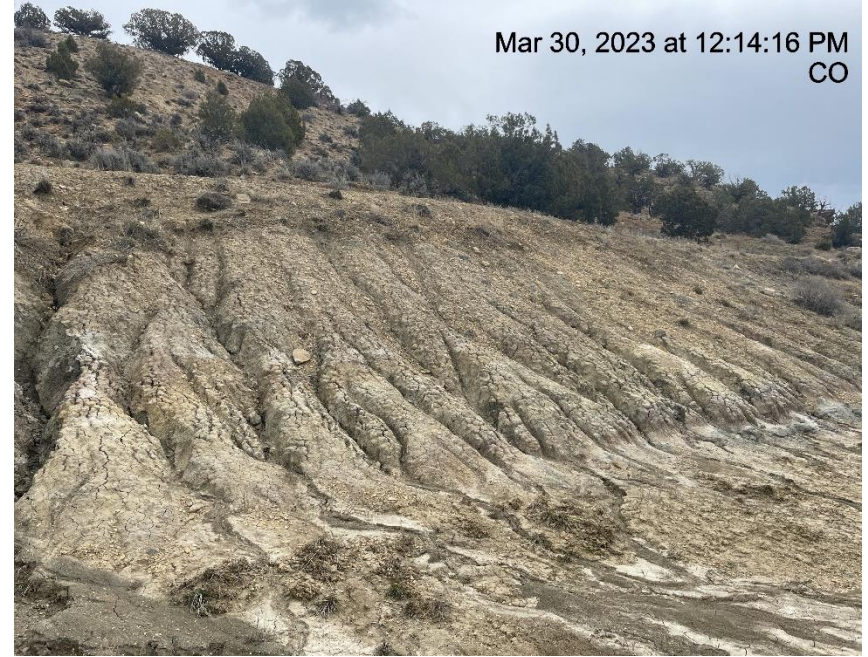
**Photo # 3765 Lack of stabilization/Rill & Gully erosion/transport of sediment onto location/insufficient run on controls/BMP's (East side of location on slope)**

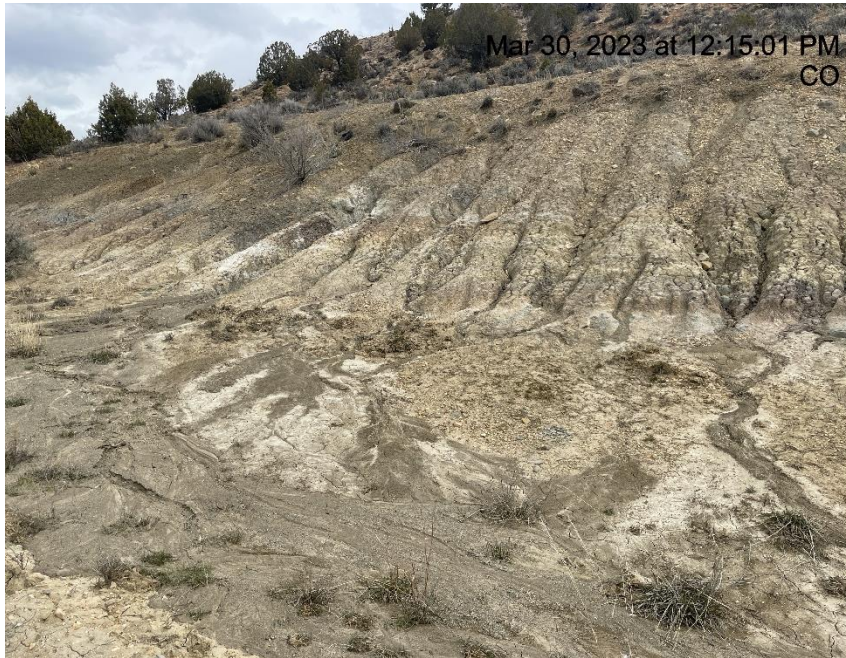
**Photo # 3766 Lack of stabilization/Rill & Gully erosion/transport of sediment onto location/insufficient run on controls/BMP's (East side of location on slope)**

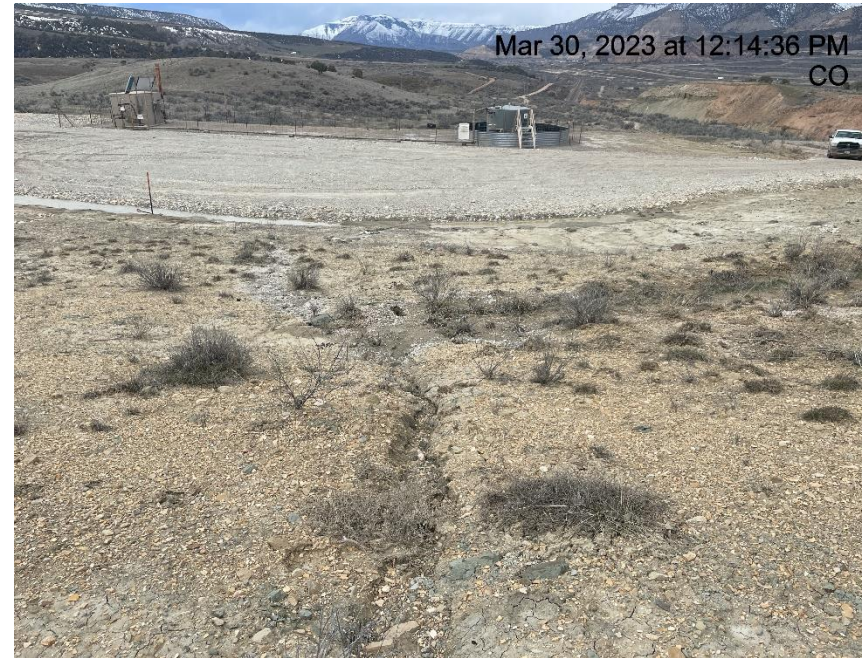
**Photo # 3767 Rill erosion (NE area of location)**

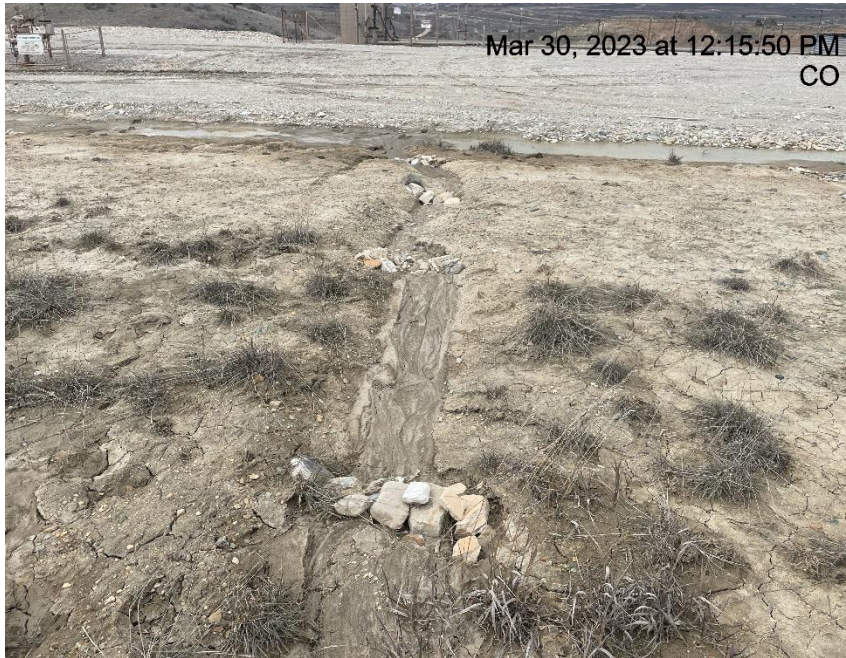
**Photo # 3769 Check dam needs maintenance (NE area of location)**

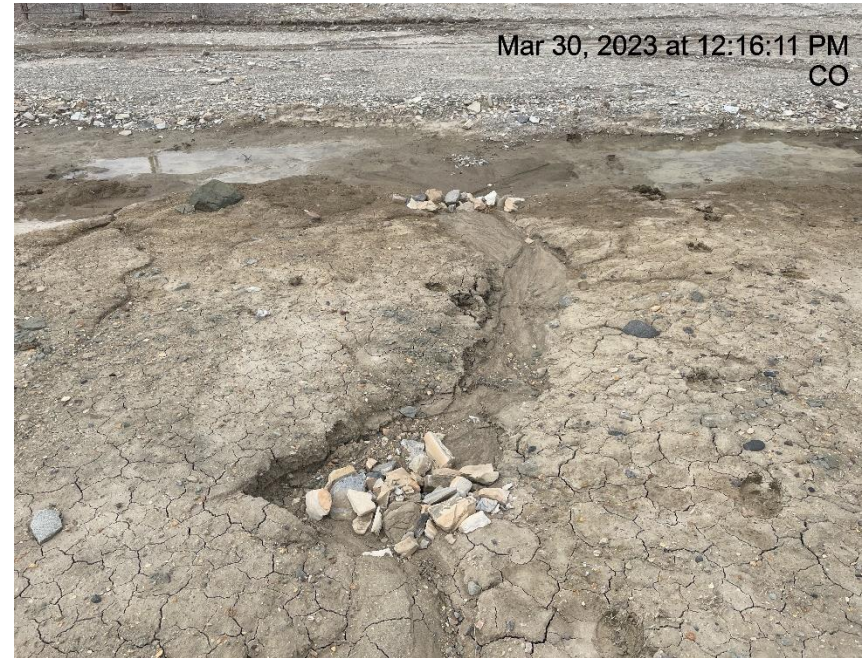
**Photo # 3770 Check dam needs maintenance (NE area of location)**

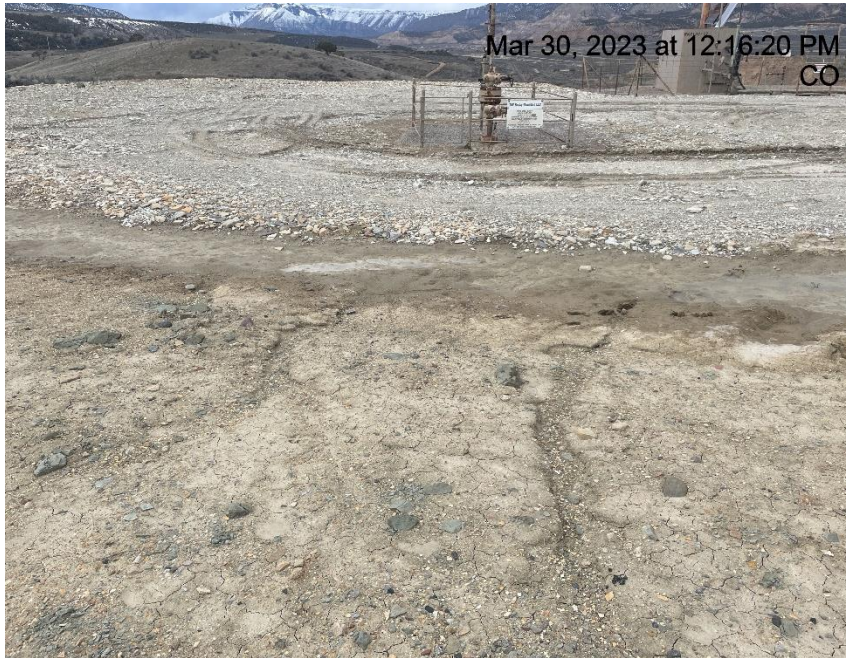
Photo # 3771 Rill erosion (SE area of location)

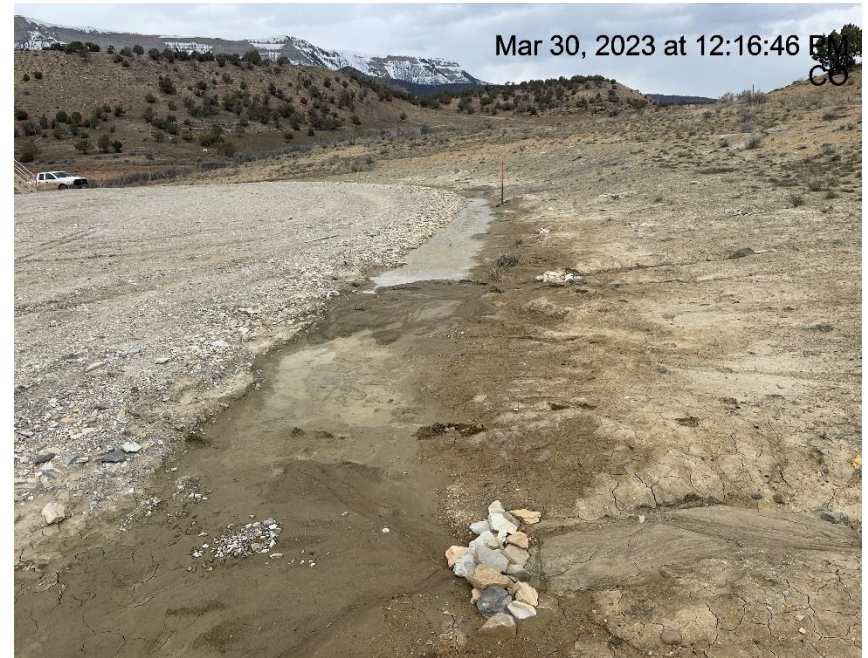
Photo # 3773 Check dam & ditch need maintenance (East side of location)

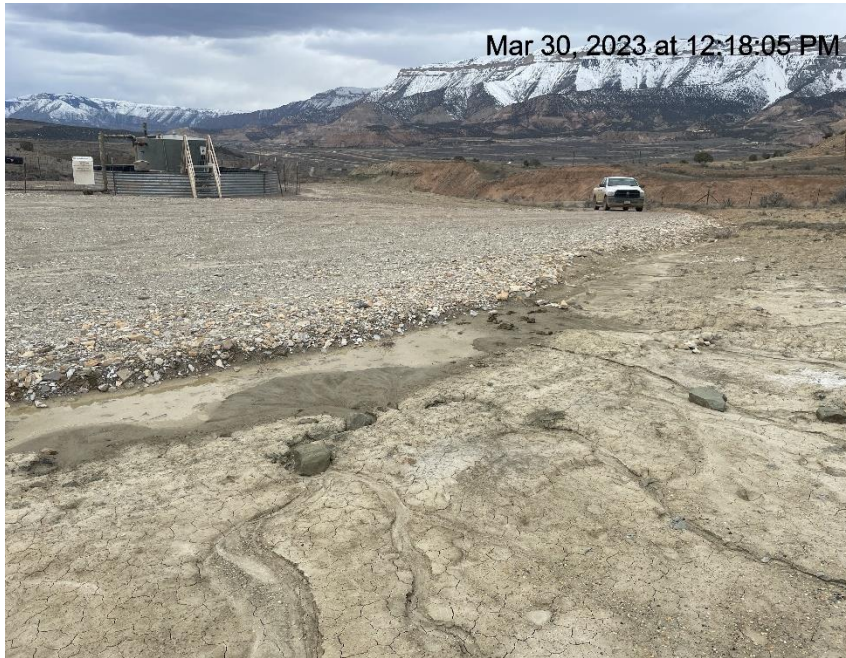
**Photo # 3778 Rill erosion (NE area of location)**

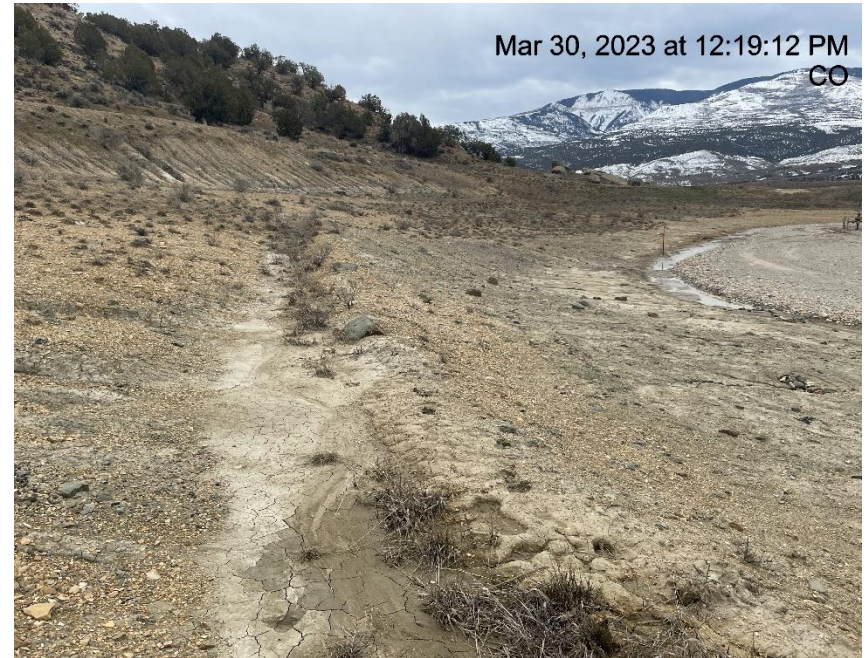
**Photo # 3779 Ditch needs maintenance (NE area of location)**

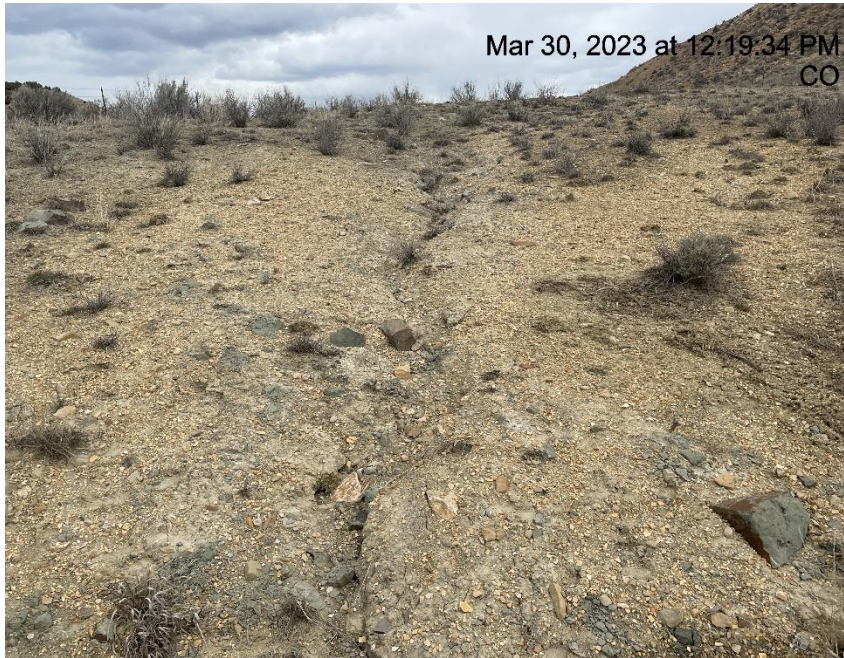
Photo # 3780 Rill erosion (NE area of location)

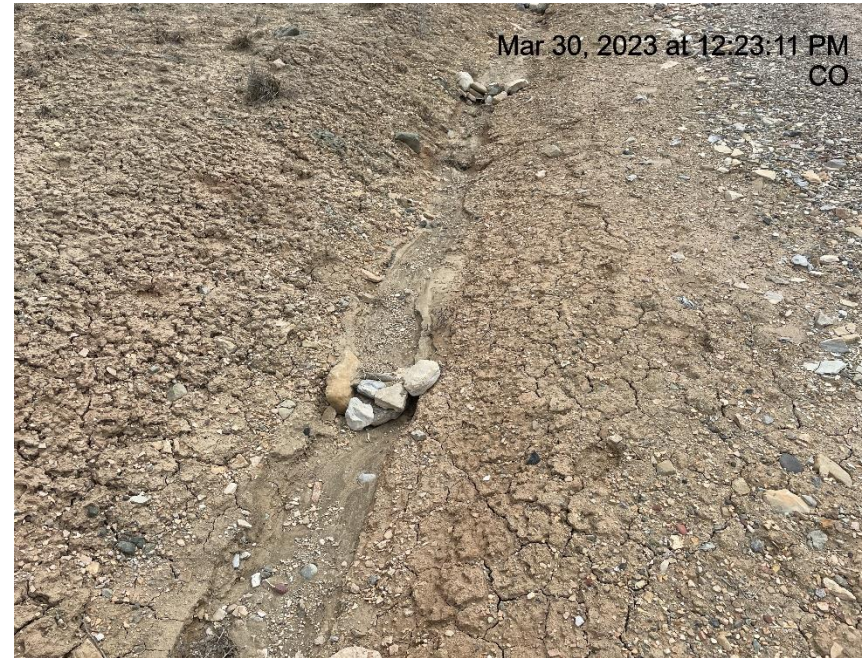
Photo # 3782 Check dam needs maintenance (NE area of location)

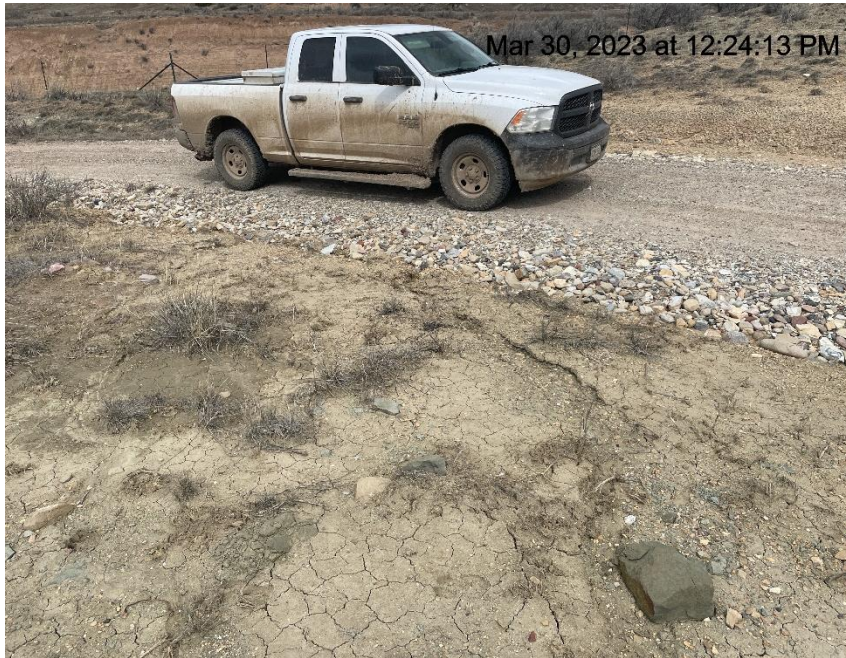
**Photo # 3783 Rill erosion (NW area of location near entrance)**

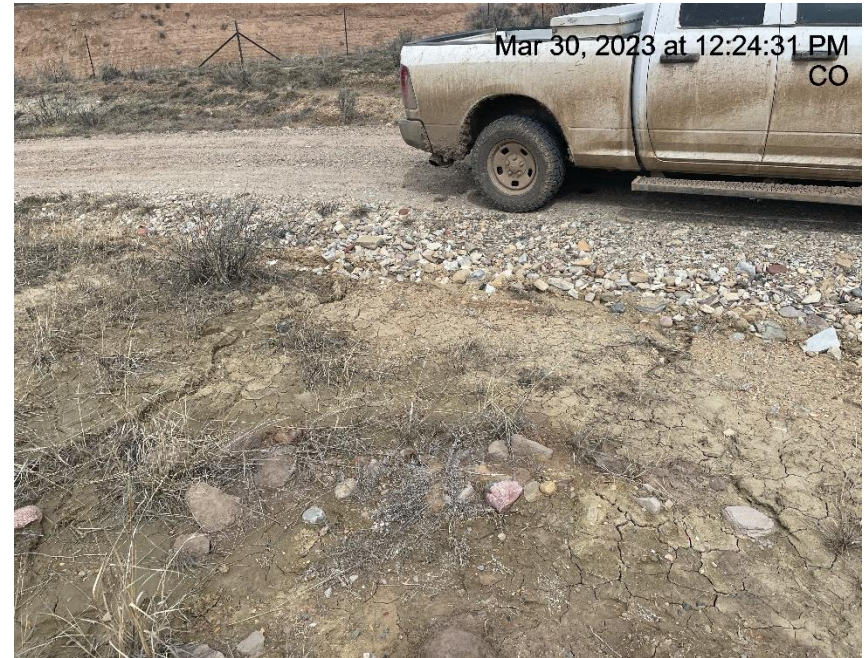
**Photo # 3784 Rill erosion (NW area of location near entrance)**

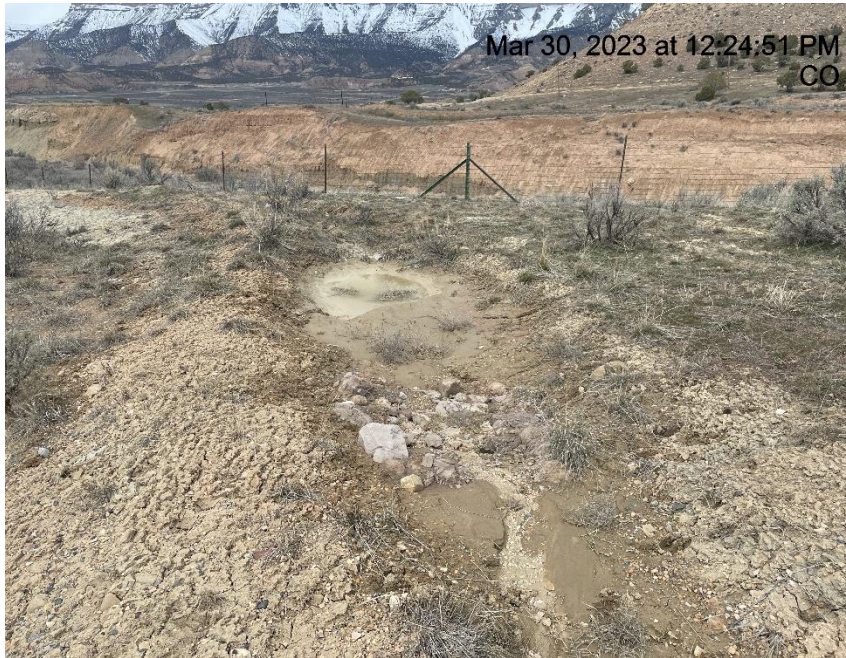
**Photo # 3785 Sediment trap needs maintenance (North side of spur road approximately 60 yards from location)**

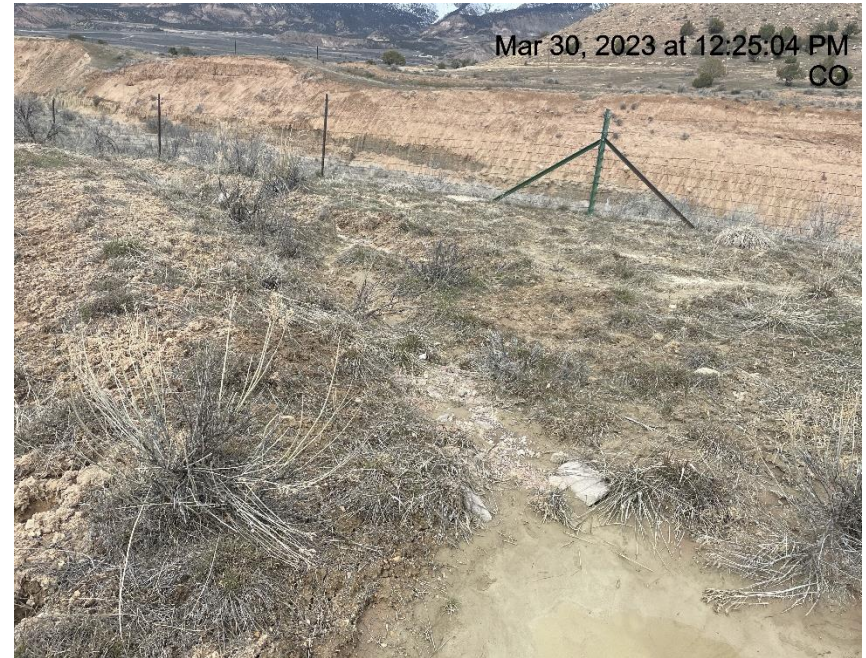
**Photo # 3786 Sediment trap needs maintenance (North side of spur road approximately 60 yards from location)**

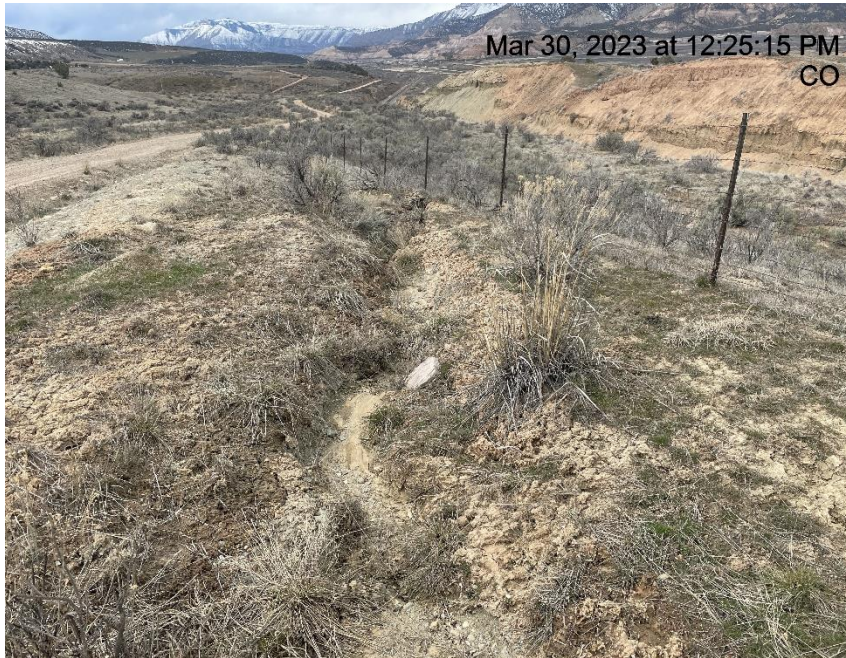
**Photo # 3787 Ditch coming out sediment trap/insufficient run off controls/BMP's/erosion & transport of sediment**

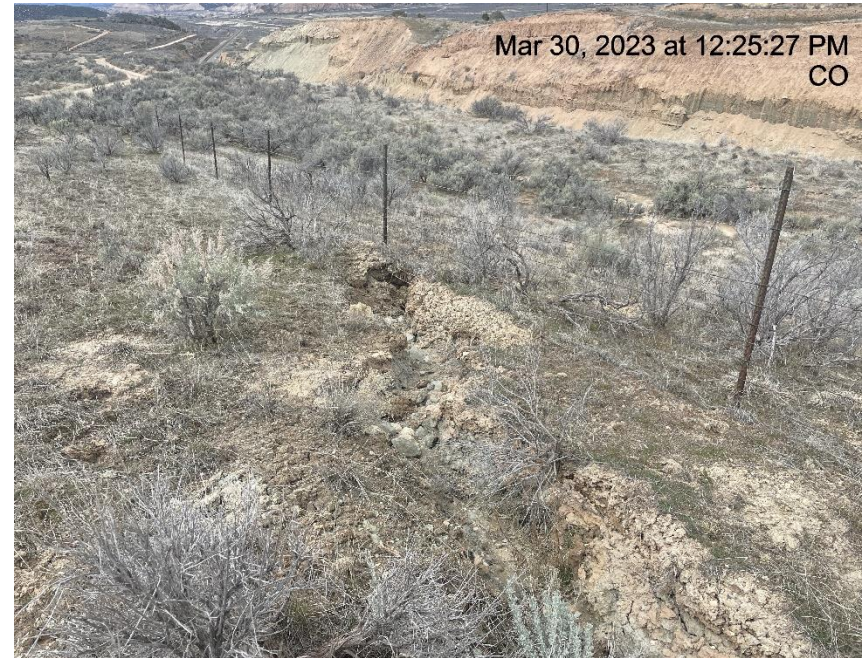
**Photo # 3788 Ditch coming out sediment trap/insufficient run off controls/BMP's/erosion & transport of sediment**

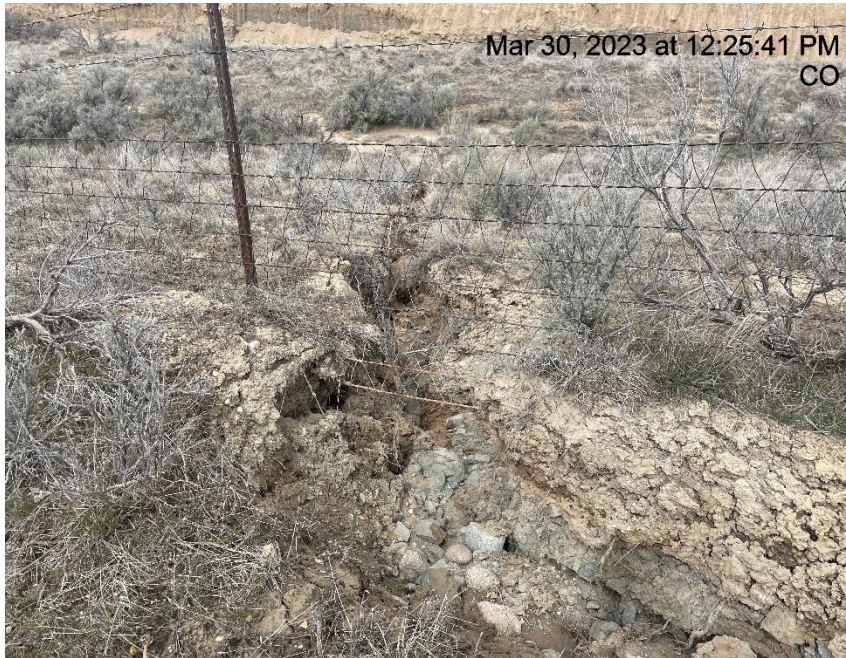
**Photo # 3789 Ditch coming out sediment trap/insufficient run off controls/BMP's/erosion & transport of sediment**

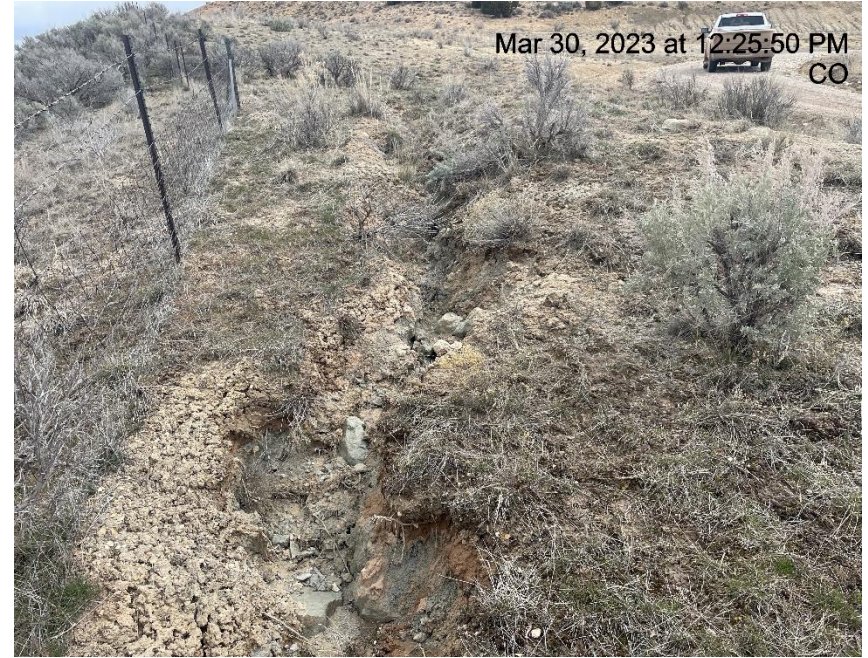
**Photo # 3790 Ditch coming out sediment trap/insufficient run off controls/BMP's/erosion & transport of sediment**

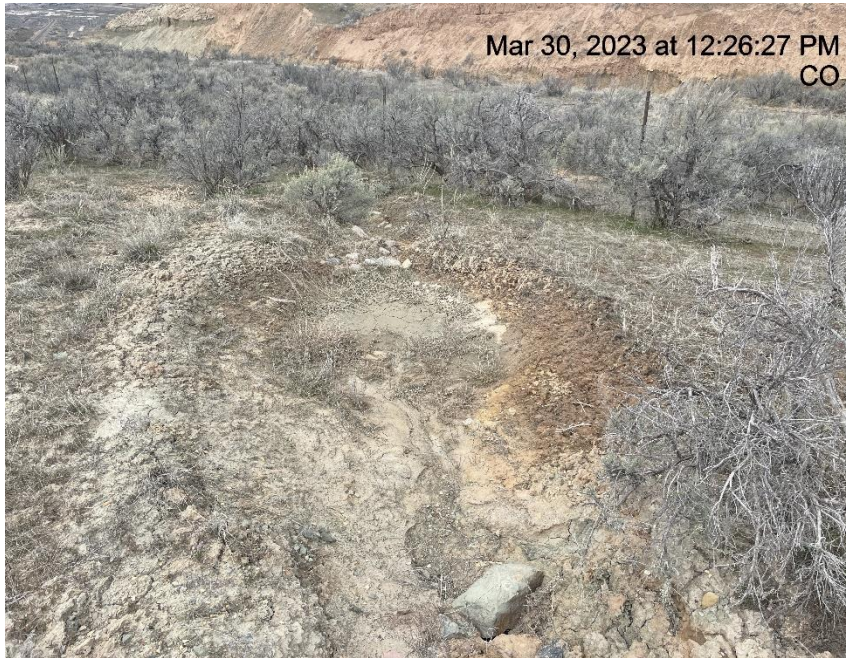
**Photo # 3791 Sediment trap needs maintenance (North side of spur road approximately 150-200 yards from entrance to location)**

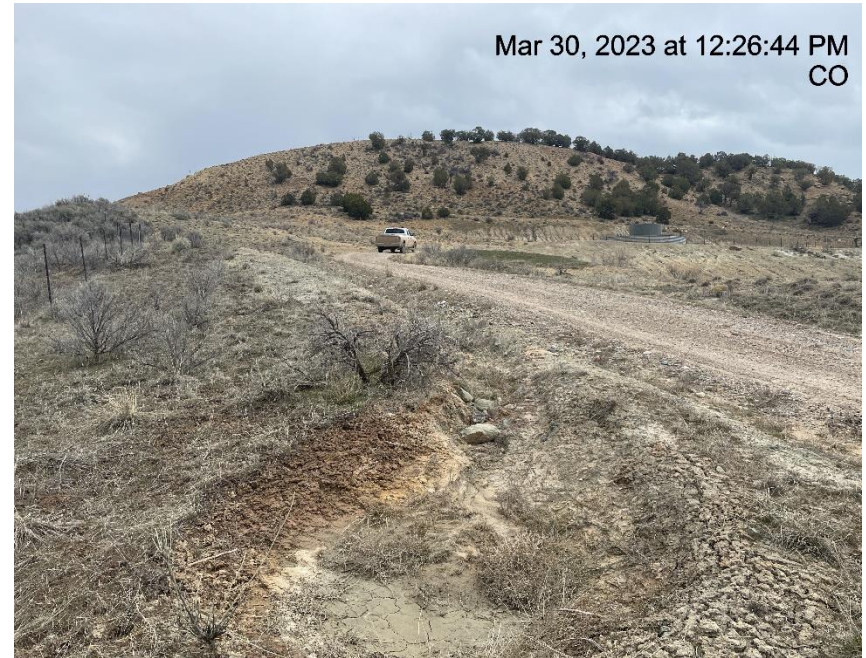
**Photo # 3792 Sediment trap needs maintenance (North side of spur road approximately 150-200 yards from entrance to location)**
