# Inspection Photos

API: 043-06059

Operator: JAVERNICK OIL

Inspection Date: 3/31/2023

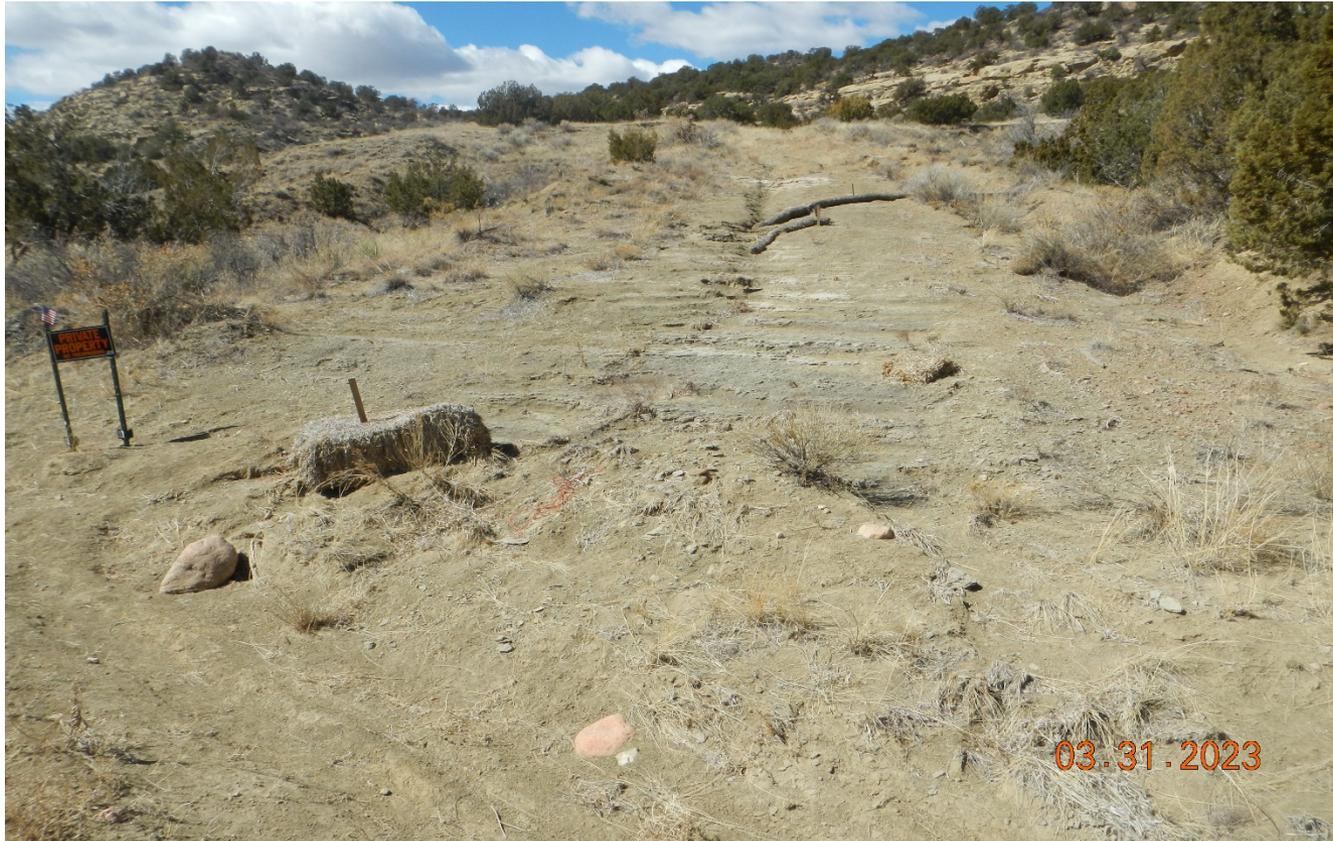
**Photo 1.** Facing southwest toward the former access road. This area is not stabilized with vegetation and there is erosion has occurred. It appears topsoil has been scoured off this area of the former road.

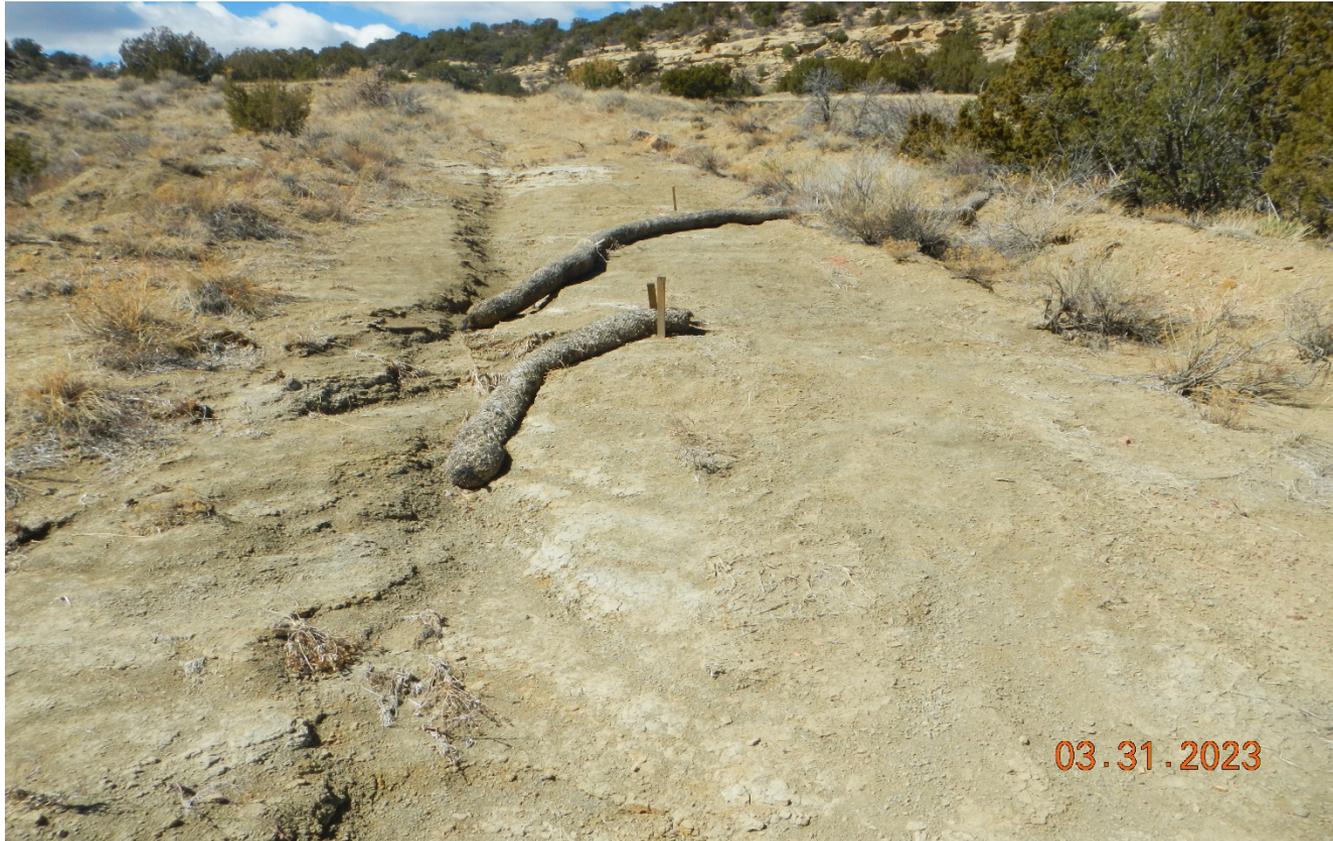
**Photo 2.** Facing southwest toward the former access road. There were temporary erosion controls installed which have washed out. This area of the access road needs to be reclaimed and stabilized for long term stabilization.

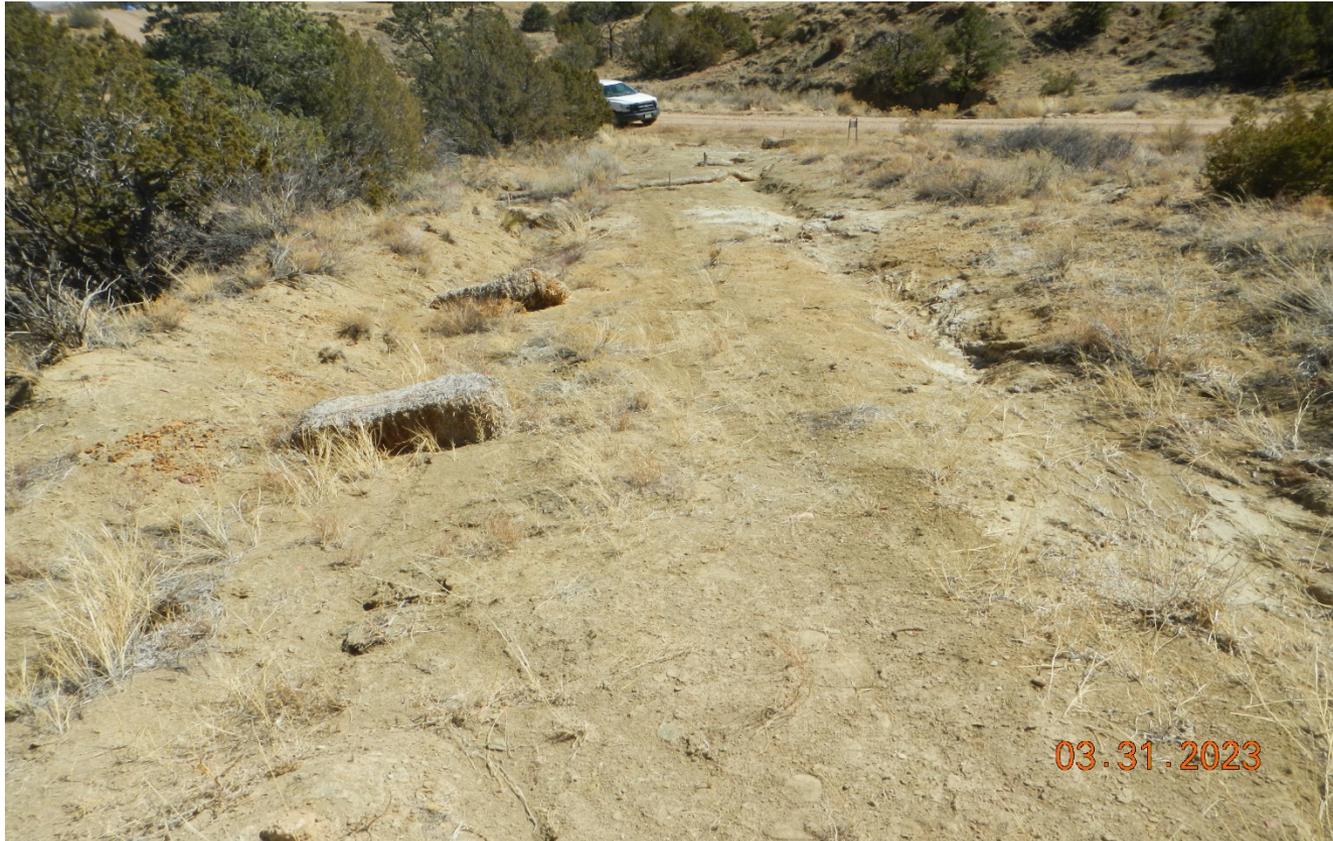
**Photo 3.** Facing back down the access road. There is stormwater erosion occurring on both side of the former road. Straw bales were placed on the left side and not staked in. The bales are degrading and are insufficient. This area needs to be reclaimed and stabilized for long term stabilization.

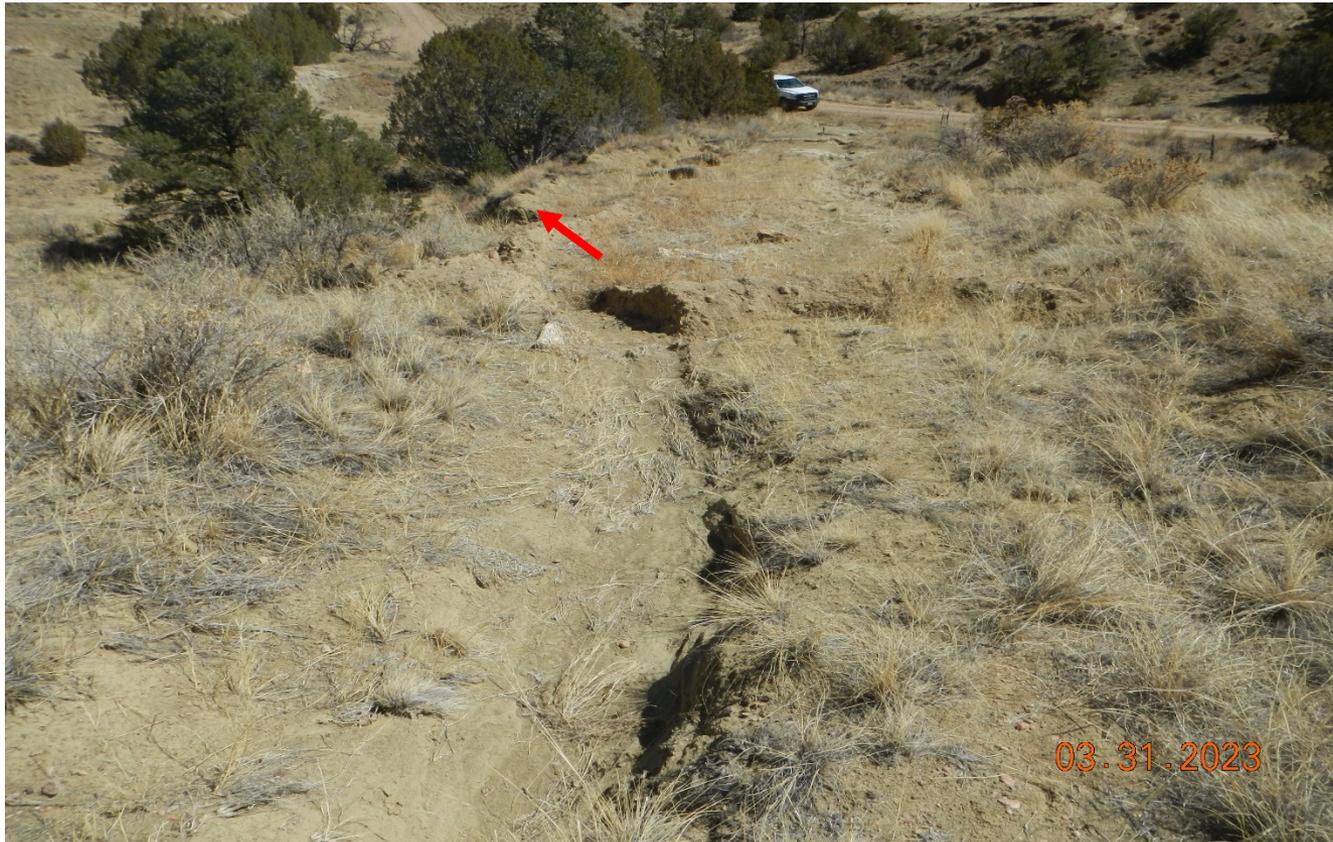
**Photo 4.** Further up along the access road facing northeast. There is an erosion channel directed down to the left side shown at red arrow.

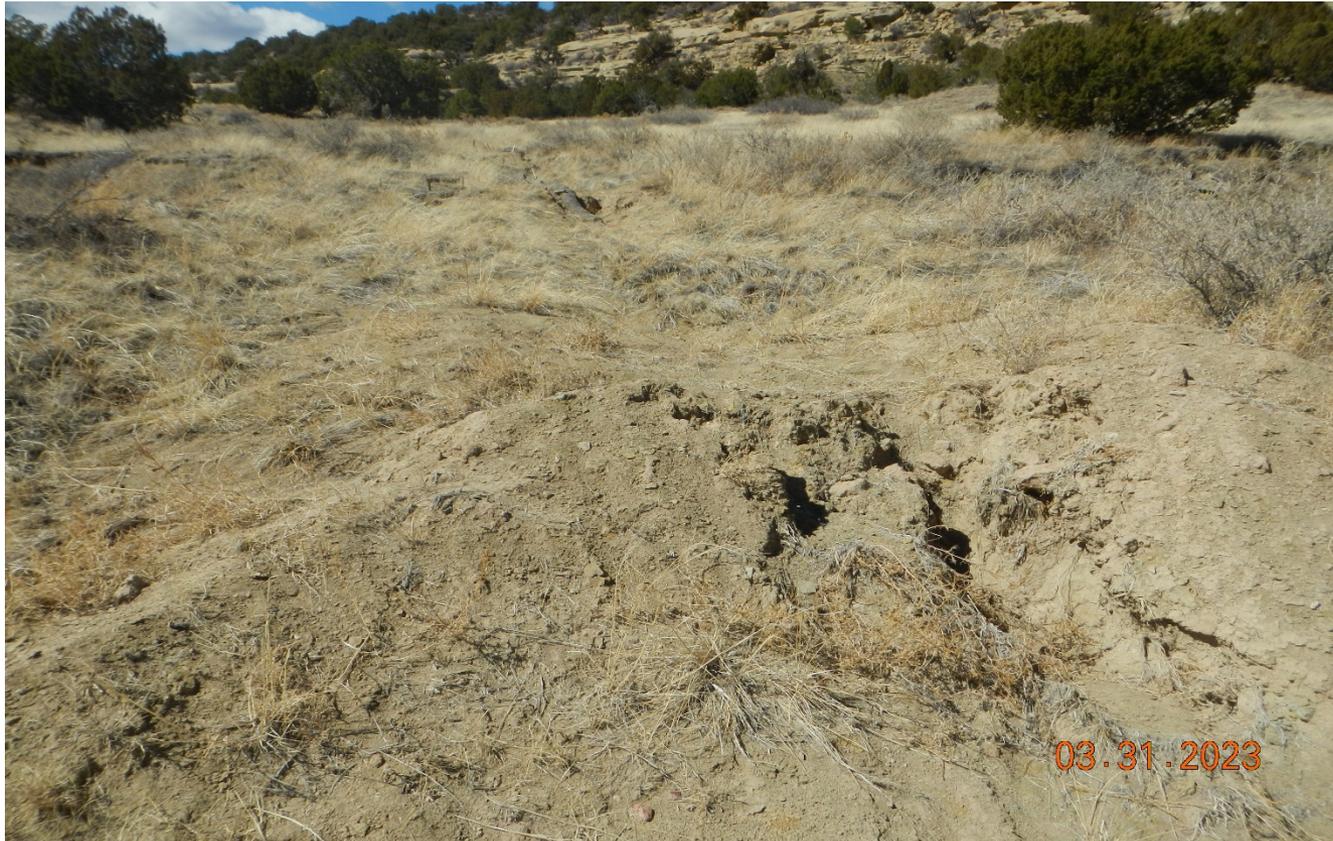
**Photo 5.** Facing southwest along the access road. It appears soil piles were placed along the road to slow stormwater however they have since eroded and washed out.

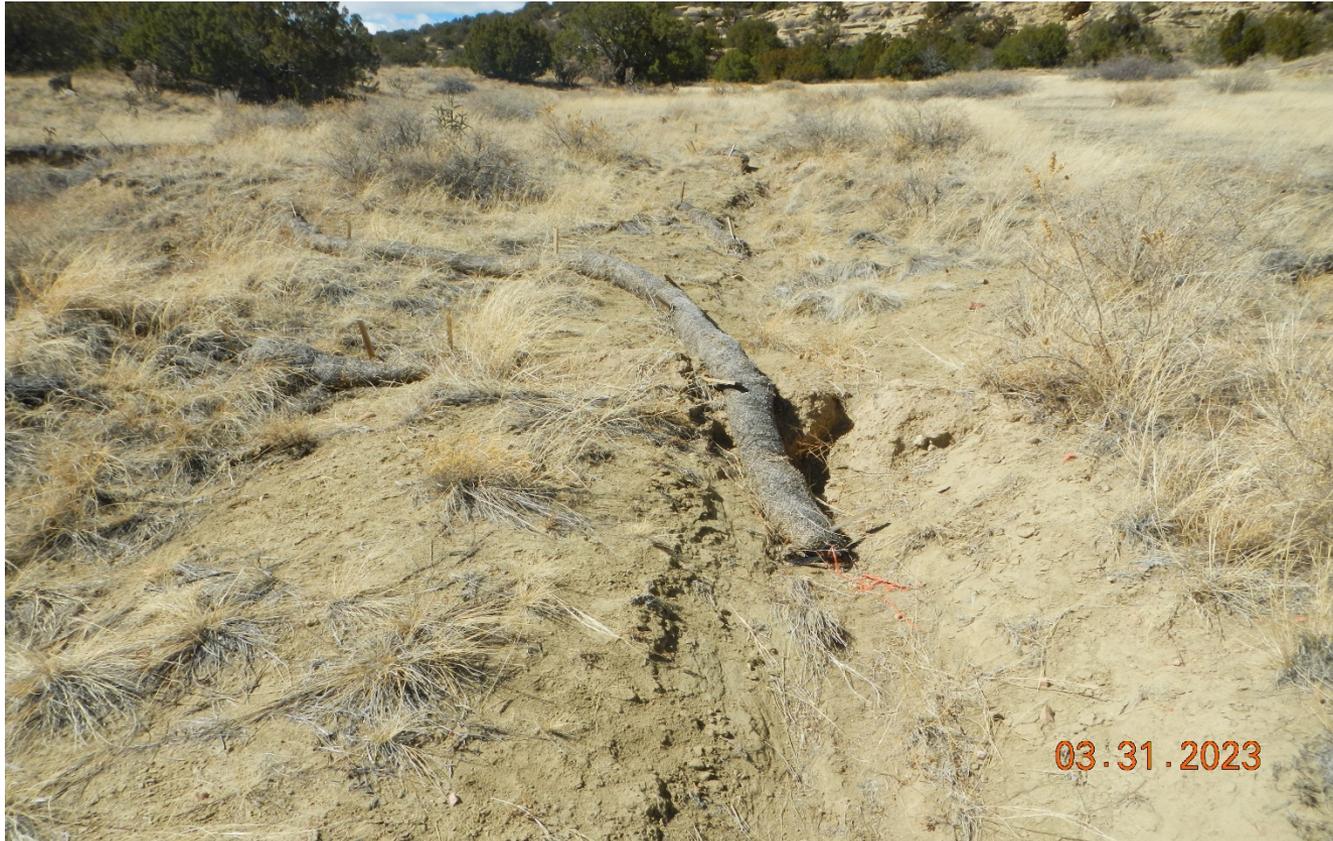
**Photo 6.** Facing southwest along the former access road. It appears that the stormwater from the location is directed down the road which is causing erosion issues shown in previous photos. Wattles that were installed have been washed out.

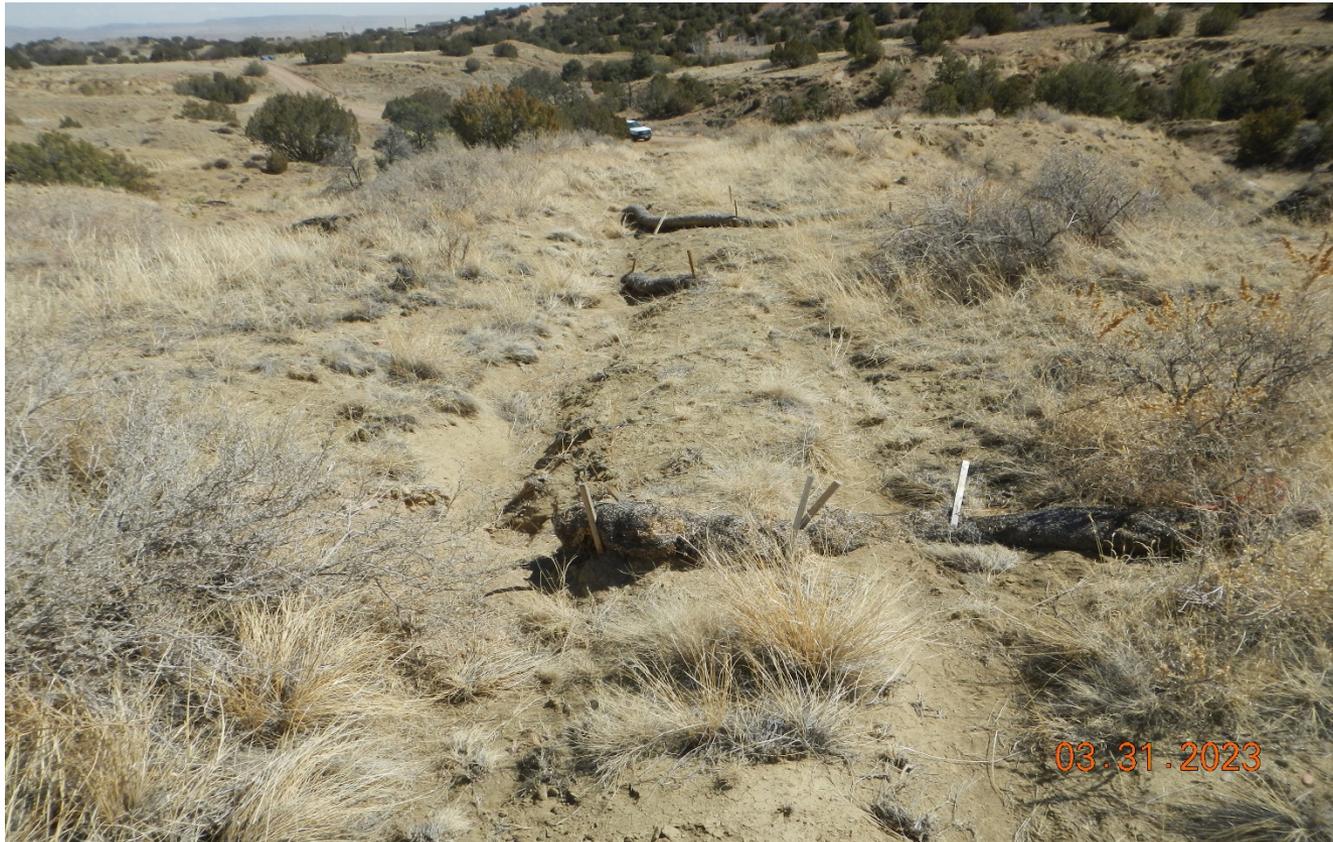
**Photo 7.** Facing back northeast along the former access road. It appears that the stormwater from the location is directed down the road which is causing erosion issues shown in previous photos. Wattles that were installed have been washed out.

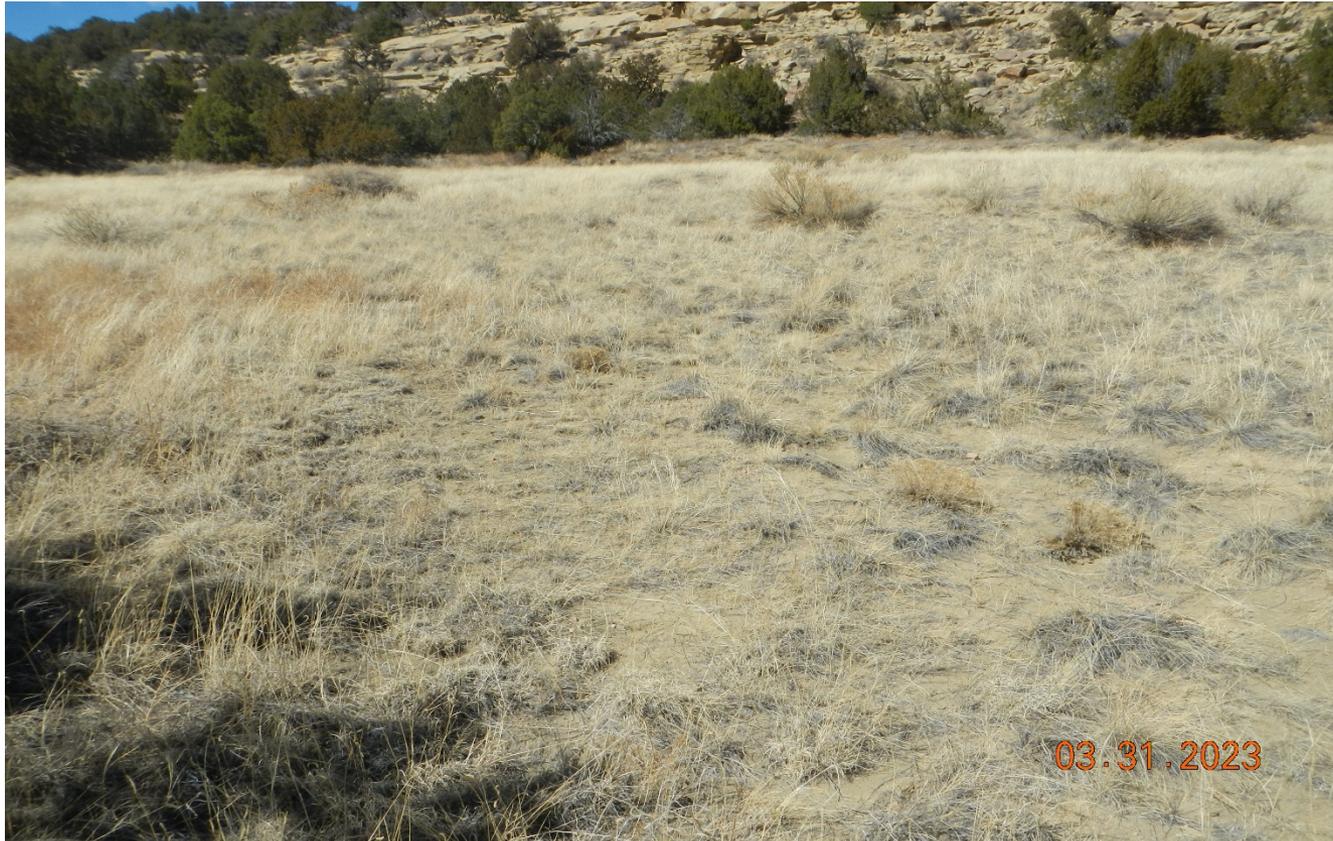
**Photo 8.** Facing west toward the location. Perennial native vegetation is progressing throughout the location.
