Inspection Photos

March 29, 2023

Location Name: SAVAGE-66S94W/28SESW

Inspection Document #: 702801410

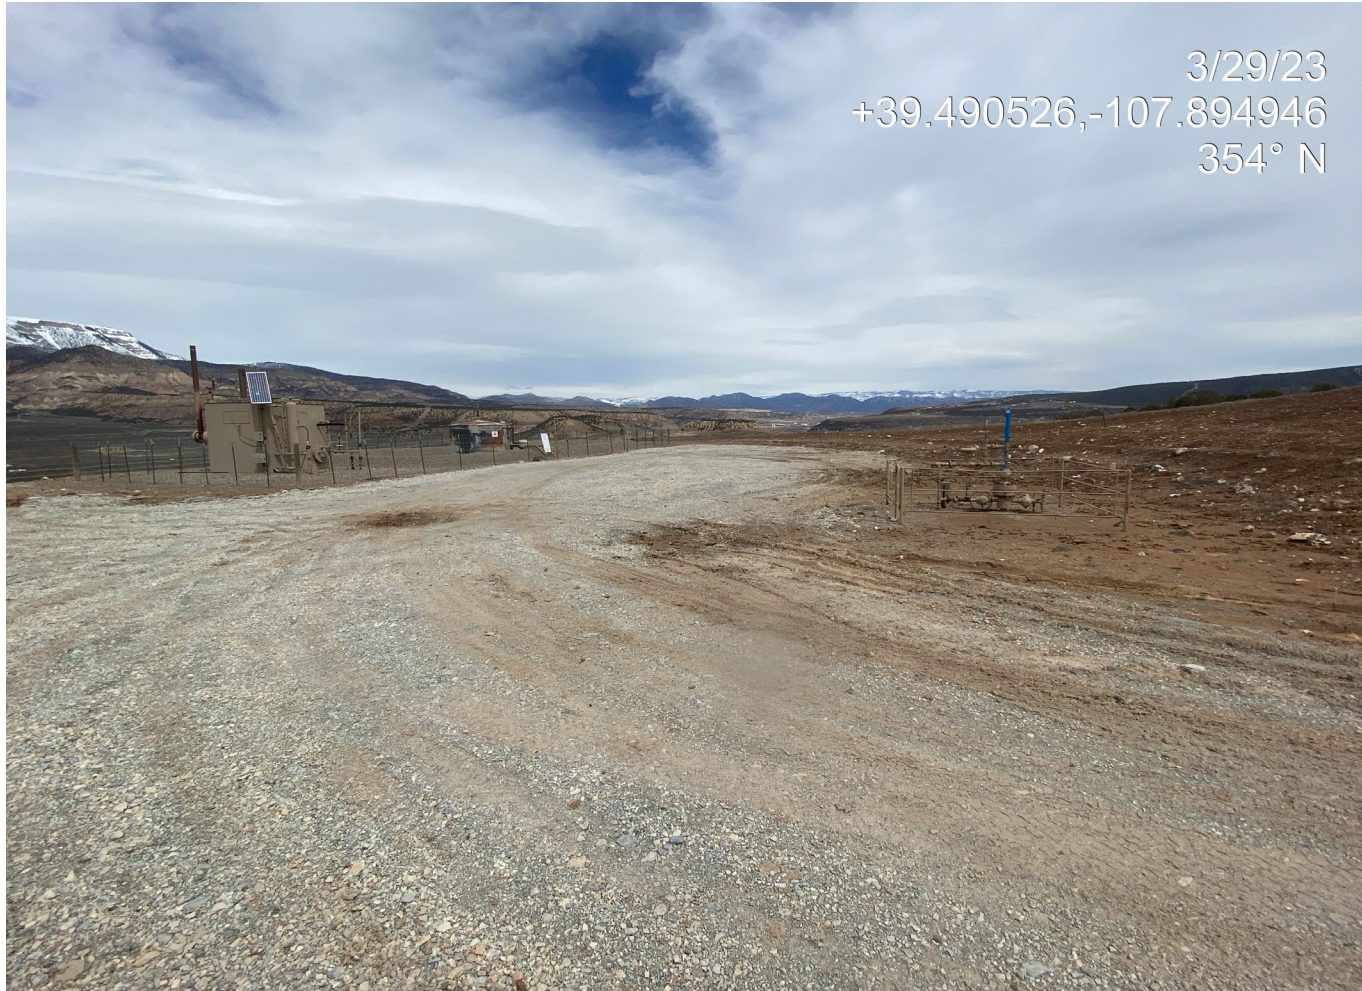
Photo 1. Photo taken from the entrance shows an overview of the location.

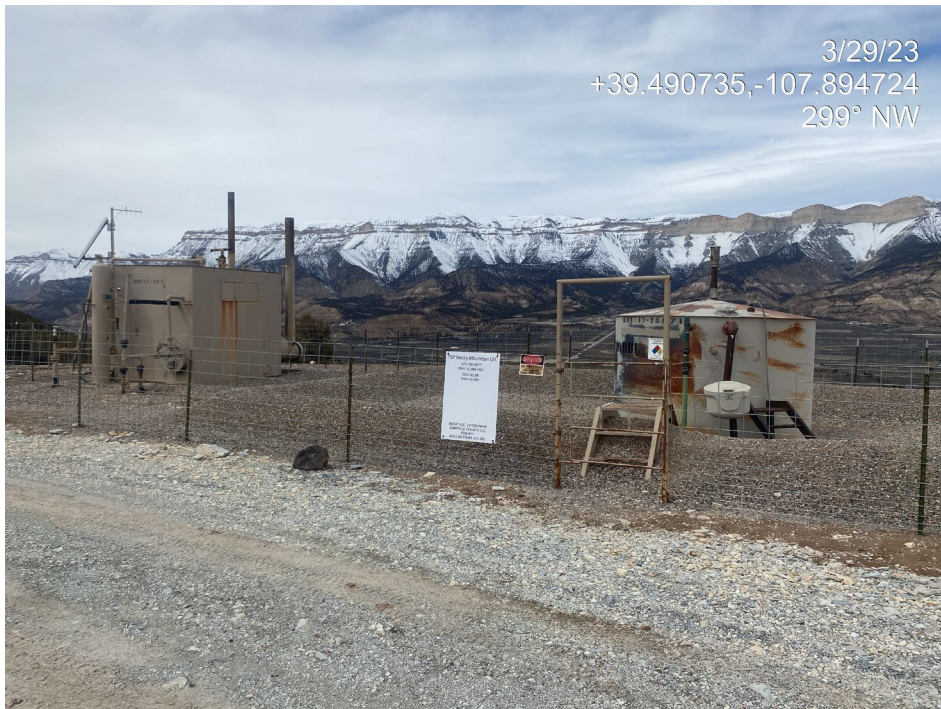
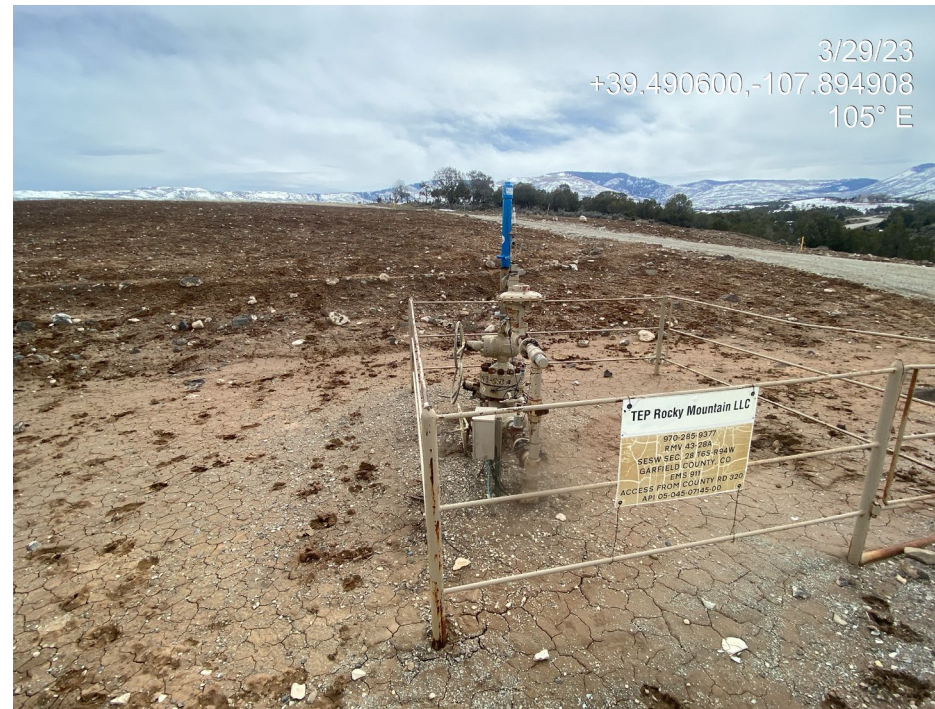
Photo 2. Photos show production areas. Note the sediment that has been transported from the southern interim area around the wellhead (right).

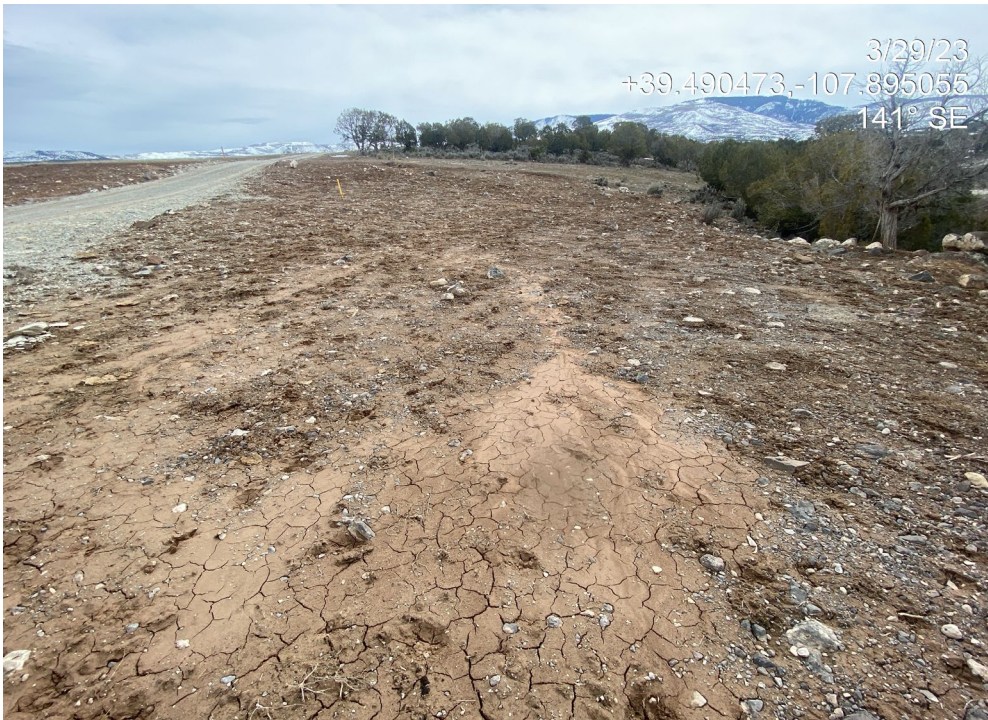
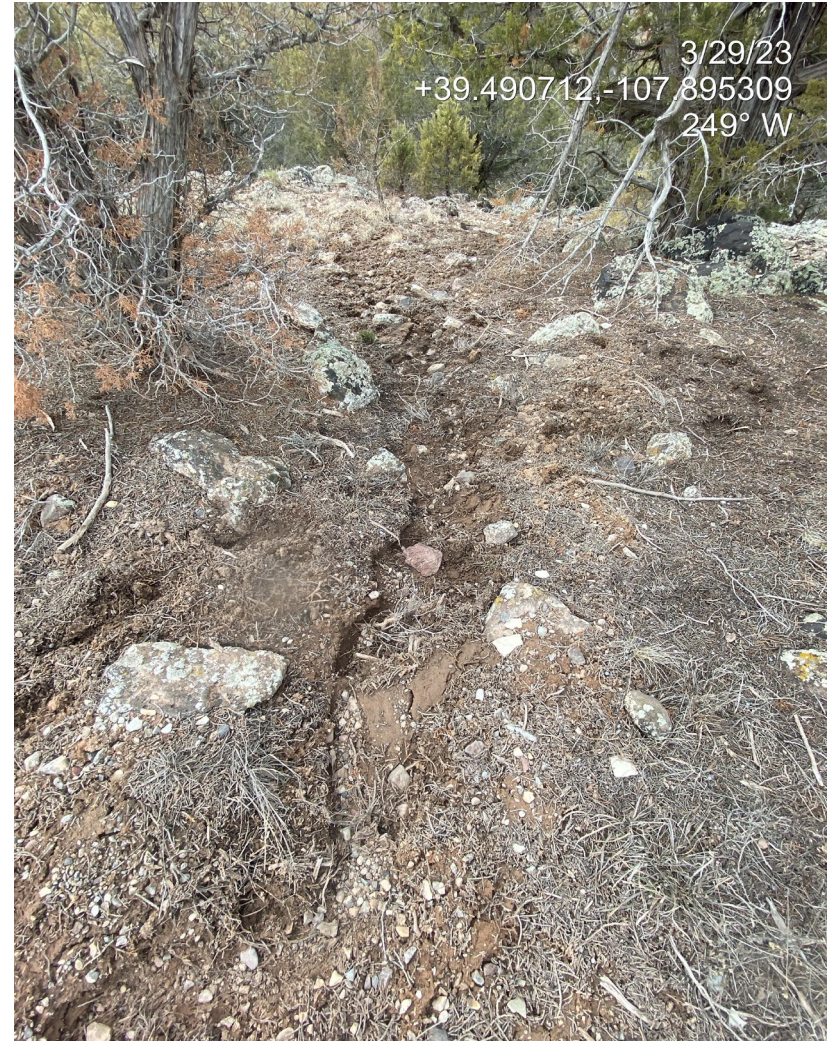
Photo 3. Photos show lack of stabilization of the western interim area resulting in sheet erosion and sediment transport (left) and offsite degradation (right).

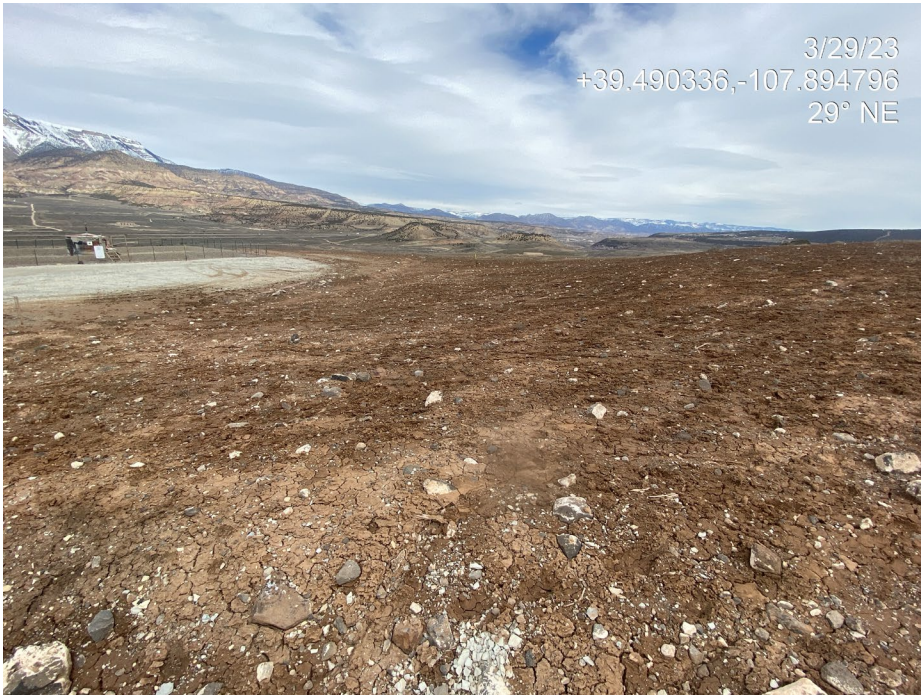
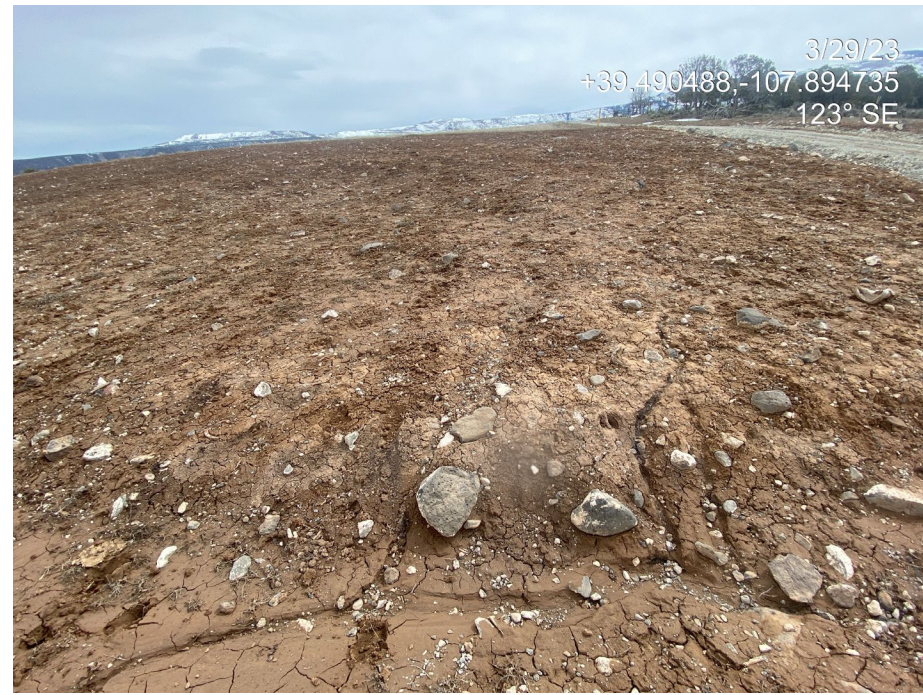
Photo 4. Photos show soils in the southern interim area are bare and unstabilized (left) resulting in rill erosion (right).

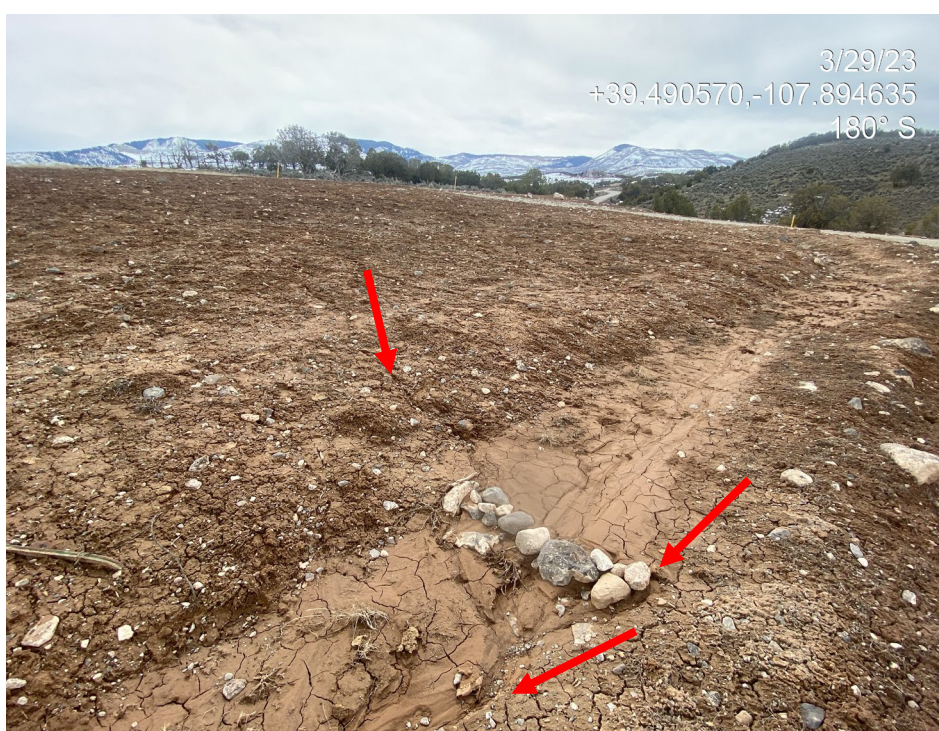
Photo 5. Photo shows the stormwater ditch at the south of the location is full of sediment lost from the southern interim area. Note rills in interim area and degradation to the stormwater ditch and rock check dam.

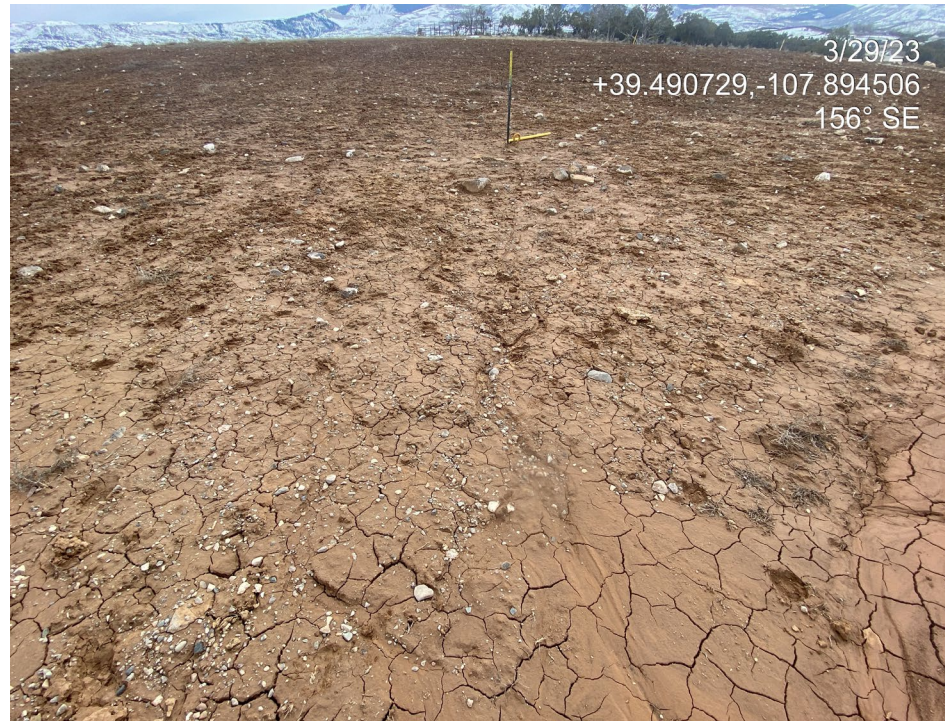
Photo 6. Photo shows sheet and rill erosion and sediment transport from the unstabilized southern interim area.

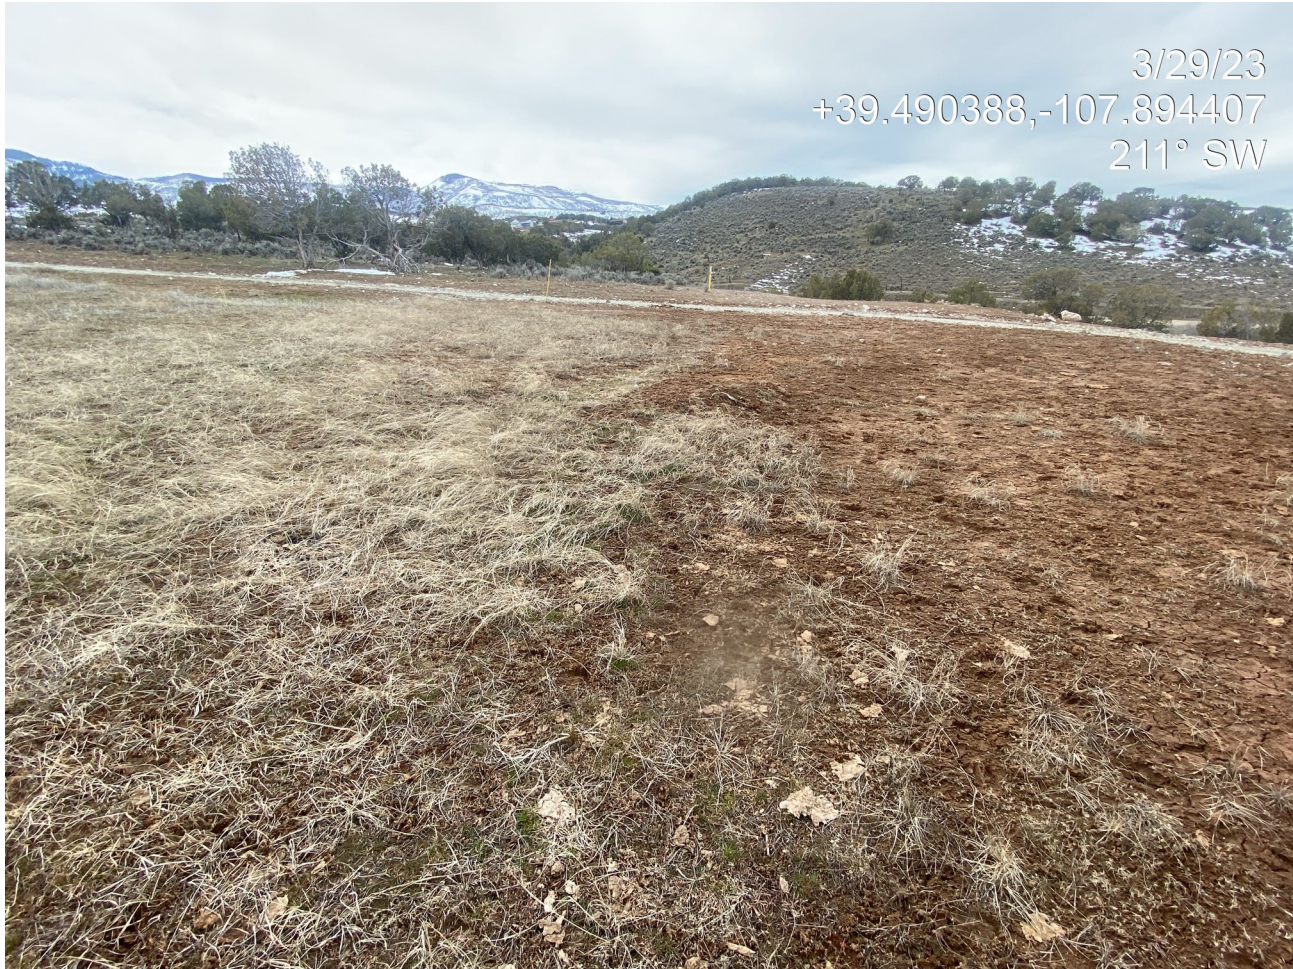
Photo 7. Photo shows the transition between stabilized, vegetated areas to the south of the location and unstabilized, bare areas in the southern interim area.

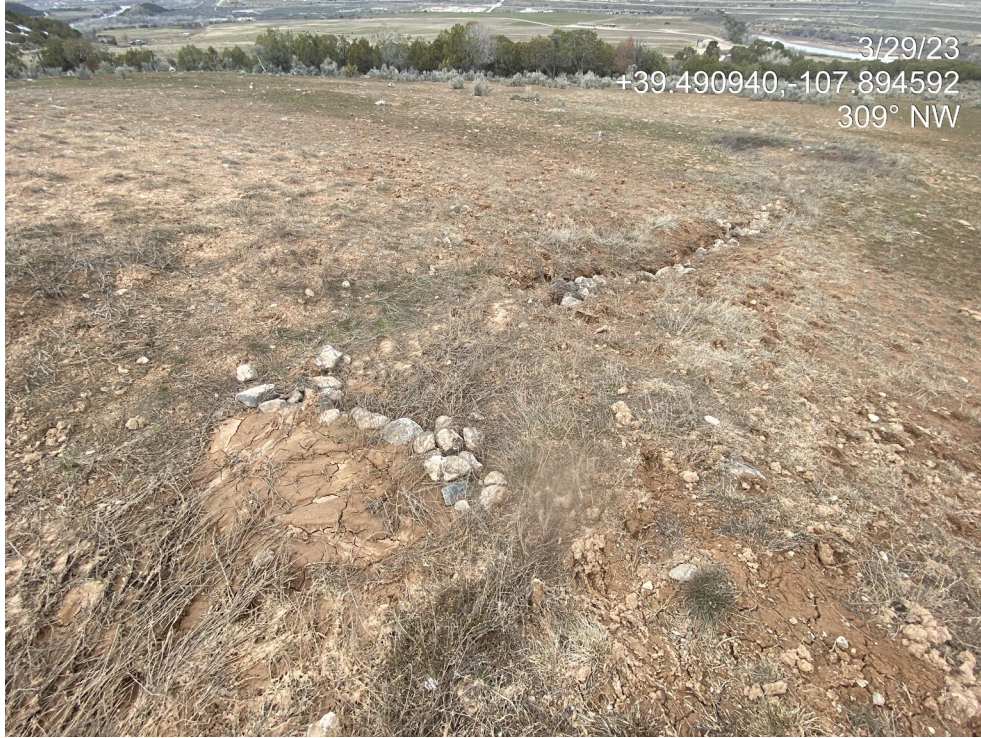
Photo 8. Photo shows an overview of the northern interim area including a stormwater ditch/slope drain. Northern interim areas are partially vegetated, however, erosion degradation is present.

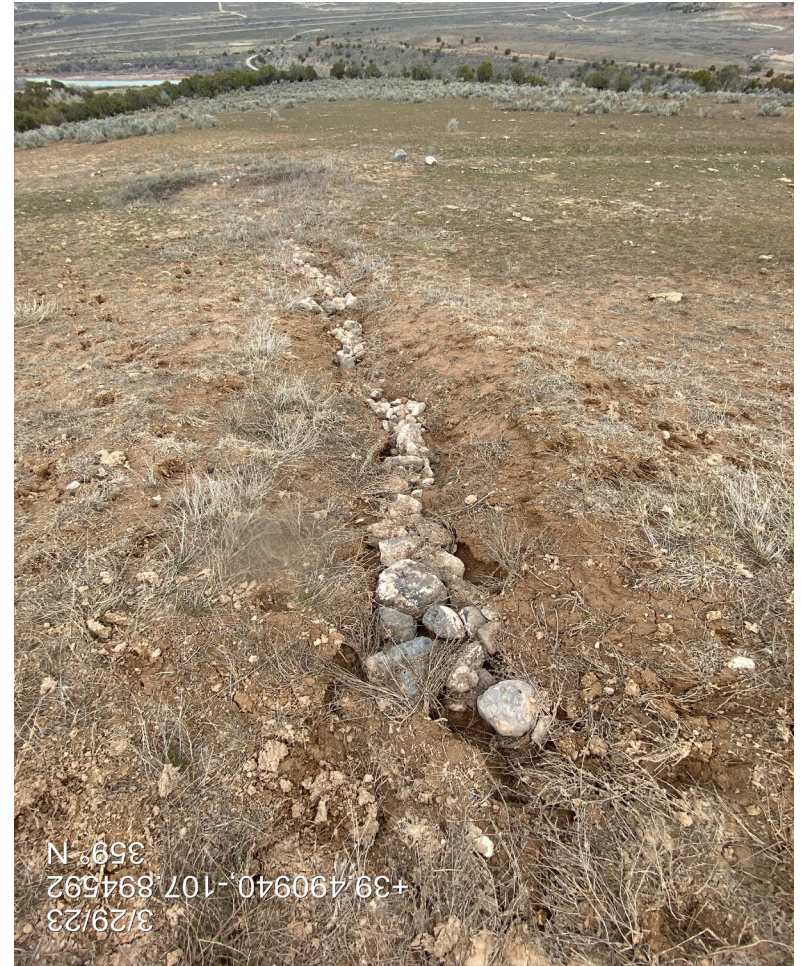
Photo 9. Photo shows degradation in the stormwater ditch/slope drain at the north of the location.

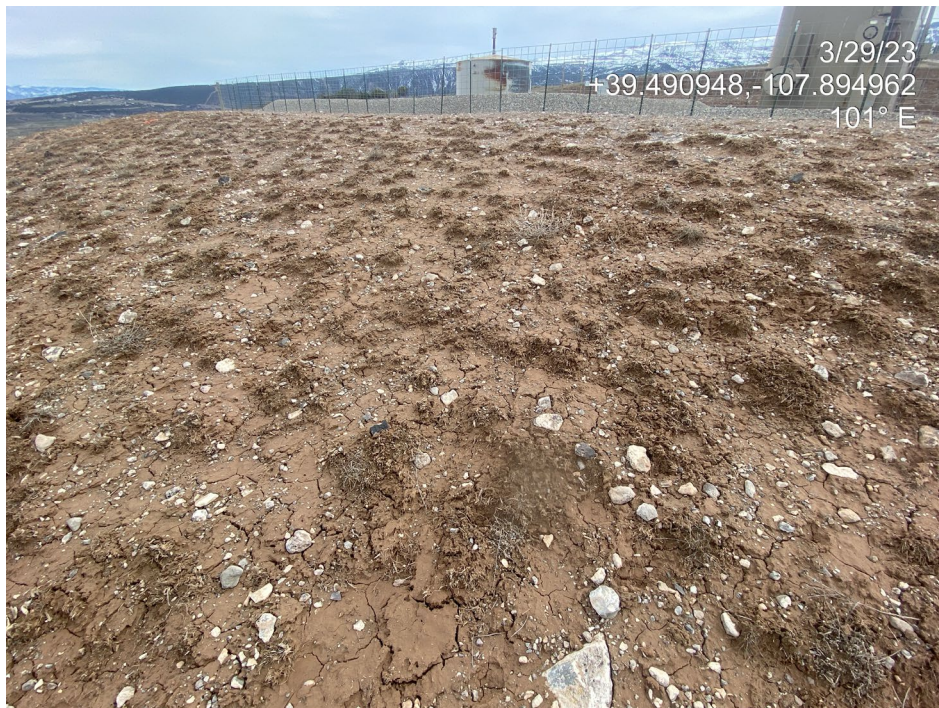
Photo 10. Photo shows pedestaling around vegetation in the northern interim area indicating erosion.

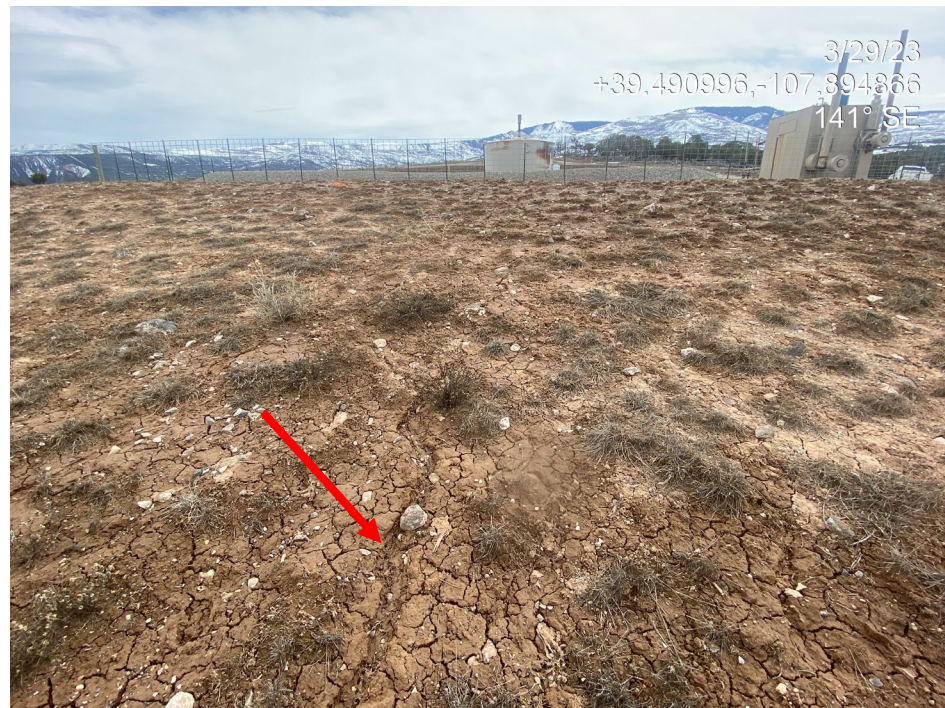
Photo 11. Photo shows pedestaling and a rill in the northern interim area indicating erosion.
