Inspection Photos

Operator: TEP Rocky Mountain LLC - #96850

Location Name: FORCE-66S94W/33NWSE

Inspection Document #: 702801416

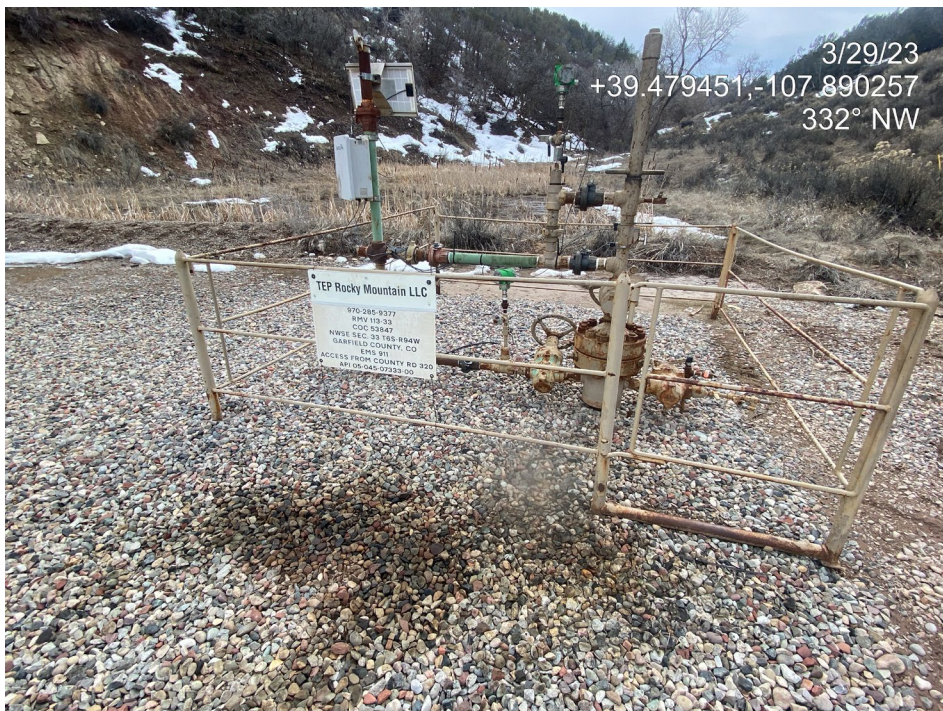
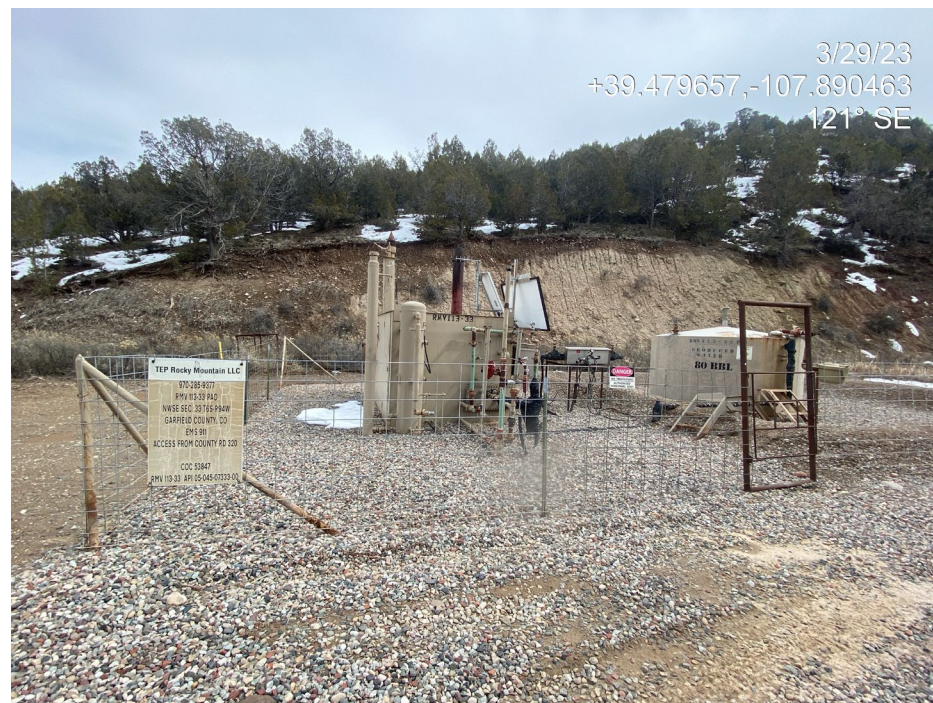
Photo 2. Photos show production areas. Note stained gravel at the wellhead (left).

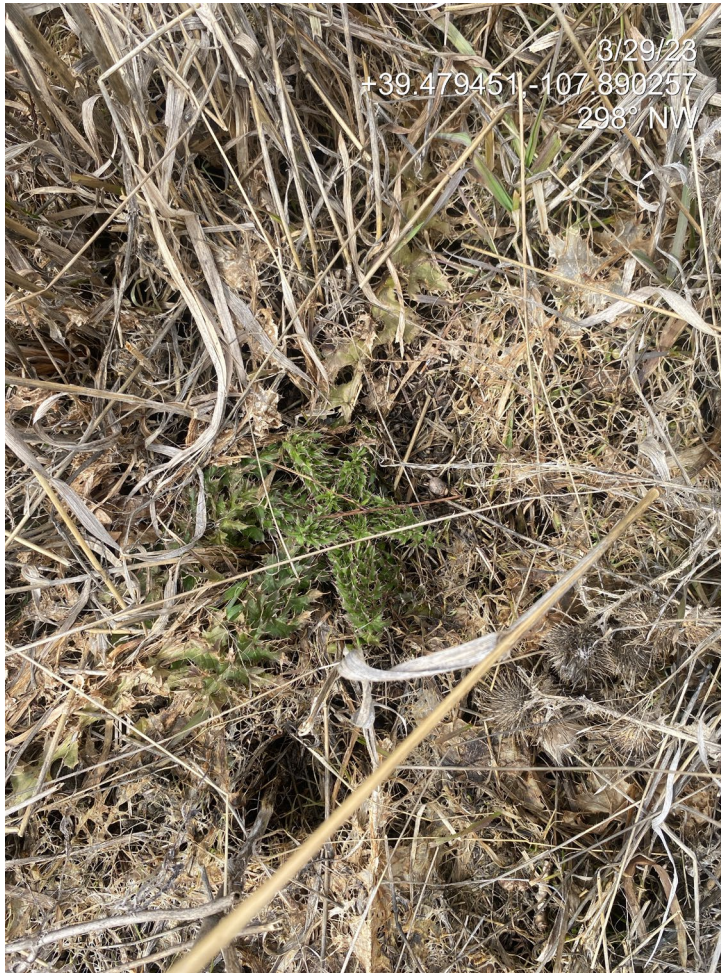
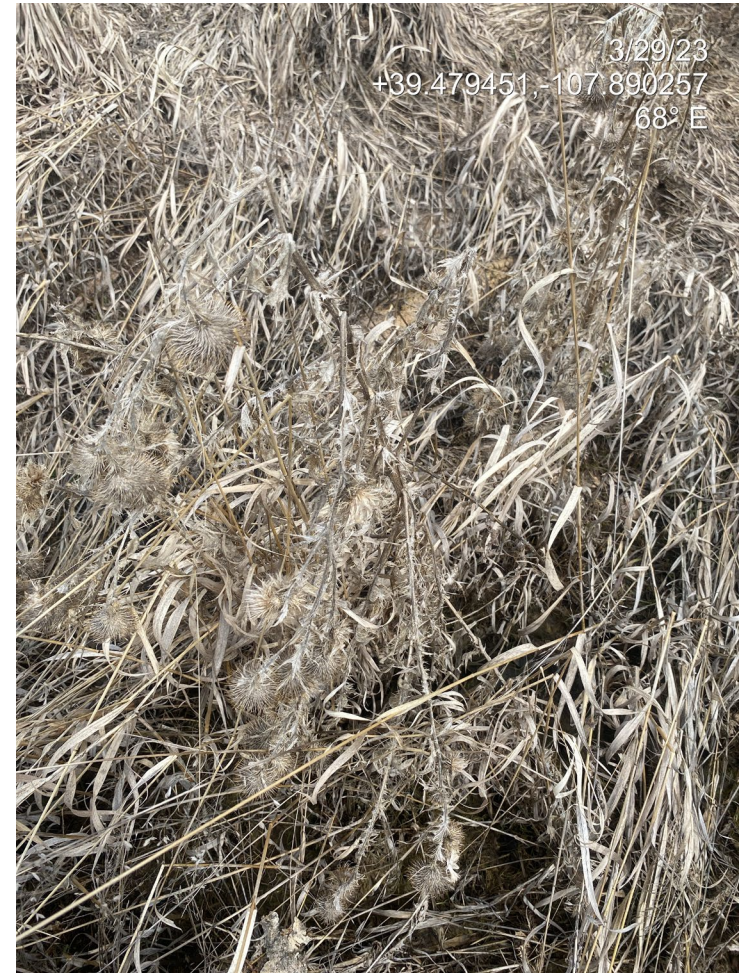
Photo 3. Photos show bull thistle (List B Noxious) in the southern interim area.

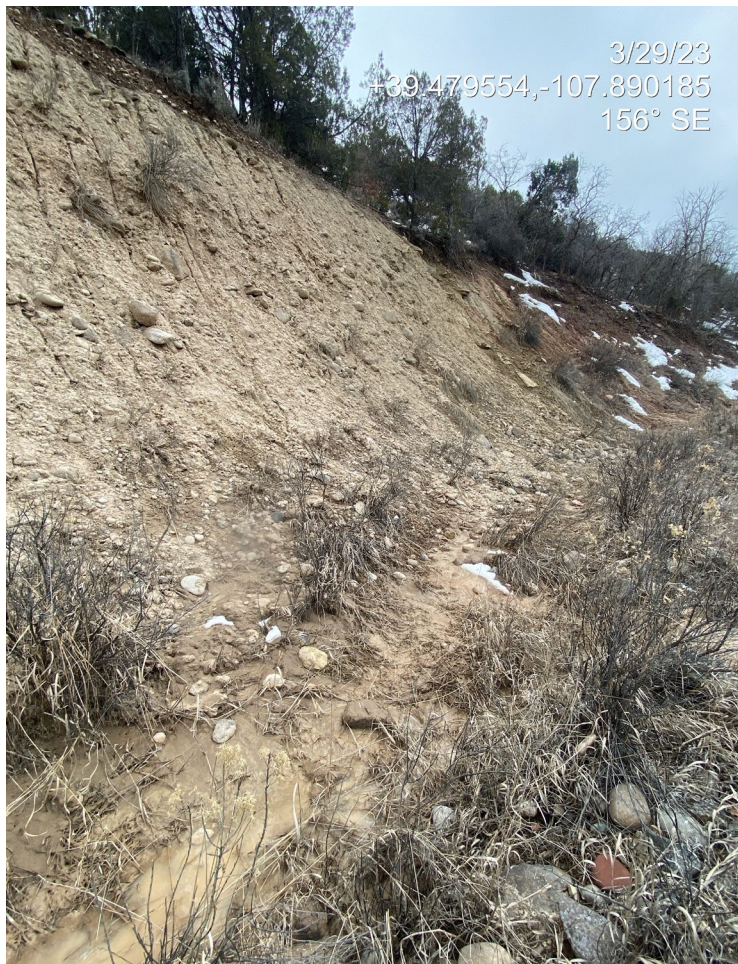
Photo 4. Photo shows the eroding cut to the east and sediment laden stormwater flowing at the base of the cut.

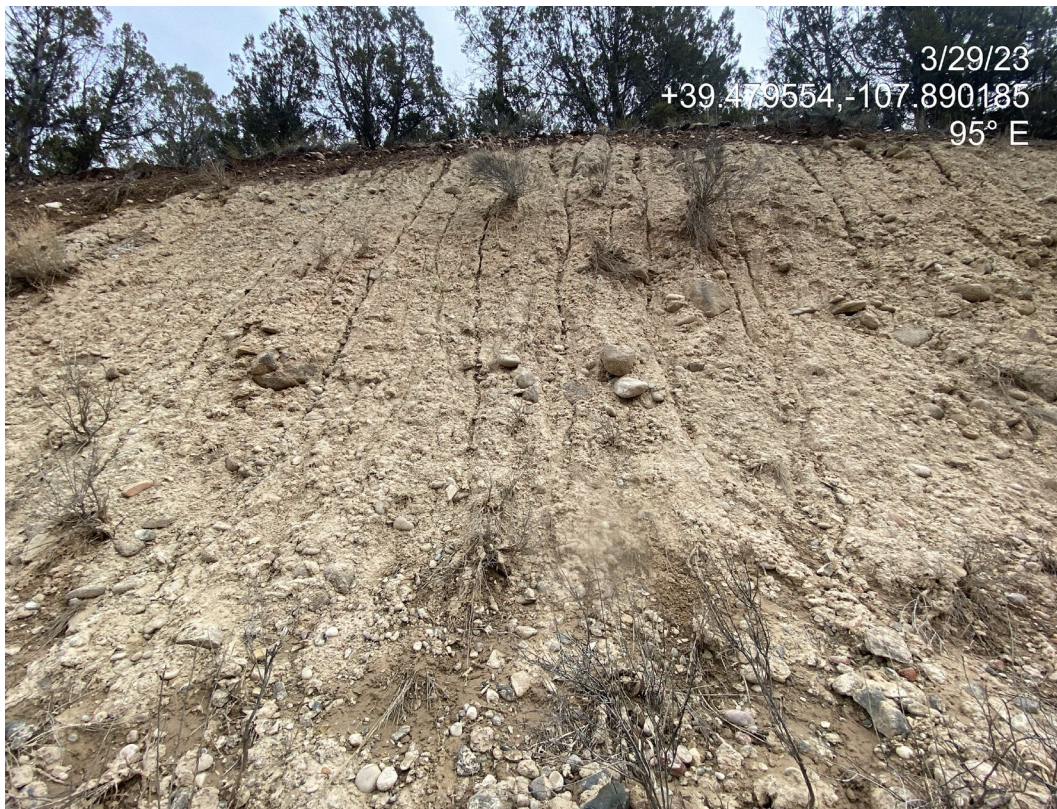
Photo 5. Photo shows rill erosion on the eastern cut slope.

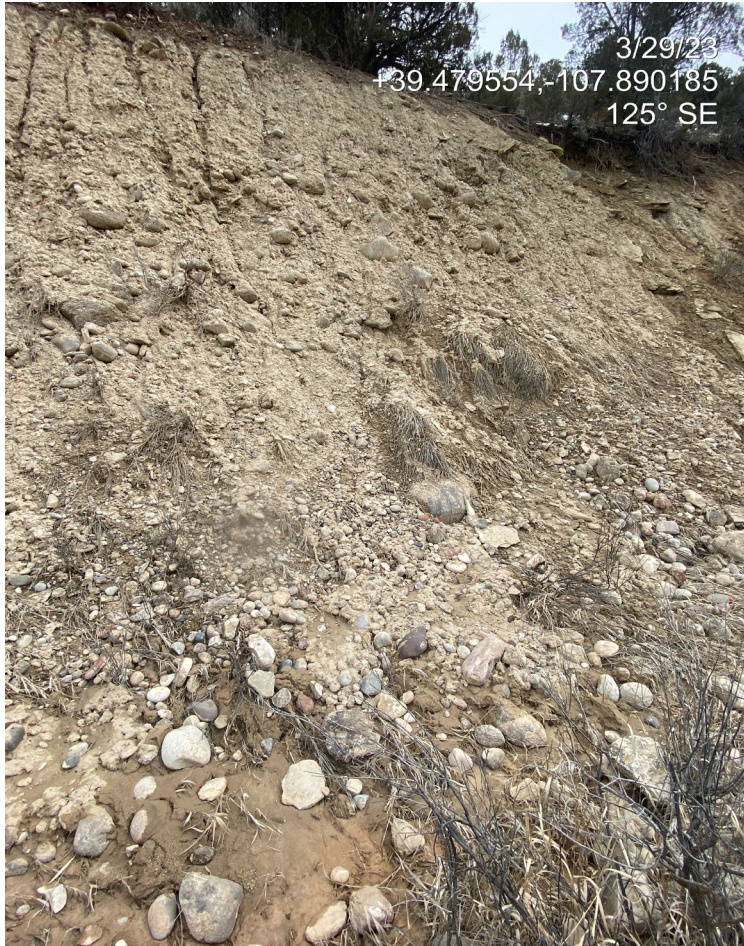
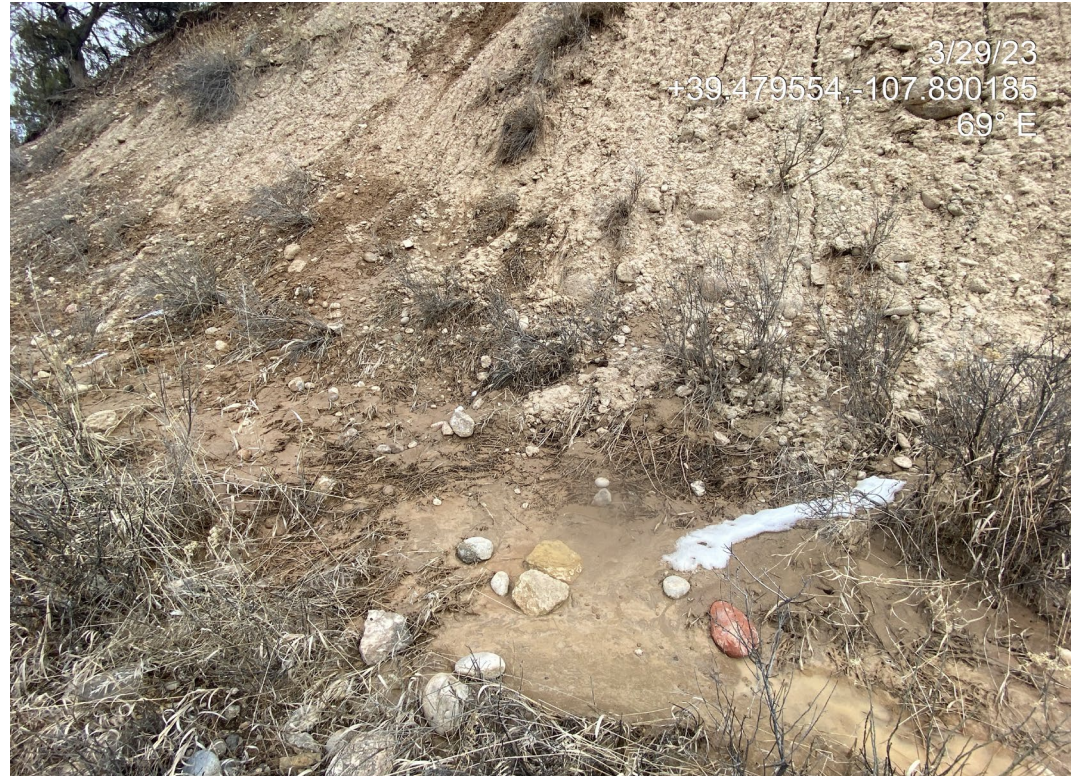
Photo 6. Photos show sediment accumulating at the base of the eastern cut slope. Erosion is resulting in degradation to the slope, smothering vegetation below and contributing sediment loads to stormwater.

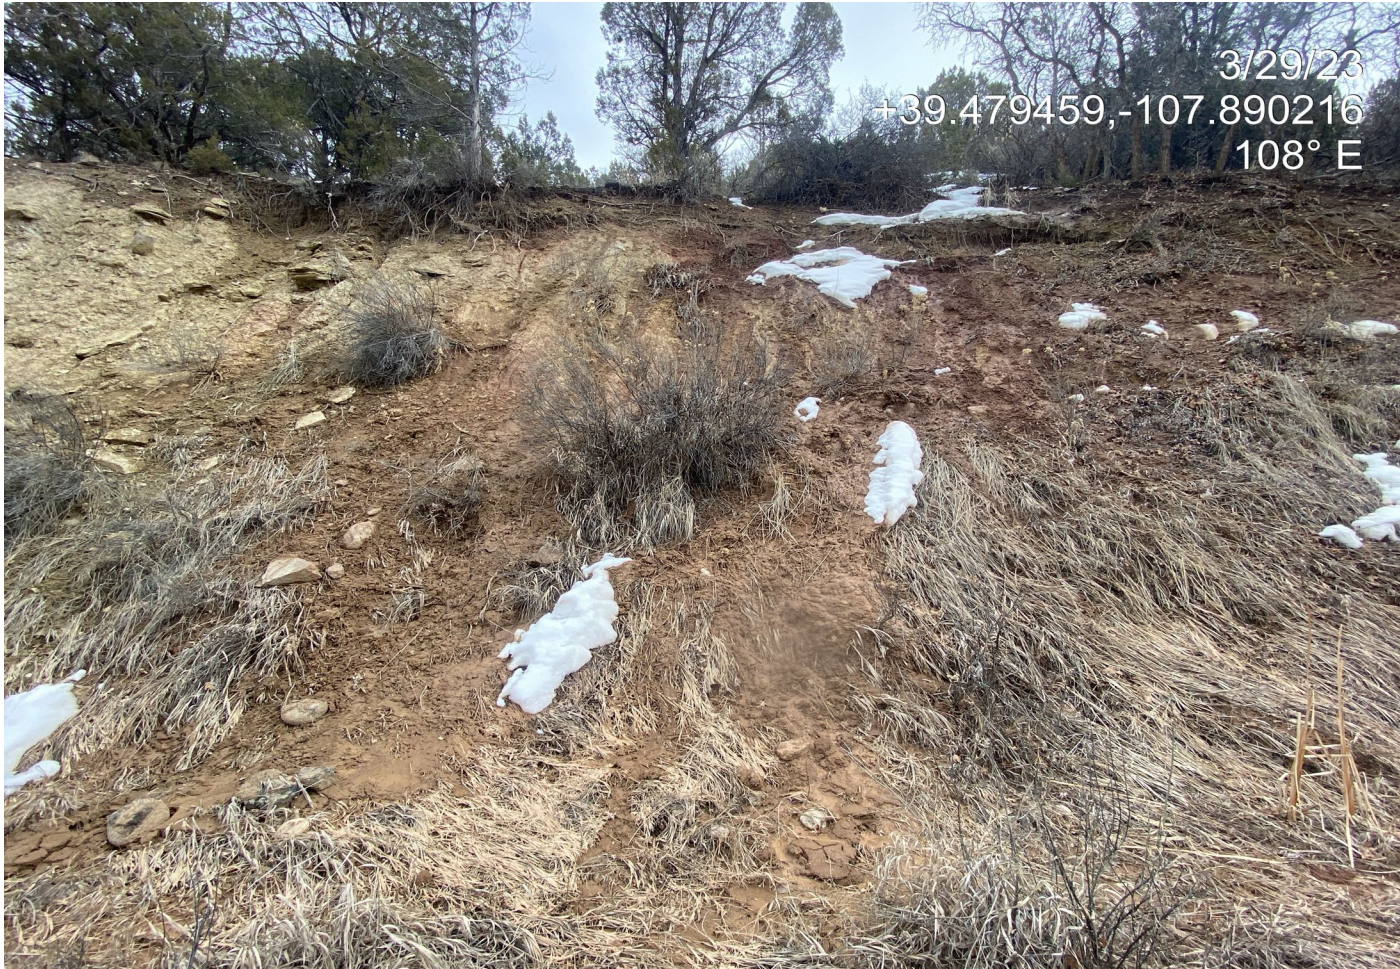
Photo 7. Photo shows sloughed soil accumulating at the base of the southeastern cut slope and covering vegetation. Note also exposed roots at the top of the cut also indicating soil loss.
