Inspection Photos

Location Name: TEP ROCKY MOUNTAIN LLC WEBSTER/HEATH RMV 236-28 pad

Location ID: 324046

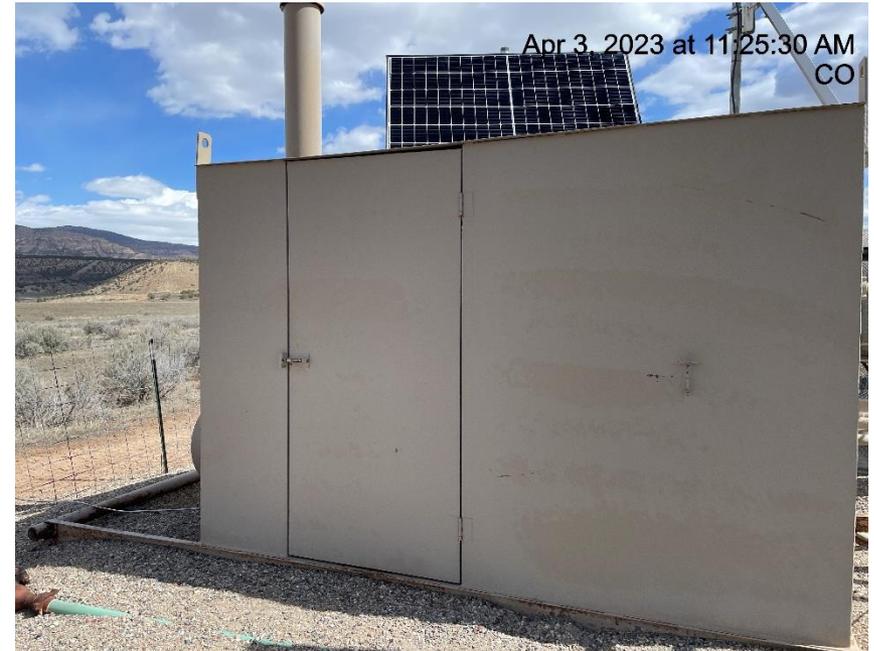
Photo # 4093 Meter calibration info not conspicuously posted

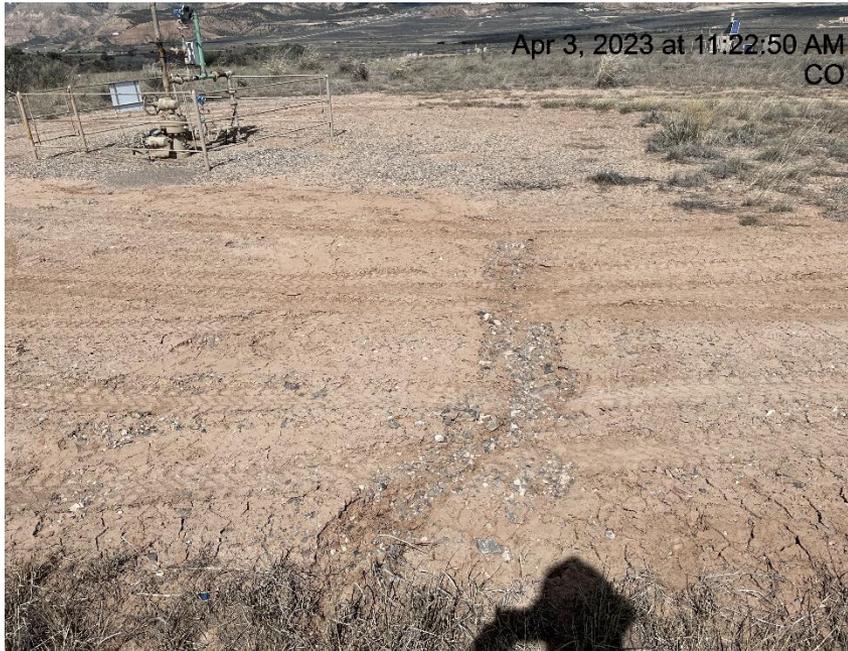
Photo # 4091 Rill erosion

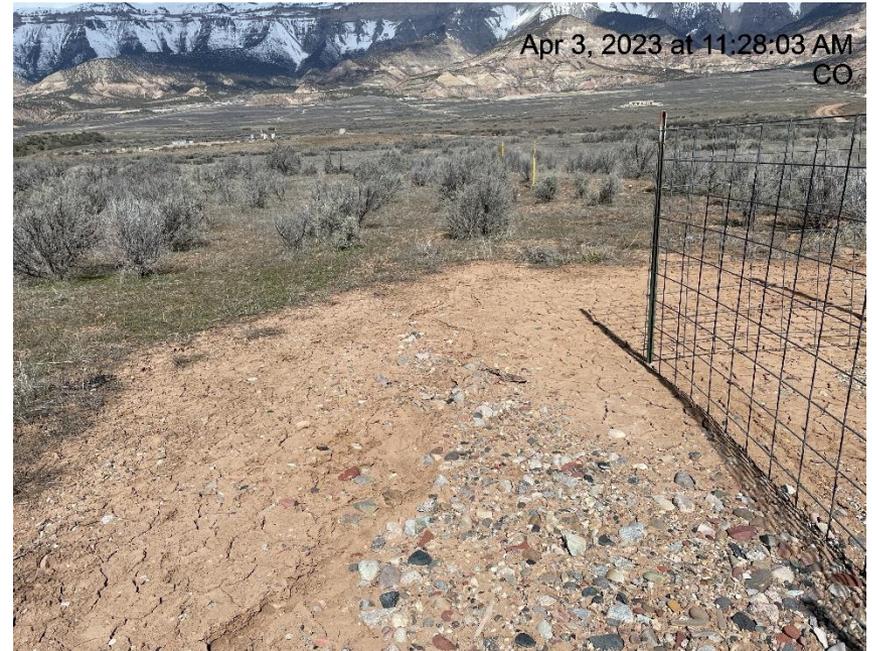
Photo # 4096 Rill erosion & transport of sediment (near production unit)

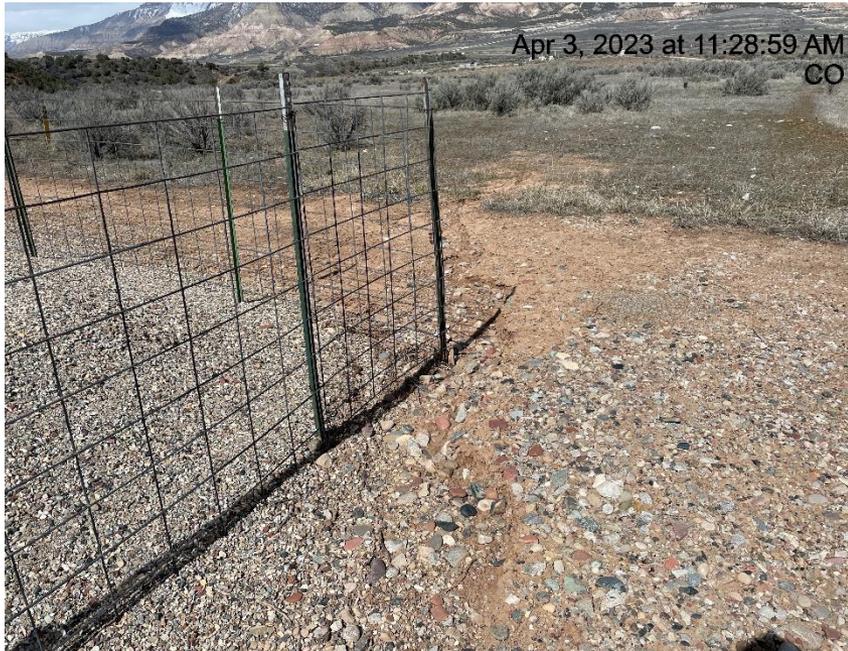
Photo # 4098 Rill erosion & transport of sediment off location (near production tank & containment)

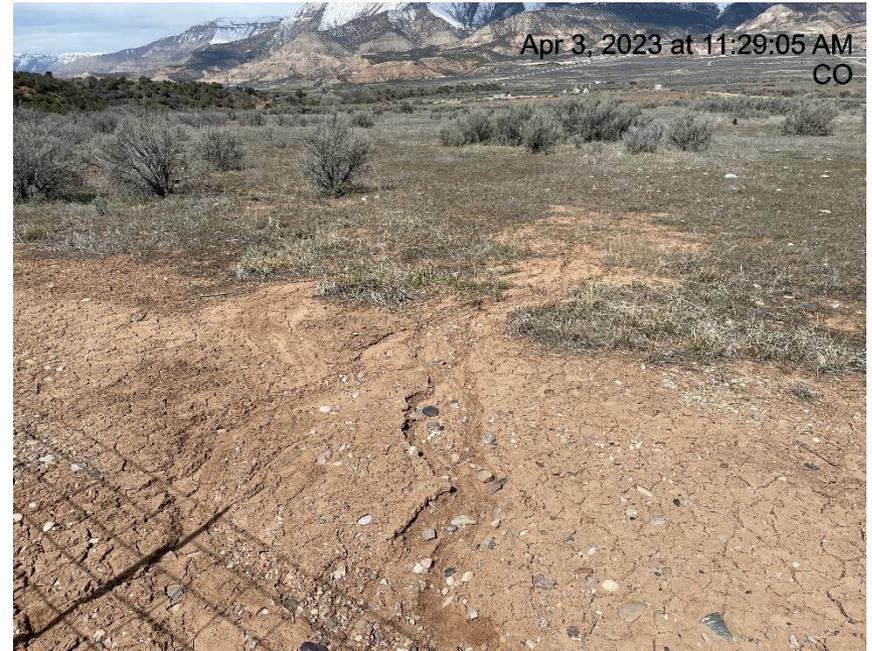
Photo # 4099 Rill erosion & transport of sediment off location (near production tank & containment)

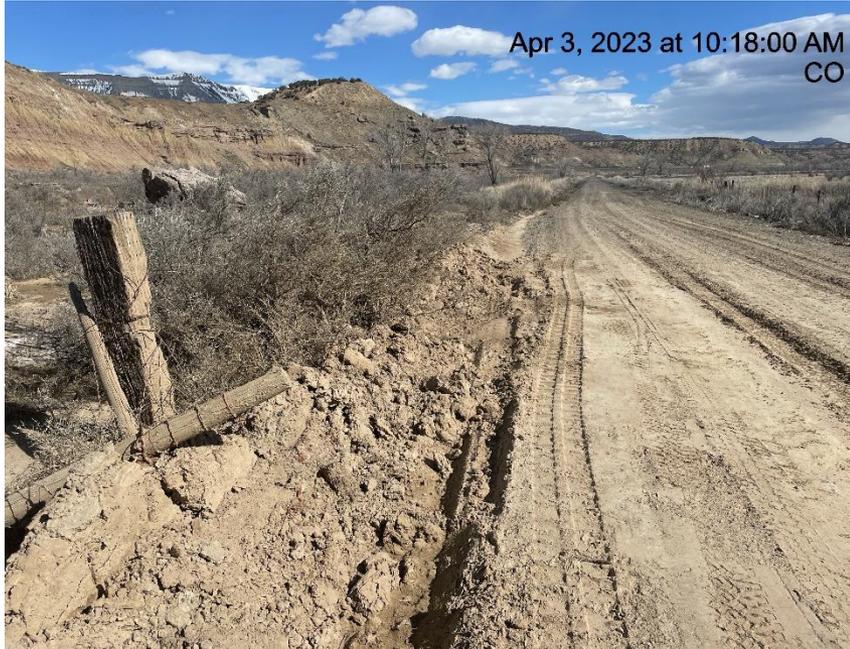
**Photo # 3995 Transport of sediment/insufficient BMP's
(approximately 1.5 miles down lease road)**

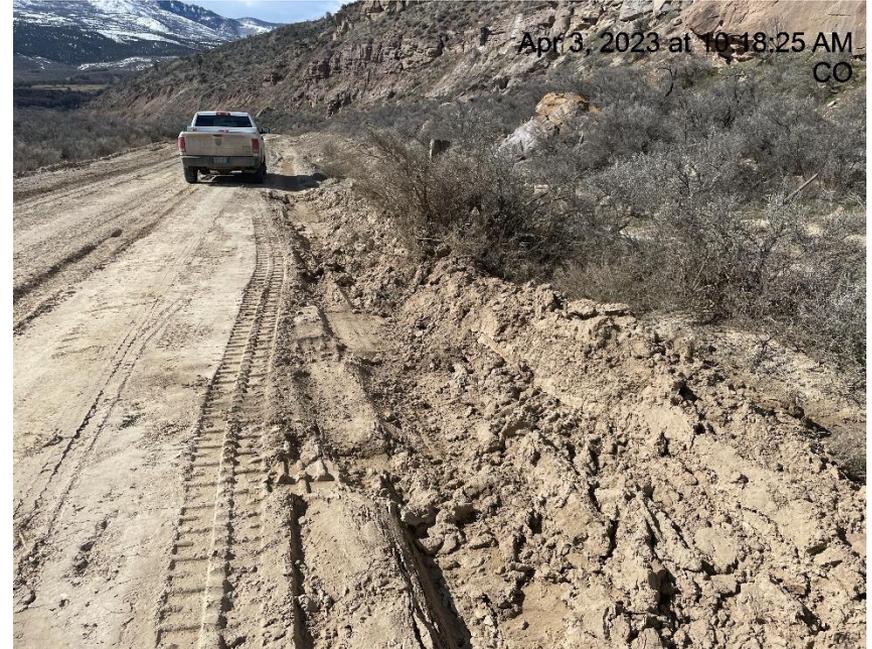
**Photo # 3996 Transport of sediment/insufficient BMP's
(approximately 1.5 miles down lease road)**

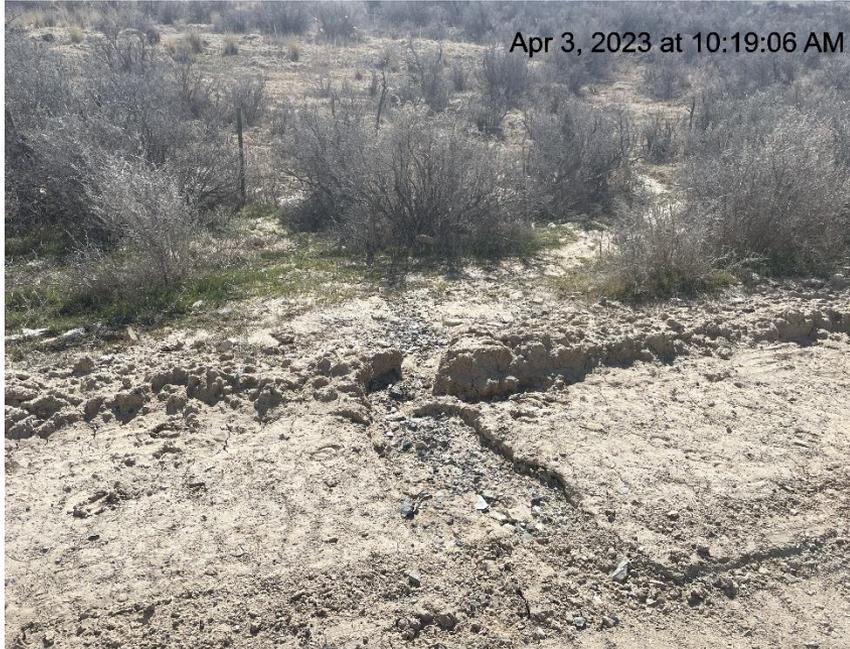
Photo # 3997 Rill erosion & transport of sediment off lease road (approximately 1.5 – 1.6 miles down lease road)

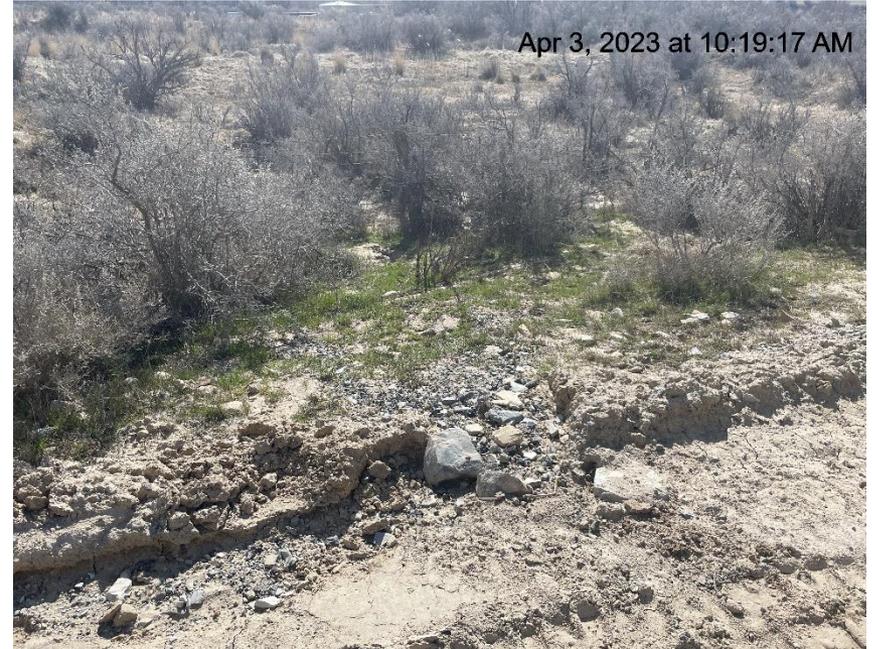
Photo # 3998 Rill erosion & transport of sediment off lease road (approximately 1.5 – 1.6 miles down lease road)

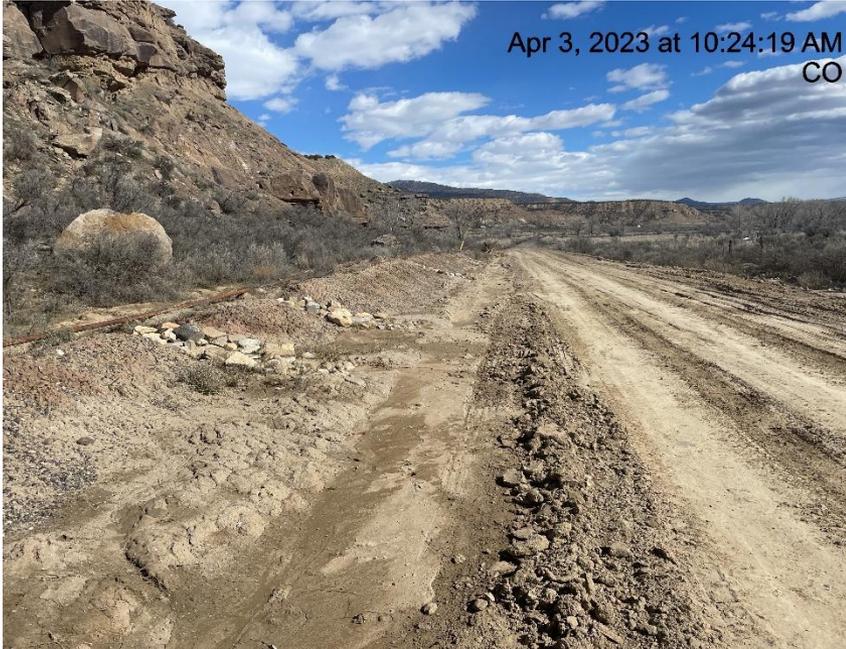
Photo # 4000 Transport of sediment/Insufficient run on controls /BMP's (approximately 1.5 – 1.6 miles down lease road)

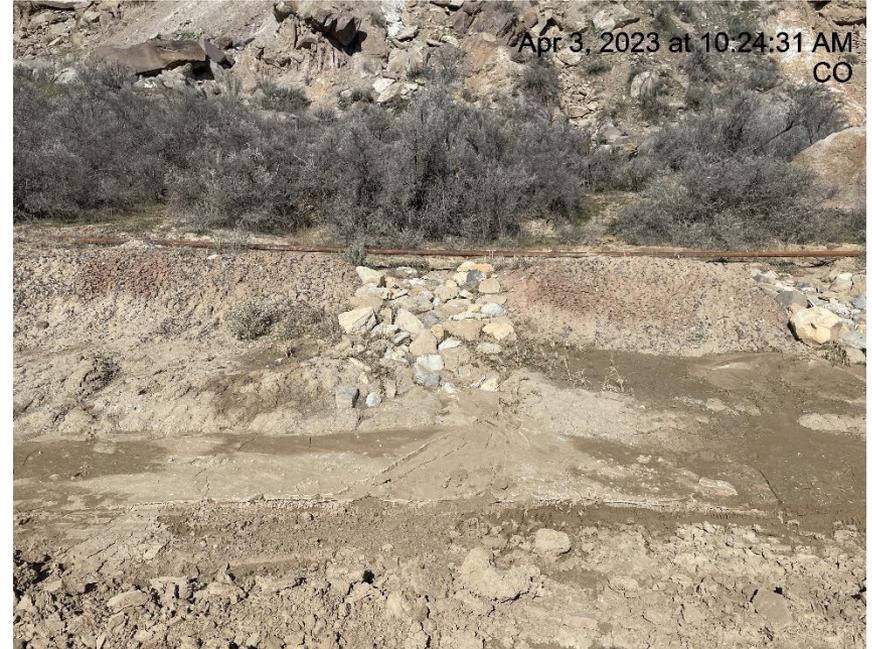
Photo # 4001 Transport of sediment/Insufficient run on controls/ BMP's (approximately 1.5 – 1.6 miles down lease road)

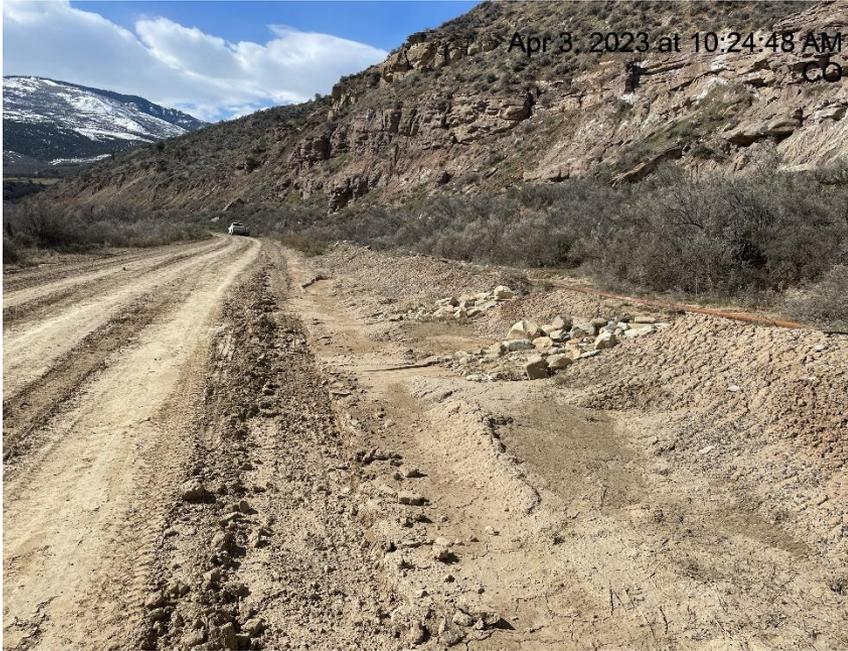
Photo # 4003 Transport of sediment/Insufficient run on controls/BMP's (approximately 1.5 – 1.6 miles down lease road)

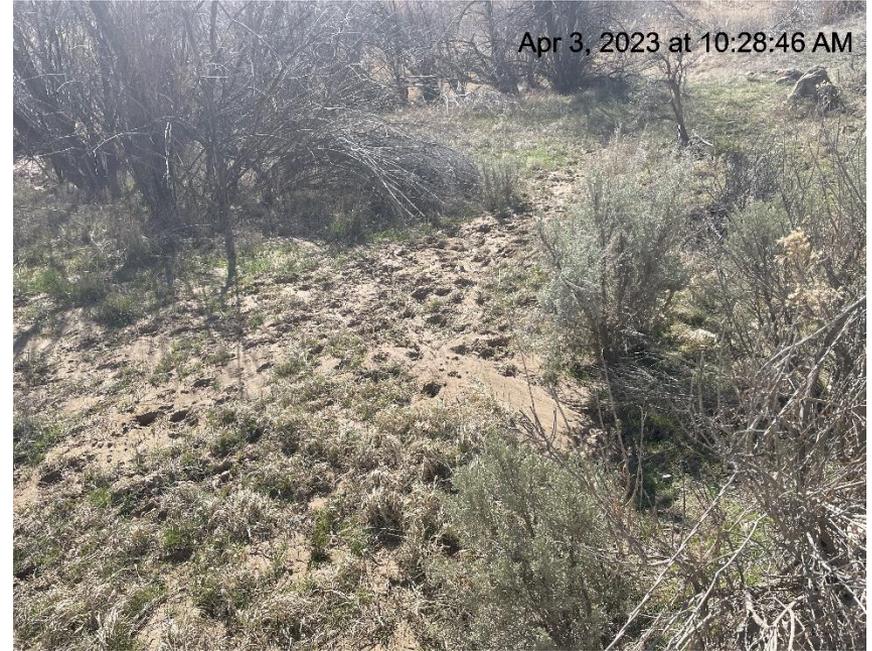
Photo # 4009 Transport of sediment off lease road & into vegetation (approximately 1.6 miles down lease road)

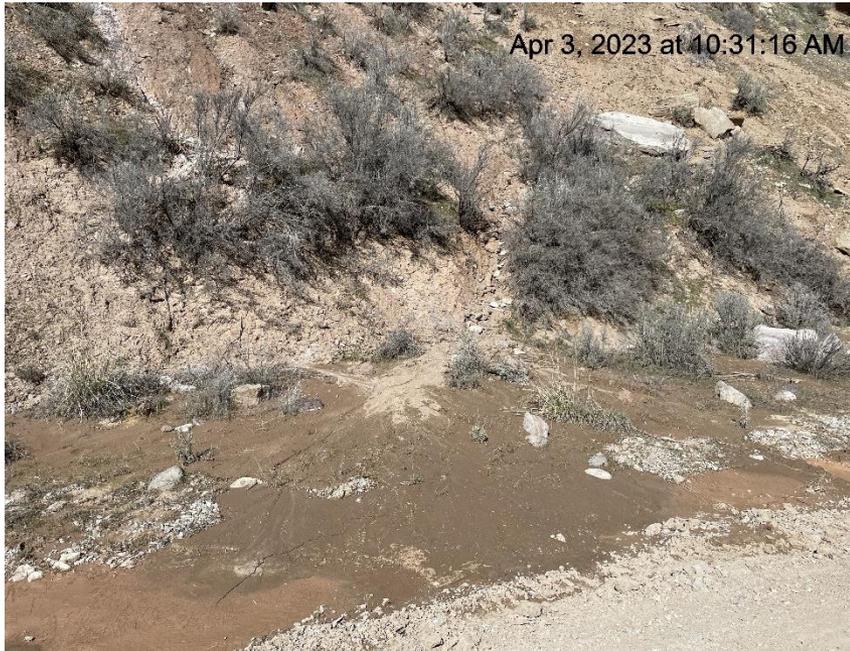
Photo # 4010 Sediment transport/insufficient BMP's (approximately 1.6 – 1.7 miles down lease road)

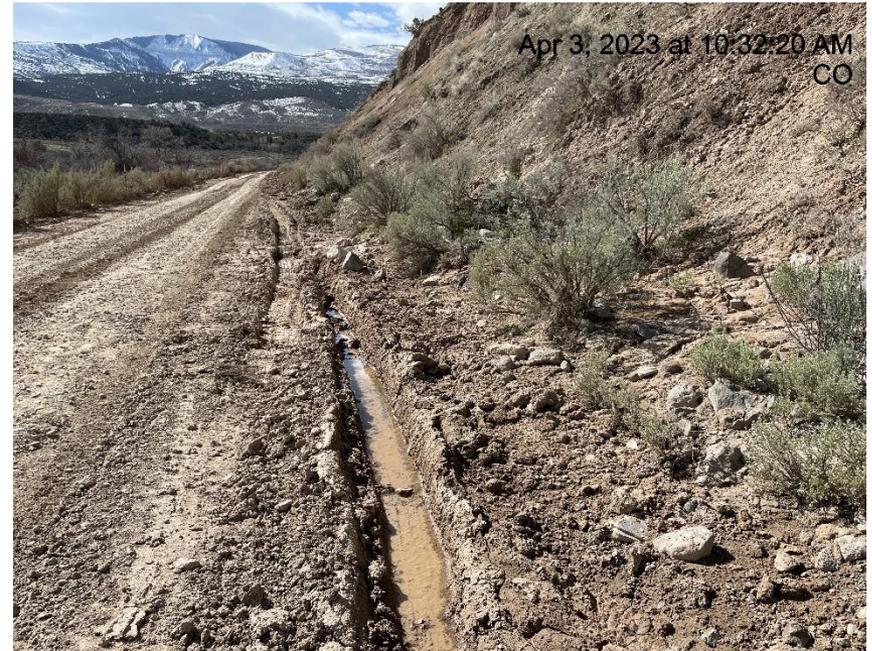
Photo # 4011 Photo # 4010 Sediment transport/insufficient BMP's (approximately 1.6 – 1.7 miles down lease road)

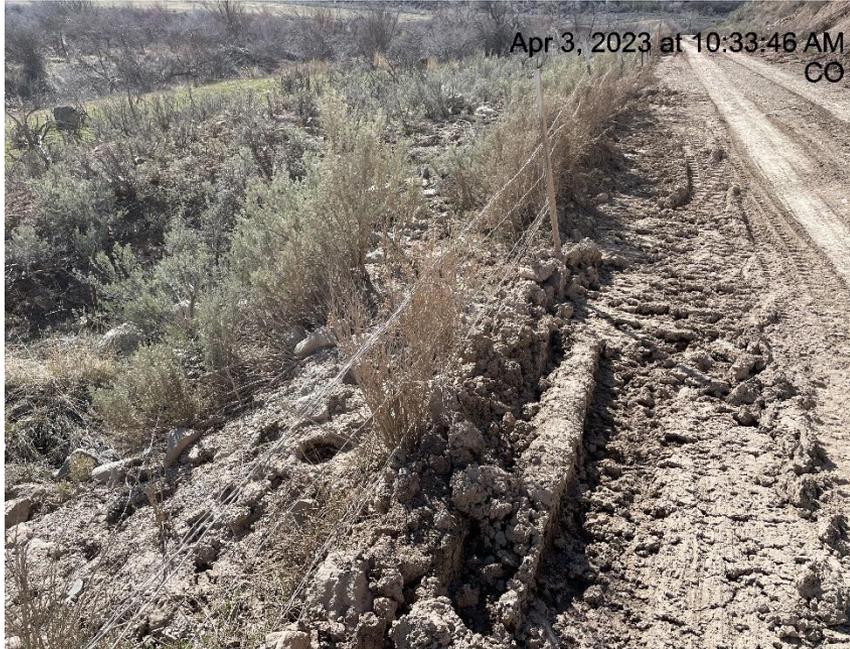
Photo # 4015 Sediment transported off lease road/insufficient BMP's (approximately 1.6 – 1.7 miles down lease road)

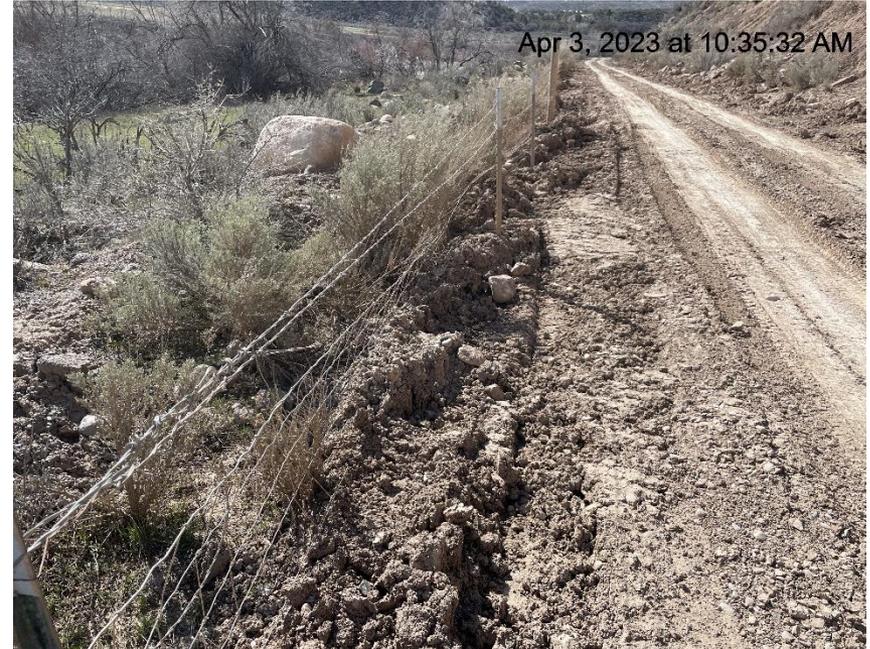
Photo # 4016 Sediment transported off lease road/insufficient BMP's (approximately 1.6 – 1.7 miles down lease road)

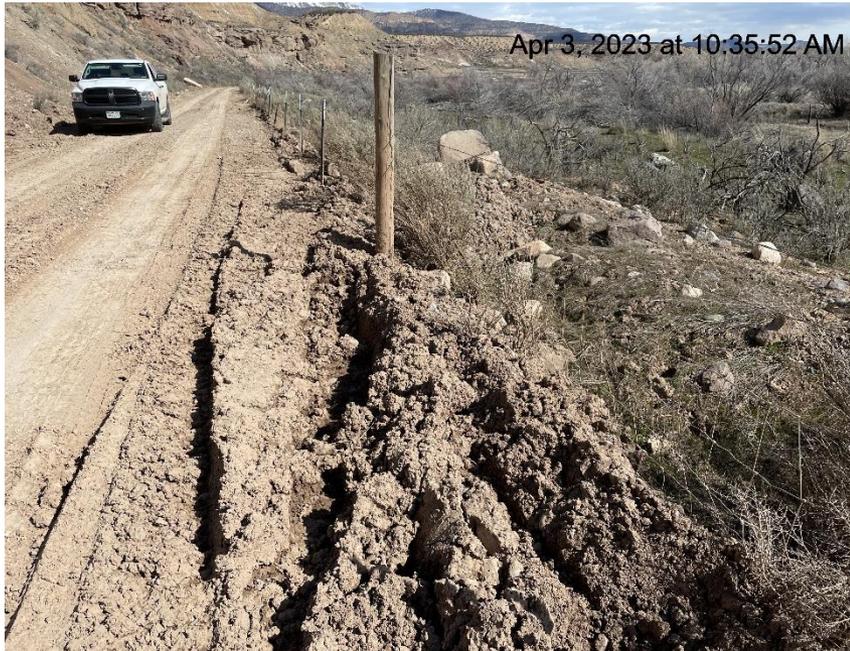
Photo # 4017 Sediment transported off lease road/insufficient BMP's (approximately 1.6 – 1.7 miles down lease road)

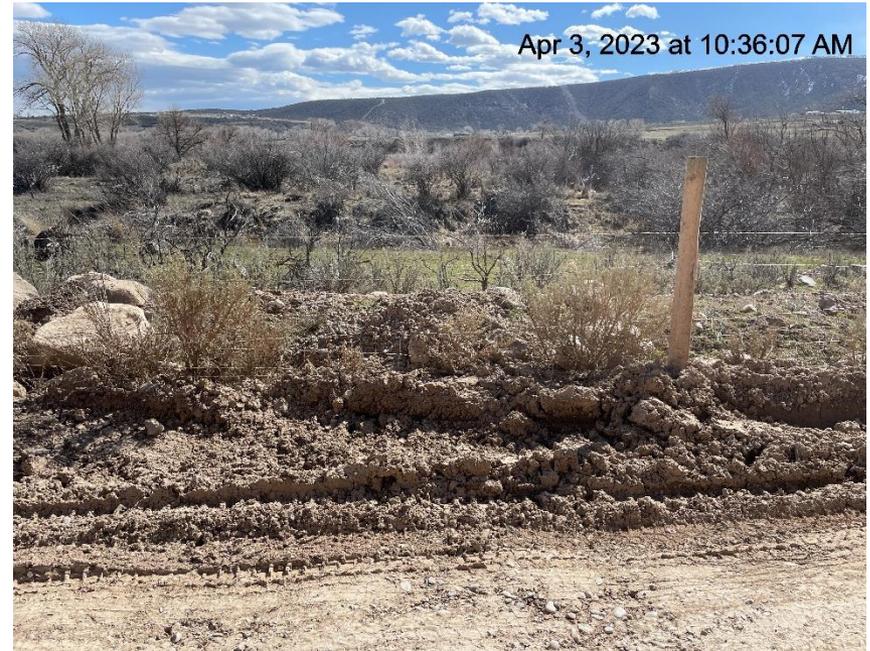
Photo # 4018 Sediment transported off lease road/insufficient BMP's (approximately 1.6 – 1.7 miles down lease road)

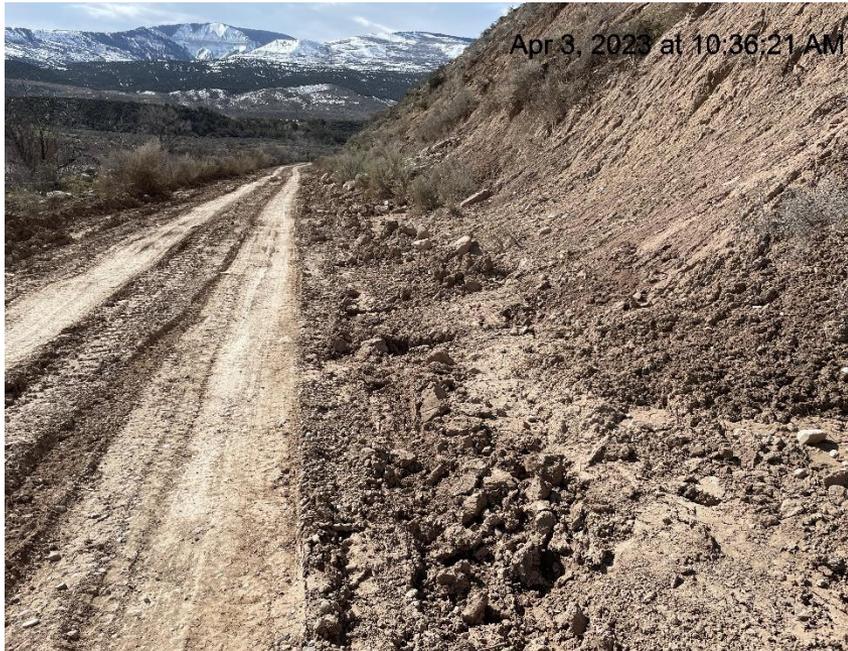
Photo # 4019 Lack of stabilization on slope/transport of sediment/insufficient BMP's (approximately 1.6- 1.7 miles down lease road)

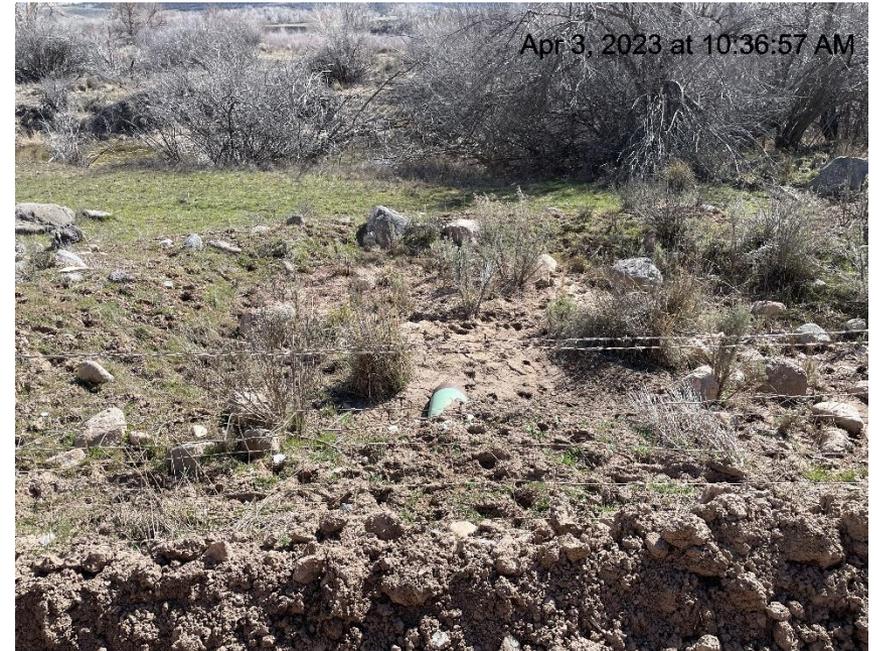
Photo # 4020 Culvert & sediment trap need maintenance (approximately 1.6- 1.7 miles down lease road)

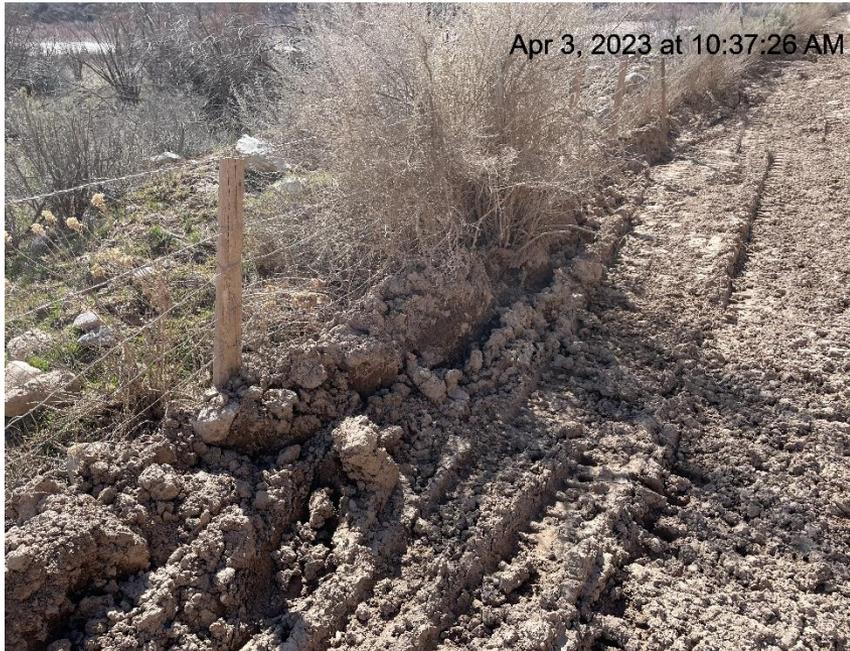
**Photo # 4021 Transport of sediment/insufficient BMP's
(approximately 1.7 miles down lease road)**

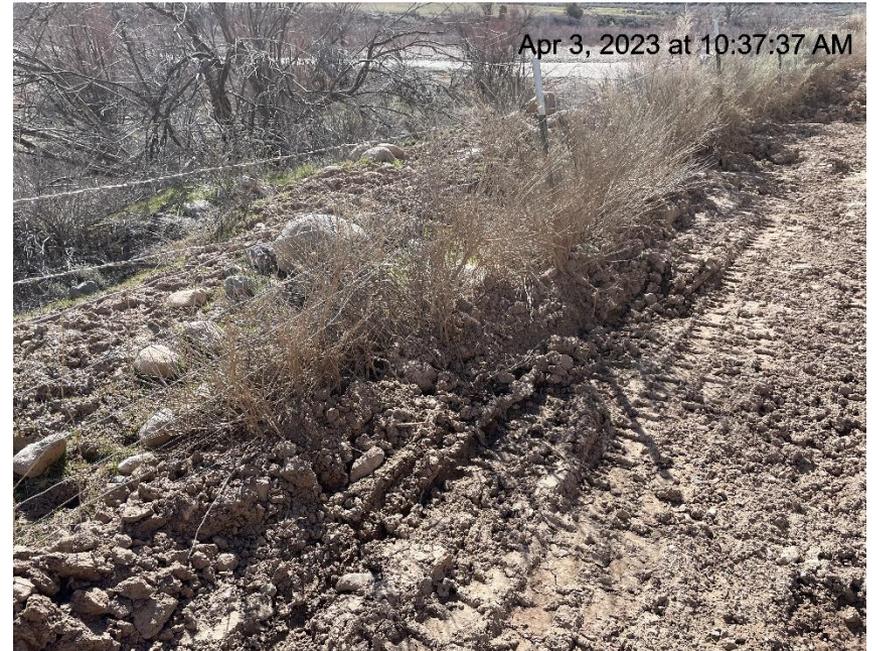
**Photo # 4022 Transport of sediment/insufficient BMP's
(approximately 1.7 miles down lease road)**

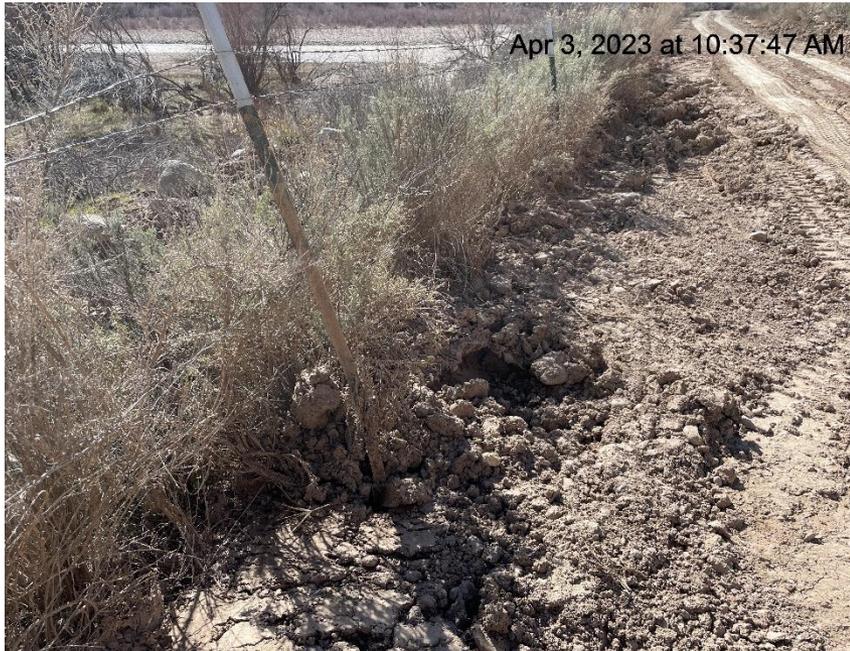
Photo # 4023 Sediment transported into vegetation

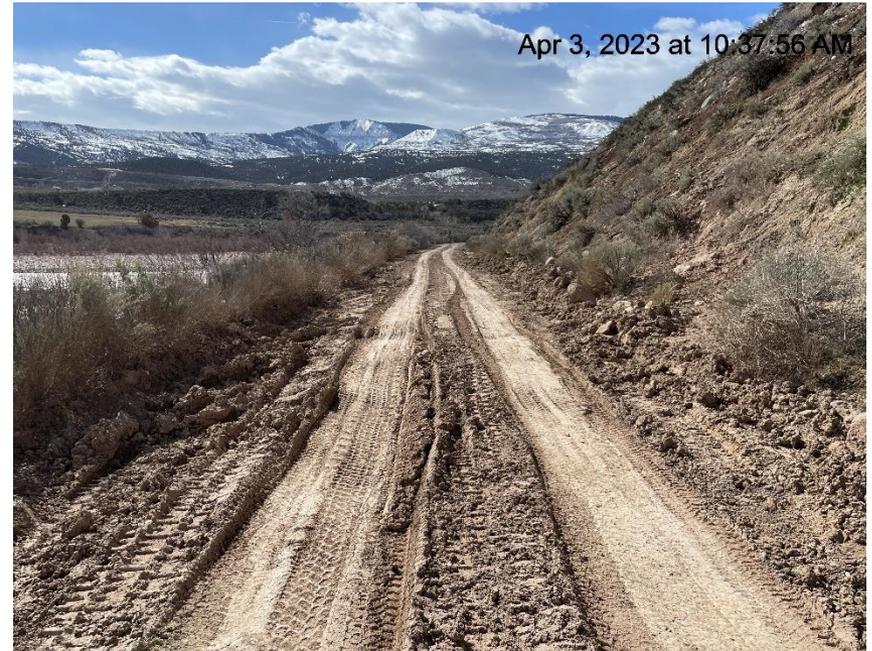
**Photo # 4024 Lack of stabilization/insufficient tracking
BMP's/insufficient run on controls/BMP's/transport of sediment
(approximately 1.7 miles down lease road)**

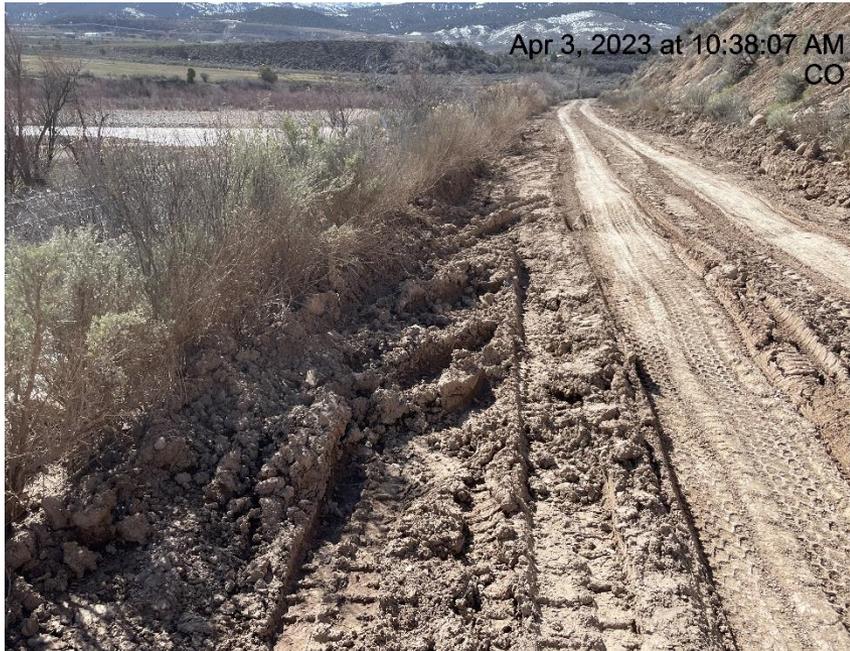
Photo # 4026 Insufficient BMP's/Sediment transported off lease road & into vegetation (approximately 1.6 – 1.7 miles down lease road)

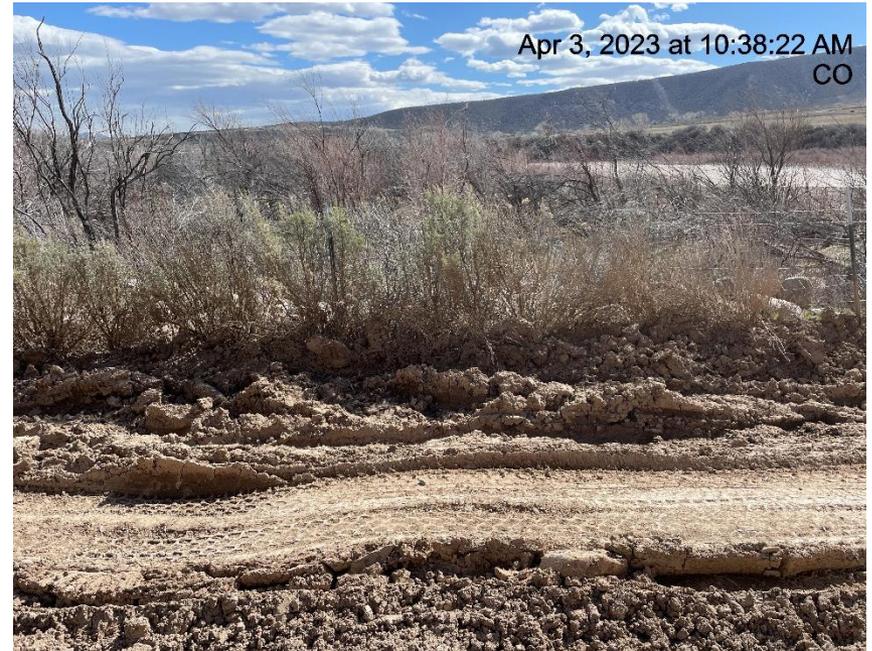
Photo # 4027 Lack of stabilization/Insufficient tracking BMP's (approximately 1.7 miles down lease road)

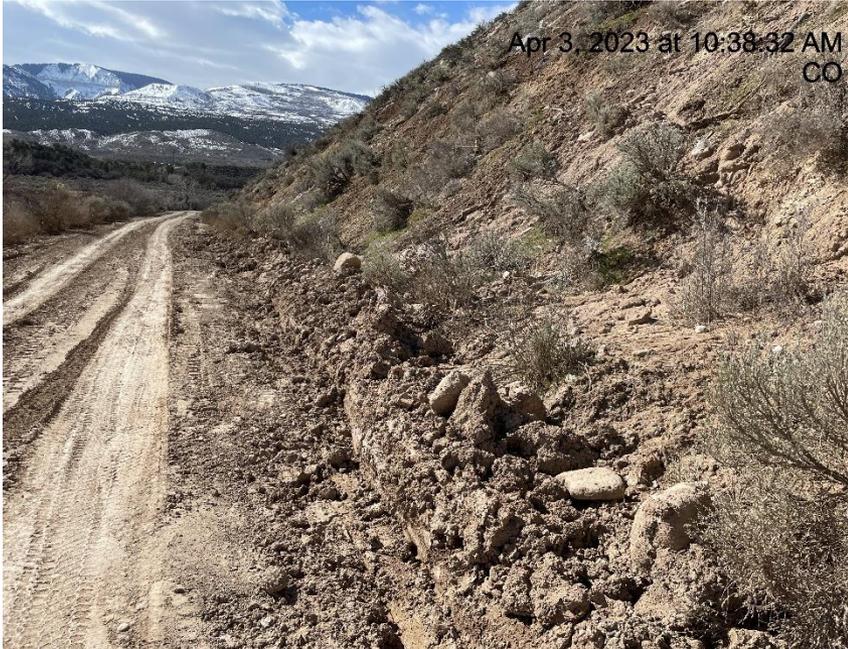
Photo # 4028 Insufficient run on BMP's (approximately 1.6 – 1.7 miles down lease road)

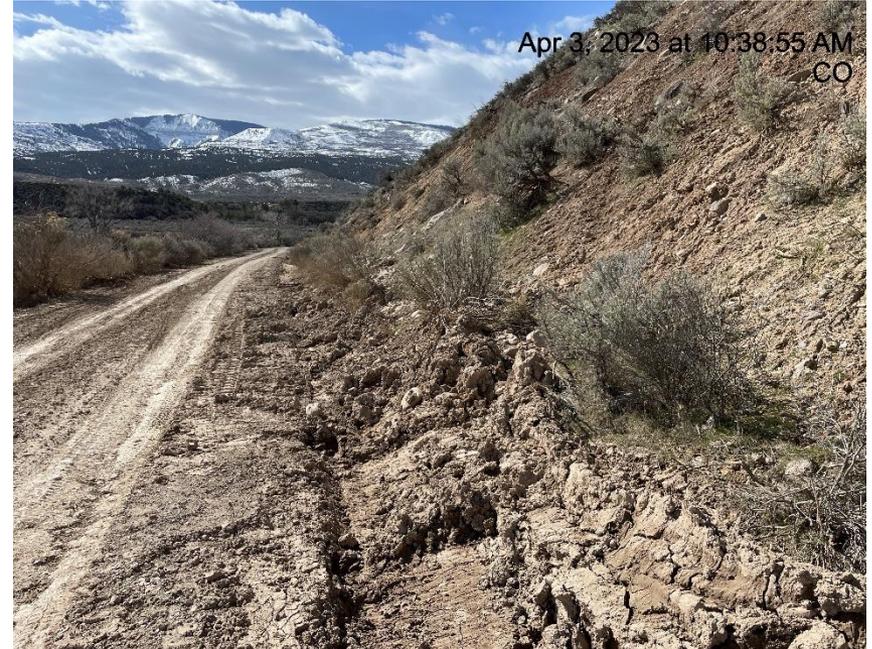
Photo # 4029 Insufficient run on BMP's (approximately 1.6 – 1.7 miles down lease road)

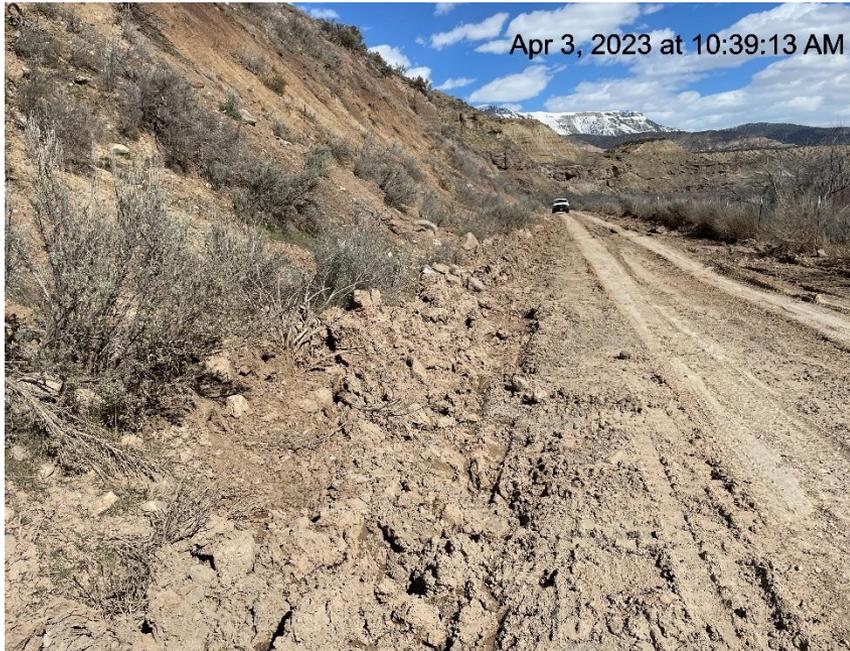
Photo # 4030 Insufficient run on BMP's (approximately 1.6 – 1.7 miles down lease road)

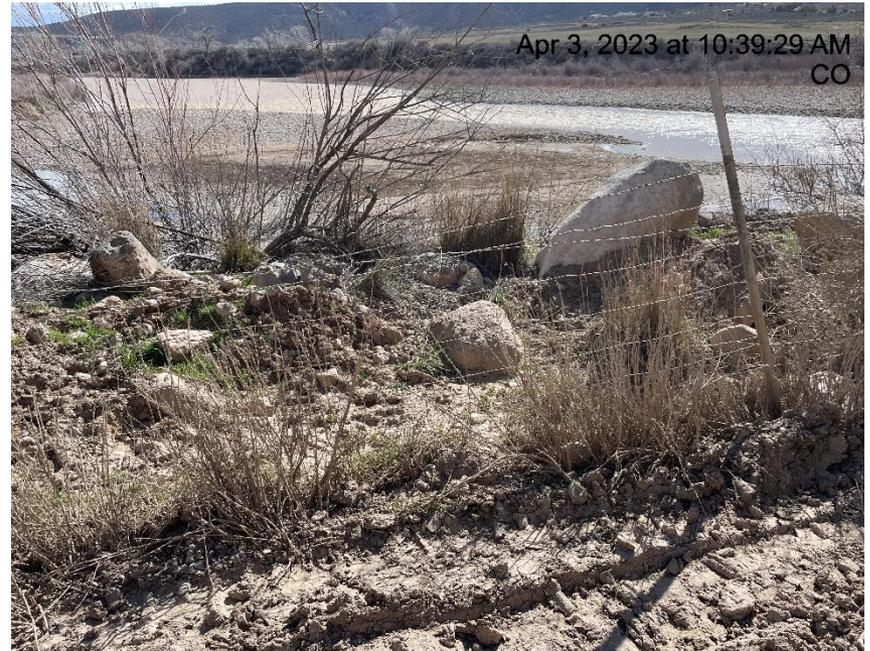
Photo # 4031 Insufficient BMP's/Sediment transported off lease road & into vegetation near the Colorado River (approximately 1.7 – 1.8 miles down lease road)

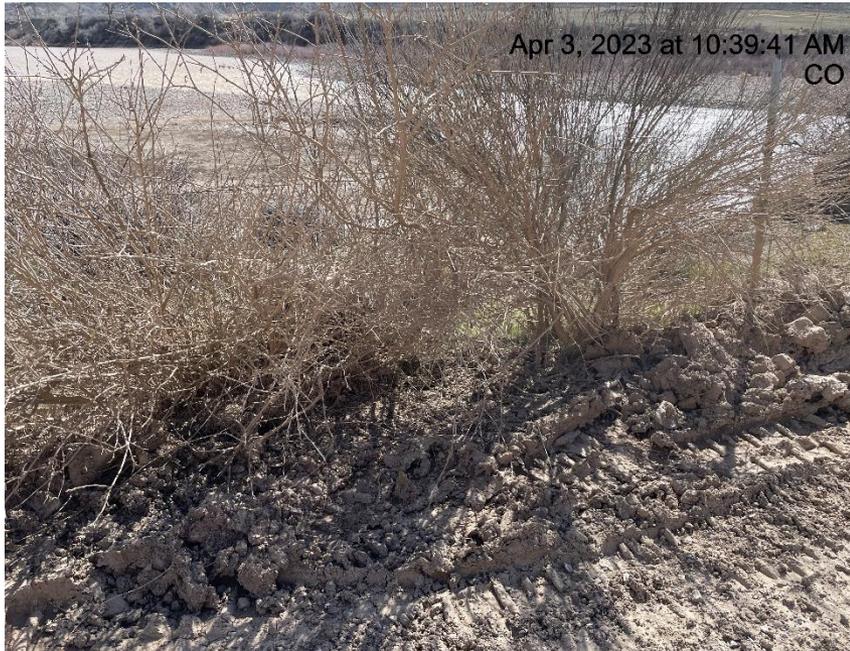
Photo # 4032 Insufficient BMP's/Sediment transported off lease road & into vegetation near the Colorado River (approximately 1.7 – 1.8 miles down lease road)

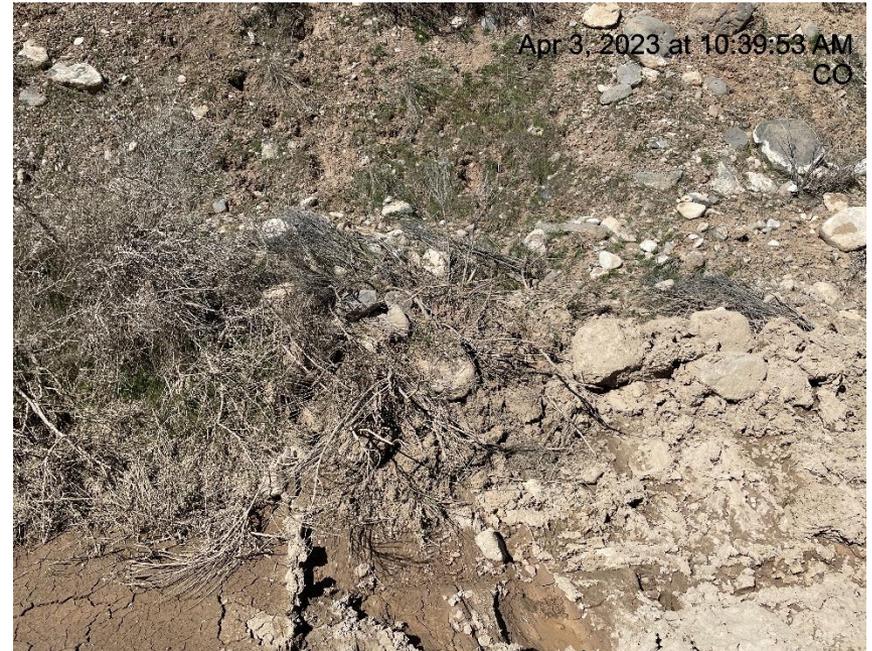
Photo # 4033 Insufficient BMP's/Sediment transported off lease road & into vegetation (approximately 1.7 – 1.8 miles down lease road)

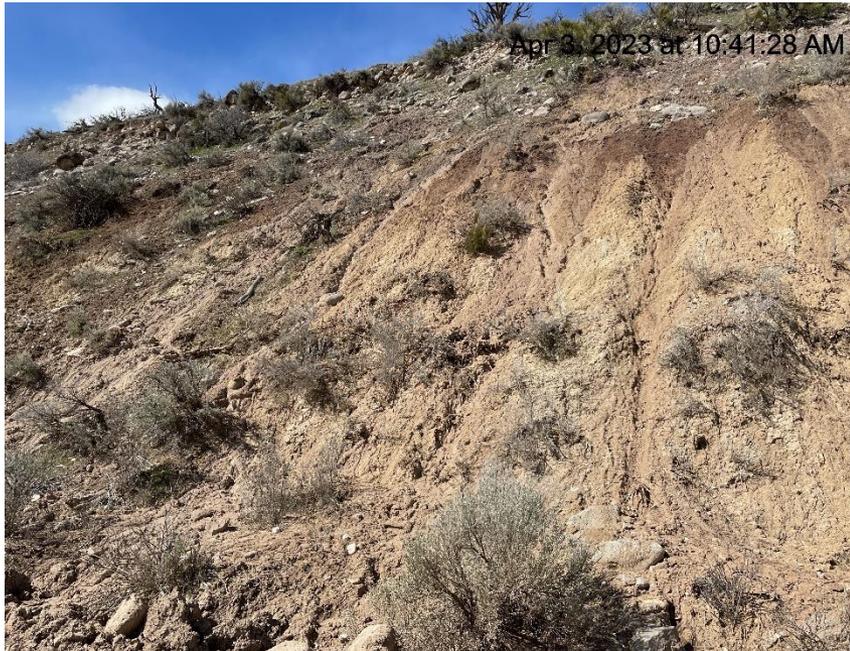
Photo # 4038 Lack of stabilization on slope/Insufficient run on controls/BMP's/transport of sediment (approximately 1.7 miles down lease road)

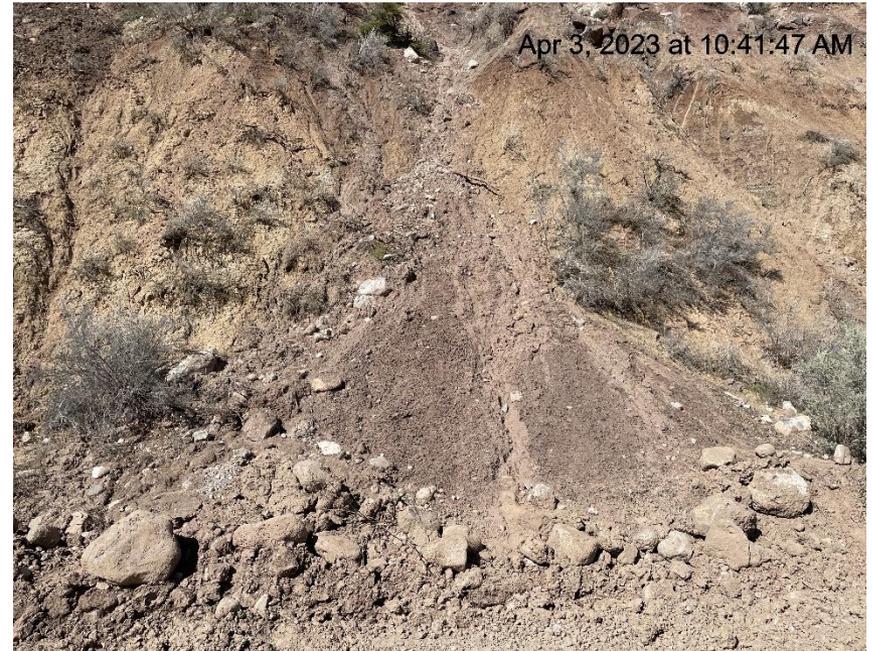
Photo # 4039 Lack of stabilization on slope/Insufficient run on controls/BMP's/transport of sediment (approximately 1.7 miles down lease road)

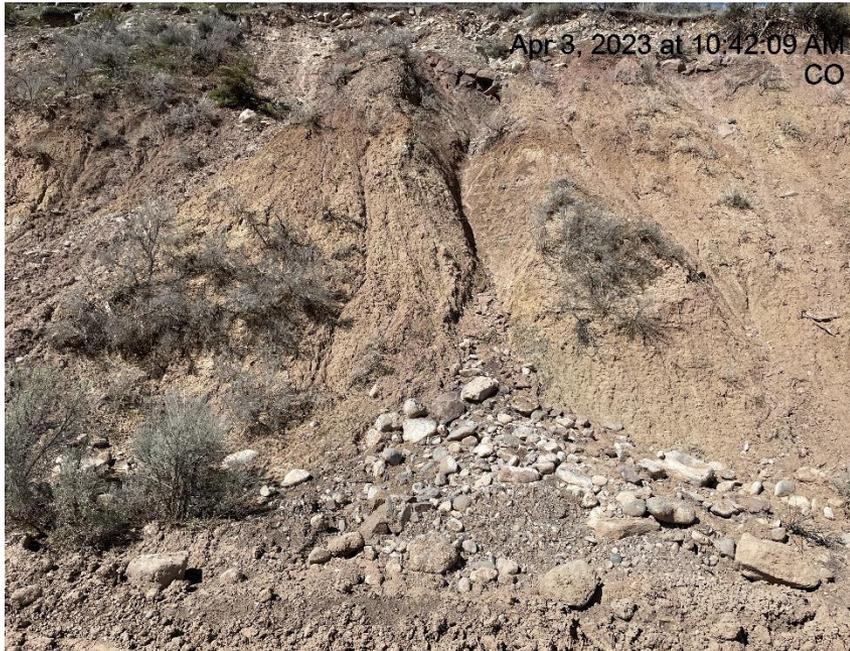
Photo # 4040 Lack of stabilization on slope/Insufficient run on controls/BMP's/transport of sediment (approximately 1.6 – 1.7 miles down lease road)

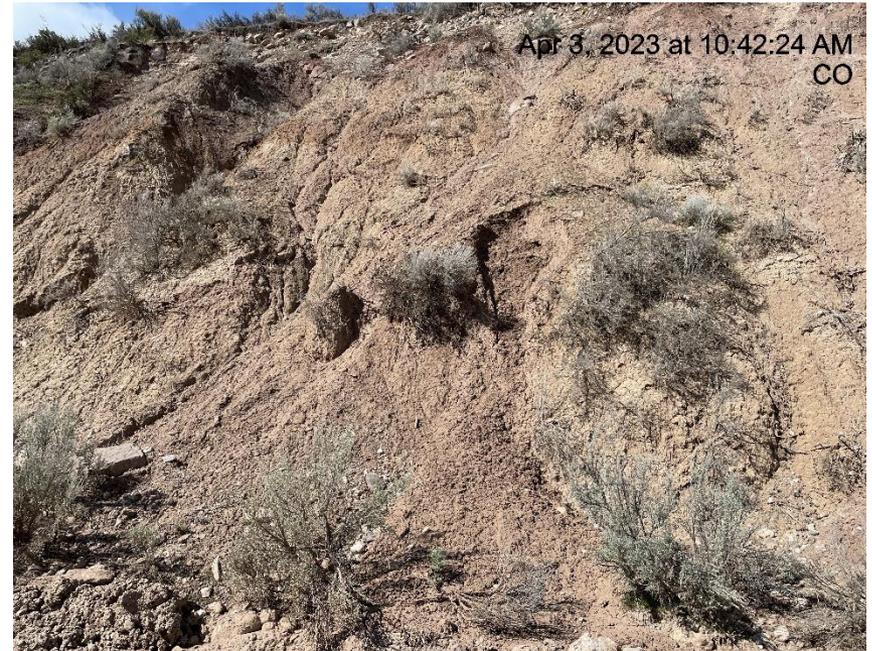
Photo # 4041 Lack of stabilization on slope/Insufficient run on controls/BMP's/transport of sediment (approximately 1.6 – 1.7 miles down lease road)

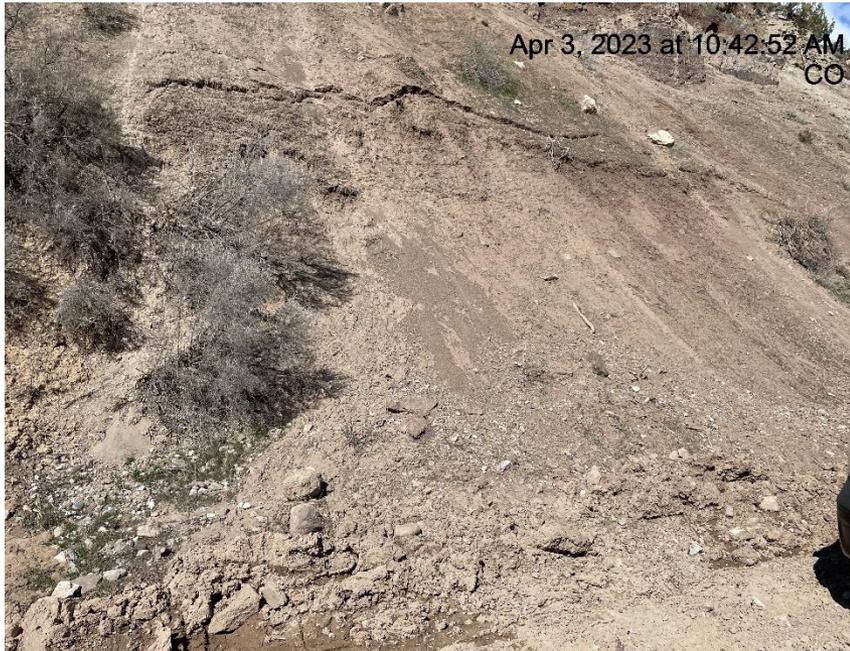
Photo # 4043 Lack of stabilization on slope/Insufficient run on controls/BMP's/transport of sediment (approximately 1.6 – 1.7 miles down lease road)

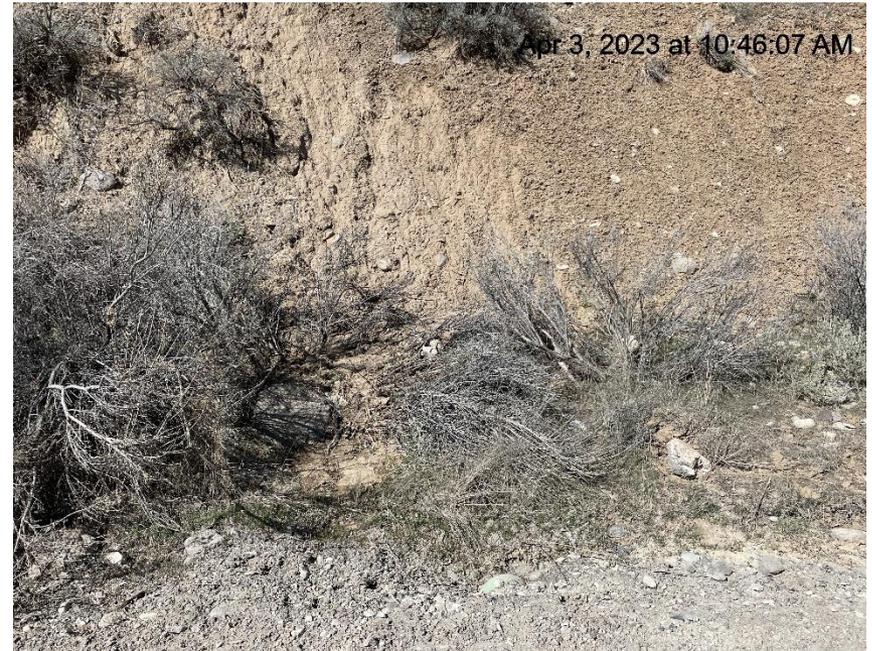
Photo # 4047 Lack of stabilization on slope/Insufficient run on controls/BMP's/transport of sediment (approximately 1.6 – 1.7 miles down lease road)
