Inspection Photos

Location Name: TEP ROCKY MOUNTAIN LLC WEBSTER/HEATH RMV 236-28 pad

Location ID: 324046

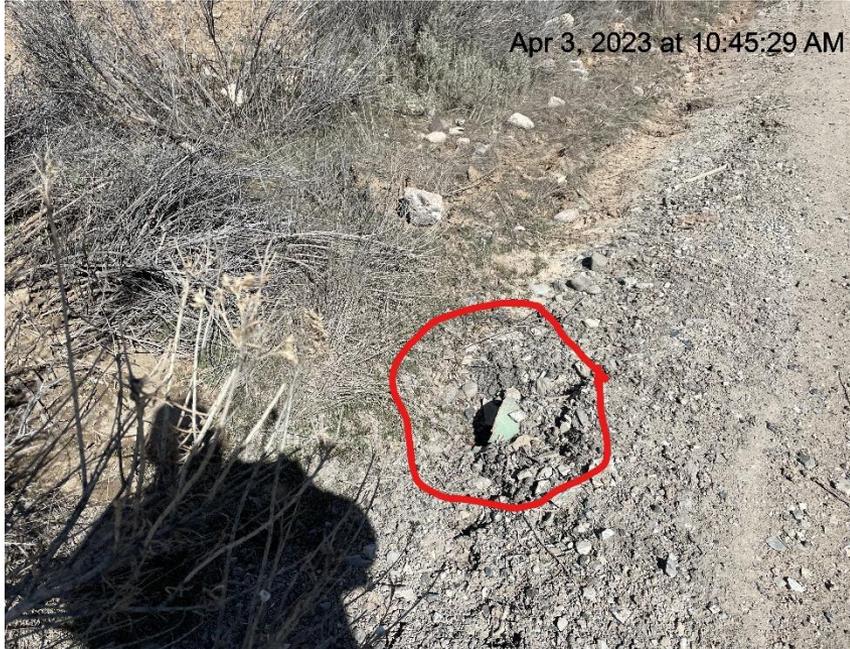
Photo # 4044 Culvert has insufficient BMP's, allows direct discharge into the Colorado River (approximately 1.8 – 1.9 miles down lease road)

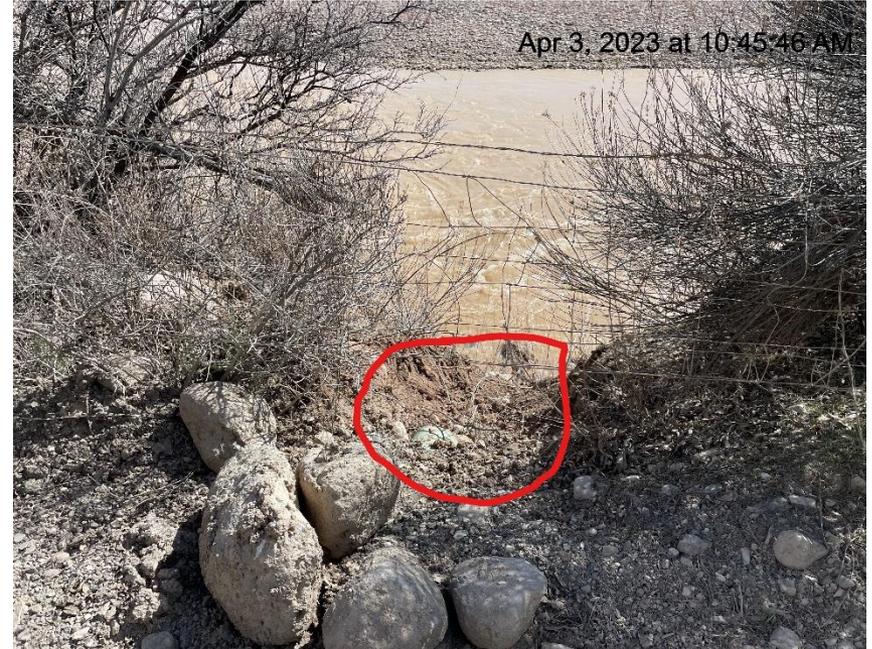
Photo # 4045 Culvert has insufficient BMP's, allows direct discharge into the Colorado River (approximately 1.8 – 1.9 miles down lease road)

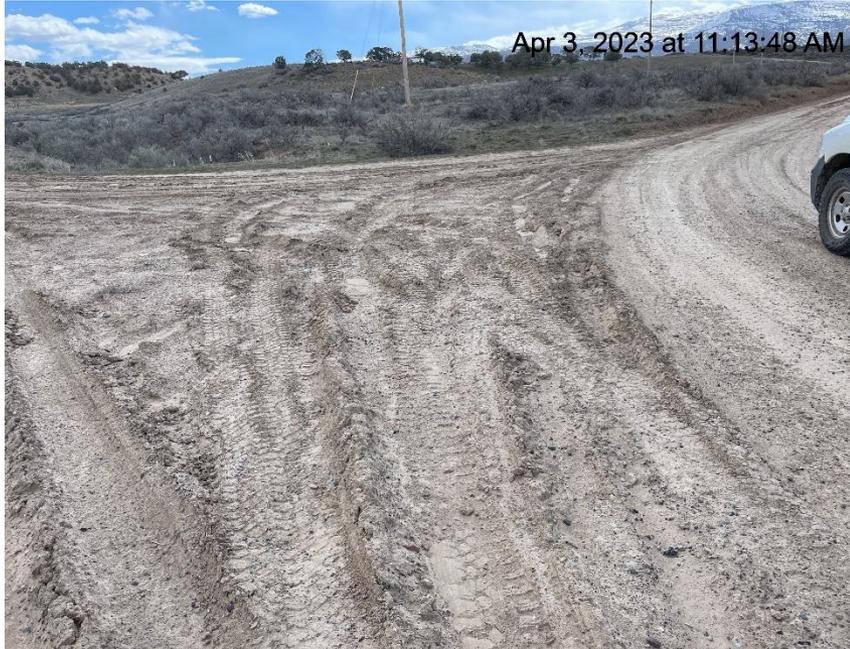
**Photo # 4080 Lack of stabilization/Insufficient tracking
BMP's (approximately 3.5 miles down lease road)**

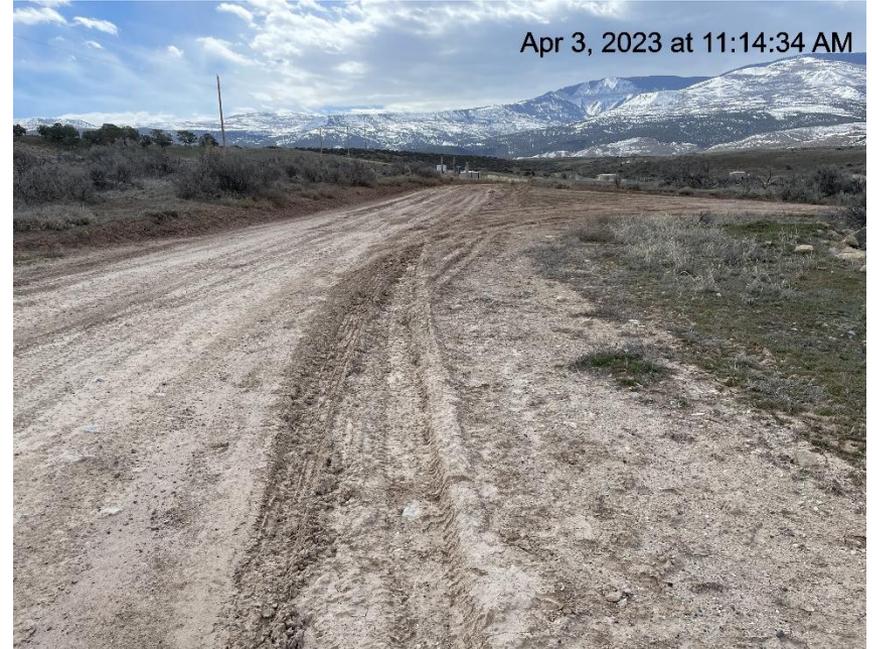
**Photo # 4081 Lack of stabilization/Insufficient tracking
BMP's (approximately 3.5 miles down lease road)**

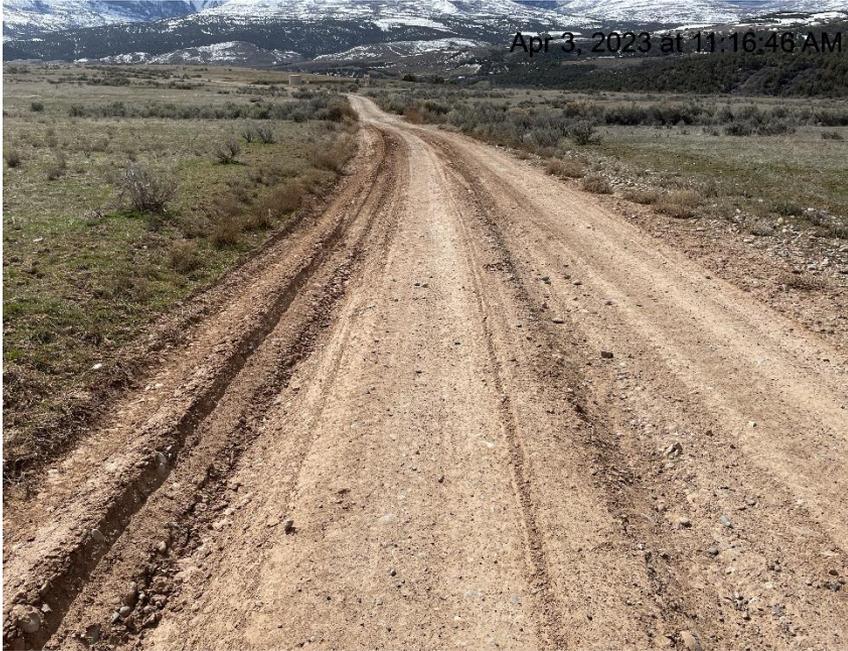
**Photo # 4083 Lack of stabilization/Insufficient tracking
BMP's (approximately 3.8 miles down lease road)**

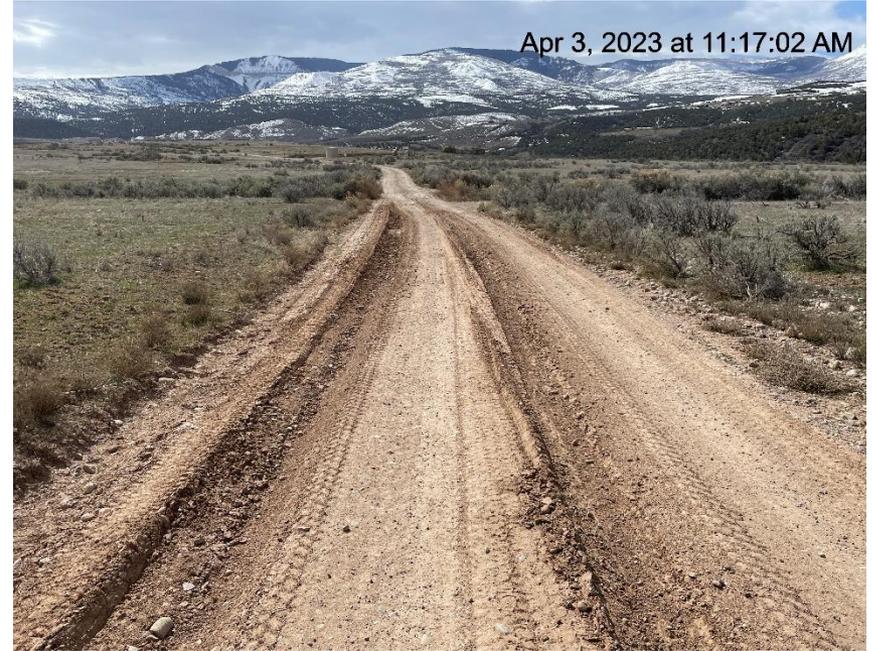
**Photo # 4084 Lack of stabilization/Insufficient tracking
BMP's (approximately 3.8 miles down lease road)**
