Inspection Photos

3/31/2023

Operator: LOCIN OIL CORPORATION - 51130

Location #322414

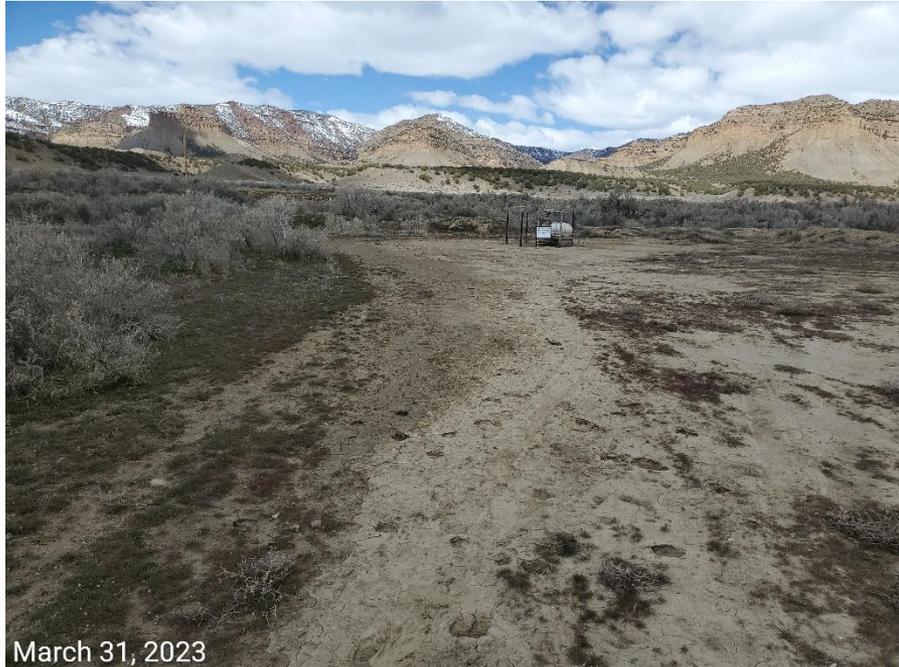
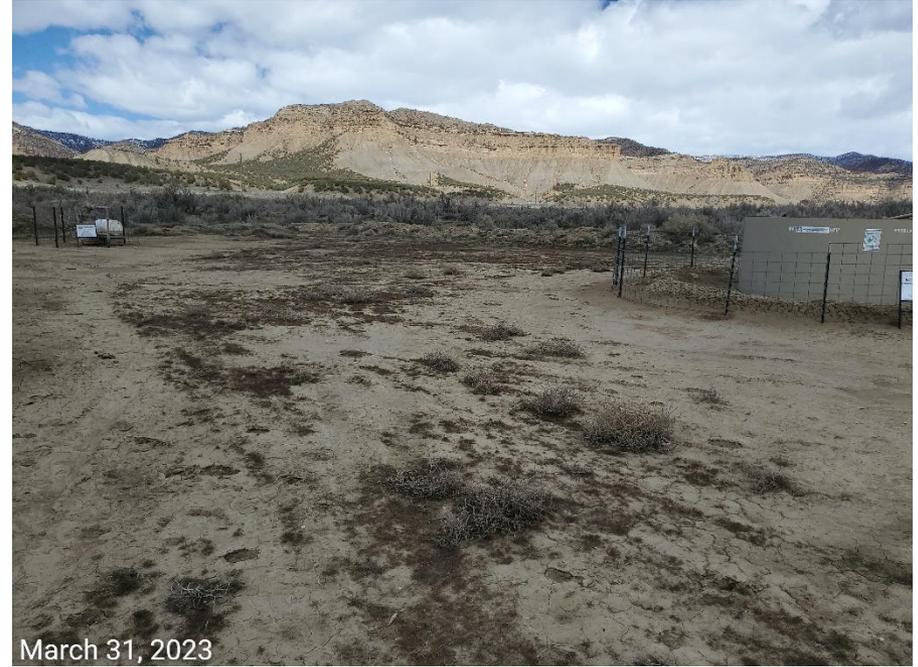
Photo 1: Photos 1-2 taken from the south end of the Location. Photos provide an overview of the Location from west, northwest, northeast to east.

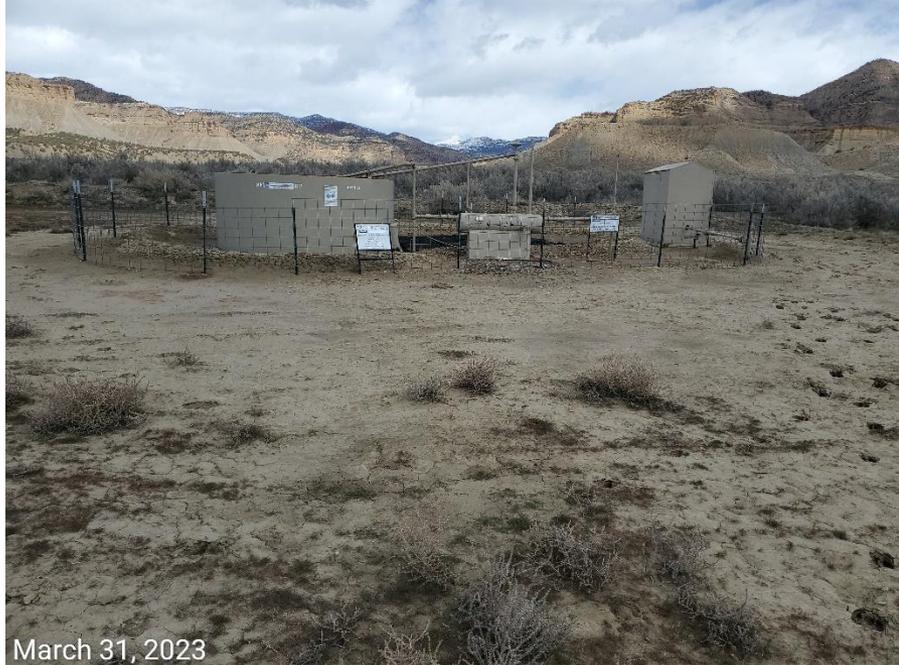
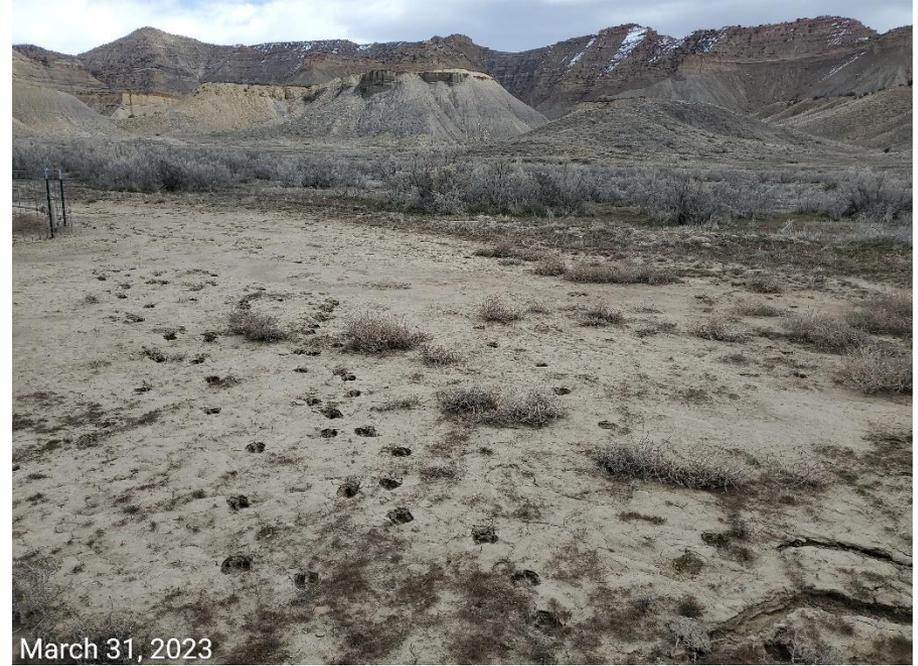
Photo 2: See comments under photo 1.

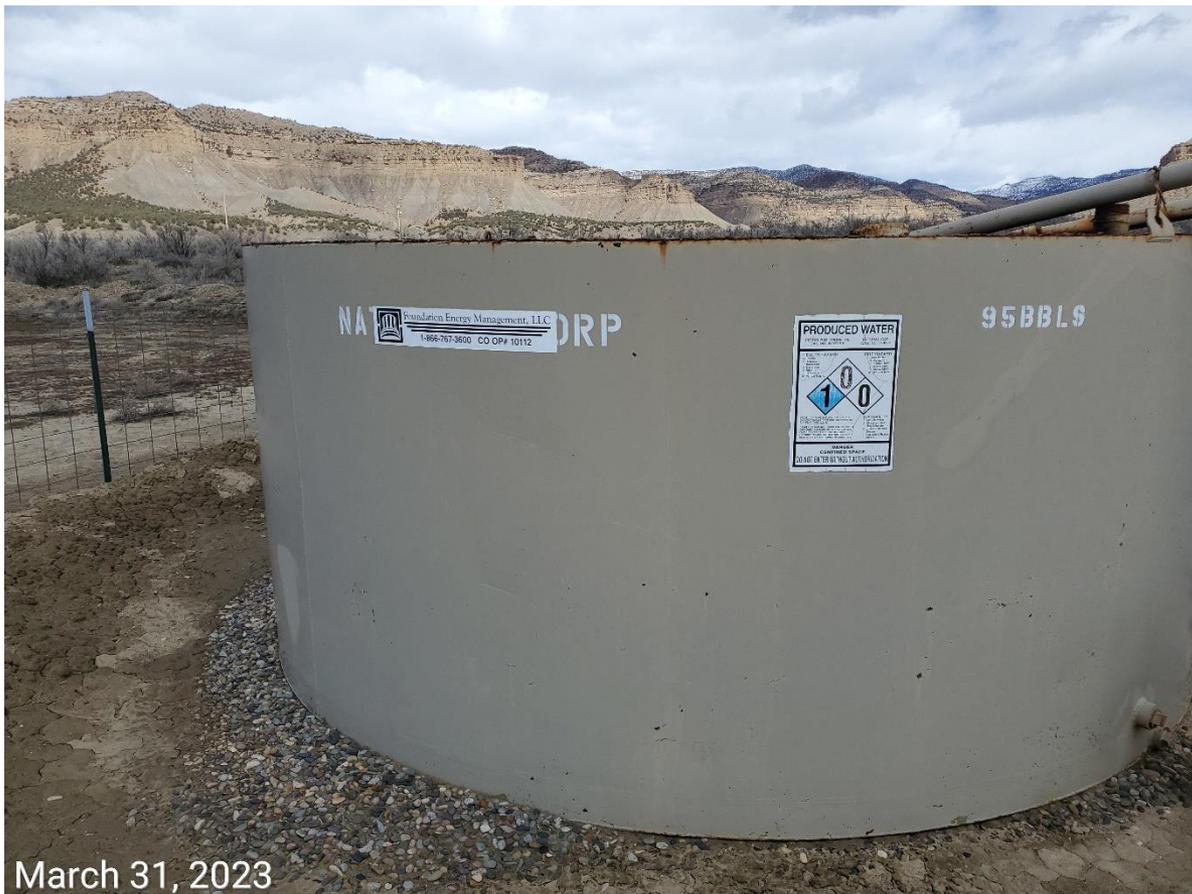
Photo 3: Incorrect Operator information on tank.

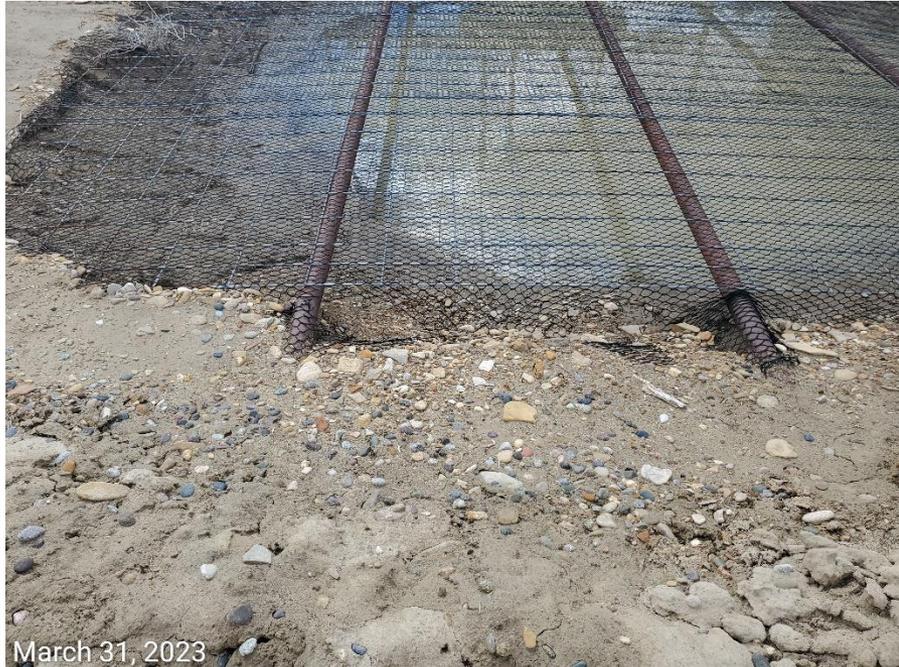
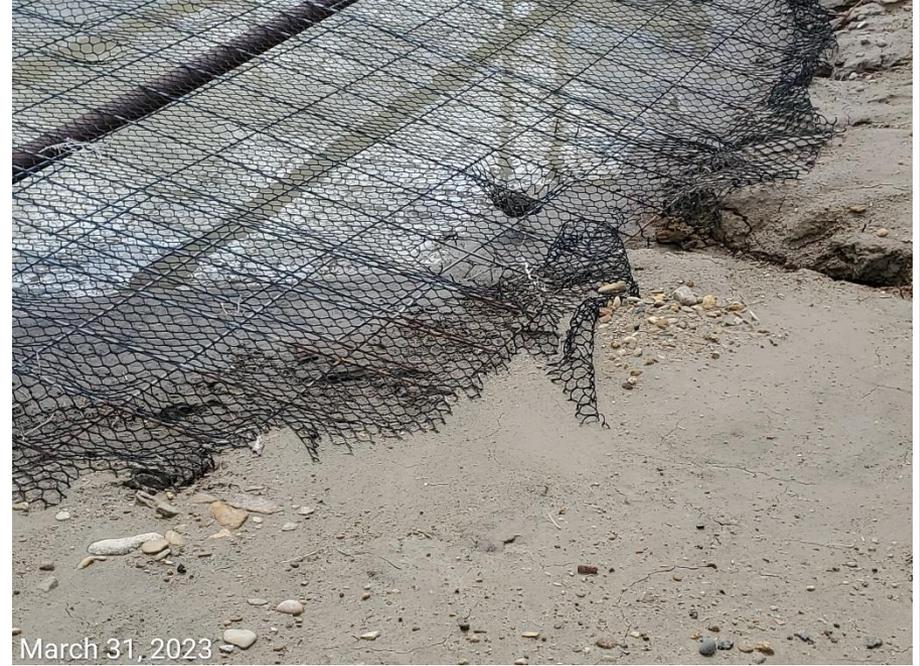
Photo 4: Holes observed in netting at pit; BMP not in proper functioning condition.

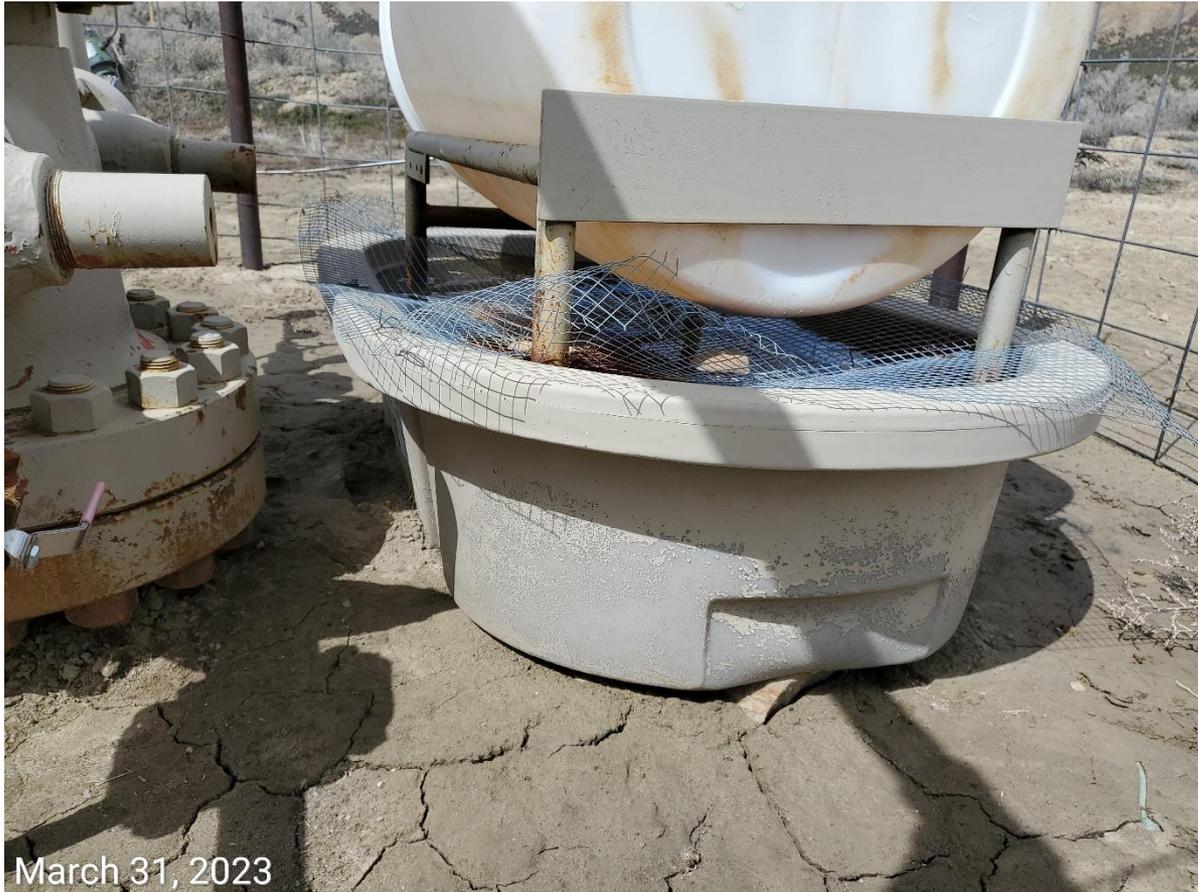
Photo 5: Photo taken from the methanol tank adjacent to the wellhead. Photo shows the wildlife protection BMP (wire fence/net) at the tank has not been properly secured to the containment BMP, which has resulted in bird mortality within the secondary containment.

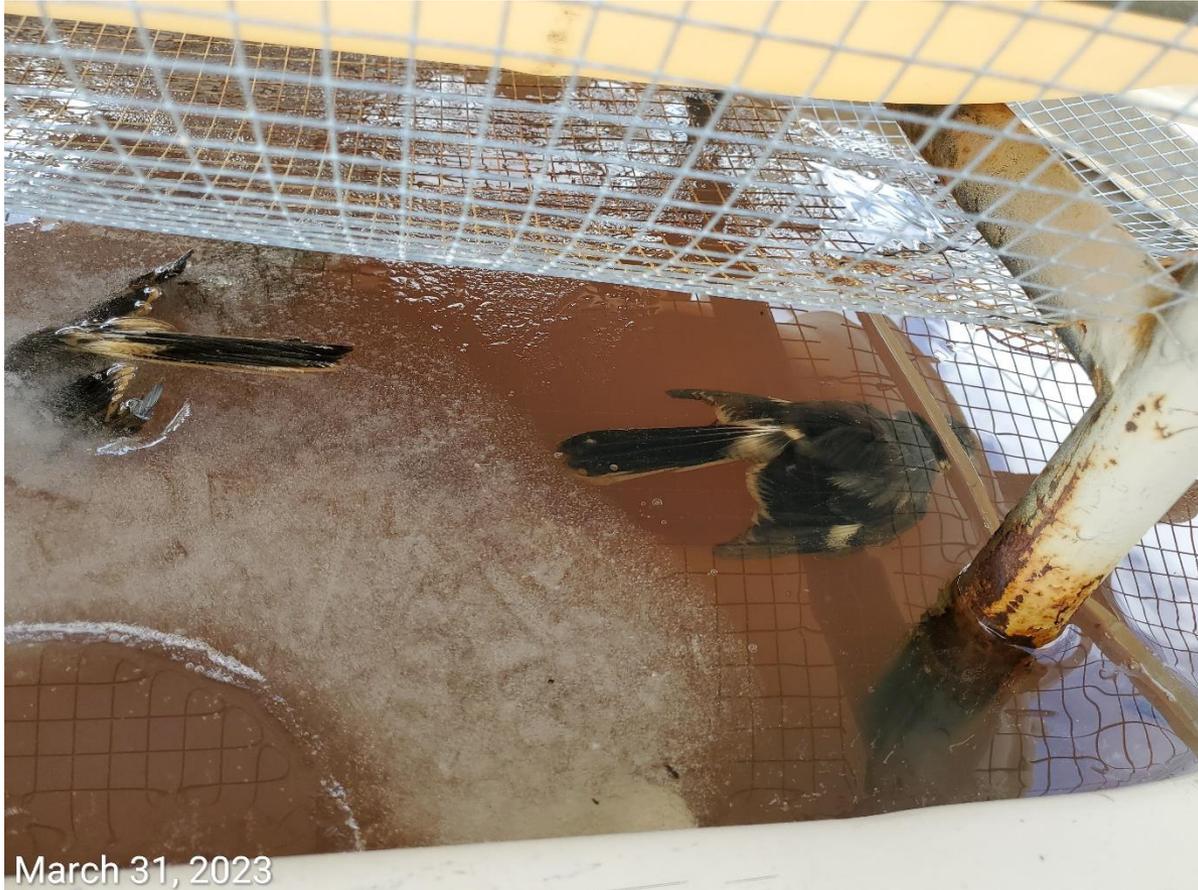
Photo 6: Continued from photo 5. Photo shows wildlife (bird) mortality due to improperly installed/maintain wildlife protection BMPs; bird species observed appears to be Spotted Towhee (*Pipilo maculatus*). Photo also shows containment BMP has filled with fluids, and is not longer adequate to contain a spill.

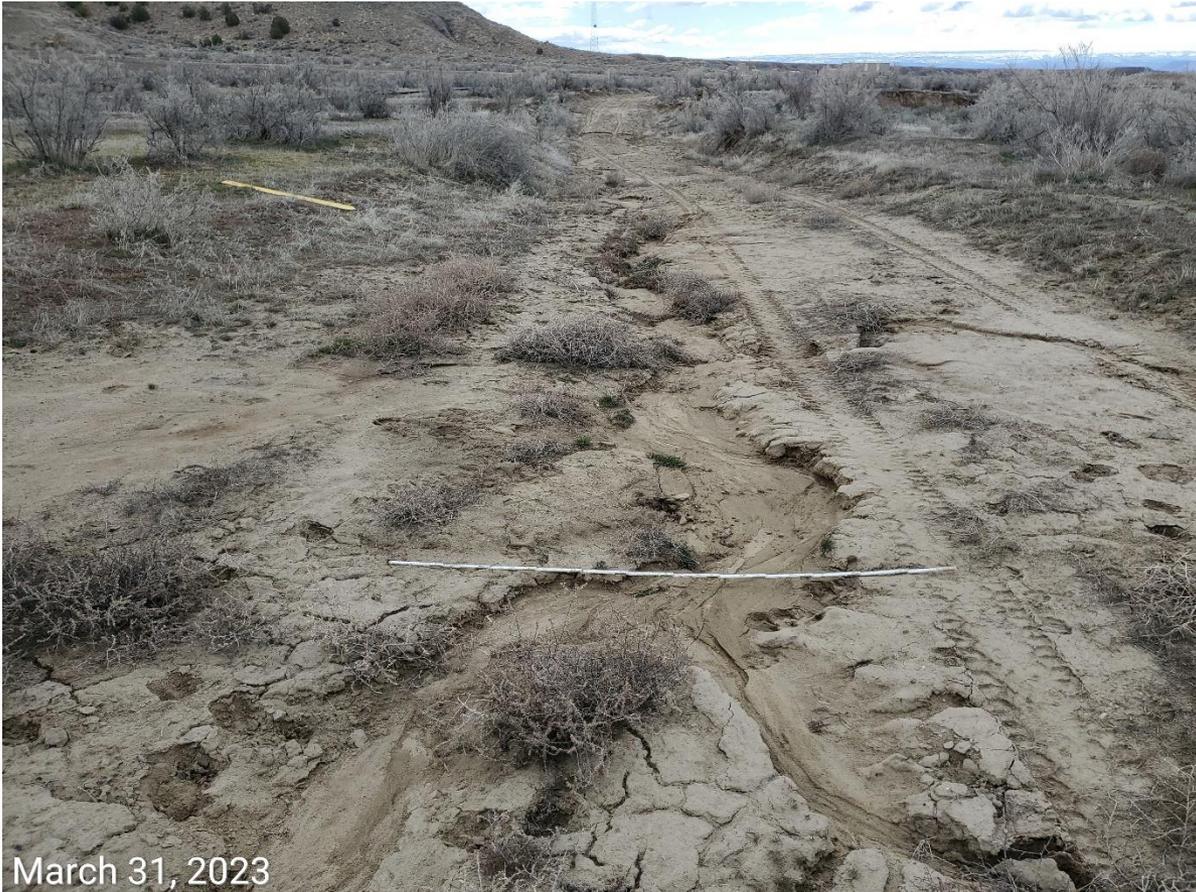
Photo 7: Photo shows erosion degradation due to stormwater runoff on the access road. 6 foot measuring stick for reference. Road lacks stabilization.

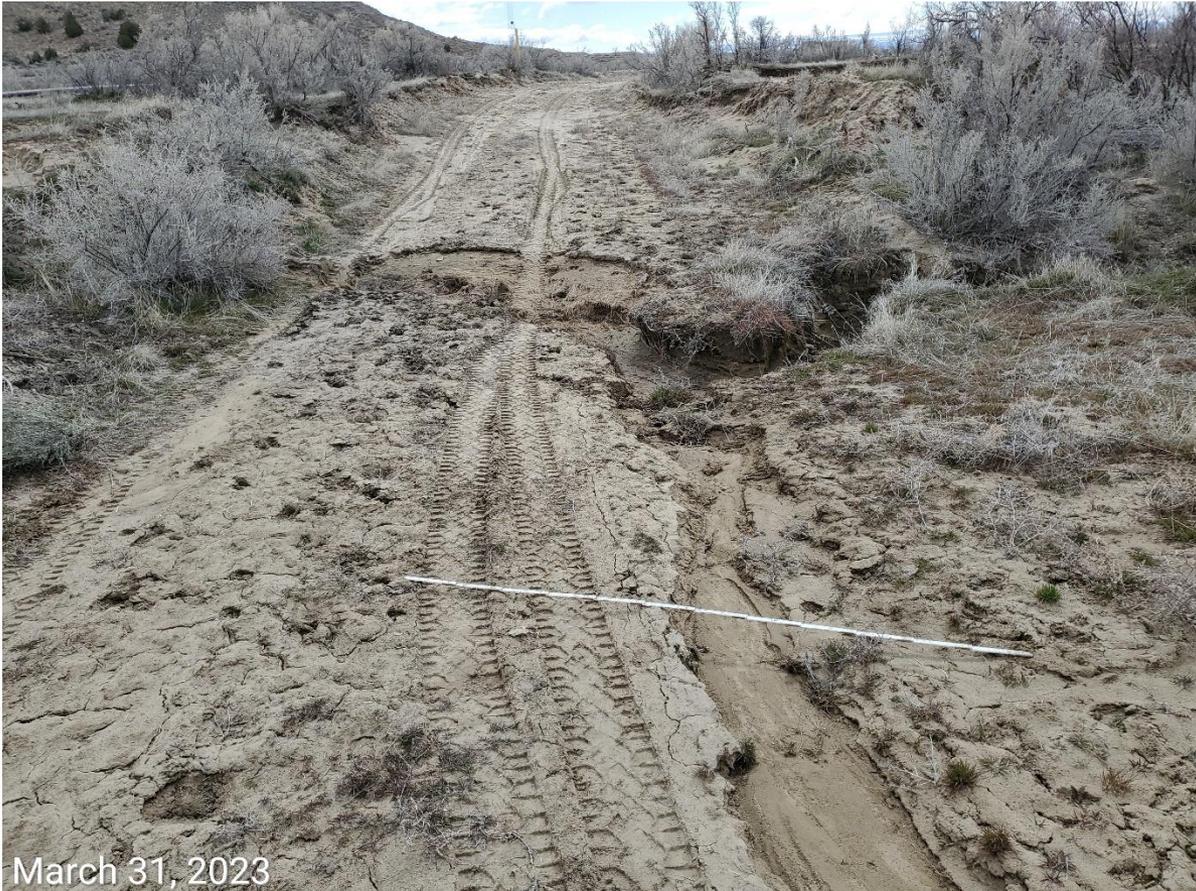
Photo 8: Photo shows gully erosion degradation due to stormwater runoff on the access road. 6 foot measuring stick for reference. Road lacks stabilization.

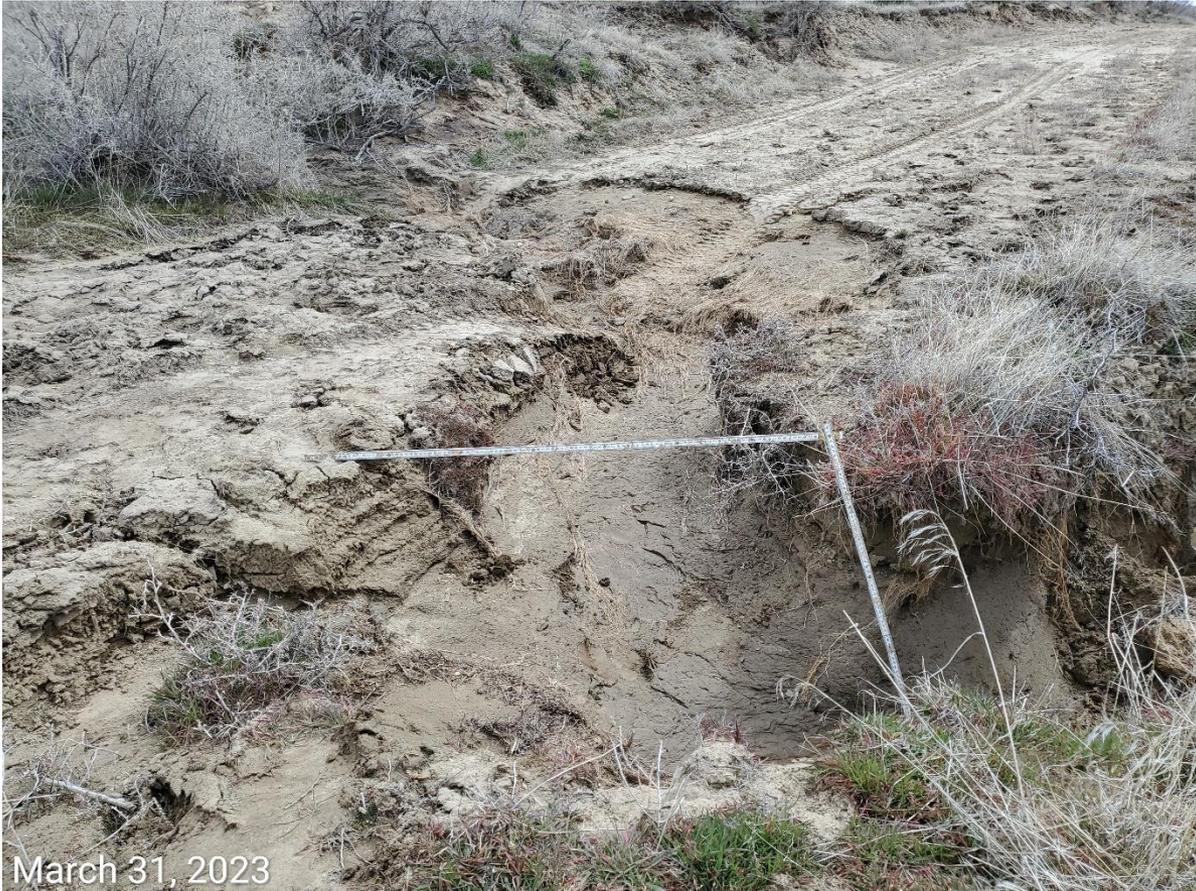
Photo 9: Gully erosion at access road. Photo shows gully depth on that road itself is approximately 2 feet deep. Road lacks stabilization.

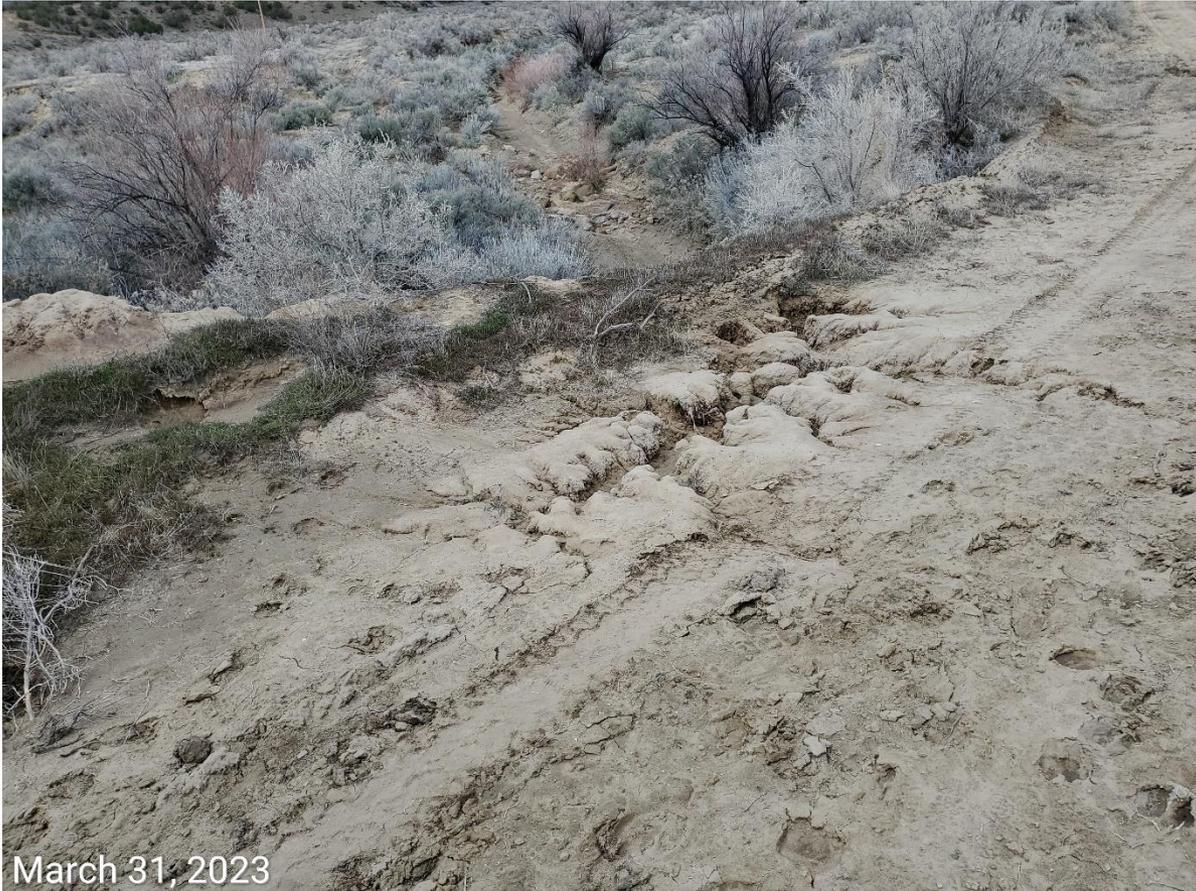
Photo 10: Photos 10-12 shows a section of the access road that runs parallel to “Salt Creek”. Stormwater runoff has resulted in erosion degradation and stabilization concerns; areas of access road at risk of sloughing into Salt Creek

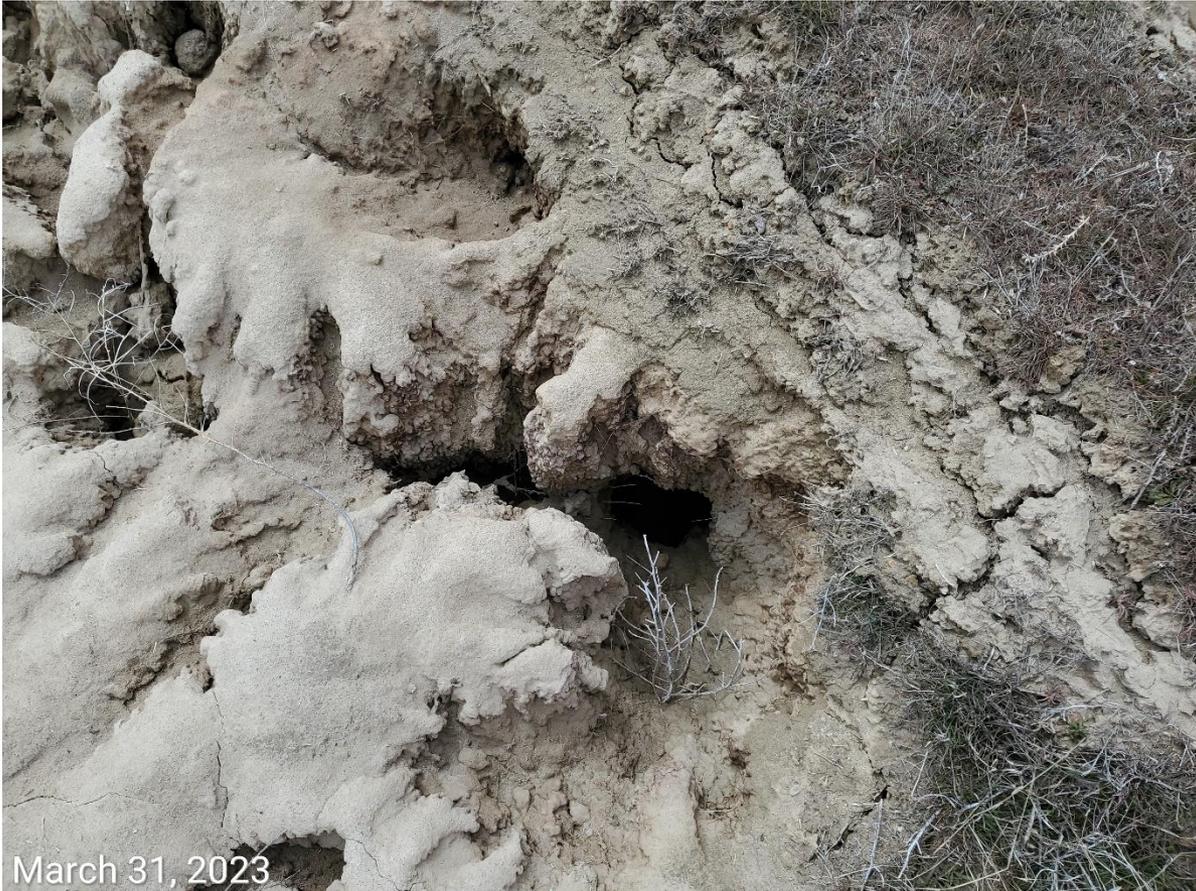
Photo 11: See comments under photo 10. Photo shows point where stormwater cuts directly beneath the access road. Reclamation Specialist was unable to determine depth of the hole.

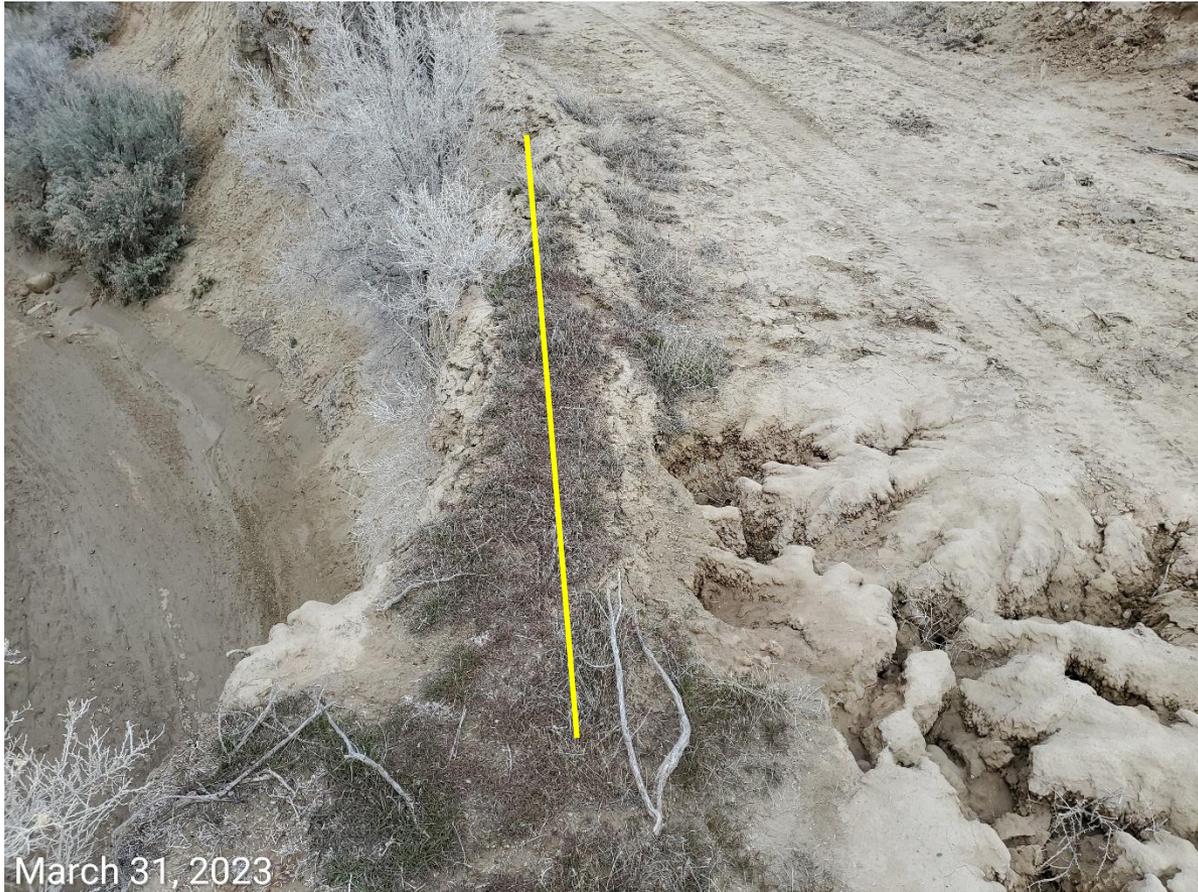
Photo 12: See comments under photo 10. Photo shows areas of access road (right of line) at risk of eroding into Salt Creek (left of line). Road lacks stabilization.

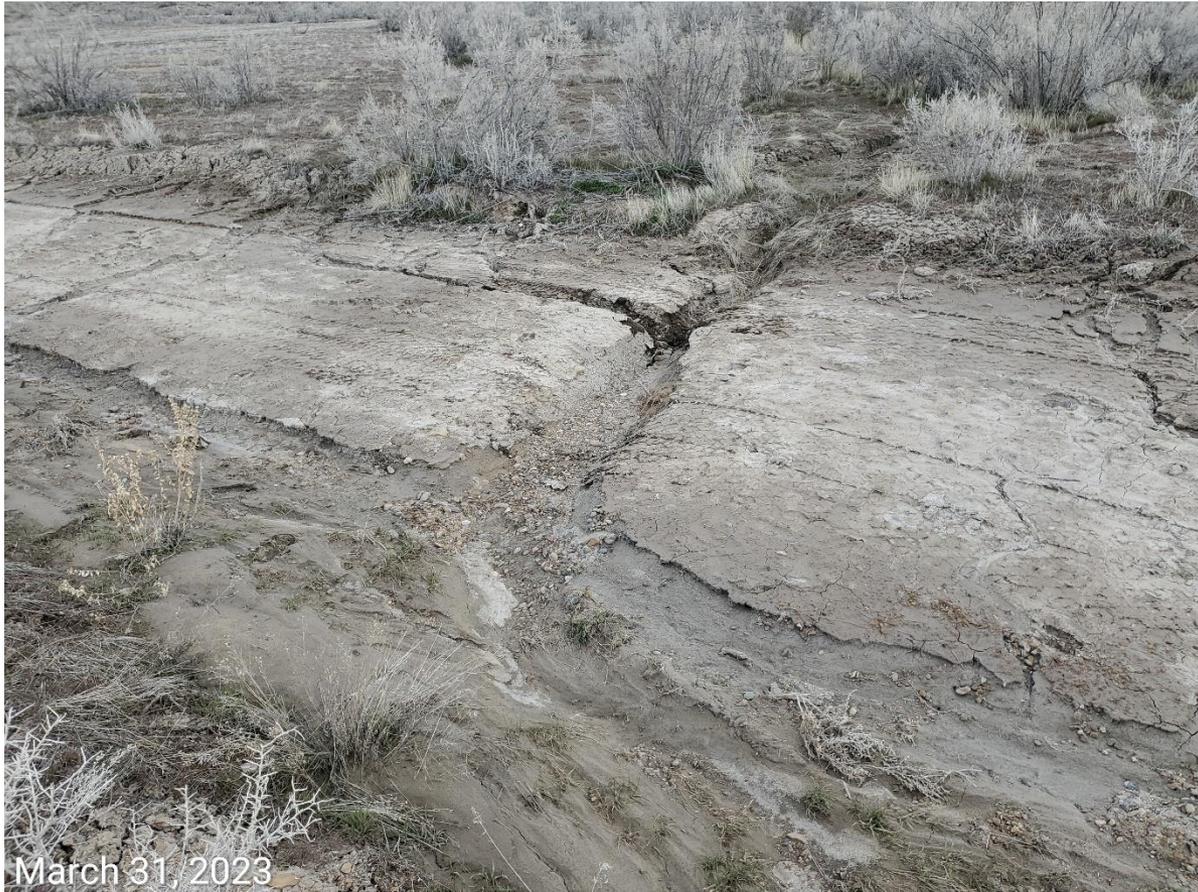
Photo 13: Erosion degradation on access road; stormwater and erosion control BMPs missing or insufficient. Road lacks stabilization.

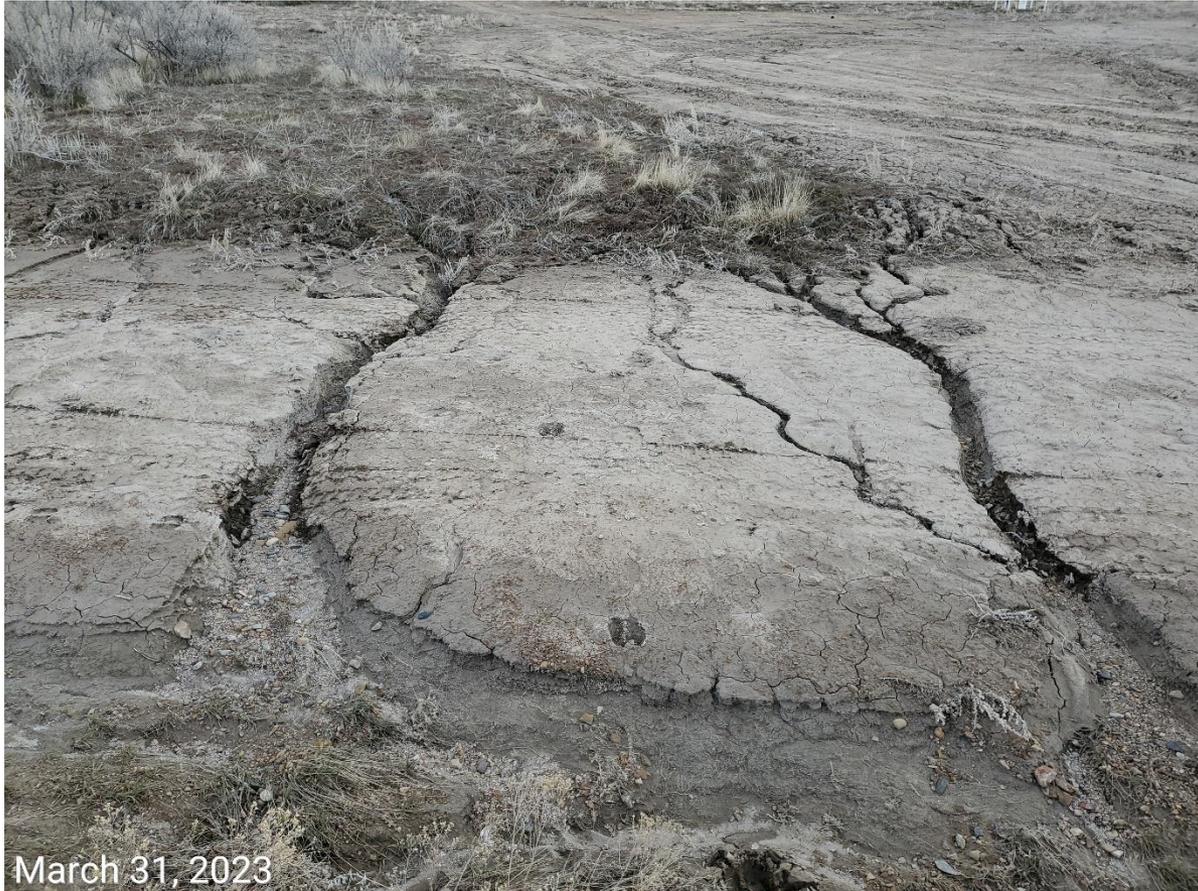
Photo 14: Erosion degradation on access road; stormwater and erosion control BMPs missing or insufficient. Road lacks stabilization.

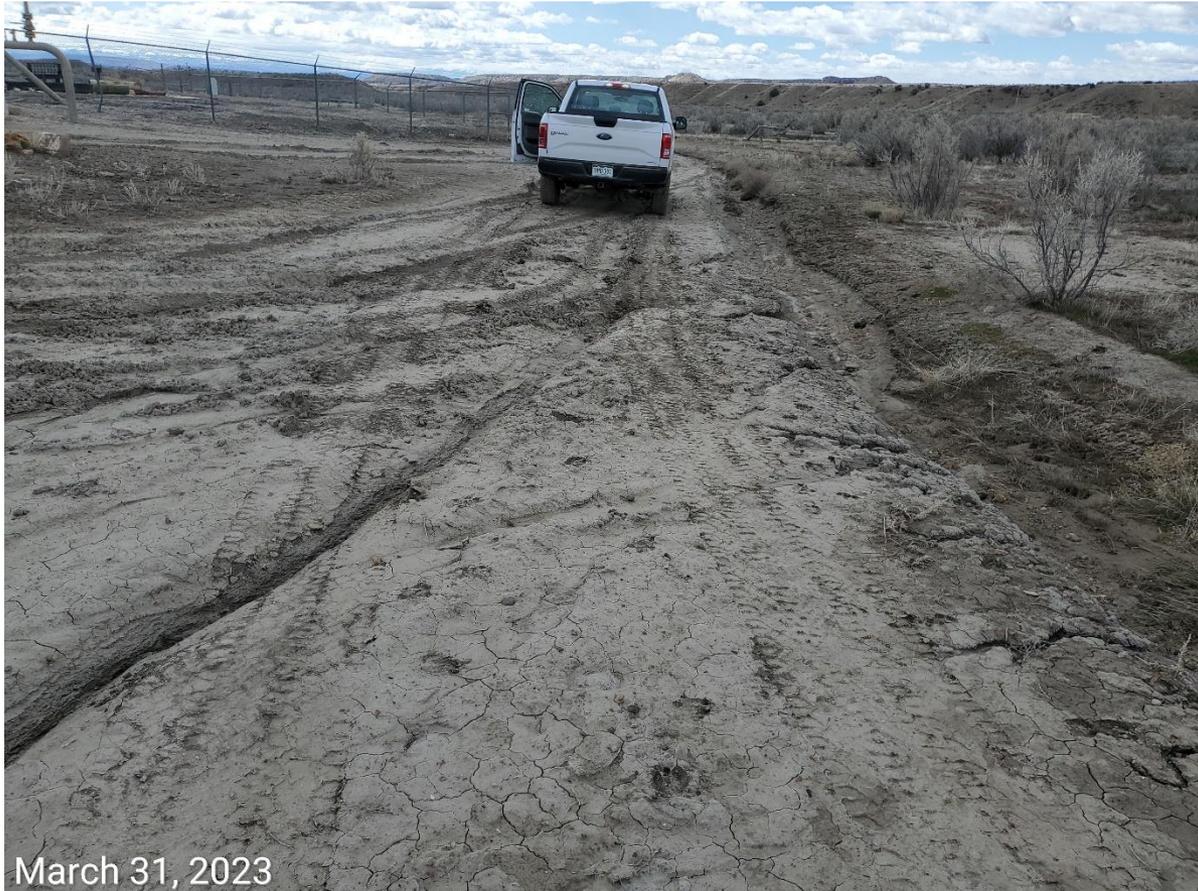
Photo 15: Erosion degradation on access road; tracking controls missing or insufficient; rutting evident. Road lacks stabilization.

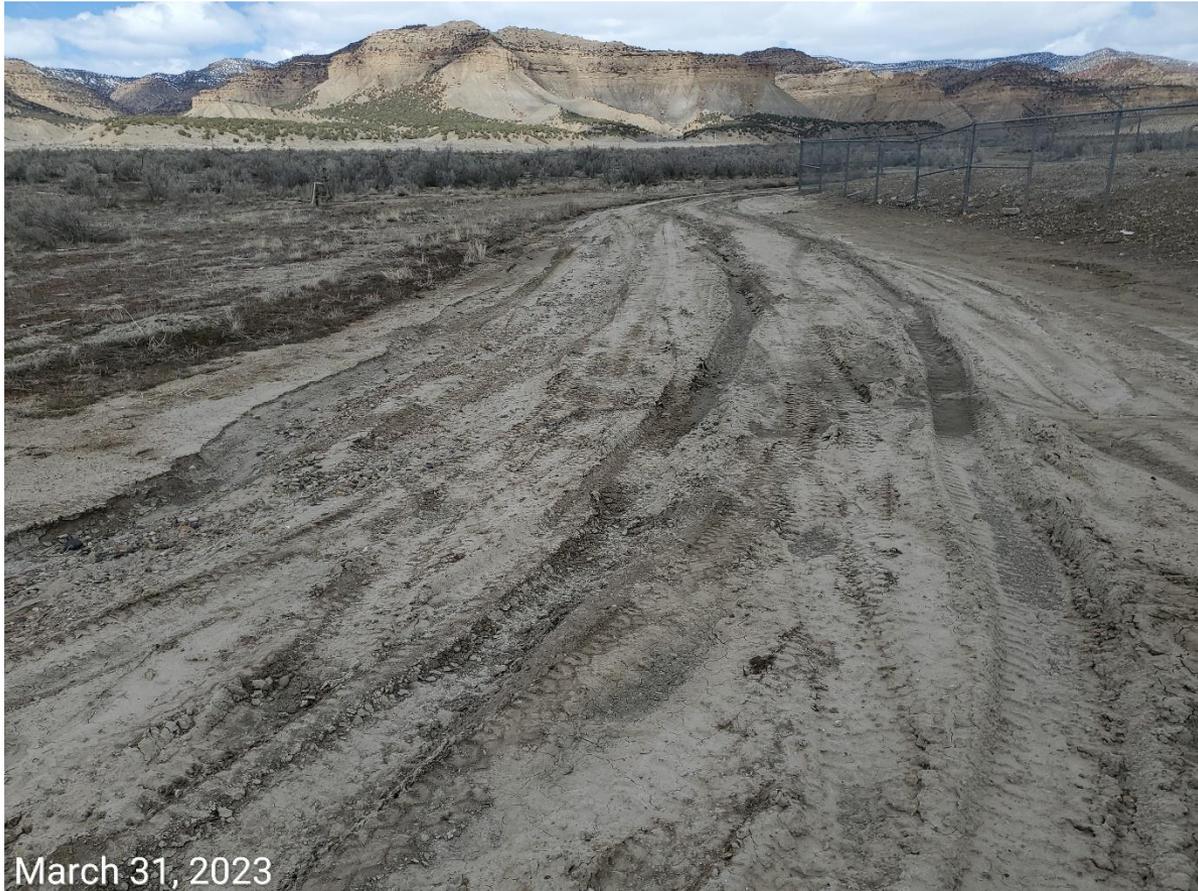
Photo 16: Erosion degradation on access road; tracking controls missing or insufficient; rutting evident. Road lacks stabilization.
