Storm Water Management and Erosion control

Location Name: TEP ROCKY MOUNTAIN LLC T & T Assoc. LTD /PA 21-7

Location #: 420224

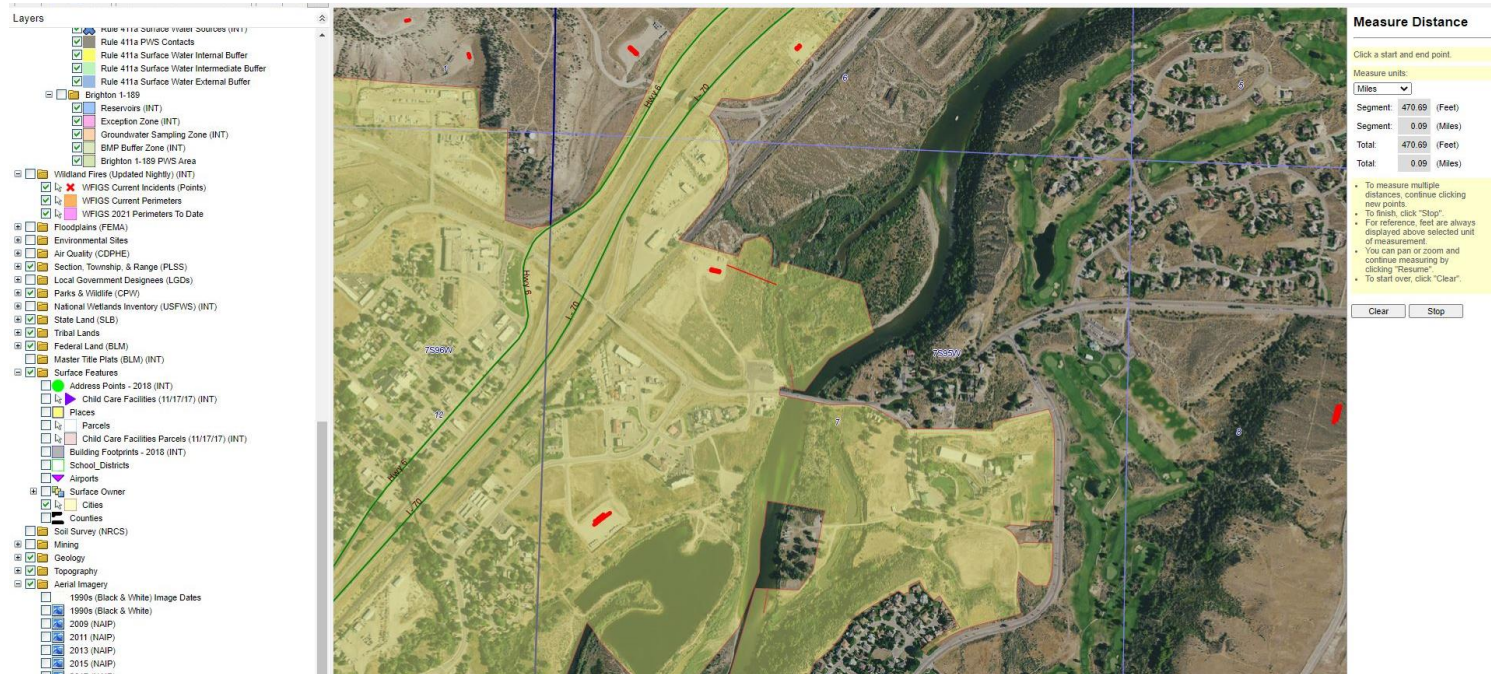
Location Overview: Location is approximately 150 yards from the Colorado River.

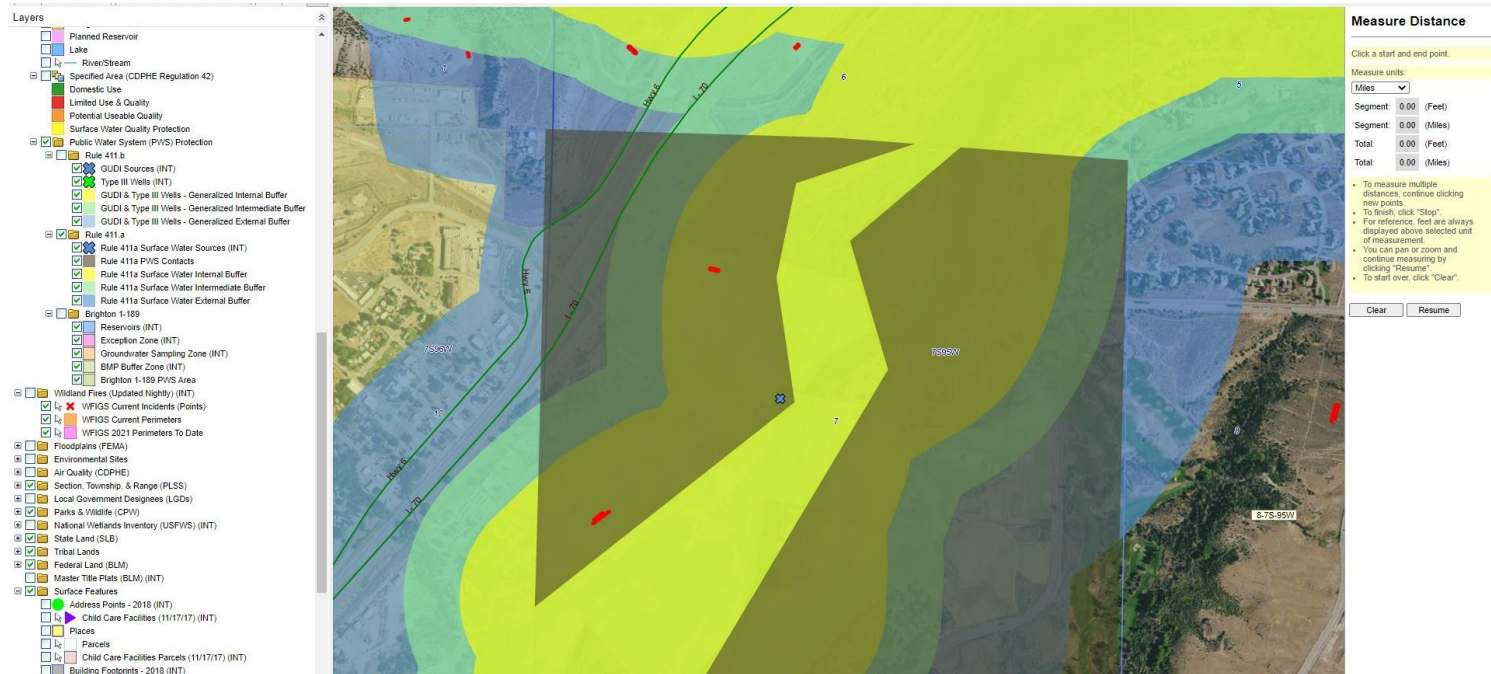
Location Overview: Location is located in a 411 a. internal buffer zone.

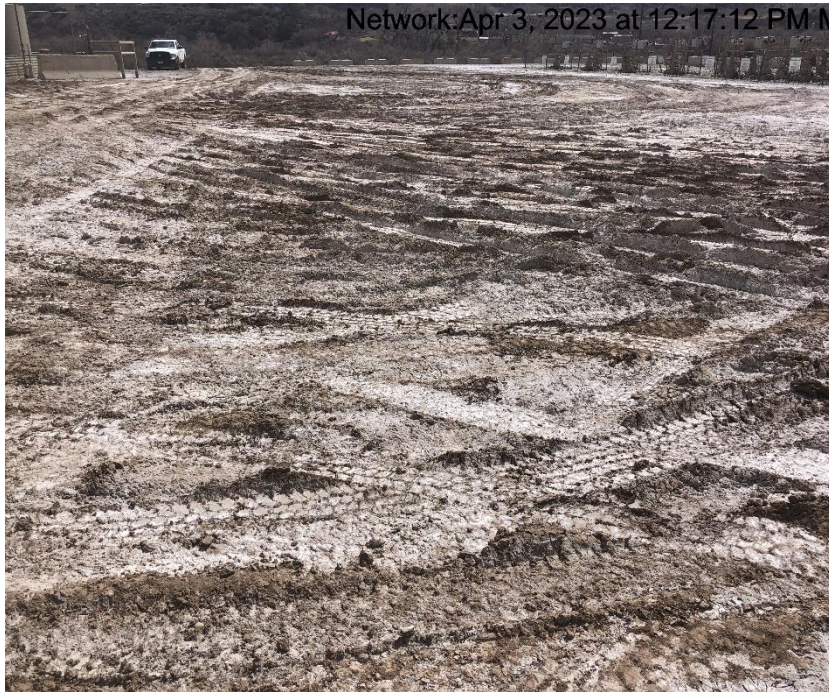
Photo #9460 Location lacks stabilization.

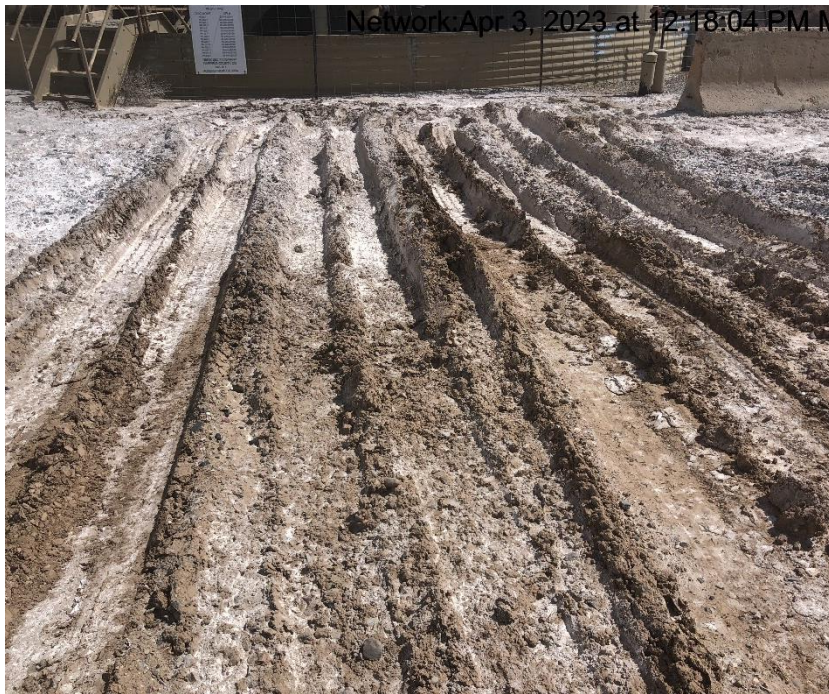
Photo #9464 Location lacks stabilization

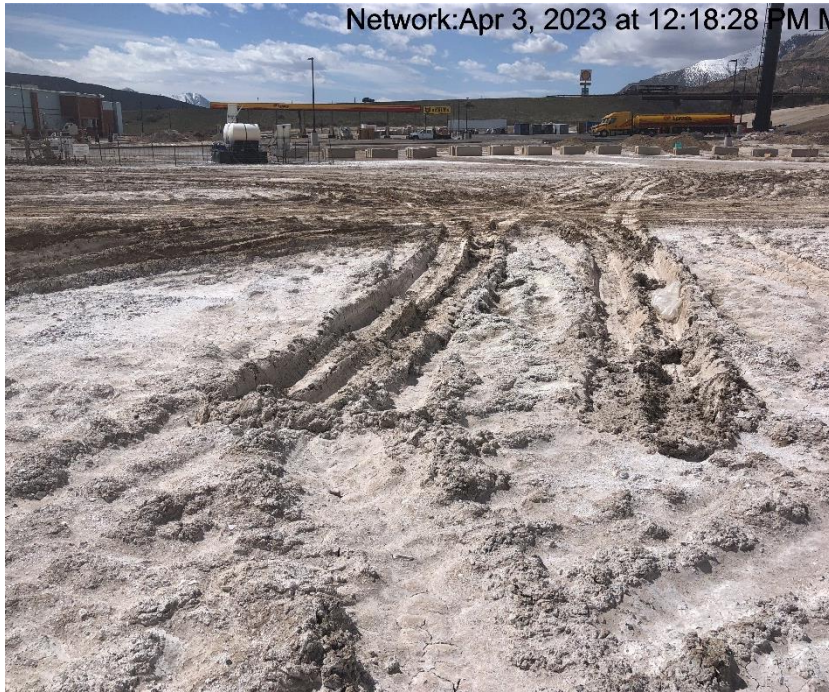
Photo #9466 Location lacks stabilization

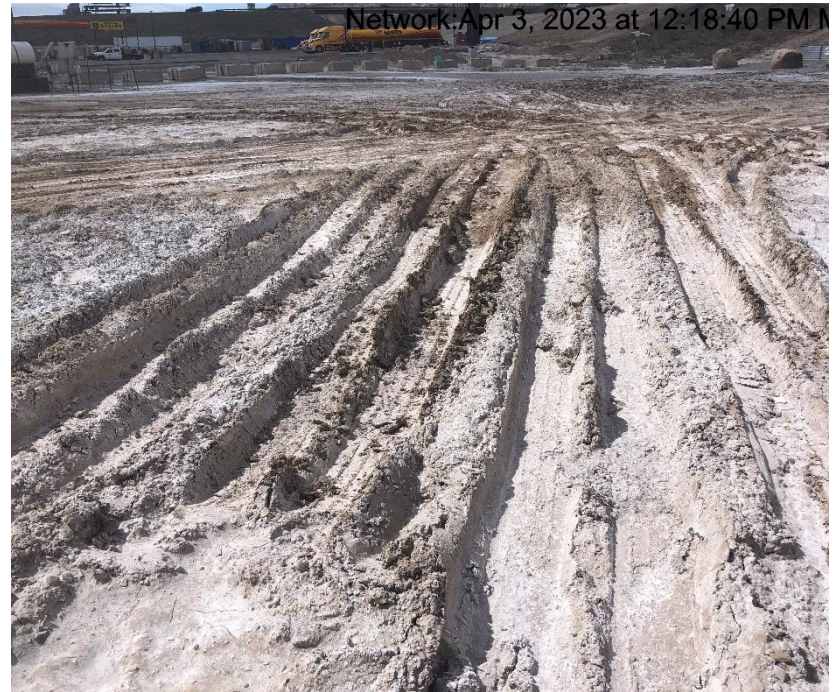
Photo #9467 Location lacks stabilization.

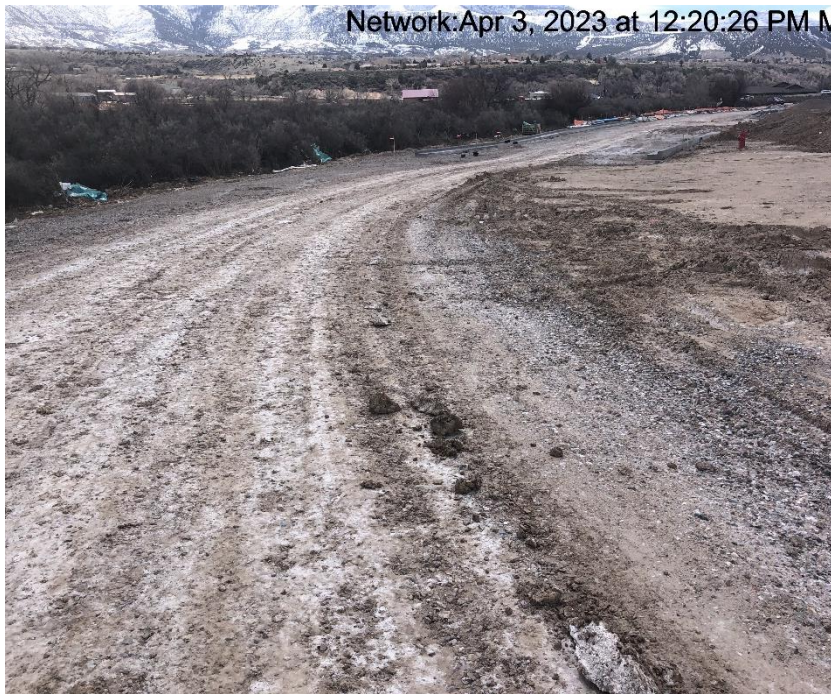
Photo #9472 Insufficient tracking BMP at entrance to location.

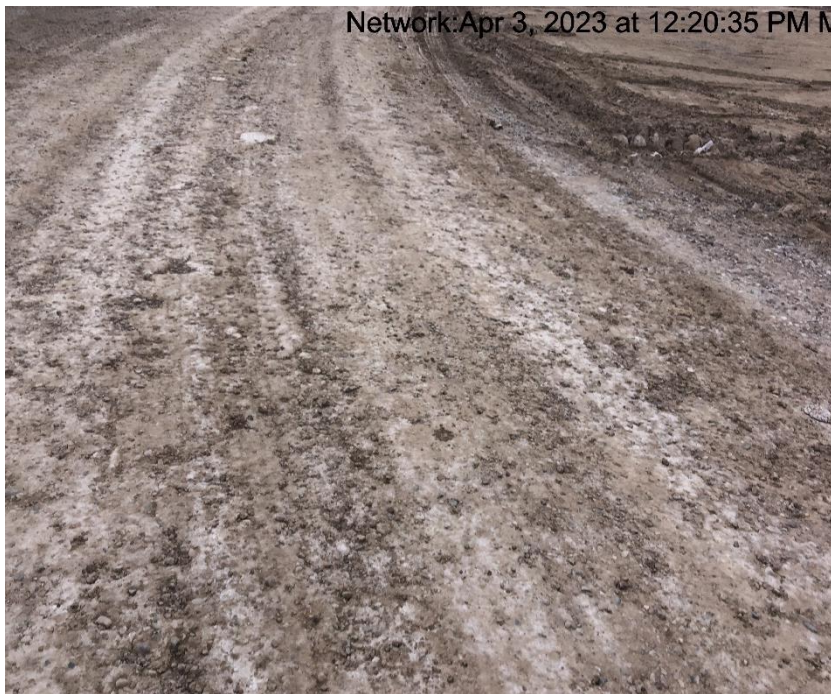
Photo #9473 Insufficient track BMP at entrance to location.
