Storm Water Management and Erosion control

Location Name: TEP ROCKY MOUNTAIN LLC HENRY-67S95W /3SWNW

Location #: 334731

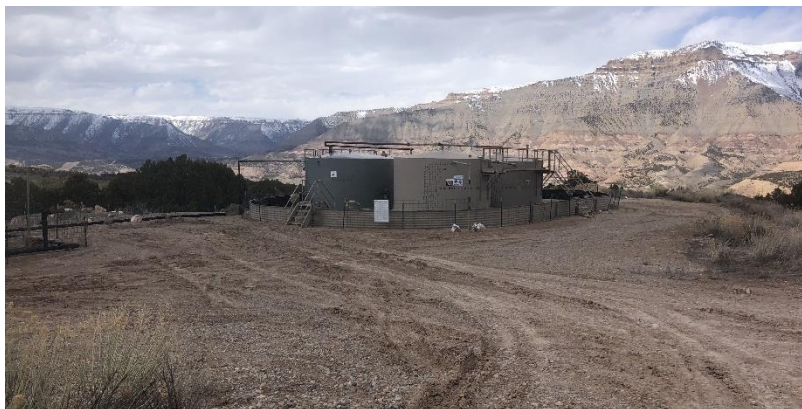
North West corner of location.

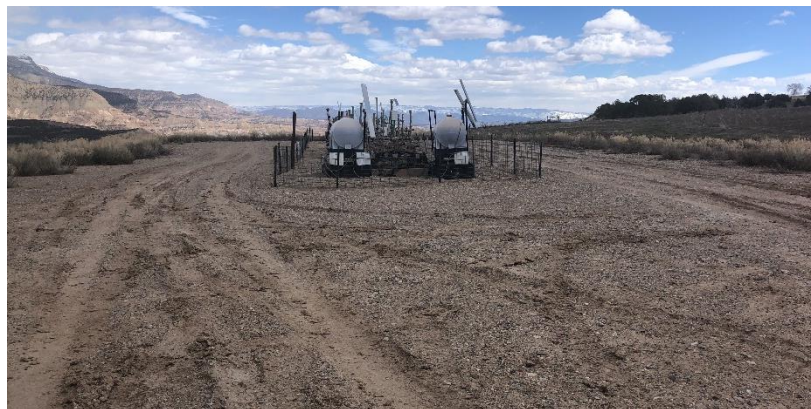
North East corner of location.

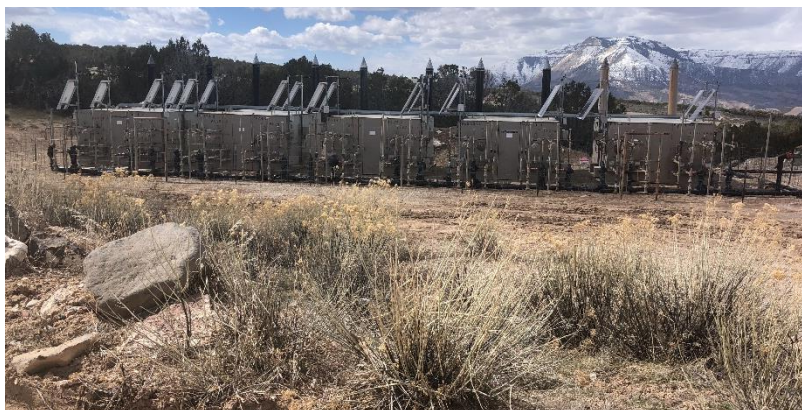
South West corner of location.

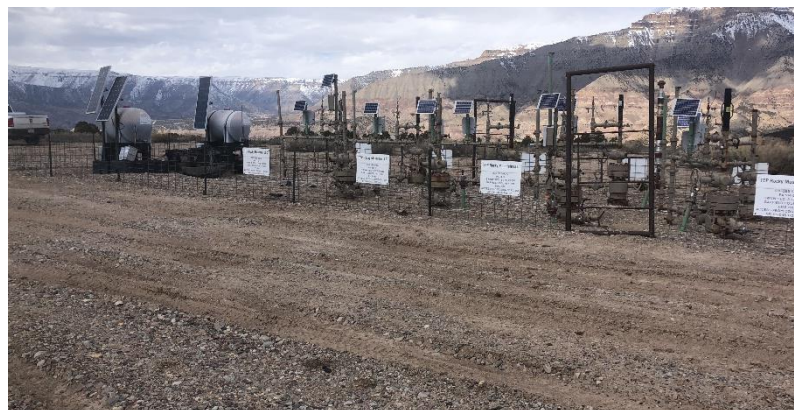
South East corner of location.

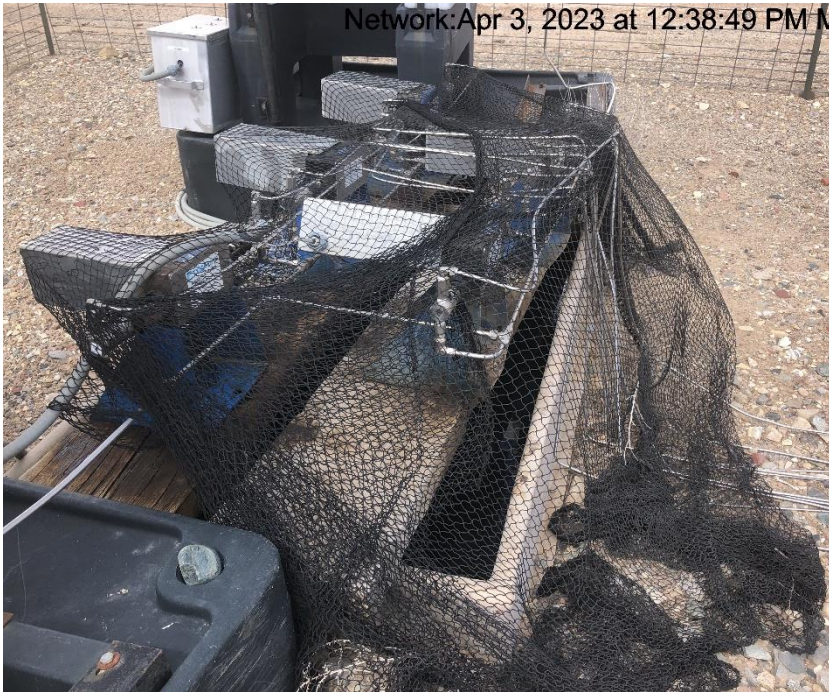
**Photo #9480 Spill prevention and materials handling
BMP insufficient.**

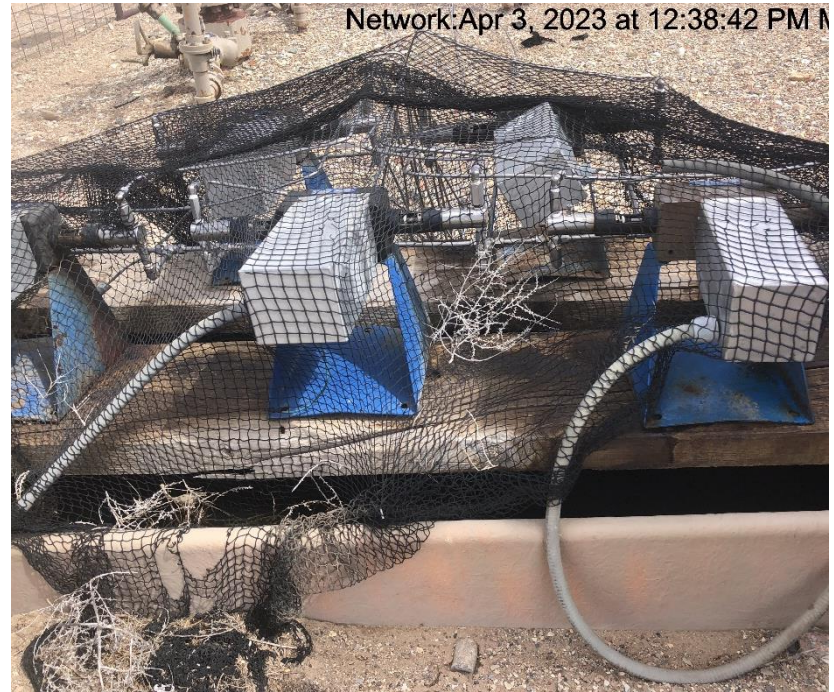
**Photo #9479 Spill prevention and materials handling
BMP insufficient.**

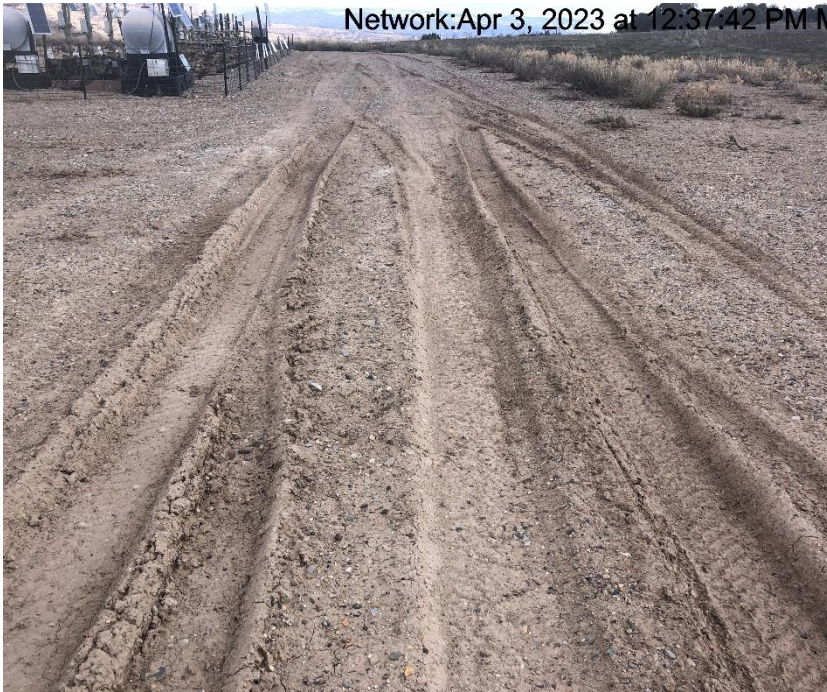
Photo #9475 Location lacks stabilization.

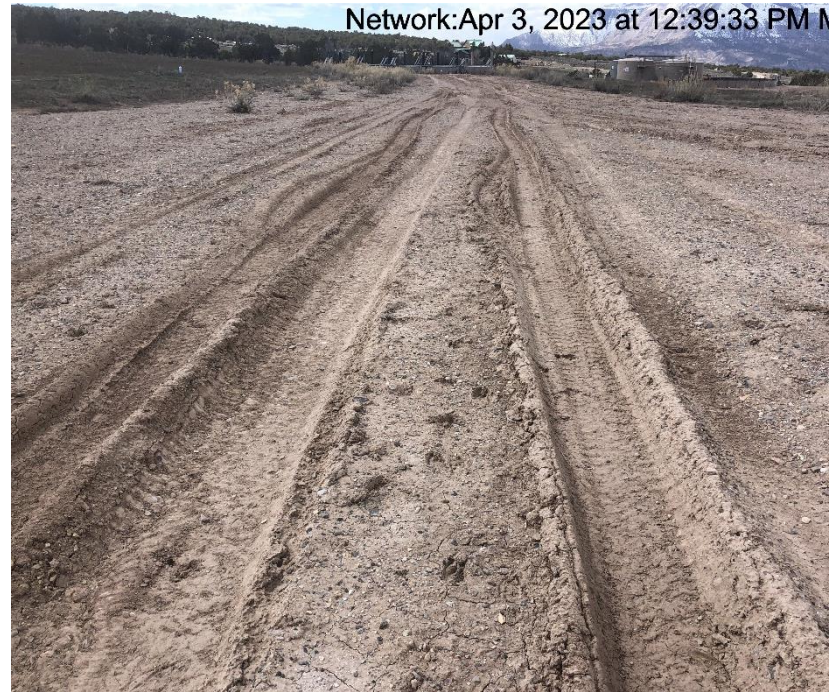
Photo #9482 Location lacks stabilization.

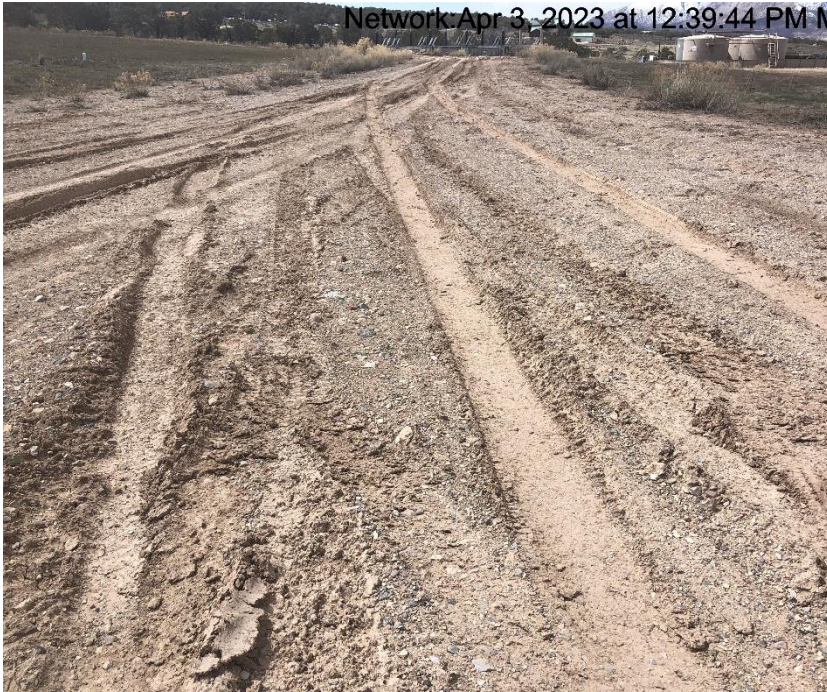
Photo #9483 Location lacks stabilization.

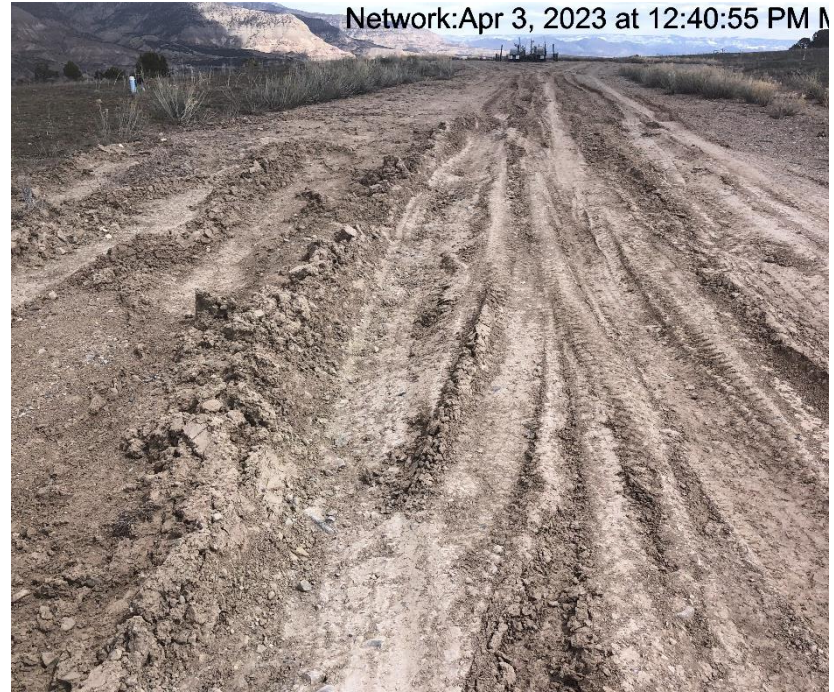
Photo #9484 Location lacks stabilization

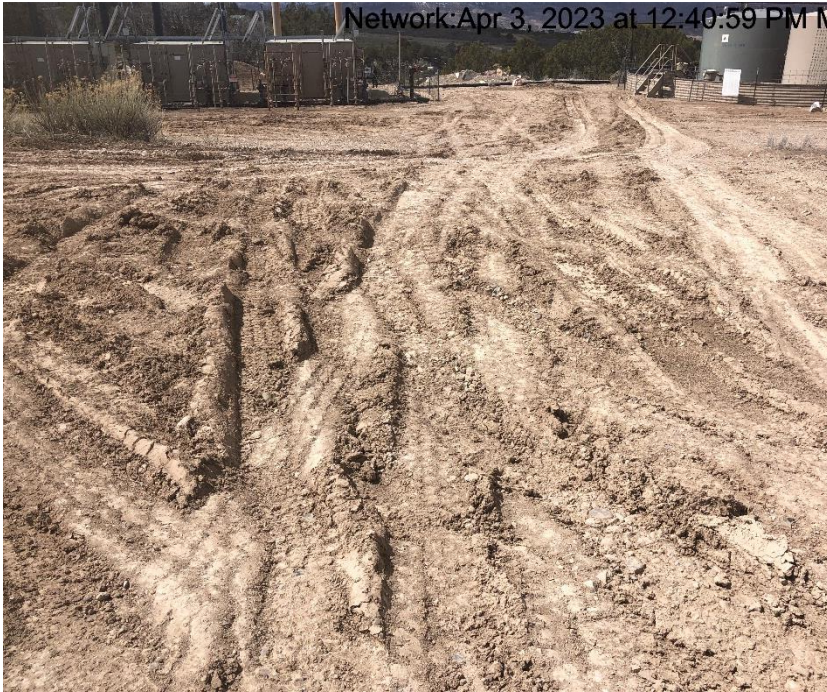
Photo #9485 Location lacks stabilization

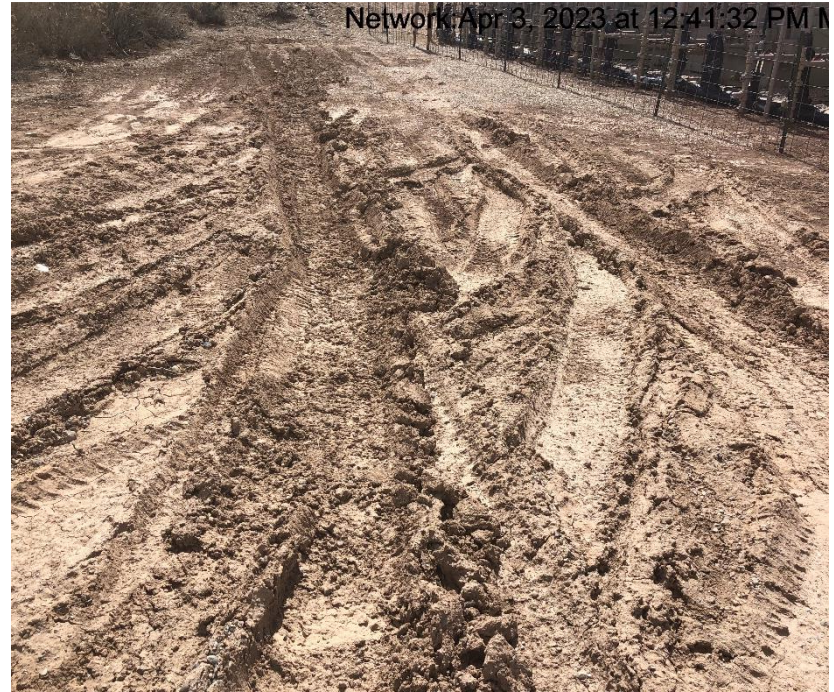
Photo #9489 Location lacks stabilization

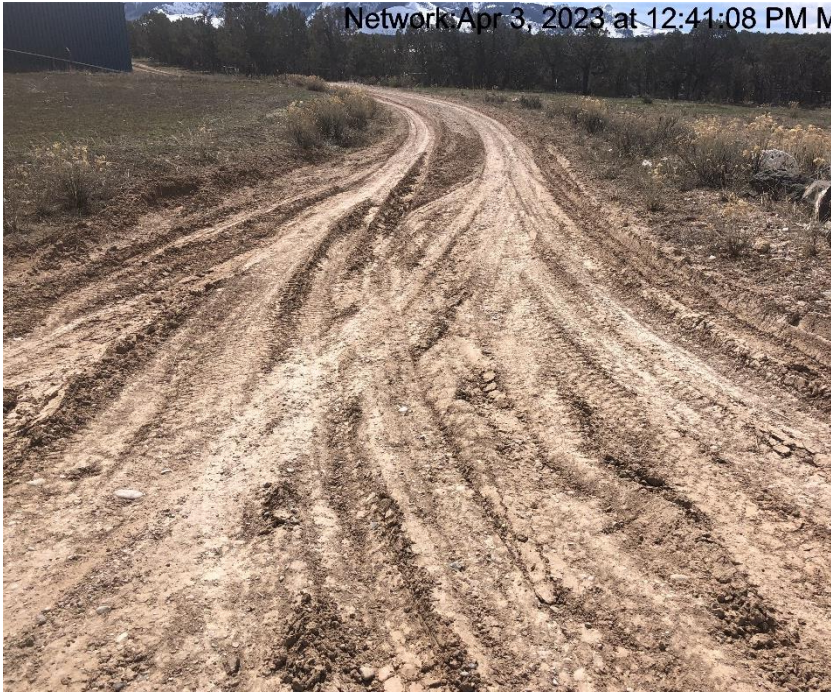
Photo #9486 Insufficient tracking BMP at entrance to location.
