Inspection Photos

API: 071-09521

Operator: EVERGREEN NATURAL RESOURCES

Inspection Date: 4/4/2023

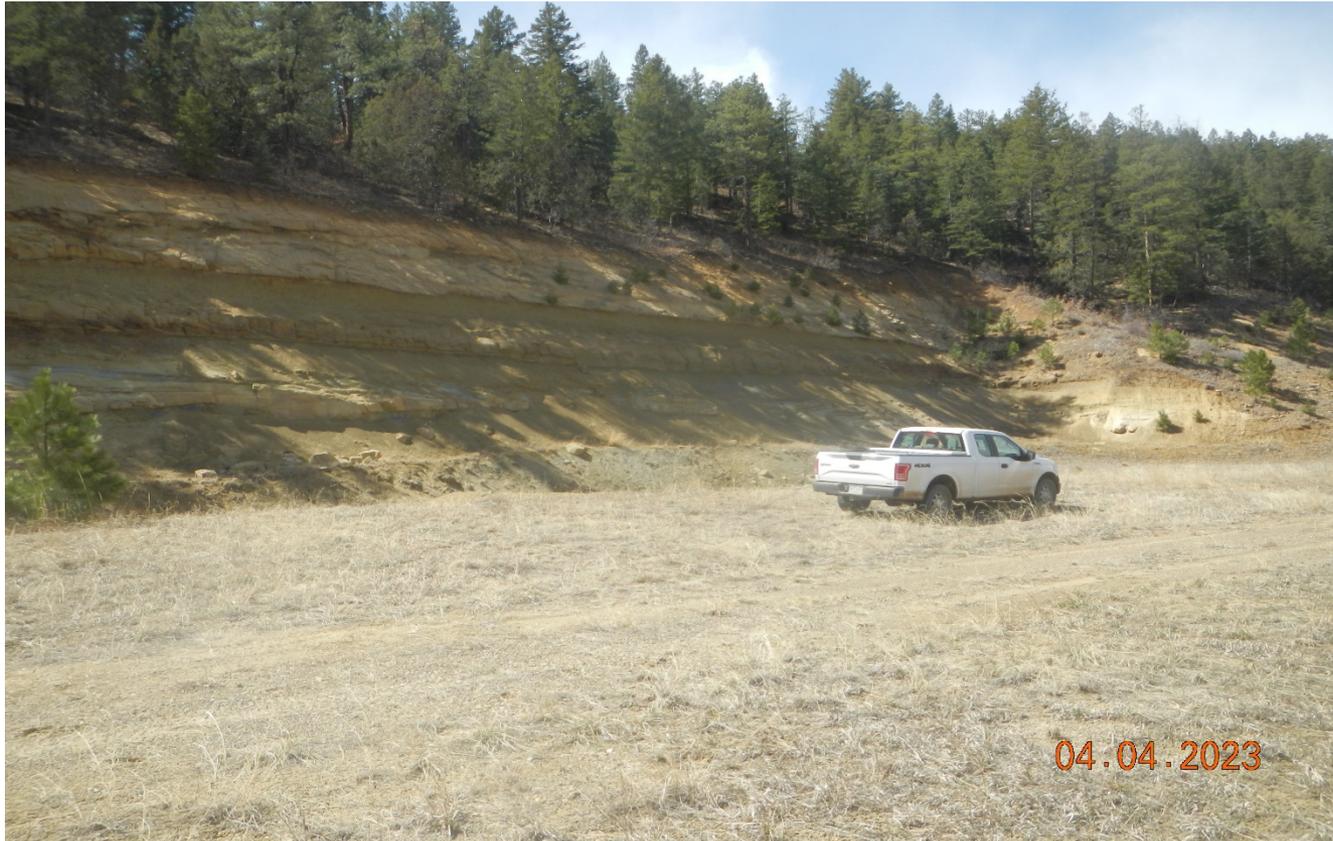
Photo 1. Facing southwest at the location. The location has not been recontoured and a steep cut slope remains. Previous corrective action not completed.

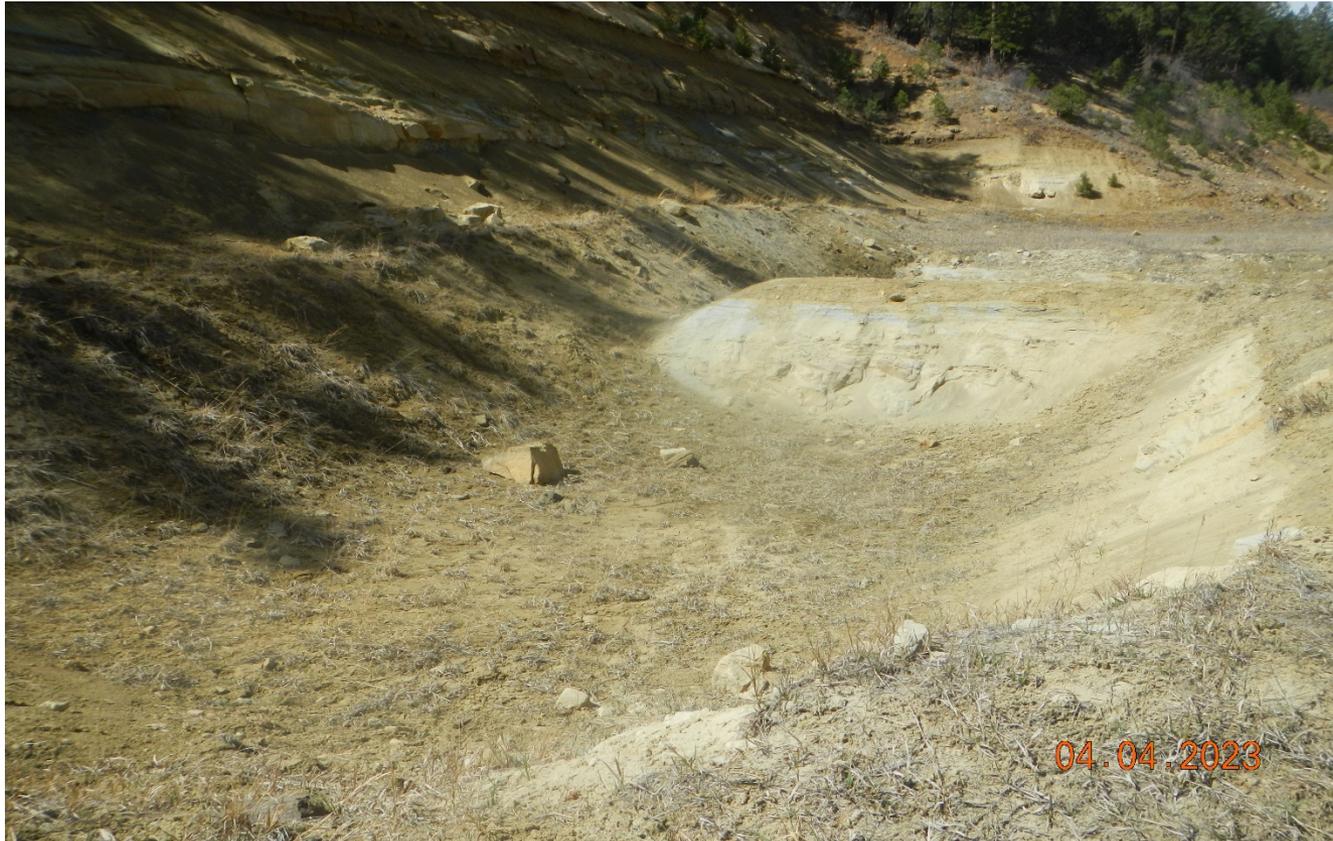
Photo 2. There is a pit that remains along the base of the cut slope at the location.

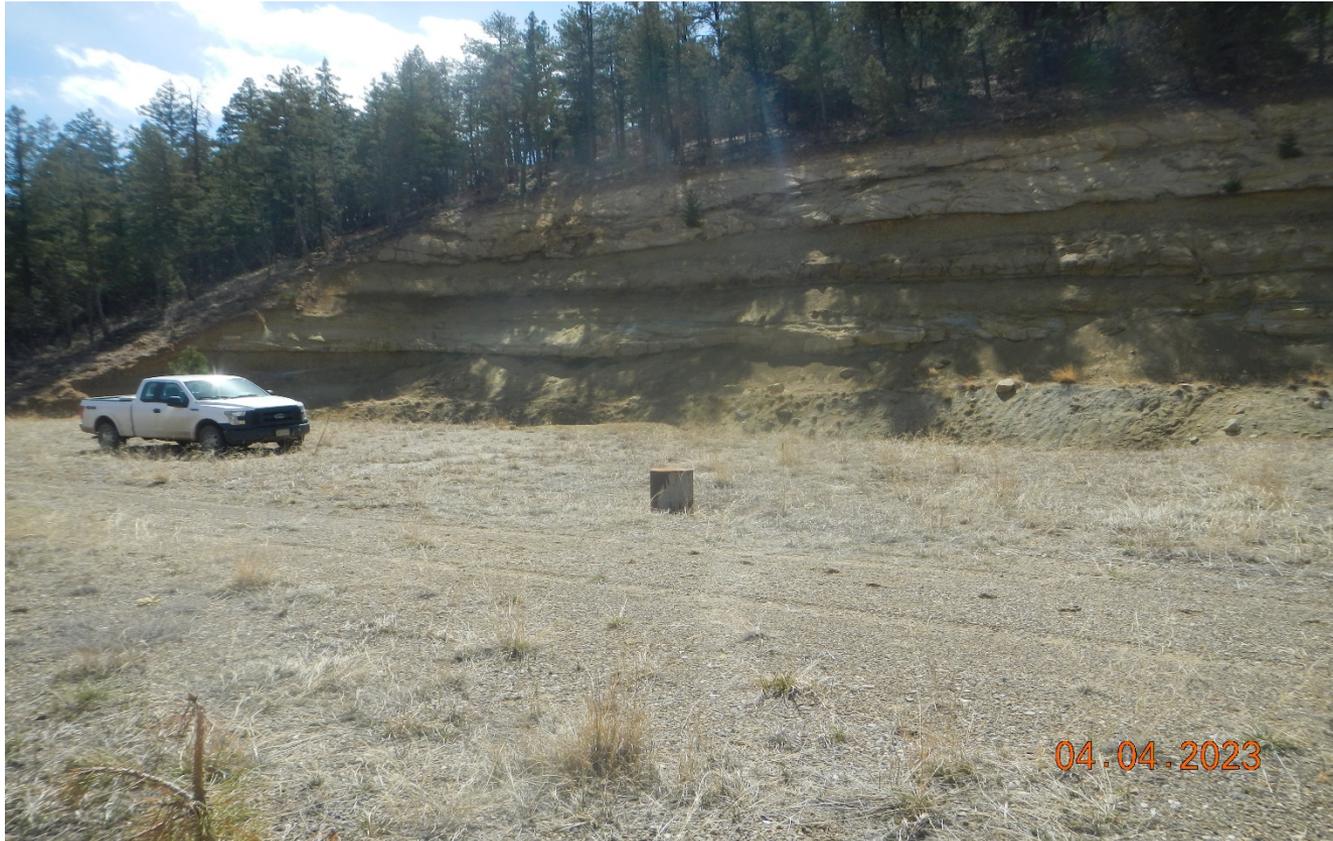
Photo 3. Facing southeast toward at the location.

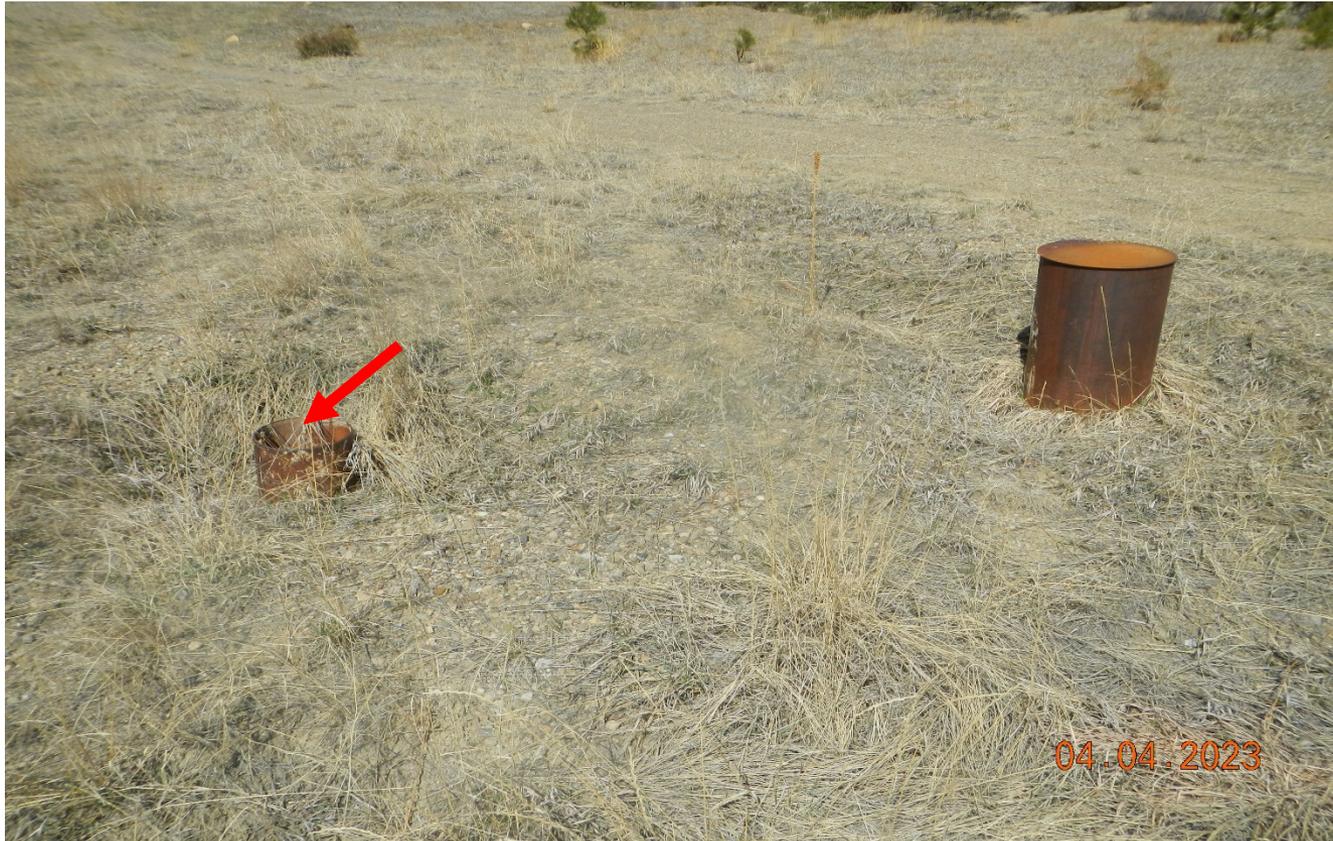
Photo 4. There are 3 steel casings that remain at center of the location. The casing shown at red arrow is not covered to prevent entry. The steel casings need to be removed.

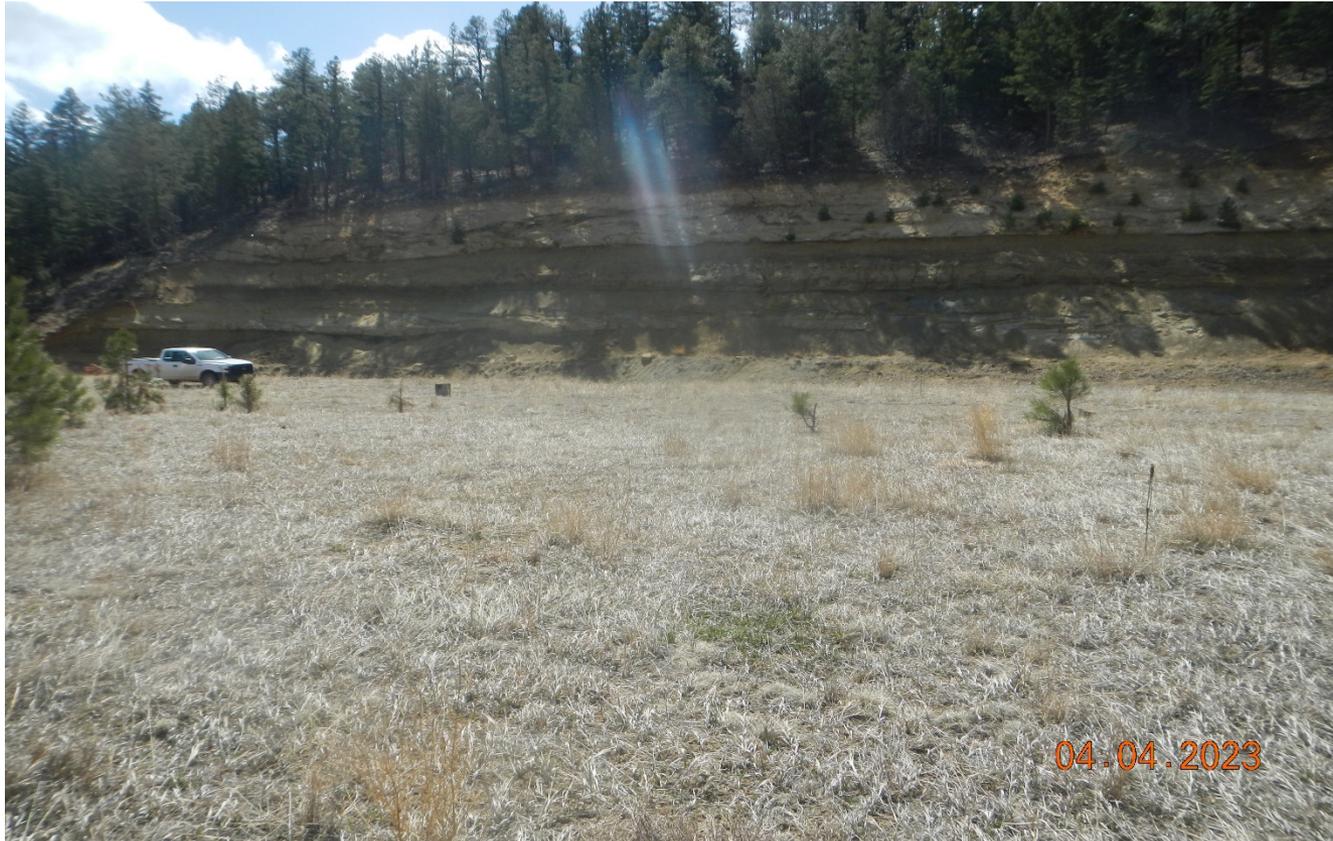
Photo 5. Facing southeast toward the location. The abandoned location needs to be recontoured and reclaimed.

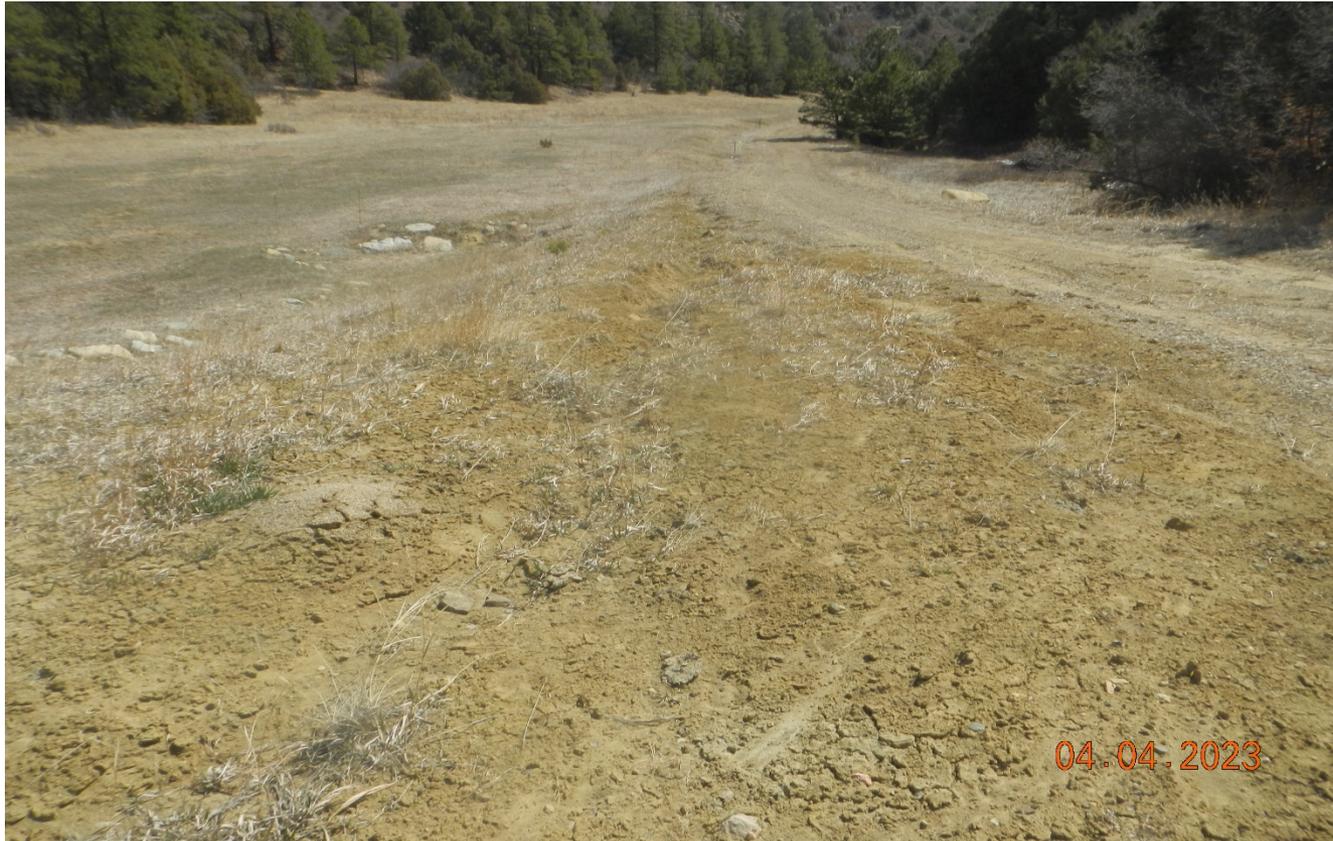
Photo 6. There are some signs of erosion at the east side of the location.
