Construction and Stormwater Inspection

Operator: VERDAD RESOURCES LLC - 10651

Location ID: 466345

Inspection Document #: 708200080

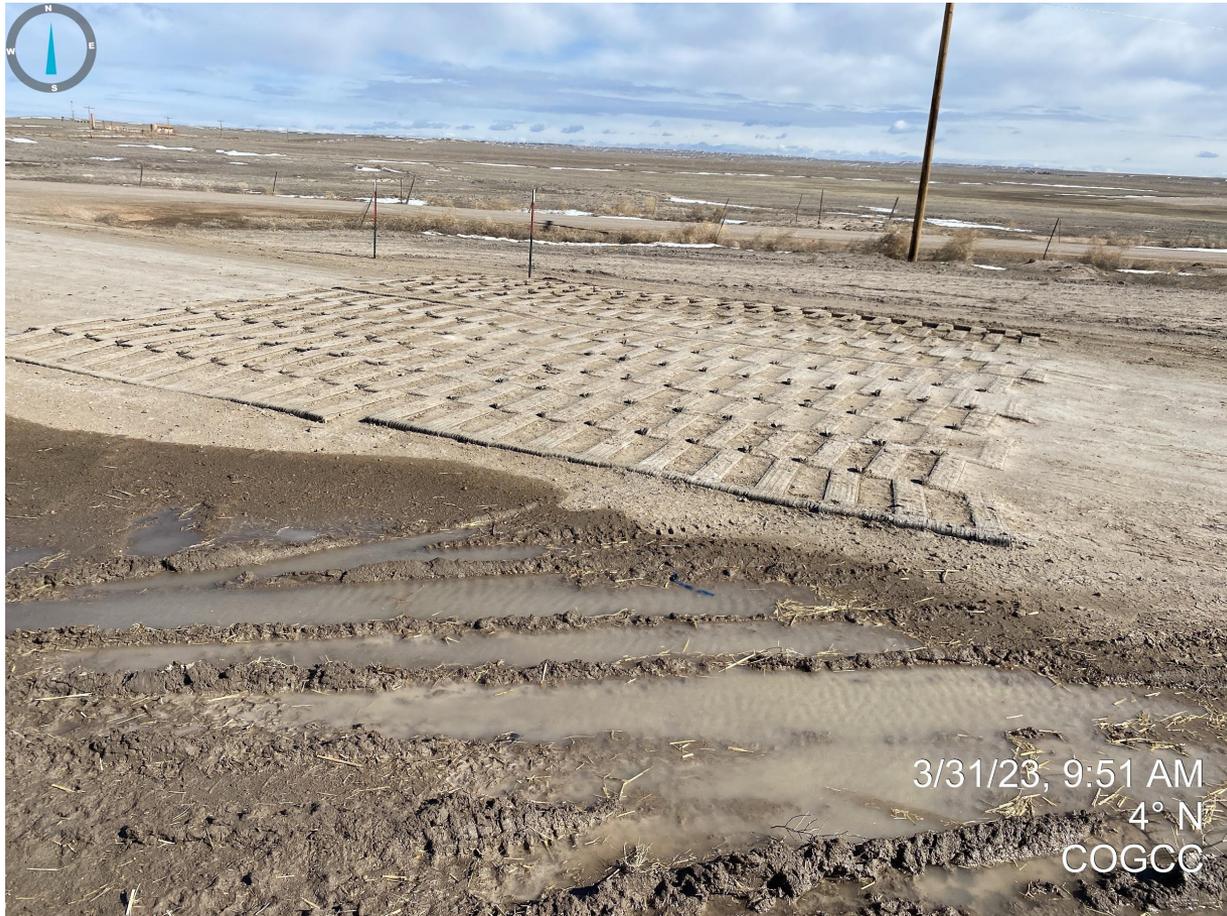
Photo 1. Tracking pad requires maintenance.

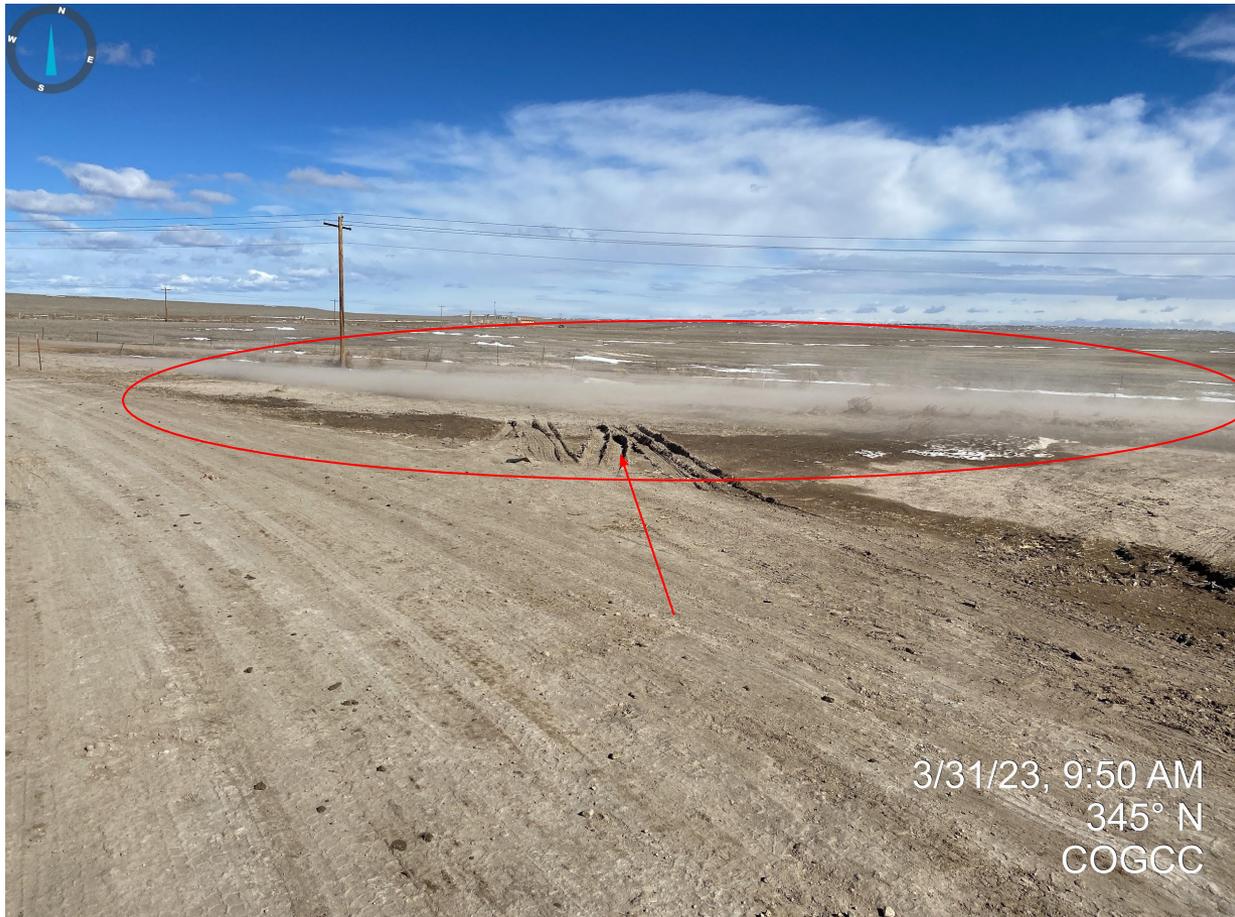
Photo 2. Facing north near the entrance to the pad. Photo illustrates that the location has not been properly stabilized with evidence of wind erosion and dust blowing off location. Additionally, vehicle tracks were observed going through the interim areas and not staying on the access/lease road (red arrow).

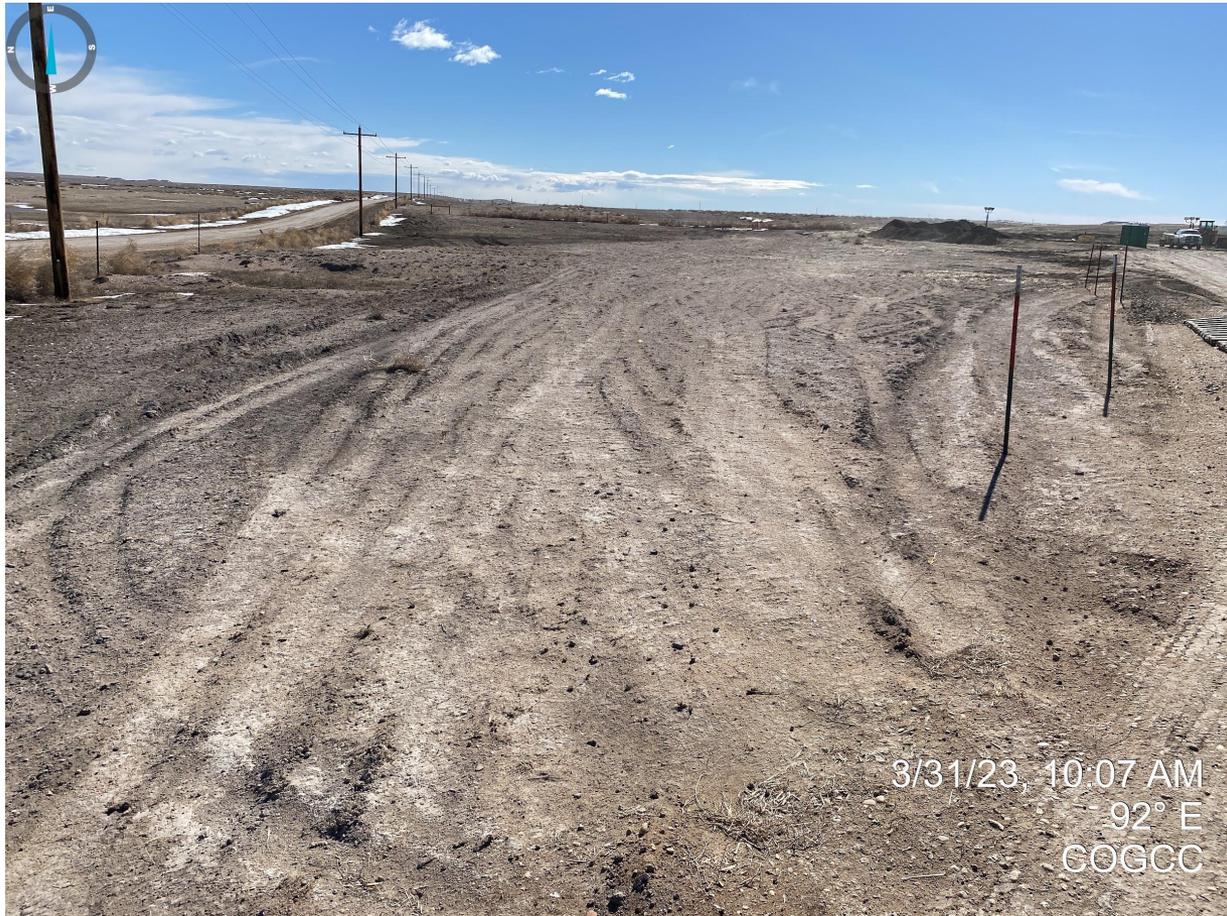
Photo 3. Facing south near the location entrance; see comments in Photo 2.

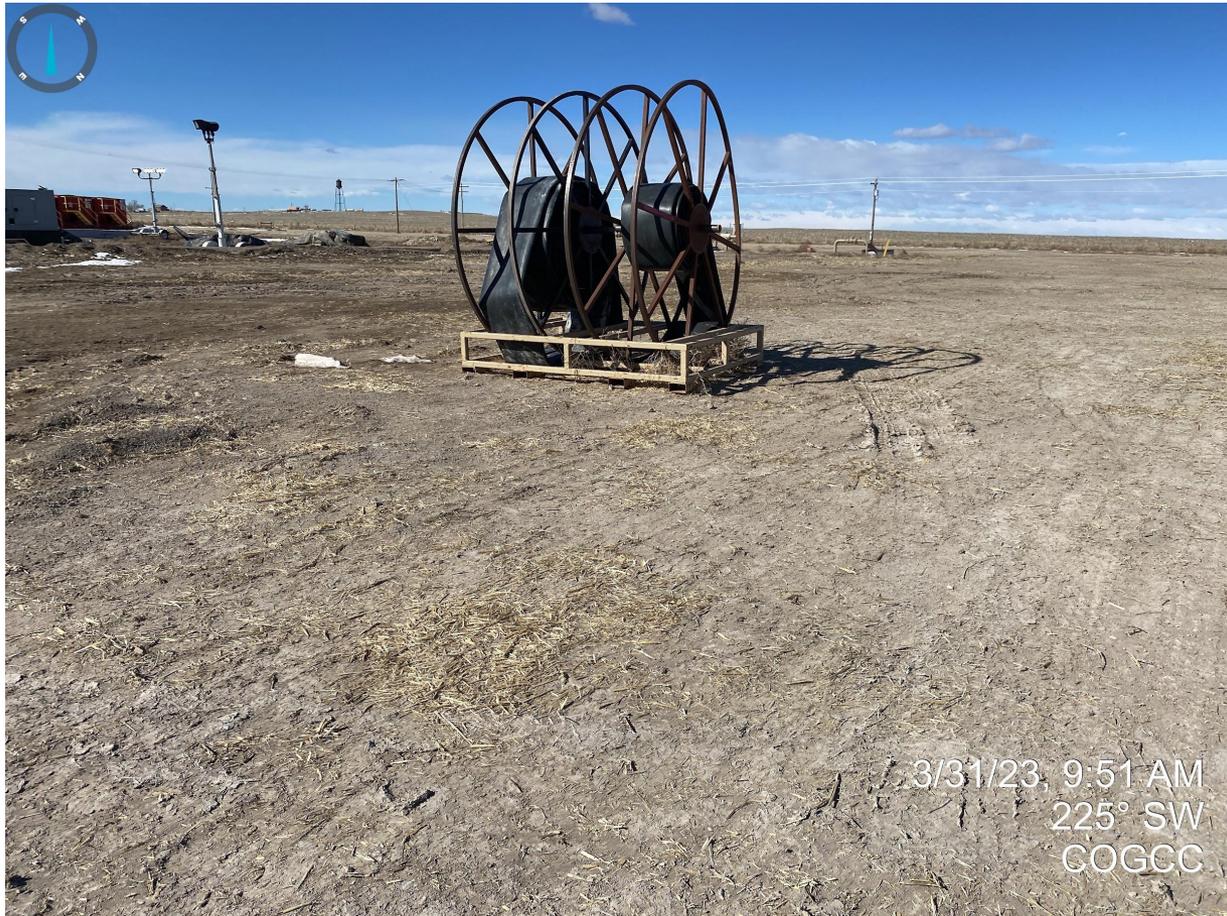
Photo 4. Facing southwest near the location entrance. Materials/supplies were being stored within the recently seeded/reclaimed area. Additionally, this reclaimed area is not properly stabilized and most of the straw mulch has blown away and Staff observed dust originating and blowing off location from this area.

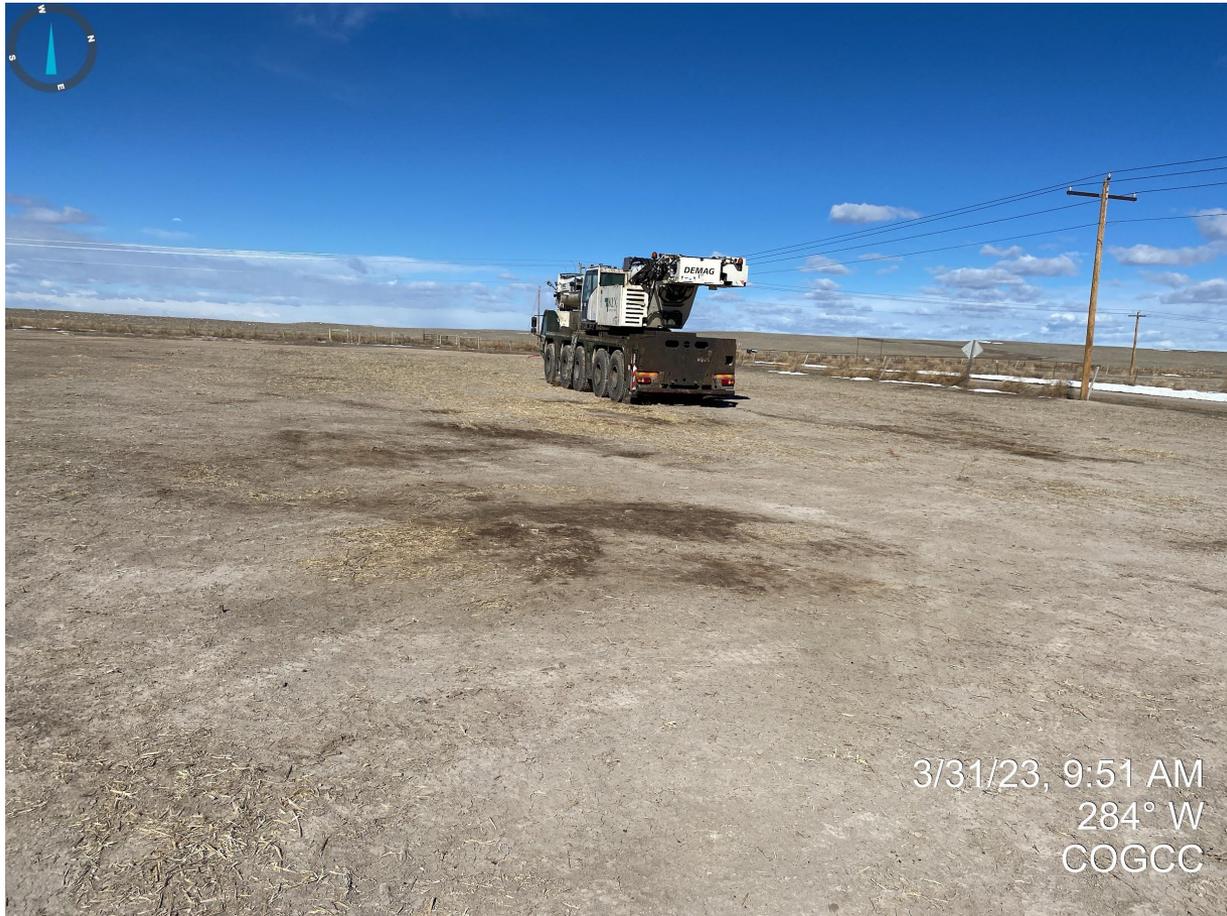
Photo 5. Facing west; see comments in Photo 4. Crane parked on reclaimed area.

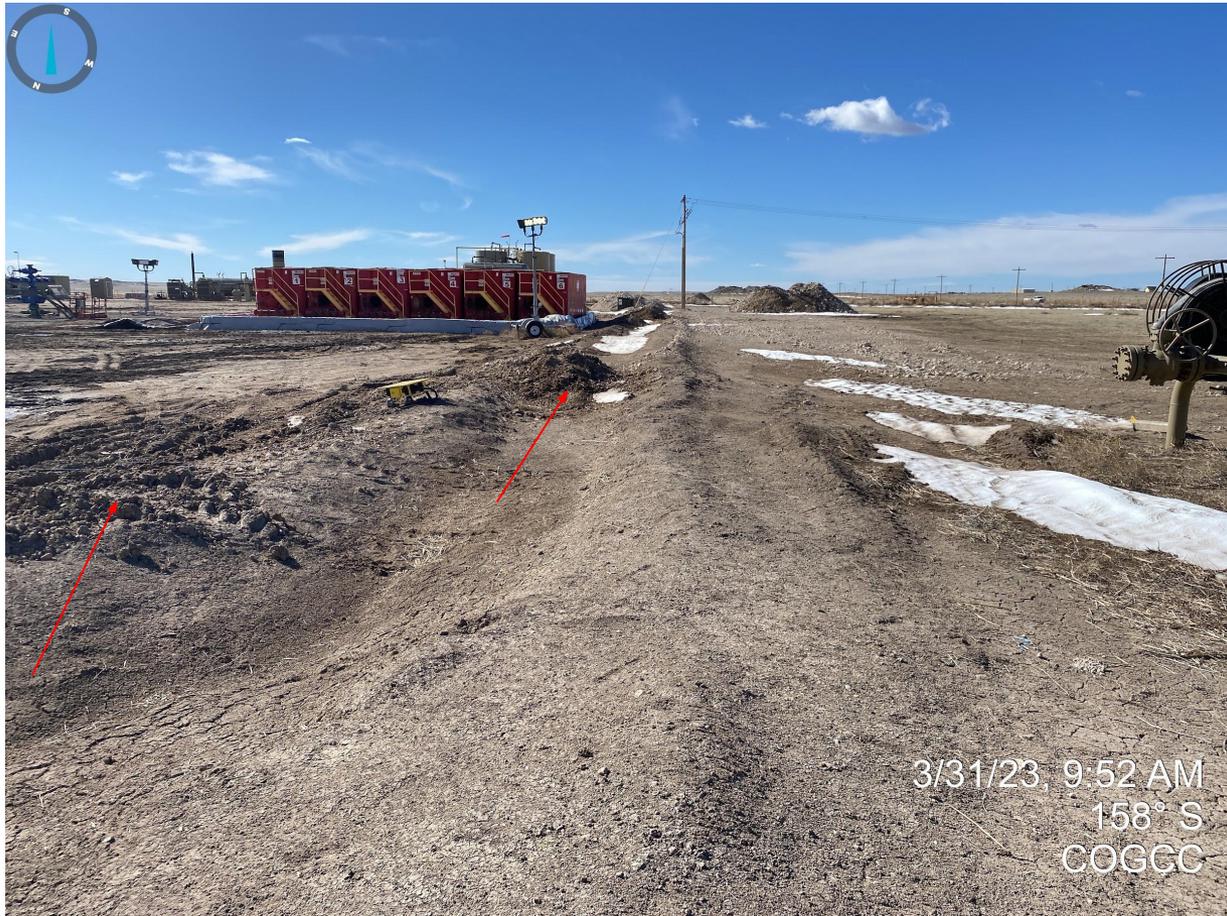
Photo 6. Facing south from the northwest corner of pad. Photo illustrates material in stormwater ditch and unconsolidated material.

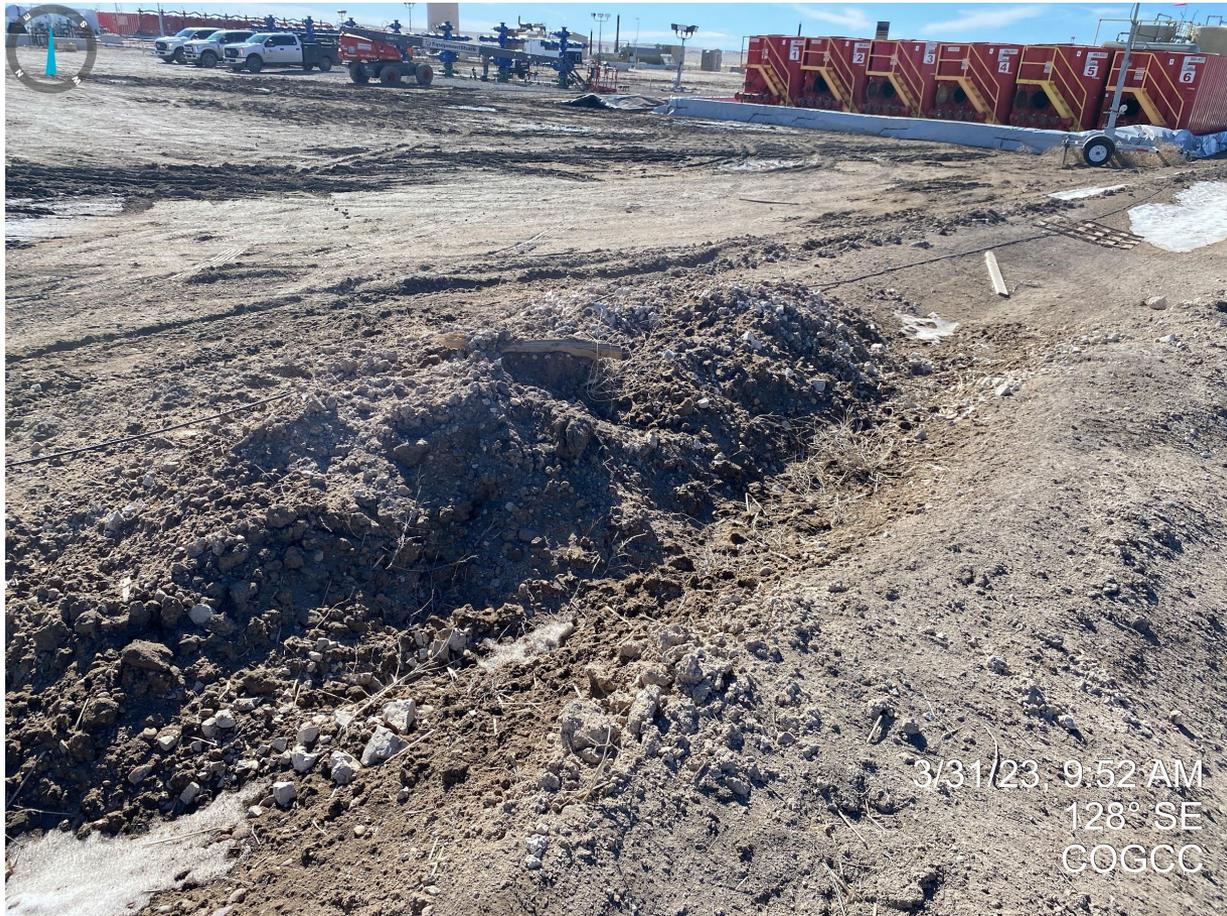
Photo 7. Close up from Photo 6.

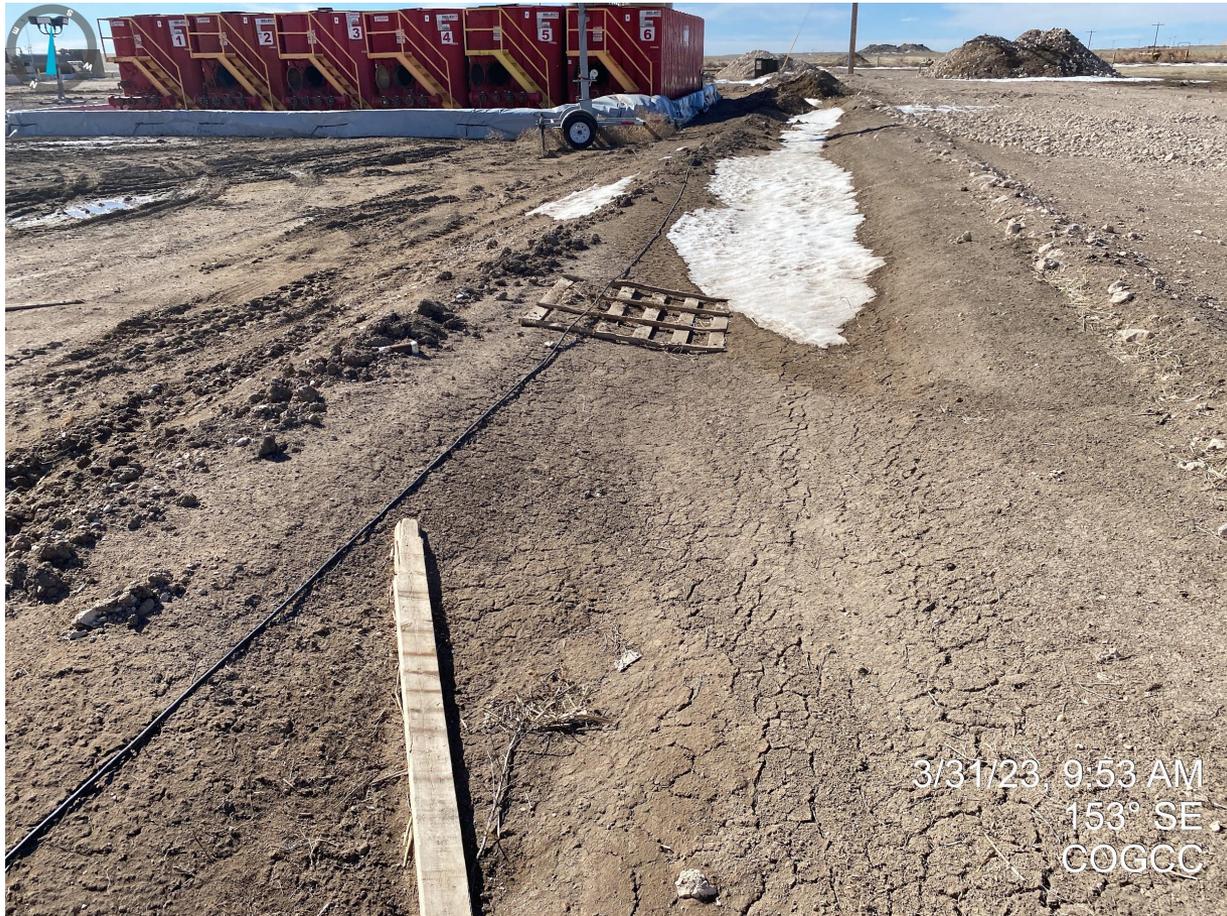
Photo 8. Facing south; debris located in ditch.

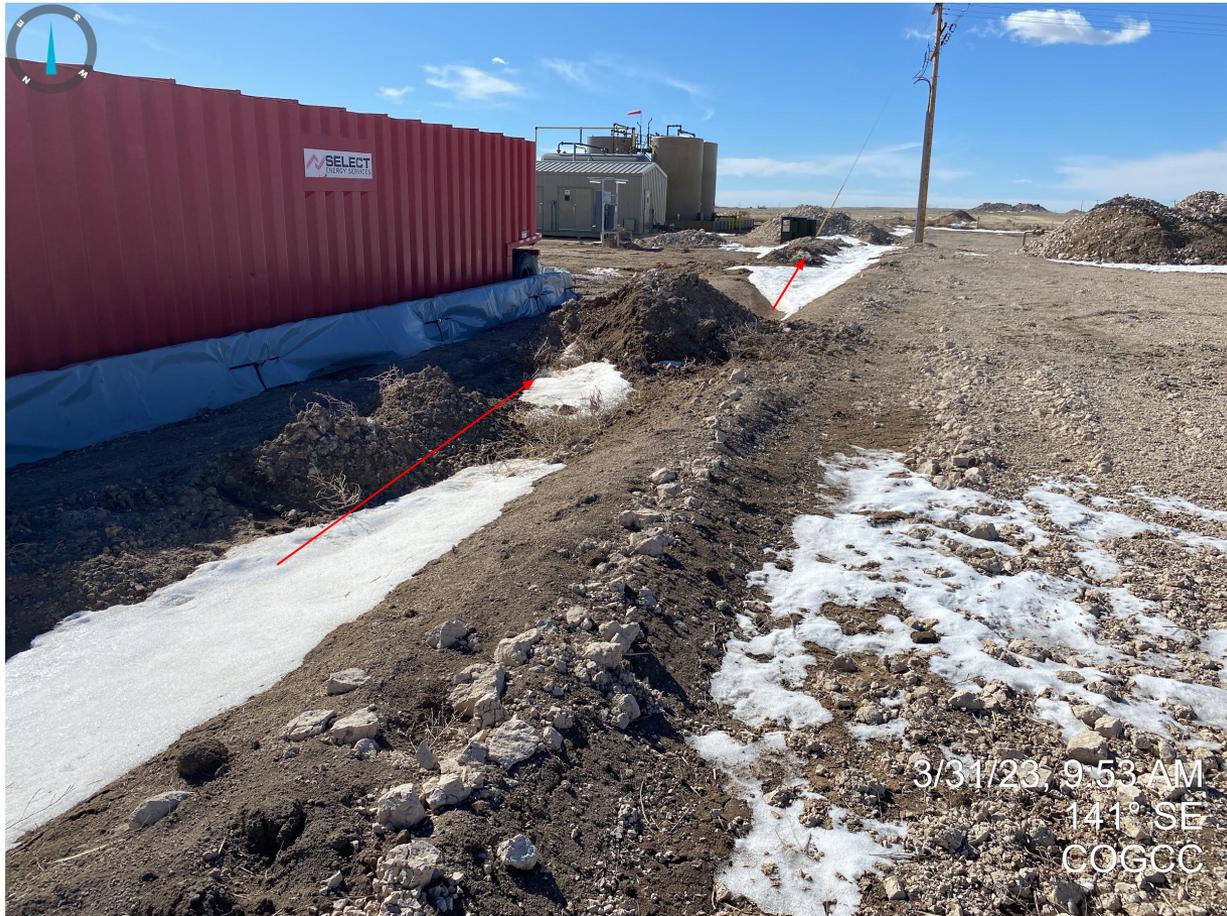
Photo 9. Facing southeast from central/western ditch and berm; material placed/stored within stormwater ditch.

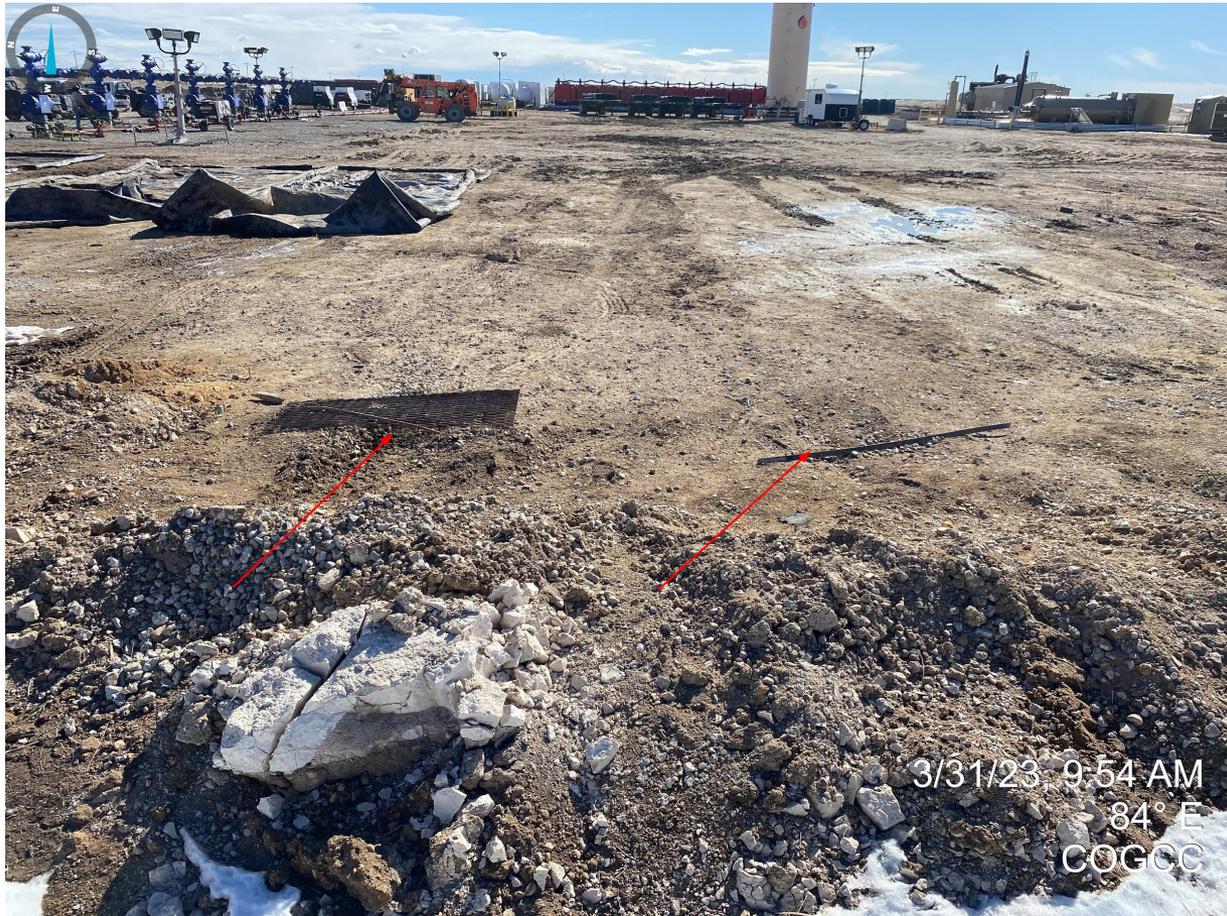
Photo 10. Facing east from stormwater ditch. Debris left on location.

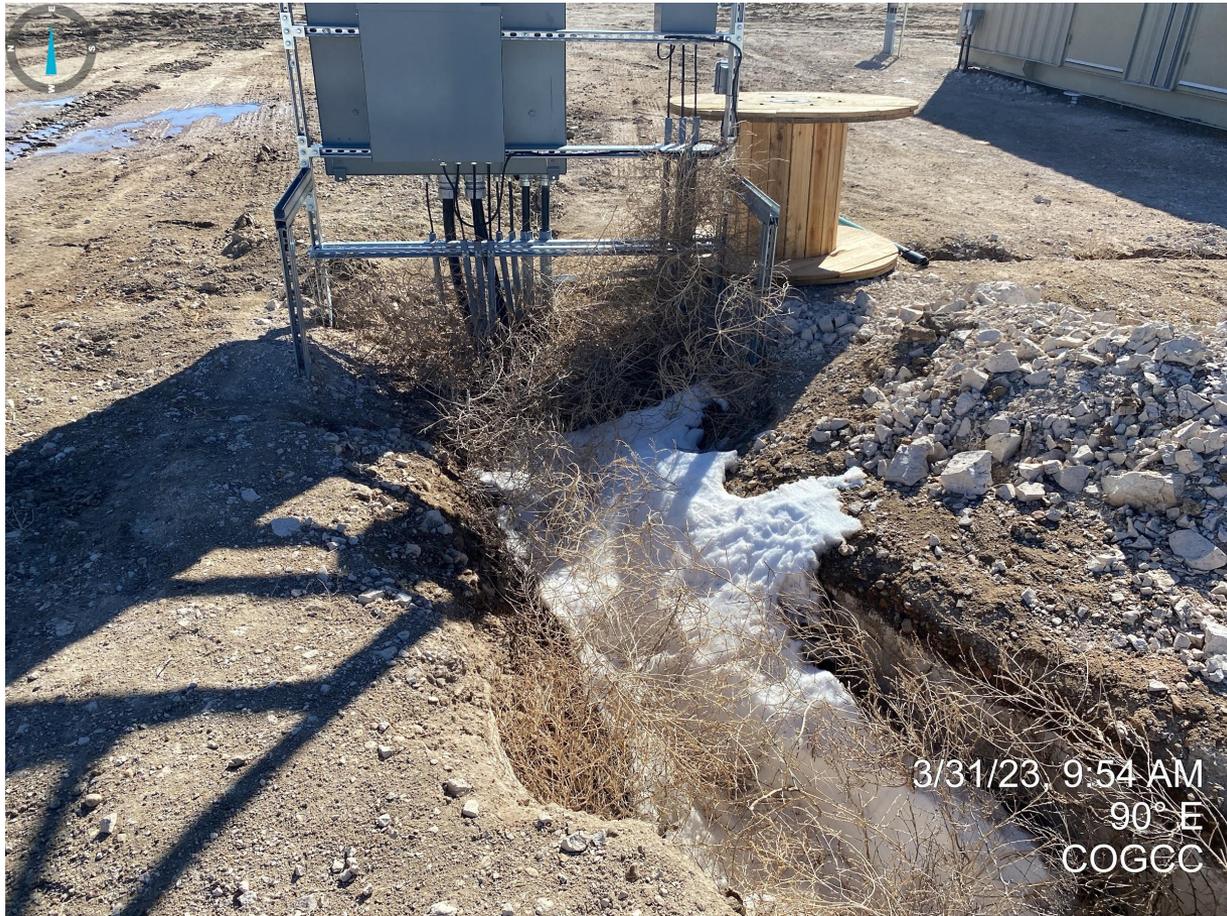
Photo 11. Facing east from southwest corner of pad. Photo illustrates open/subsided trench that hasn't been backfilled or has any type of exclusion device (e.g. construction fence) to prevent injury to personnel or wildlife.

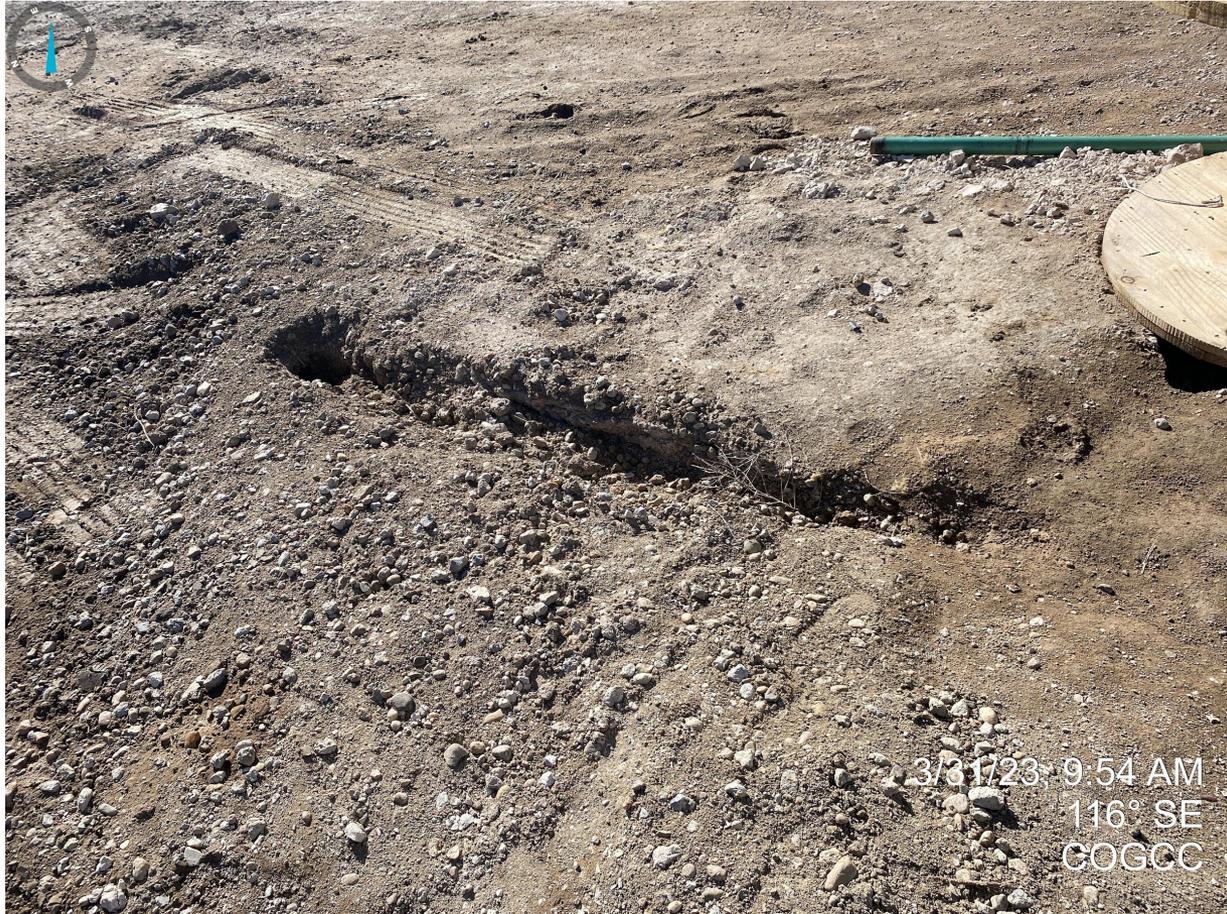
Photo 12. See comments in Photo 11.

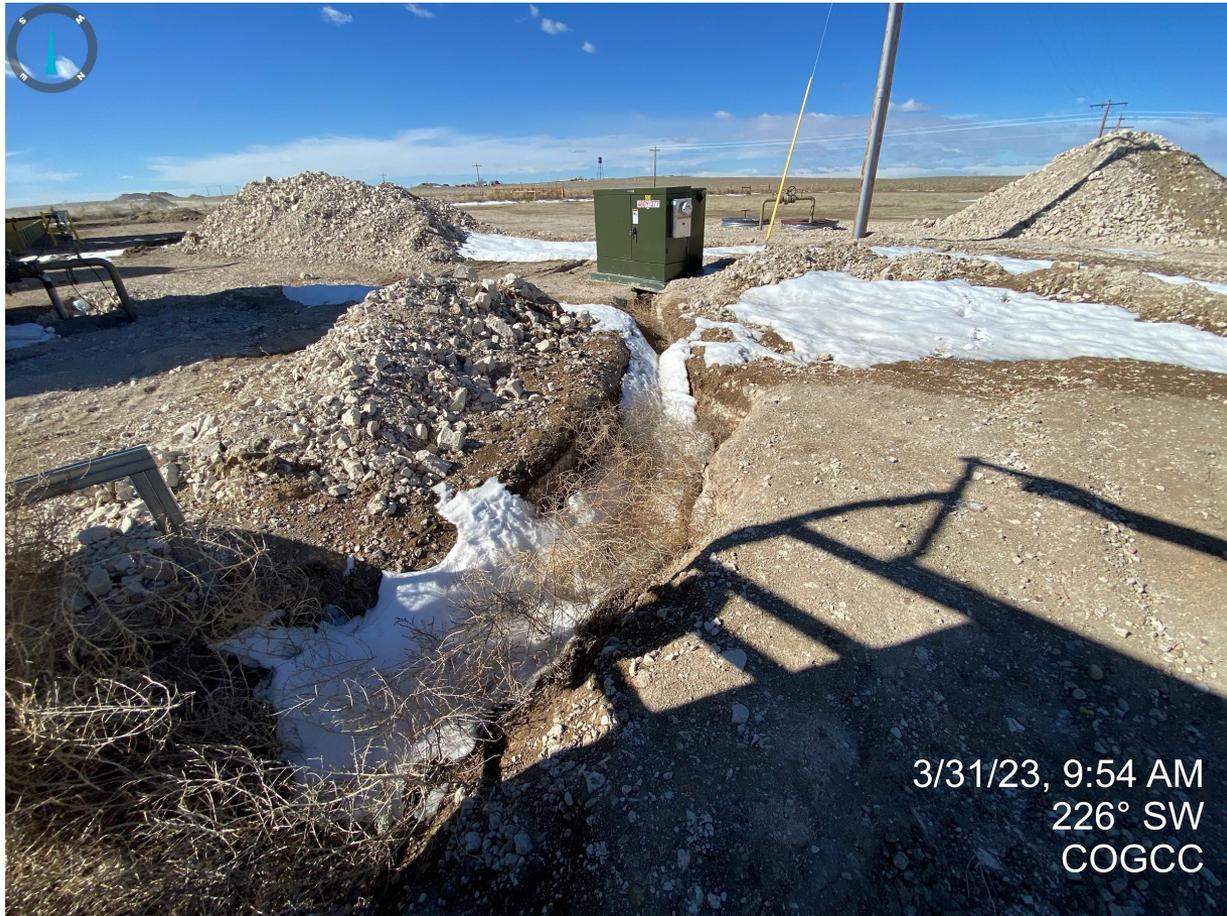
Photo 13. See comments in Photo 11.

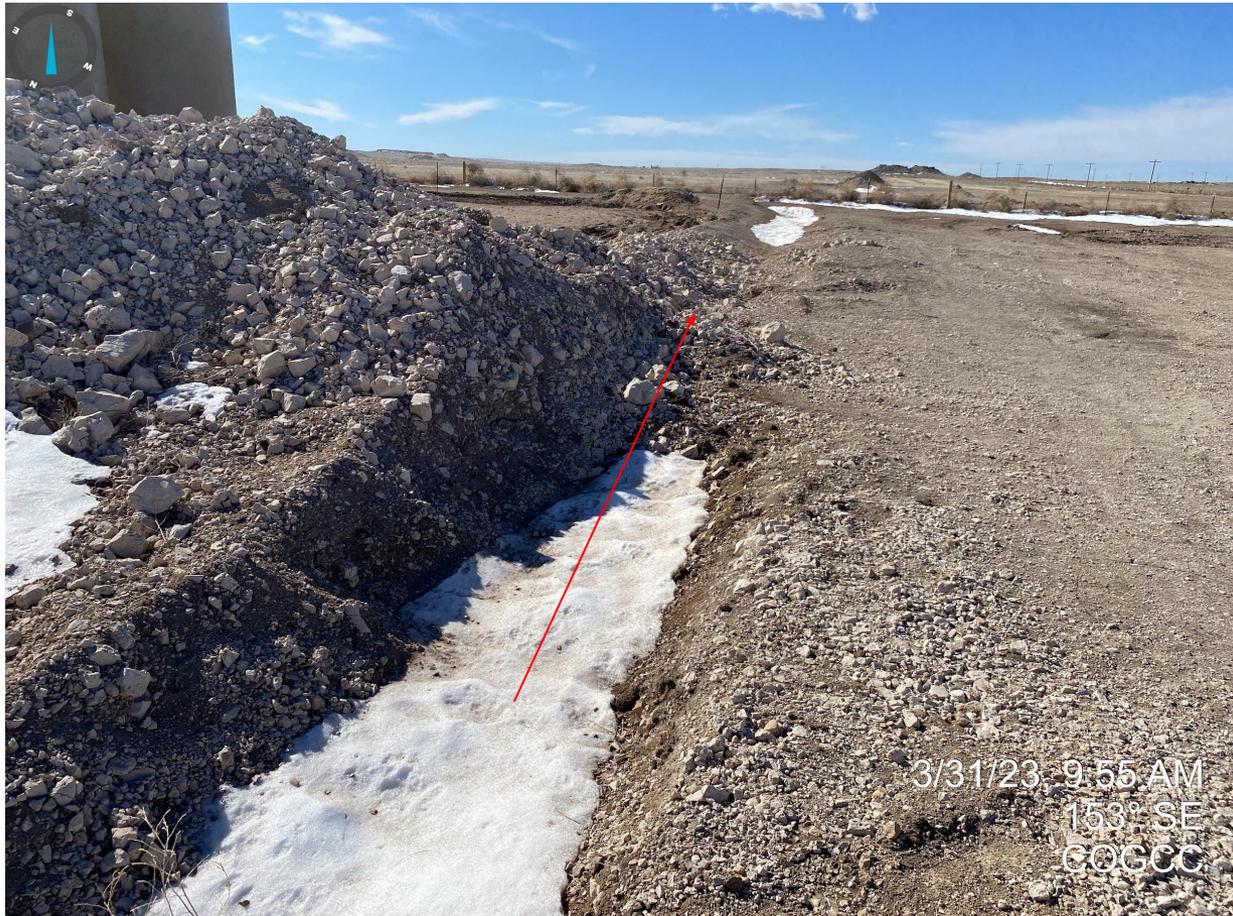
Photo 14. Facing south; material being stored in the stormwater ditch.

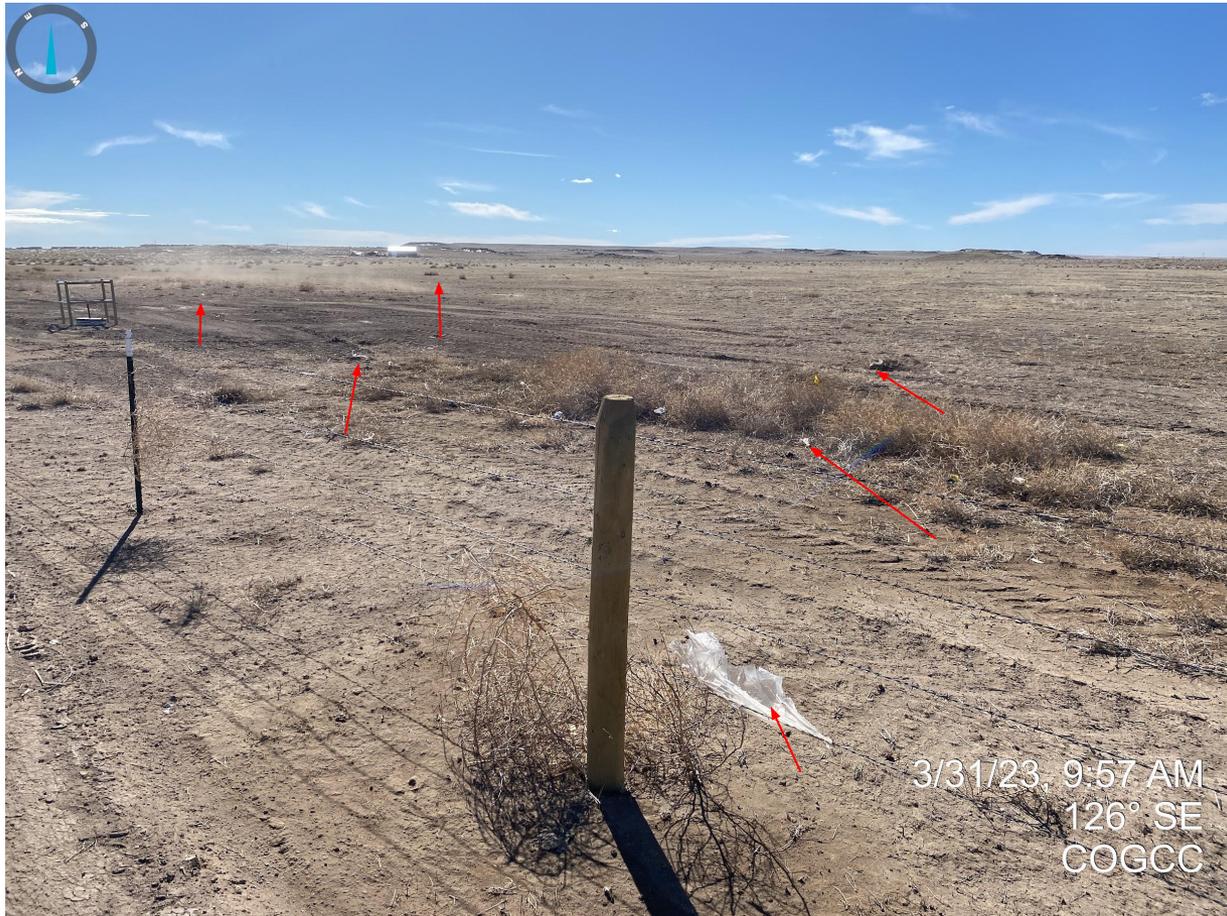
Photo 15. Facing southeast from the southern portion of the location. Photo illustrates that trash and debris have blown off location and will need to be picked up and disposed of. Examples (red arrows) do not illustrate all trash and debris; the Operator will need to identify all trash/debris off location and implement procedures and BMPs to prevent this from reoccurring.

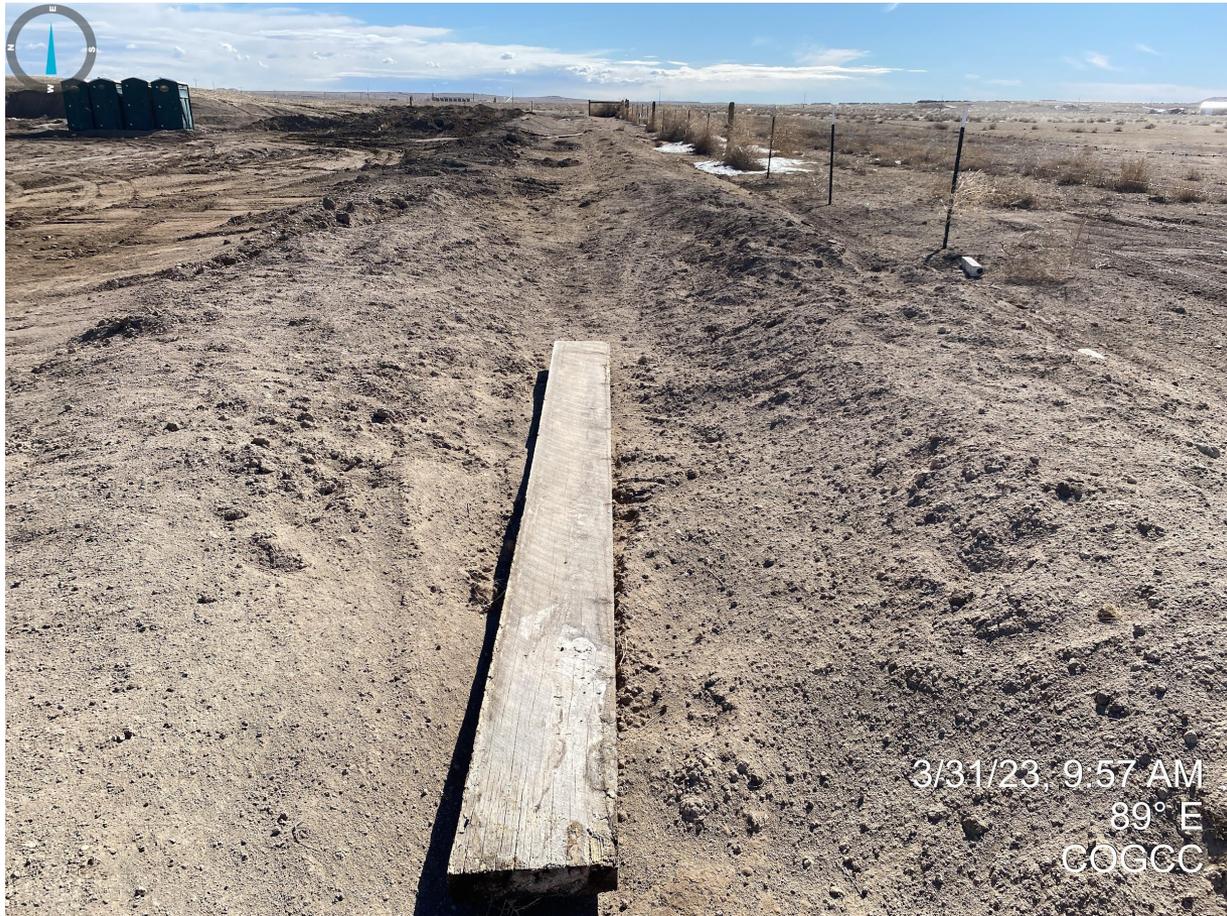
Photo 16. Debris in ditch.

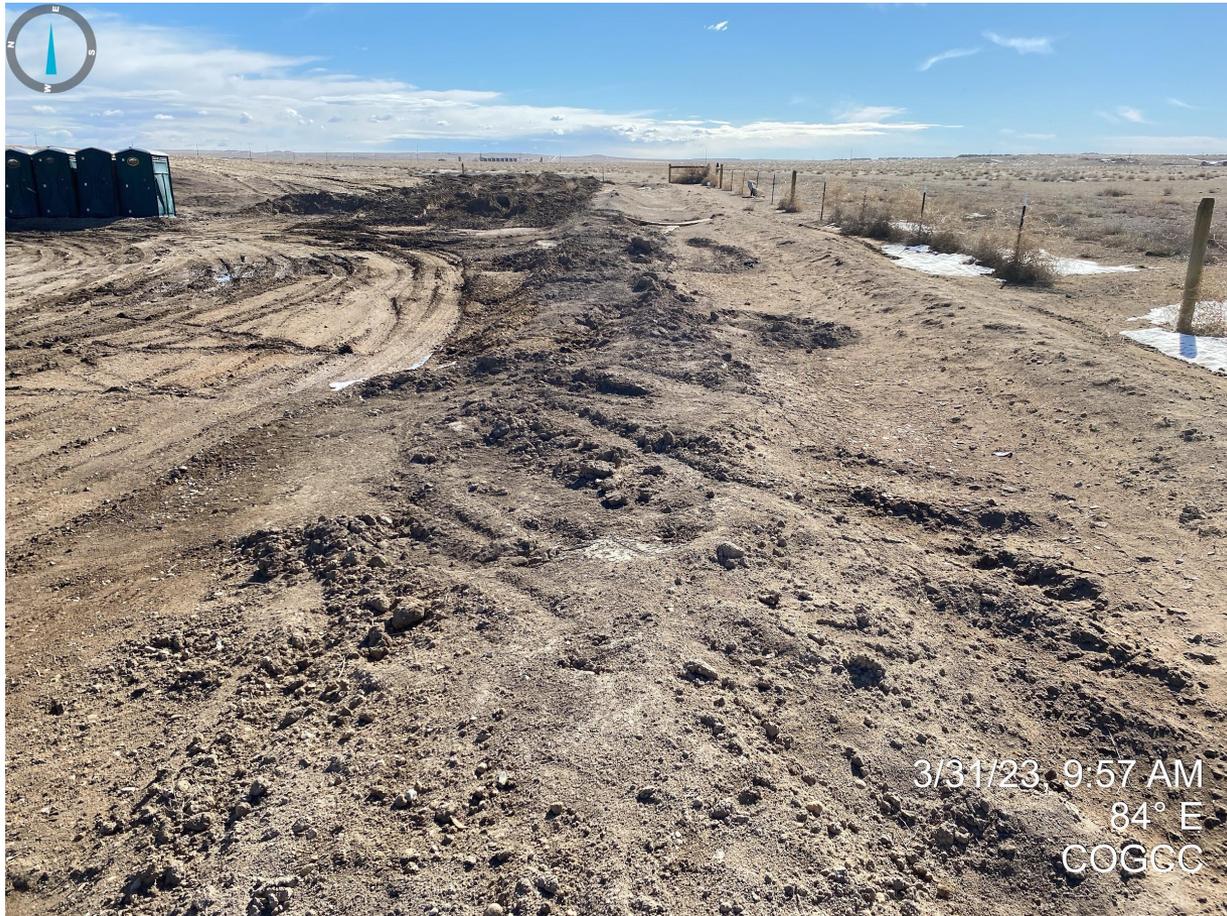
Photo 17. Facing east at southern portion of location. Photo illustrates that this portion of the ditch is comprised of unconsolidated material and will require maintenance to be a proper functioning BMP.

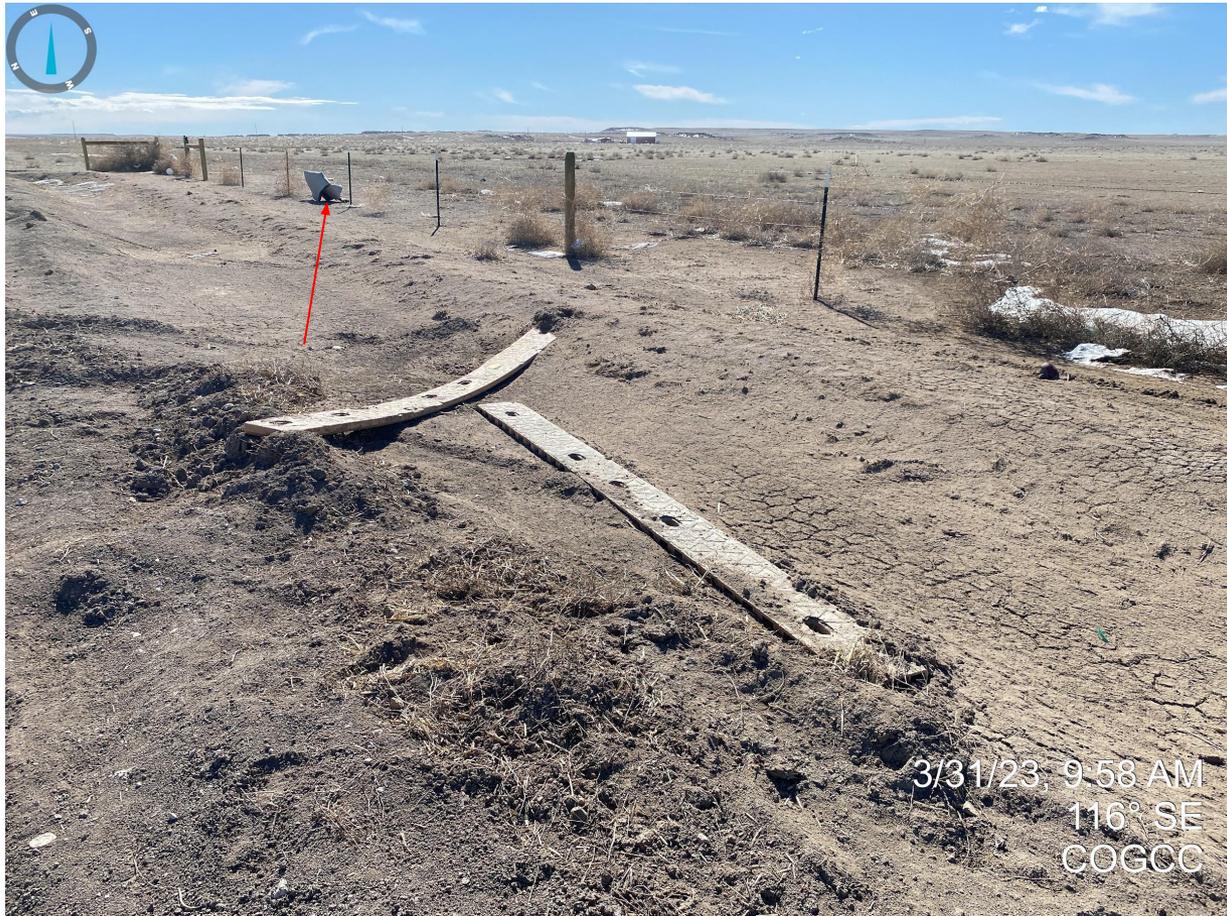
Photo 18. Debris in ditch.

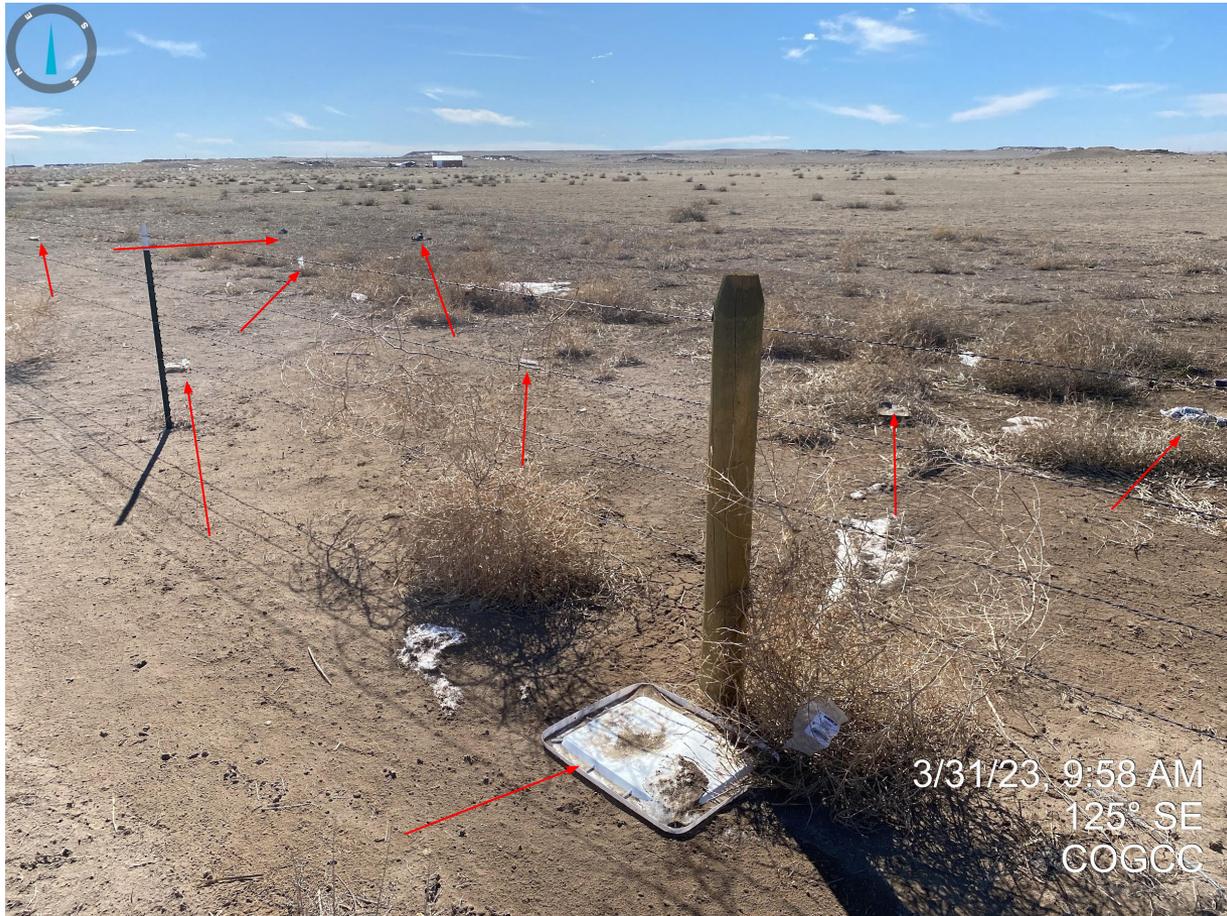
Photo 19. See comments in Photo 15.

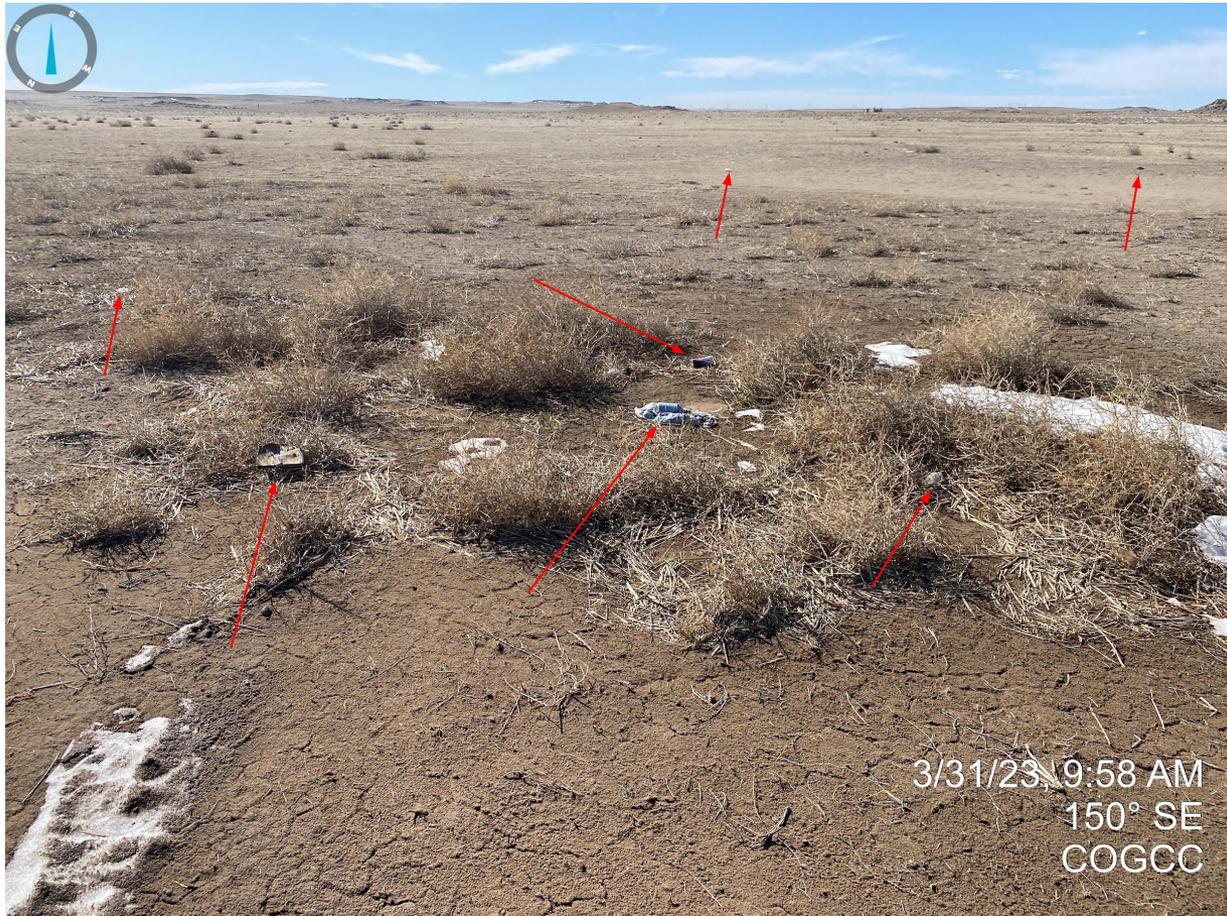
Photo 20. See comments in Photo 15.
