Construction and Stormwater Inspection

Operator: VERDAD RESOURCES LLC - 10651

Location ID: 466345

Inspection Document #: 708200080

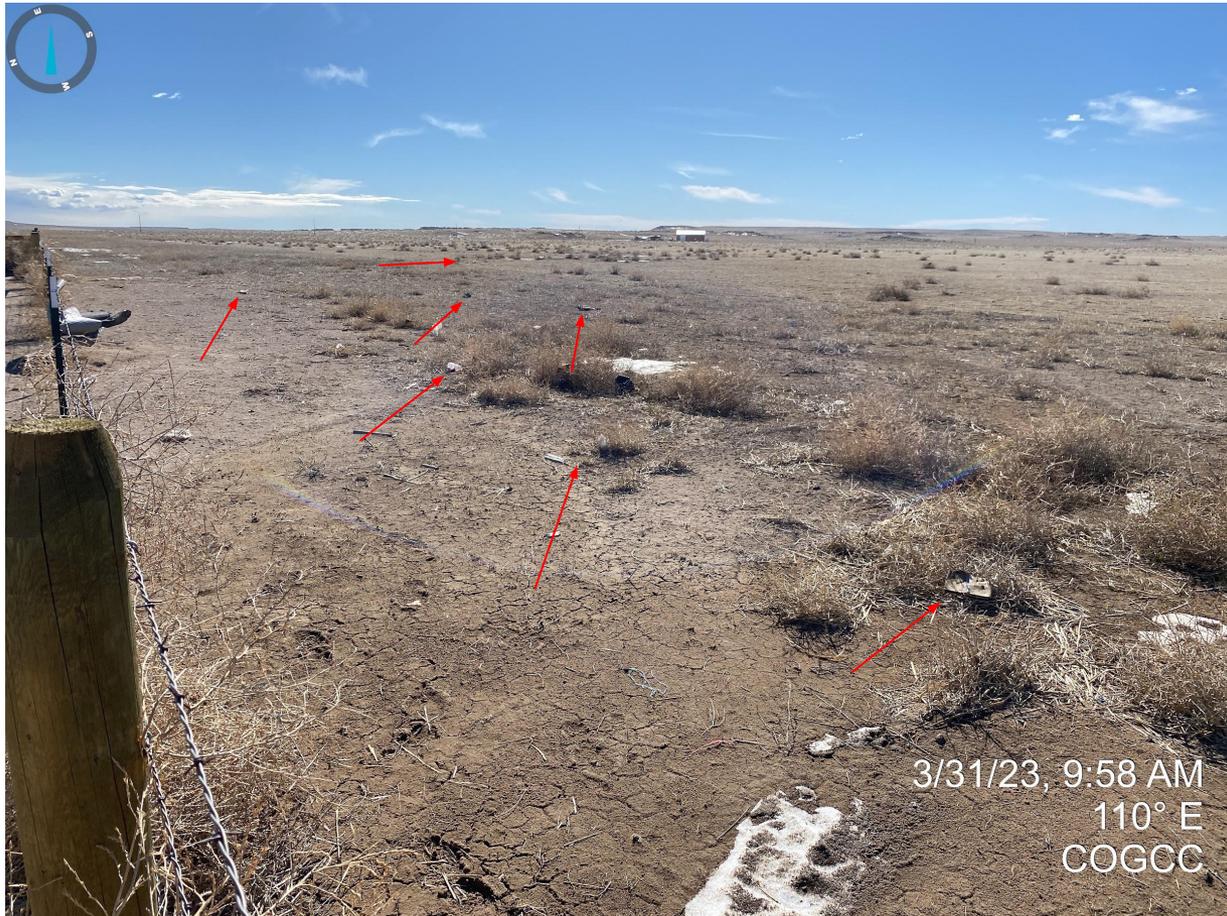
Photo 15. Facing southeast from the southern portion of the location. Photo illustrates that trash and debris have blown off location and will need to be picked up and disposed of. Examples (red arrows) do not illustrate all trash and debris; the Operator will need to identify all trash/debris off location and implement procedures and BMPs to prevent this from reoccurring.

Photo 21. See comments in Photo 15.

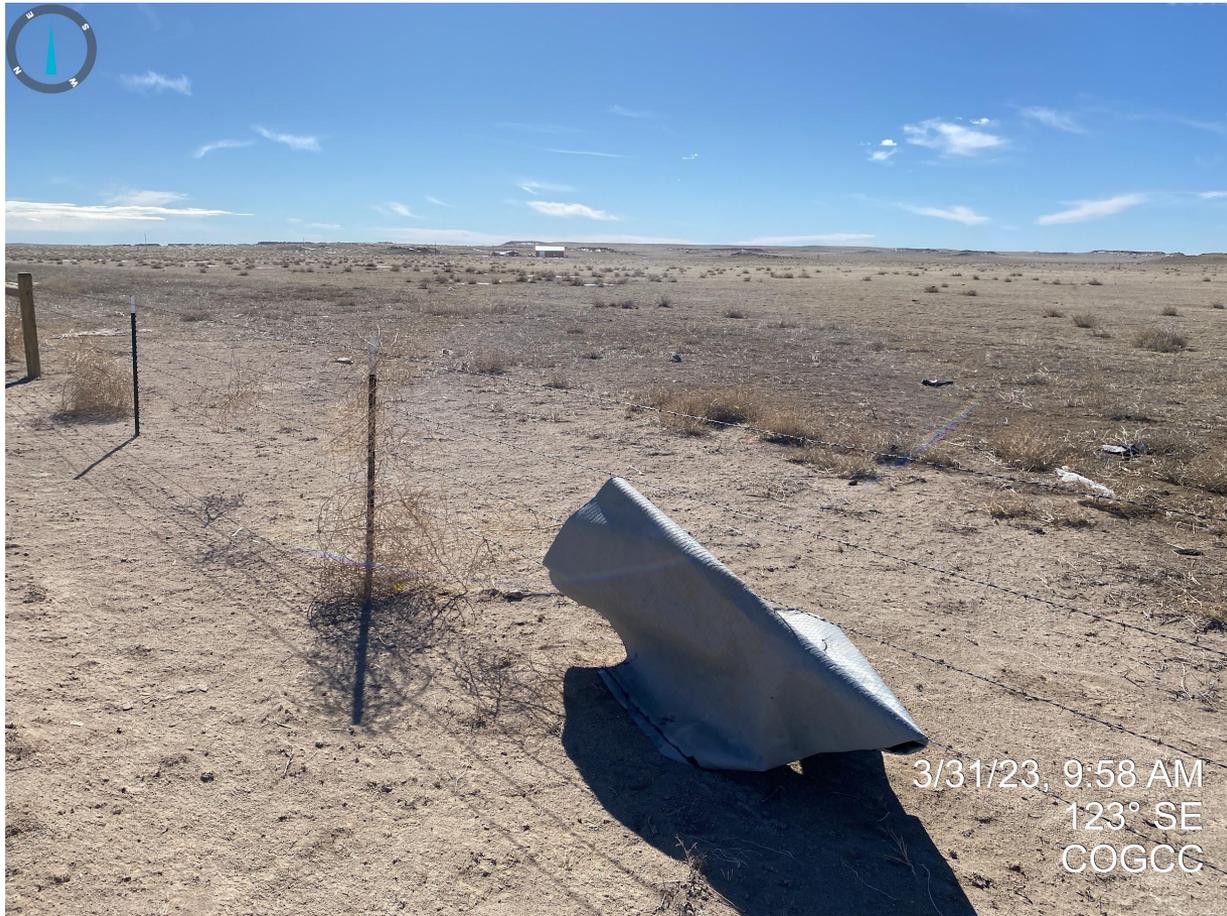
Photo 22. See comments in Photo 15.

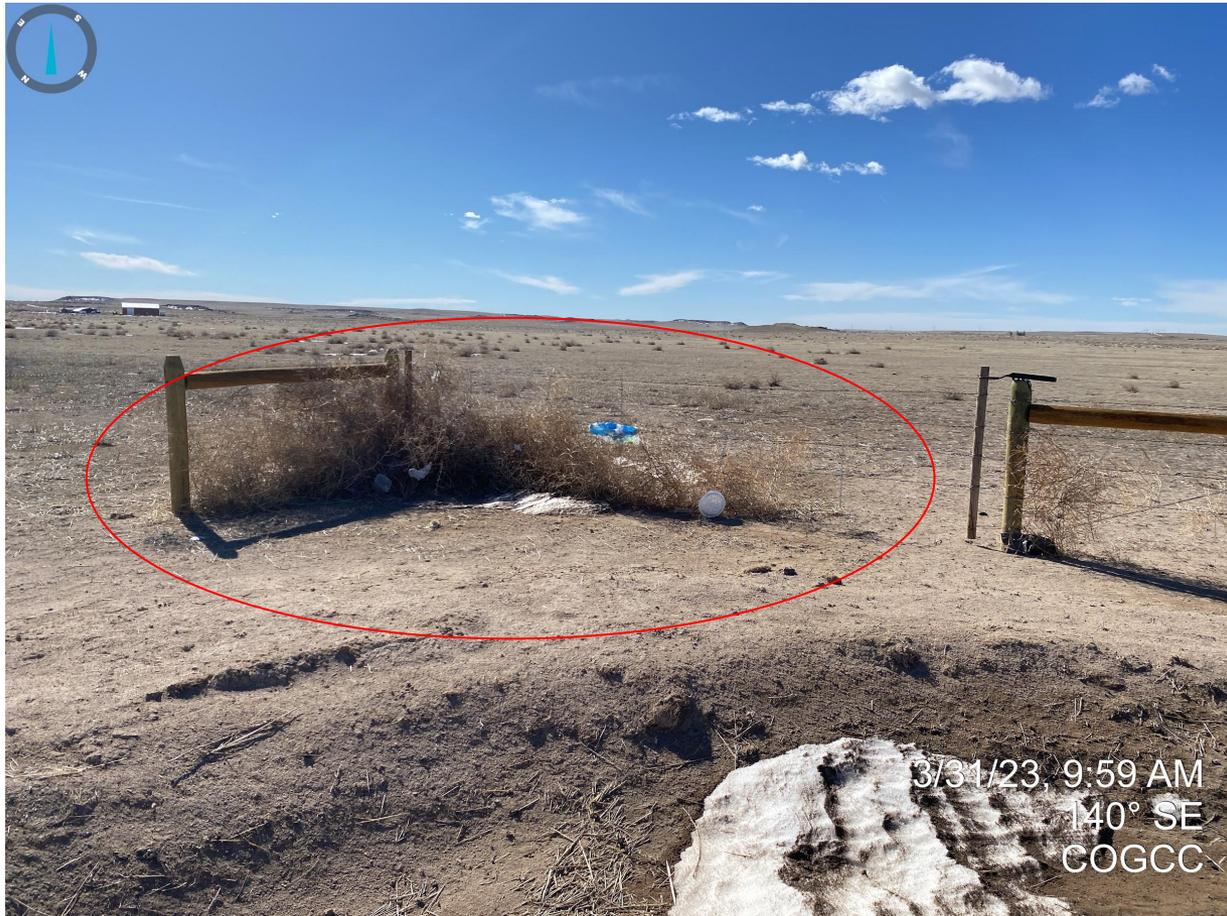
Photo 23. Facing southeast from the southeast corner of location; see comments in Photo 15.

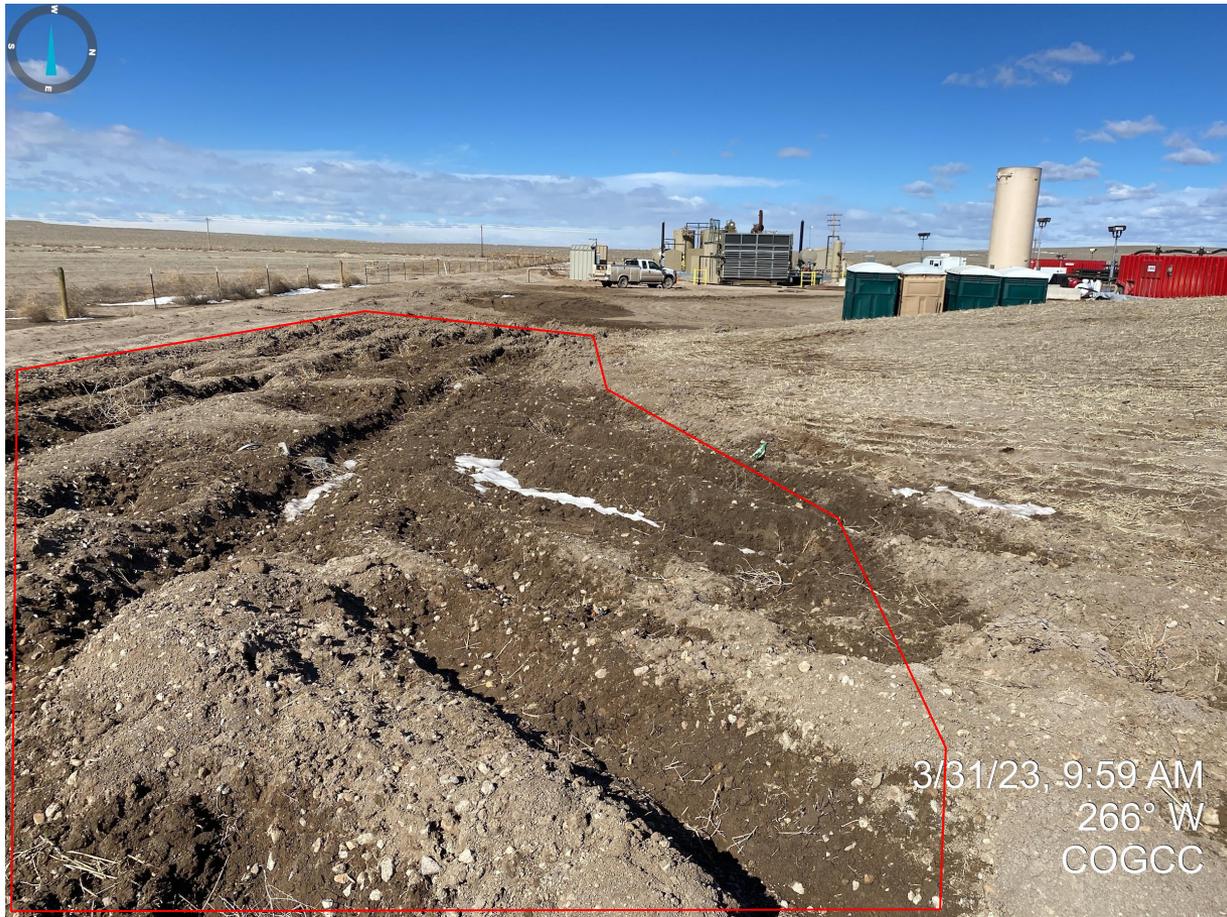
Photo 24. Facing west at the southern end of the topsoil stockpile. Photo illustrates unknown material (possibly fill material) being placed at the end of the topsoil. The operator needs to ensure that all soil horizons are properly segregated and stored to avoid mixing.

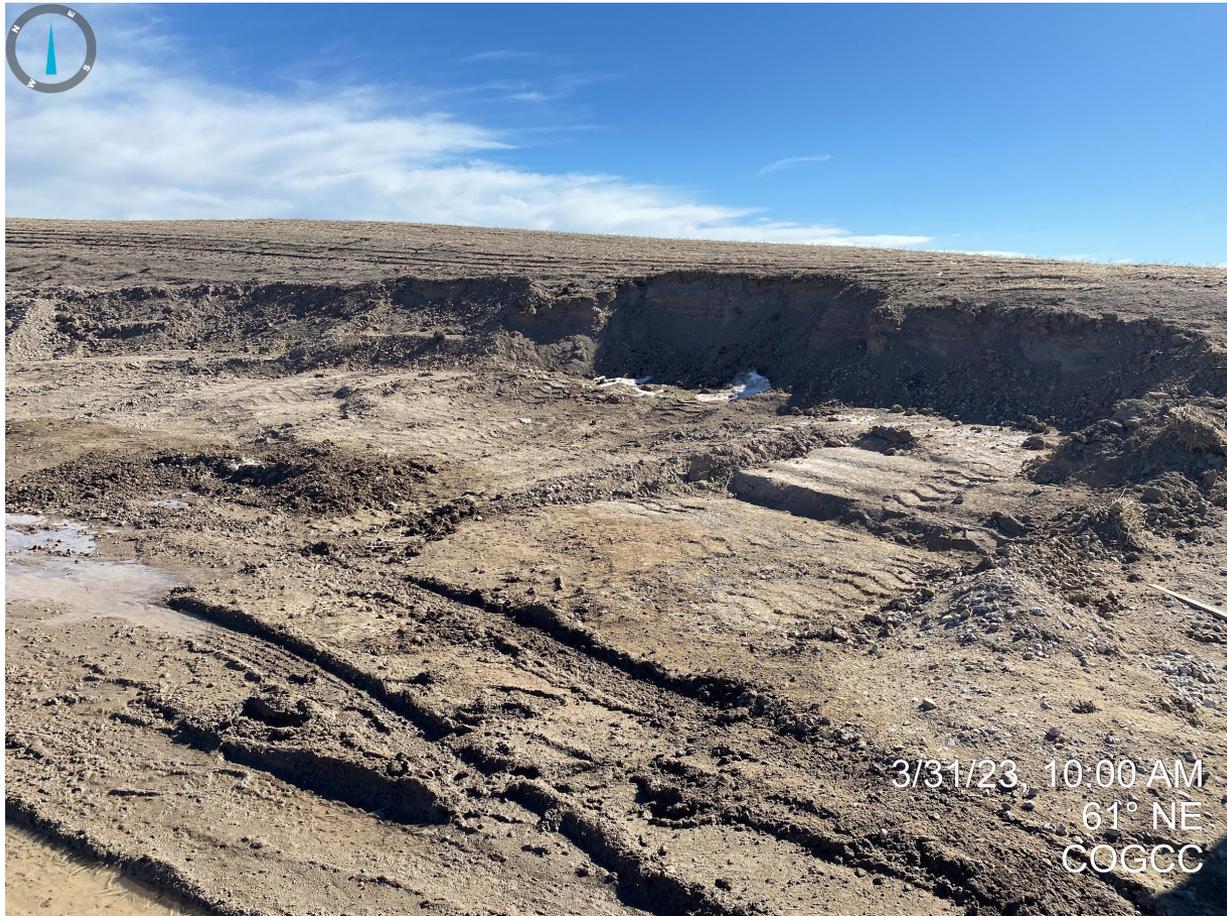
Photo 25. Facing northeast towards topsoil stockpile. It appears an area approximately 40' x 10' x 4' in size has been excavated from the topsoil stockpile. The Operator is being required to import topsoil to replace the deficit.

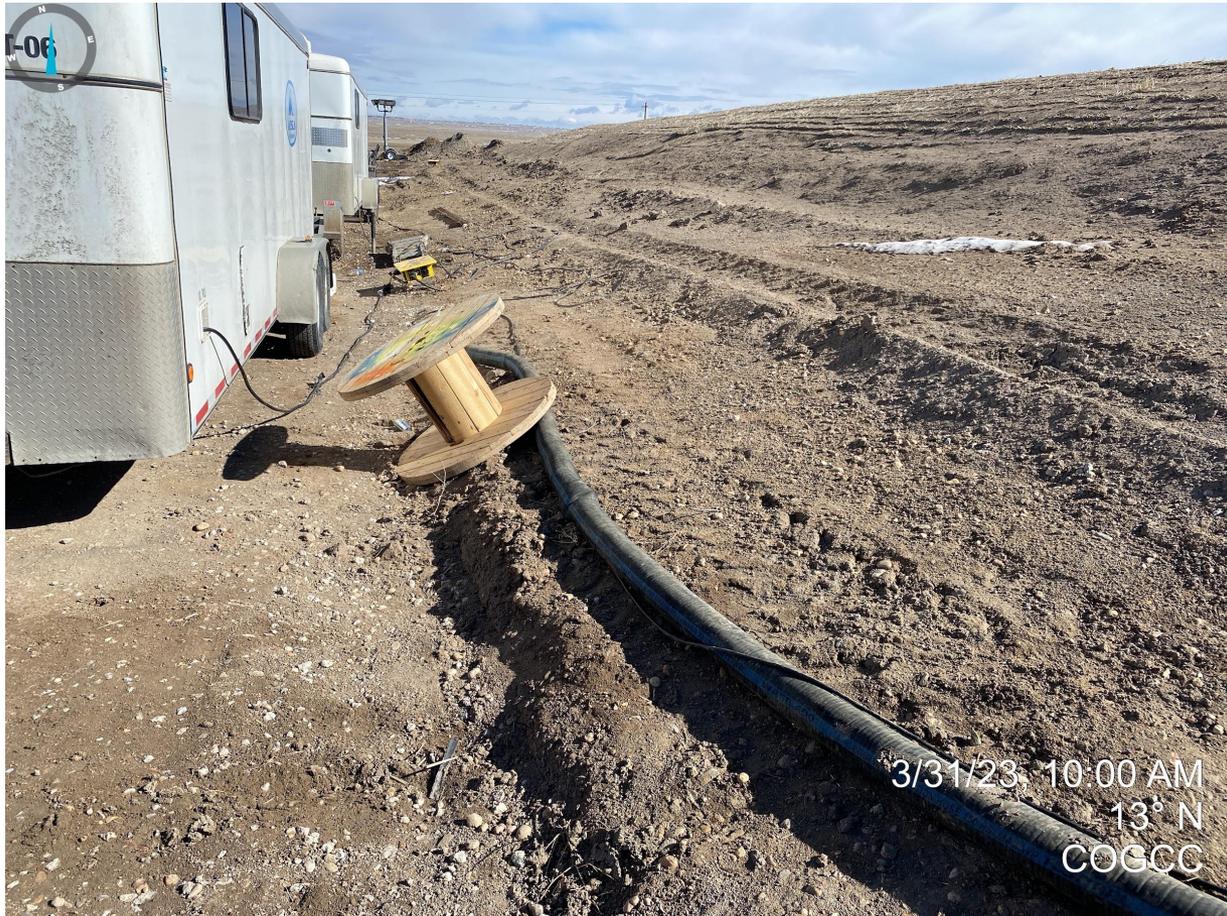
Photo 26. Facing north from the western portion of the topsoil stockpile. Photo illustrates equipment being stored on the stockpile, and the absence of stabilization BMPs on this portion of the stockpile.

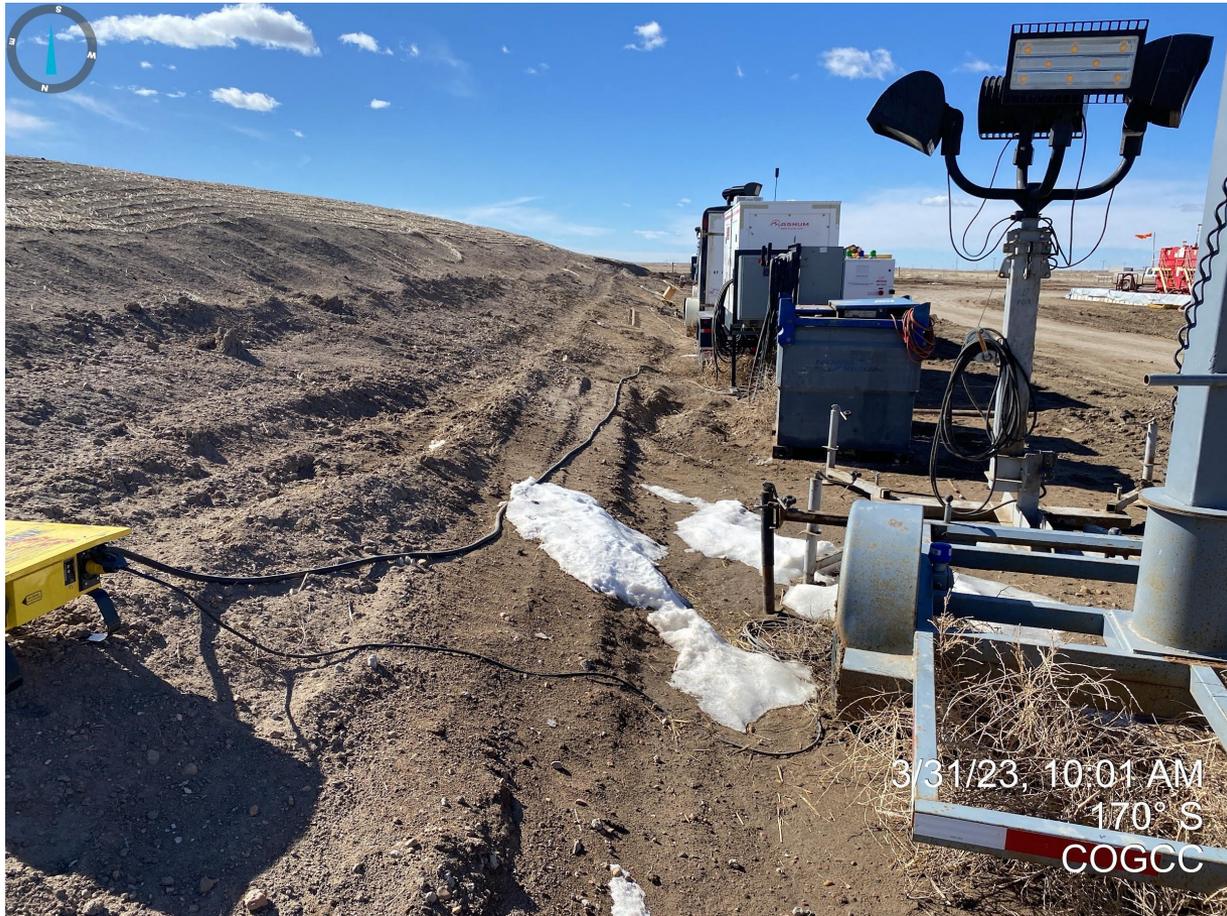
Photo 27. Facing south; see comments in Photo 26.

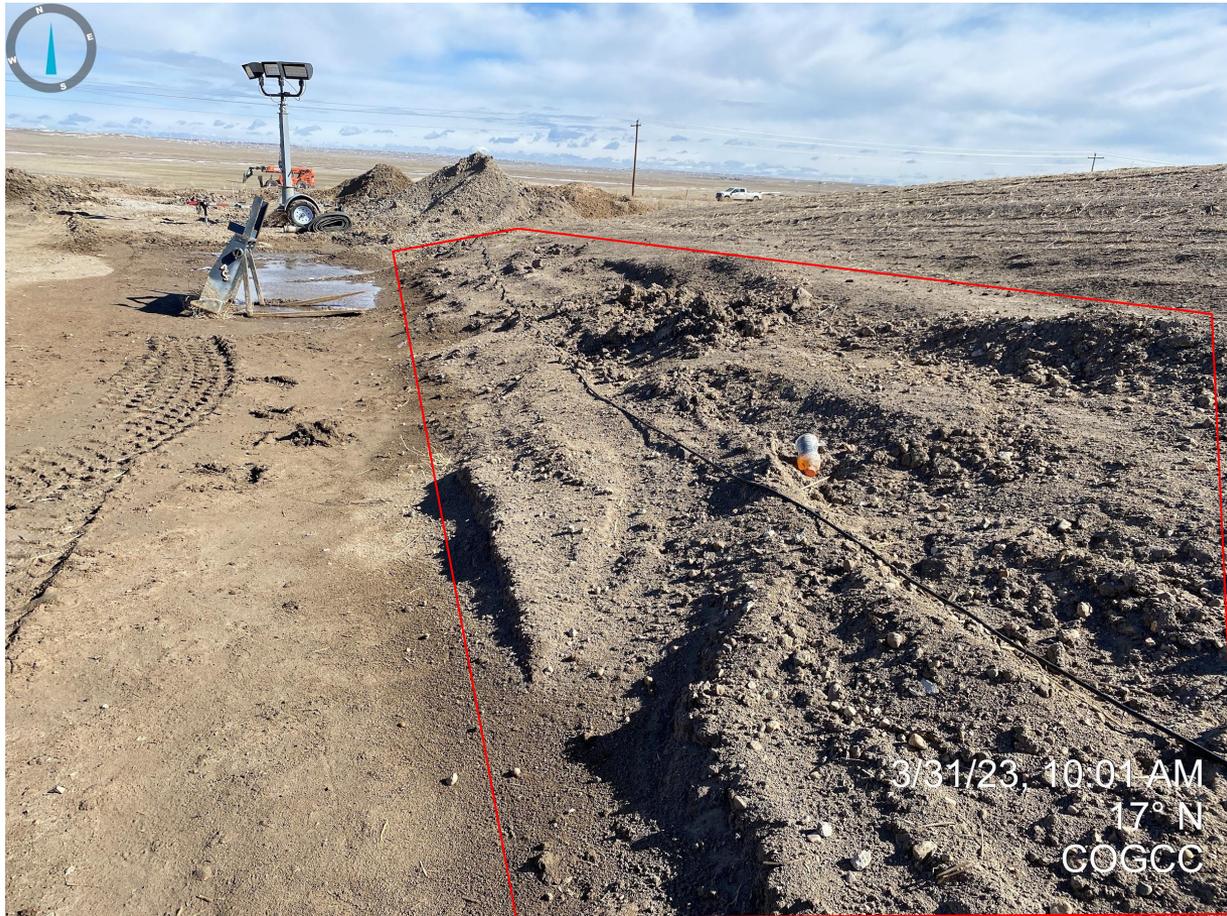
Photo 28. Facing north at the northern end of stockpile. Photo illustrates unconsolidated topsoil that is susceptible to wind and water erosion as it is not properly stabilized.

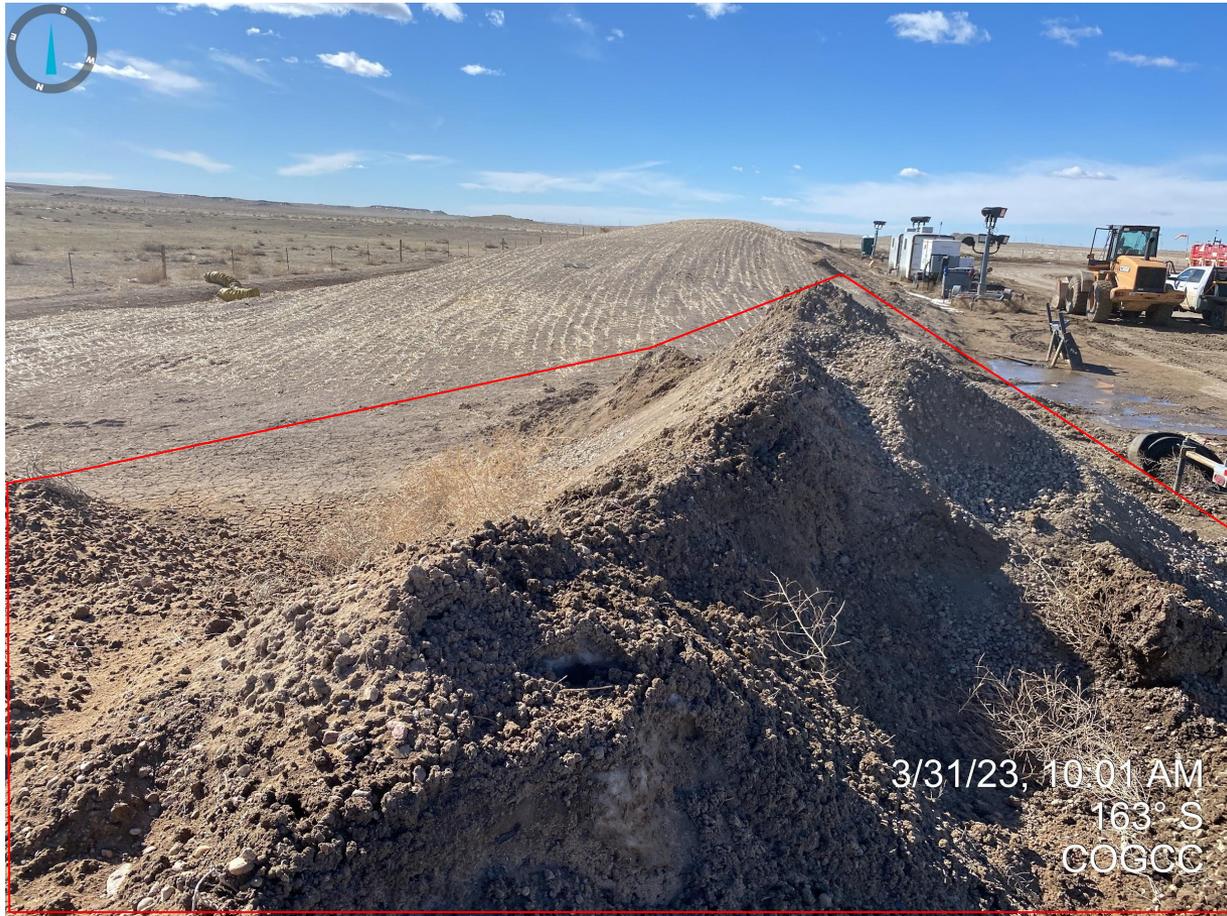
Photo 29. Facing south at the northern end of the location. Unknown material (possibly fill) being stored in close proximity to topsoil stockpile. See comments in Photo 24.

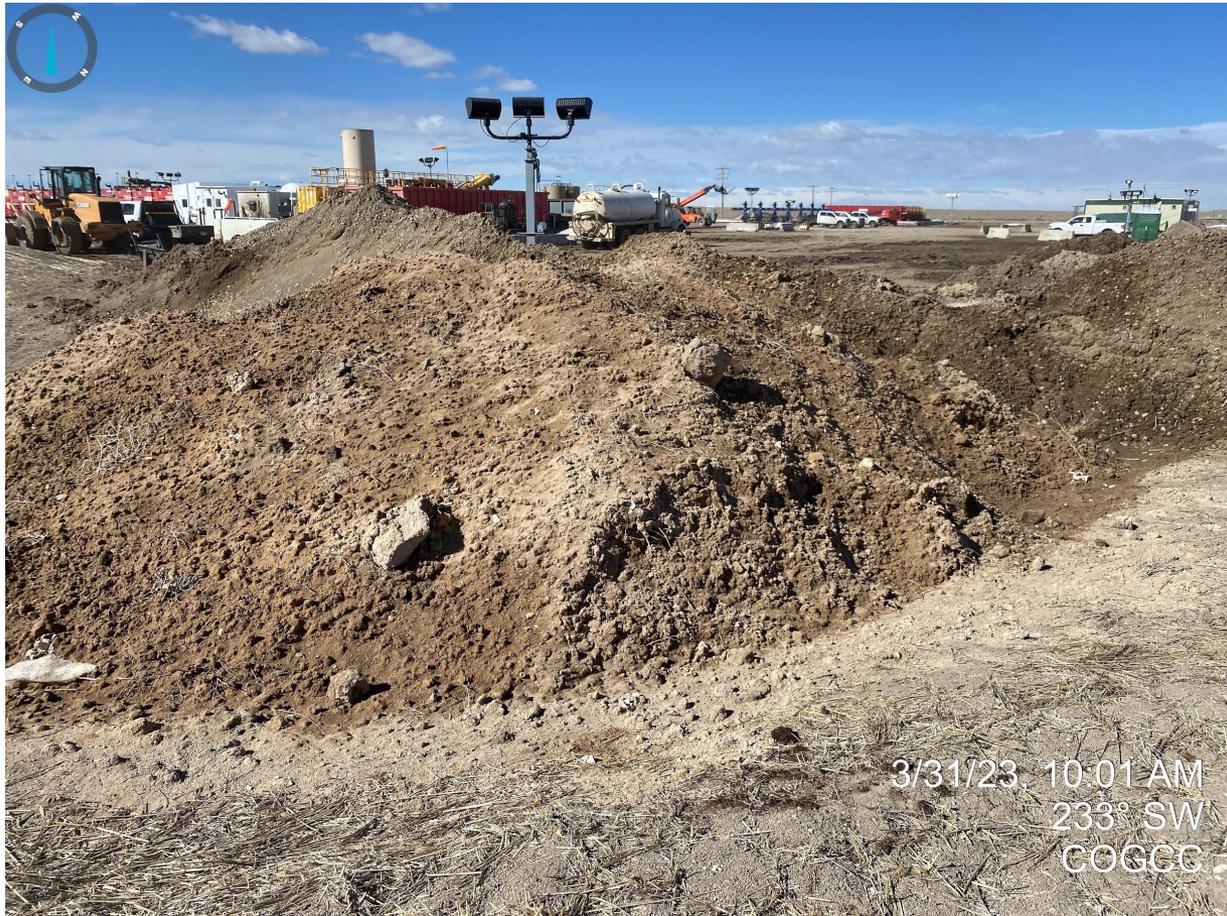
Photo 30. Facing southwest; see comments in Photo 29.

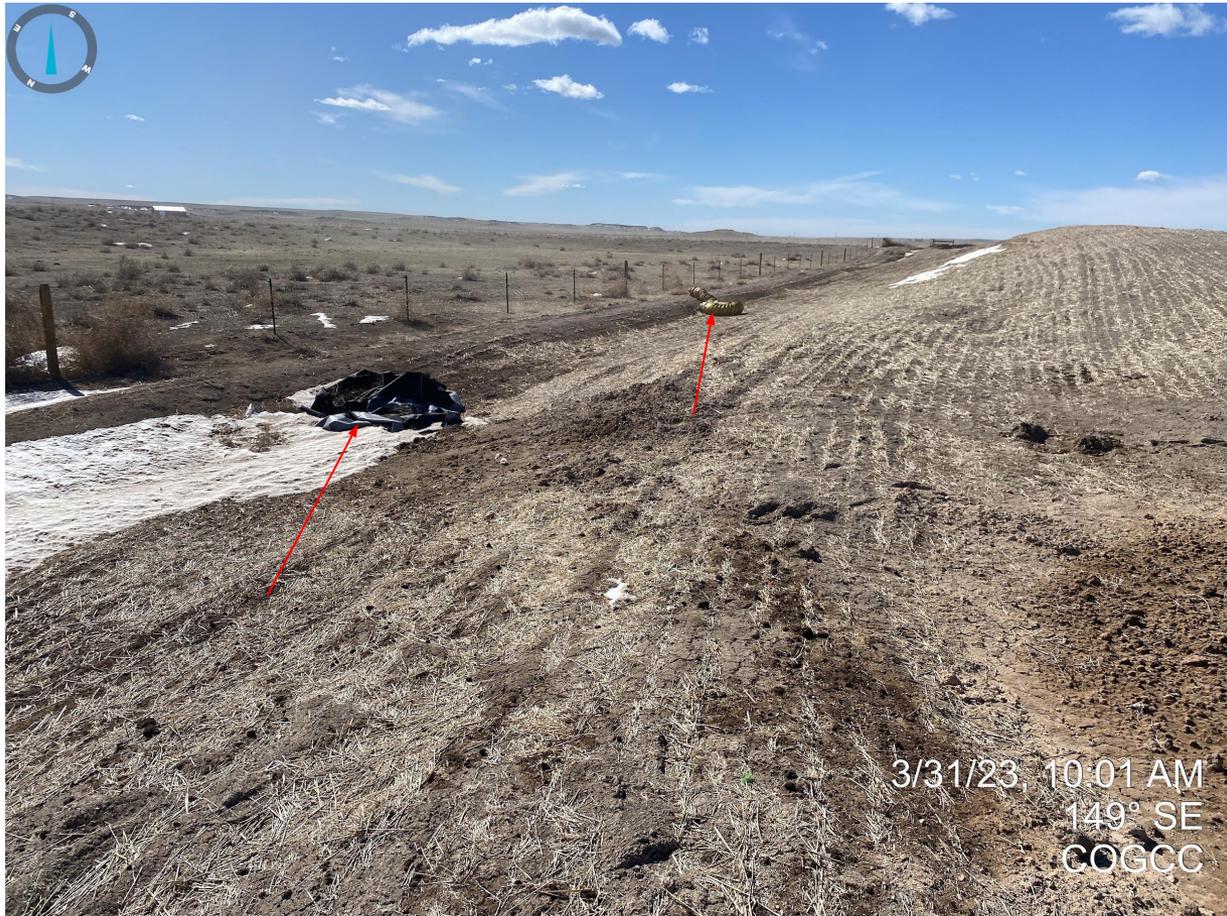
Photo 31. Facing southeast at topsoil stockpile. Debris in stormwater ditch.

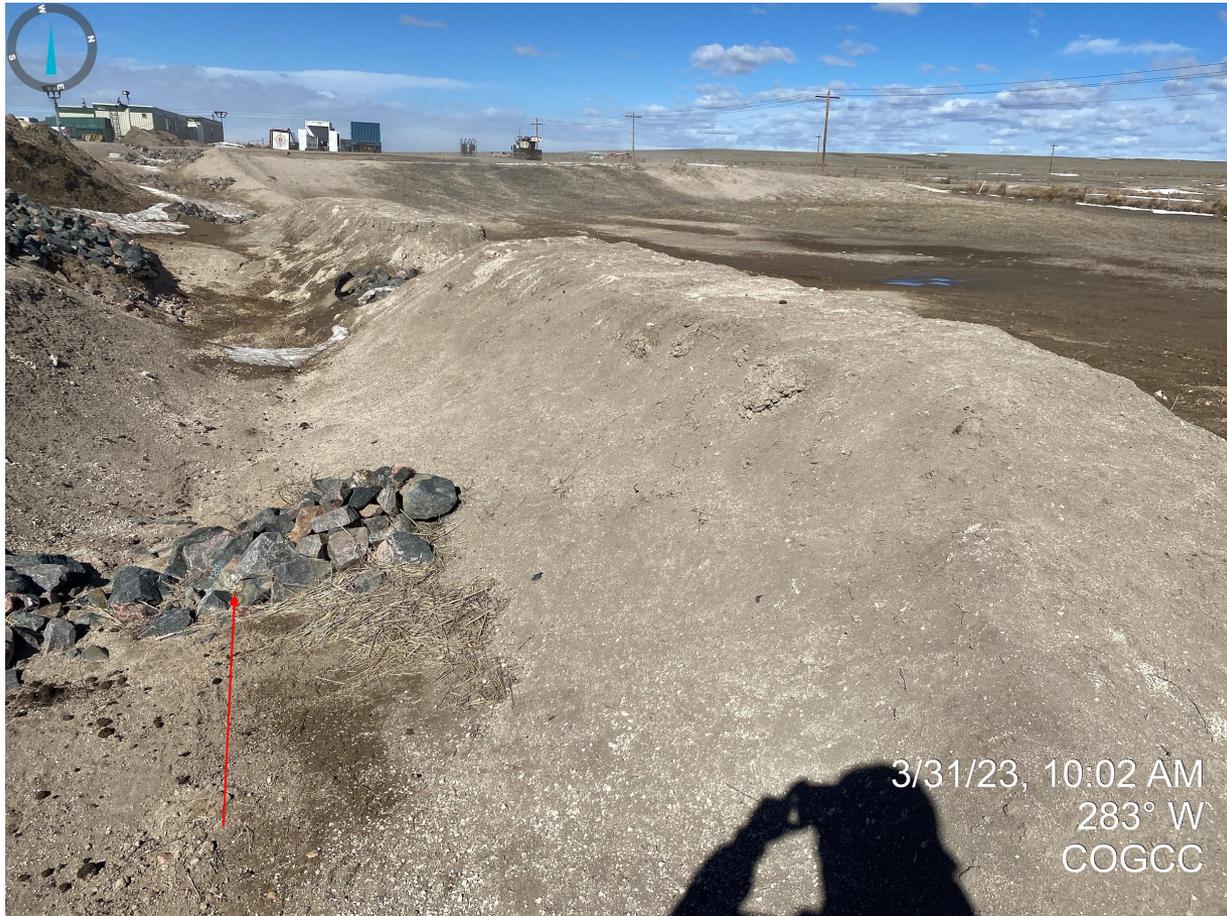
Photo 32. Facing west at northern portion of location. Berm BMPs does not appear to be an adequate BMP as the walls are nearly vertical, comprised of unconsolidated material (or lacking stabilization techniques), and have evidence of rill erosion (out of view). Additionally, rip rap check dams require maintenance as they are filled with sediment.

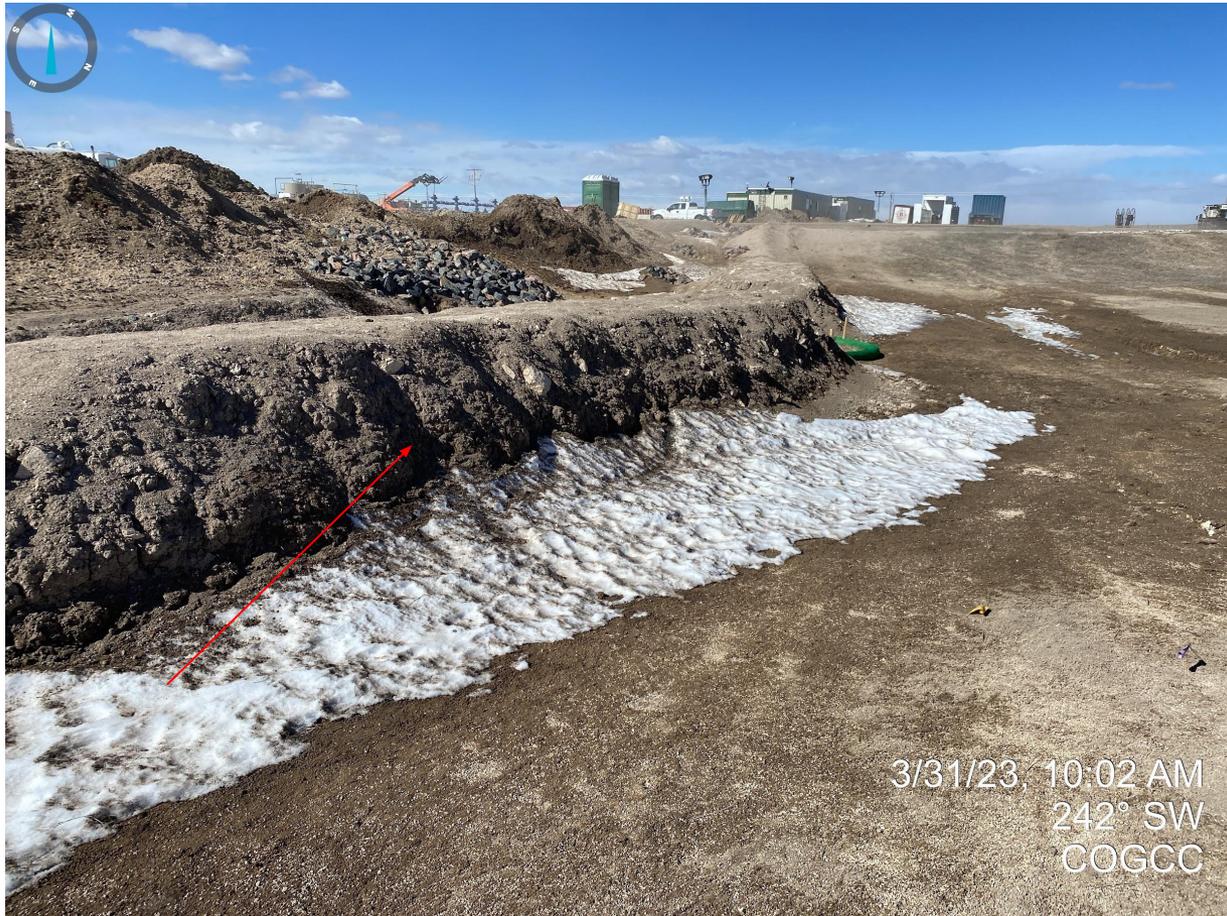
Photo 33. Facing southwest, see comments in Photo 32.

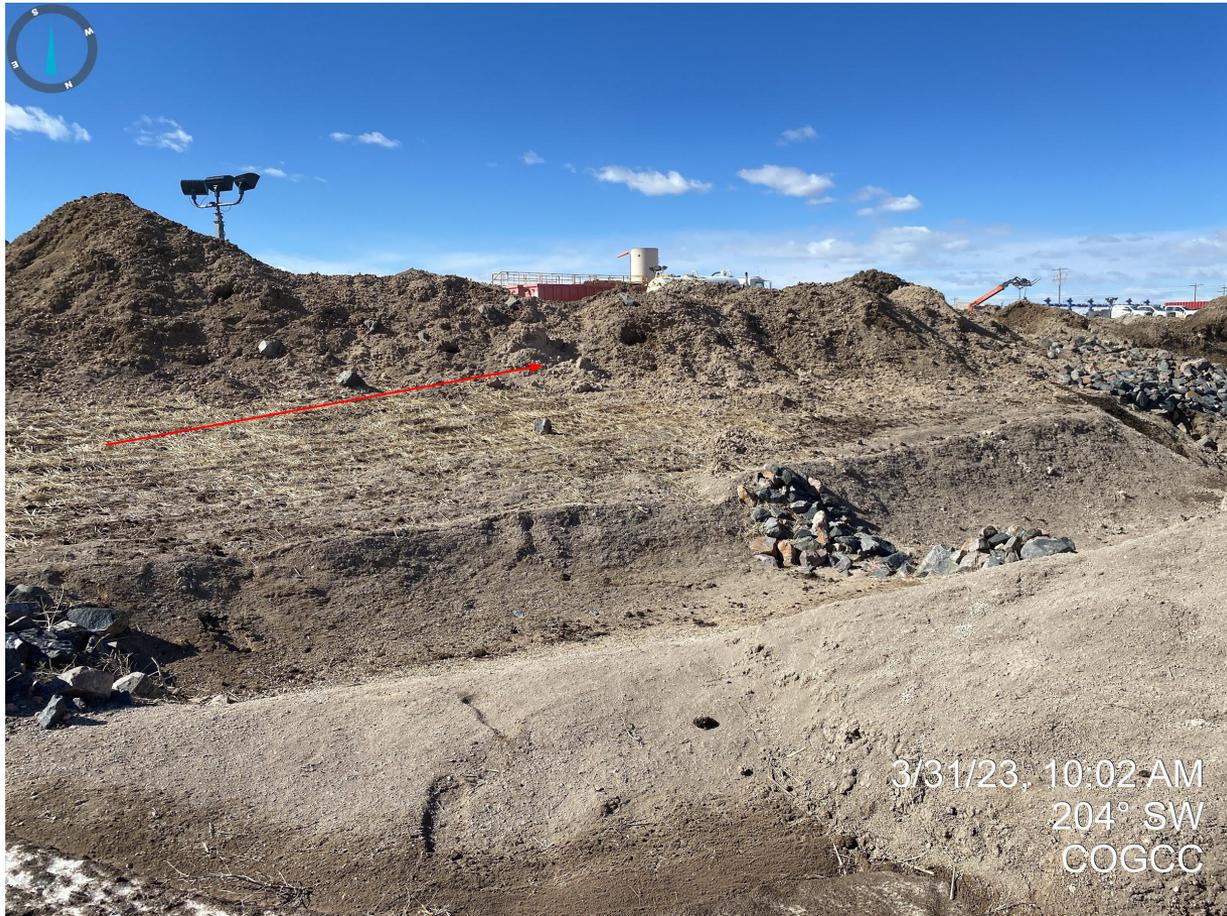
Photo 34. Facing southwest near sediment trap. Photo illustrates unconsolidated material placed next to stormwater ditch. The unconsolidated material can become a potential source of pollution itself as it is not properly stabilized.

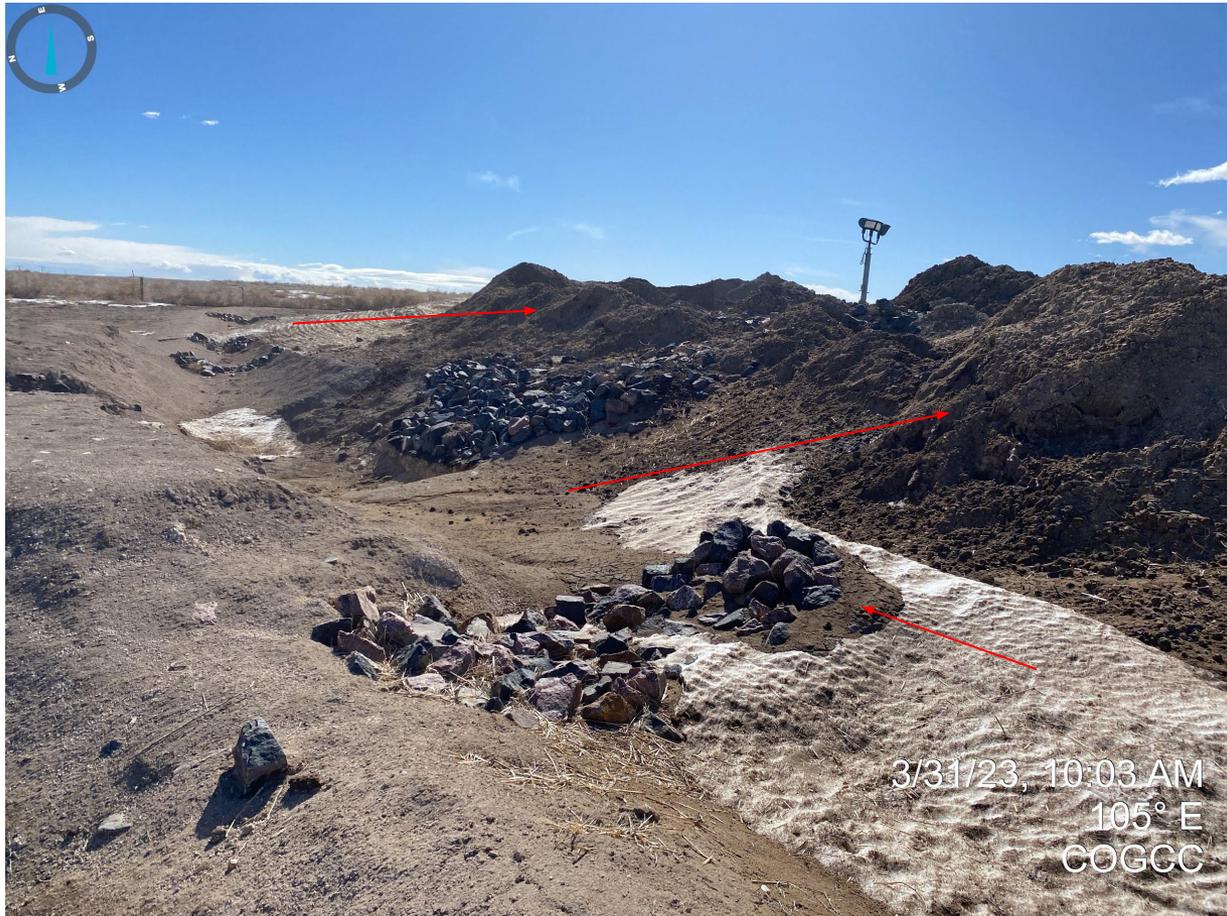
Photo 35. Facing east, see comments in Photo 34.

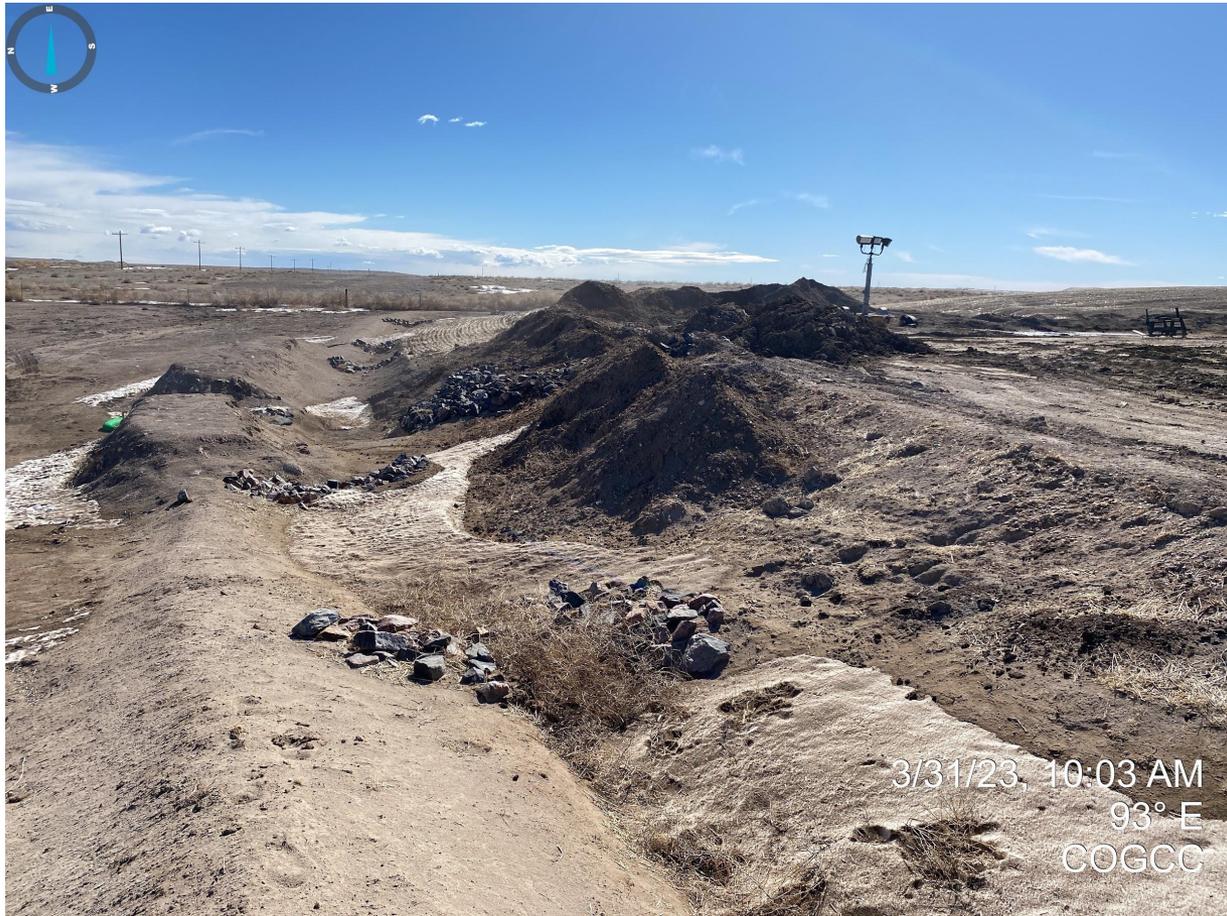
Photo 36. See comments in Photo 34.

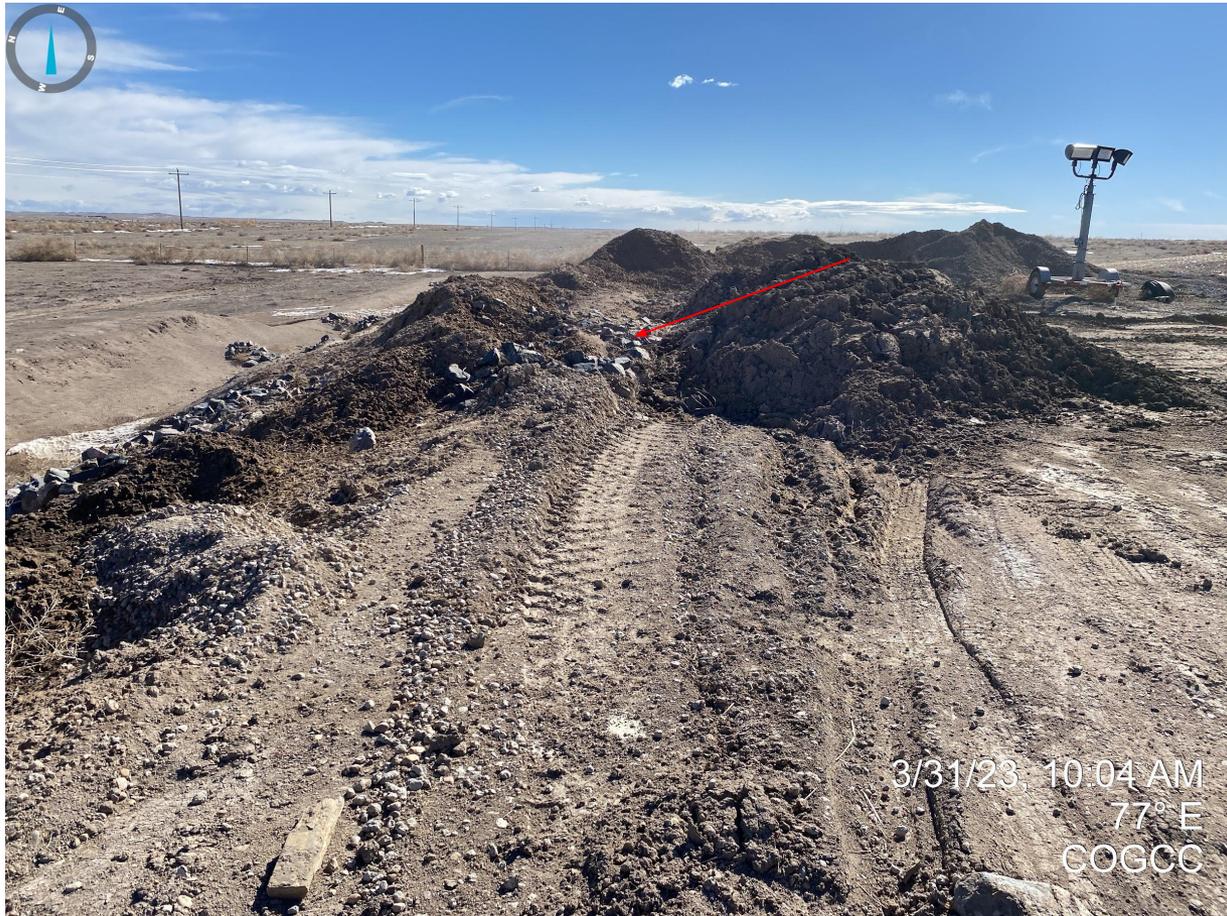
Photo 37. Unconsolidated material placed in front of rip rap portion spillway of sediment basin (red arrow).

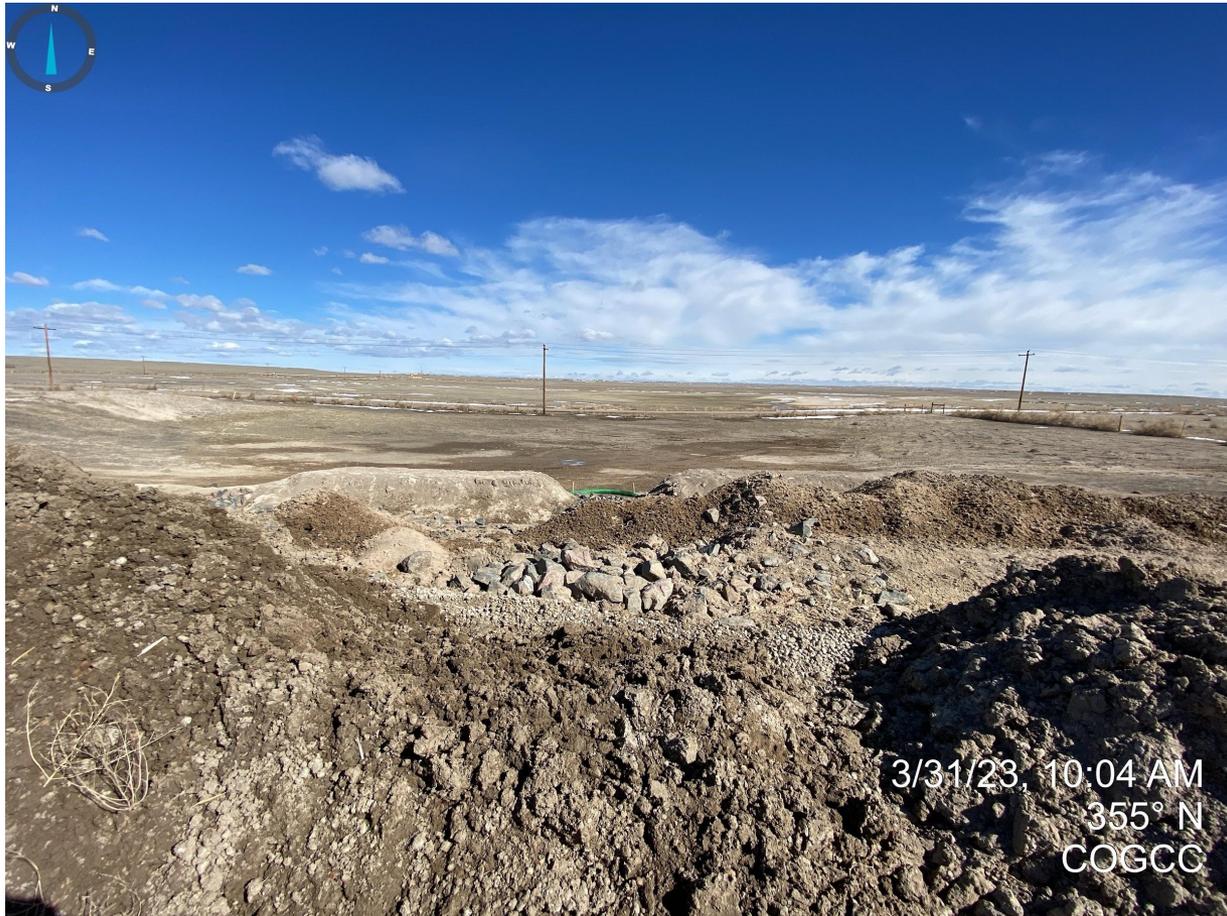
Photo 38. Facing north towards rip rap spillway; see comments in Photo 37.

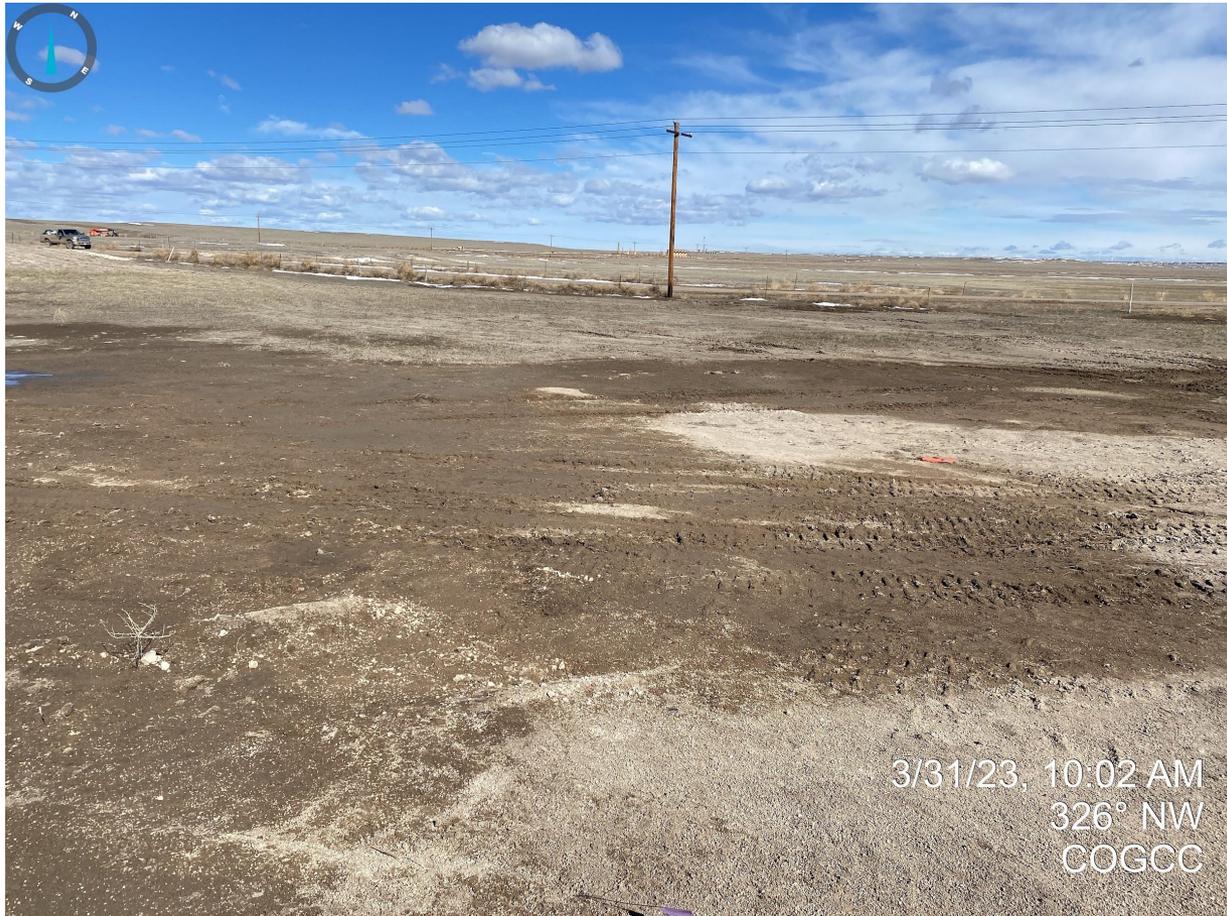
Photo 39. Facing north from the sediment trap area. Photo illustrates area that will need to be reclaimed after sediment laden stormwater discharged off location as documented in previous inspections (Doc #697504073 and 696105527)

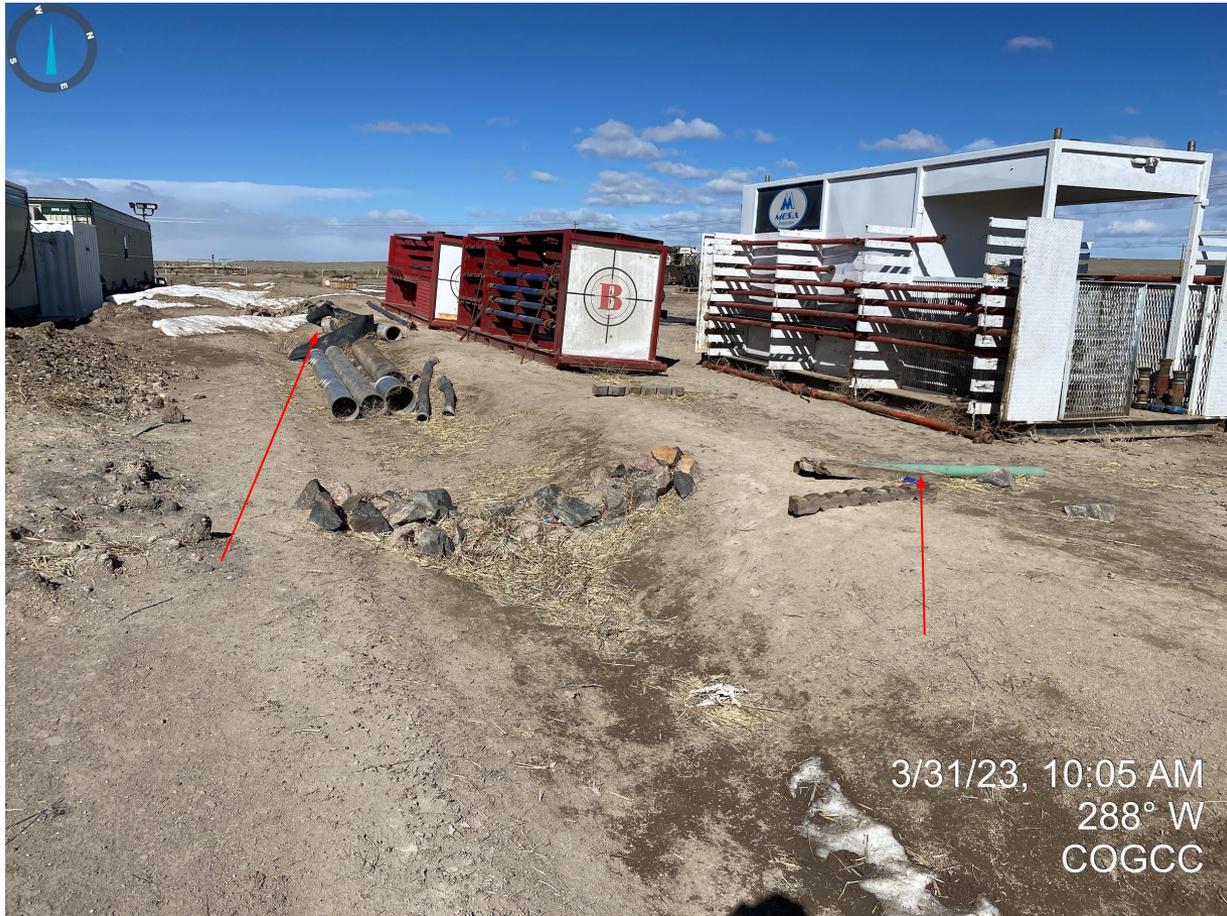
Photo 40. Facing west near location entrance. Debris and unused equipment in stormwater ditch that will need to be removed.
