Inspection Photos

4/05/2023

Operator: TEP ROCKY MOUNTAIN LLC - 96850

Location #334702

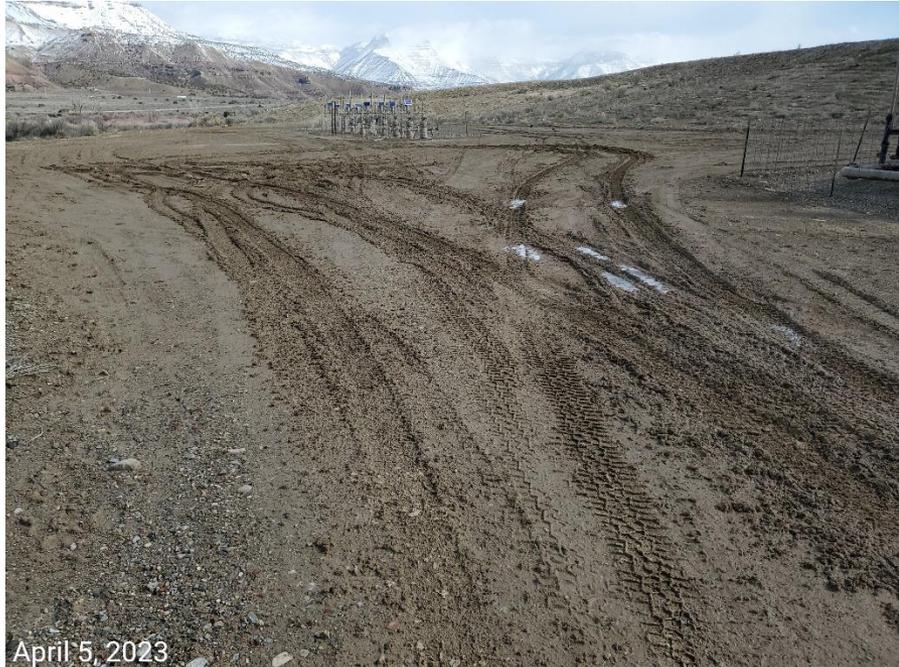
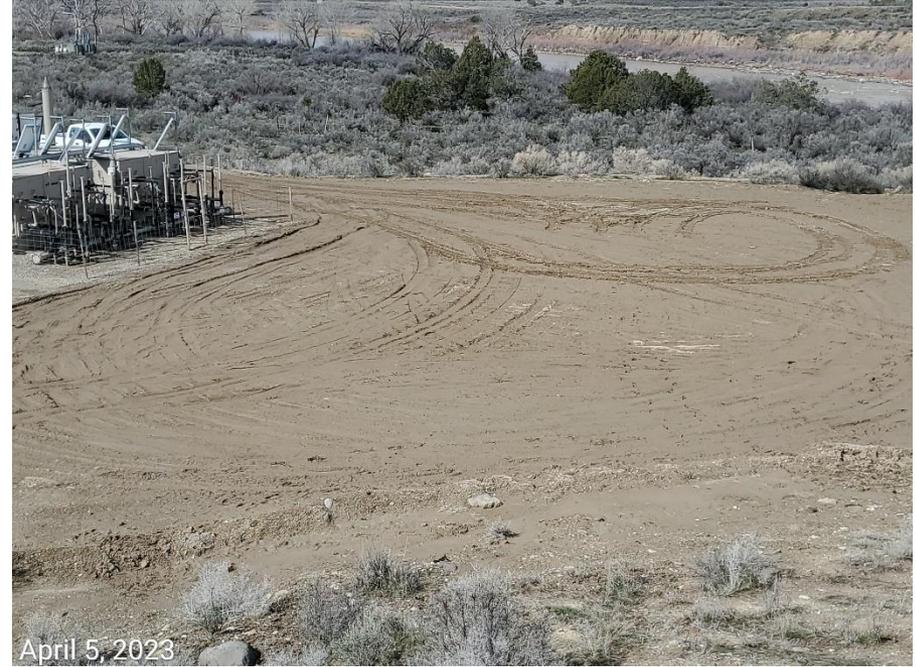
Photo 1: Photos 1-2 taken from the Location. Photos show BMPs to stabilization the Location, and to minimize erosion, degradation and off-site sediment transport remain missing or insufficient.

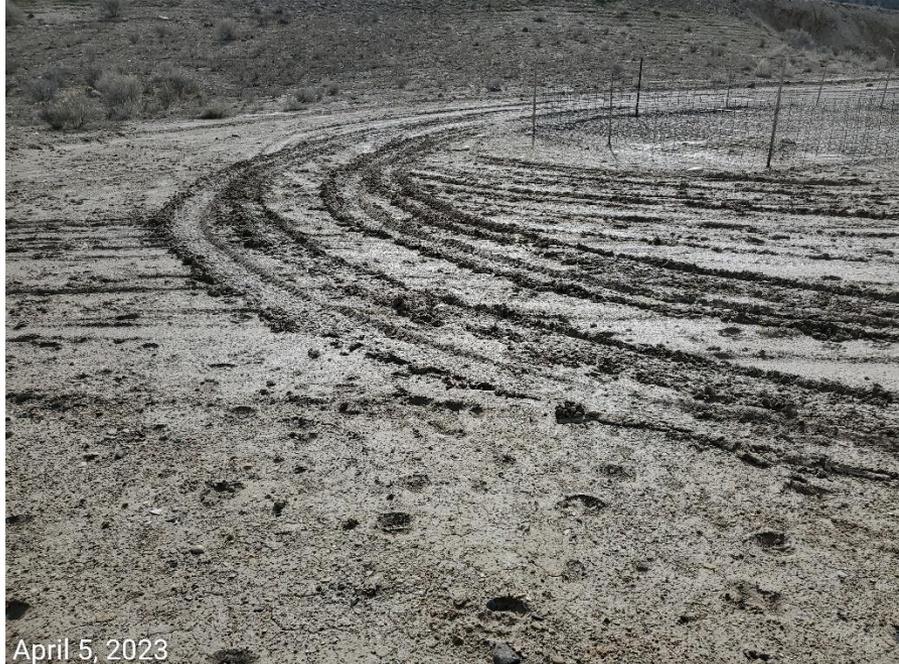
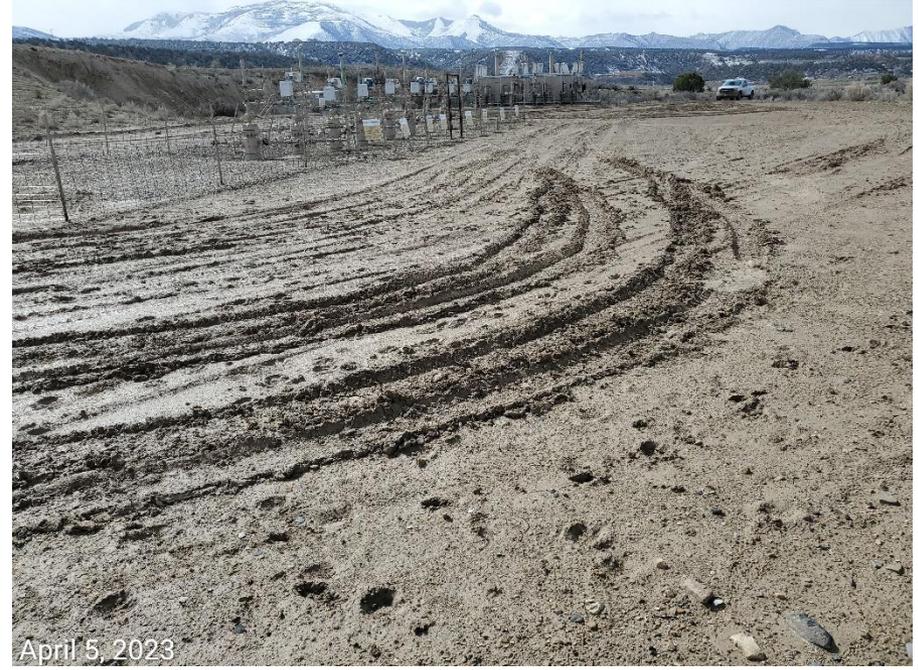
Photo 2: See comments under photo 1.

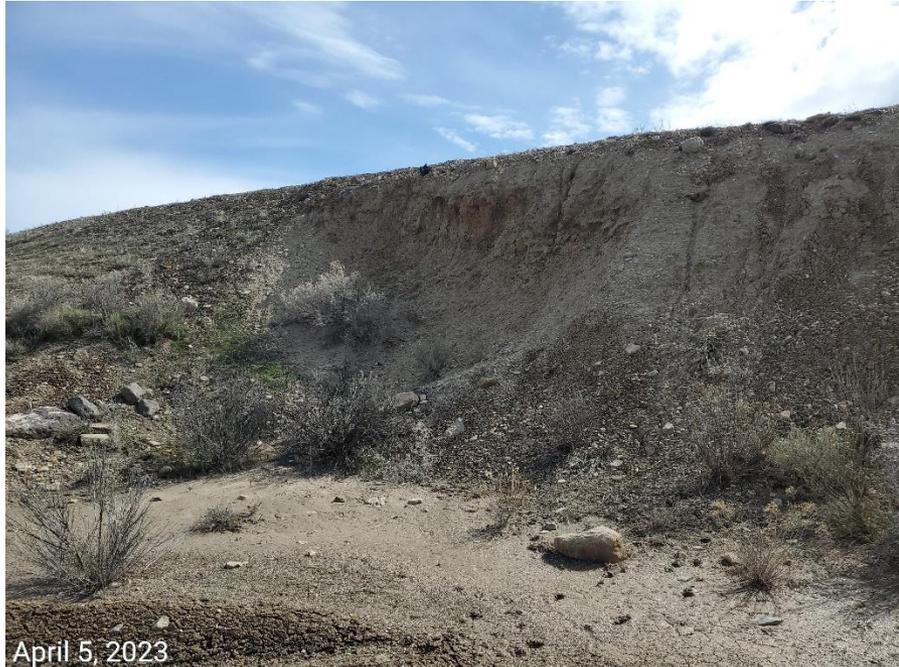
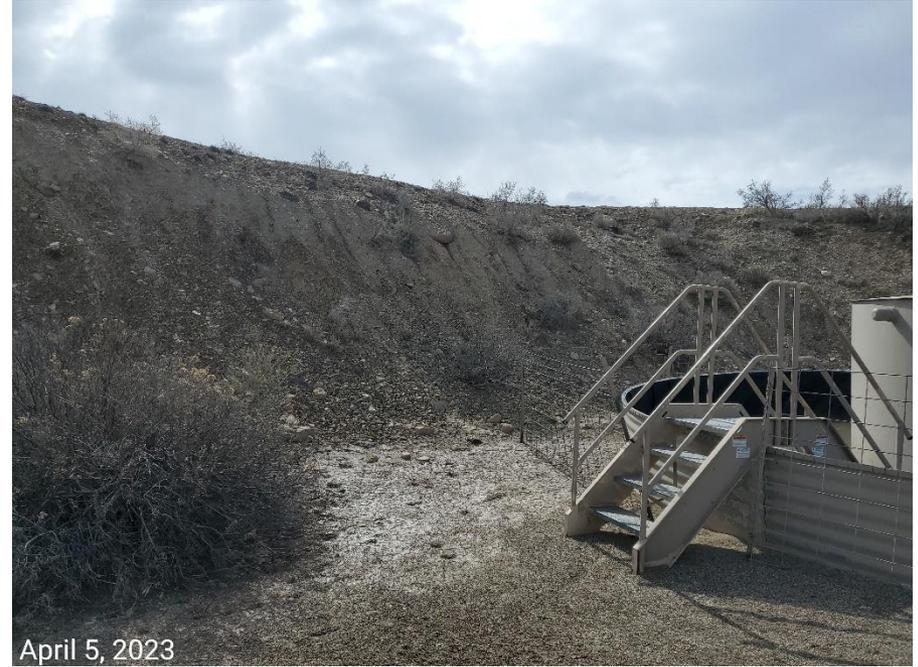
Photo 3: See comments under photo 3-5 taken from the cut slopes on the east end of the Location. Photos show BMPs to minimize erosion and degradation at the slopes remain missing or insufficient. Slopes lack stabilization.

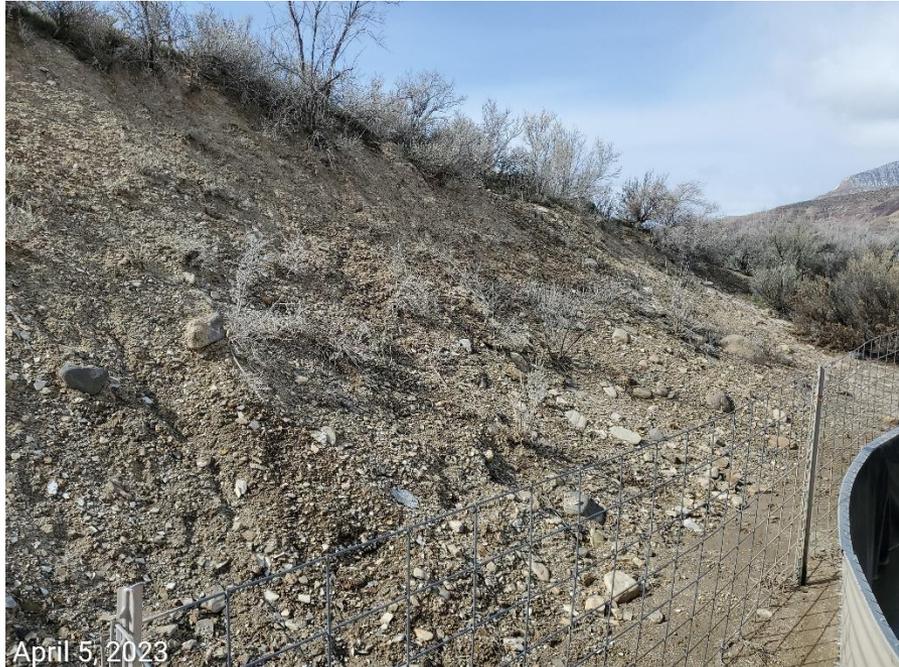
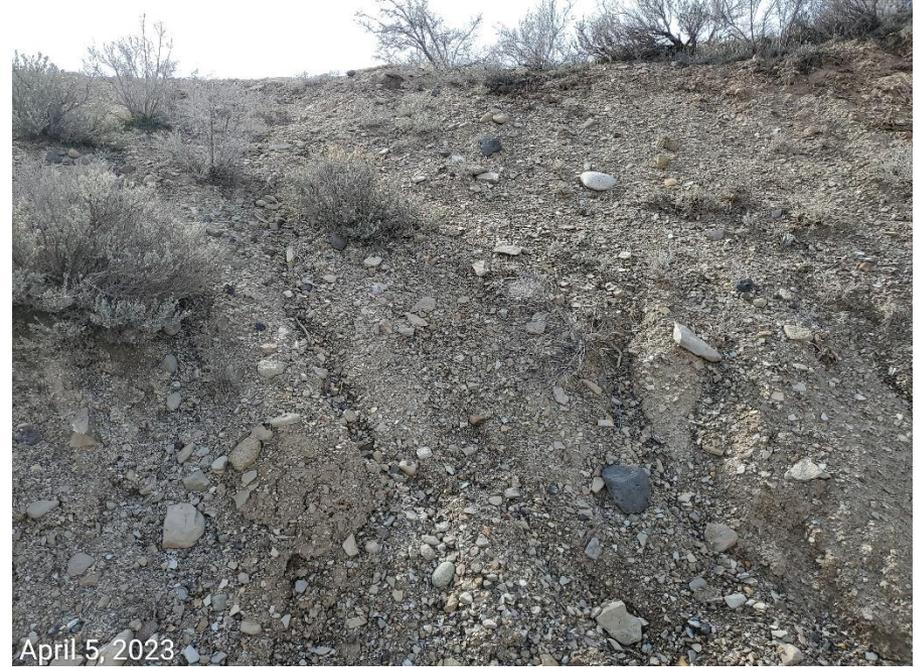
Photo 4: See comments under photo 3.

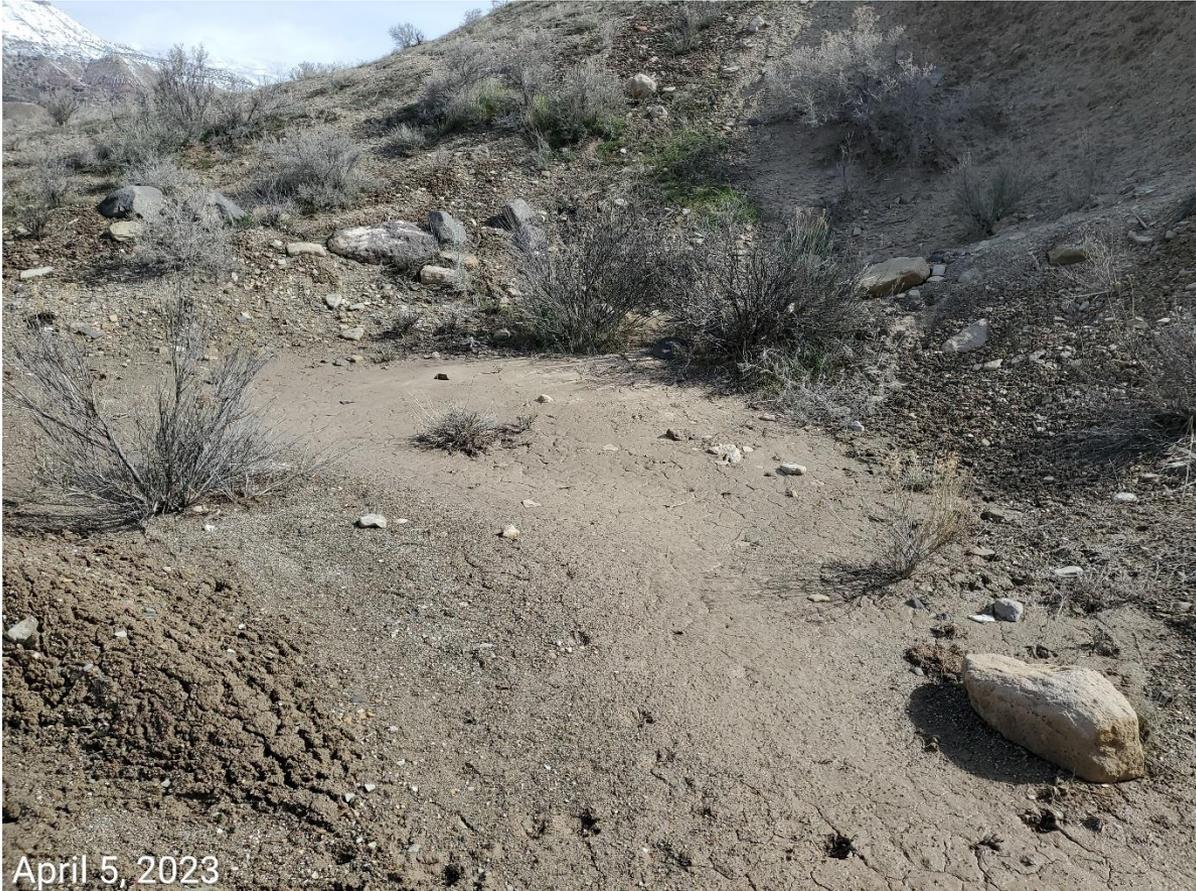
Photo 5: See comments under photo 3. Photo shows sediment deposition due to lack of stabilization at the slopes of the Location.

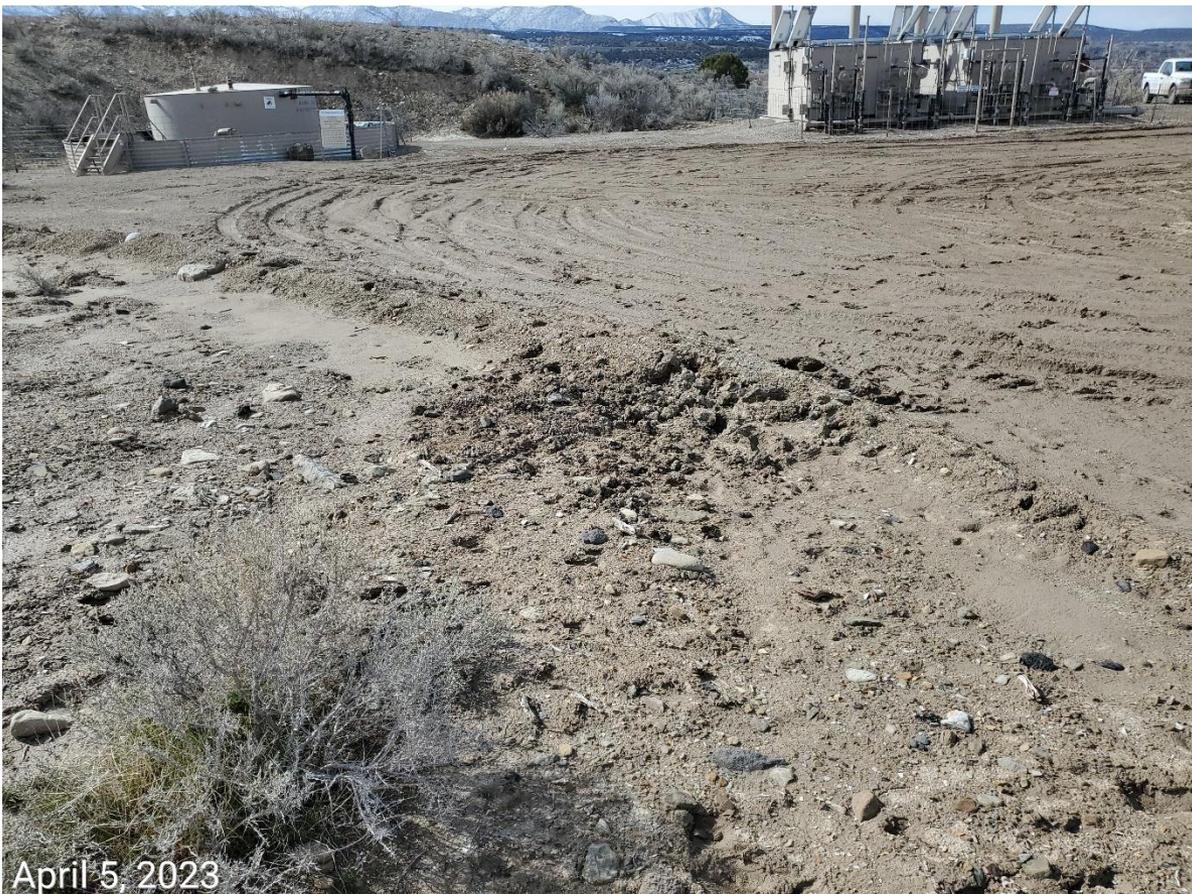
Photo 6: Anchor appears to have been removed.

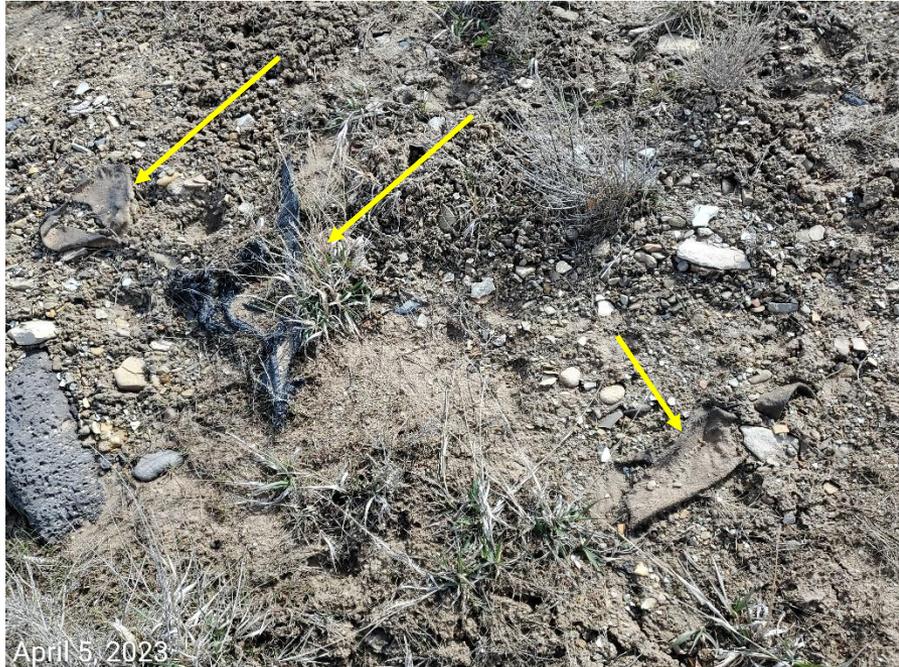
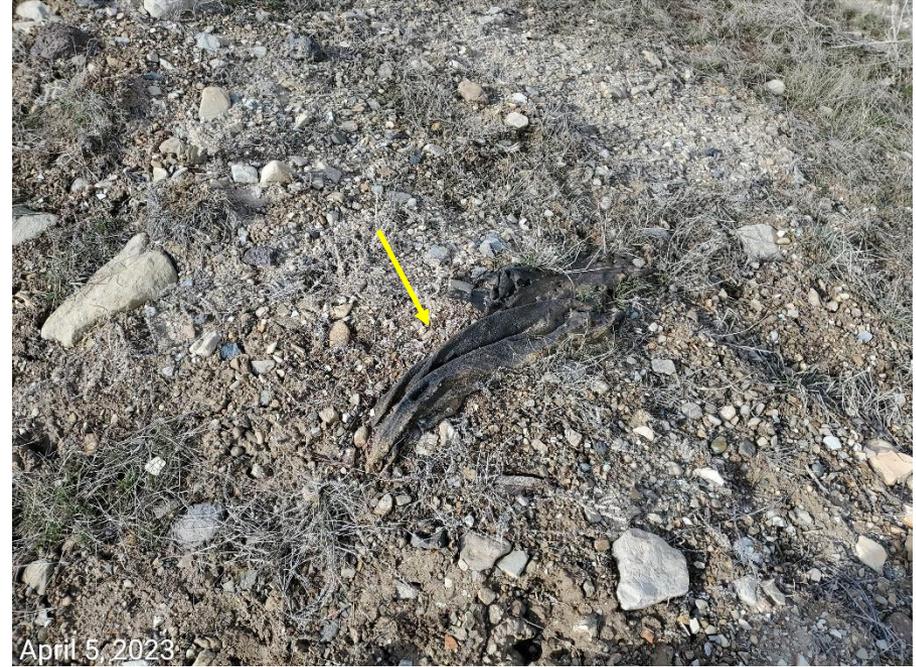
Photo 7: Photos 7-8 examples showing various trash debris (liner material, rags, etc...) observed throughout the entire interim areas on the east end of the Location. .

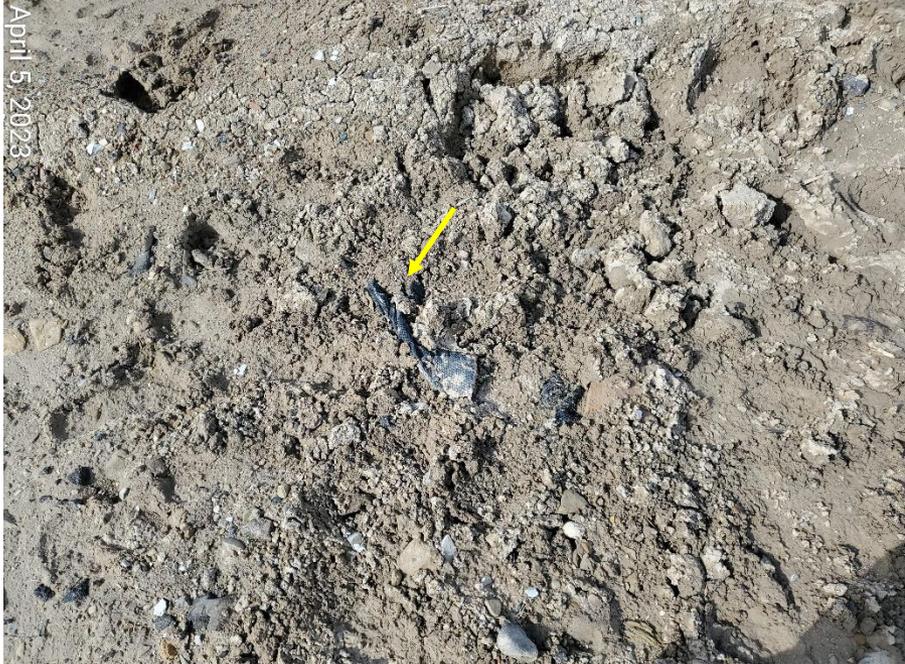
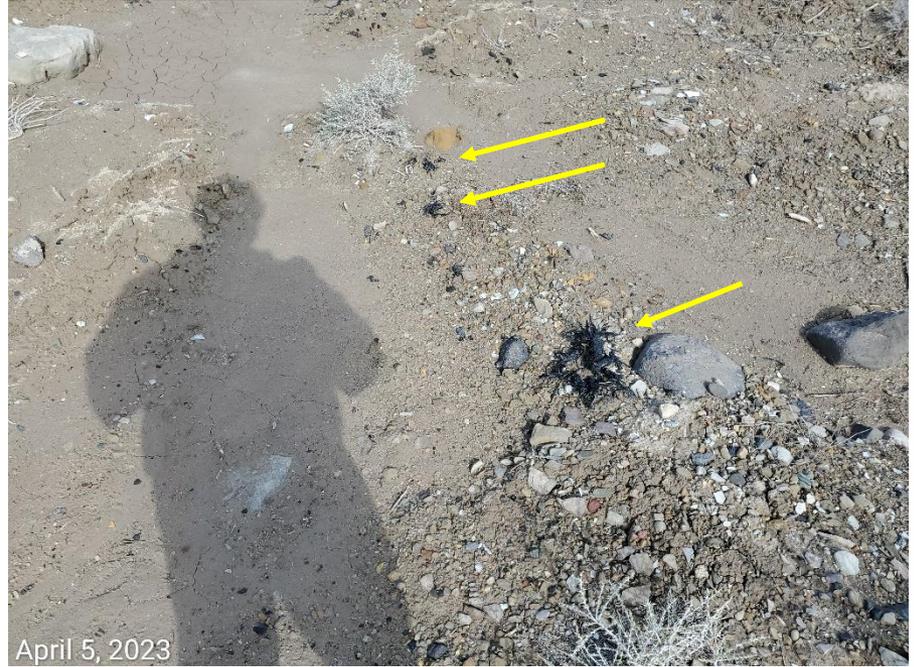
Photo 8: See comments under photo 1.

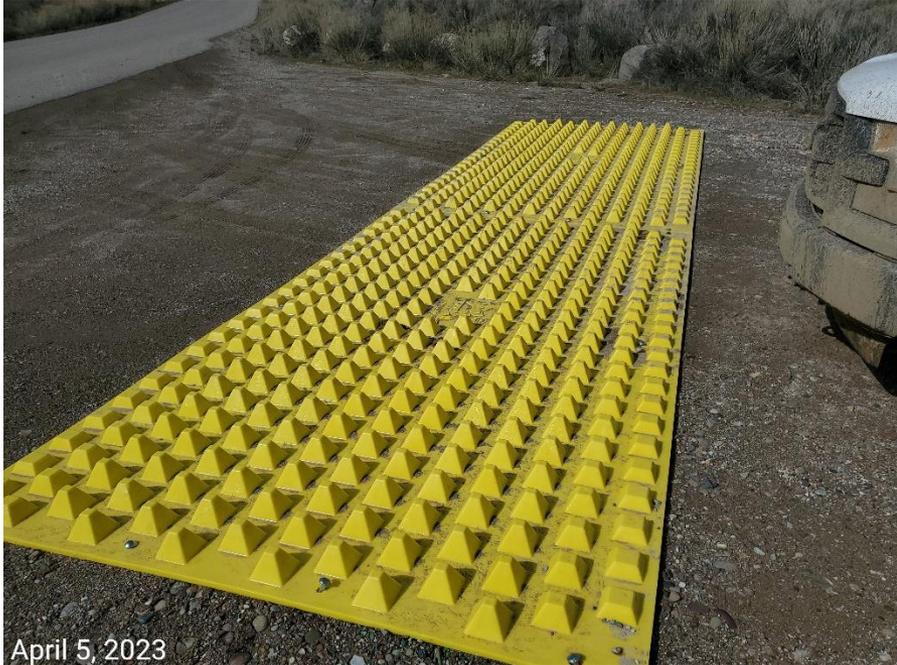
Photo 9: Photo taken from the access road entrance ~1/2 south of the Location. Photo shows Operator has implemented a single row of “reusable trackout control mats”. BMP is not per good engineering practices, and is inadequate in length to allow for at least an entire tire rotation for most off-highway, or industrial vehicle tires used in O&G.
