Inspection Photos

April 5, 2023

Location Name: Williams/RWF 342-33

Inspection Document #: 702801421

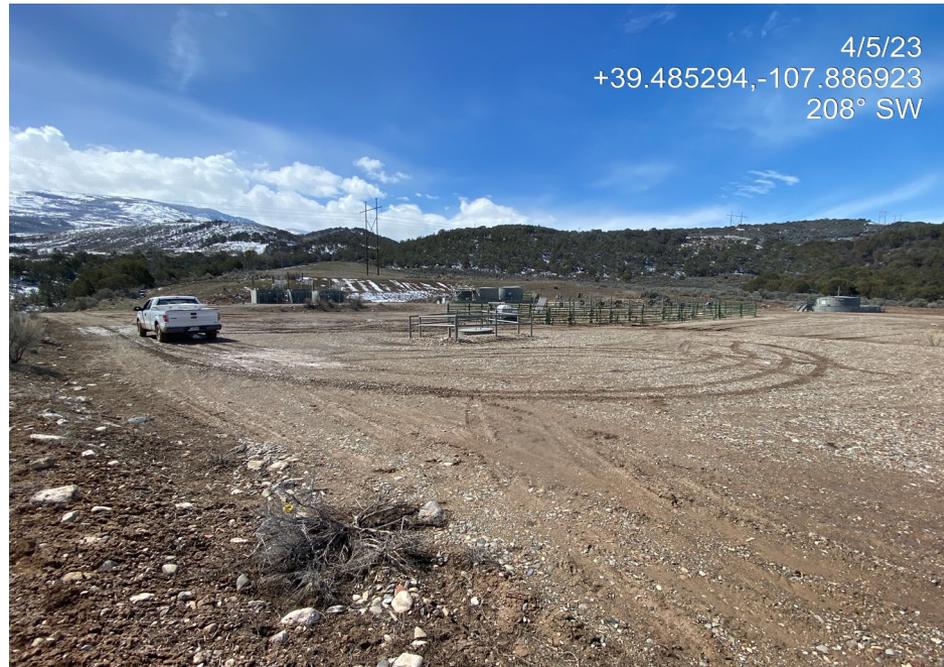
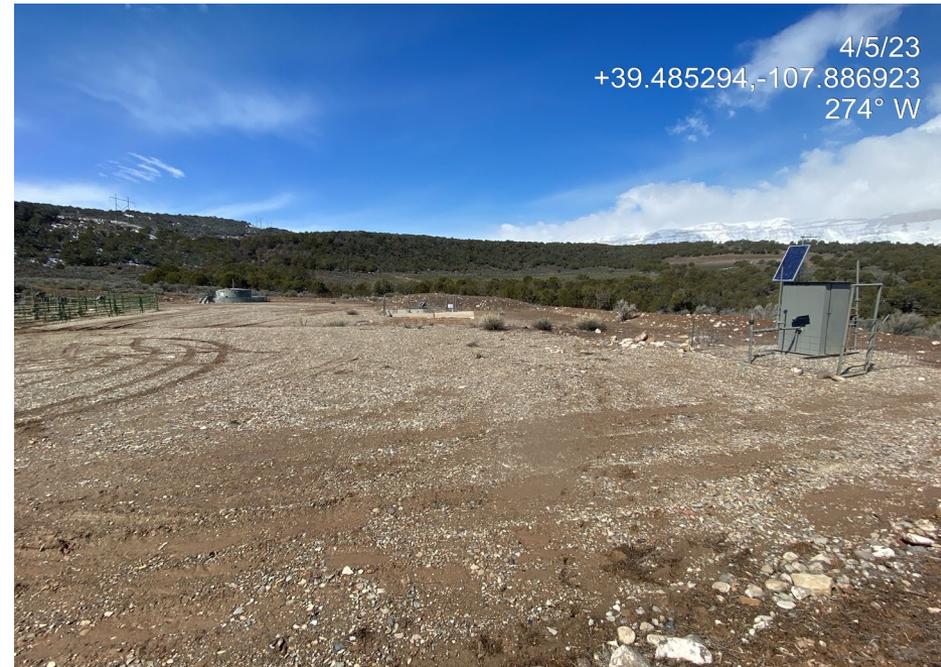
Photo 1. Photos taken from the northeast show an overview of the location to the south (left) and north (right).

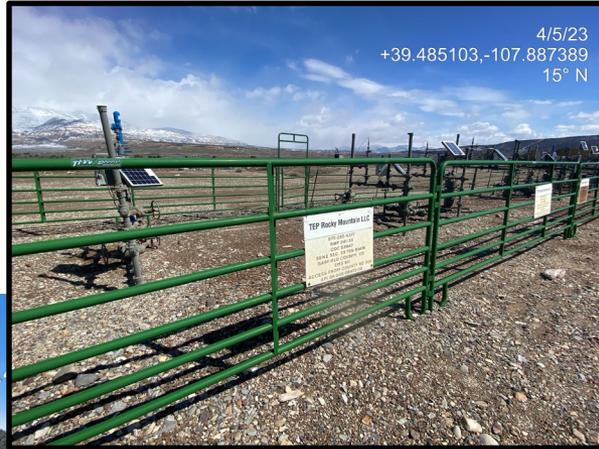
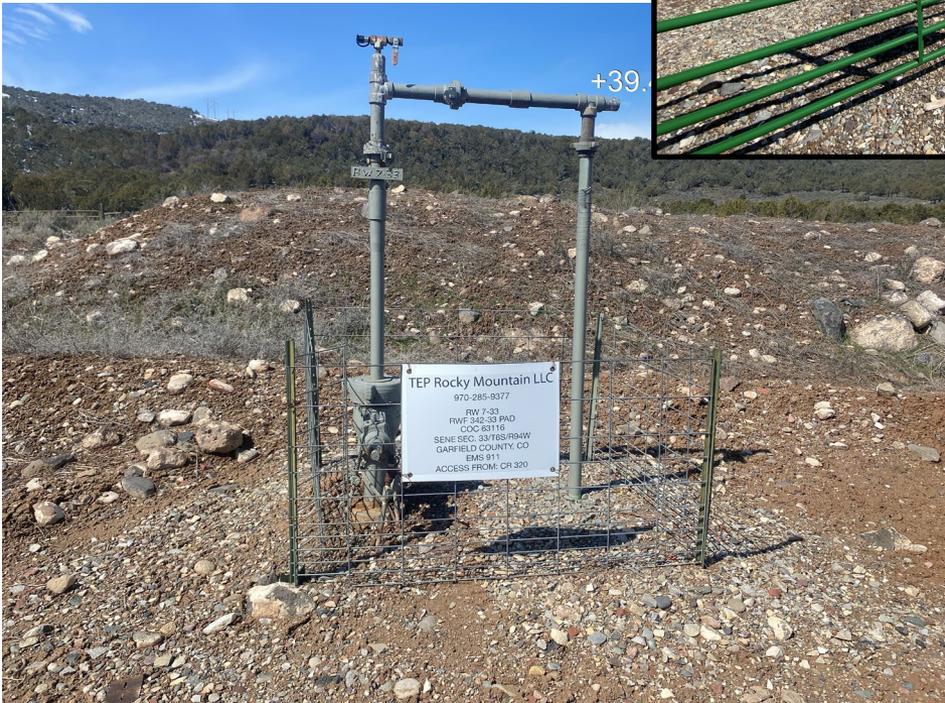
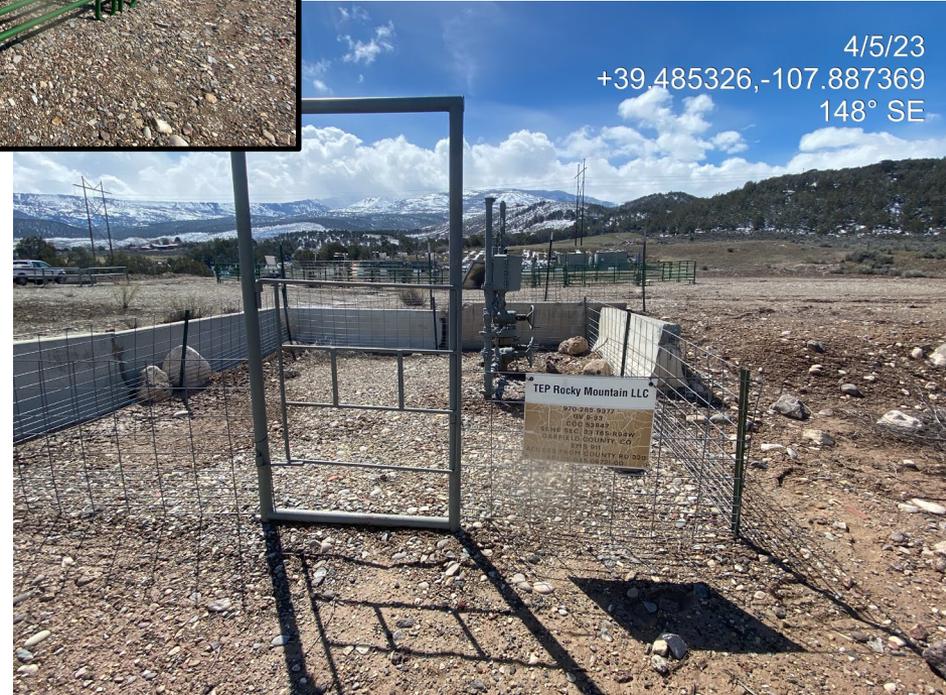
Photo 2. Photos show production areas.

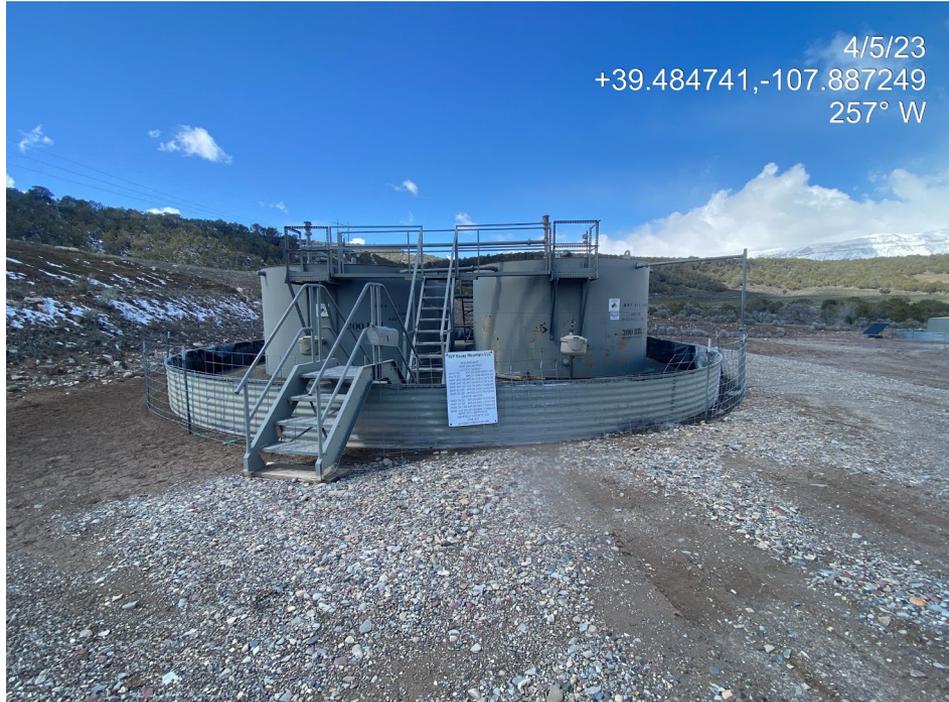
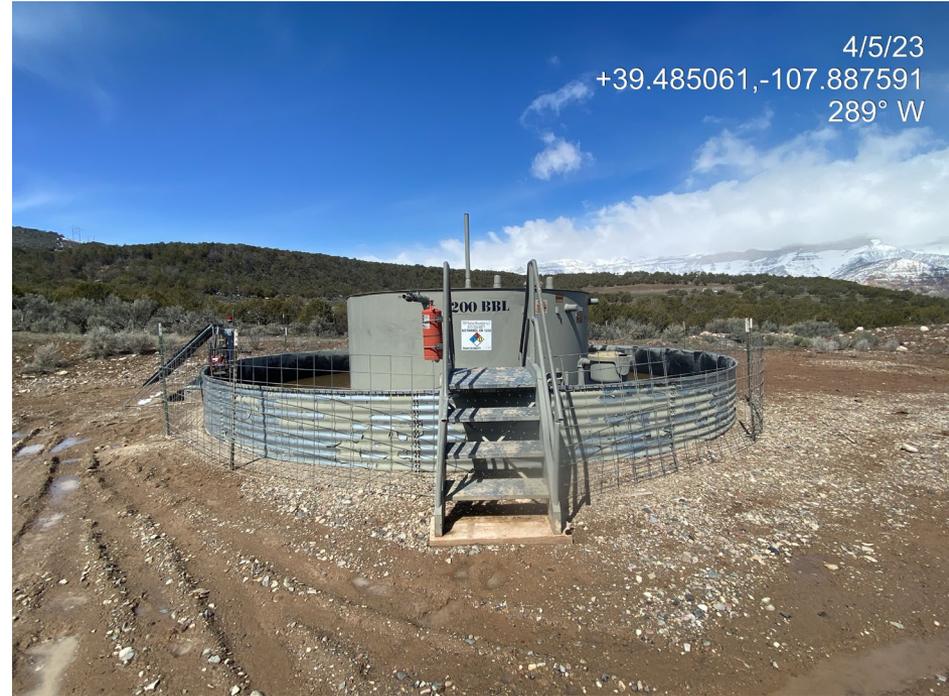
Photo 3. Photos show production areas.

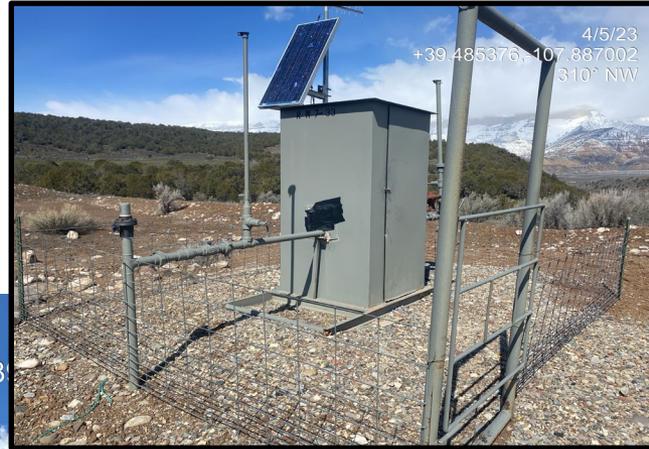
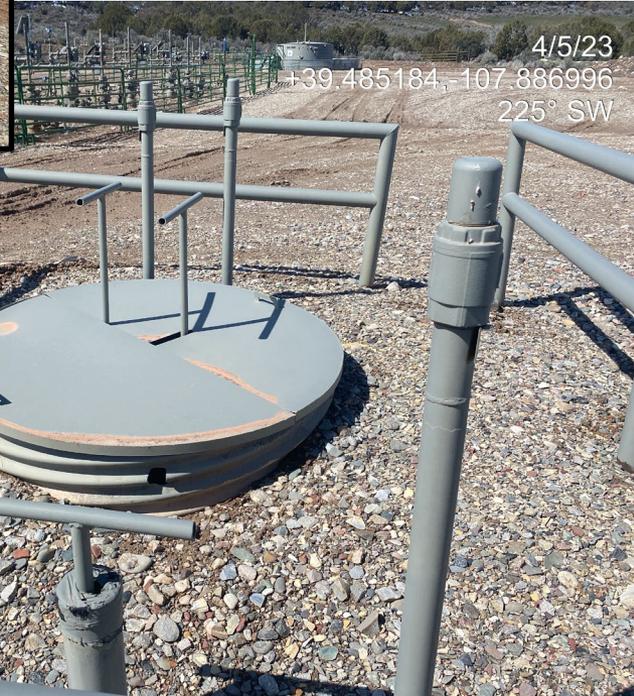
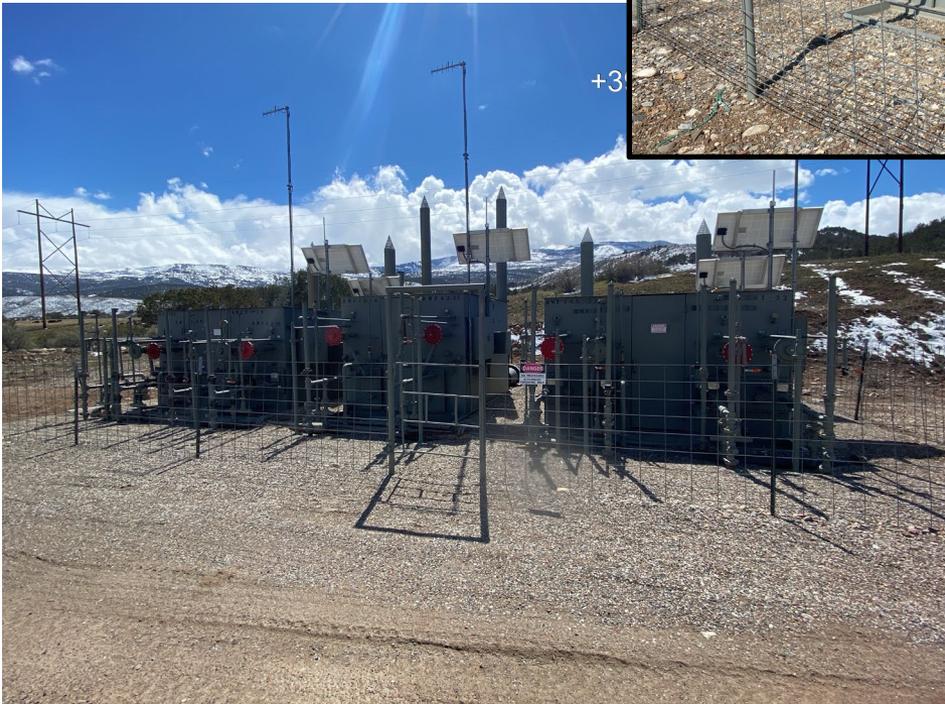
Photo 4. Photos show production areas.

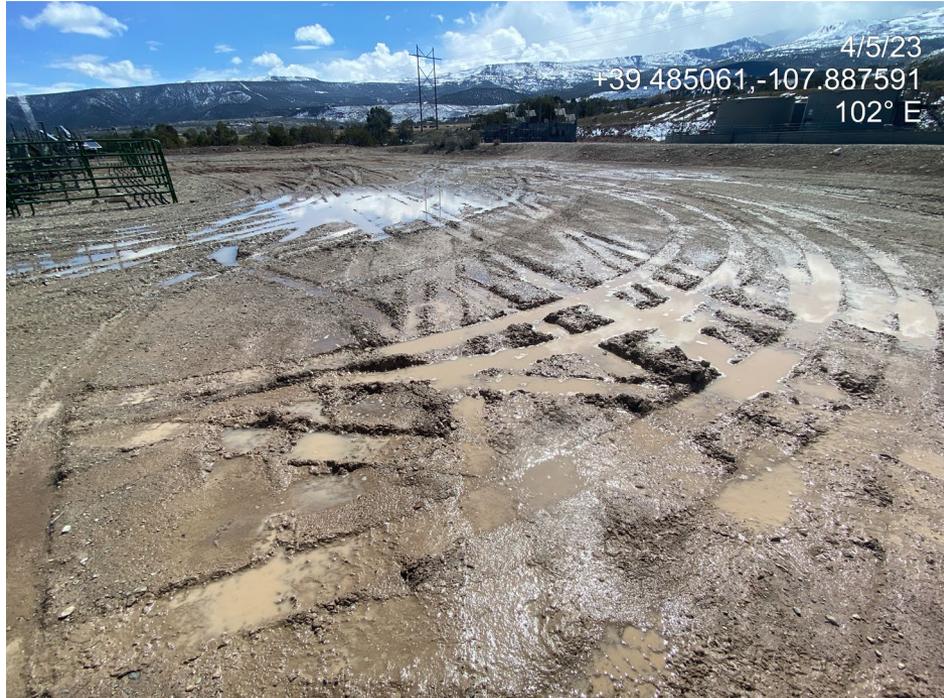
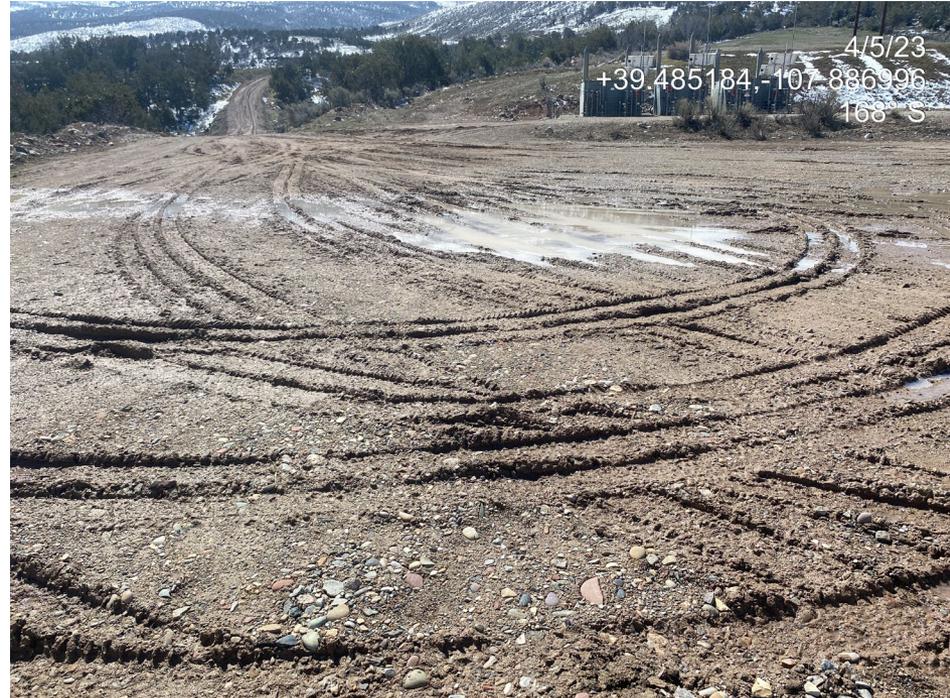
Photo 5. Photos show lack of stabilization of the working pad surface (ruts).

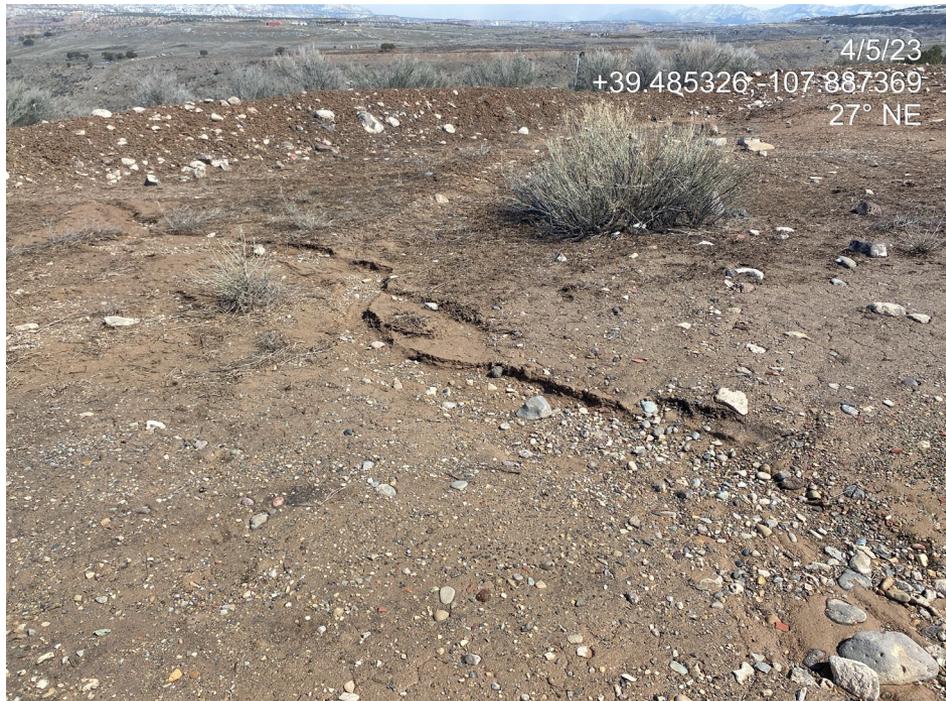
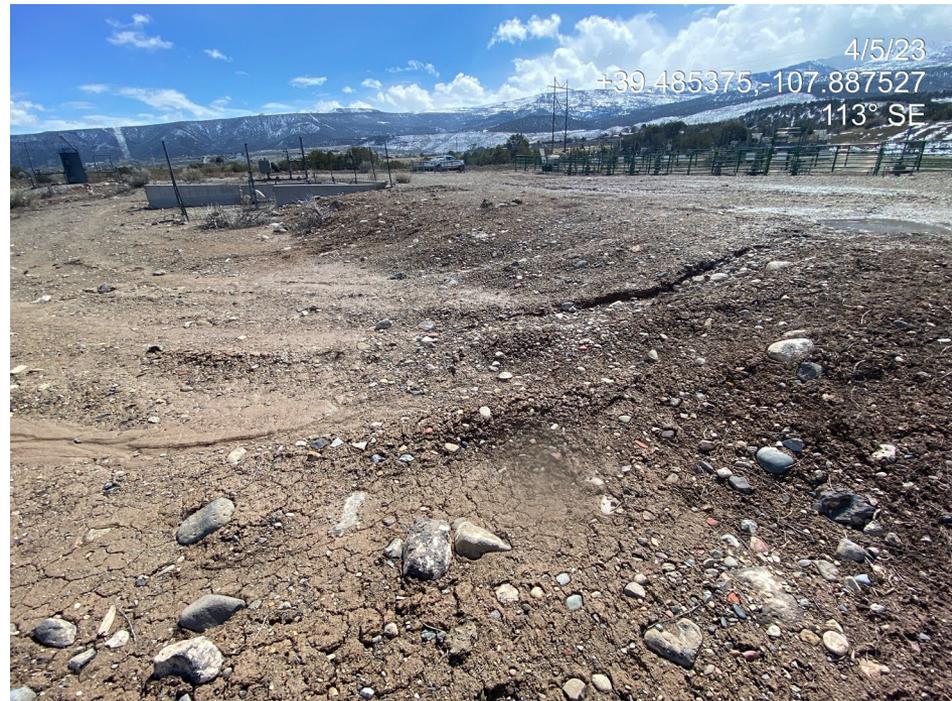
Photo 6. Photos taken from the north show lack of stabilization of the working pad surface (rill erosion).

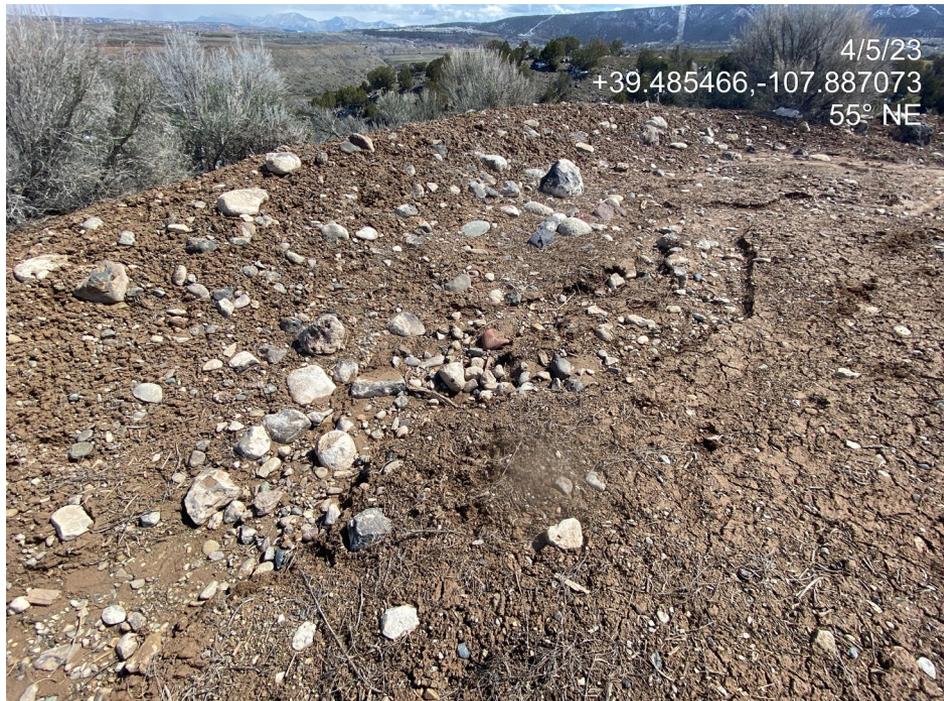
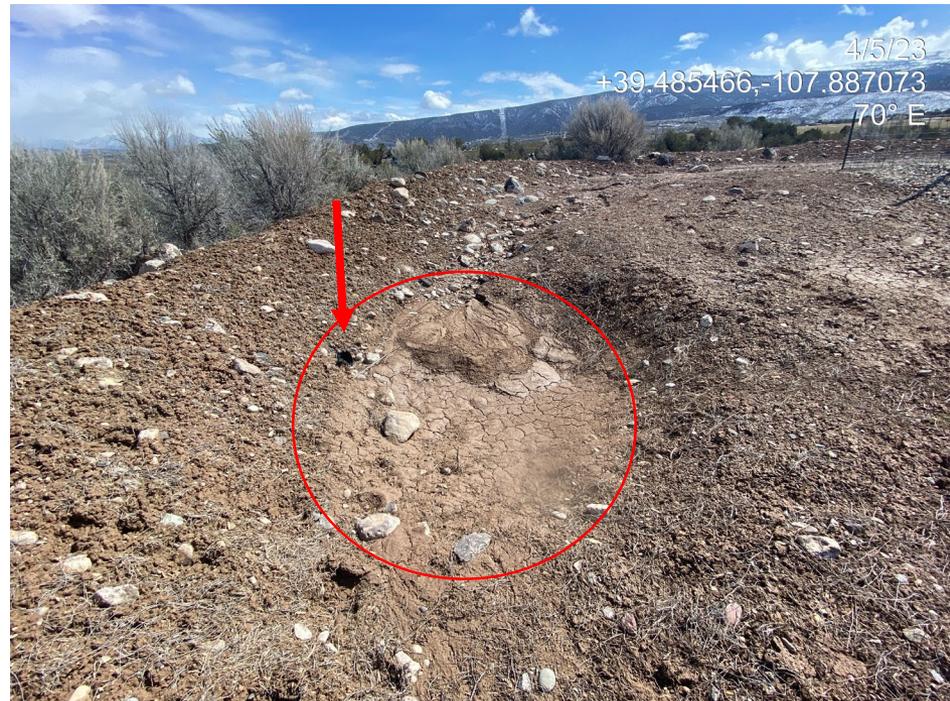
Photo 7. Photos taken from the north show lack of stabilization of the working pad surface (rill erosion). Photos show where stormwater flows into a plastic drain pipe (arrow) and what appears to be a small sediment trap (circled).

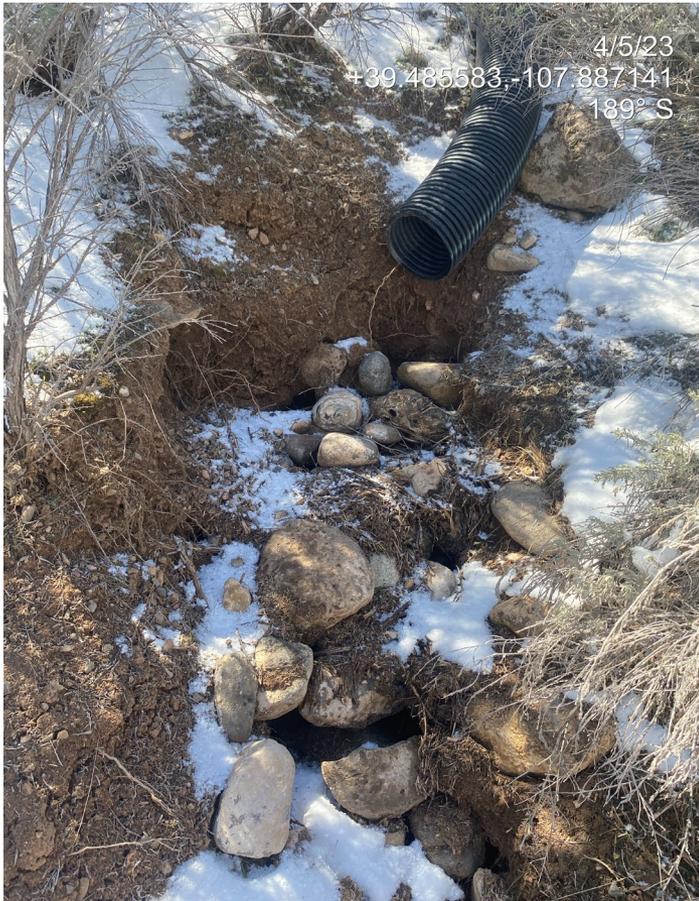
Photo 8. Photo shows the outlet for the drain pipe shown in the previous slide (left). Outlet protections are degraded, insufficient and resulting in degradation.

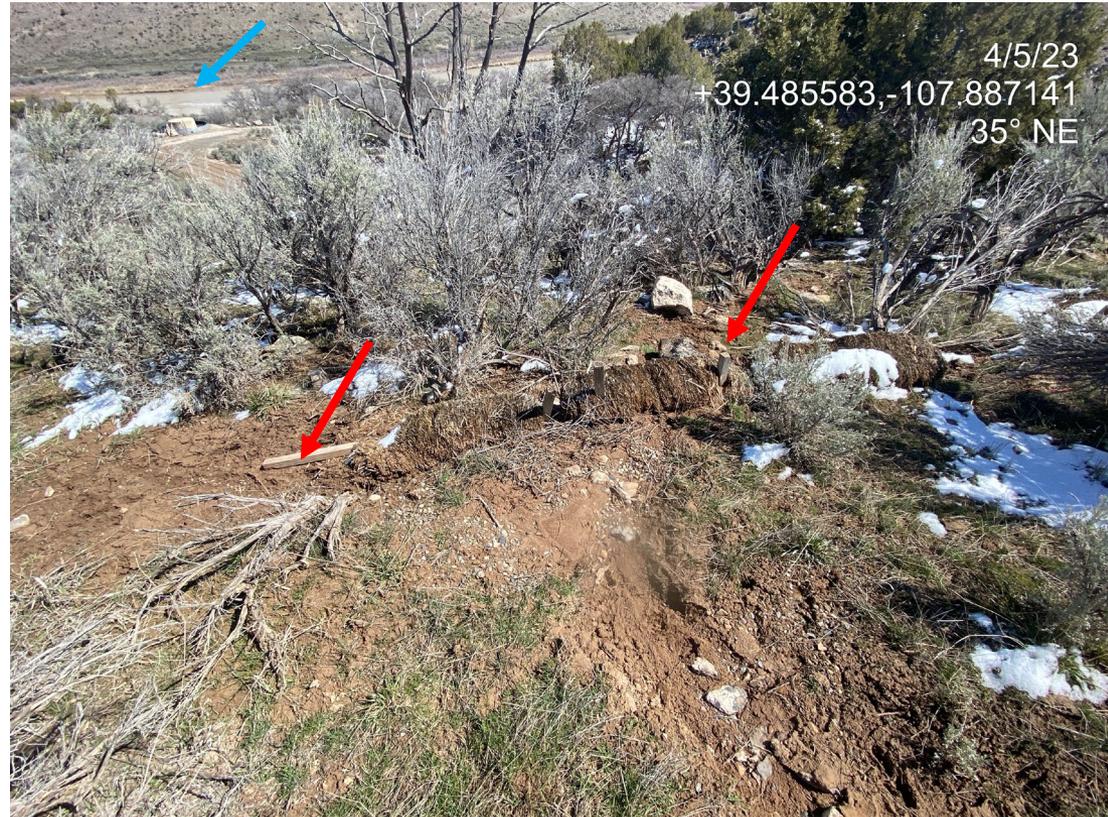
Photo 9. Photo taken just downslope of Photo 8 shows concentrated flows from the drain pipe resulting in rill erosion, sediment transport and offsite degradation. Sediment laden stormwater is bypassing straw bale BMPs (arrows). Note proximity to river (blue arrow).

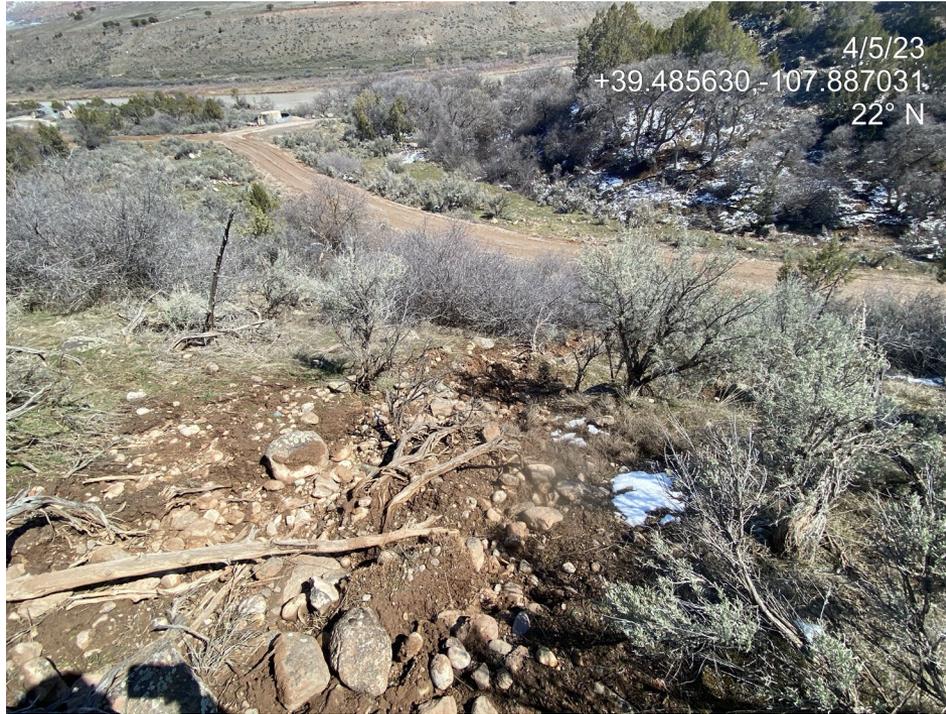
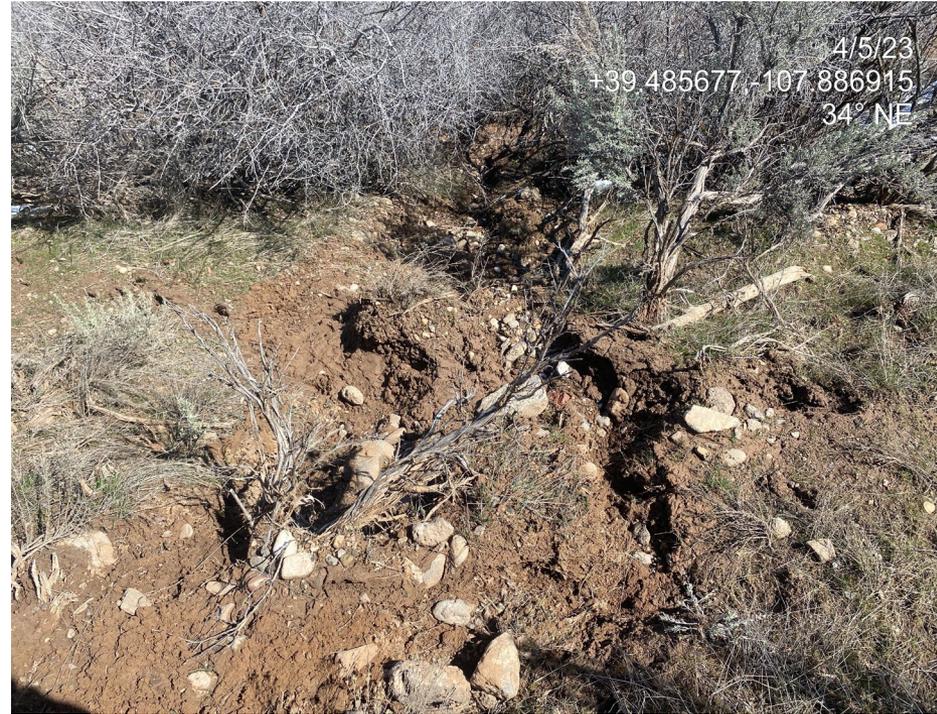
Photo 10. Photos taken just downslope of Photo 9 shows concentrated flows from the drain pipe resulting in rill erosion, sediment transport and offsite degradation.

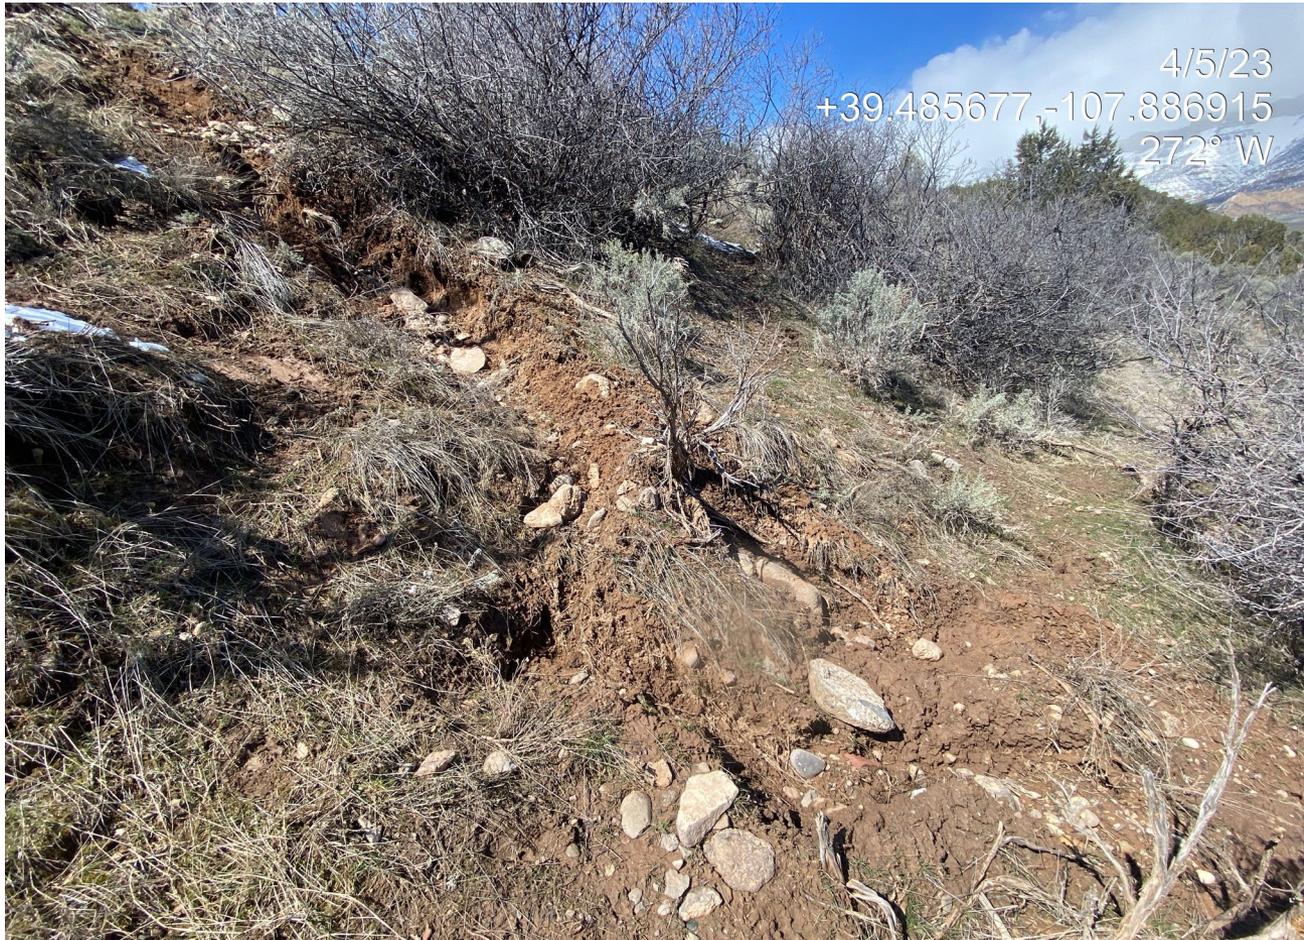
Photo 11. Photo taken just downslope of Photos 9 and 10 shows concentrated flows from the drain pipe resulting in rill erosion, sediment transport and offsite degradation.

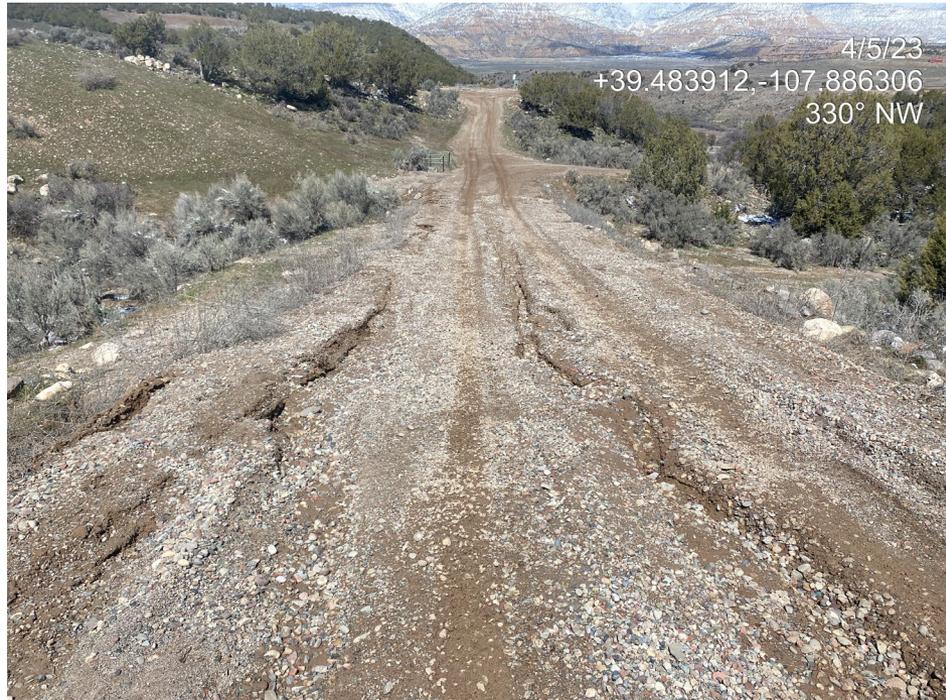
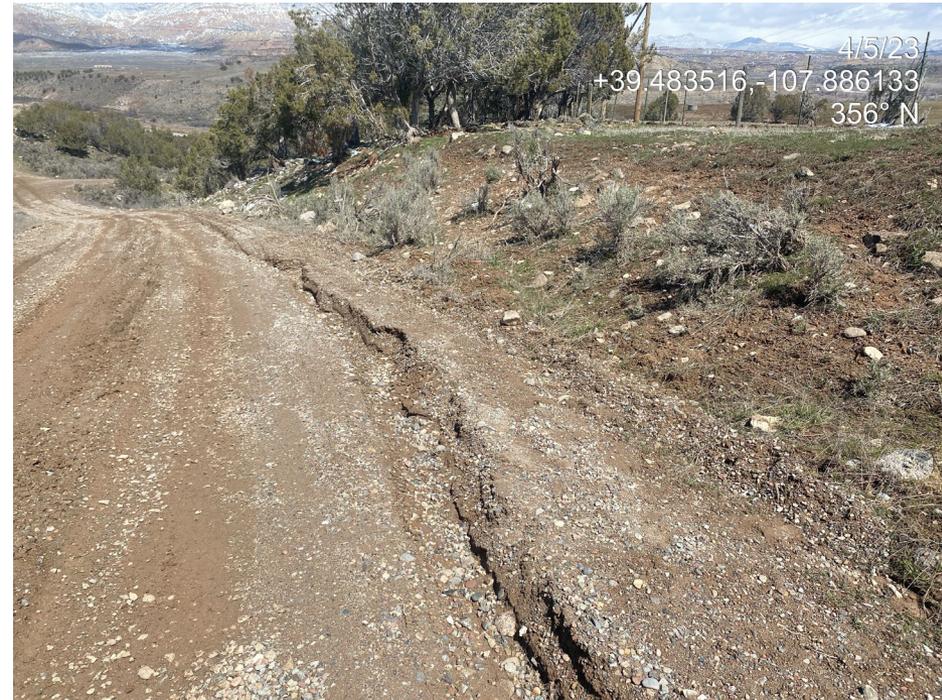
Photo 12. Photos show lack of stabilization of the access road (rills).

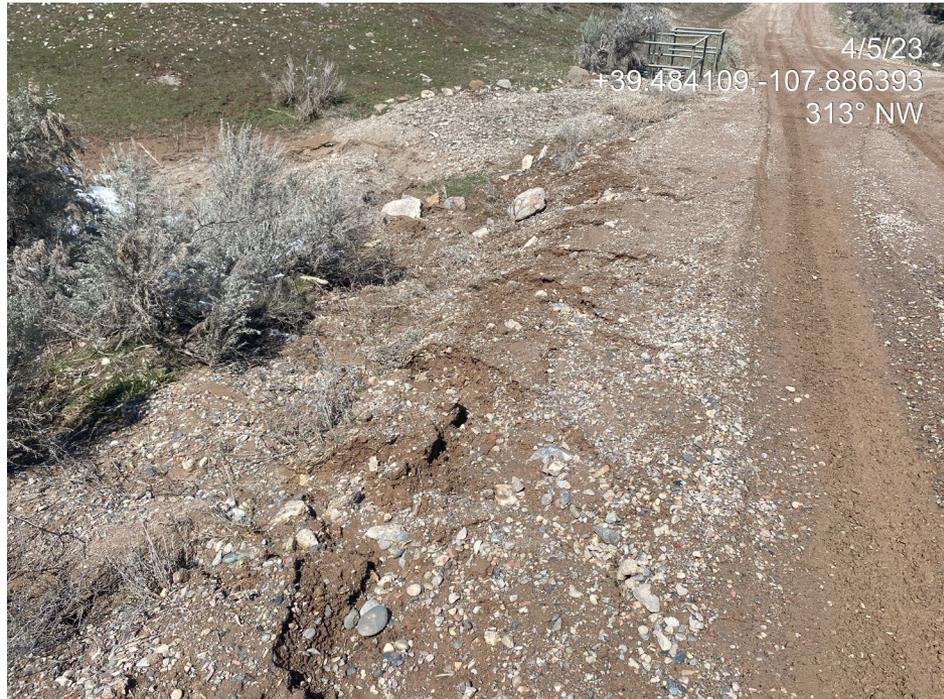
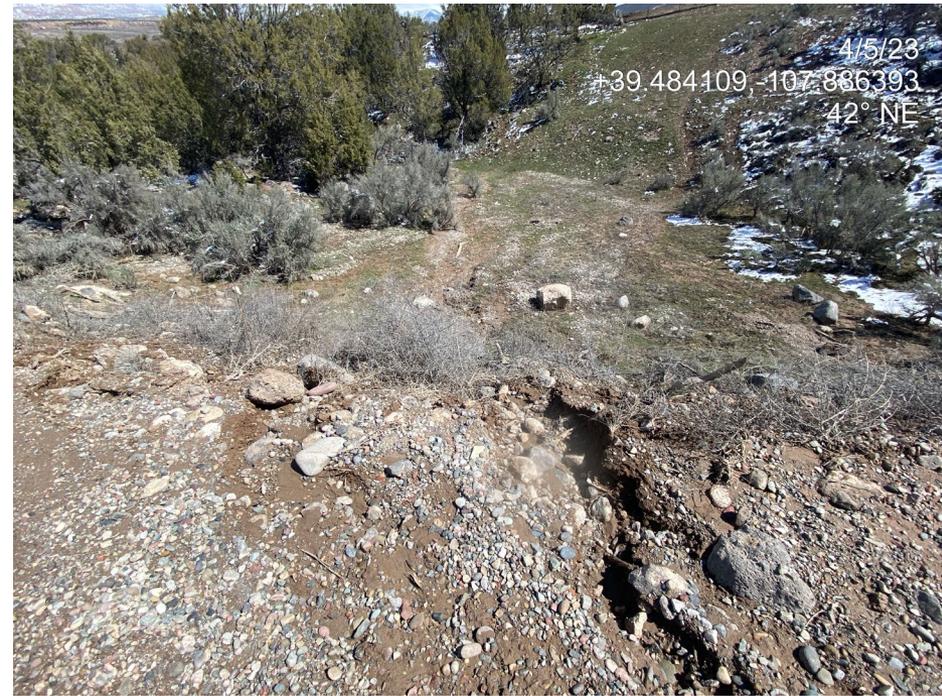
Photo 13. Photos show lack of stabilization of the access road (rills). Note the amount of road material (fine sediment and gravel) entering into the drainage.

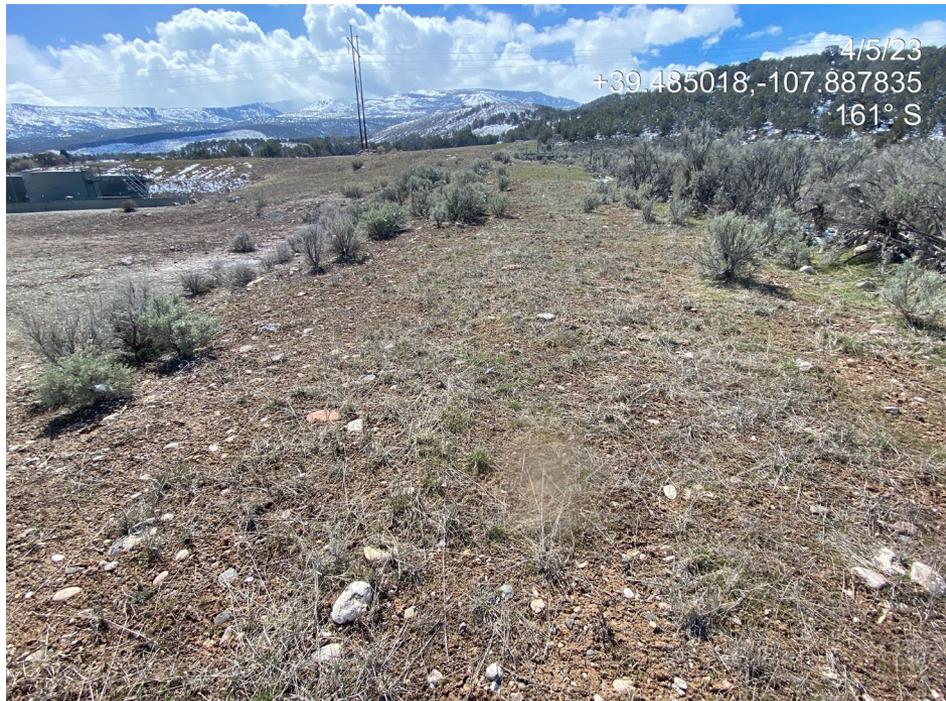
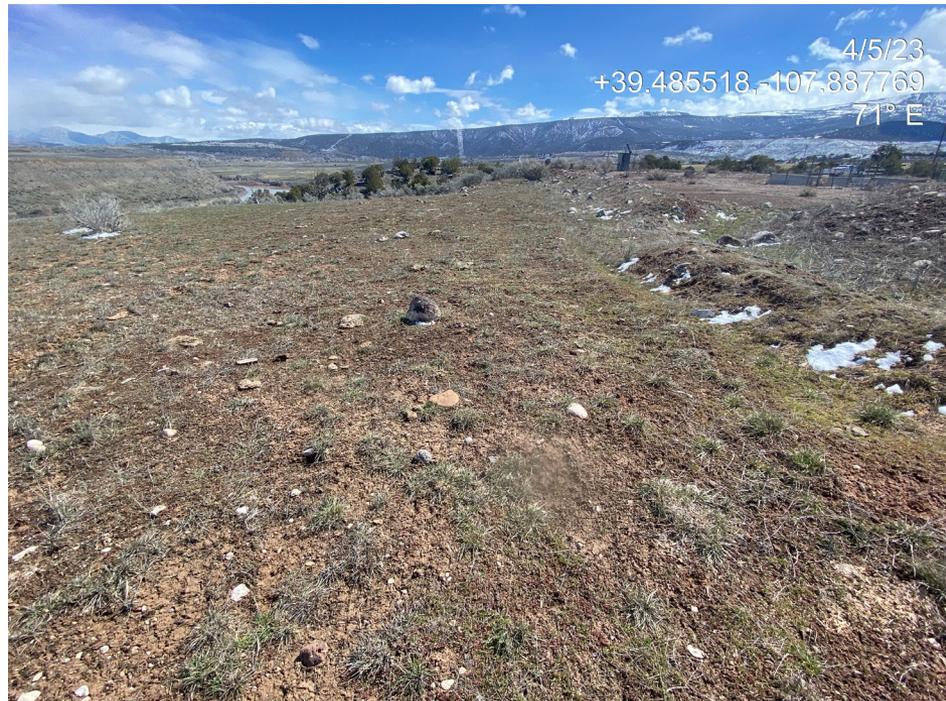
Photo 14. Photos show western (left) and northern (right) interim areas.
