# Interim Reclamation and Stormwater Inspection

Date: 03/31/2023

Operator: SUMMIT OIL & GAS LLC - 10774

Inspection Photos  
Location Name: Castor 7-59 12  
Location ID: 465272

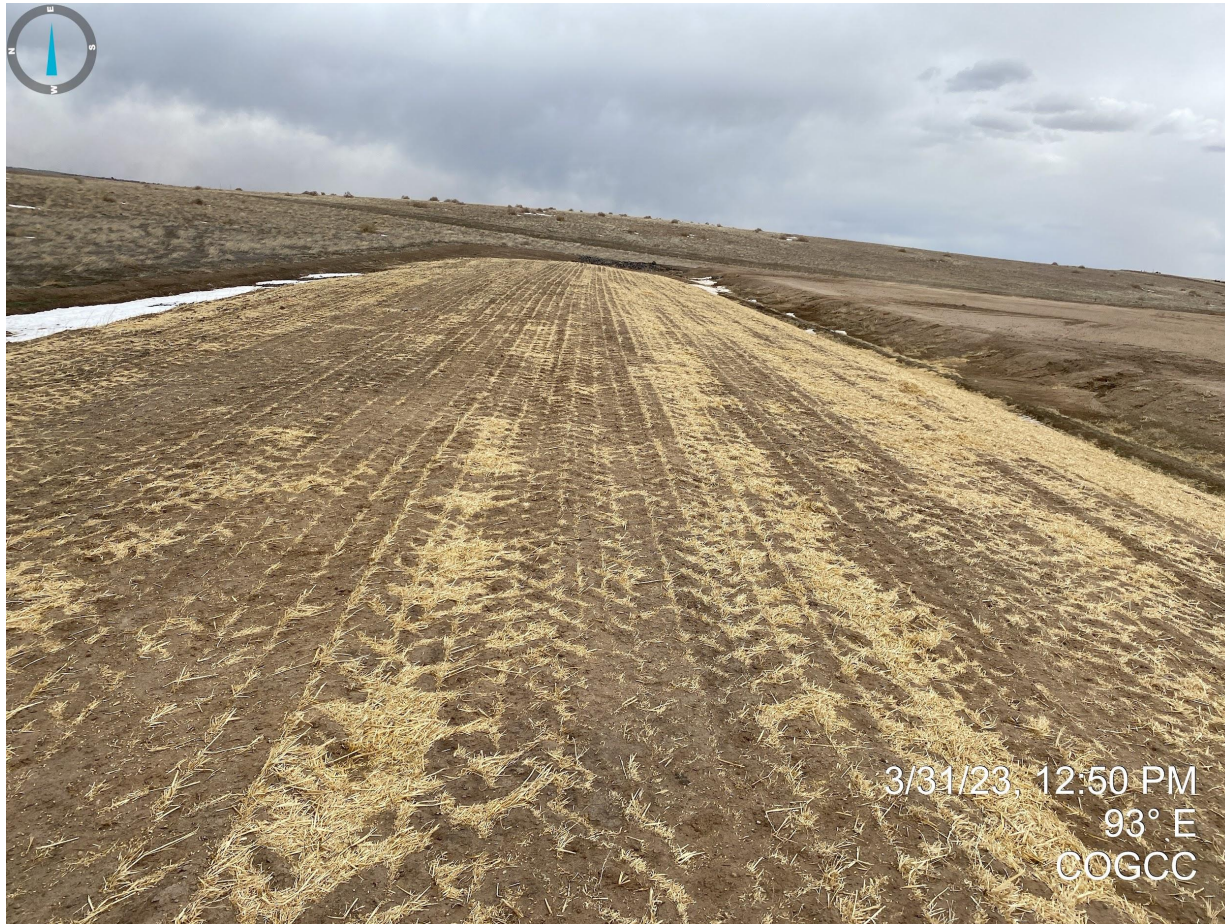
**Photo 1.** Facing east from the topsoil stockpile. It appears the Operator has performed work to stabilize the topsoil with evidence of drill rows and mulch.

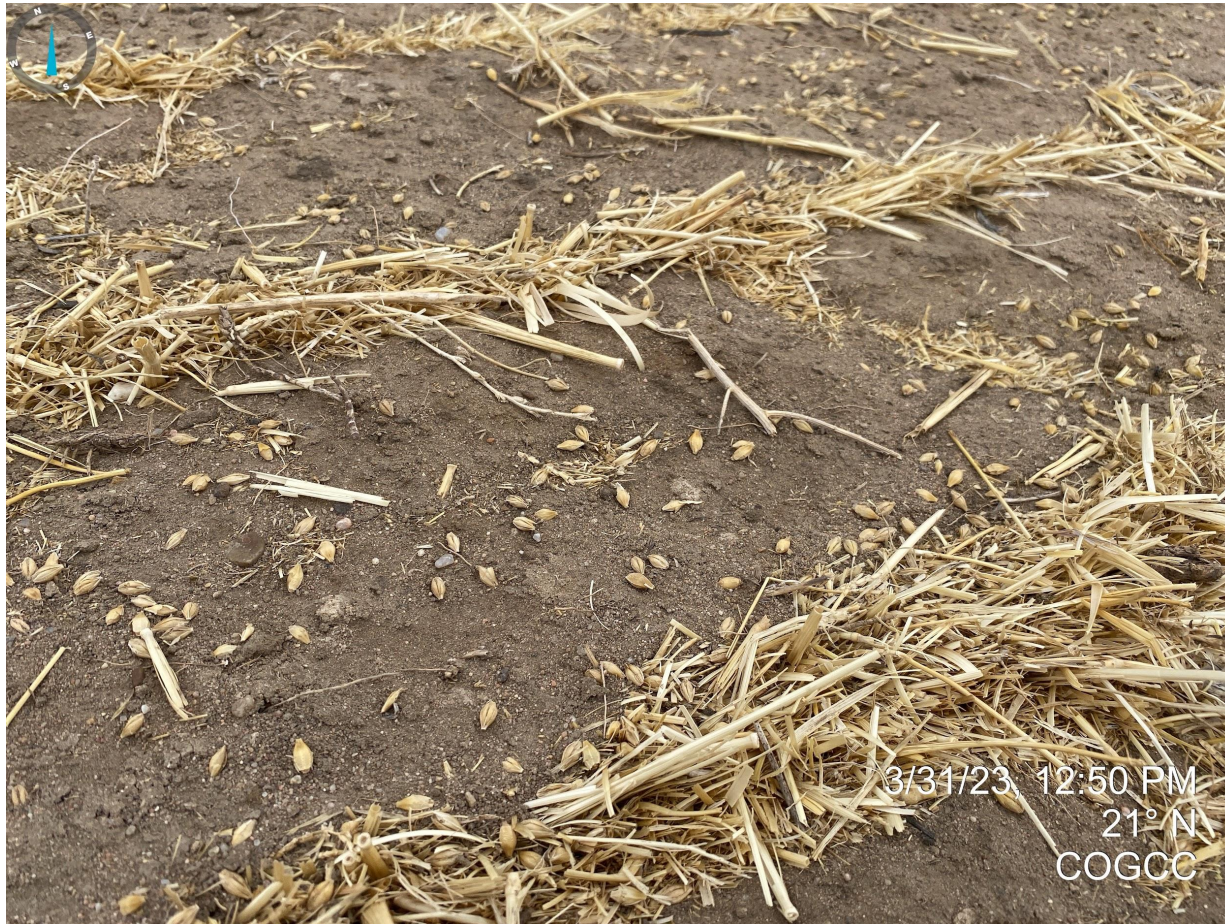
**Photo 2.** Close up photo of topsoil. It appears the Operator may have broadcasted the seed. A future inspection will be conducted to verify germination and establishment of vegetation.

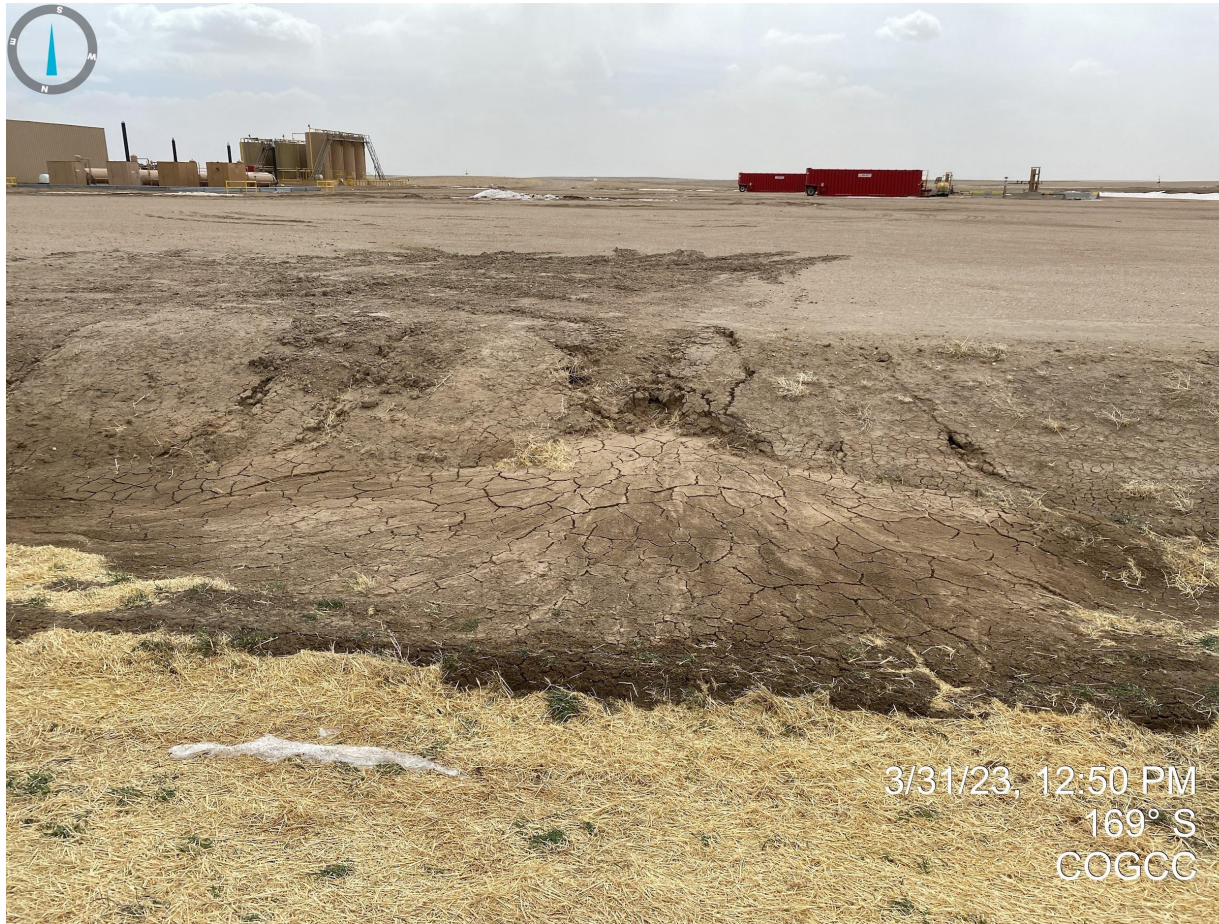
**Photo 3.** Facing south from the topsoil stockpile. Photo illustrates that the production areas don't appear to be stabilized as sediment has been deposited into the stormwater ditch. The BMP will need to be repaired and stabilized to prevent further erosion from occurring.

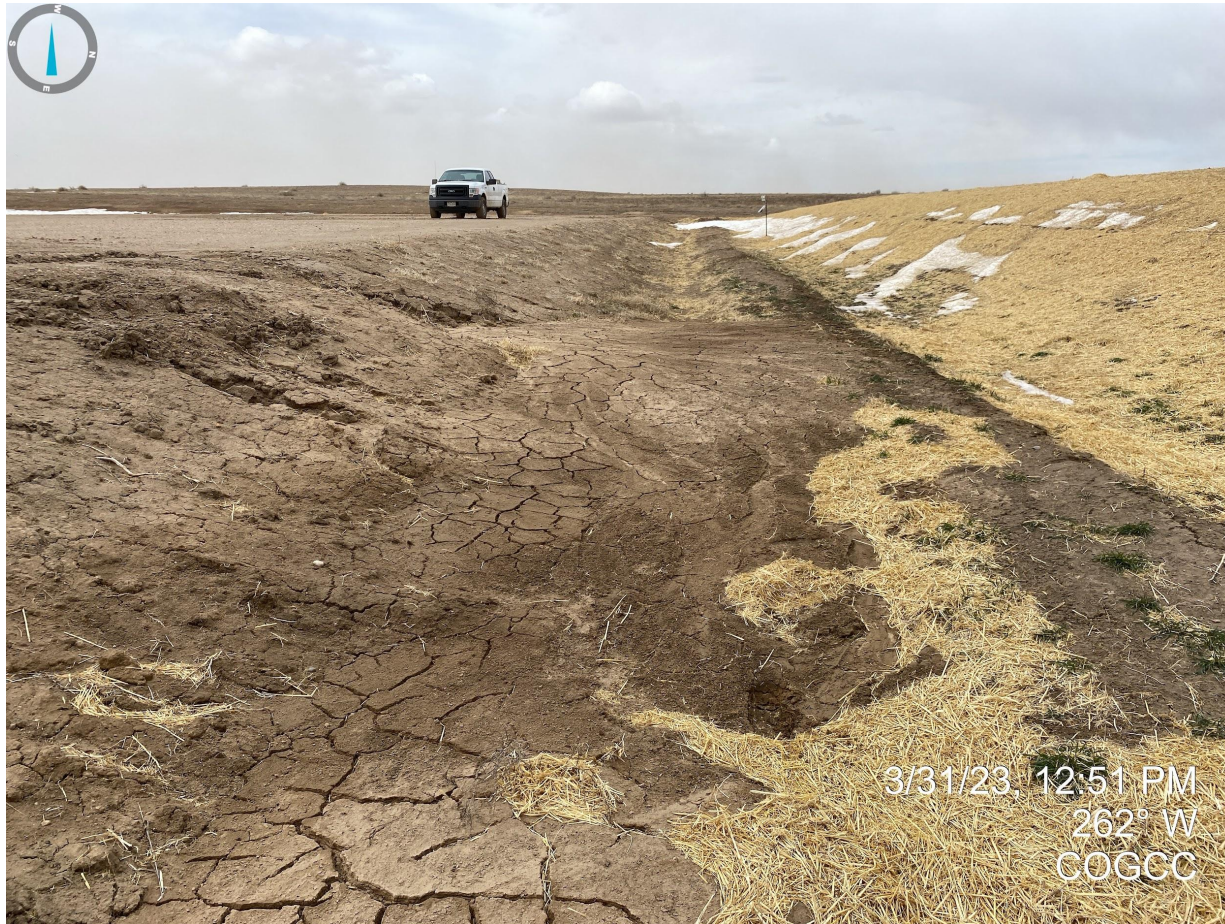
**Photo 4.** See comments in Photo 3.

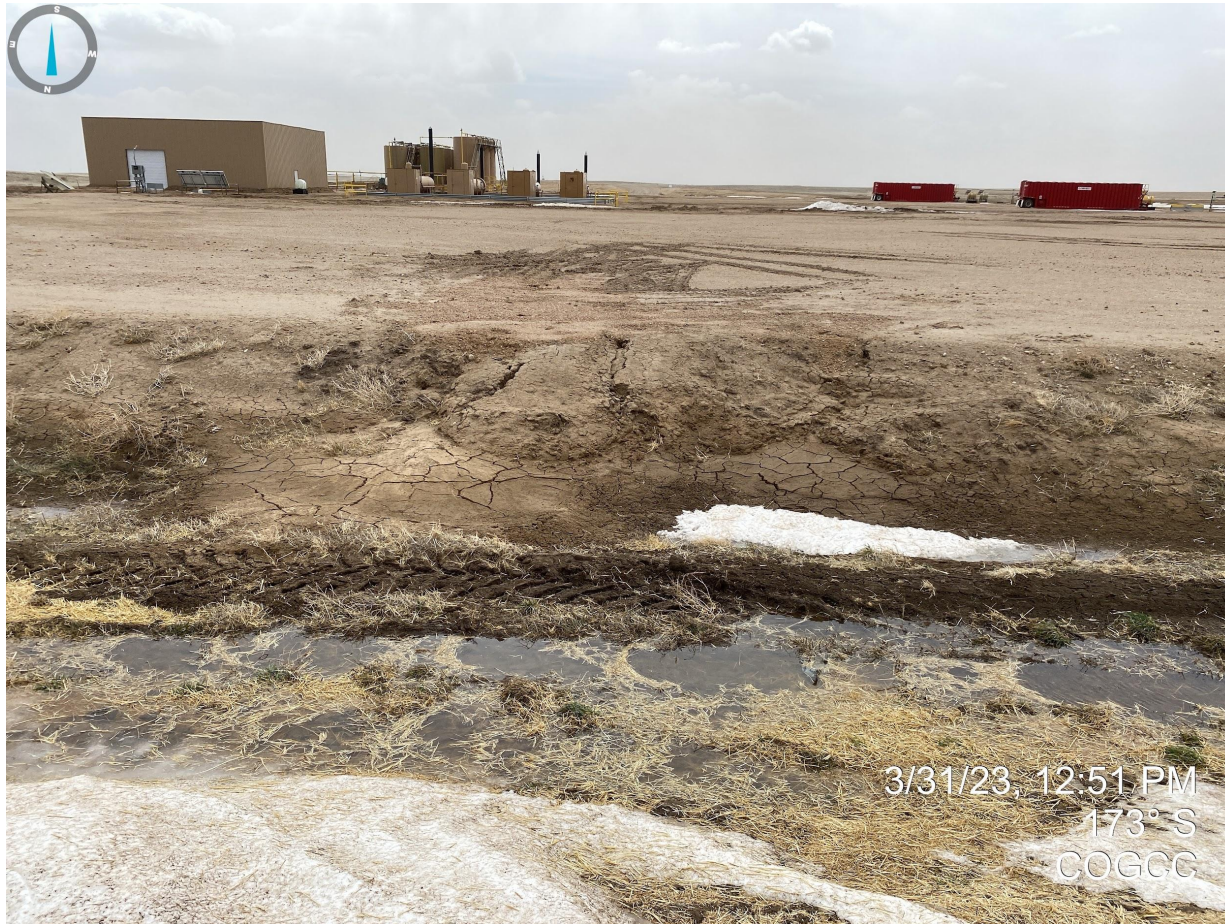
**Photo 5.** See comments in Photo 3.

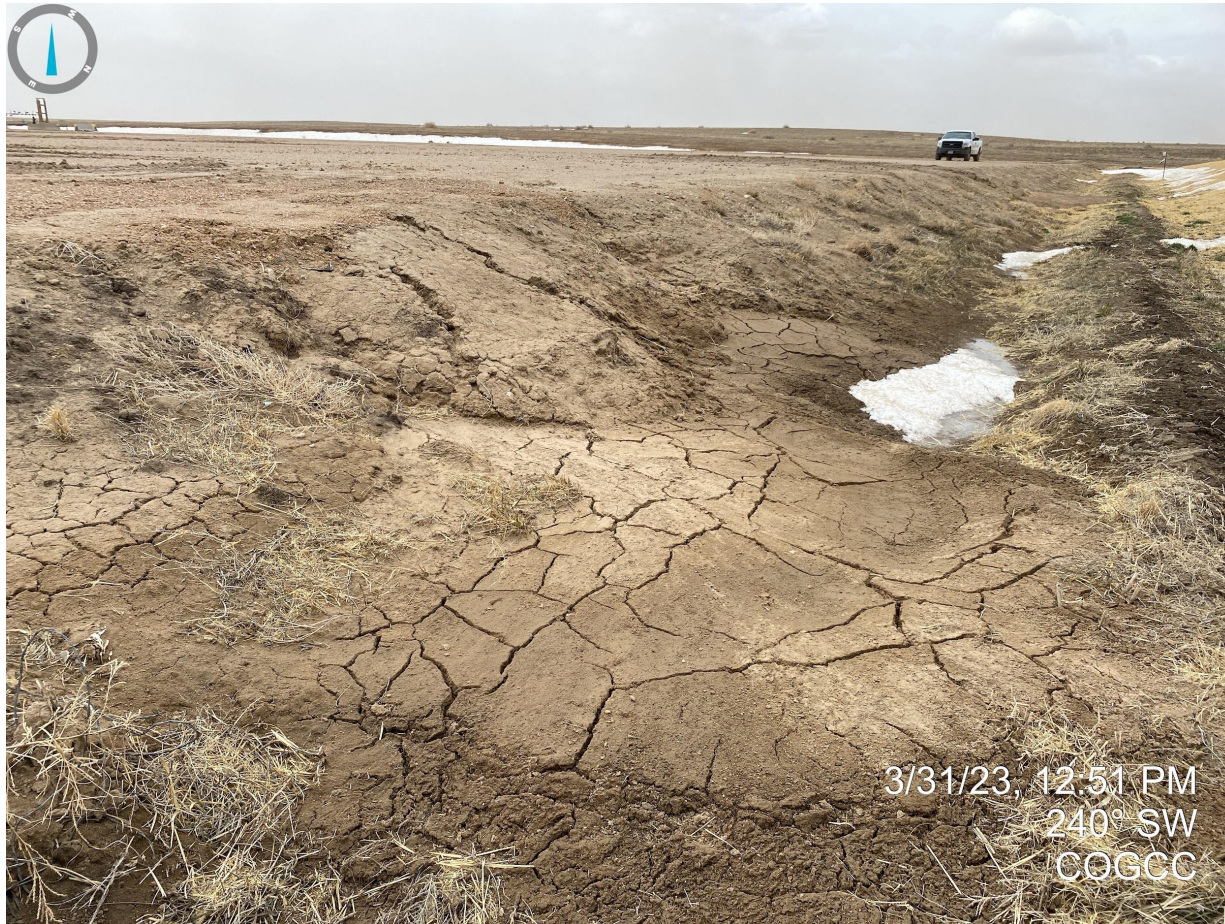
**Photo 6.** See comments in Photo 3.

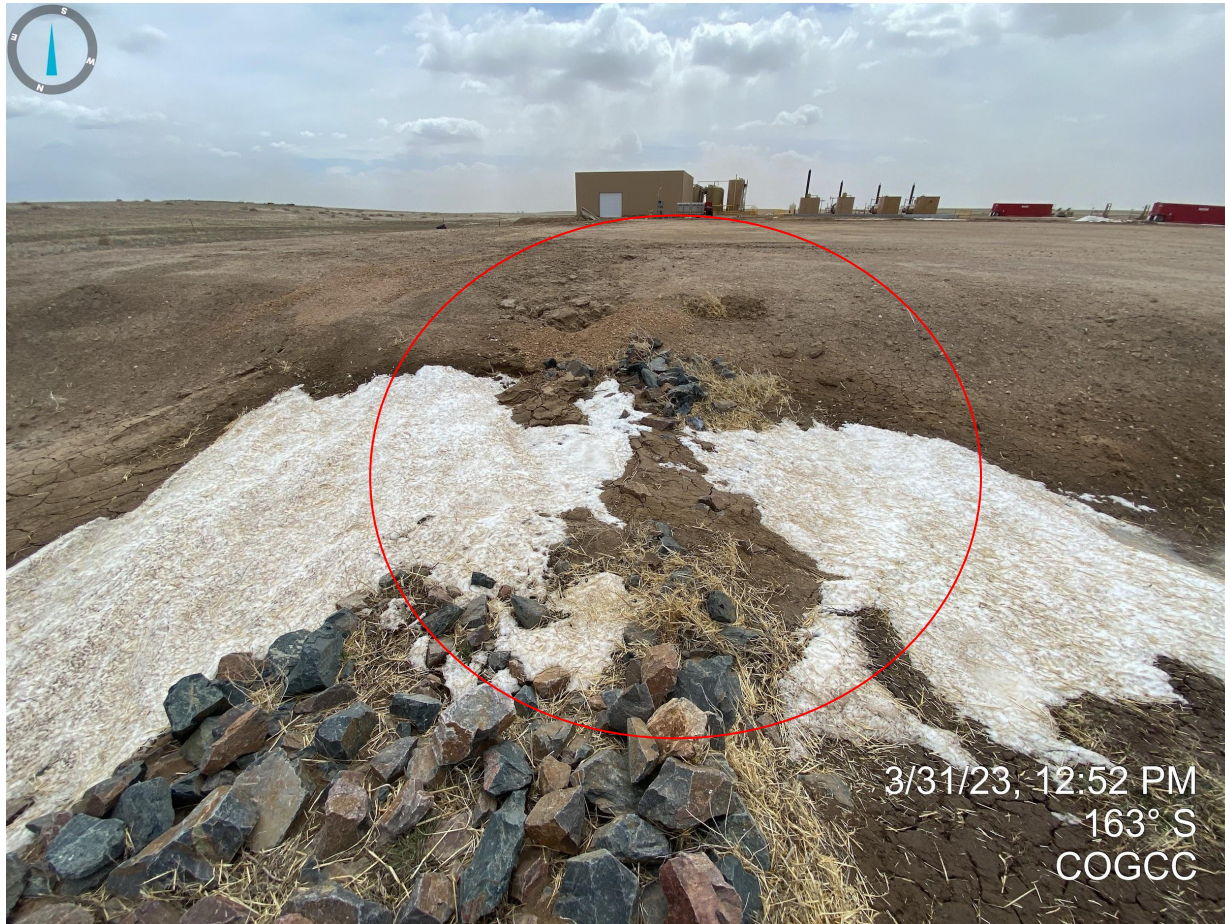
**Photo 7.** Facing south at rip rap check dam area. Rip rap structure will require maintenance as portions were observed to be filled with sediment.

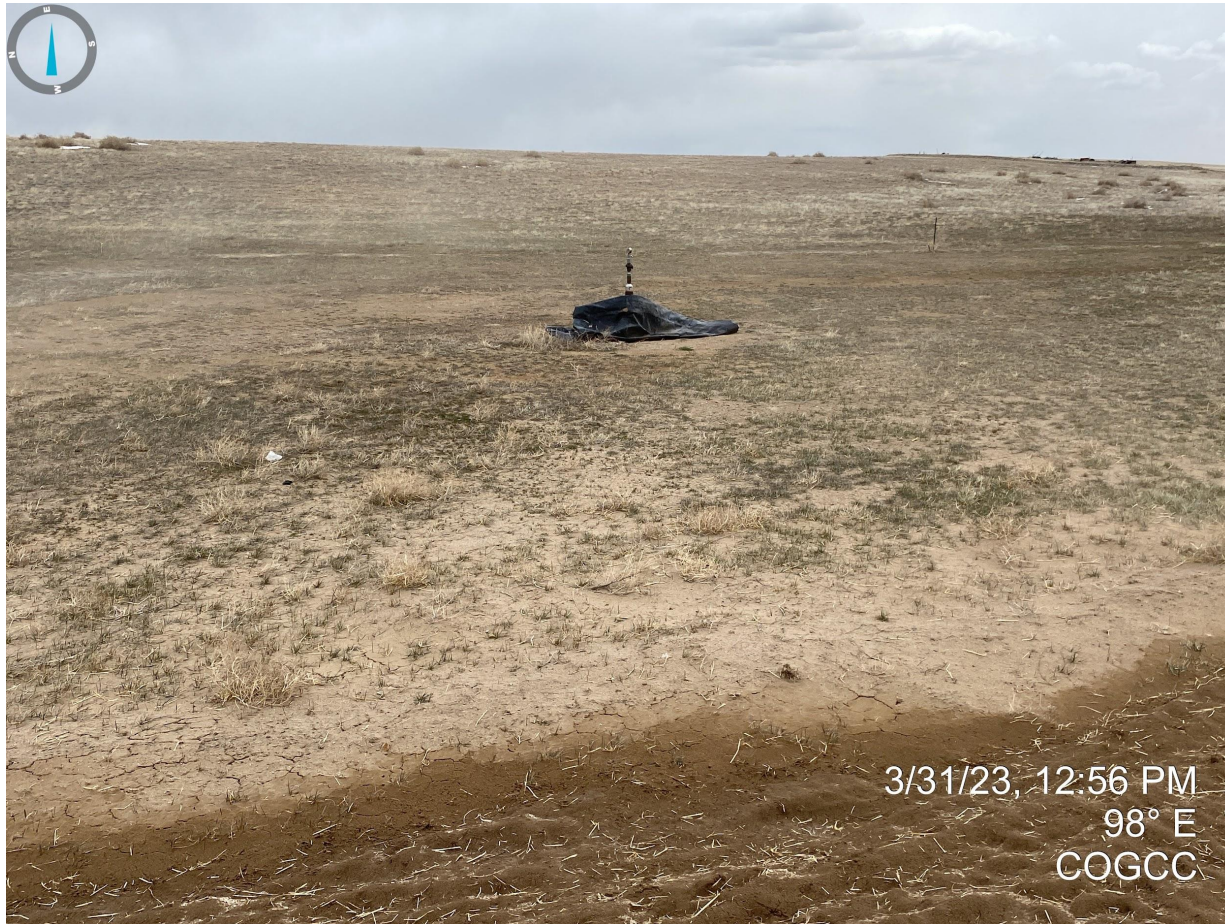
**Photo 8.** Facing east from the eastern portion of the location. Debris was observed to have blown off location and will need to be picked up.

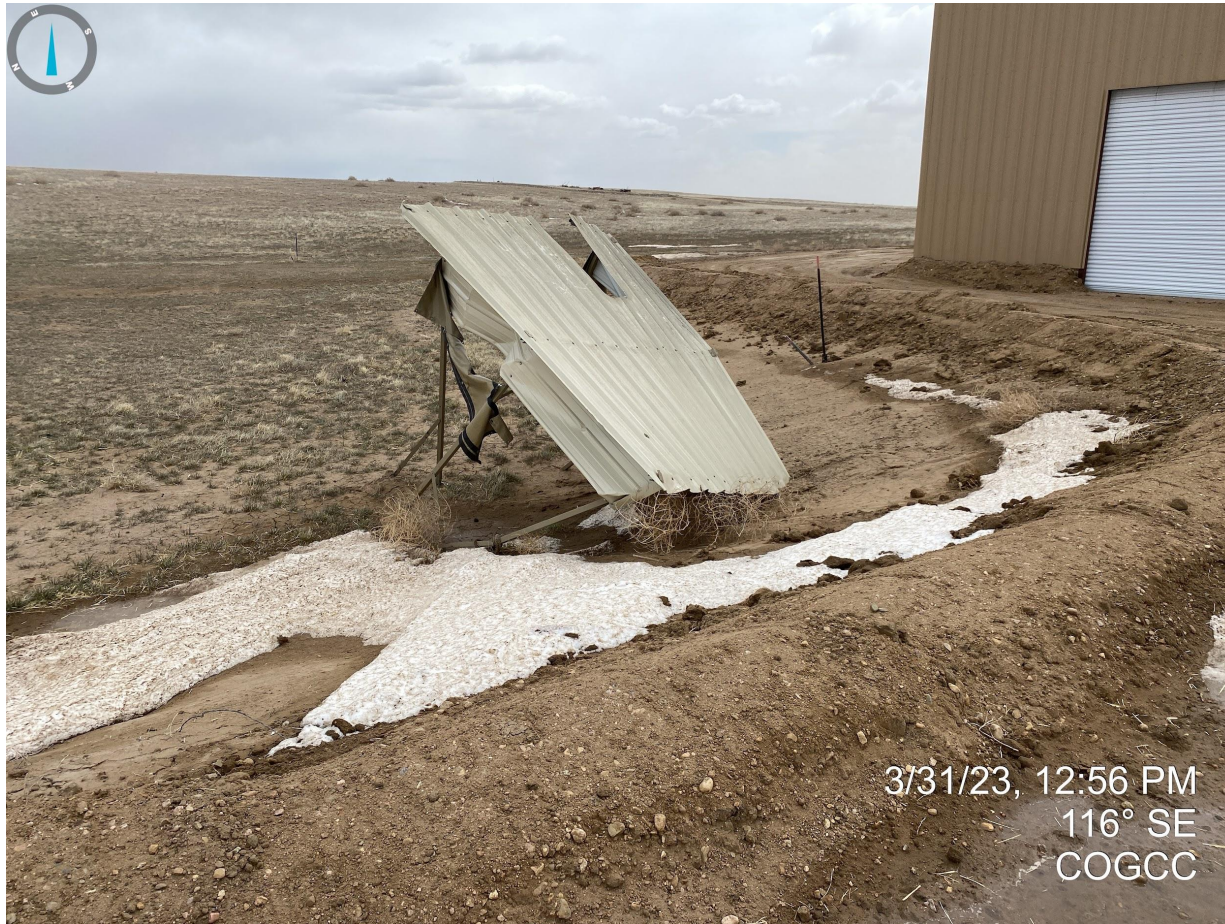
**Photo 9.** Debris blown off location doesn't appear to have been anchored down.

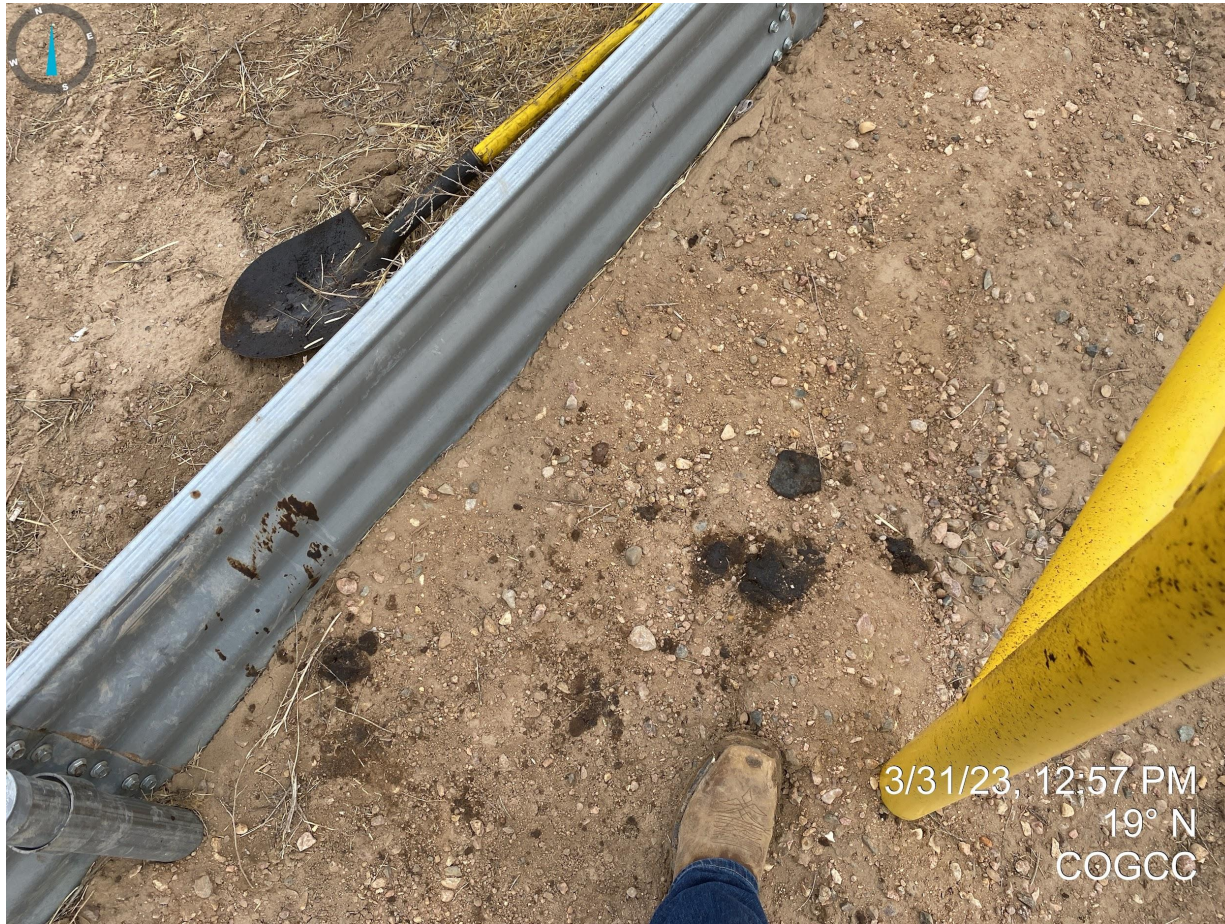
**Photo 10.** Oily waste observed near containment of separators that will need to be properly disposed of.

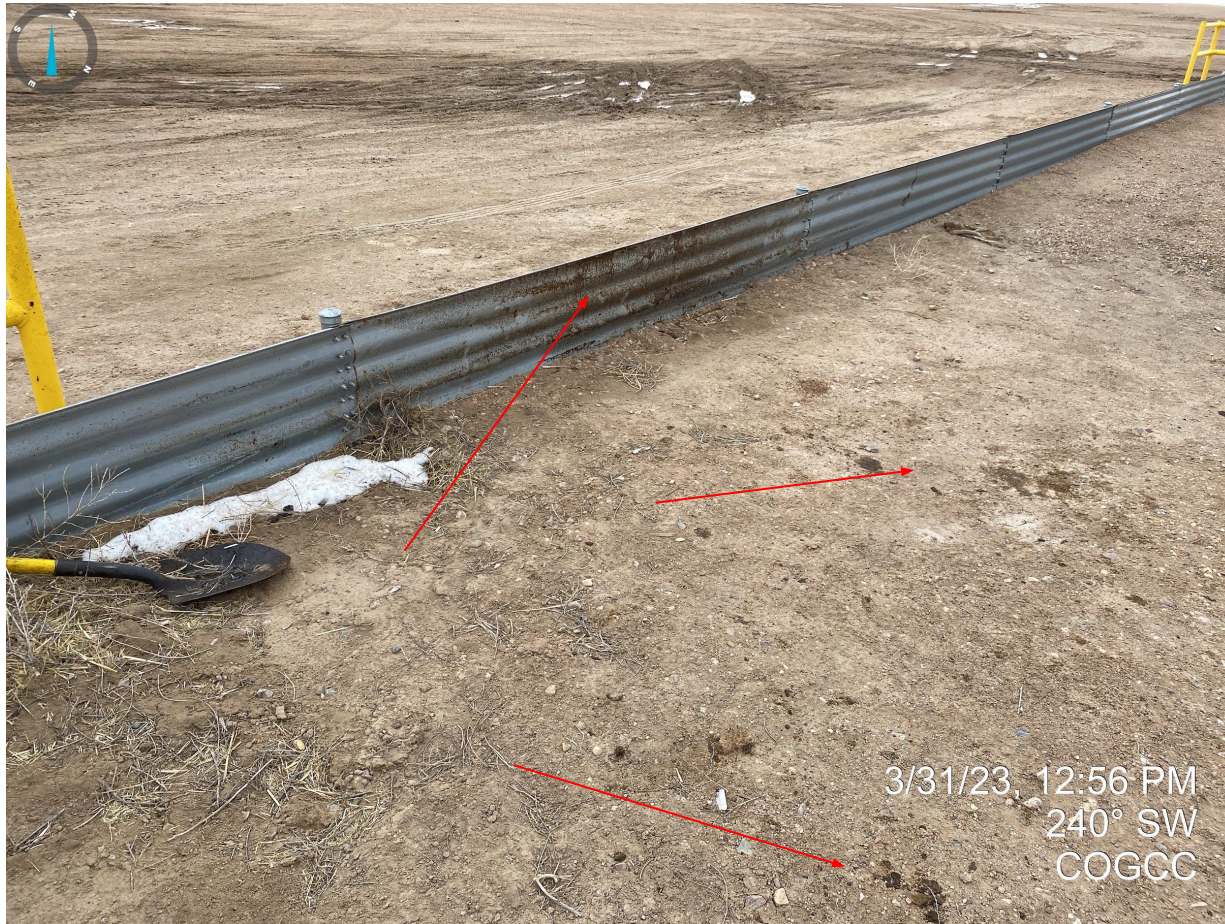
**Photo 11.** See comments in Photo 10.

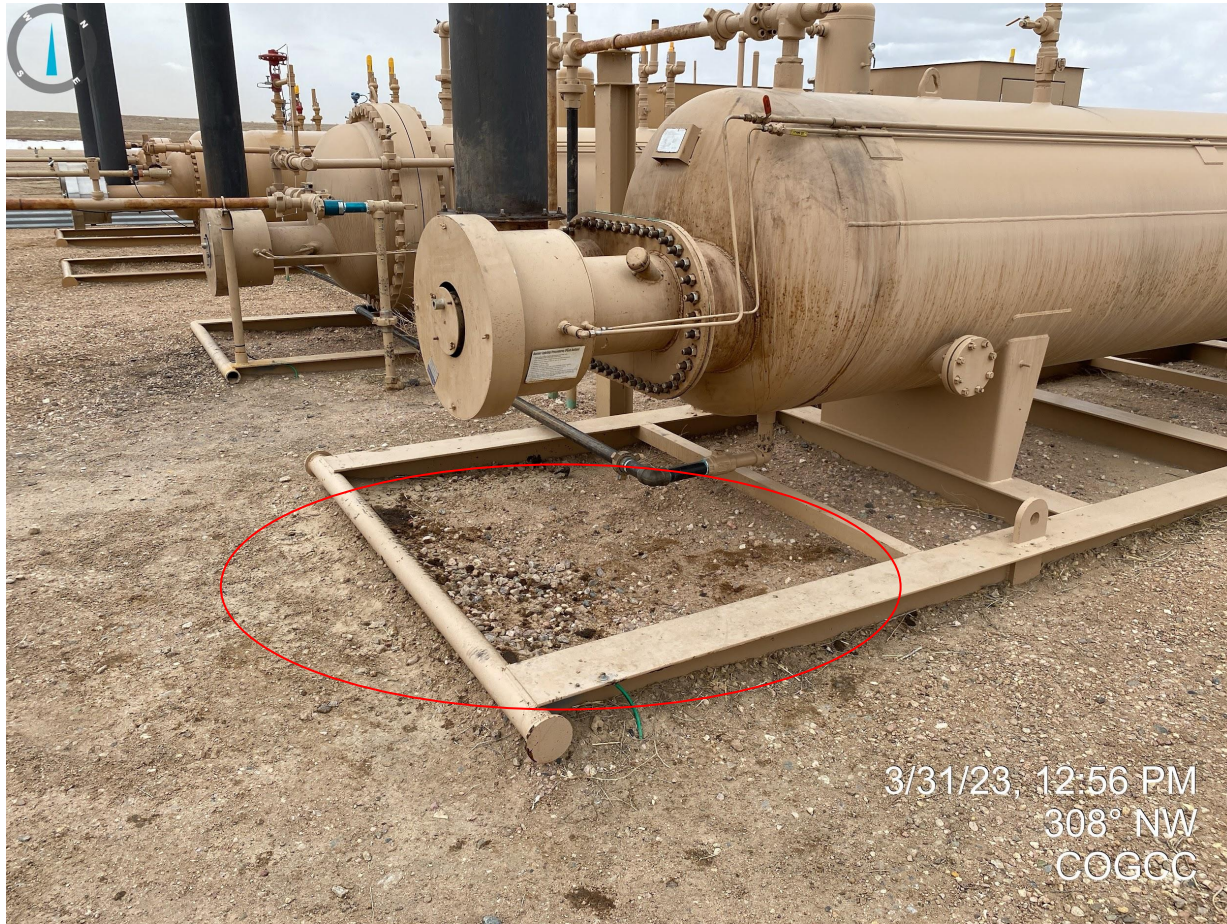
**Photo 12.** See comments in Photo 10.

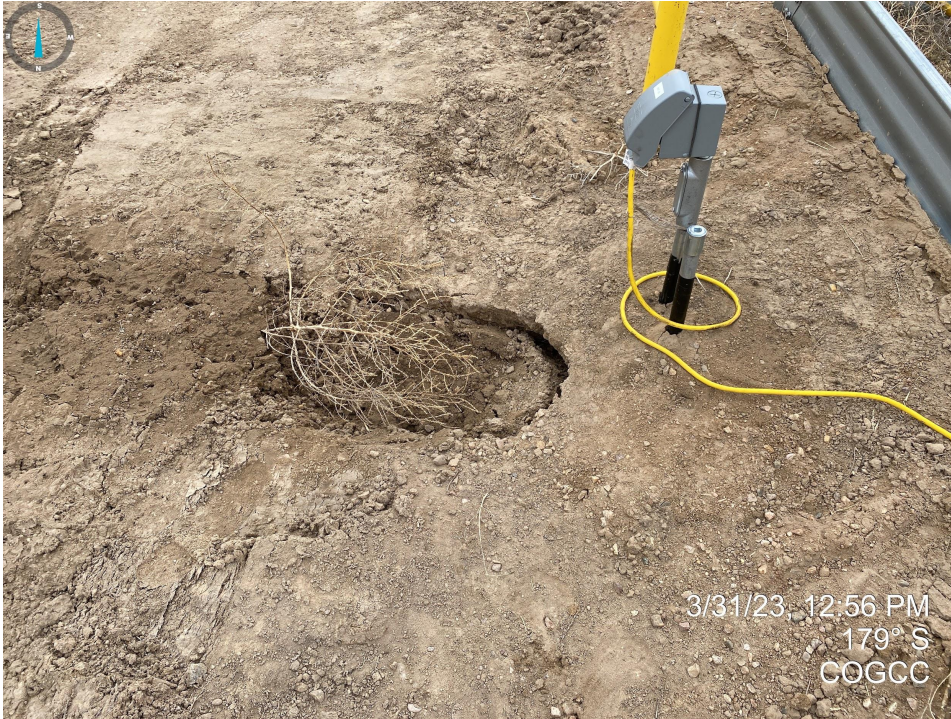
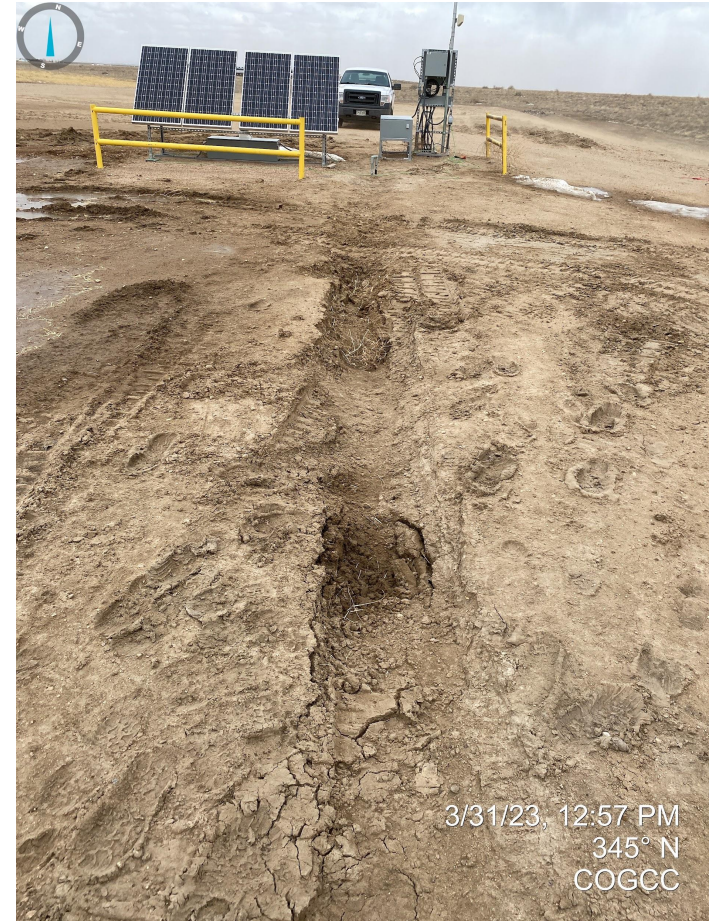
**Photos 13 & 14.** Subsidence on trench that will need to be backfilled or fenced to ensure safe operations for personnel and wildlife.

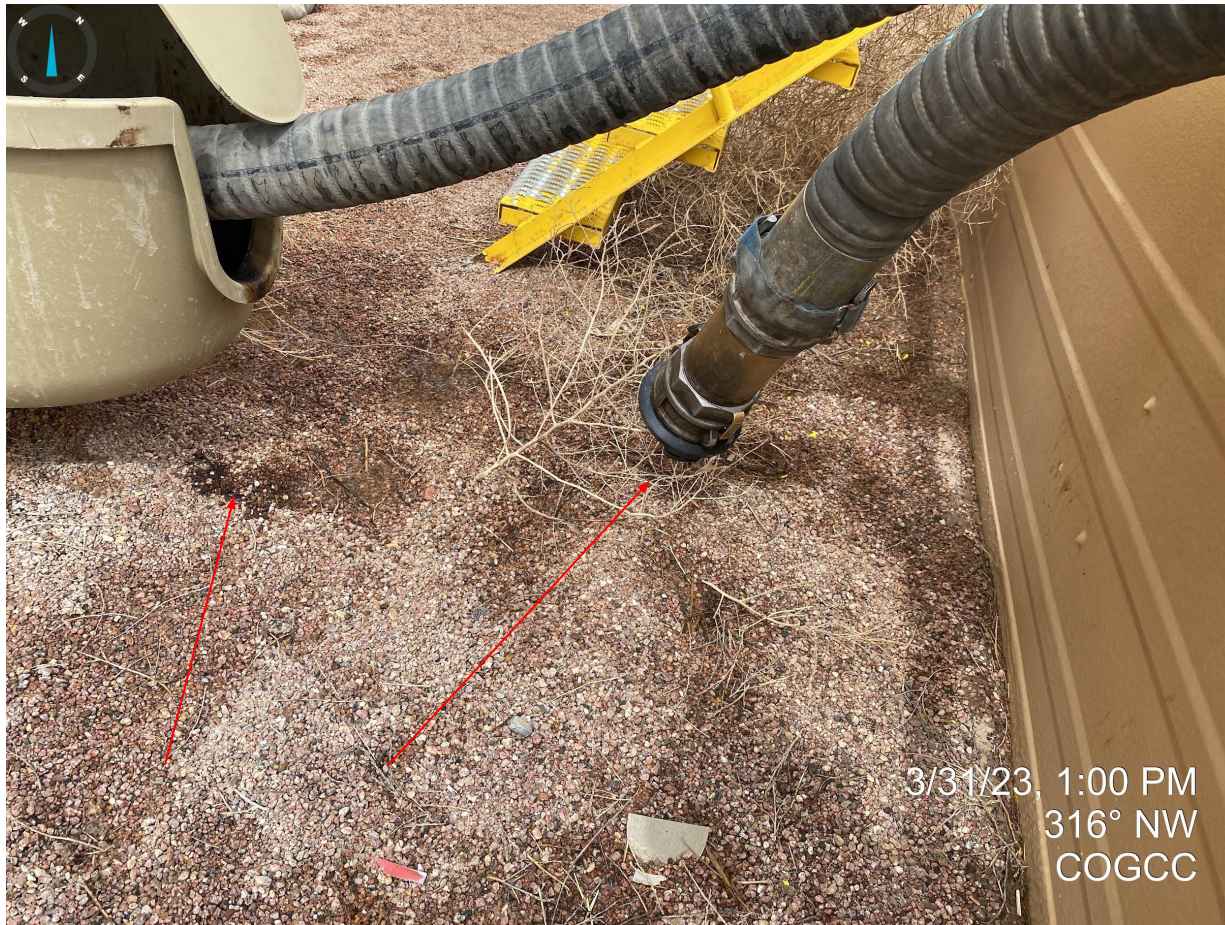
**Photo 15.** Oily waste observed on northeast side of tank battery.

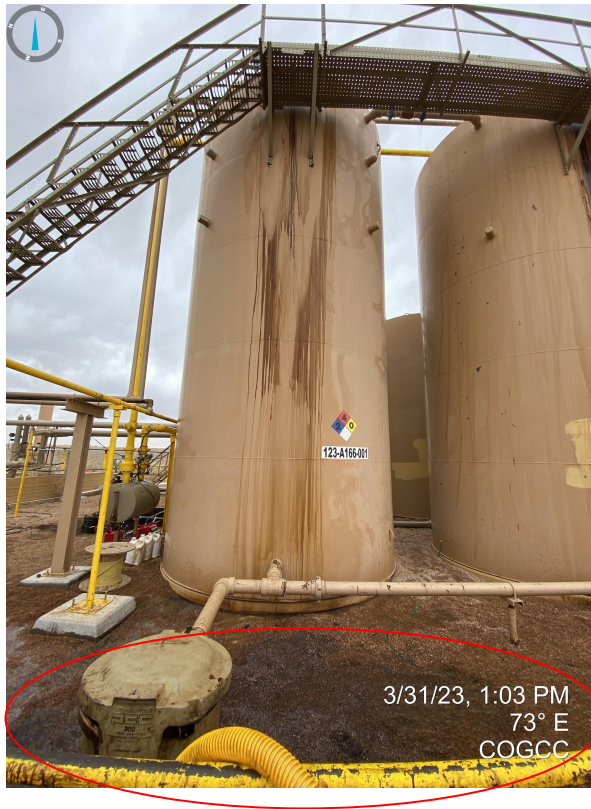
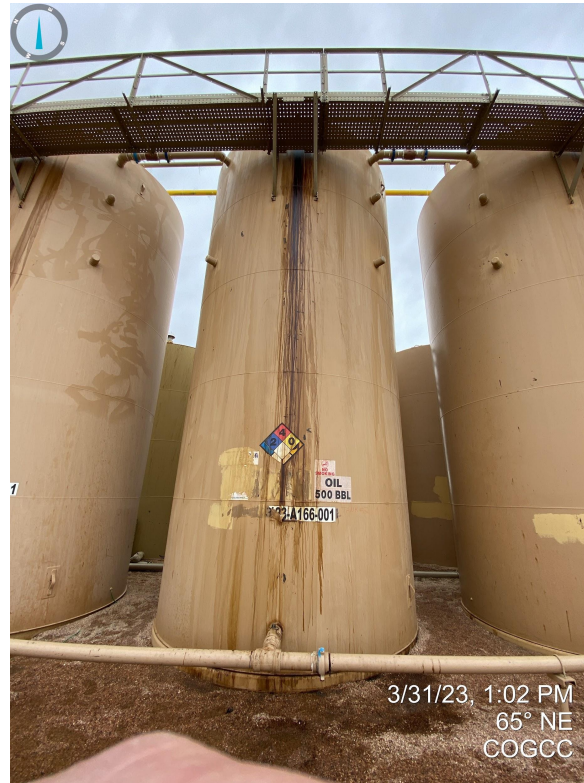
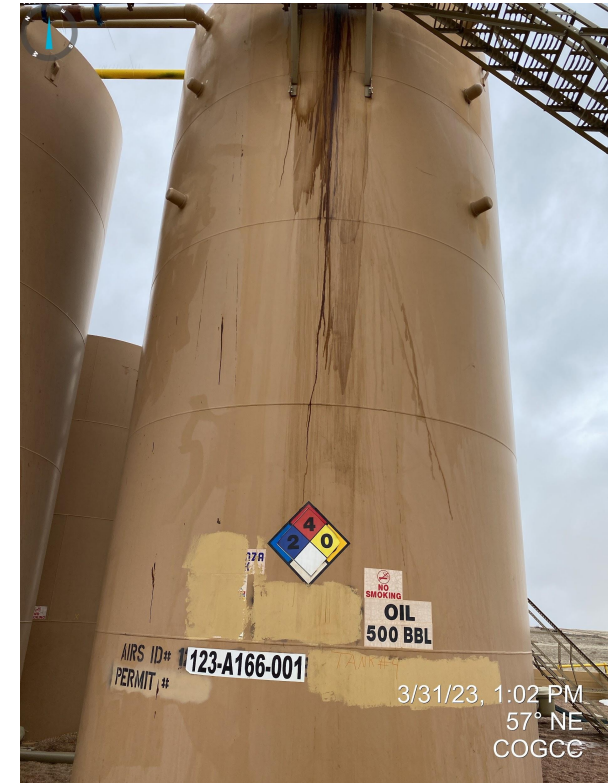
**Photos 16-18.** Photos of tanks with fluid running down the side that will require maintenance on equipment and proper cleanup. Red outline shows additional cleanup of fluids needed at load out lines.

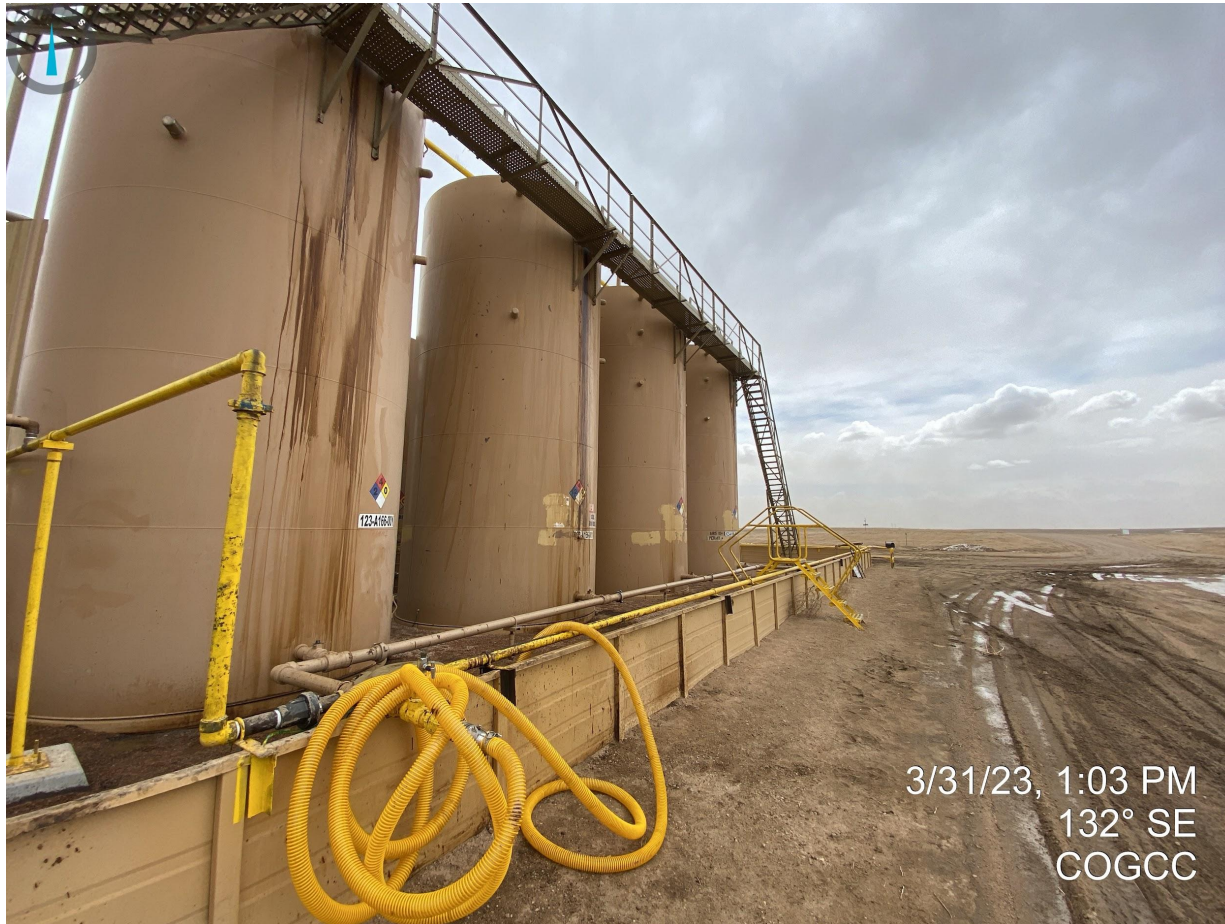
**Photo 19.** Overview of spill at tanks.

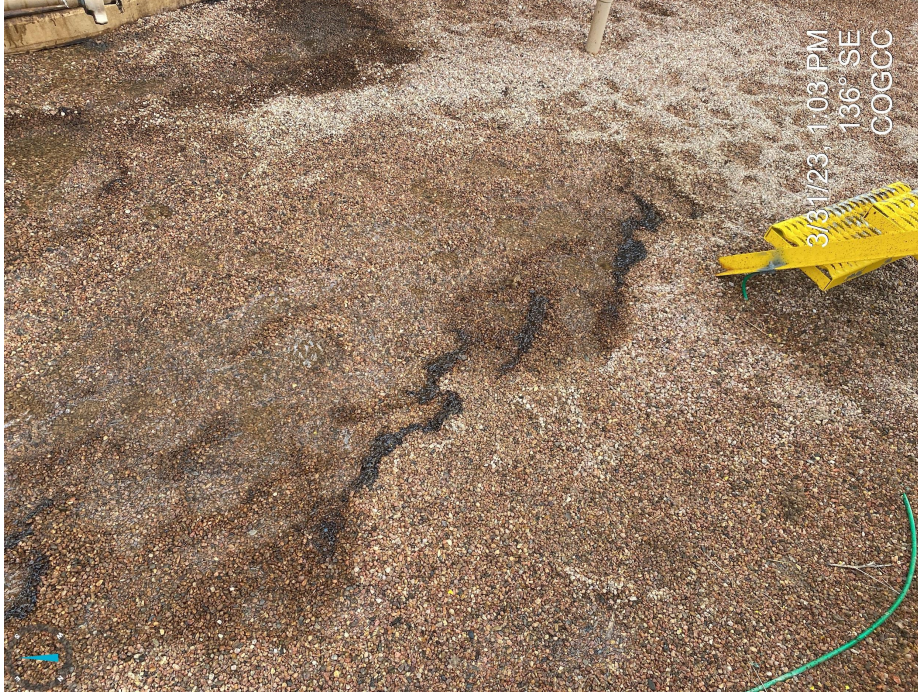
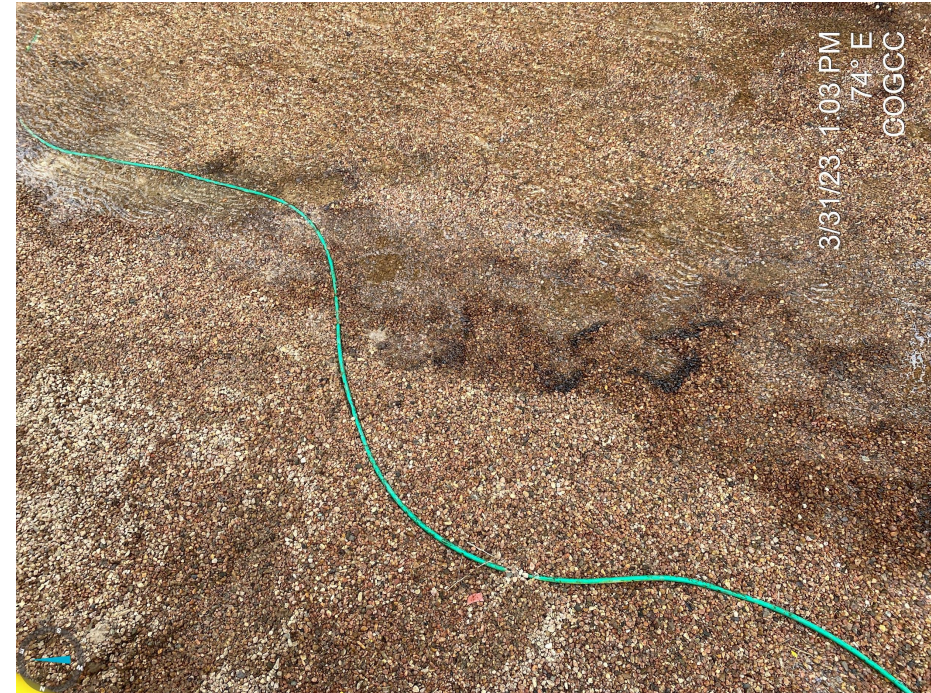
**Photos 20 & 21.** Photo illustrates additional cleanup needed for oily waste within the secondary containment.

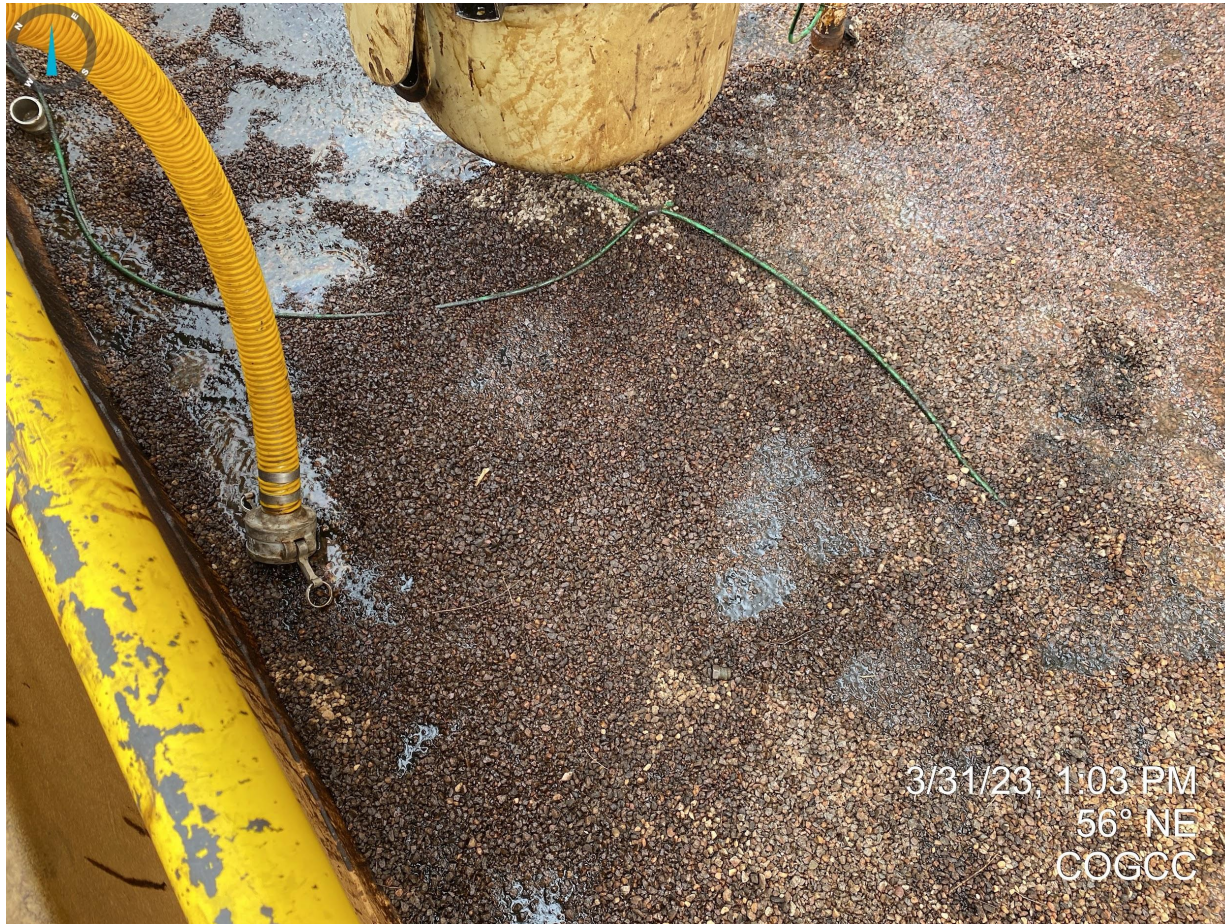
**Photo 22.** Close up of oily waste/stained soil within secondary containment at load out line.

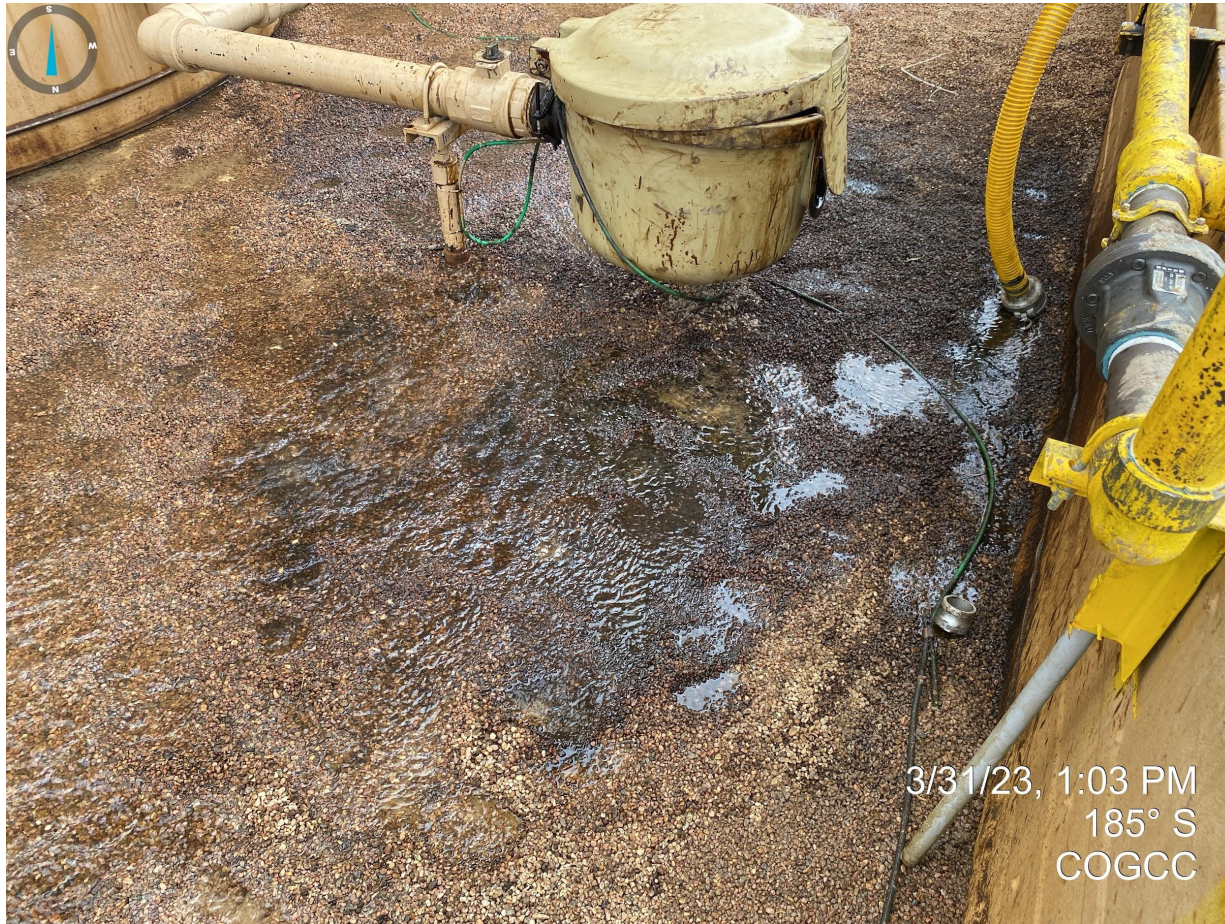
**Photo 23.** See comments in Photo 22.
