# Interim Reclamation and Stormwater Inspection

Date: 03/31/2023

Operator: SUMMIT OIL & GAS LLC - 10774

Inspection Photos  
Location Name: Castor 7-59 12  
Location ID: 465272

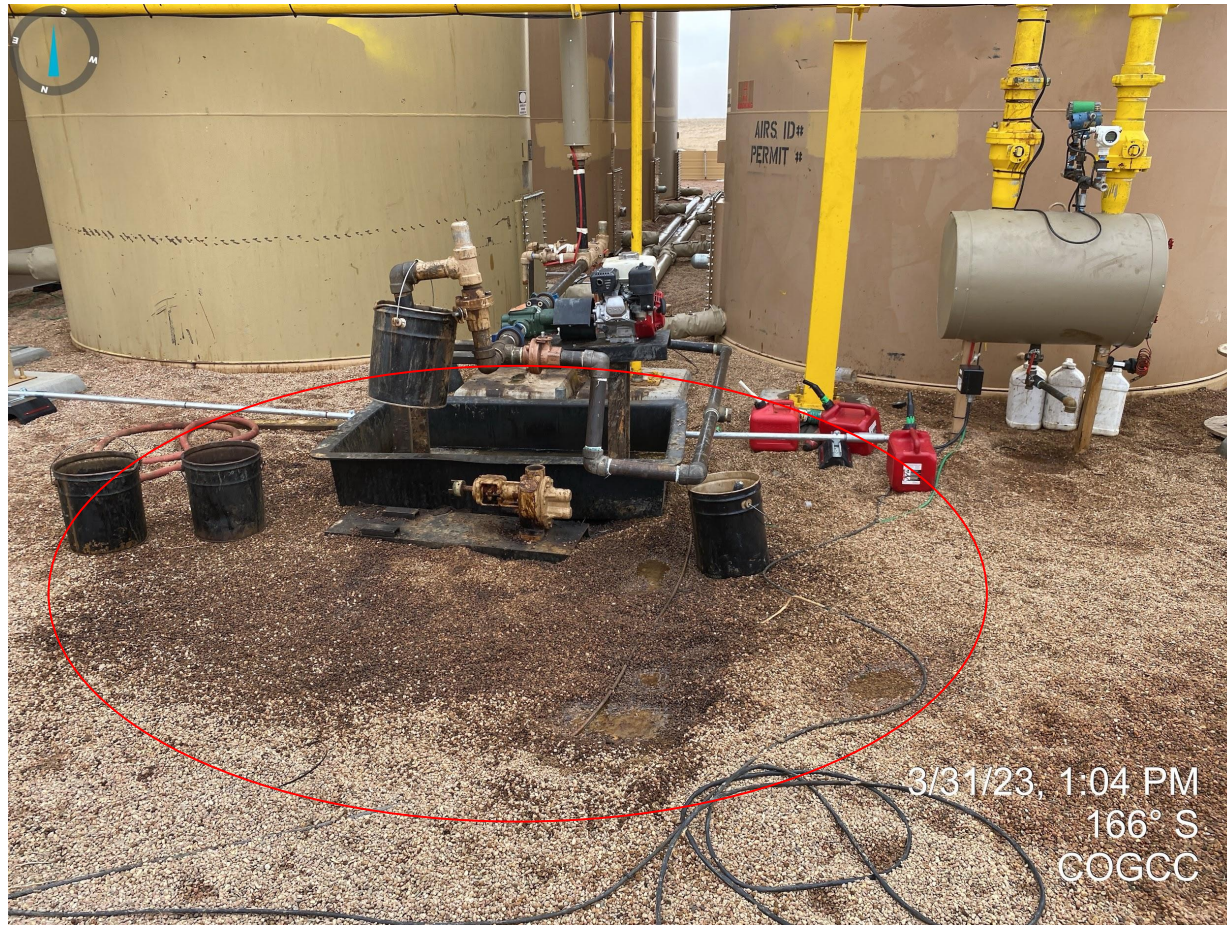
**Photo 24.** Facing south from the northern portion of the battery. Photo illustrates oily waste that requires proper cleanup.
