Interim Reclamation and Stormwater Inspection

Operator: FOUNDATION ENERGY MANAGEMENT LLC
- 10112

Location ID: 429231

Inspection Photos
Location Name: Green 1-7 Facility
Location ID: 429231

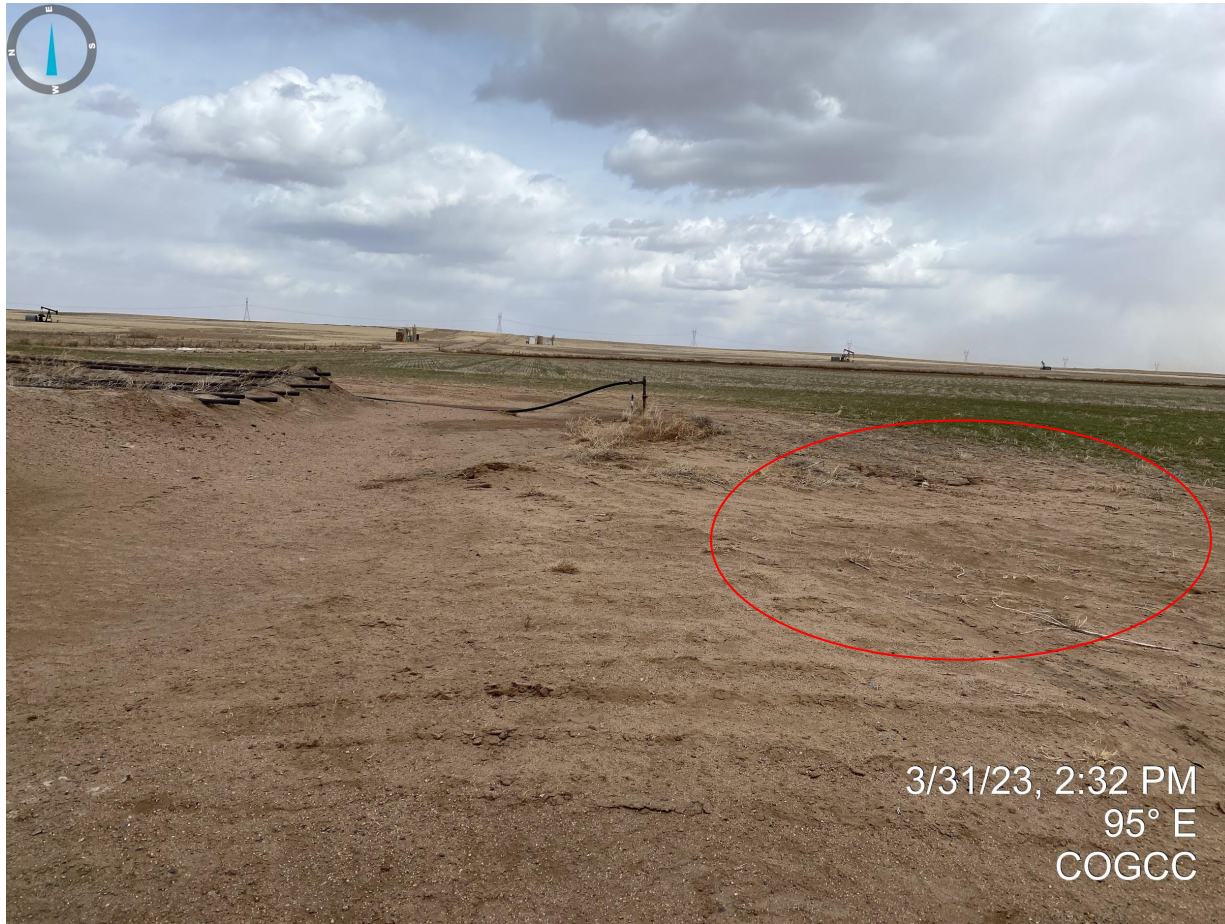
Photo 1. Water truck has been removed from the location.

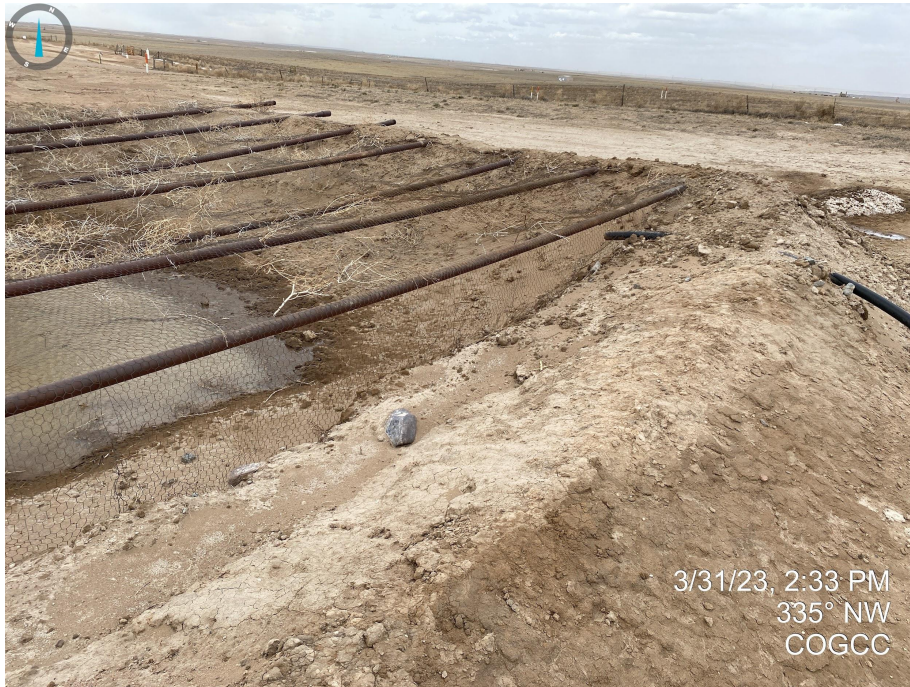
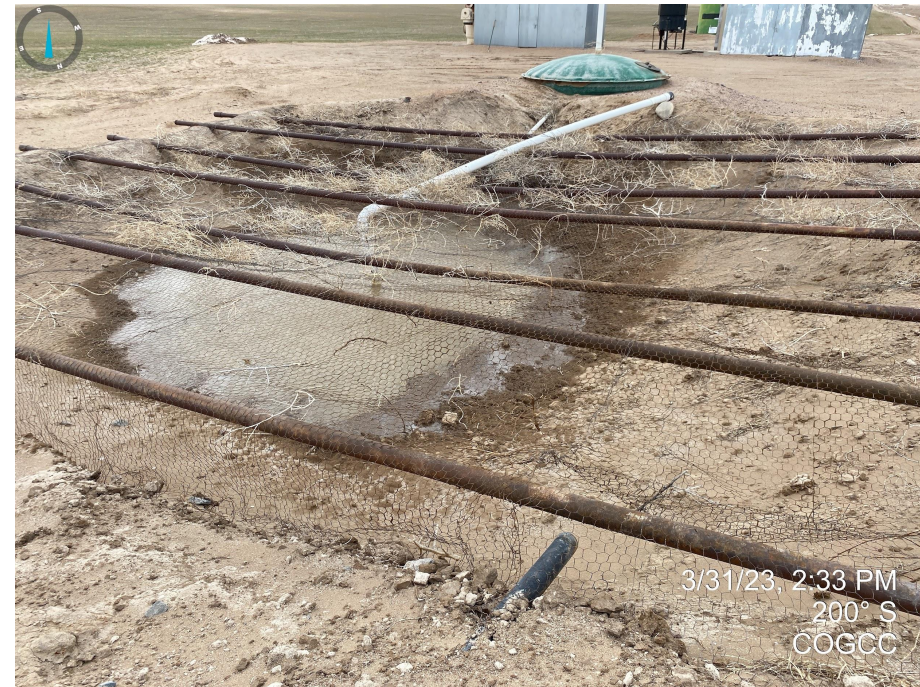
Photos 2 & 3. The hydrocarbons appear to have been removed from the produced water pit and the wildlife exclusion netting appears to have been repaired and is adequate at the time of this inspection.

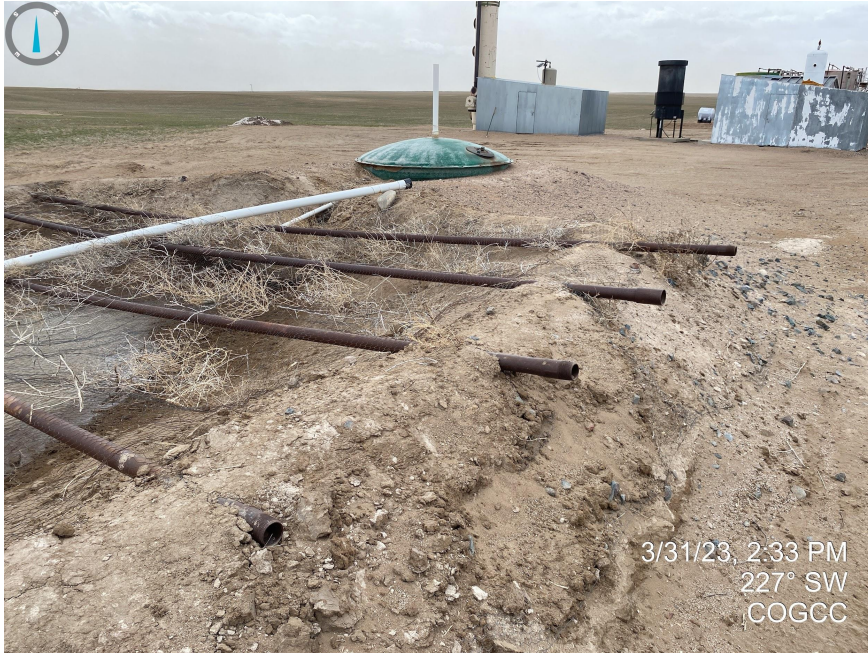
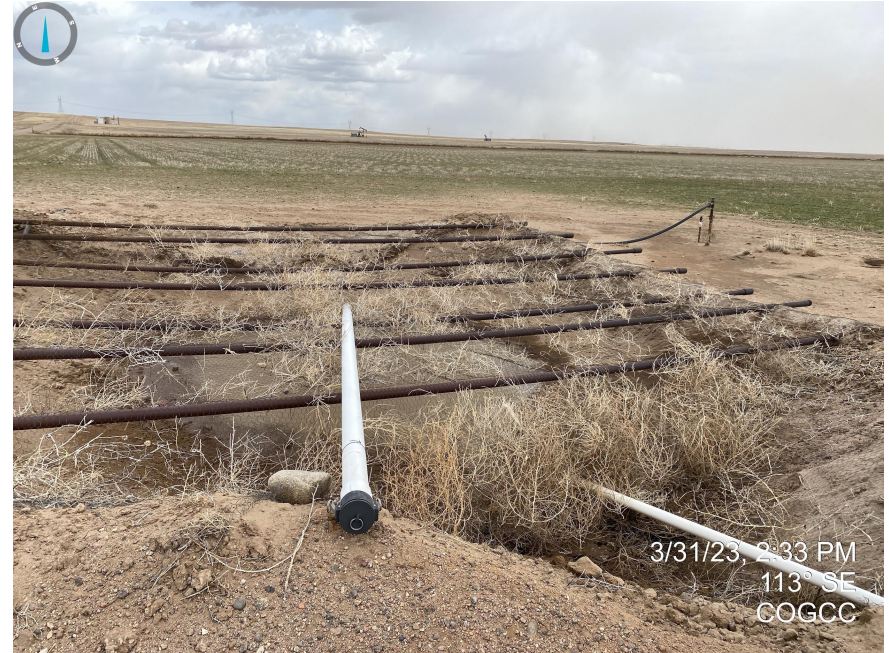
Photos 4 & 5. See comments in Photos 2 & 3.

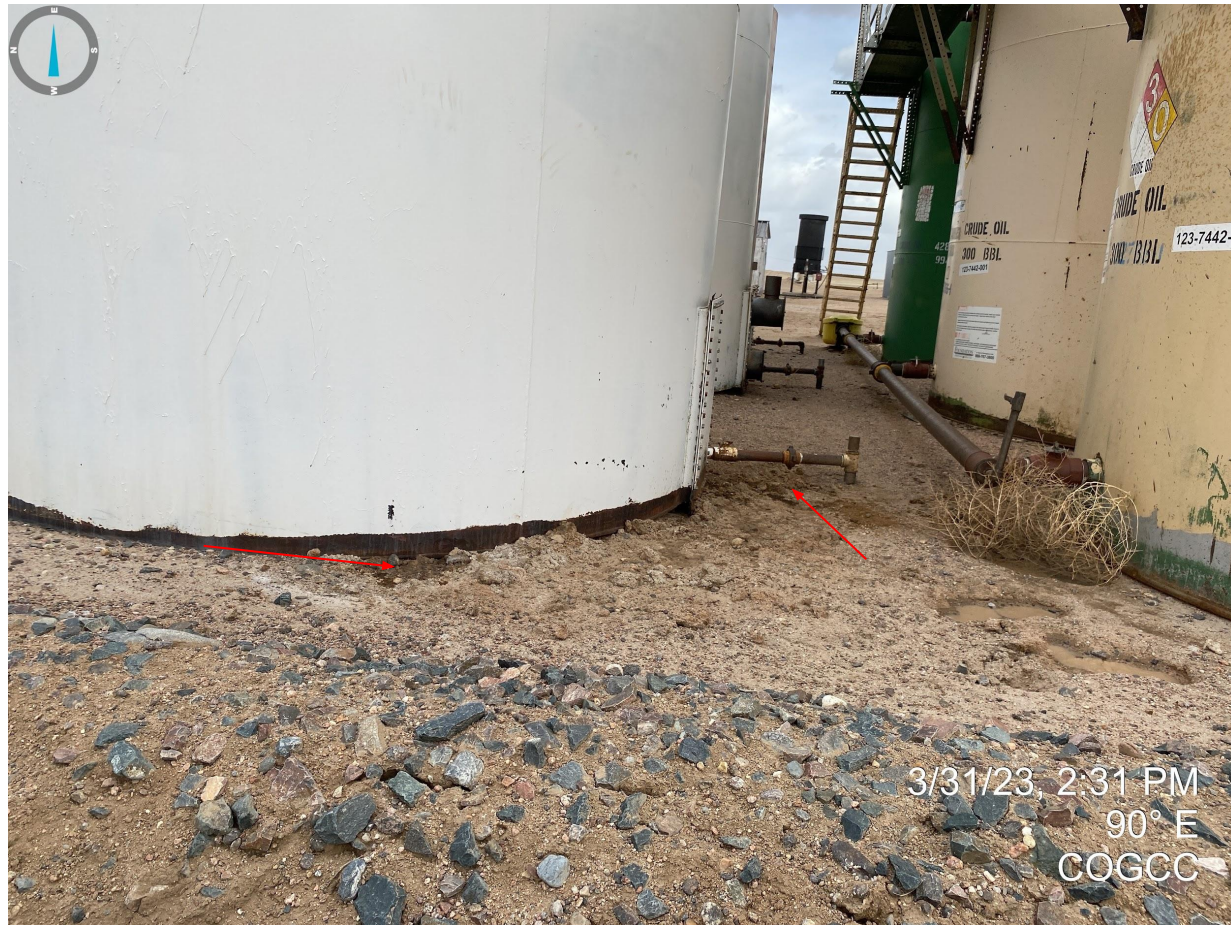
Photo 6. It appears the Operator has removed/cleaned up the stained soil previously identified, however, additional stained soil was observed at the time of this inspection. The Operator shall inspect/repair all equipment to ensure it is in good working condition to prevent any possible leaks from the tank and associated piping.

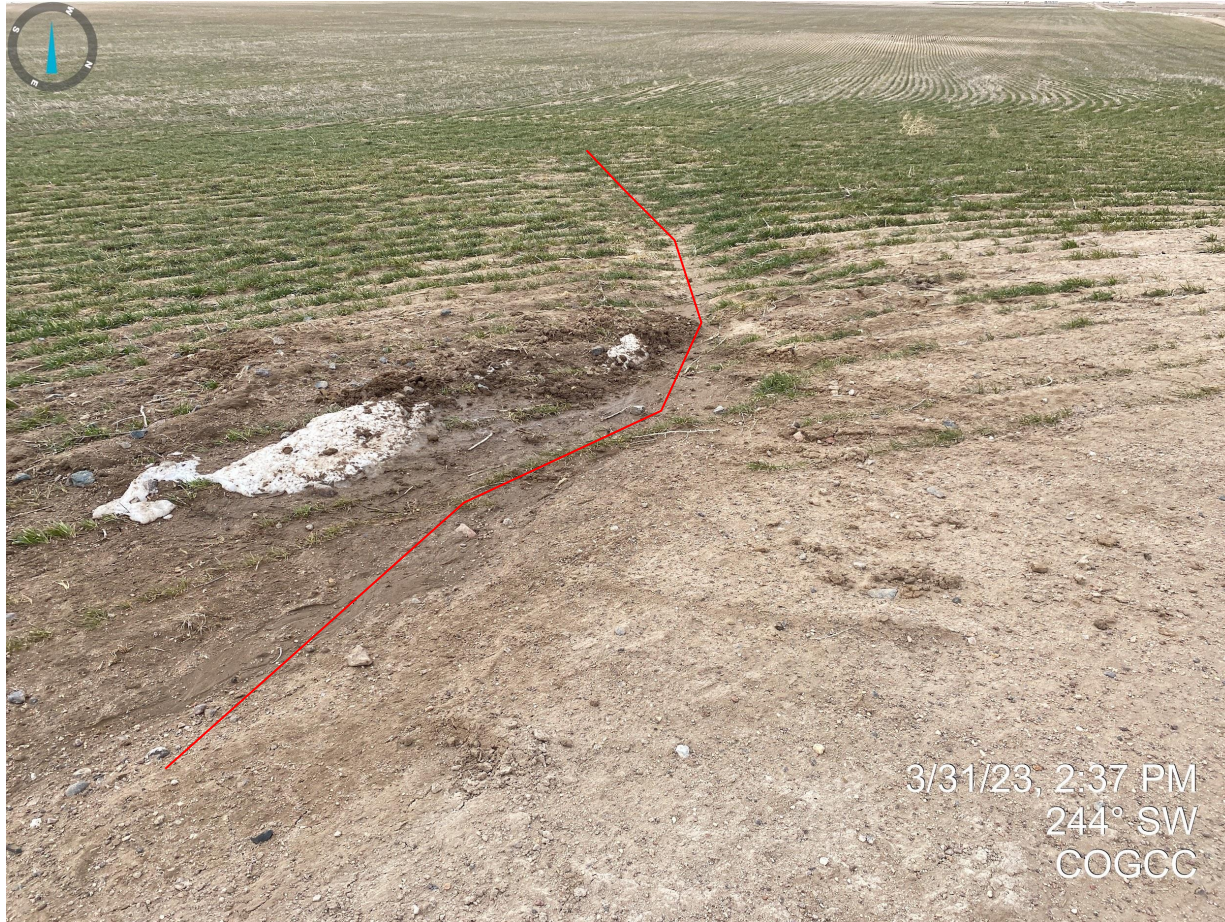
Photo 7. Facing southwest towards adjacent farm ground. Rill erosion was observed at the time of this inspection and will require stormwater BMPs to prevent any additional erosion.

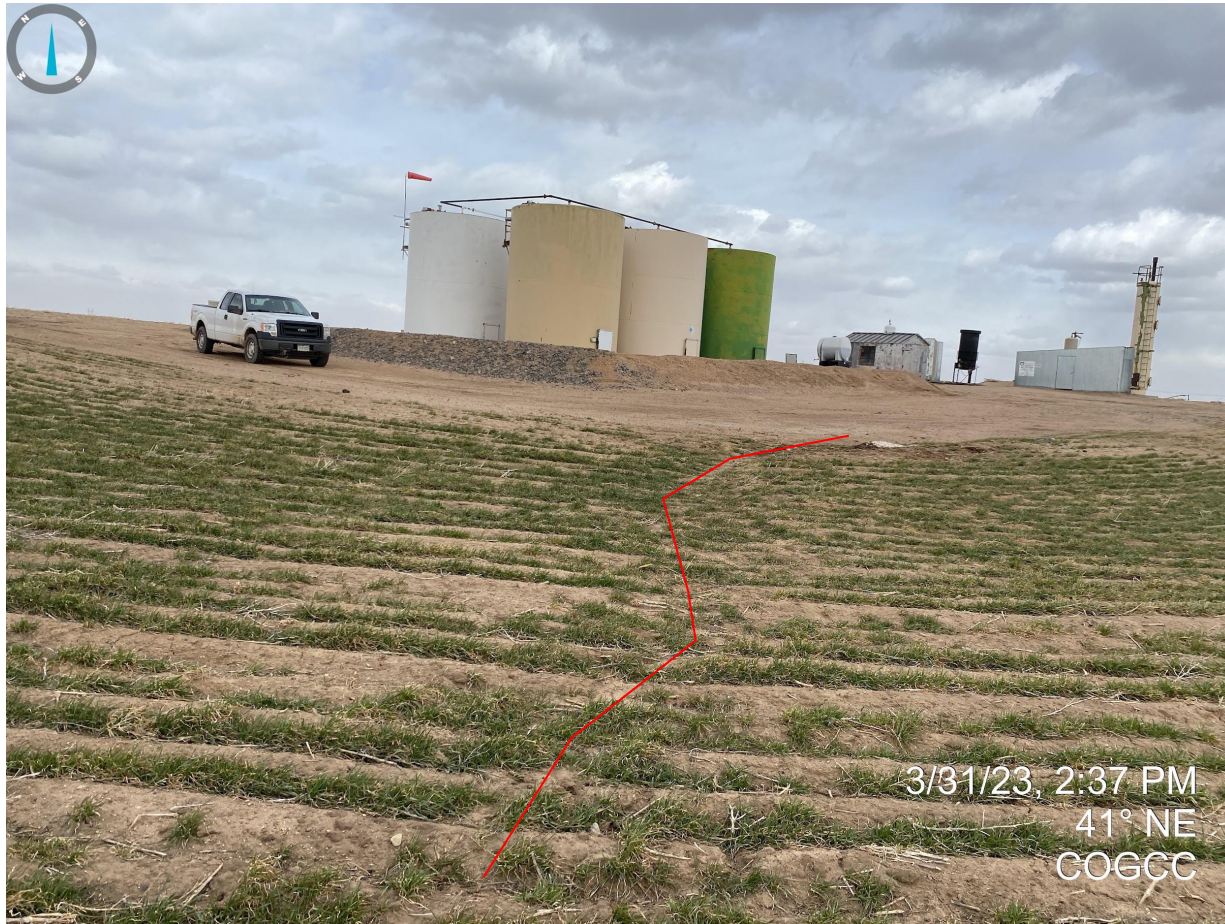
Photo 8. Facing northeast; see comments in Photo 7.

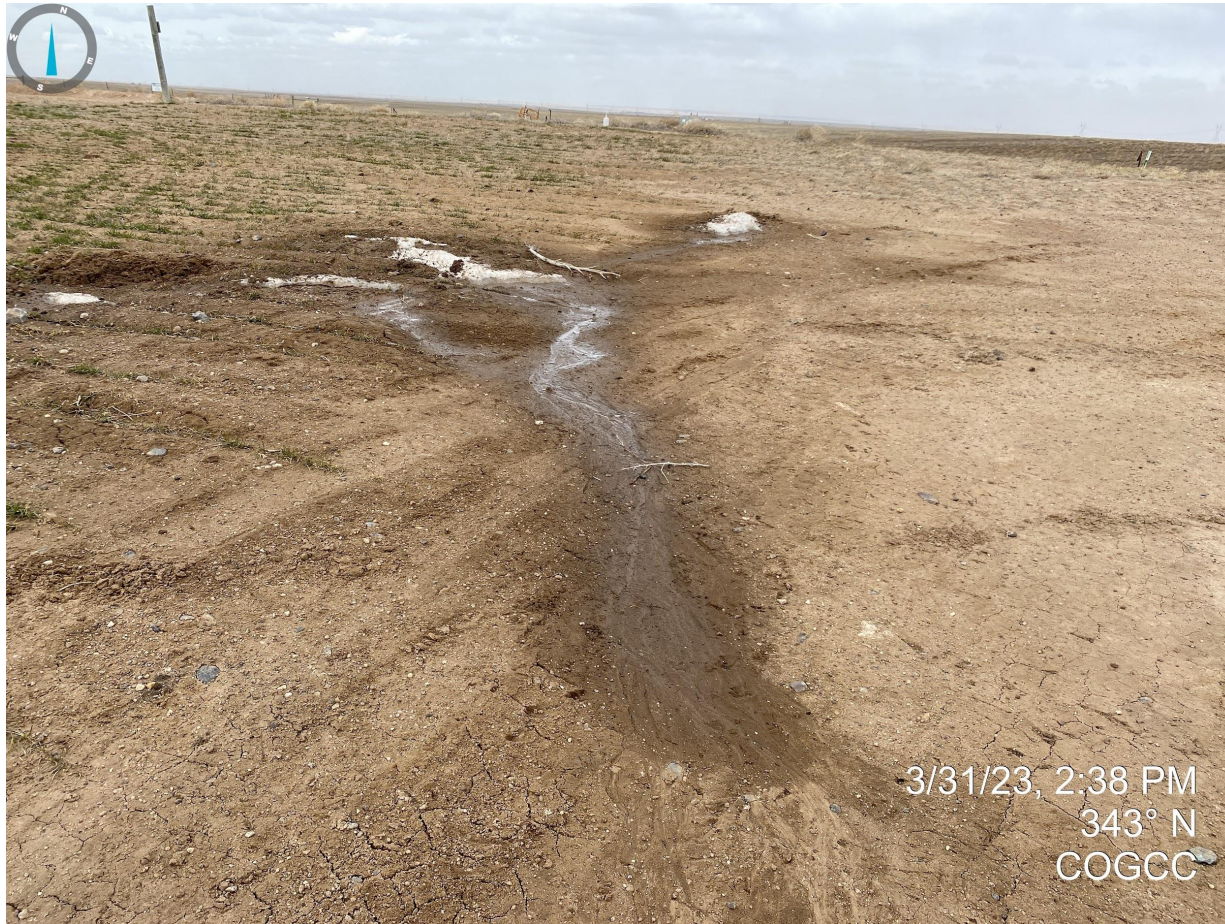
Photo 9. Facing north from the northwest corner of the location; see comments in Photo 7.
