Interim Reclamation and Stormwater Inspection

Operator: FOUNDATION ENERGY MANAGEMENT LLC
- 10112

Location ID: 331563

Inspection Photos
Location Name: State-68N60W 36SESE
Location ID: 331563

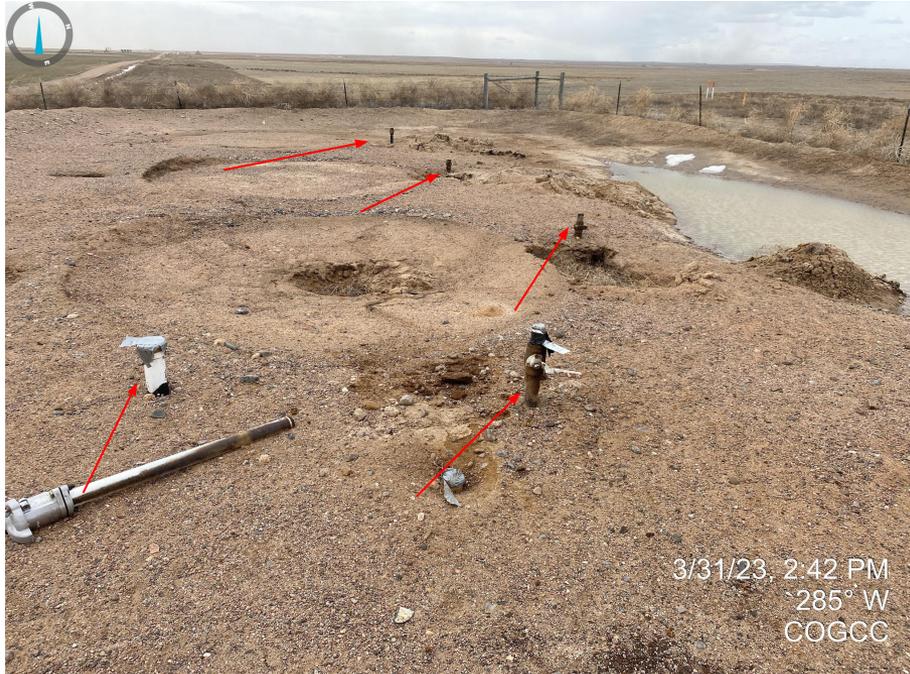
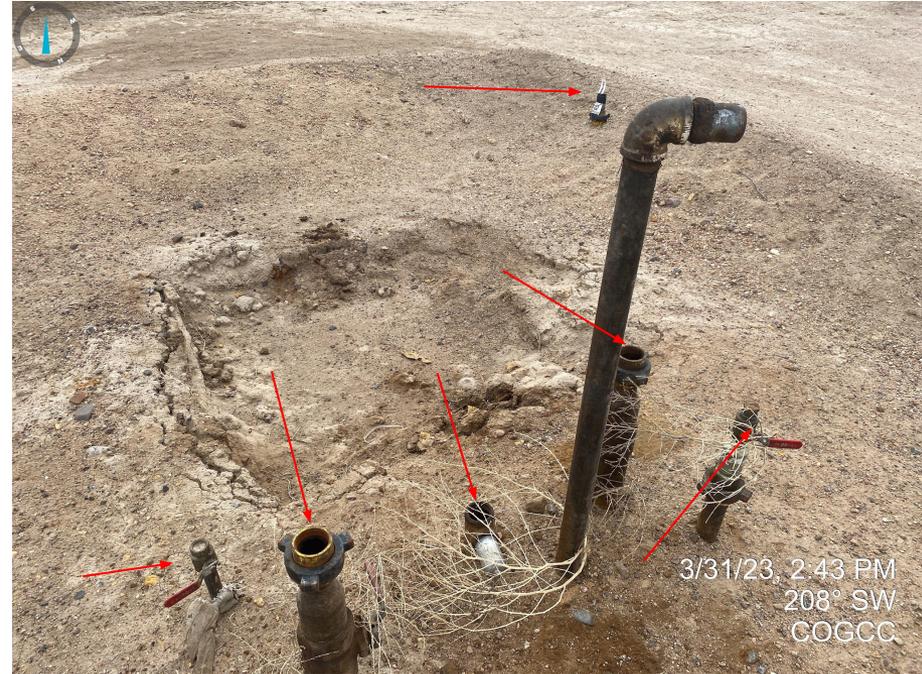
Photos 1 & 2. Abandoned risers do not have plugs or OOSLAT installed.

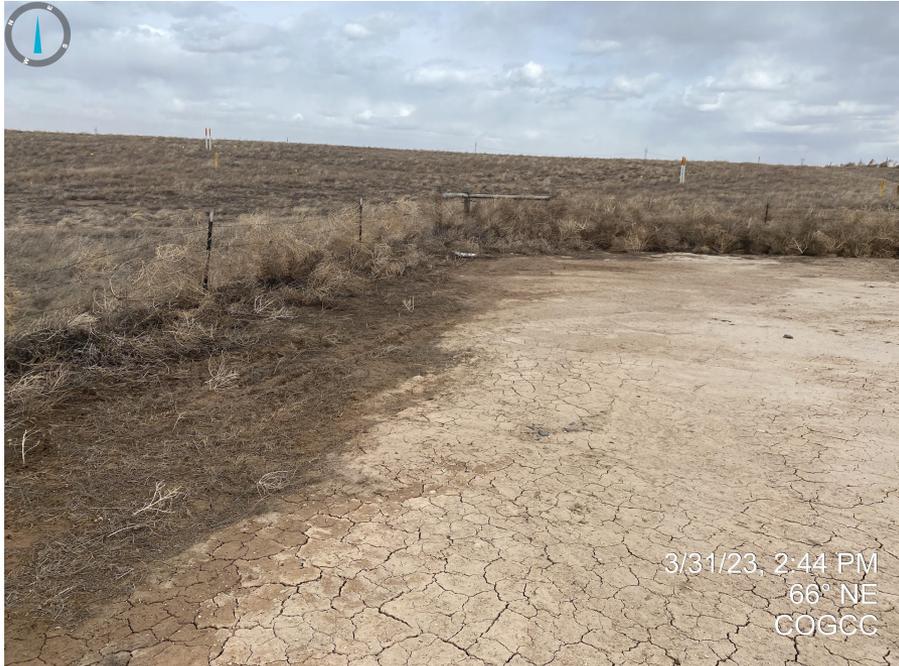
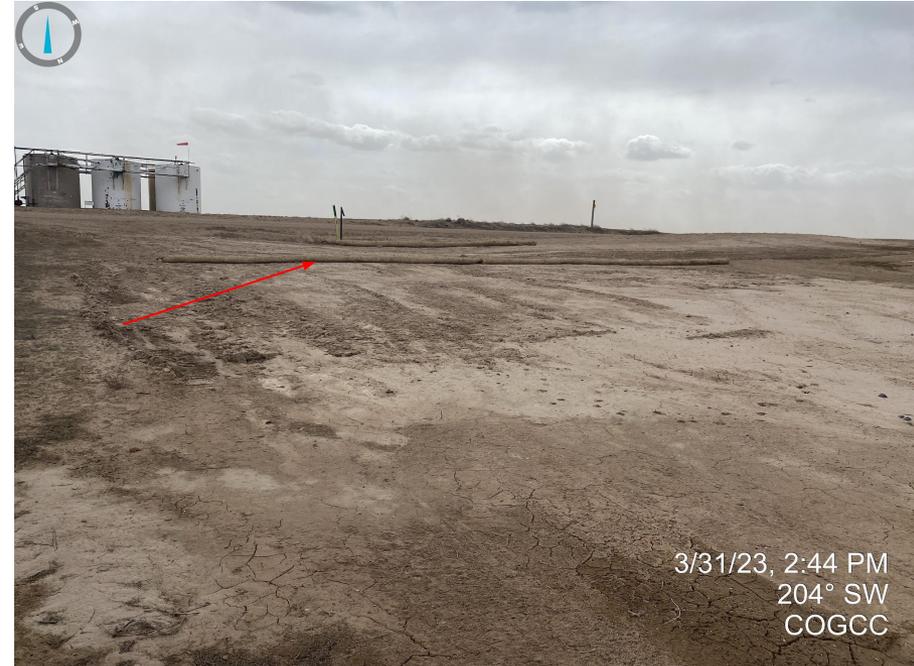
Photos 3 & 4. Taken from the northeast corner of the pad. Photo illustrates that no apparent sediment laden stormwater has exited off location (left) and that the Operator appears to have backfilled the eroded areas and installed straw wattles as a BMP for the location (right).

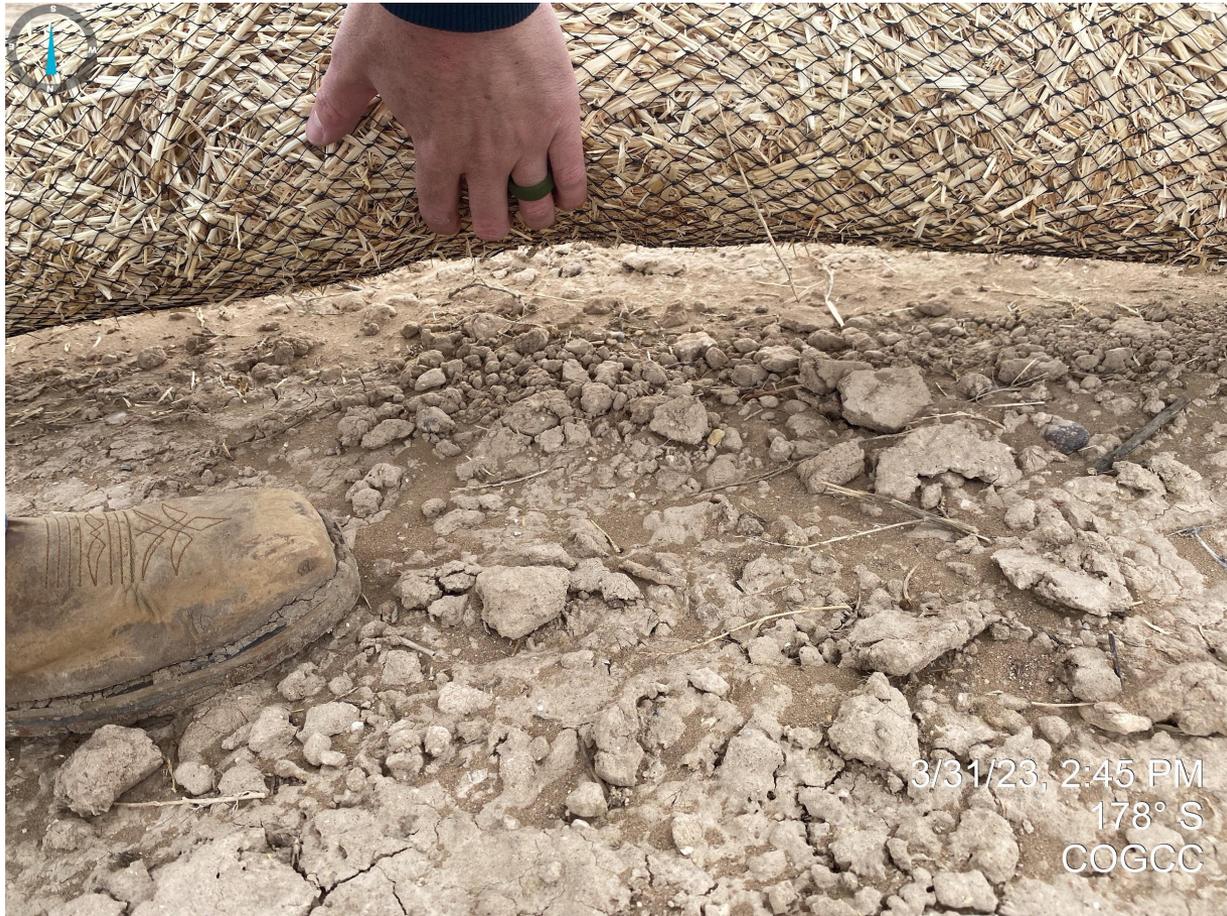
Photo 5. It does not appear the straw wattles were installed per good engineering practices as they were not trenched in. Sheet flow of water could potentially run directly underneath the straw wattles if not installed properly.

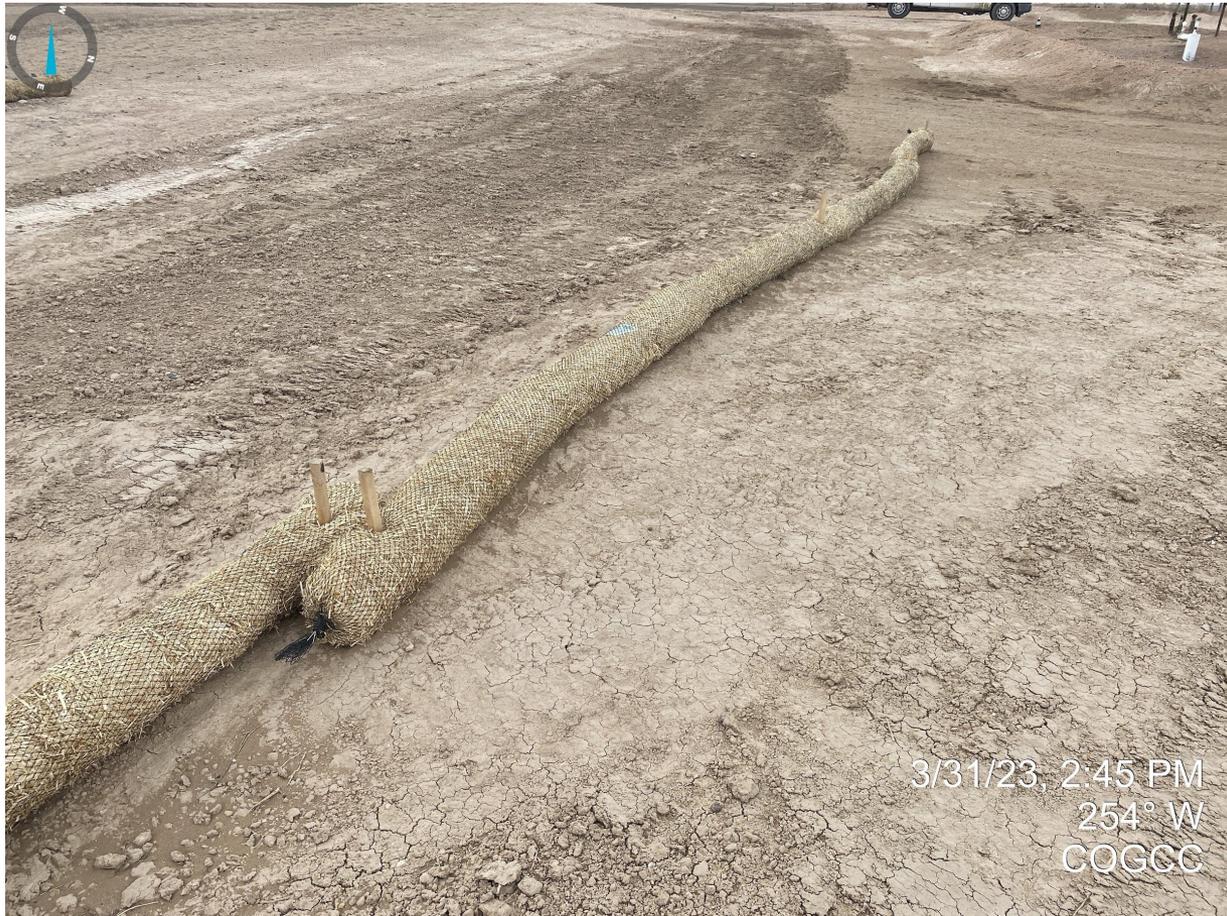
Photo 6. See comments in Photo 5.

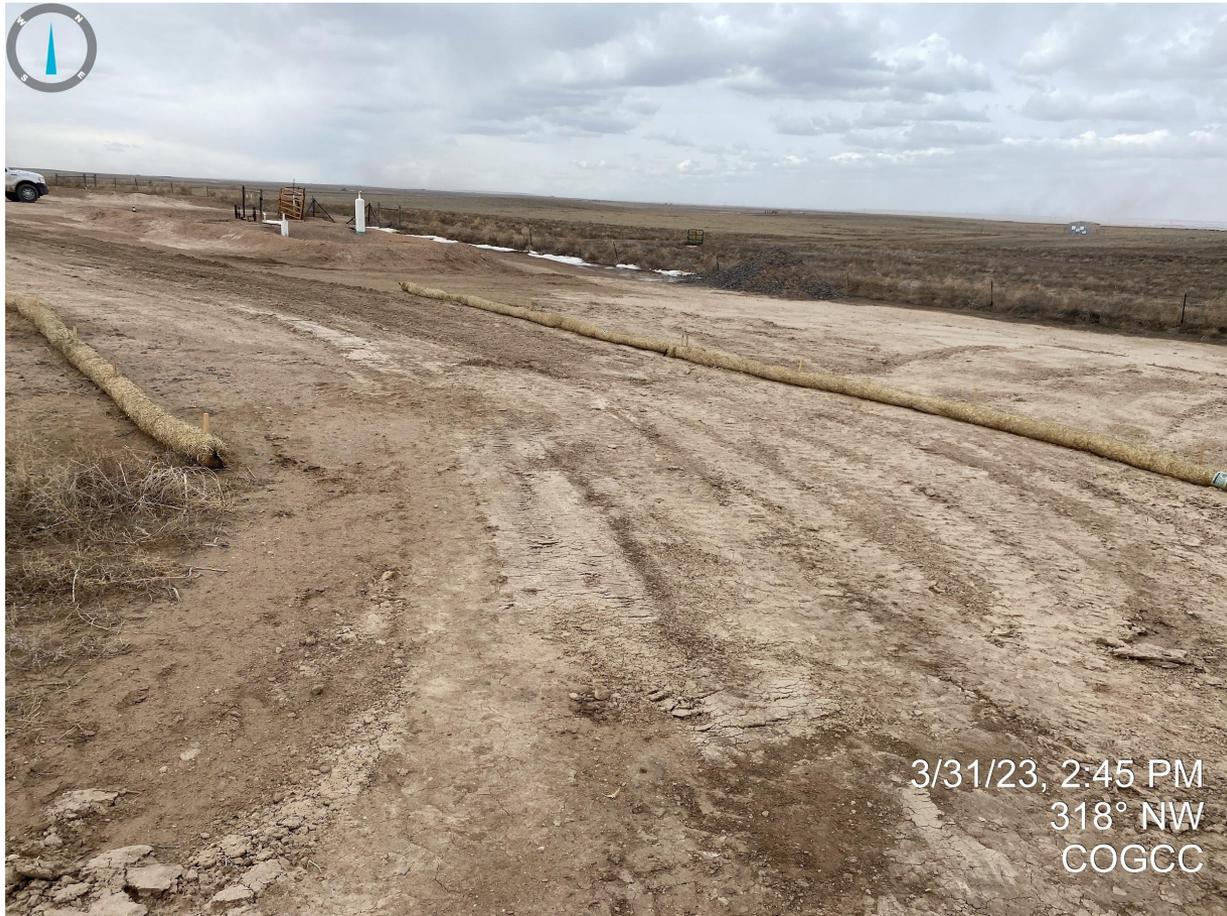
Photo 7. Overview of location with straw wattles; See comments in Photo 5.
