Chevron U.S.A. Inc. Associated Unit C 1 Location #314494

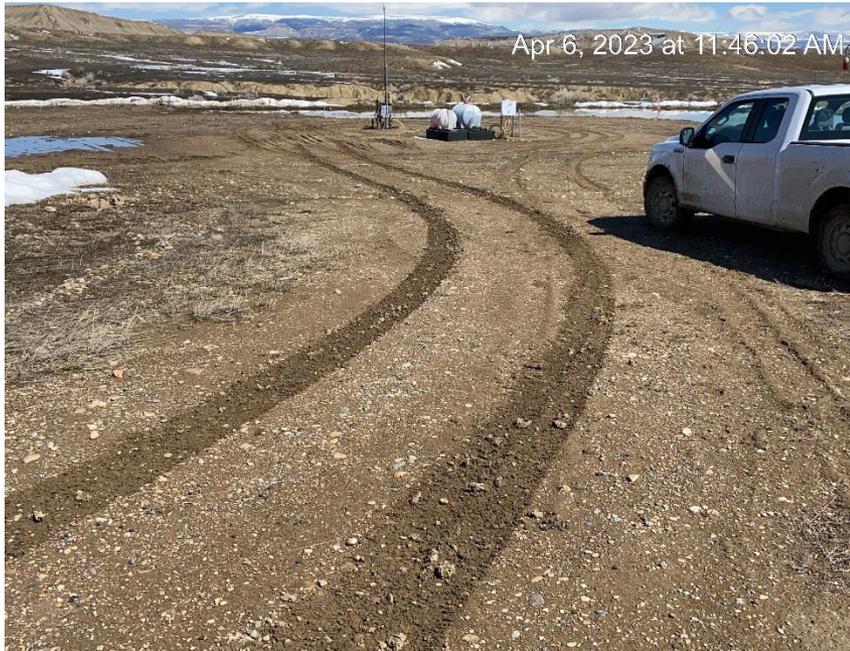
Entrance to location

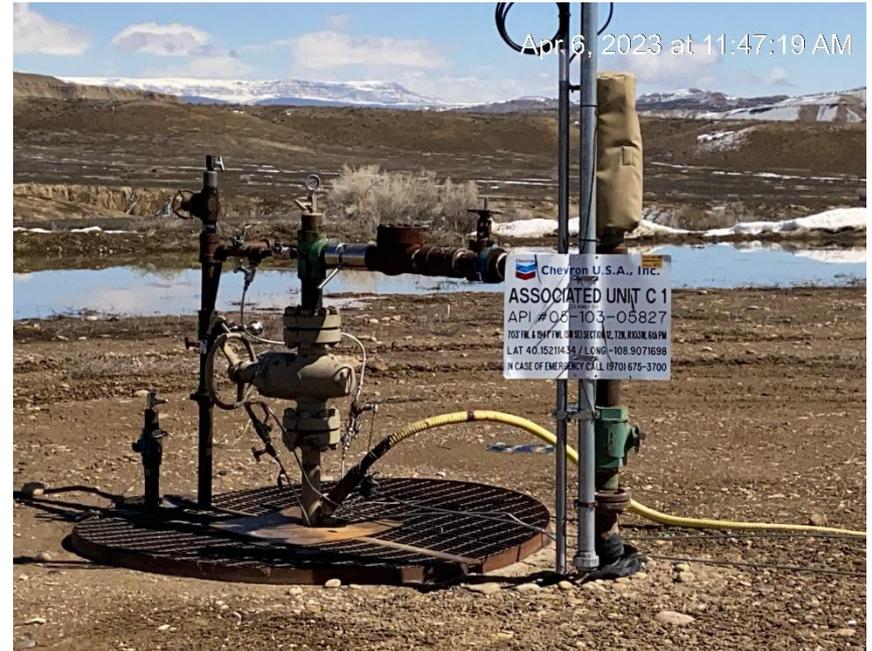
Wellhead view

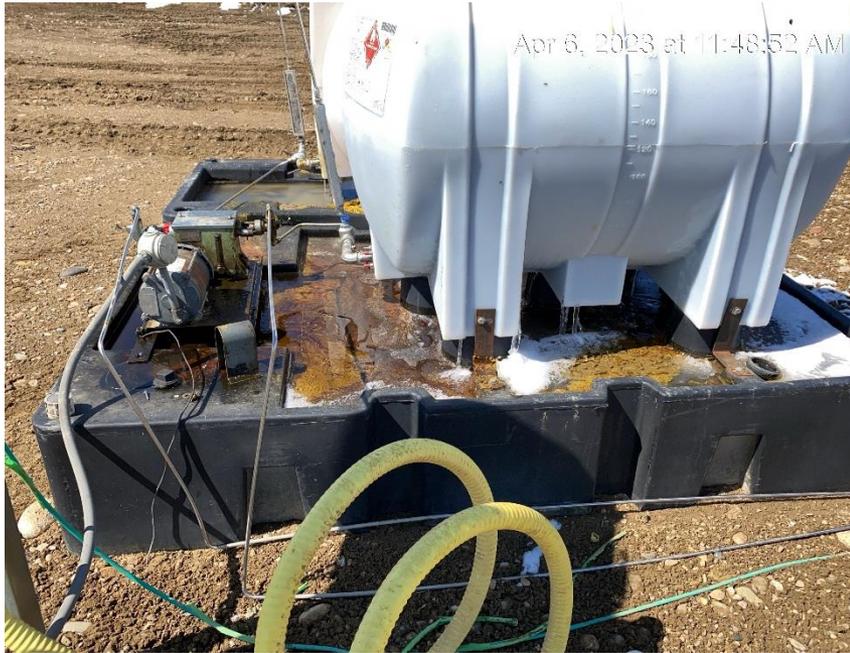
Chemical containment is full

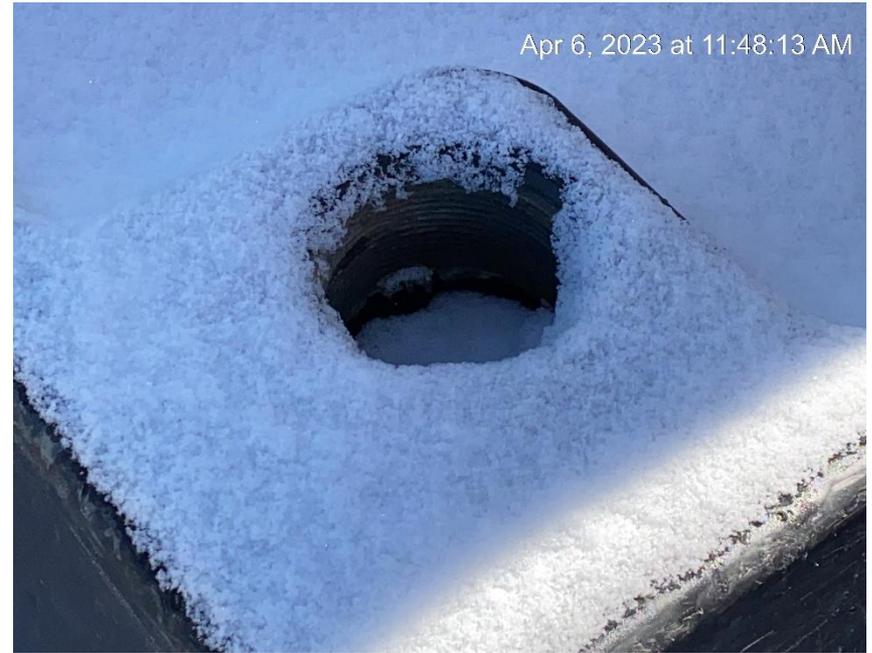
Full containment

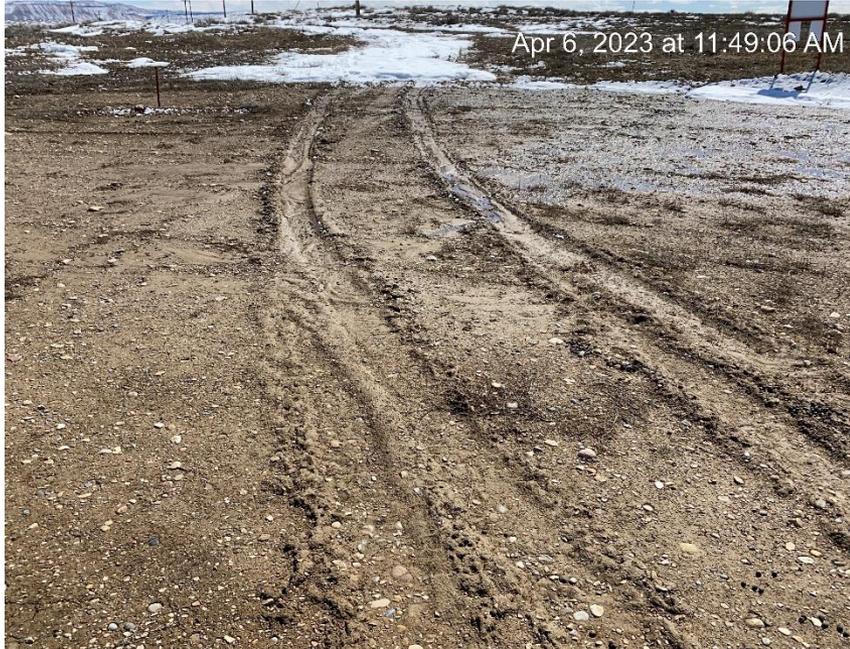
Traffic causing rutting and sediment migration

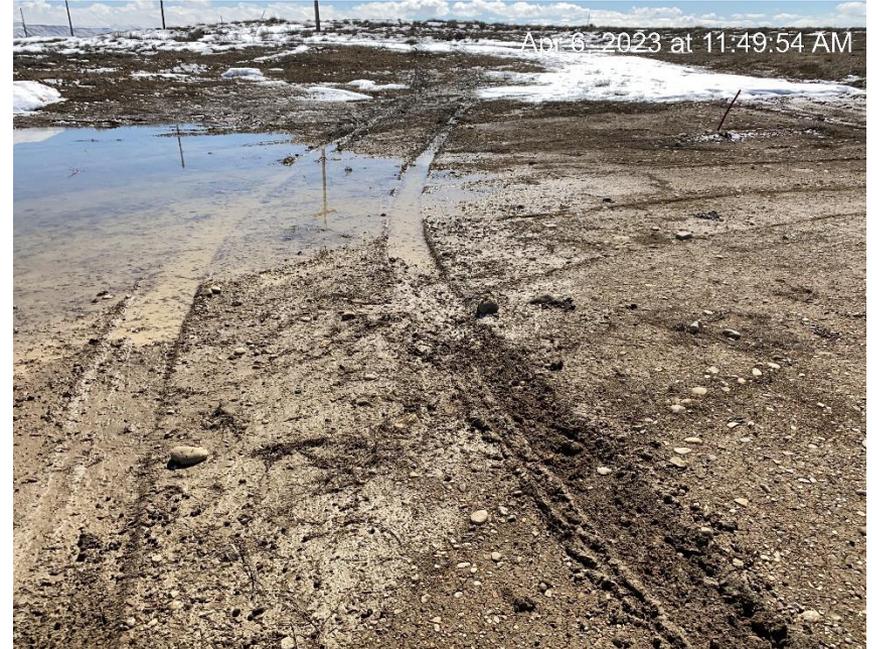
Lack of stabilization and vehicle tracking

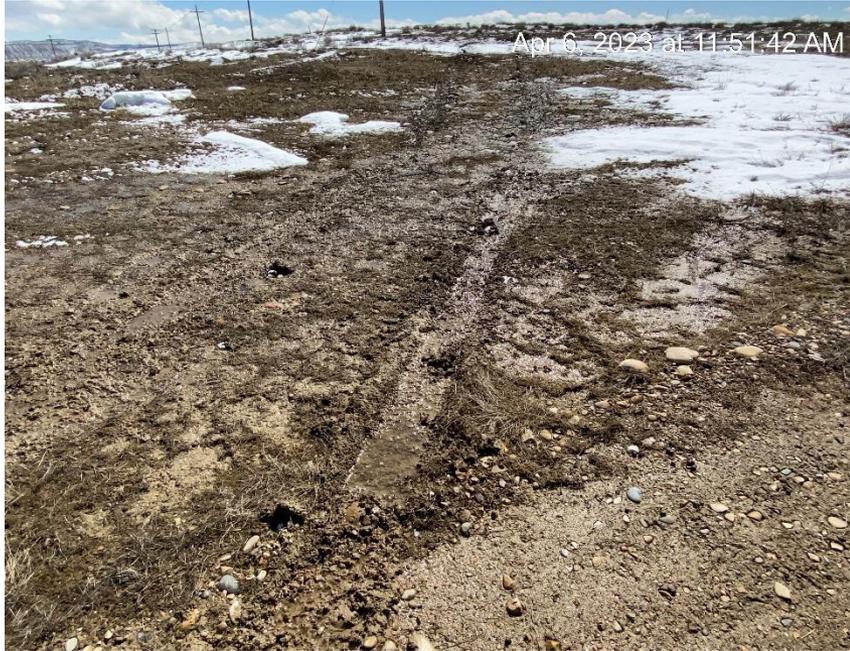
Traffic from lease road through vegetation area

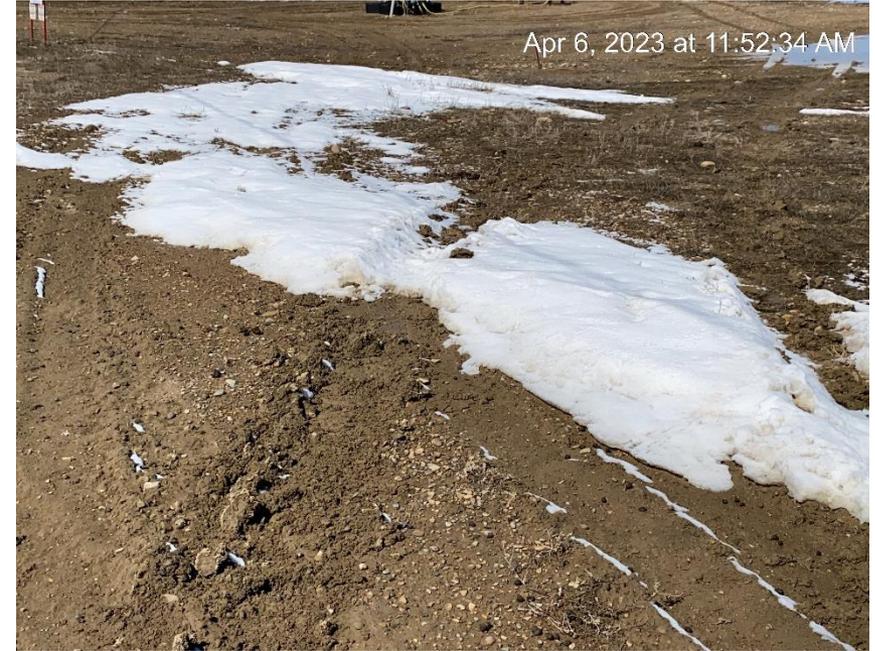
Traffic turning off lease road across vegetation area

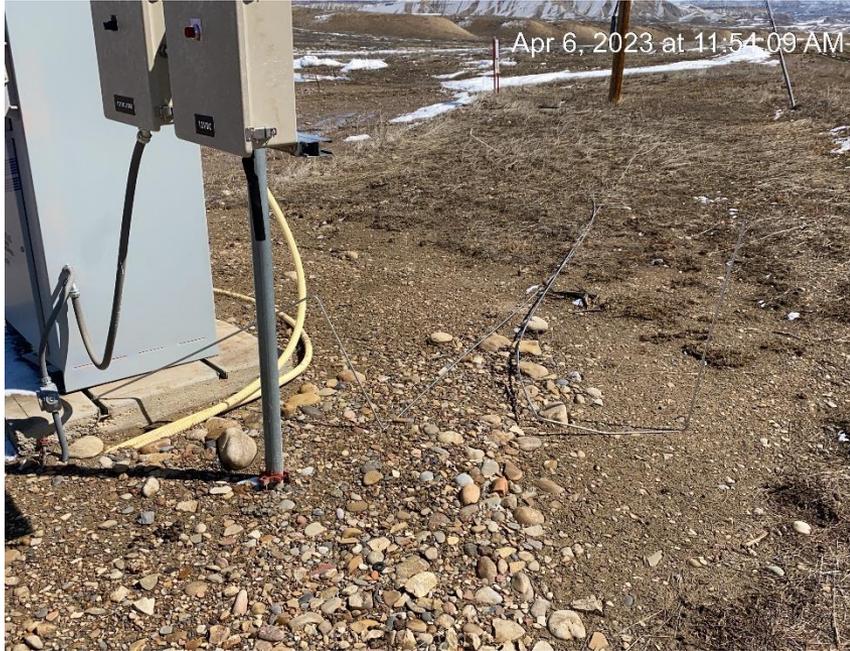
Steel tubing not in service

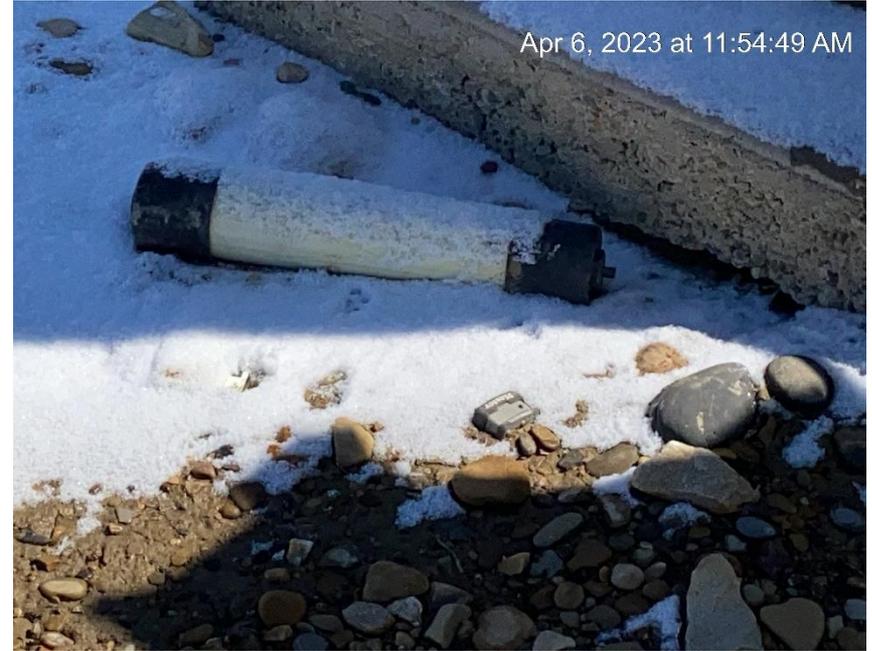
Debris in front of control panel
