**Chevron U.S.A. Inc.  
LN Hagood A-15X  
Location #315317**

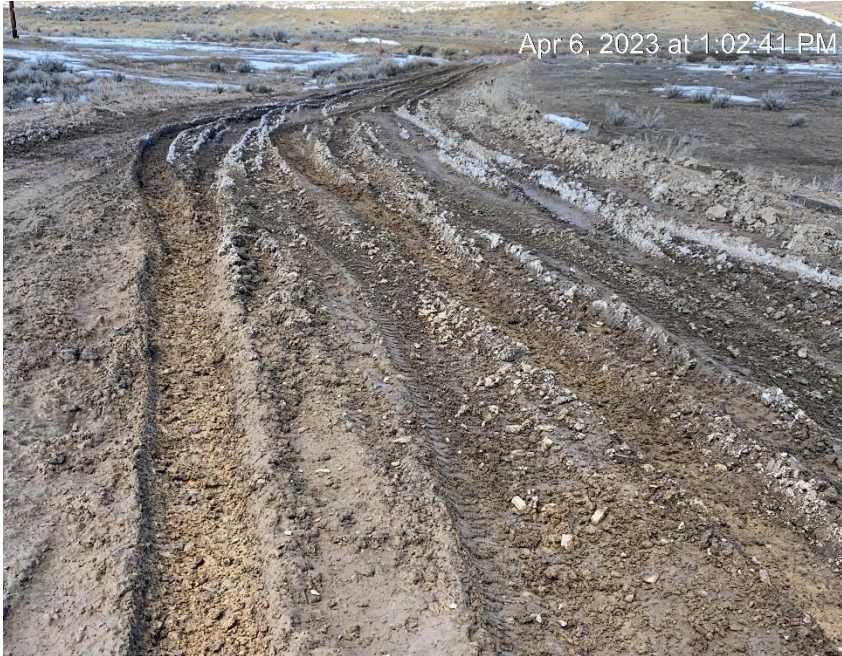
**West side access road**

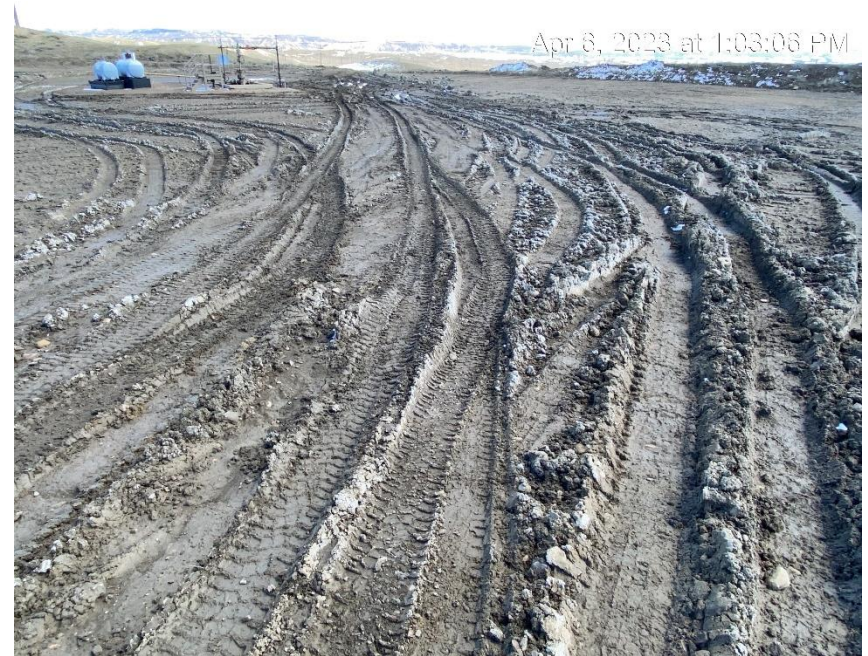
**East across location**

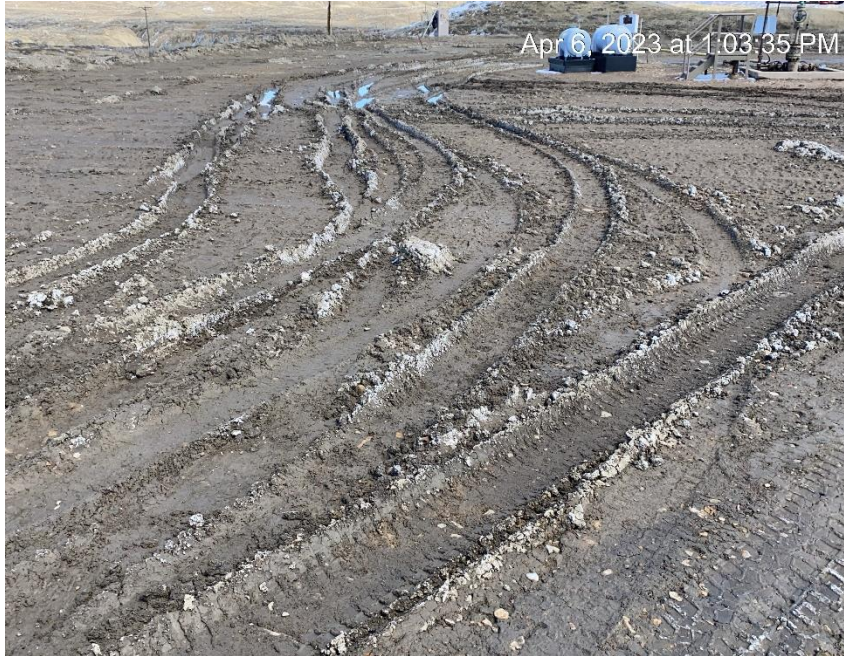
**Entrance to location**

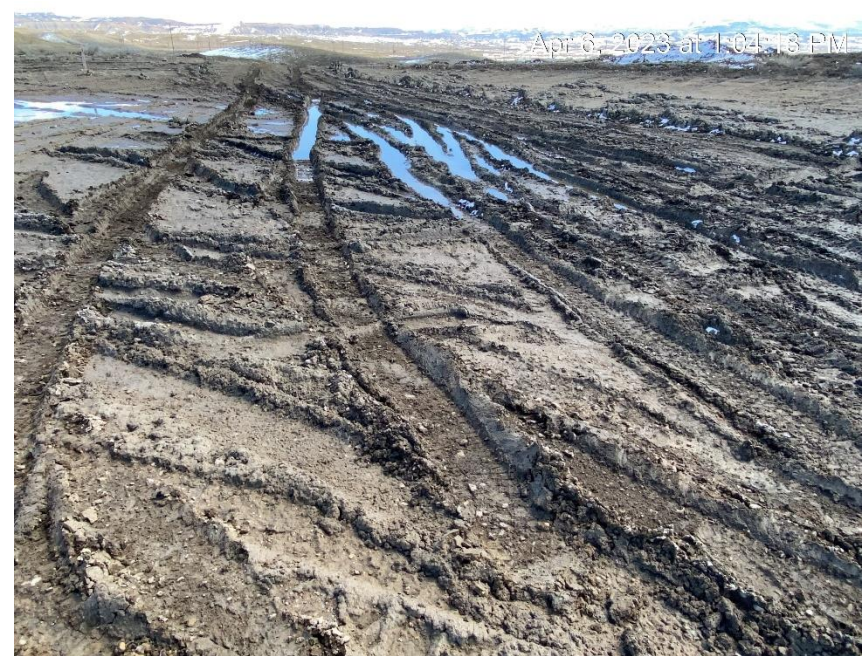
**Entrance to location**

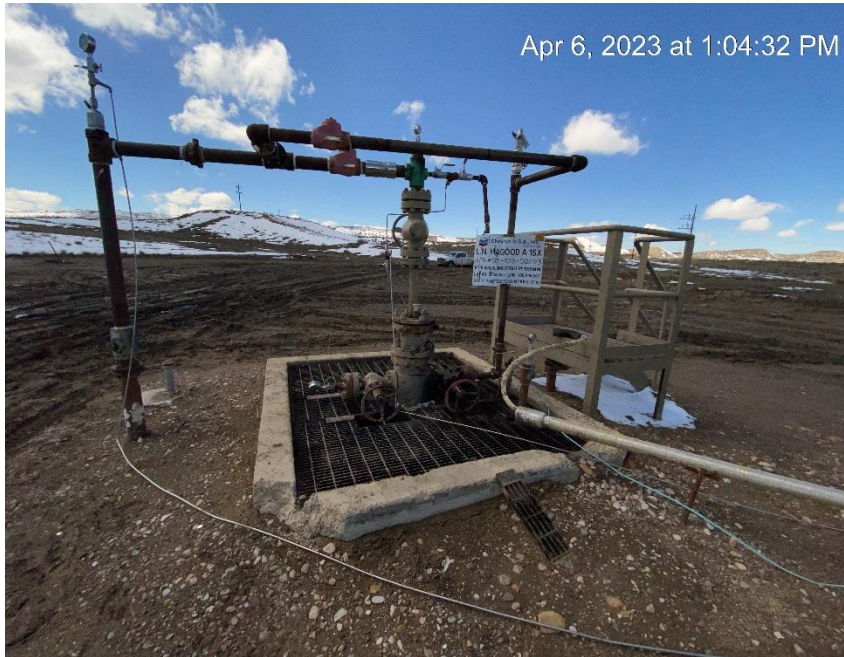
**Wellhead view**

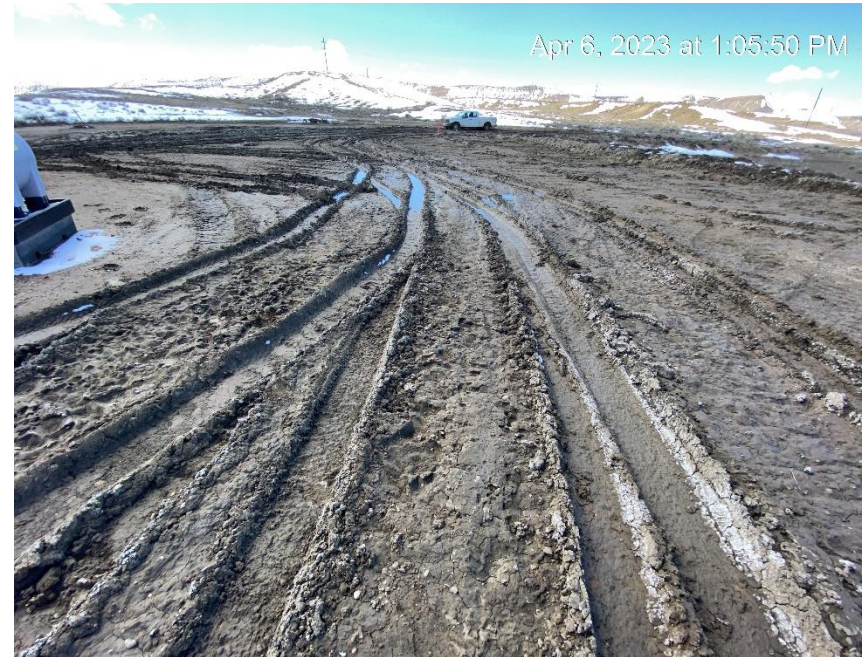
**Looking Southwest to West side entrance.**

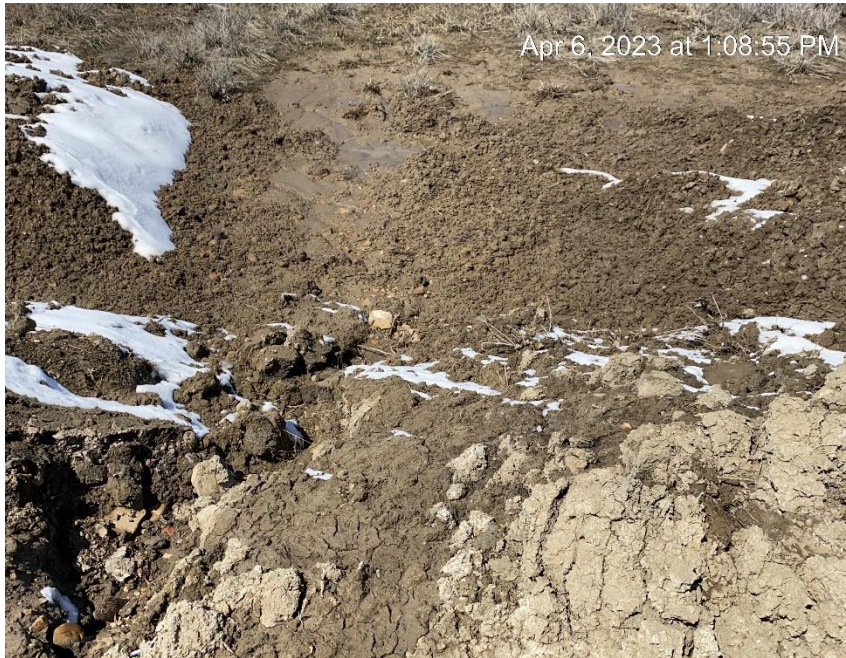
**Berm erosion and sediment migration**

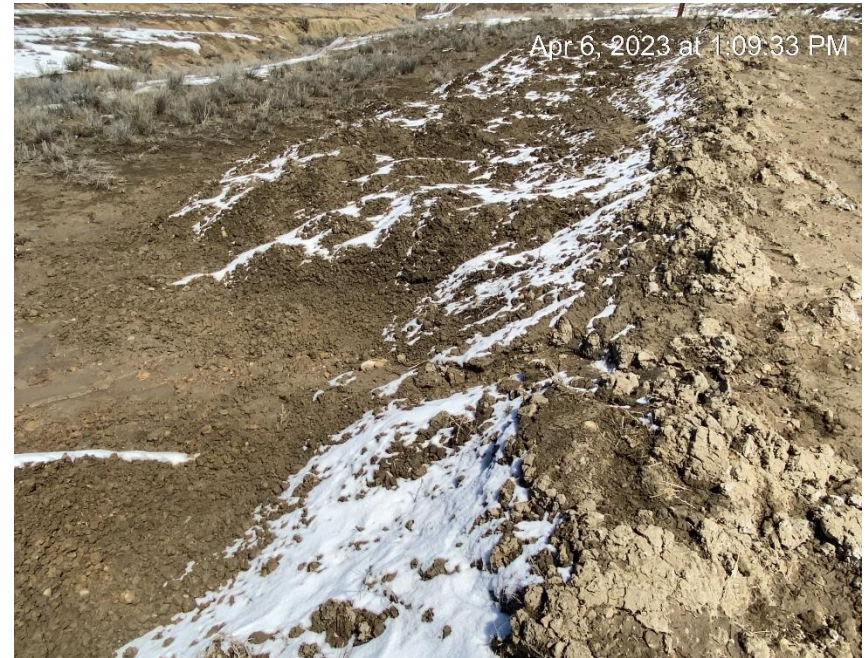
**Berm erosion with sediment migration**

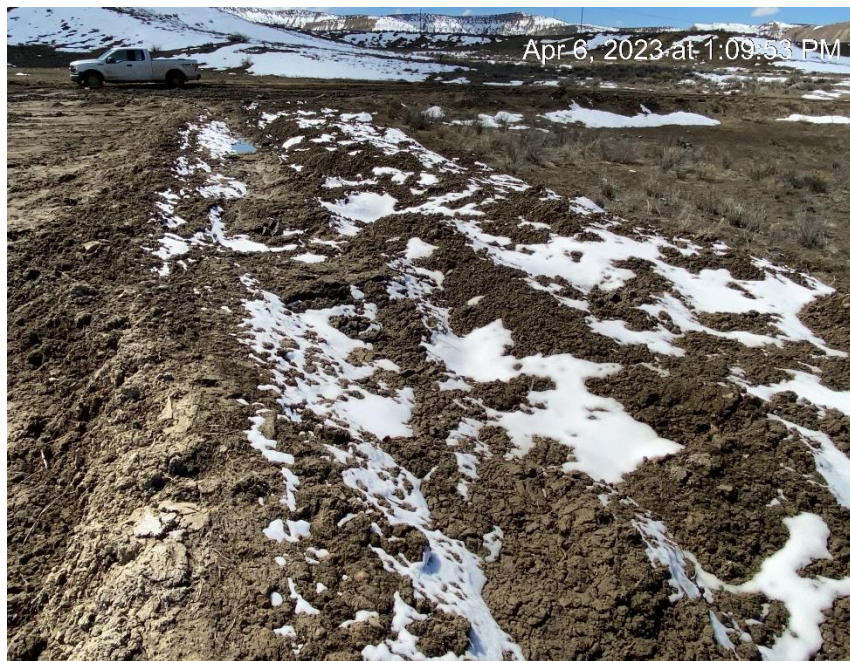
**Sediment piles pushed downhill of location**

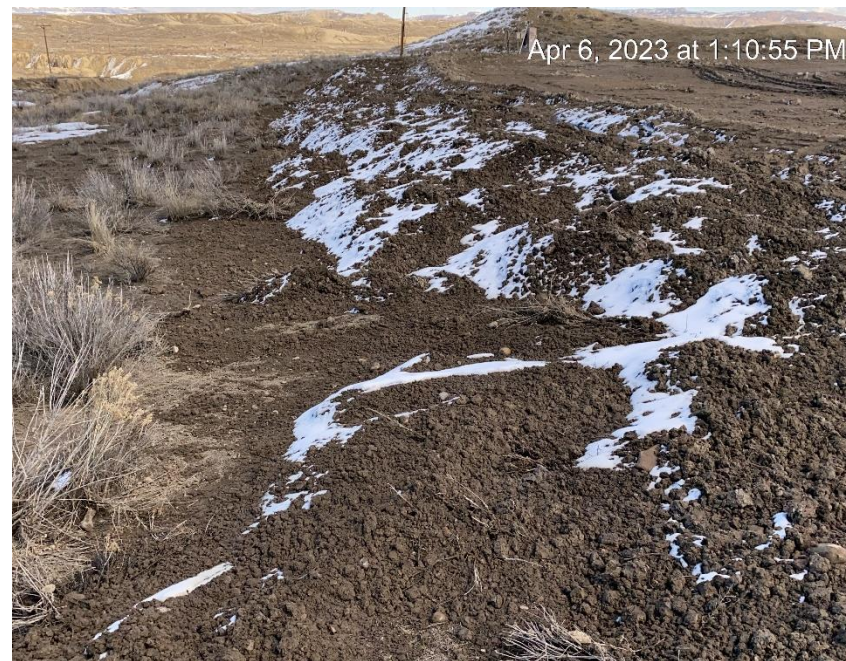
**Sediment pushed off location and downhill.**
