Inspection Photos

Location Name: CAERUS PICEANCE LLC CLEM JR.-67S95W /15NWNE

Location ID: 334653

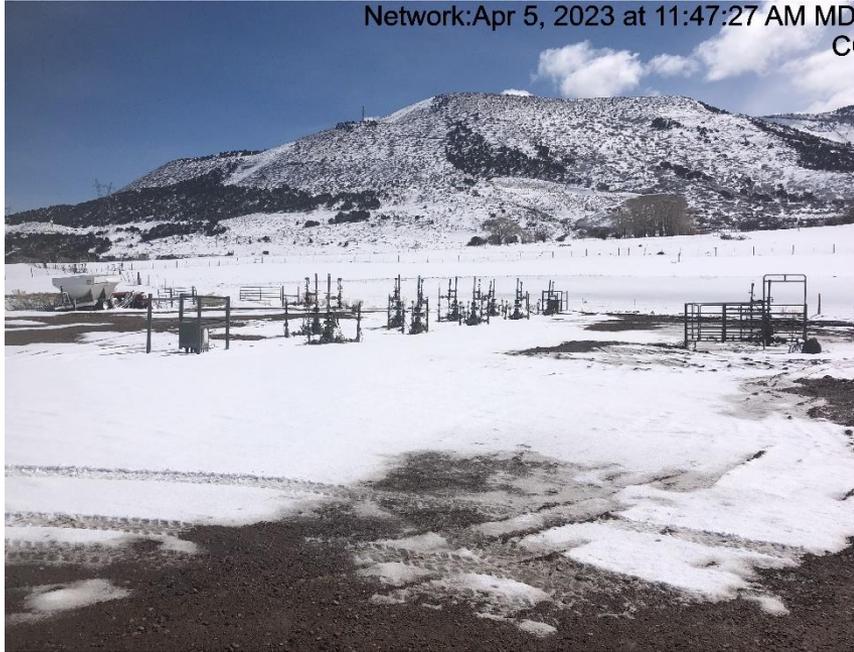
Photo #9538 From entrance to location.

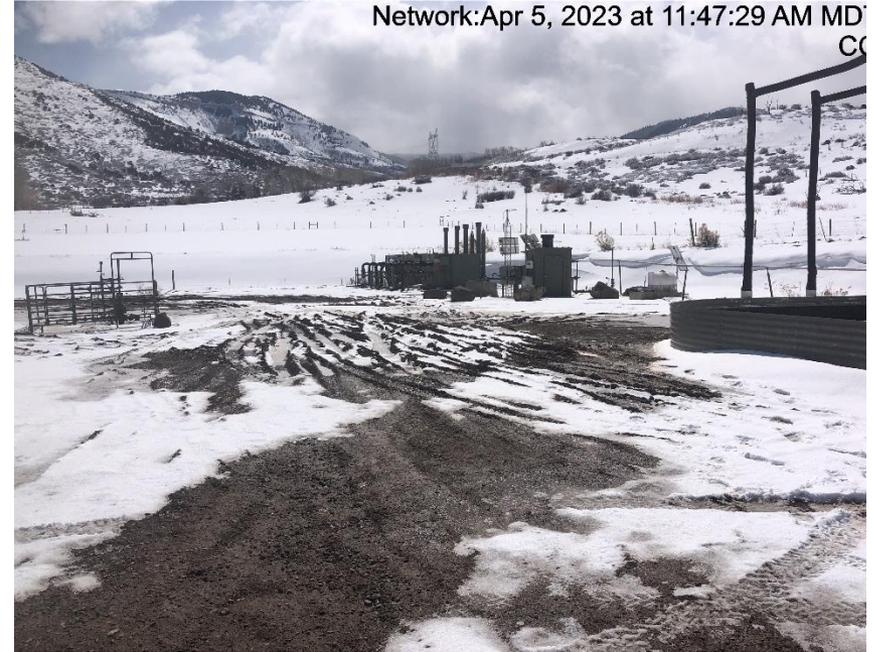
Photo #9539 From entrance to location

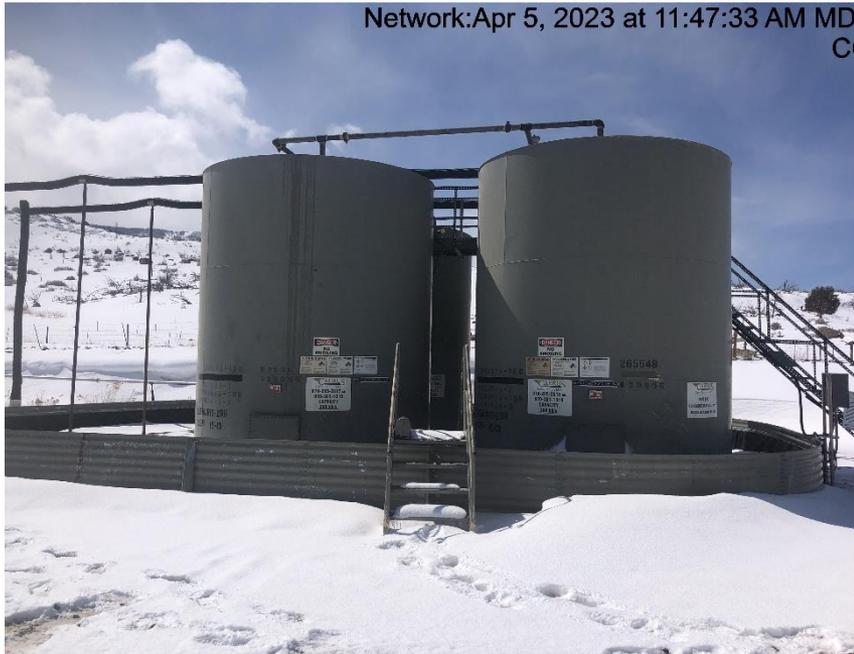
Photo #9540 From entrance to location.

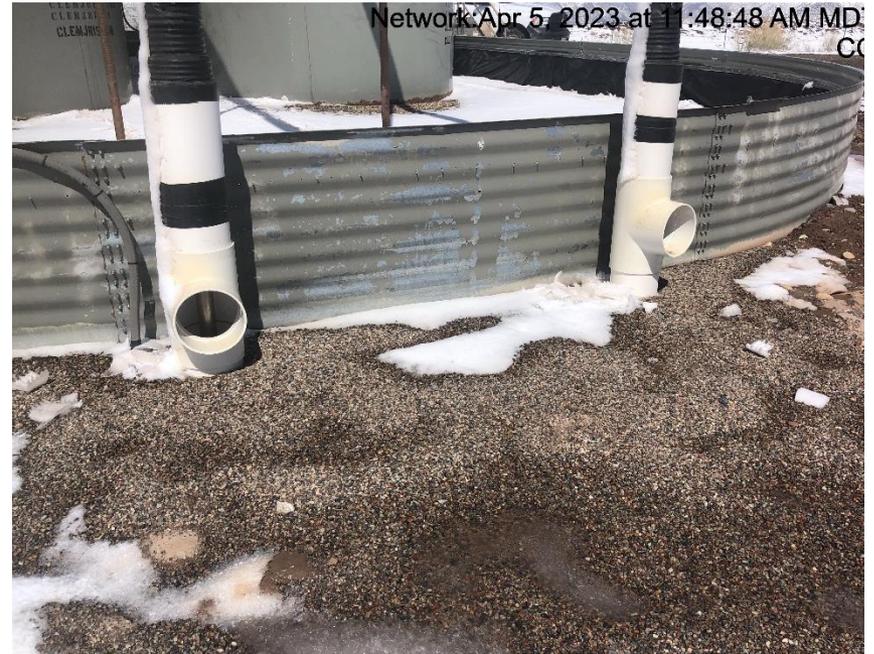
Photo #9541 Multiple places with flowline heating insulation open ended.
