Storm Water Management and Erosion control

Location Name: CAERUS PICEANCE LLC CLEM JR.-67S95W /15NWNE

Location #: 334653

Location Overview: Location is located in a high priority habitat area.

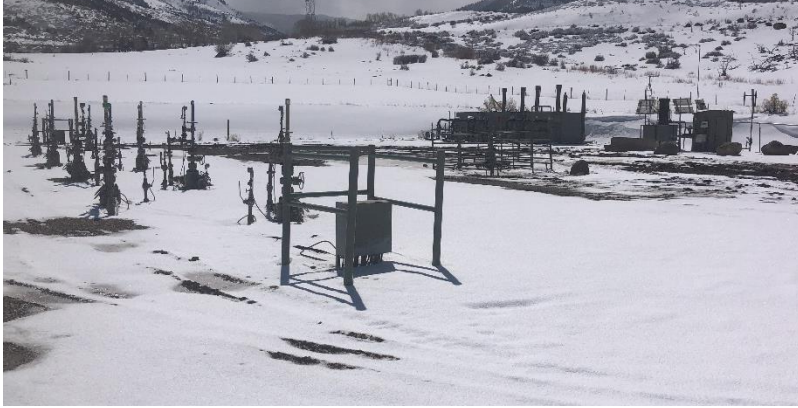
North West corner of location.

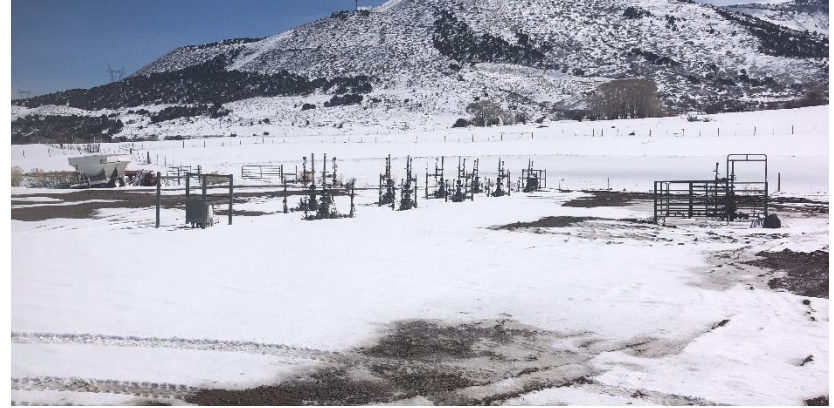
North East corner of location.

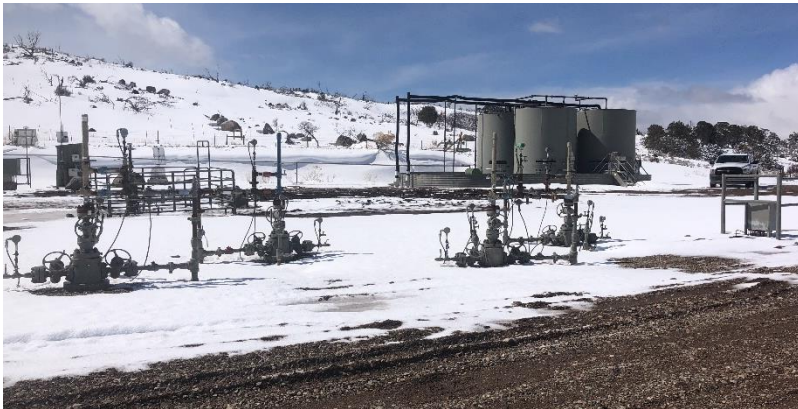
South West corner of location.

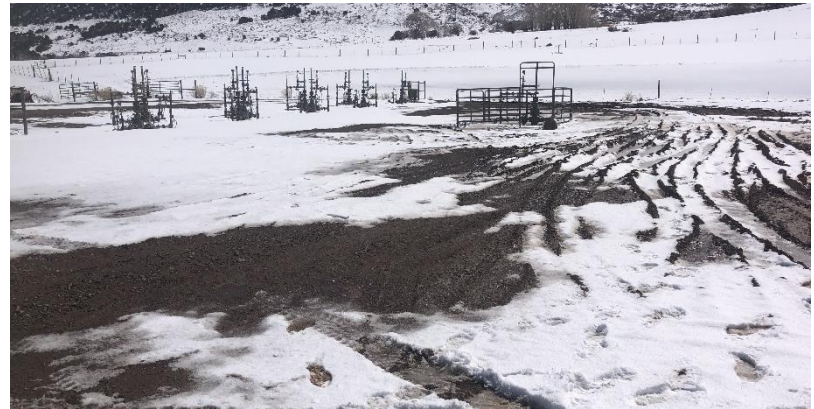
South East corner of location.

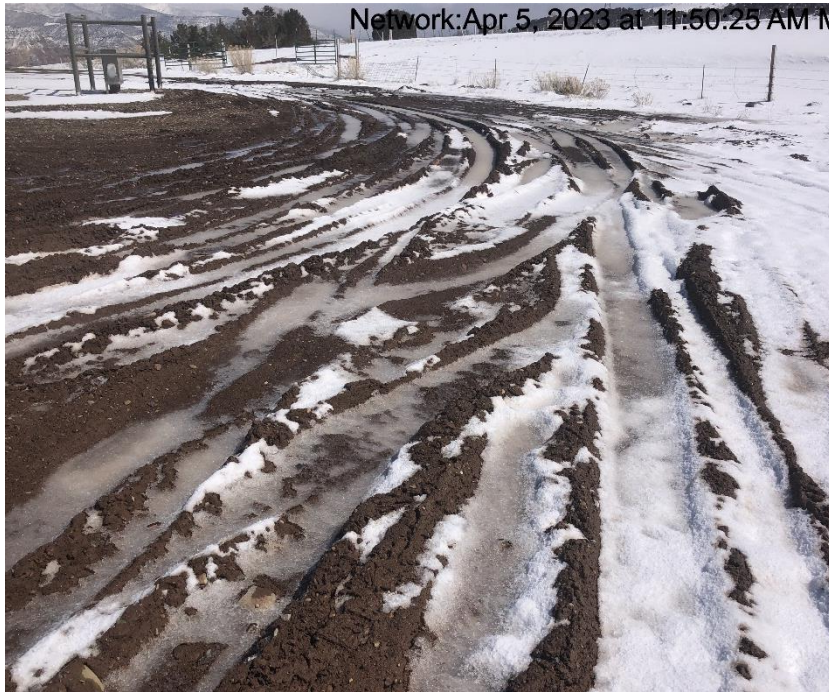
Photo #9543 Location lacks stabilization.

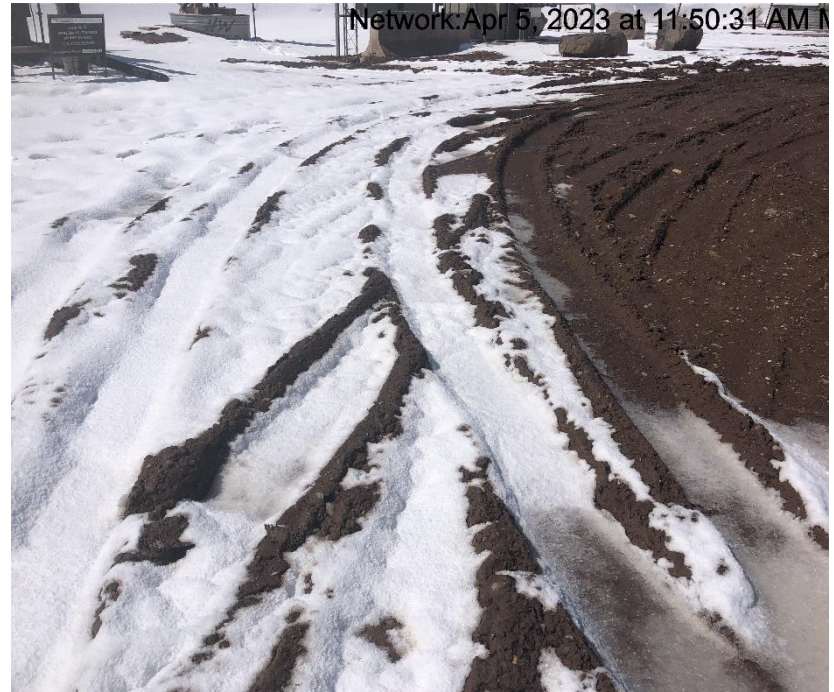
Photo #9544 Location lacks stabilization.

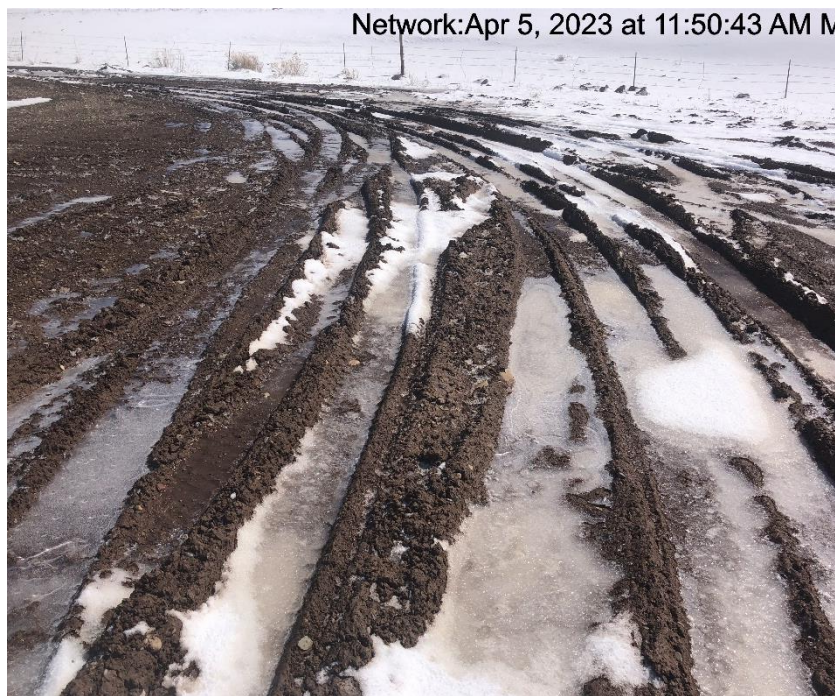
Photo #9545 Location lacks stabilization.

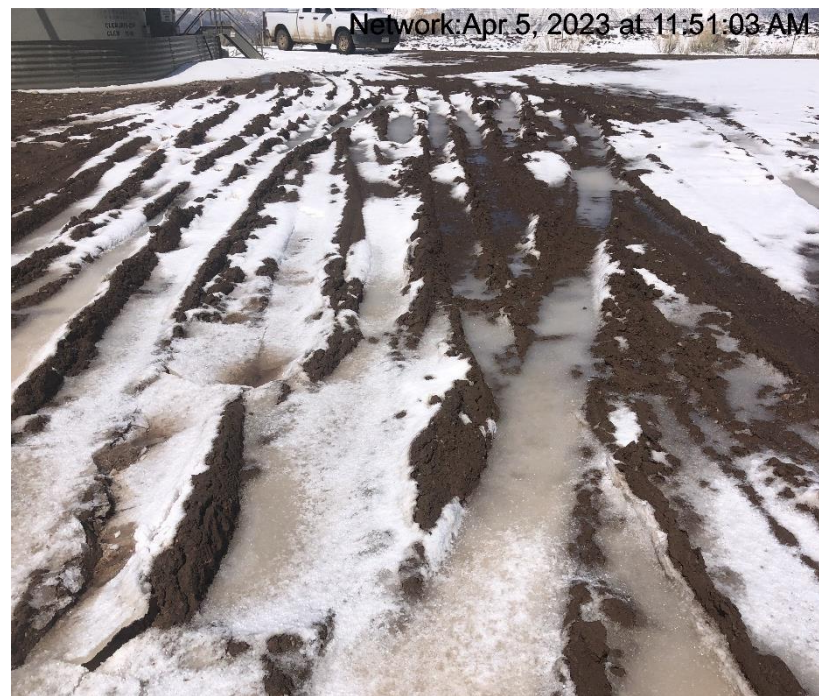
Photo #9547 Location lacks stabilization.

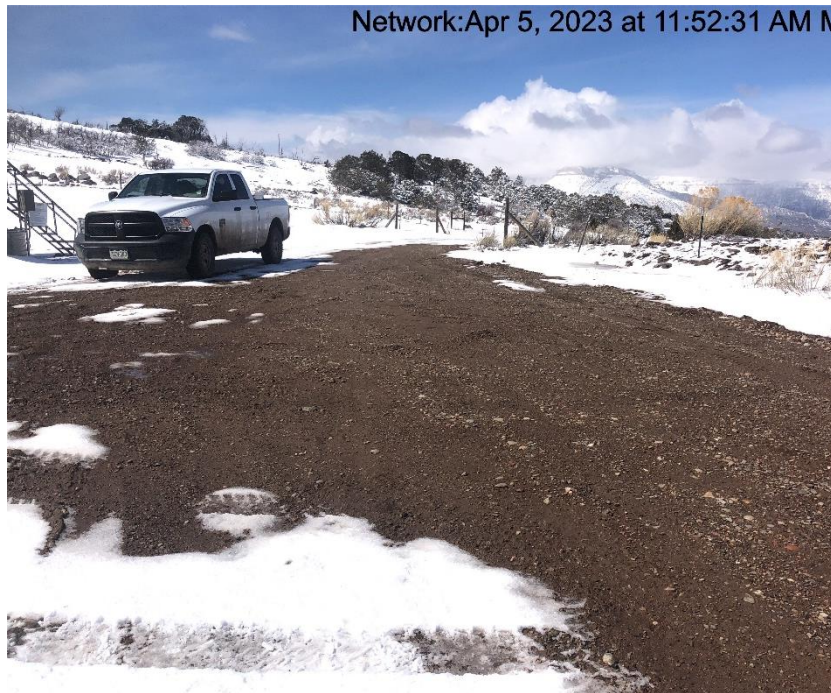
Photo #9551 insufficient tracking BMP at entrance to location

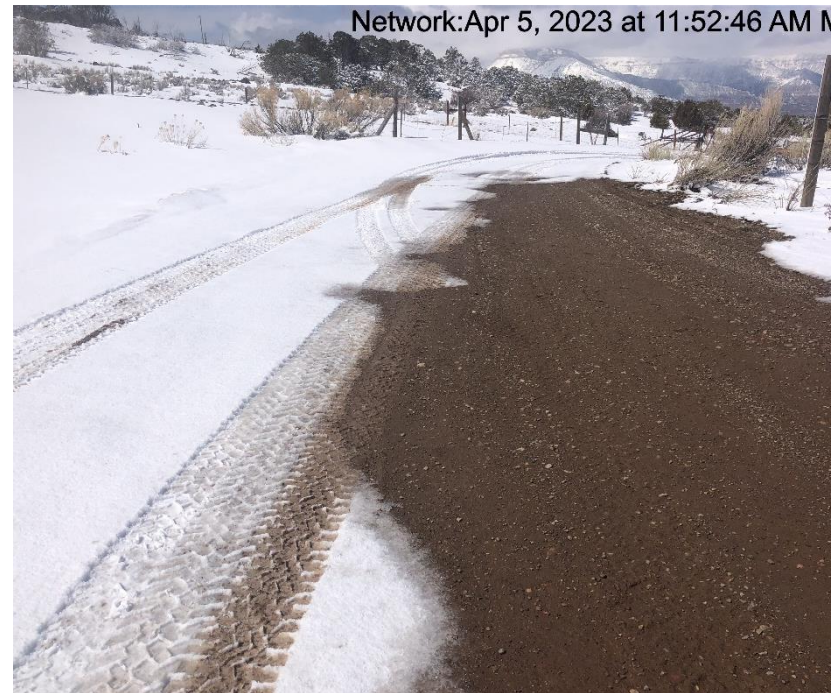
Photo #9552 insufficient tracking BMP at entrance to location
